# St. Mary's Church: **Conwy**

## Archaeological Watching Brief

GAT Project No. 2157

Report No. 950

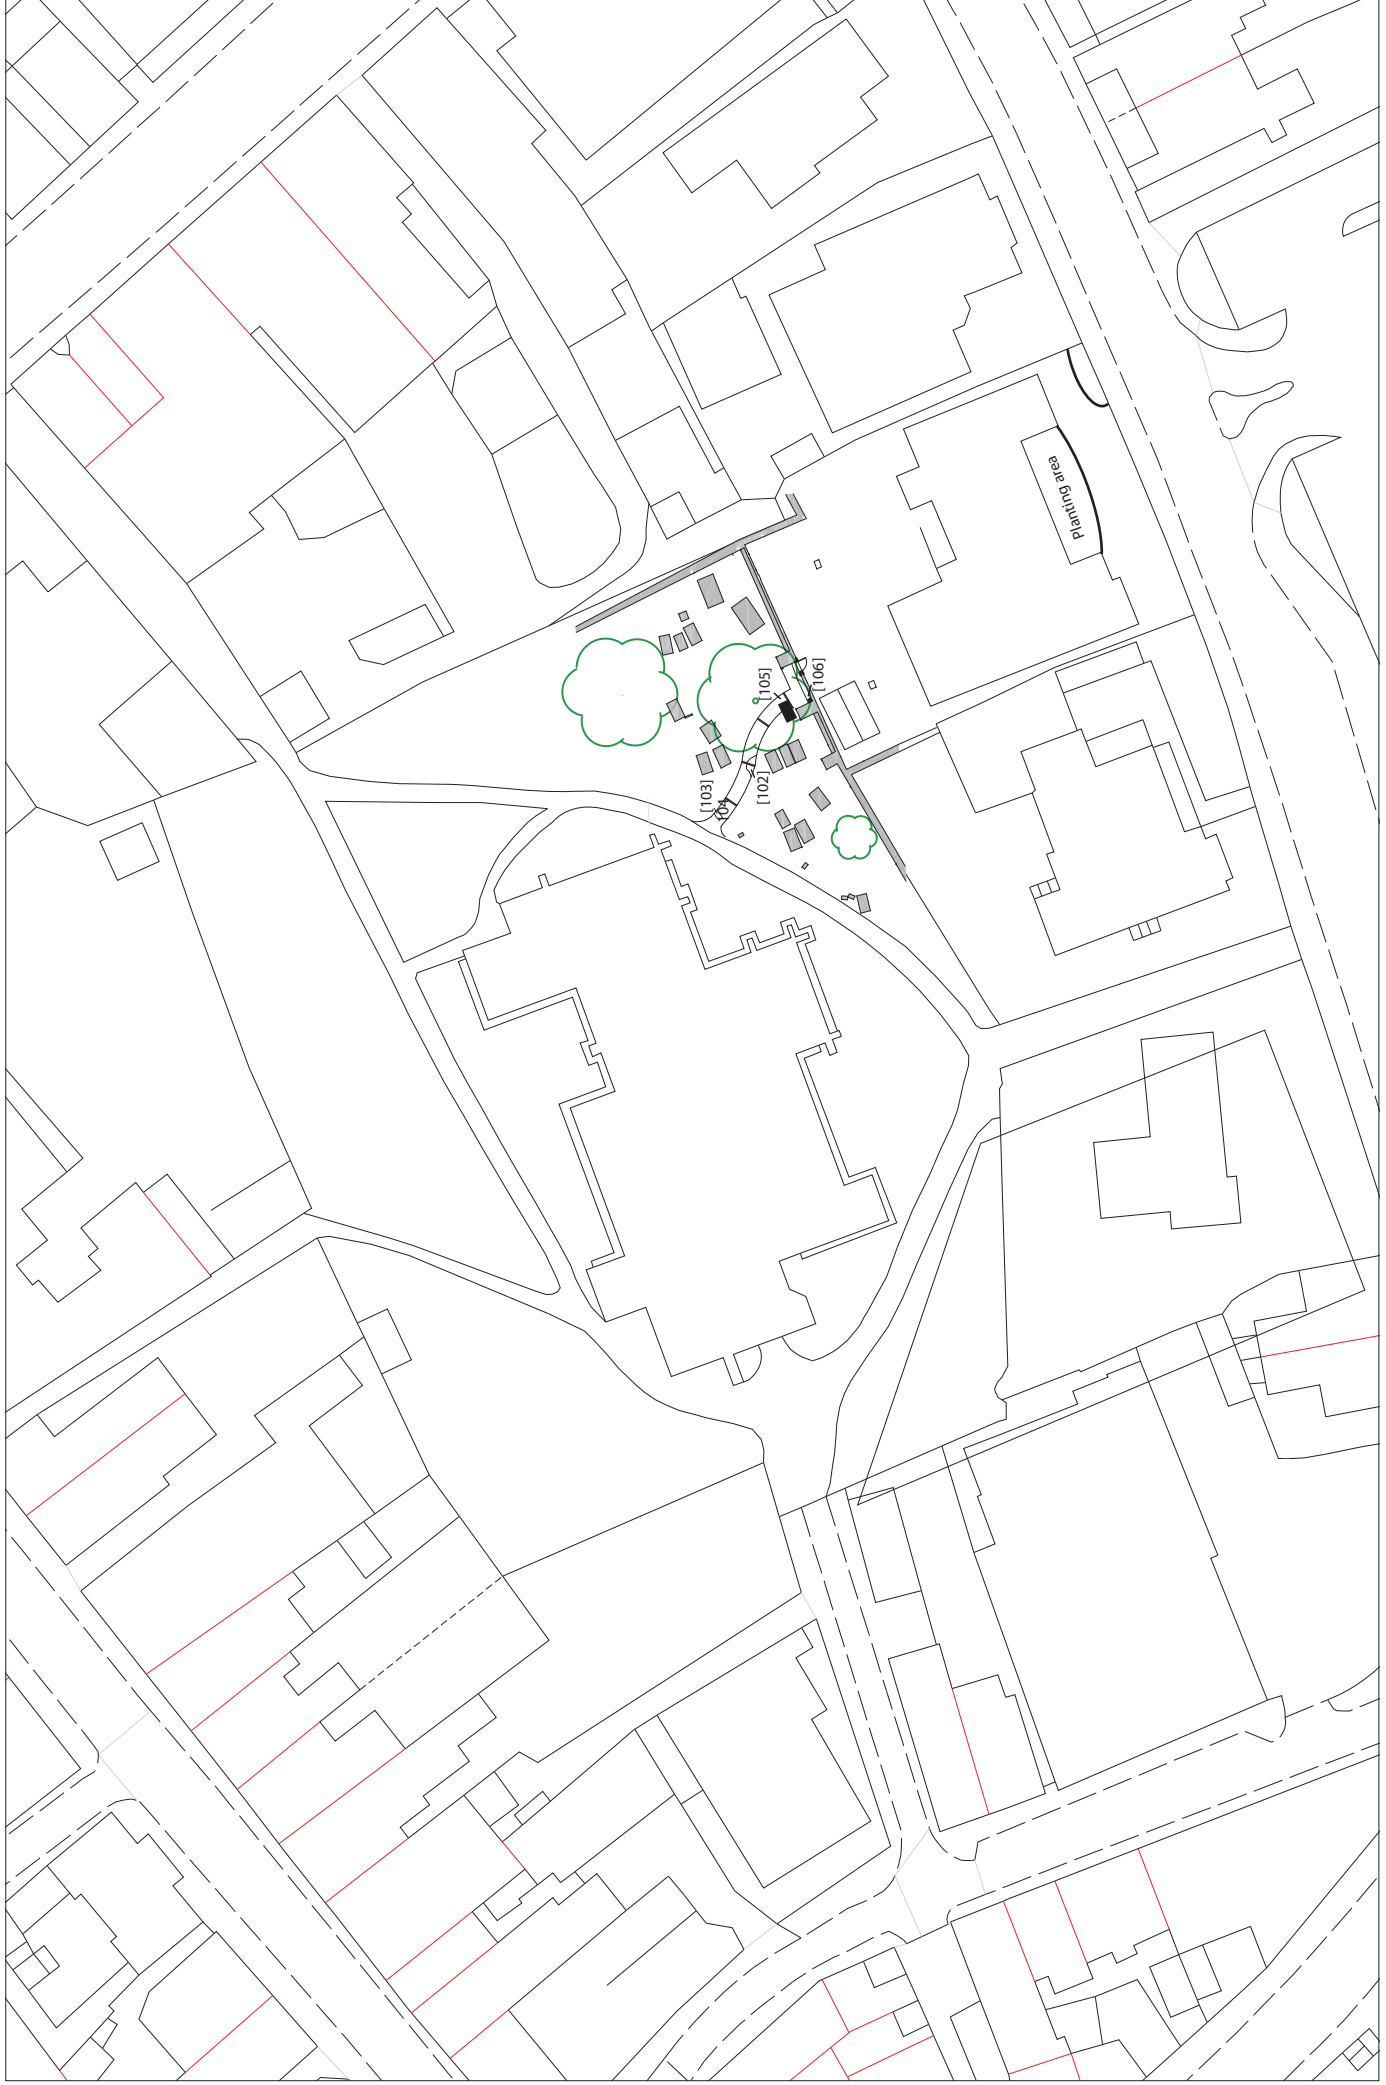
Fig. 2 Location of features identified in the text. Features identified in the text are shown in brackets. Background information taken from *Tarmaster Jones*  
Drawing no AL/2047/5/08/PL01

A possible grave cut [103] was noted 1.95m north of the tarmacadam path (Fig.2). It was 0.8m wide and 0.9m of the western end of its length was visible in the trench. The fill consisted of a light greyish brown sandy silt with small to medium rounded and sub angular stone inclusions (104). The grave was cut into a mid orangey brown clay silt subsoil (102) at a depth of 0.19m below the modern ground surface, and was not investigated further. Further south the excavation did not extend beyond the depth of the topsoil, so no further grave cuts were encountered.

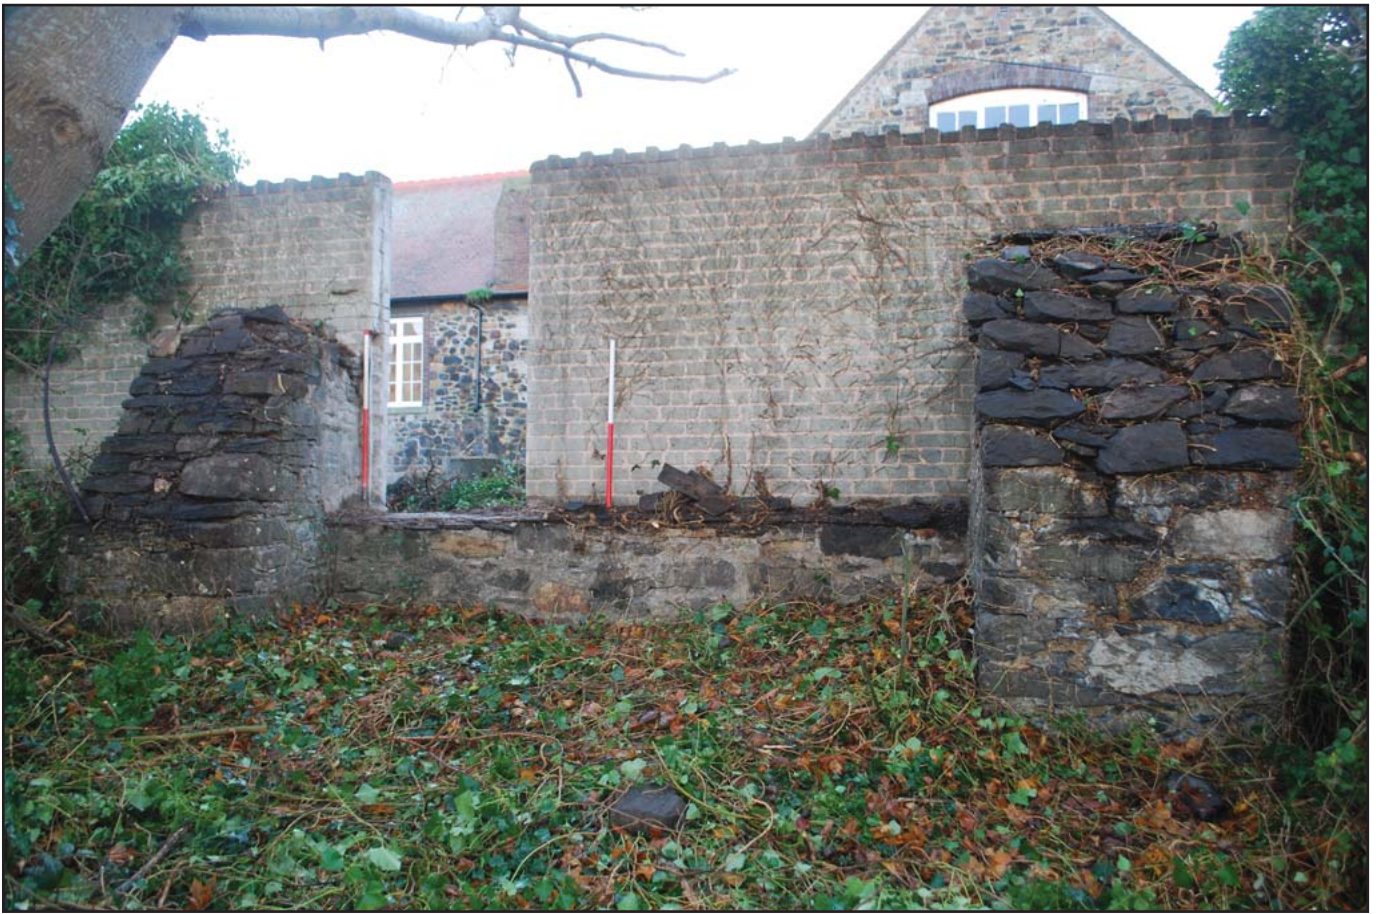
A breach 1.06m wide was made in this wall between the eastern and middle buttresses down to the level of the old wall on the graveyard side (Plate 3; Fig.2). The brick part of the wall was 0.25m thick and 0.45m wide.

**Plate 3: Breach in churchyard walls - Scales 1m**

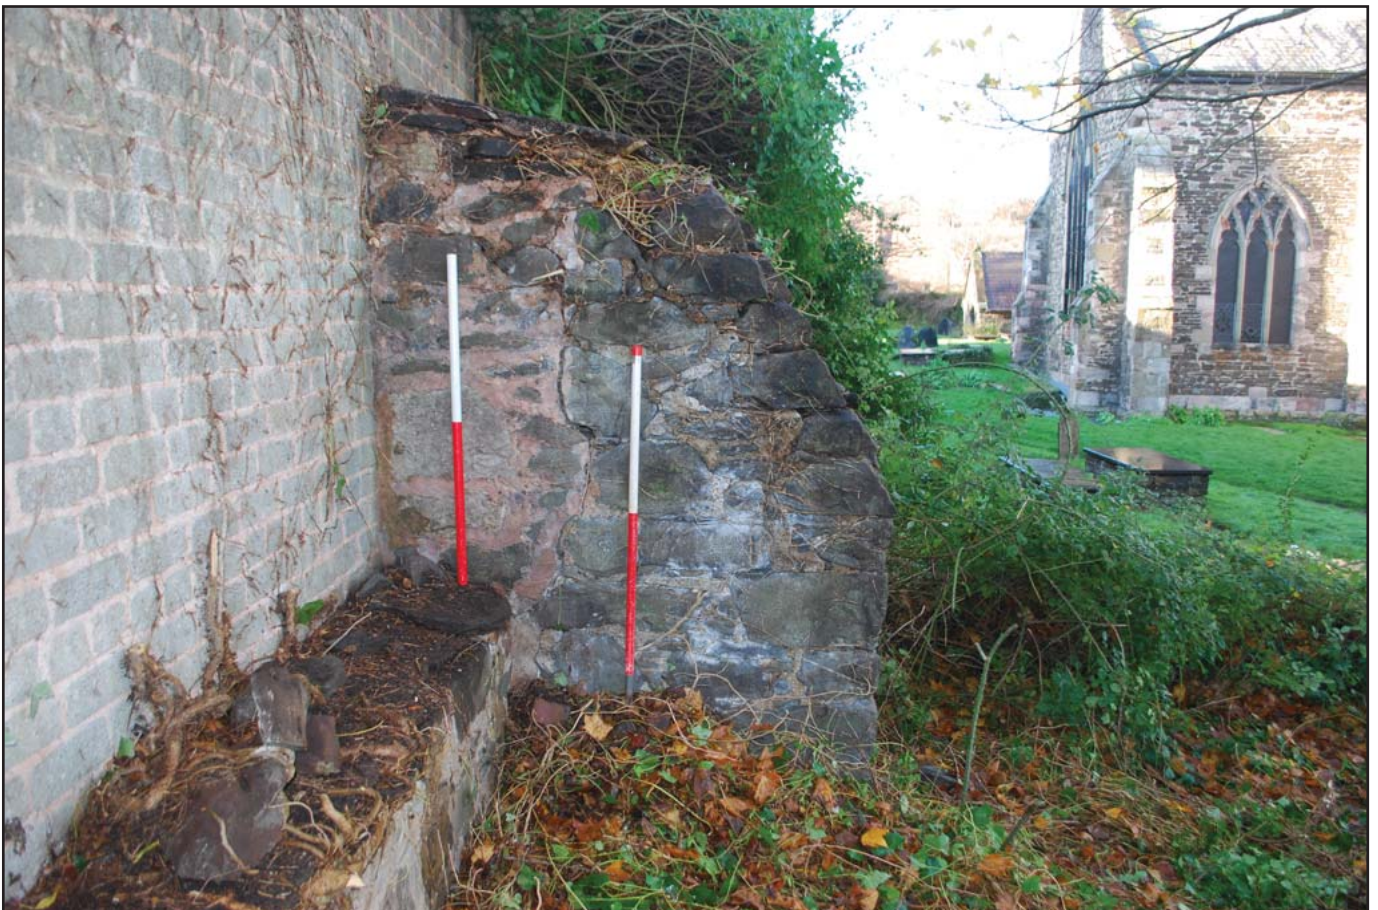
The churchyard boundary wall between the church hall and the churchyard of St. Mary's consisted on the churchyard side of 0.5m of rounded and angular shale blocks. These were topped by grey concrete bricks, making a total height for the wall of 2.9m on the graveyard side and 2.2m on the hall side, and the wall was supported by quarried granite buttresses, up to 1.2m high. The suggested interpretation of these is that there was a probable instability or collapse of an earlier churchyard wall, surviving now as

the bottom 0.5m on the churchyard side. This would initially have required the construction of the supporting buttresses and later the rebuilding of the wall at a height of greater than 0.5m (Plate 4). This suggests that the problem was a chronic one, and was probably the result of pressure from the church hall side of the wall, which was 0.6m higher than on the churchyard side. It would not have been possible to replace the lower courses of the wall as they formed a revetment for the hall yard.

**Plate 4: Buttress detail - View from South East - Scales 1m**

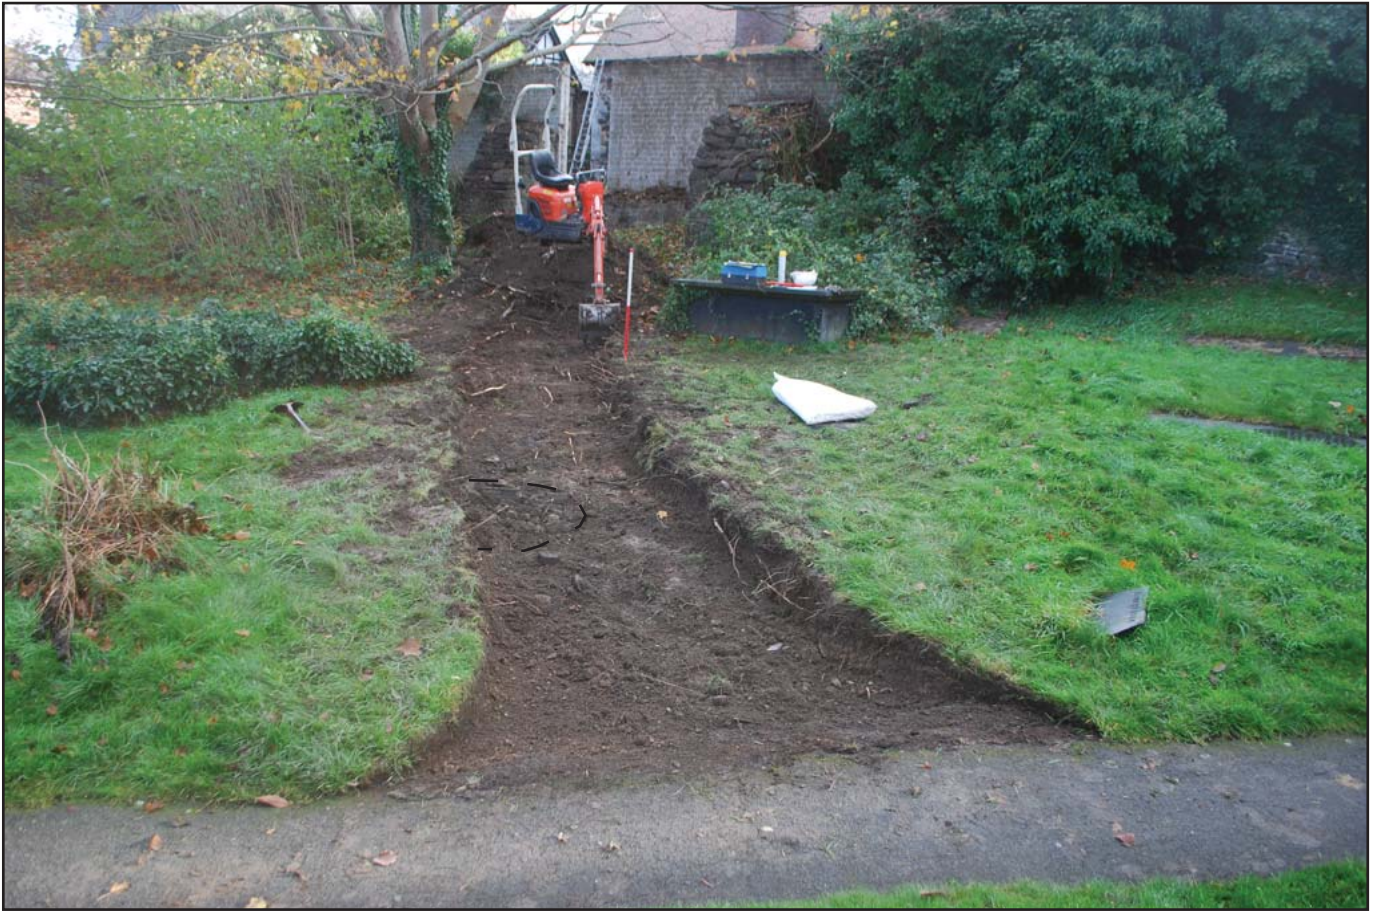
The new path from the churchyard to the church hall leads from the tarmac footpath at the east end of the church south-eastwards to the churchyard wall (Plate 5; Fig.2). It was dug through the graveyard topsoil to a depth of 110mm-200mm. The soil consisted of a dark greyish brown sandy silt, with occasional charnel fragments and small shale fragments (101), and overlay a mottled mid orangey brown clay silt, which was only noted close to the path edge.

Plate 5: Top soil stripping for path - view from North East. Grave cut annotated with a black outline

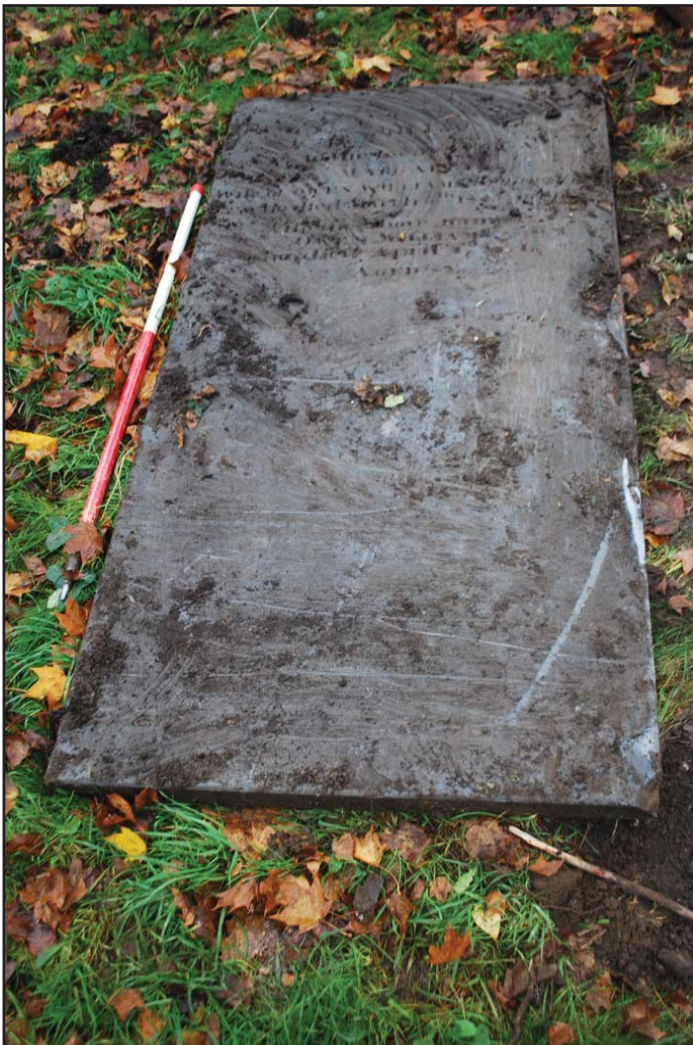
A number of gravestone and other fragments of material, including a side panel of a former box tomb (Mytum 2003) were uncovered within the topsoil along the route of the path. All the gravestones had been moved from their original positions, and were located within the topsoil deposits. A slate ledger grave slab 1.8m by 0.9m and 0.06m thick [105] was uncovered, clearly moved from its original location, possibly as part of the buttress construction (Plate 6). The inscription, on the upper part of the stone read:

Plate 6: Grave stone [105] - Scale 1m

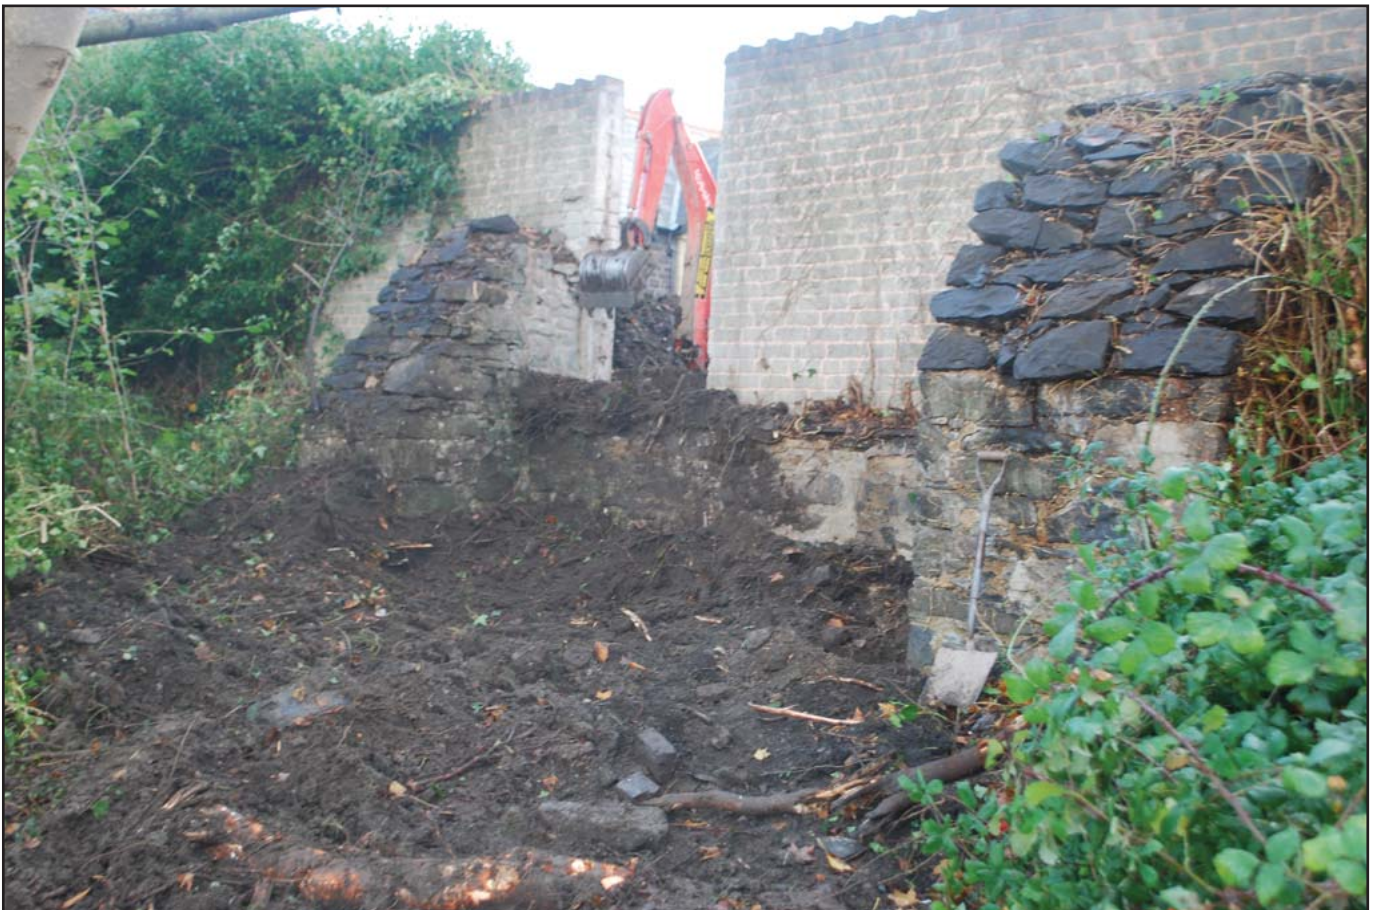
A loose fragment of former window tracery was uncovered within the rubble and topsoil material adjacent to the churchyard wall. It consisted of a single mullion fragment of red sandstone with an ogee profile, 0.3m by 0.28m. It was almost certainly removed from the church during 19<sup>th</sup> century restorations which are known to have been carried out on the building (Plate 1). The material was recovered from within the rubble against the churchyard wall, strongly suggesting the area of the churchyard was formerly used for clearance (Plate 8).

Plate 8: General view of wall area during excavation of soil build up

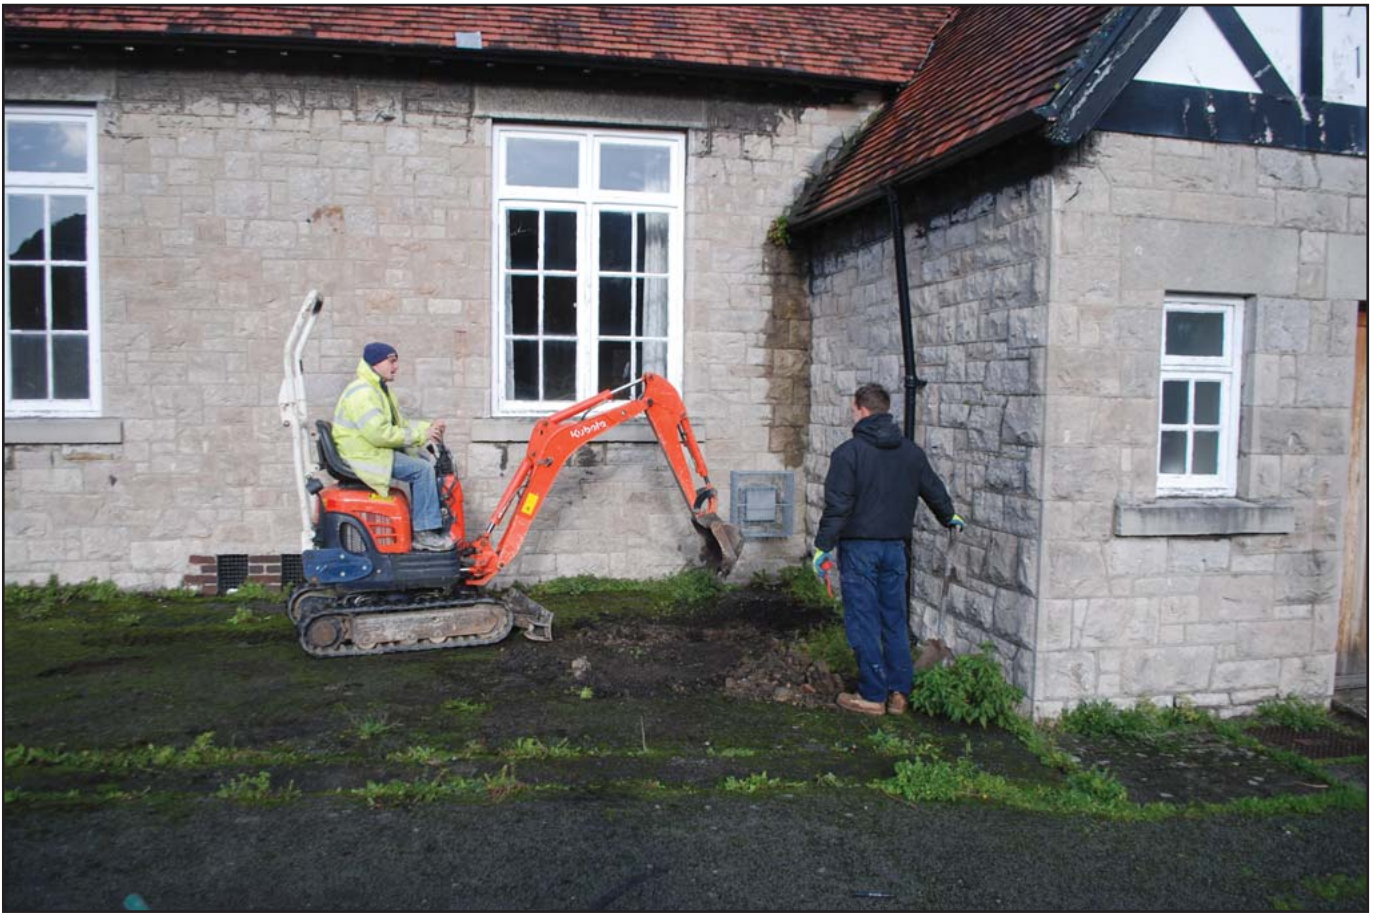
Excavations were carried out on the church hall forecourt to a depth of 0.3m on the south side of the hall (Plate 9; Fig. 2). The deposits consisted of 0.1m of tarmacadam overlying make-up layers of mid yellowish brown silty clay (002), within which was a service trench containing a drainage pipe. All deposits noted formed part of make up layers or service trenches cut through them, and there was no prospect of recovering any archaeological evidence. The concrete yard surface to the rear of the hall was undisturbed.

**Plate 9: Church hall during initial ground works - View from Rose Hill Street to the South**

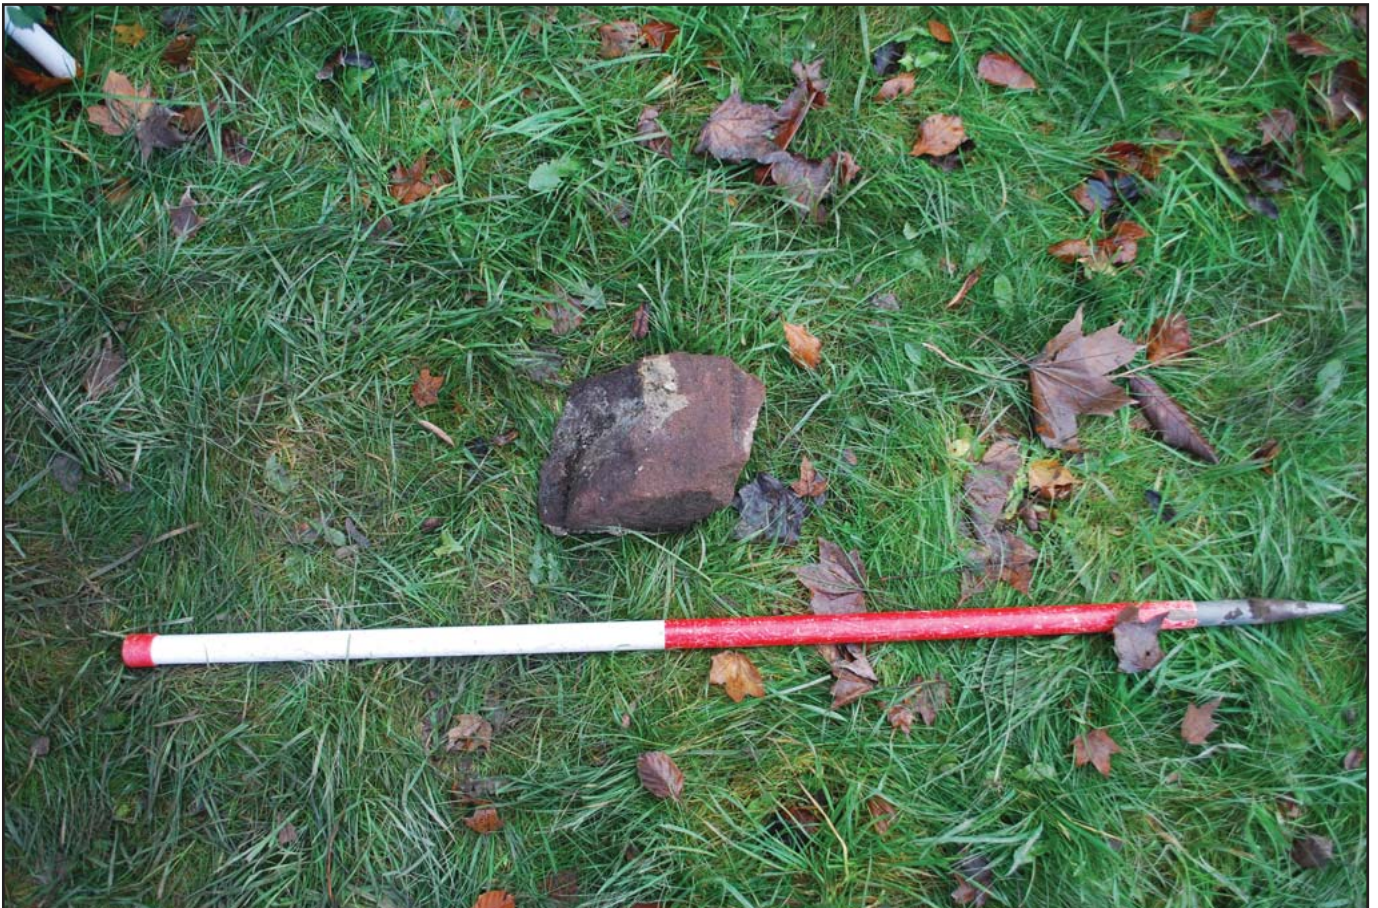
**Plate 10: Fragment of medieval window tracery - Scale 1m**
