North West Wales Dendrochronology Project:  
**Gronant, Holyhead**

Report No. 854

March, 2010

**Gronant, Llanfachraeth, Anglesey. NGR SH 32708517**

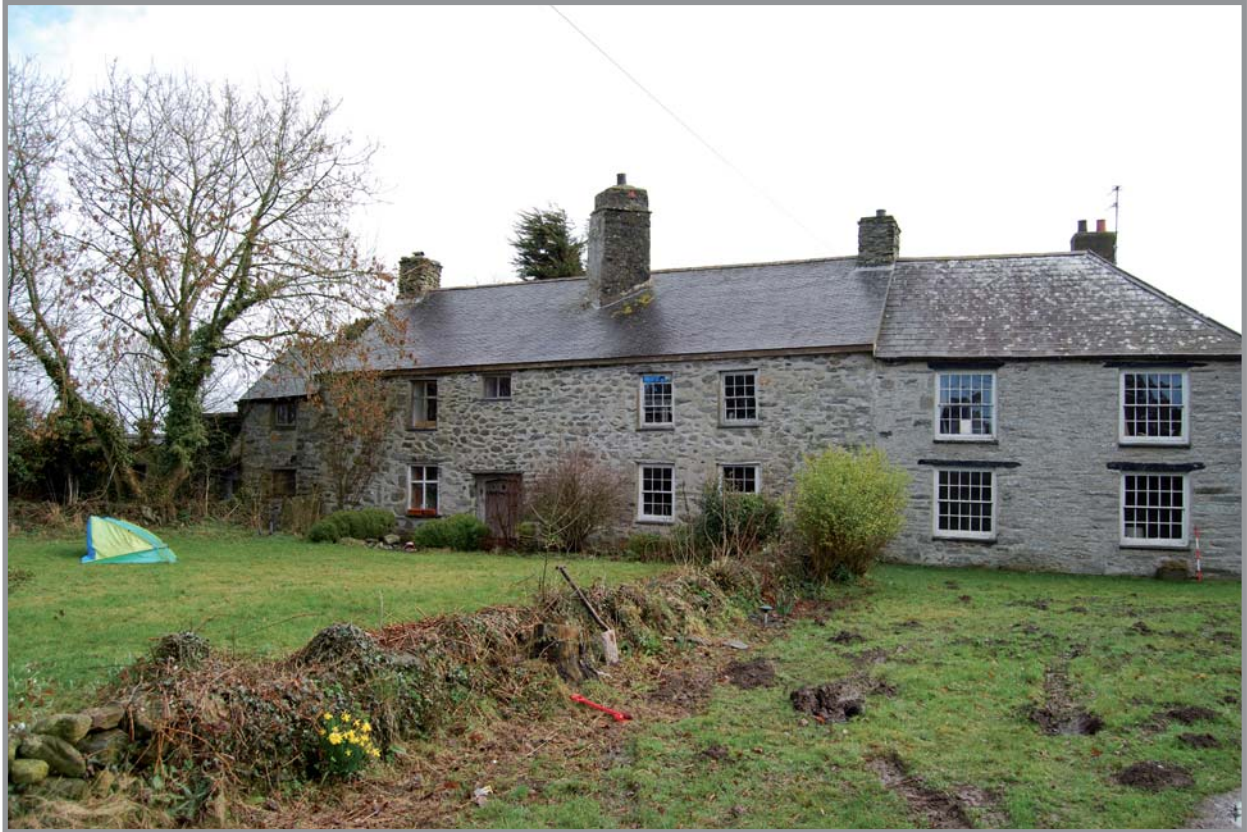
**Plate 1:** Gronant west facing elevation showing building A to the north and the 19th century infill extension to the south.

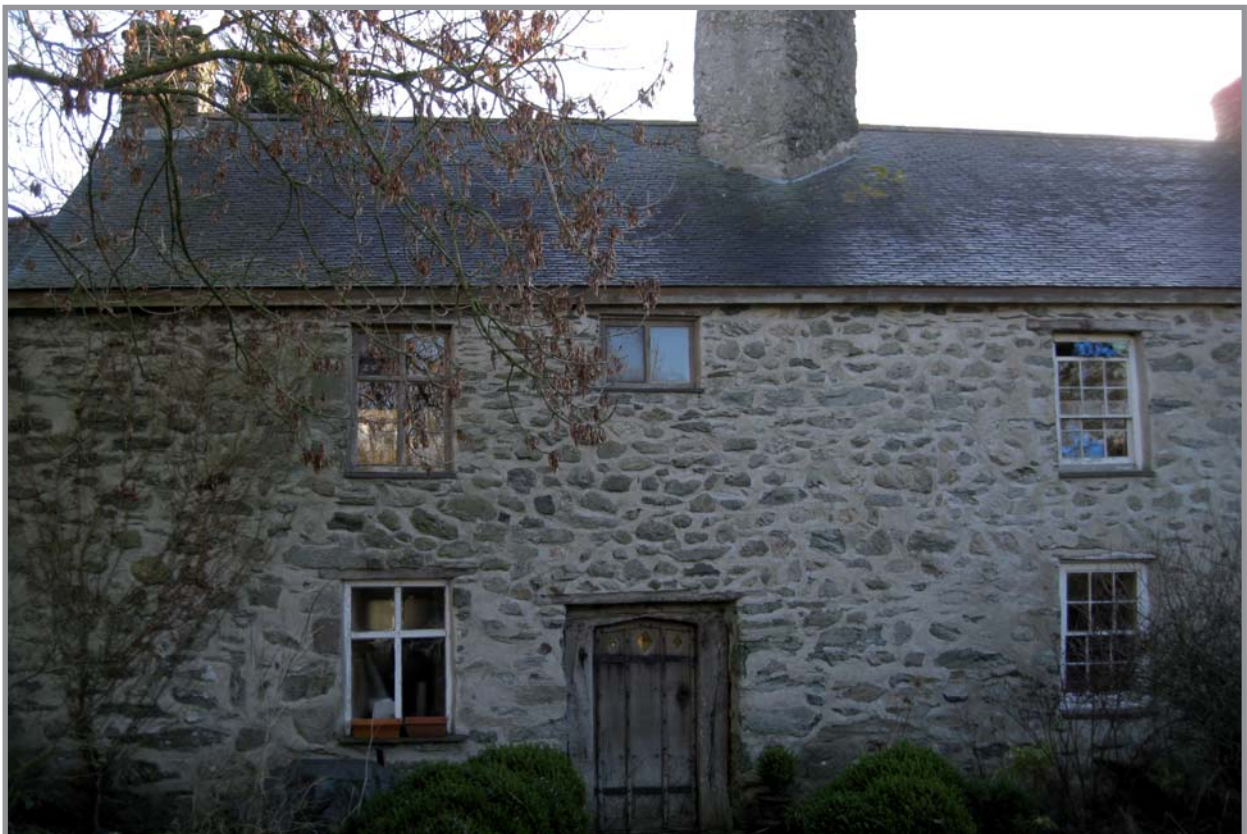
**Plate 2:** Gronant west facing elevation of building A, showing doorway which leads into the west passage, which retains its original frame supporting a Tudor arched lintel

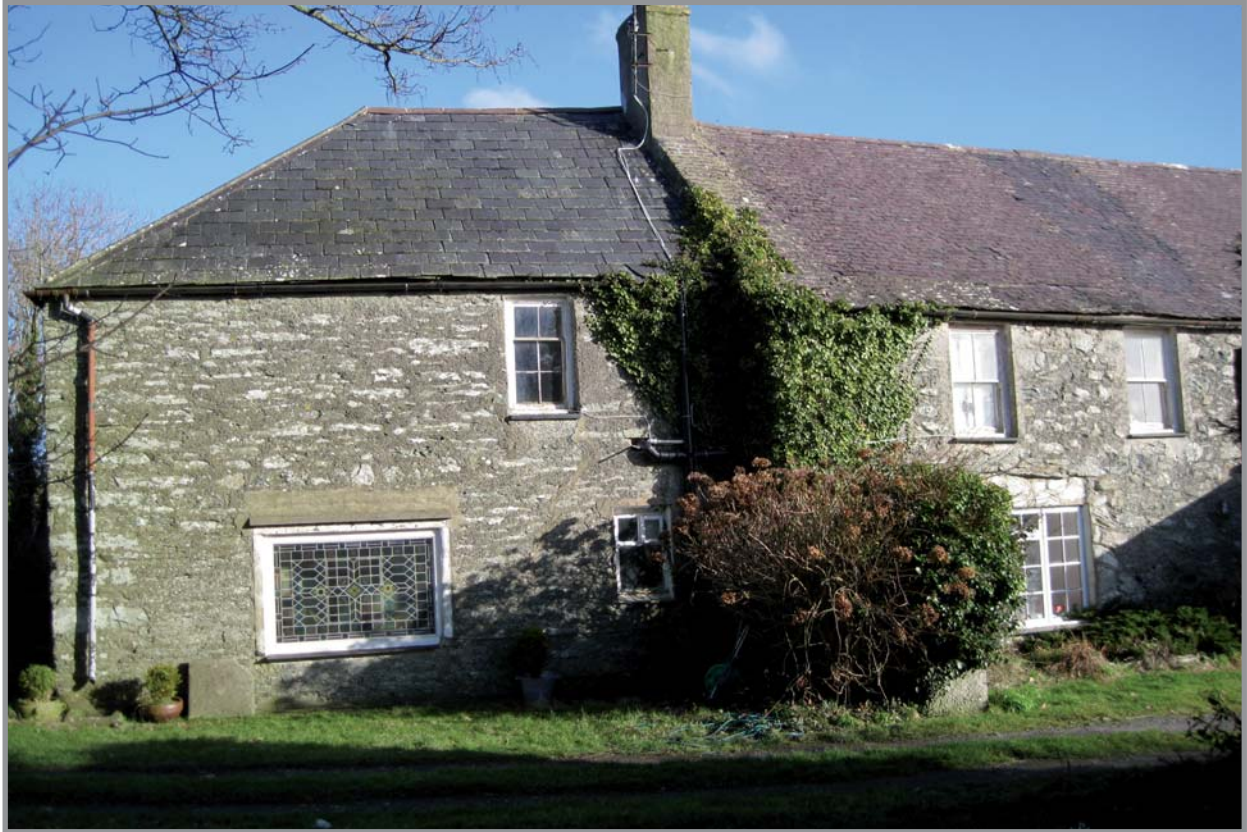
**Plate 3:** Gronant south facing elevation showing connecting 19th century wing, with re-set stained glass window and building B

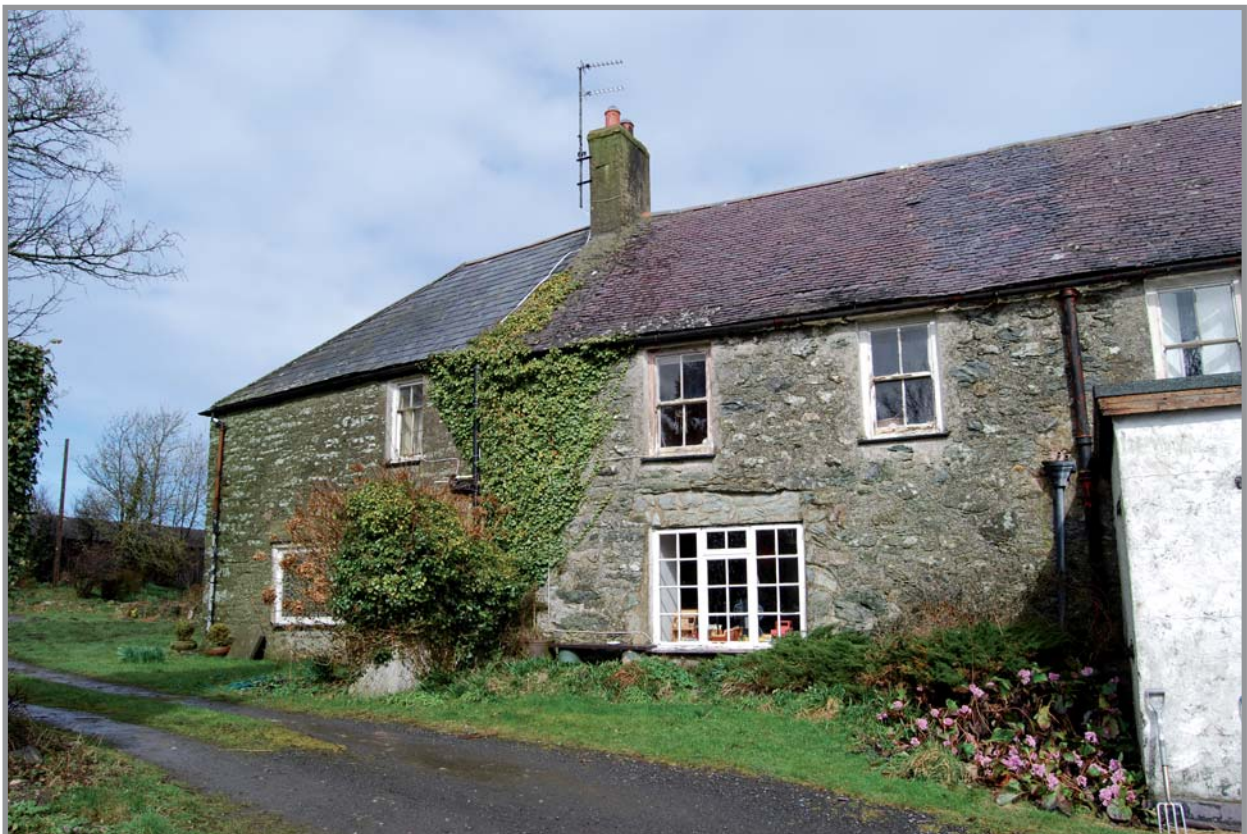
**Plate 4:** Gronant south facing elevation of building B, showing a large single window on the ground floor and three windows above which are now four-pane sash

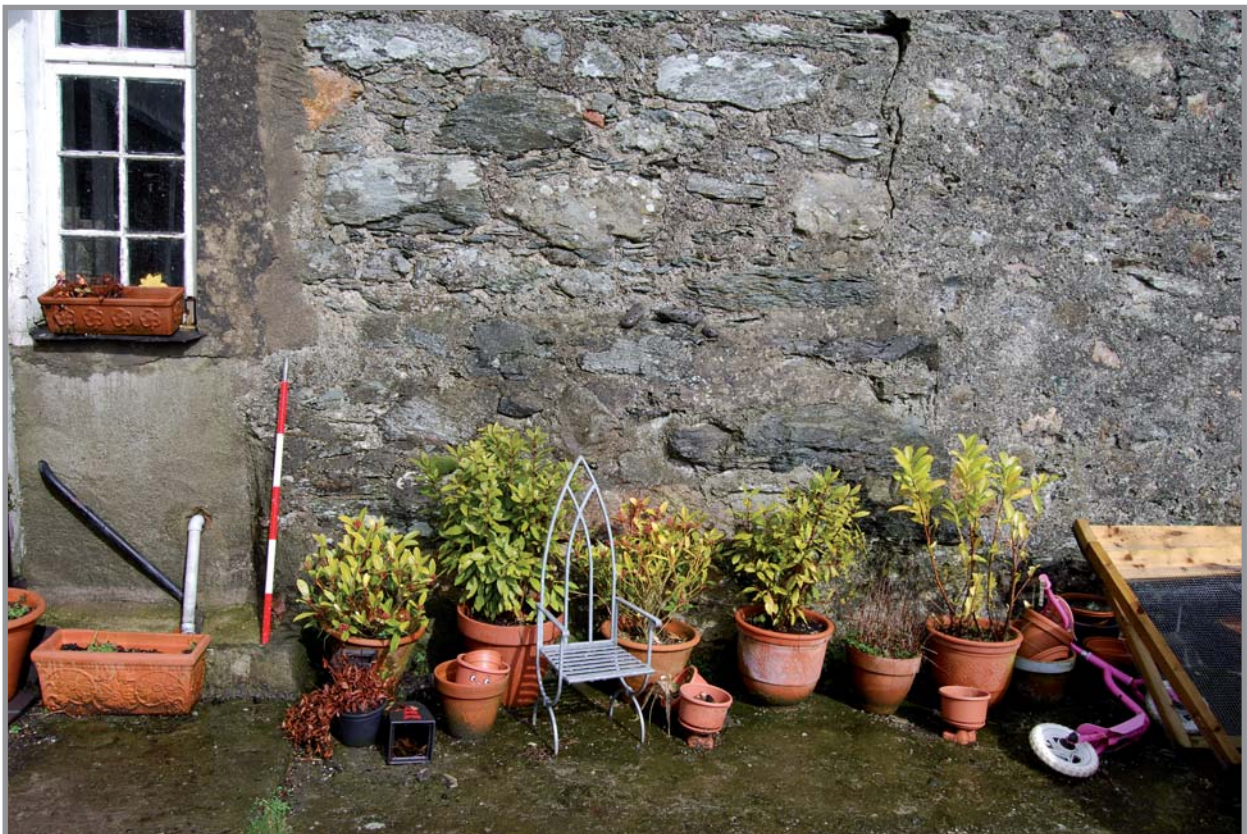
**Plate 6:** Gronant south facing elevation of building B, showing possible original foundations

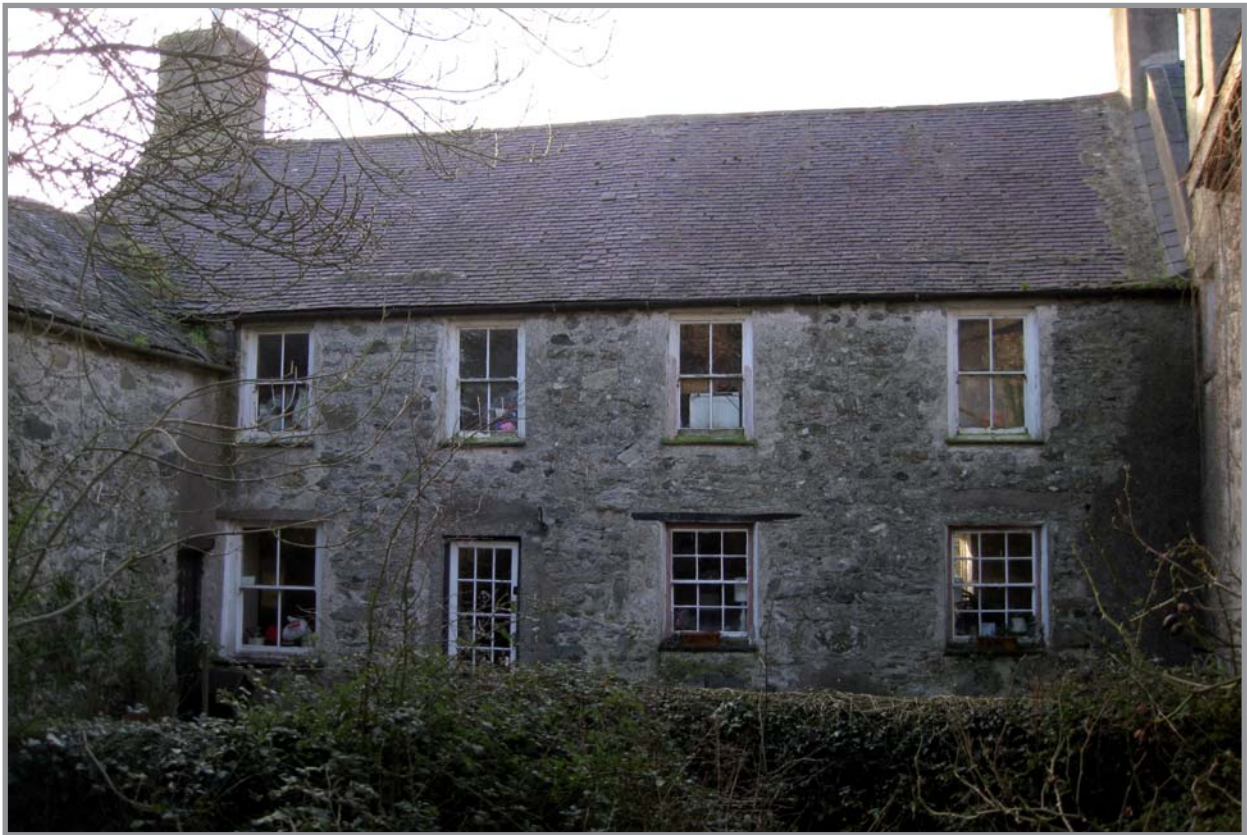
**Plate 9:** Gronant north facing elevation showing building B with four sash windows on the first floor, two 12-pane windows to the east and a four pane to the west. The change in masonry shows that the window east of the door was once a door

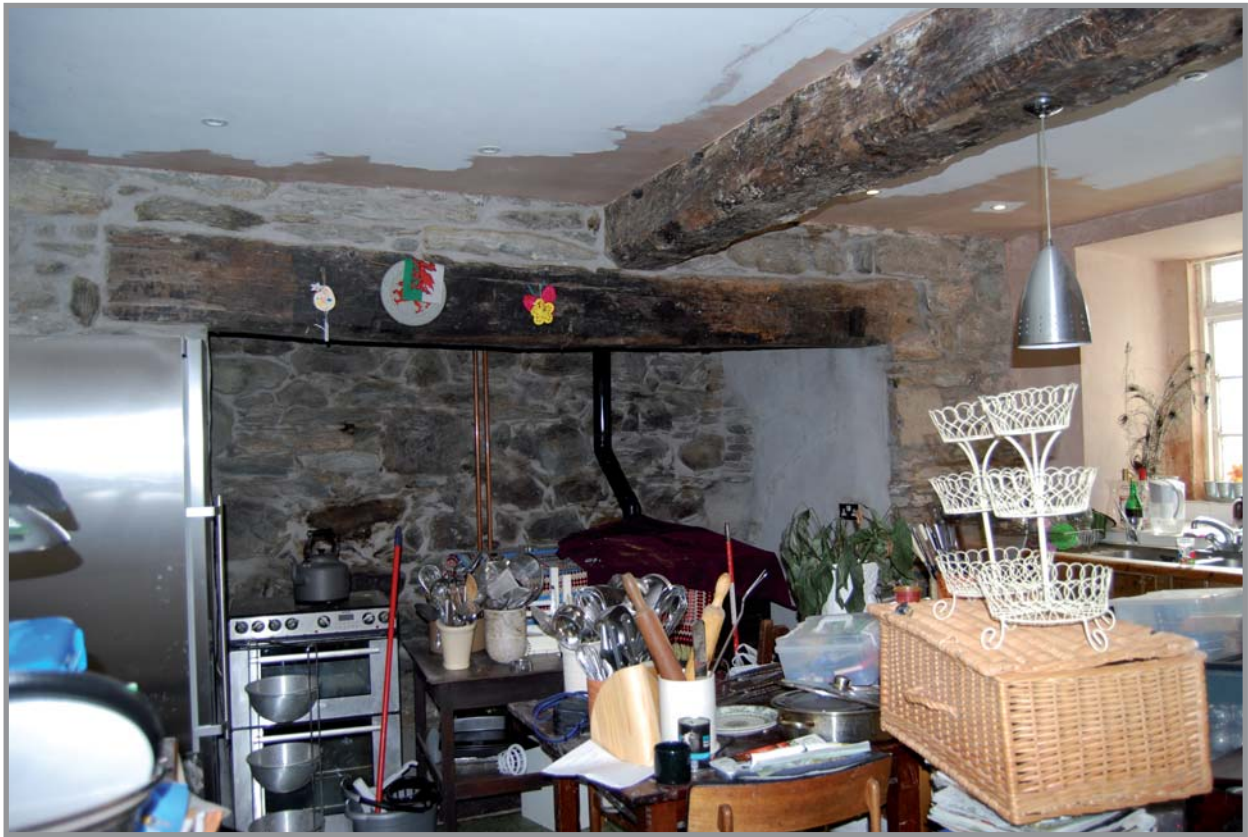
**Plate 13:** Gronant building B kitchen facing south west showing a large fireplace and axial beam

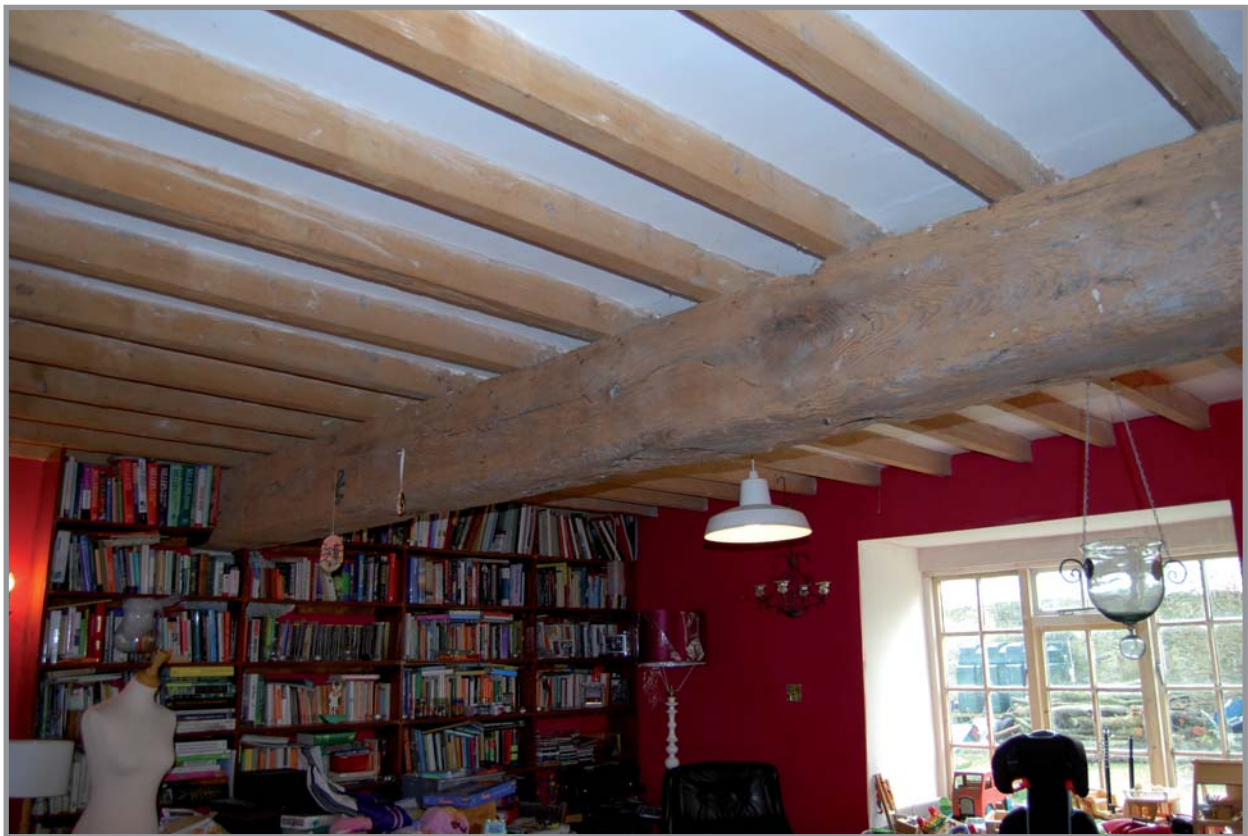
Internally the house is of two rooms. To the east is a kitchen, and to the west a single large hall. A large square axial beam runs longitudinally from east to west across the two rooms, though it may be two timbers joined within the dividing wall. This supports a later ceiling. A large fireplace occupies the east wall of the kitchen, the chimney supported on a large beam. These are the only two early timbers visible in the house. The west gable wall shows no evidence of an internal fireplace, however the external face (now enclosed by the connecting wing) is some 1.5m wide, and appears to include a chimney which would originally have been external. This is used by a fireplace in the connecting wing.

**Plate 14:** Gronant building B living room facing south west showing the large square axial beam which runs east to west across the entire of building B

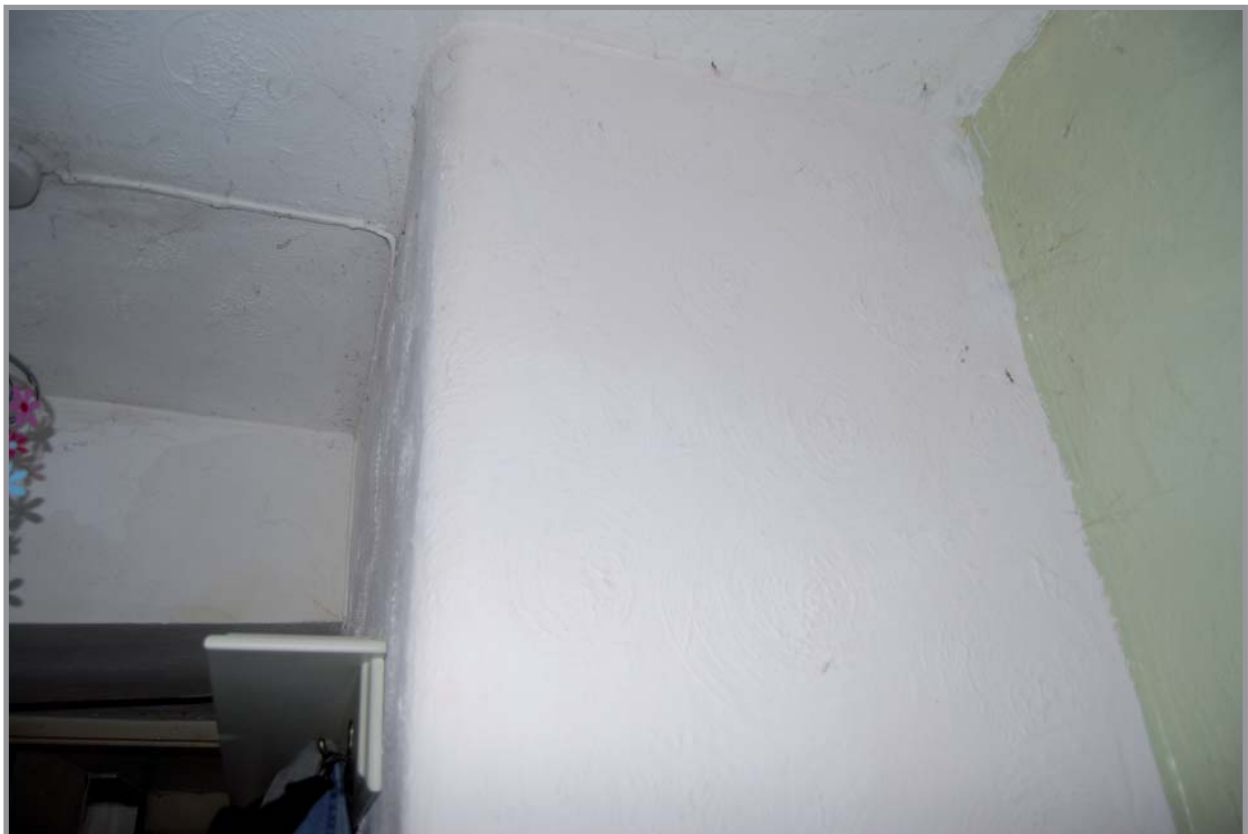
**Plate 16:** Gronant building B facing north showing the external chimney now blocked

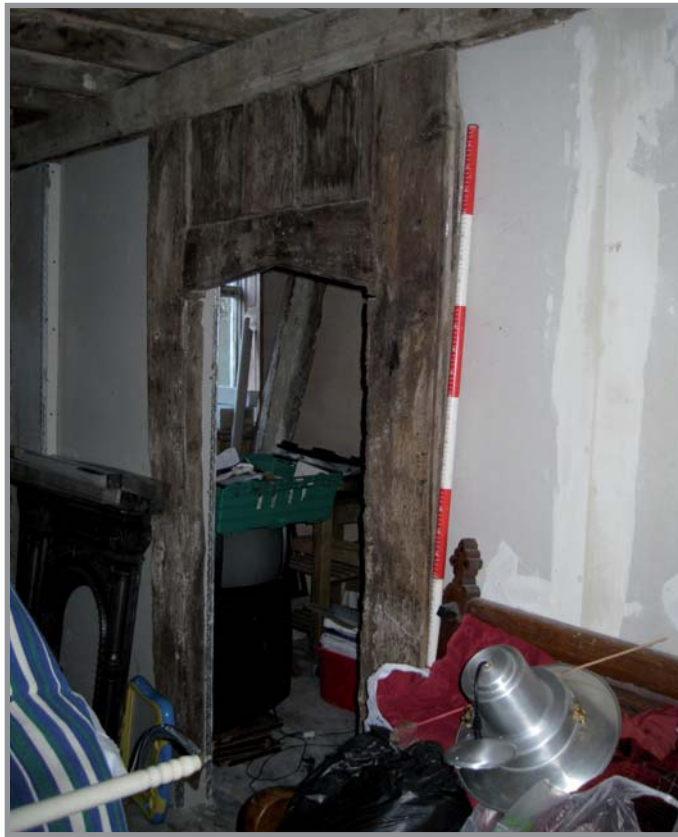
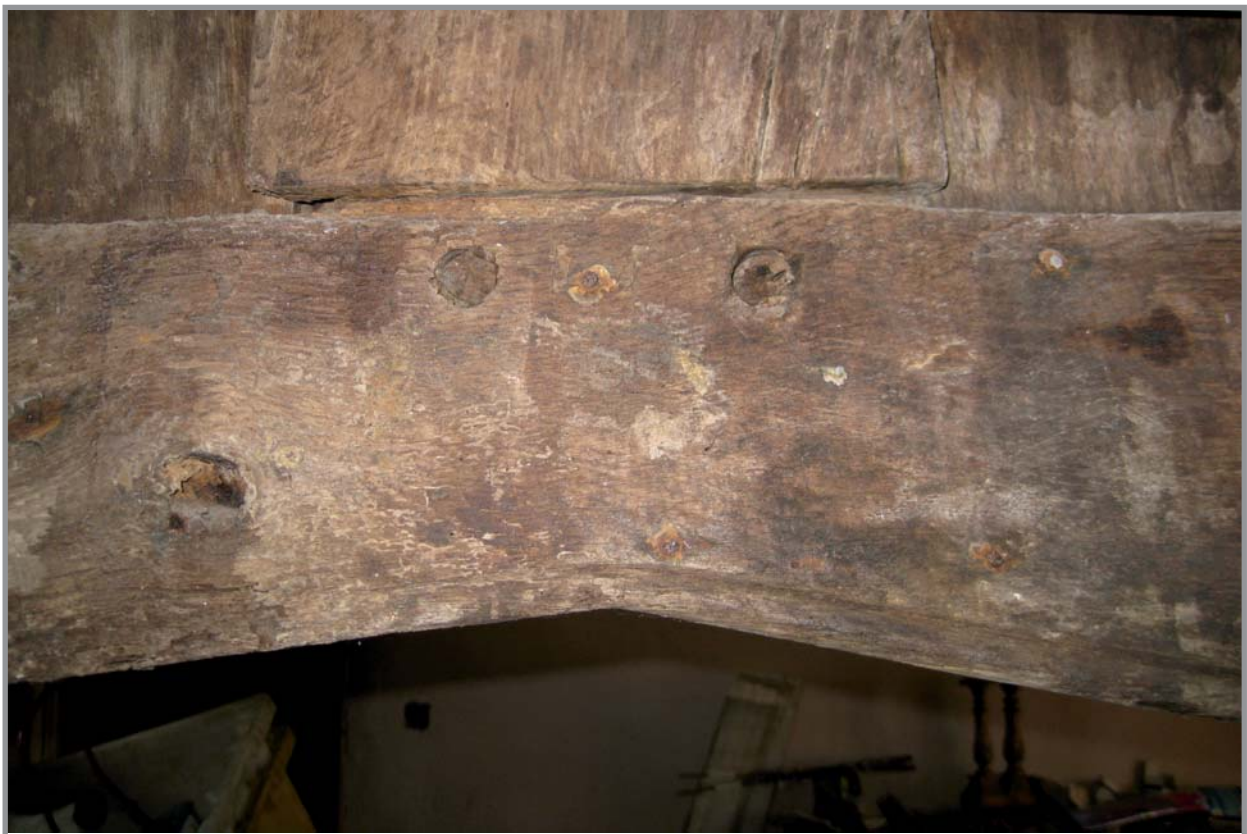
The post and panel screen has lost most of its timbers. The top and bottom rails remain, and so does the single door into the outer bay. The top rail is moulded on the lower corner, the moulding pierced by peg holes for the posts and panels. Towards the west end of the passage the two posts either side the door into the outer bay survive, with the lintel forming a Tudor (shallow pointed) arch. Above the lintel is a central post with two panels either side. The top rail is in to parts, the east side being narrower than the west side. The ceiling joists lie on top of the top rail.

**Plate 19:** Gronant building A. Post and panel screen

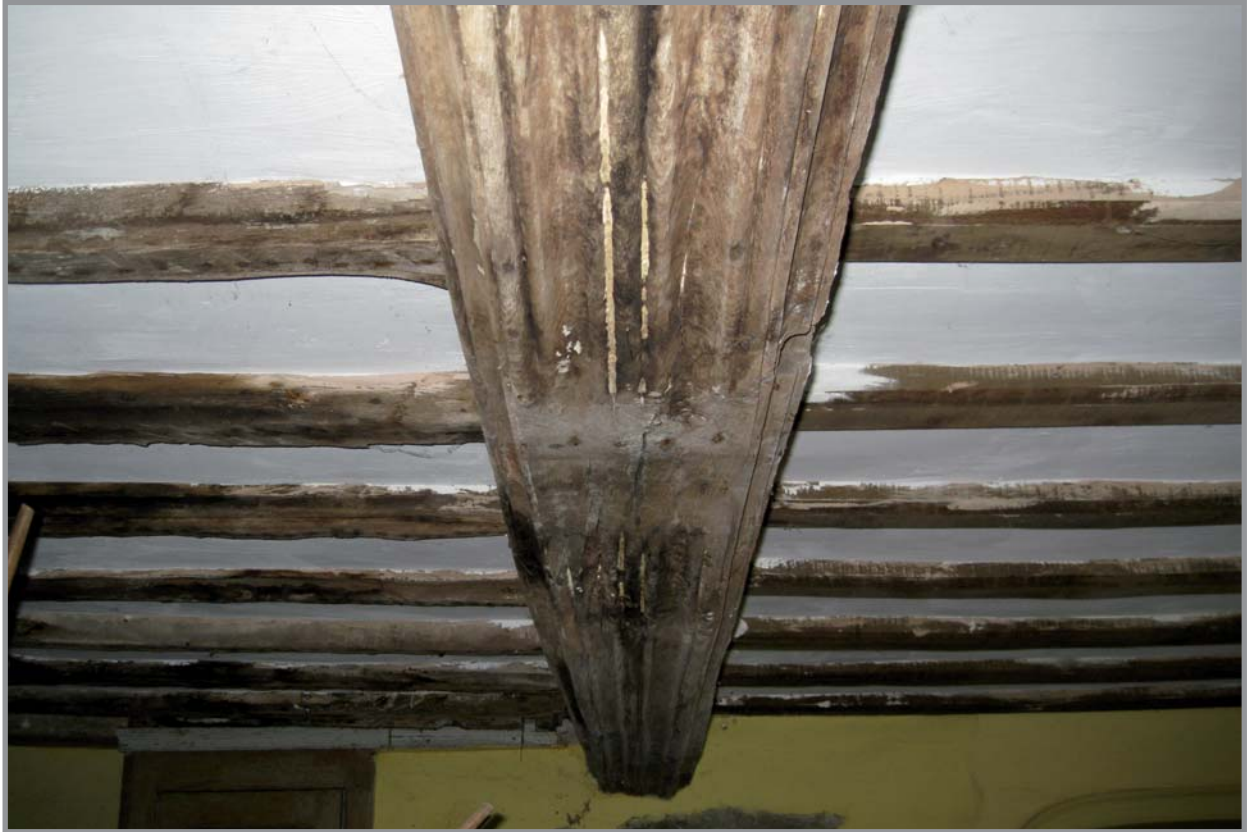
The hall is entered on the north side of the fireplace. The ceiling is supported on a heavily moulded beam which runs the length of the room from north to south, from the east wall of the fireplace through to the south gable wall. The largely original joists lie on top of the beam. Access to the fireplace was not possible, nor was the south side of the room clearly visible. The two closely spaced 12 pane sash windows on the east and those more widely spaced on the west both have heavily moulded internal lintels. The south wall contained a small fireplace, with a wide arched full

**Plate 23:** Gronant building A. Heavily moulded beam

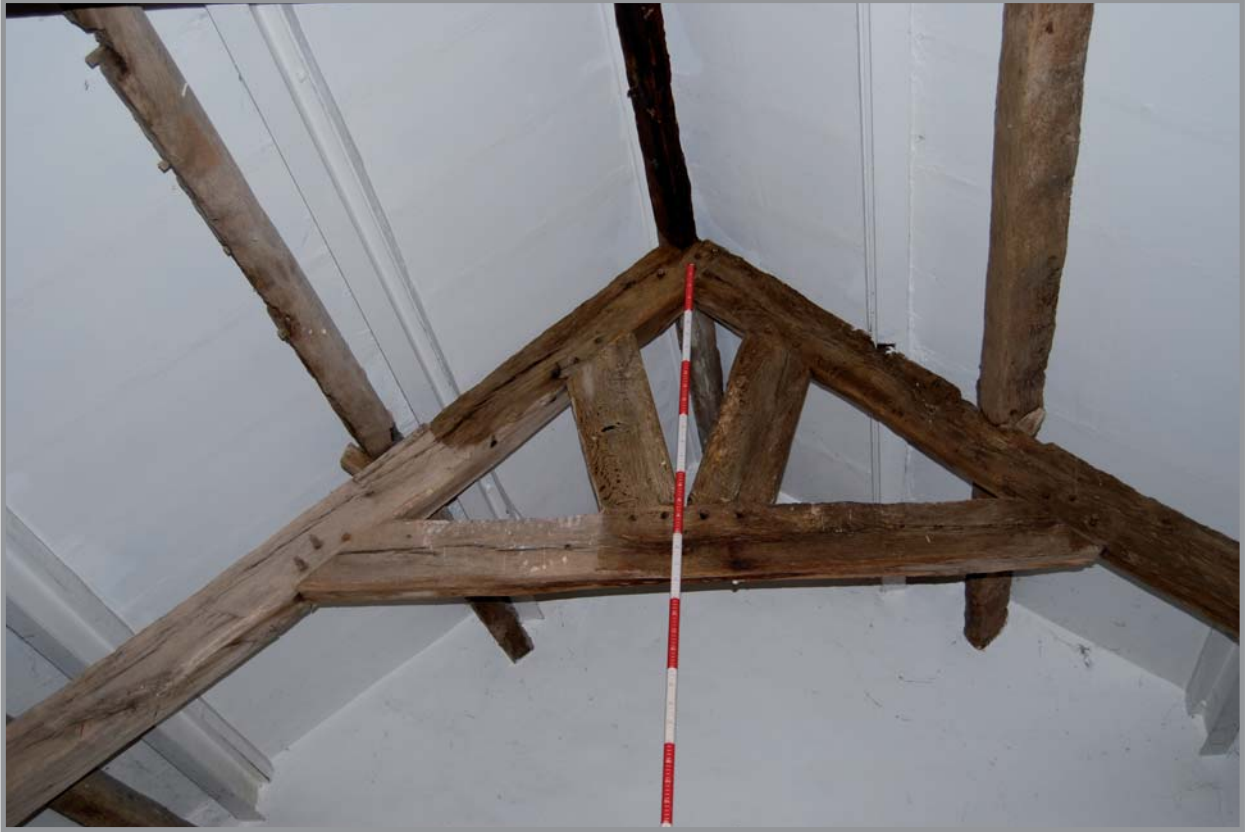
**Plate 27:** Gronant building A, first floor. Truss 1 facing south

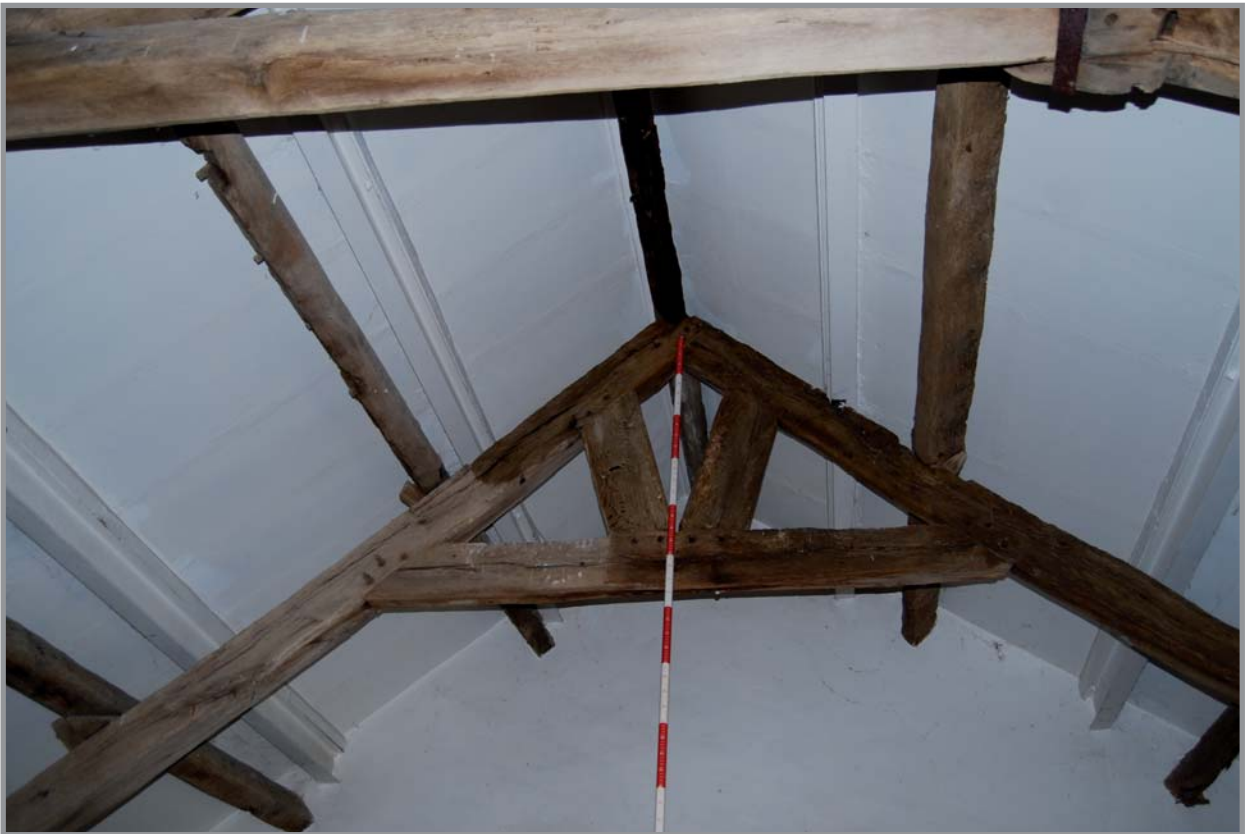
**Plate 28:** Gronant building A, first floor. Truss 2 facing north
