# North West Wales Dendrochronology Project: Trefadog, Llanfaethlu

Project No. G2113

Report No. 1021

Trefadog, Llanfaethlu, Anglesey. NGR SH 29288613

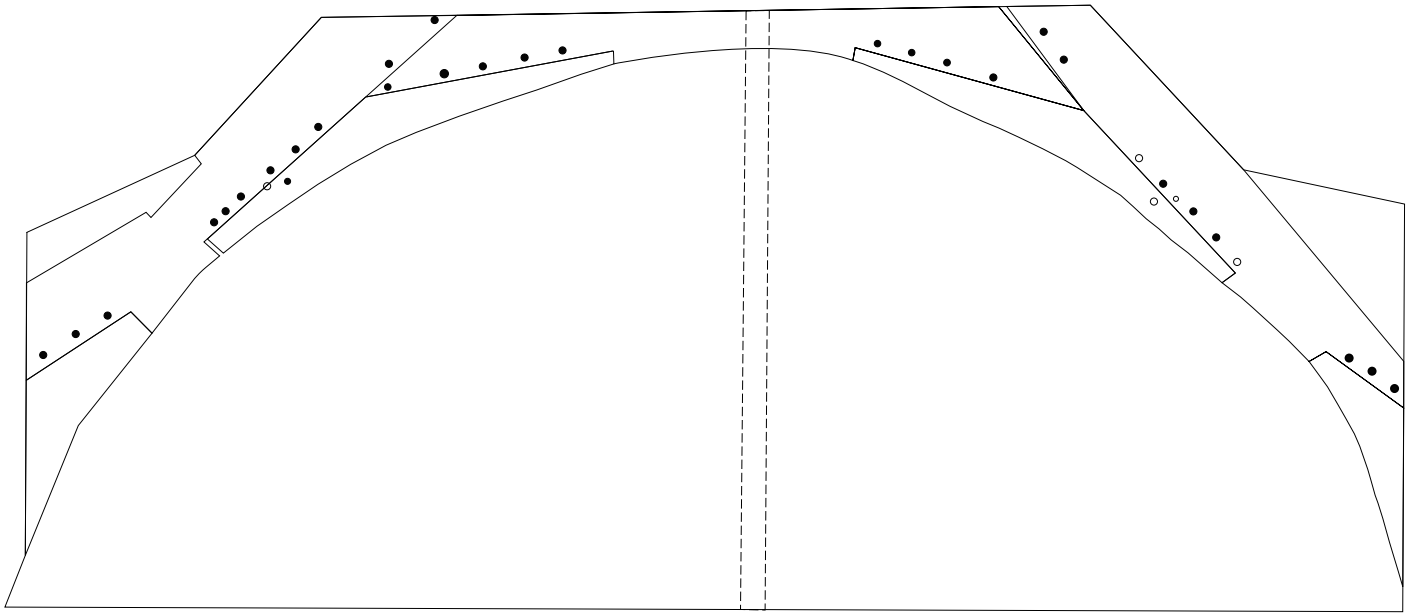
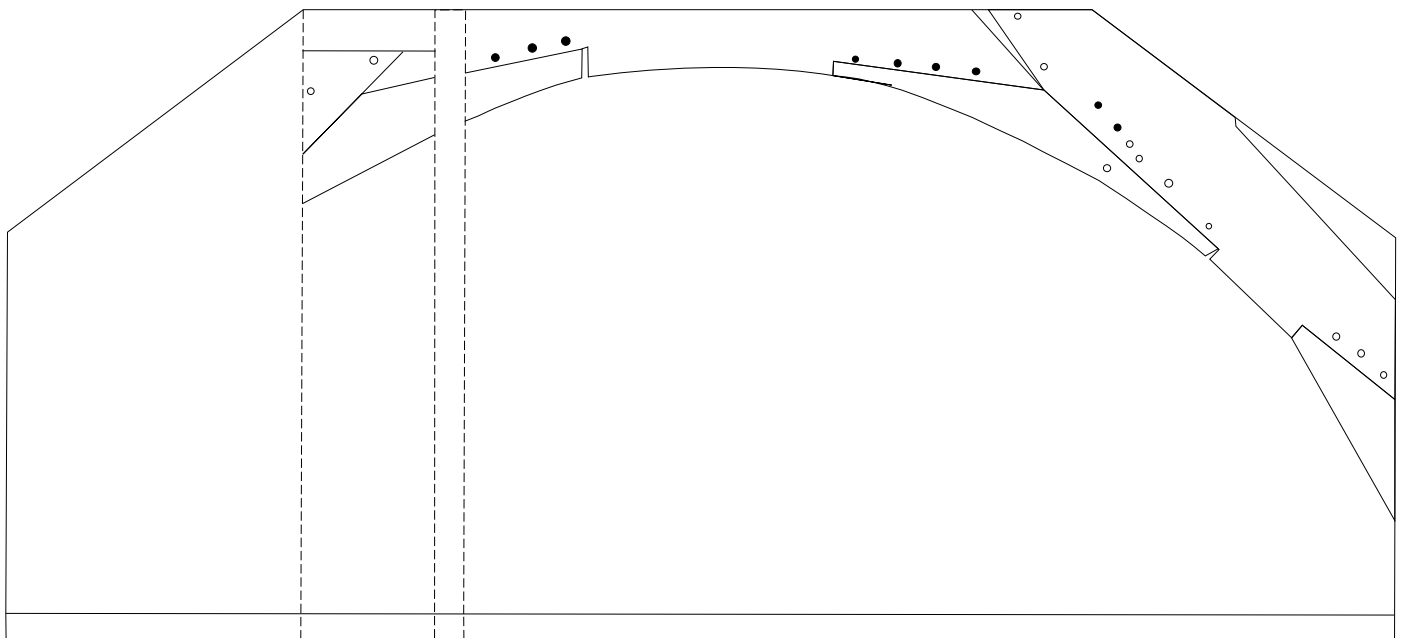
Figure 4: Trefadog, southern cruck

The northern face of the southern cruck which divides the hall

The southern face of the southern cruck which divides the hall

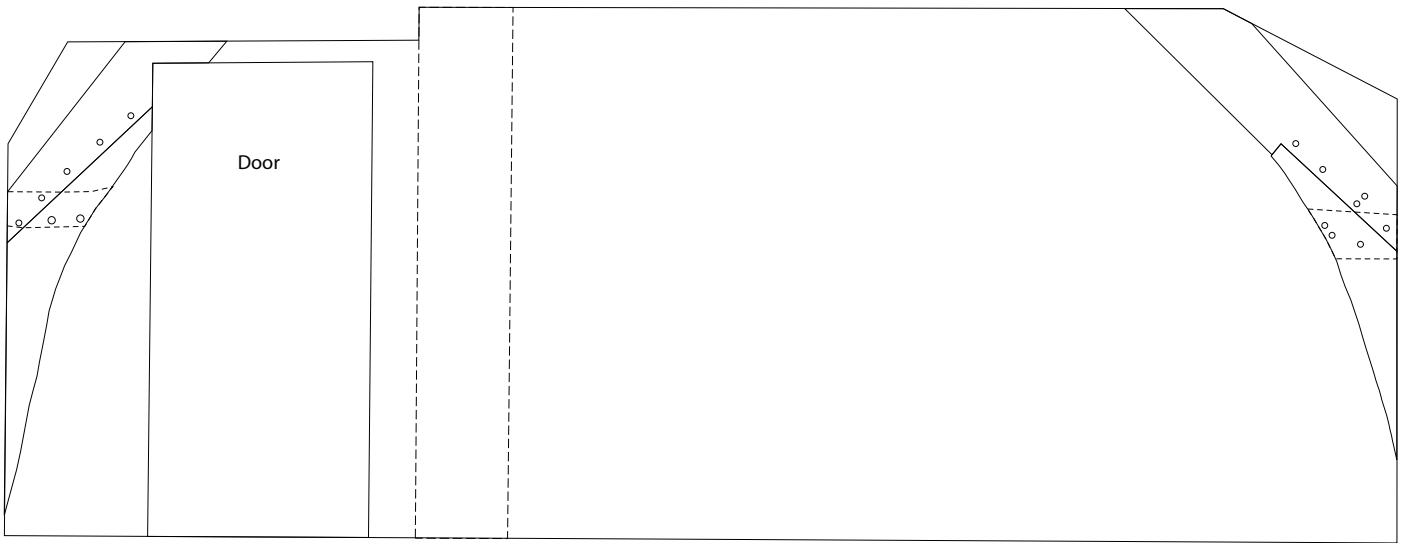
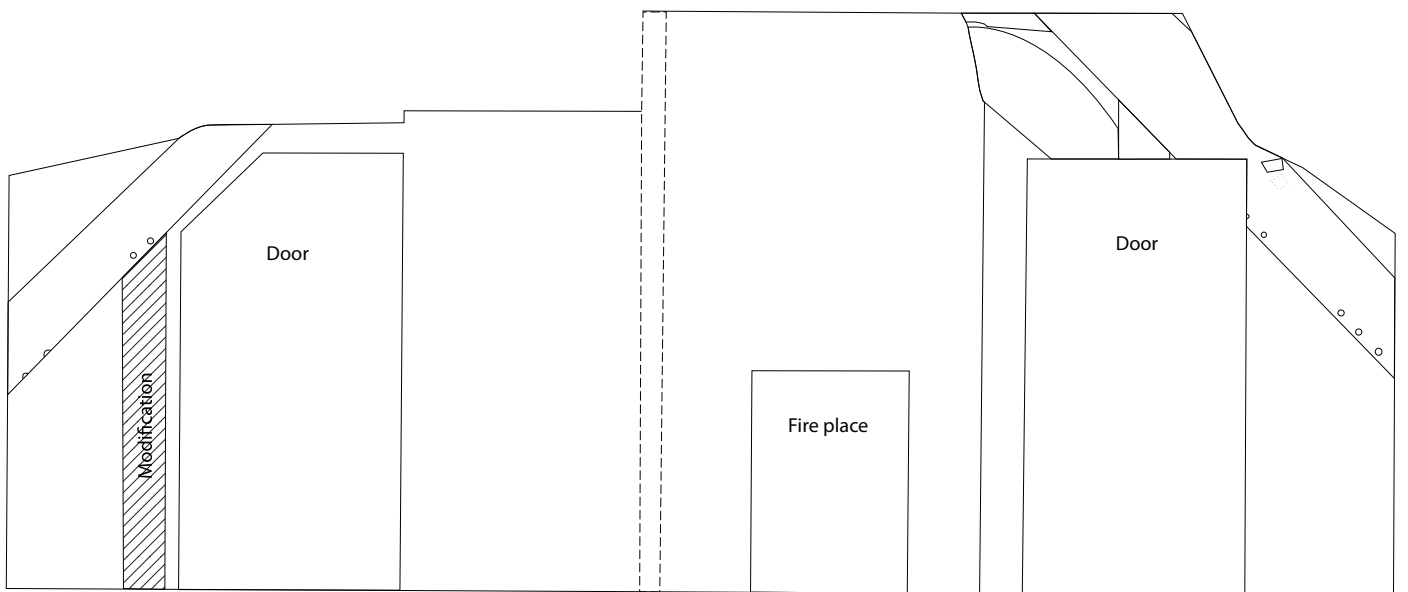
Figure 5: Trefadog, the crucks on the northern and the southern sides of the cross passage

The southern face of the cruck on the northern side of the cross passage

The southern face of the cruck on the southern side of the cross passage

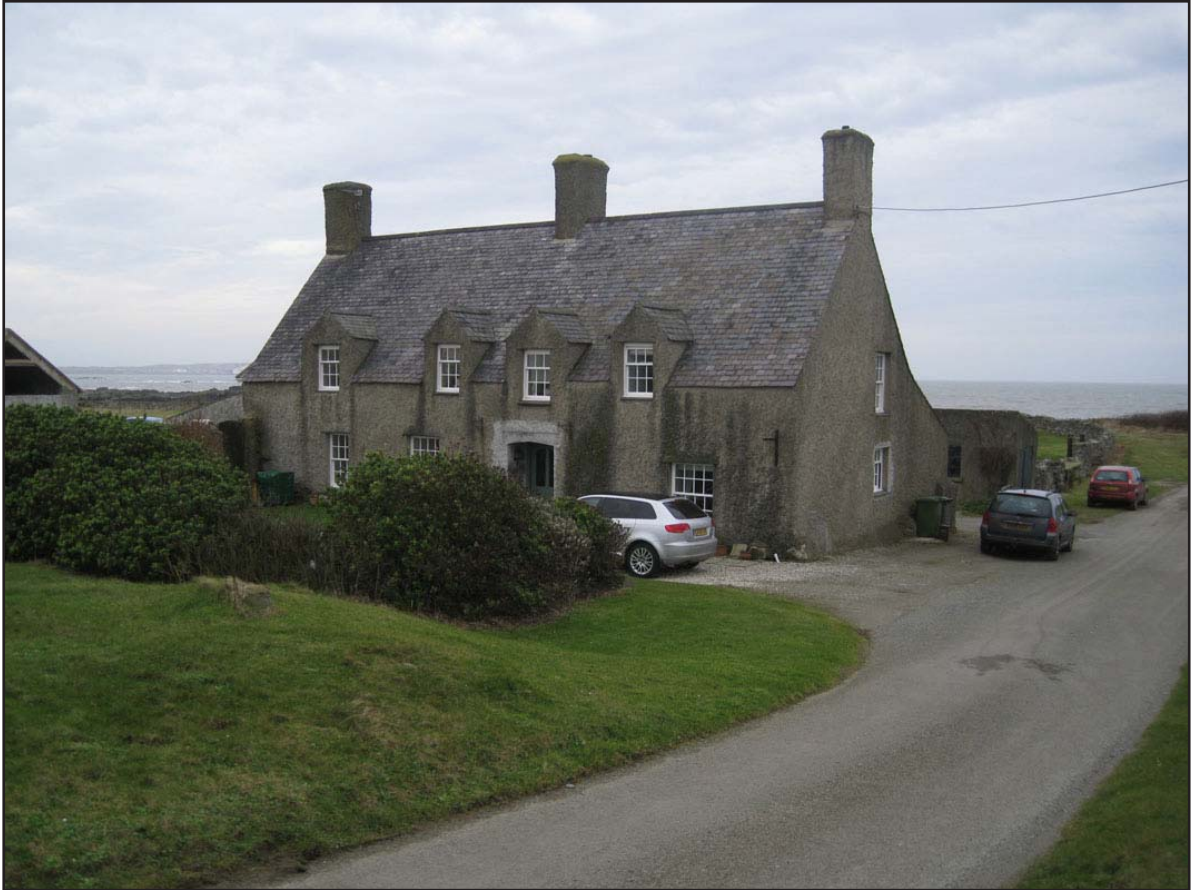
**Plate 01:** The eastern elevation of Trefadog; view from the northeast.

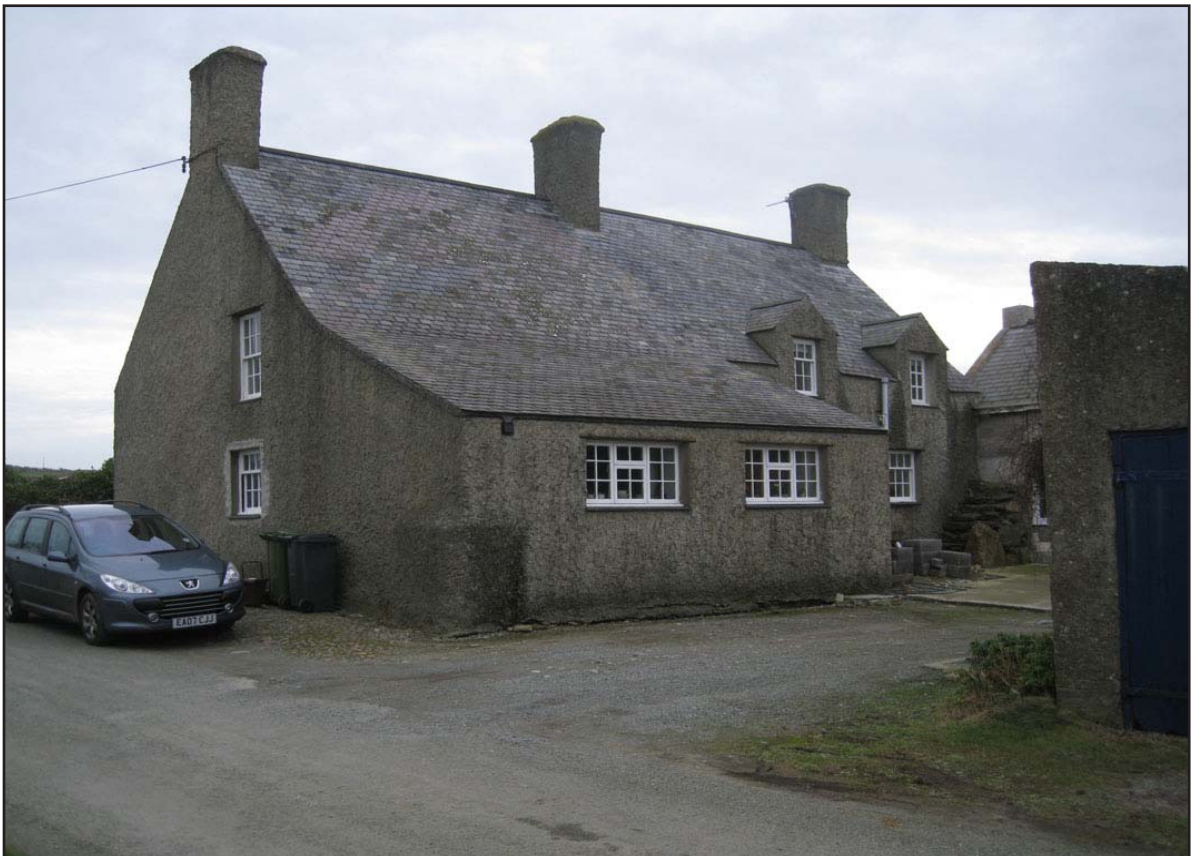
The house is aligned approximately north-south, parallel to the coast edge, and is in a slight hollow 50m from the sea. The house is of two storeys, of rendered stone. The slate roof is modern. There are three rectangular chimney stacks, two at the gables and one to the left (south) of centre. The main front faces east, with an off-centre door to the north, two replaced sash windows to the south and one to the north. Four gabled dormers, all fitted with replaced sash windows, light the first floor. The north side of the house has a catslide addition occupying the north half, of probable 19<sup>th</sup> century date, though with modern horizontal casement windows in the west wall. The south side of the house is lit by a sash window on the ground floor and two gabled dormers on the first floor. A rear door lies in the corner created by the catslide extension (see plate 2).

**Plate 02:** The western elevation of Trefadog; view from the northwest.

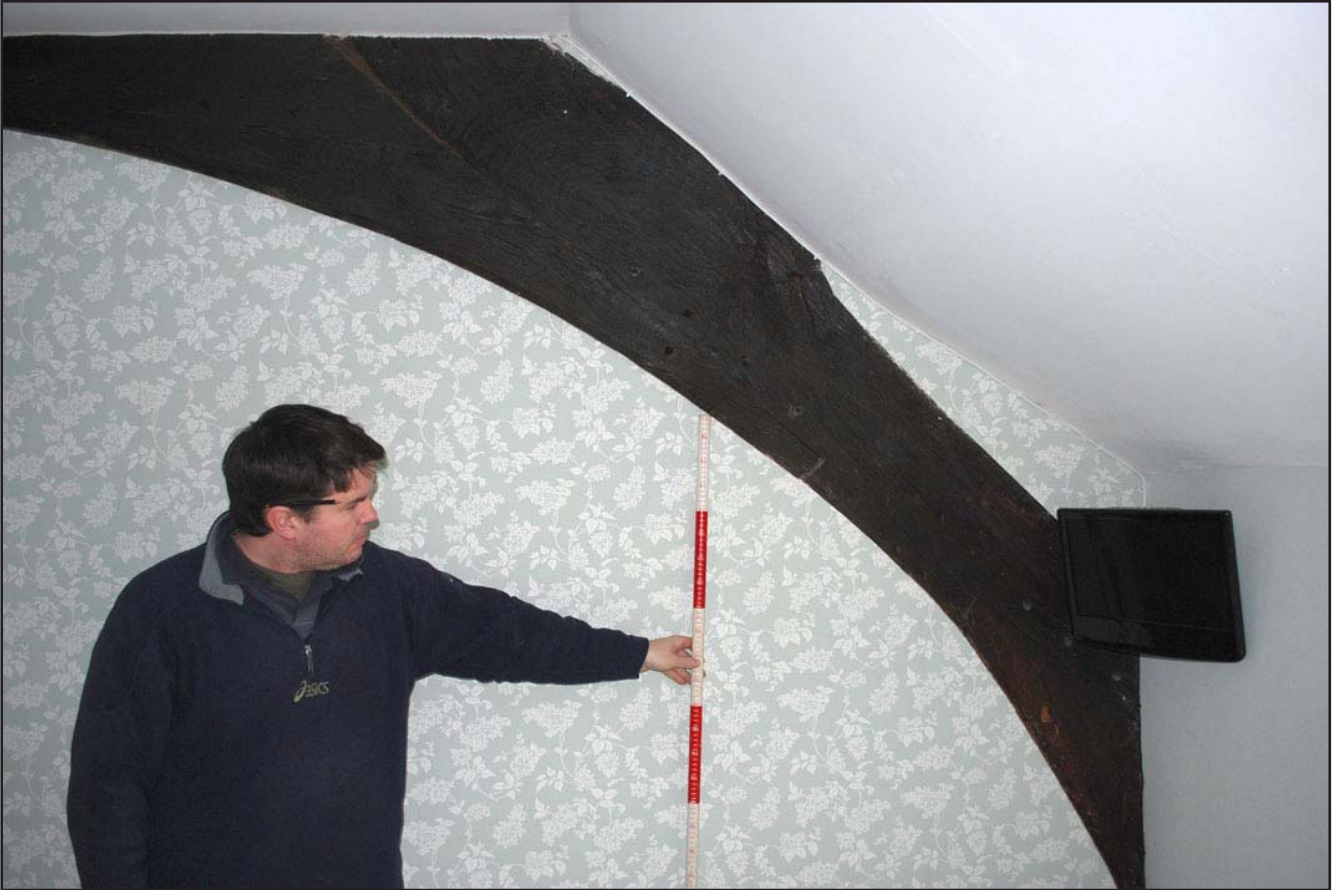
The cruck which divides the hall consists of two principals which disappear into the wall on either side. These have a jointed vertical post which curves onto the principal to form the bend of the cruck. The two are fastened by a wide mortise and tenon joint held with three pegs. It is not possible to see how far the vertical post goes into the wall. None of the vertical posts appear to go below the level of the present first floor, and it is not known if they ever went below that level. An arch-braced collar beam is partly visible below first-floor ceiling level – the remainder hidden by the ceiling. The braces are joined to the collar and principals by mortise and tenon joints (see plates 1 to 6).

**Plate 3:** The eastern side of the southern face of the southern cruck which divides the hall; view from the south.

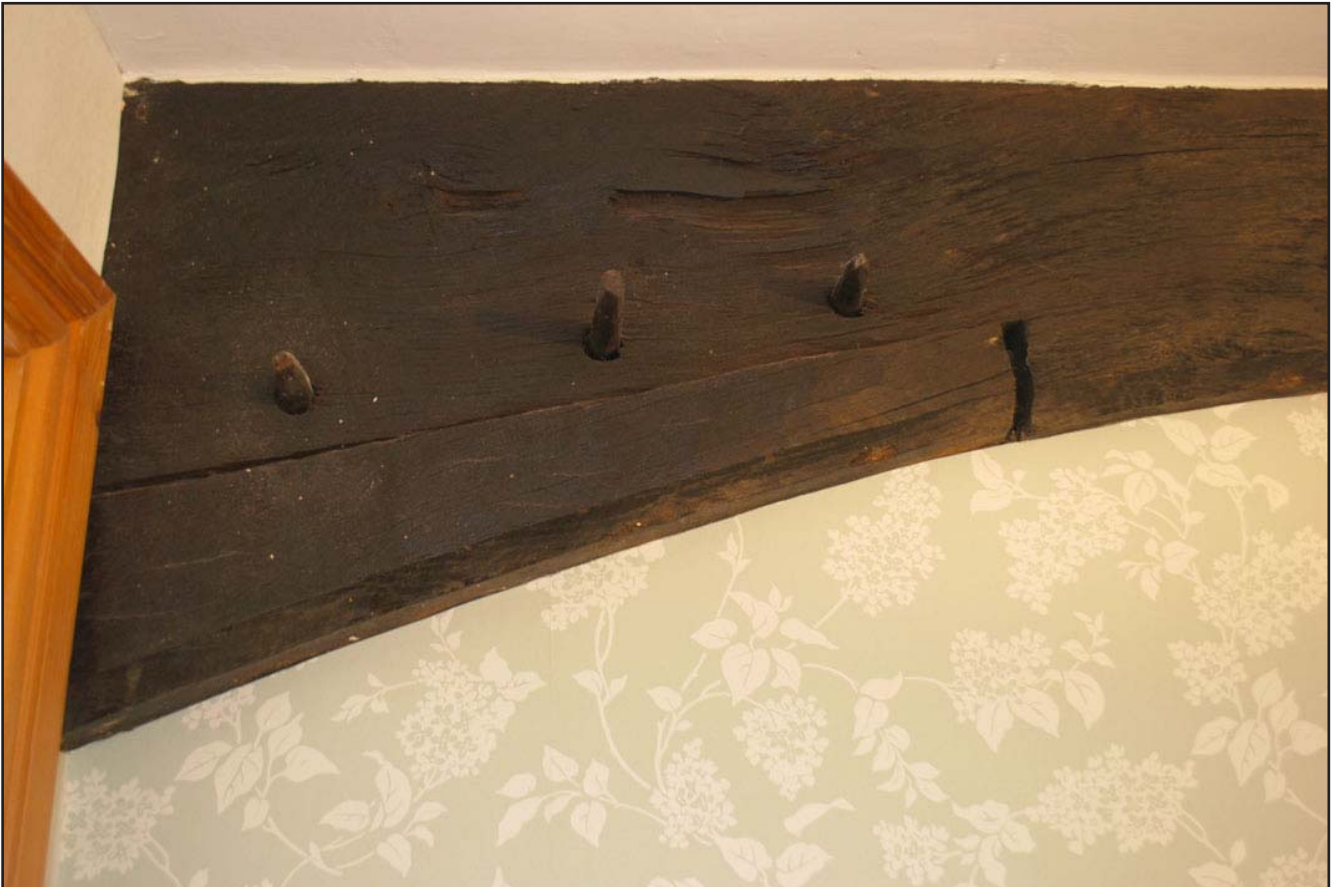
**Plate 4:** Close up of the pegs which join the jointed vertical post with the principal to form the bend of the southern cruck. This is the western side of the southern face; view from the south.

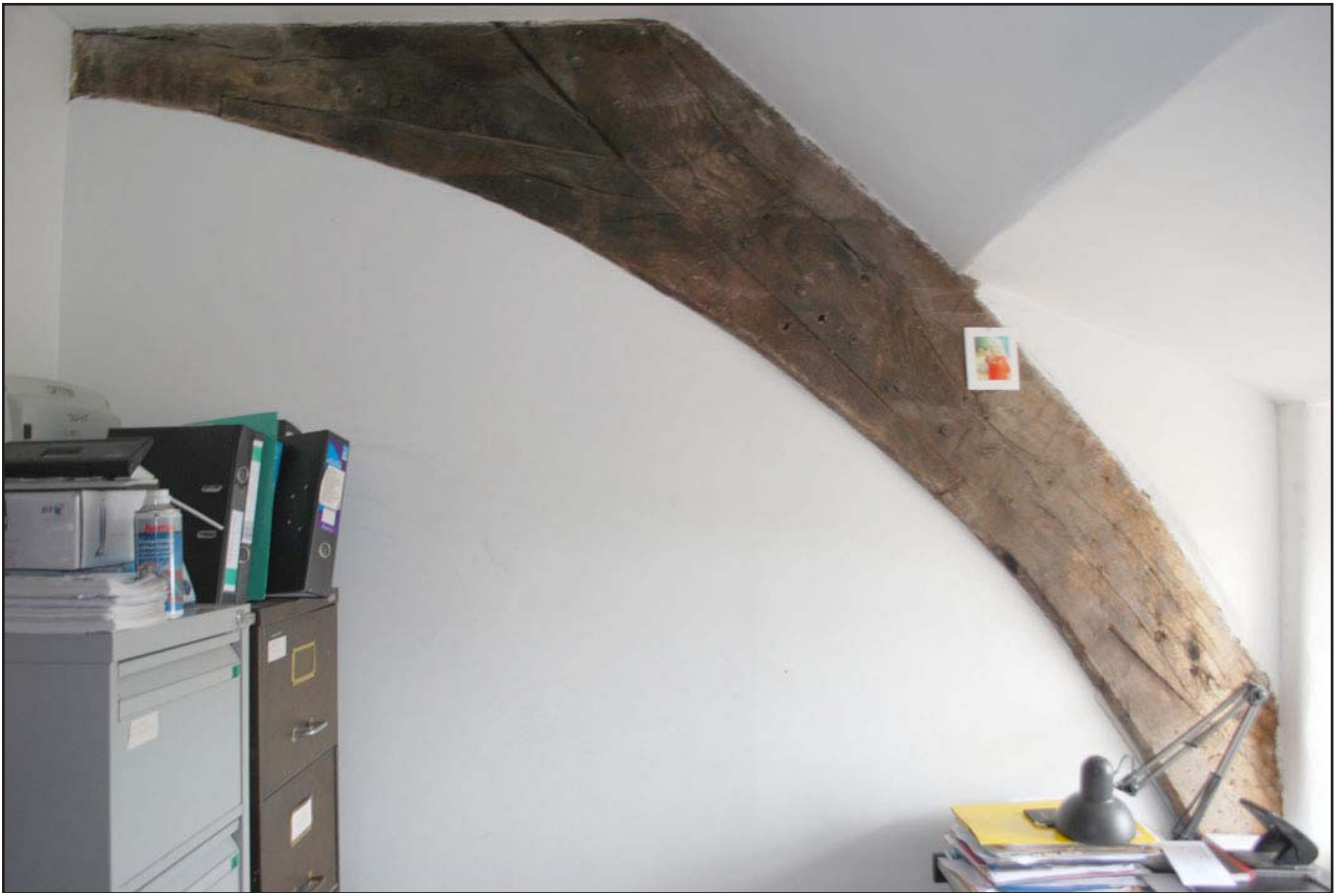
**Plate 5:** The western side of the northern face of the southern cruck which divides the hall; view from the north.

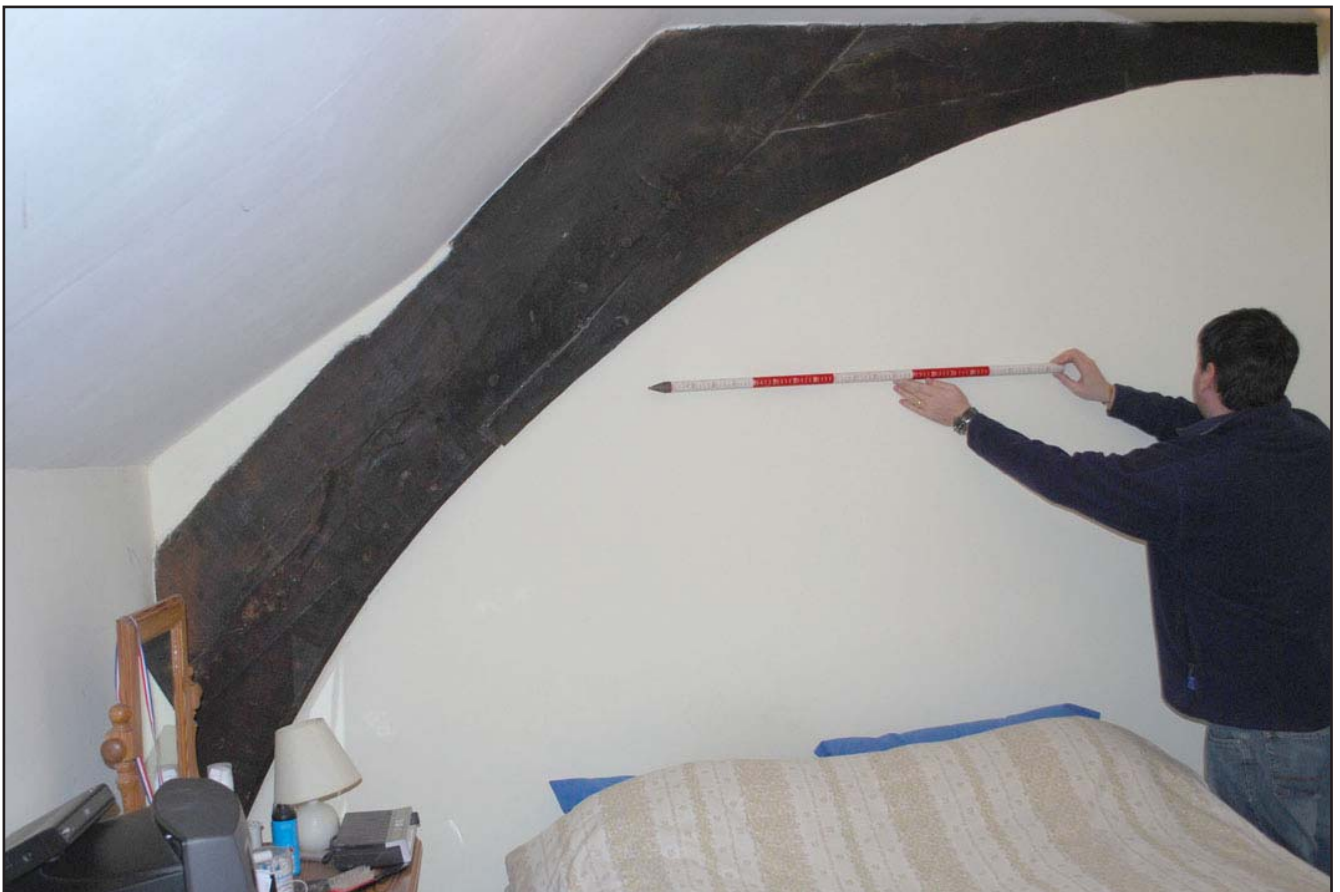
**Plate 6:** The eastern side of the northern face of the southern cruck which divides the hall; view from the north.

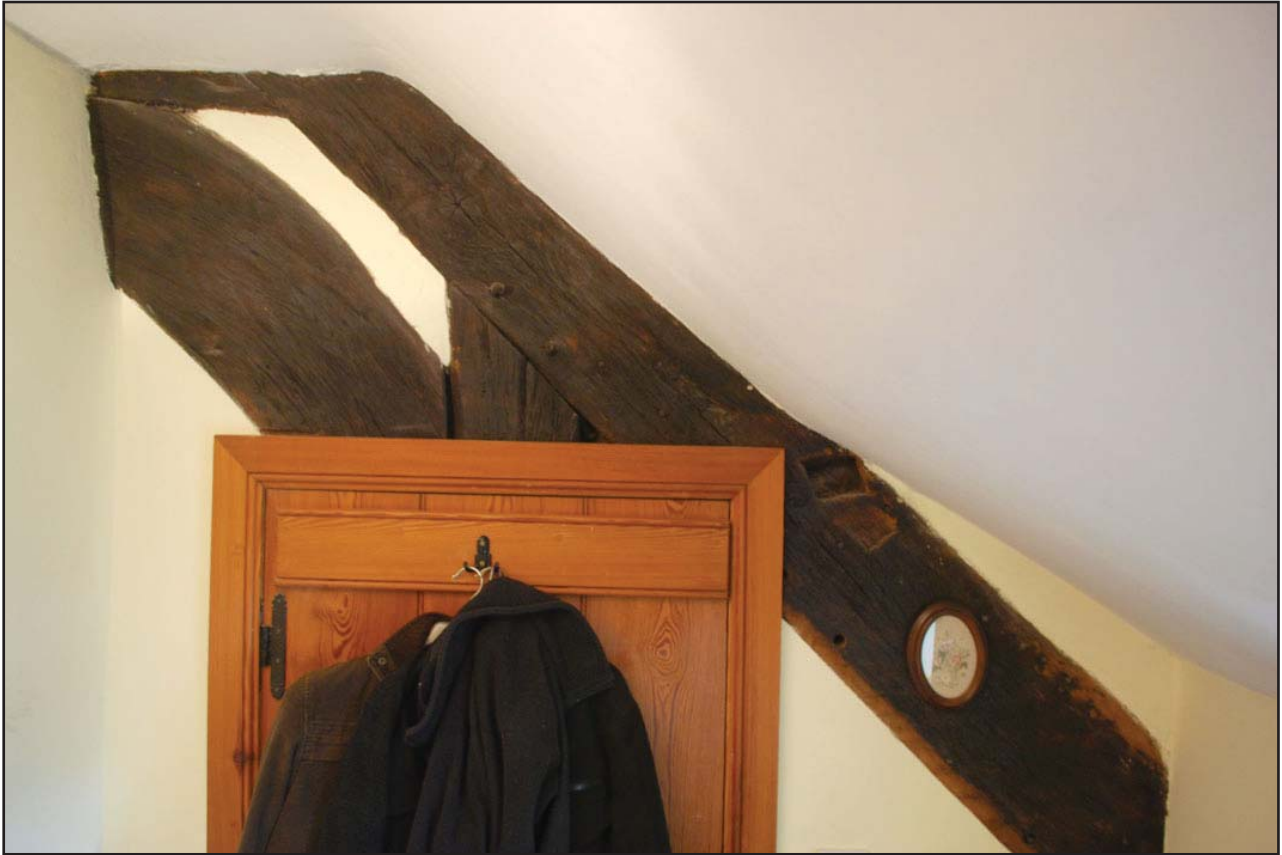
The cruck forming the south side of the screens passage is only partially visible and appears to have been modified on the west side. The arch-bracing to the collar beam on the east side links to a vertical post. There is only a small section left of this, as it has been cut by a door, but it is probable that this vertical post once continued down to ground floor level, and formed part of the screens partition. A vertical wall post, but with less of a curve than on the hall cruck, is linked to the end of the principal, and continues downwards in the lateral wall. This is partly mirrored on the west side, but the vertical post has been replaced with a modern one lower down the principal. Two dowel holes mark the likely location of the original vertical post. There is no evidence for a curving brace to the collar beam, though not enough of the collar beam is visible to confirm if one formerly existed (see plates 7 to 9).

Plate 7: The eastern side of the southern face of the central cruck which forms the south side of the screens passage; view from the south.

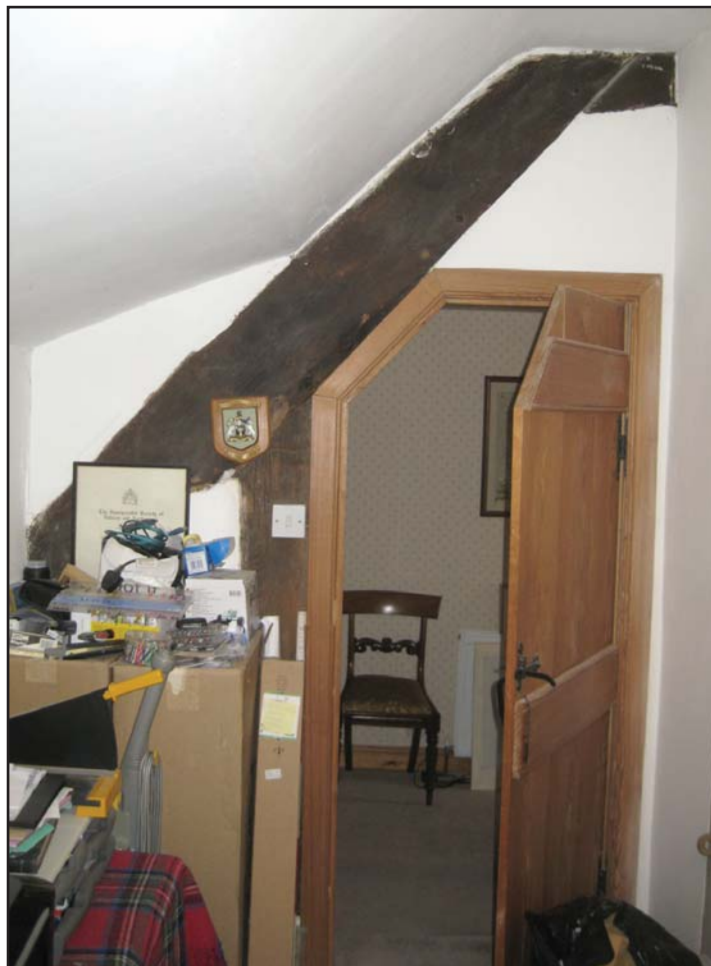
Plate 08: The western side of the southern face of the central cruck which forms the south side of the screens passage

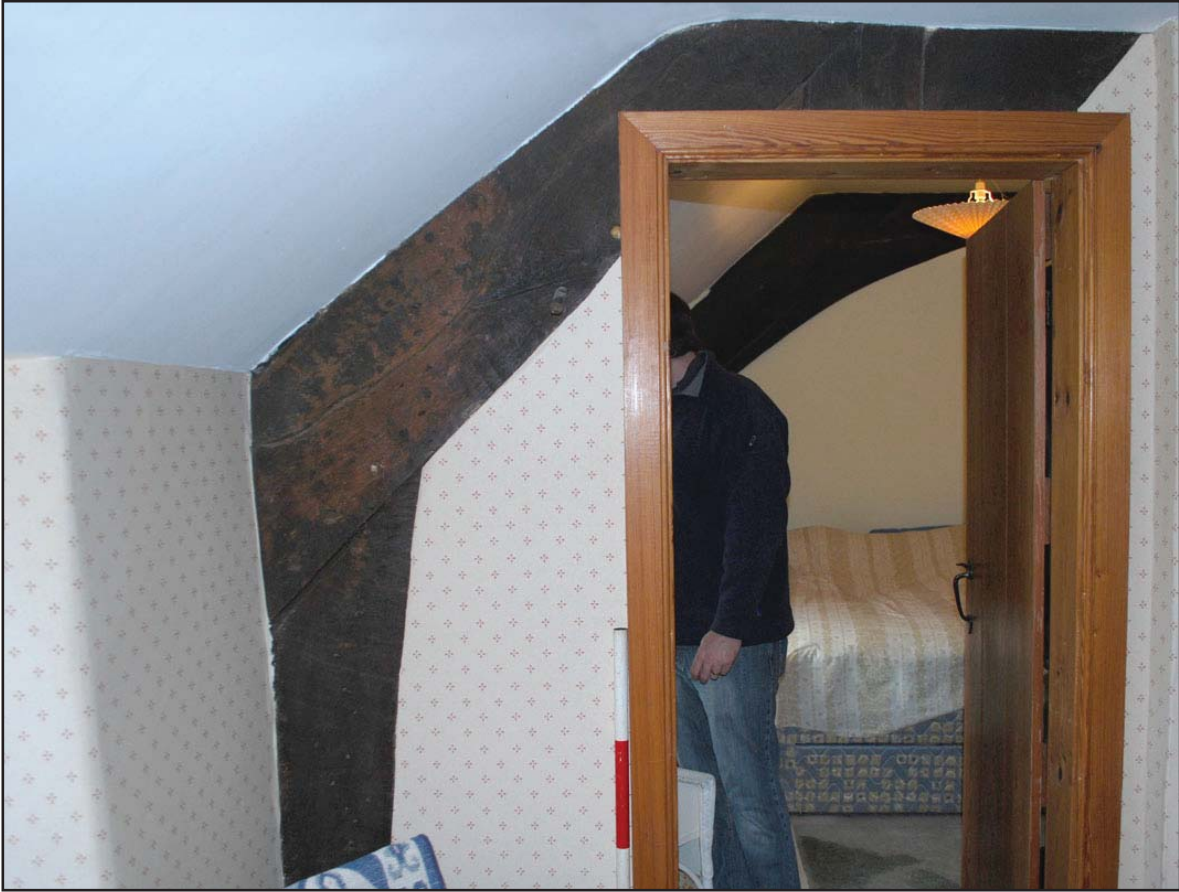
Plate 9: The eastern side of the northern face of the central cruck which forms the southside of the screens passage; view from the north.

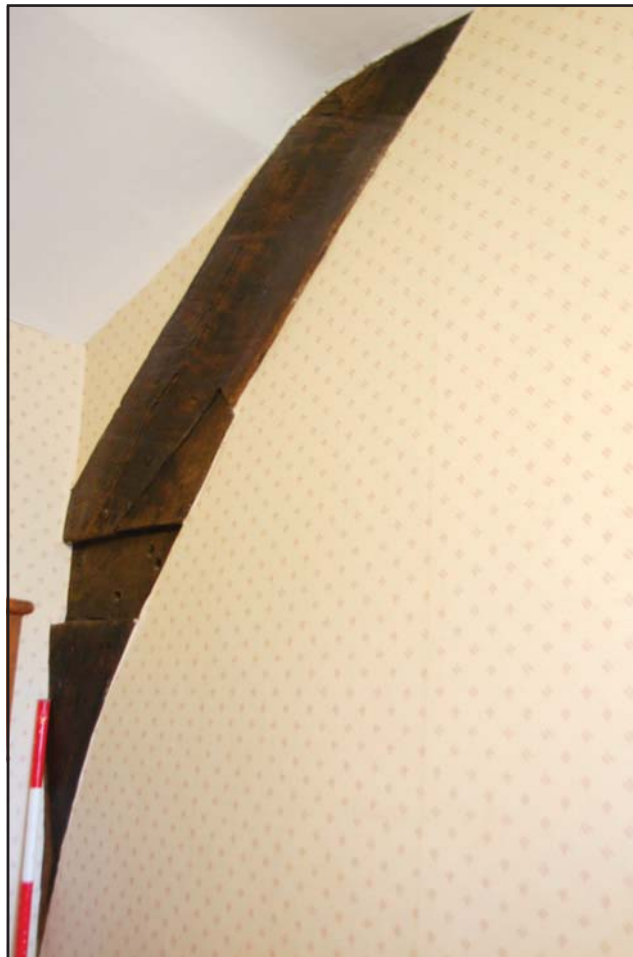
The northern passage cruck is different again. Here the principles are jointed onto vertical wall plates, but there is no collar beam visible, nor any bracing. A housing for a tie beam, however, lies across the cruck joint on the south face – an odd arrangement, but possibly original. The tie beam has been removed, but a housing exists on both east and west sides. The different nature of this truss suggests the outer rooms were two storey (see plates 10 to 12).

Plate 10: The eastern side of the southern face of the northern cruck which forms the southside of the screens passage

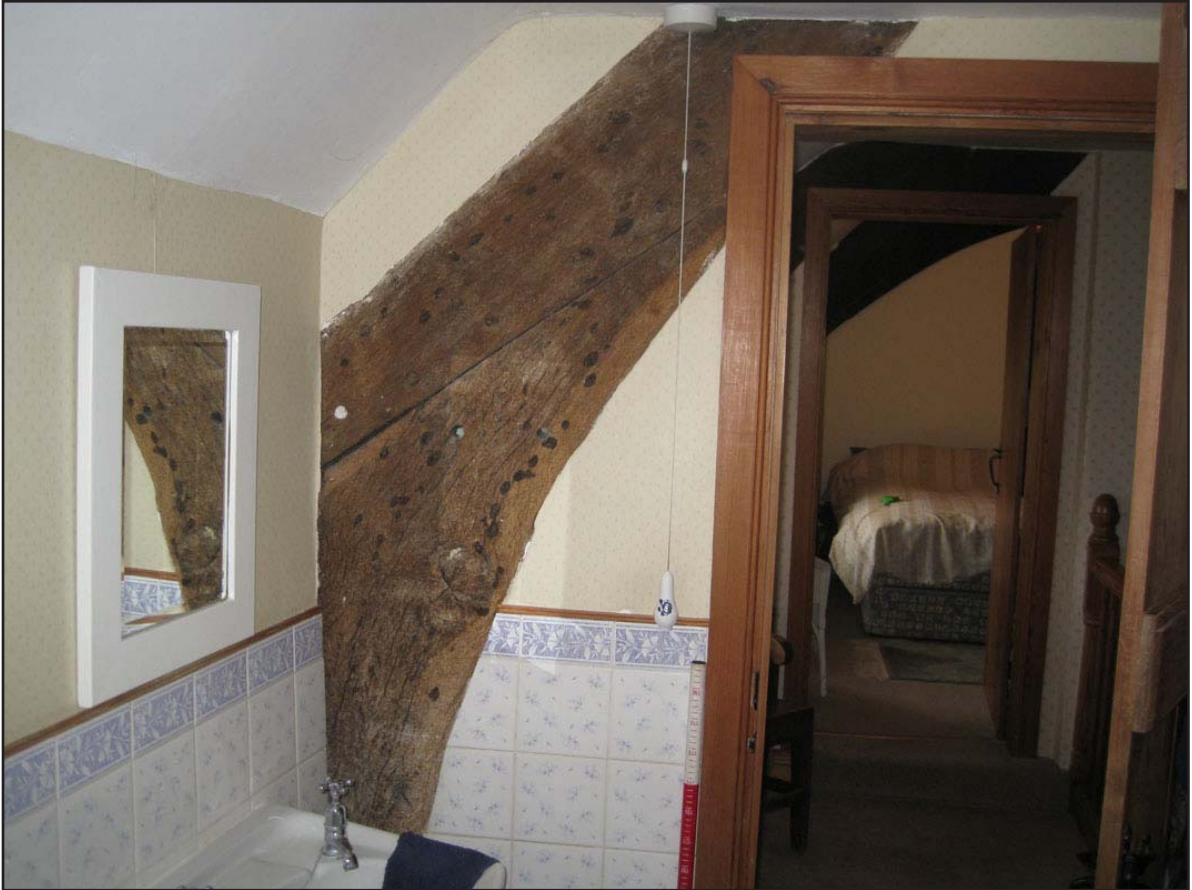
Plate 11: The eastern side of the northern face of the northern cruck which forms the northside of the screens passage; view from the north.

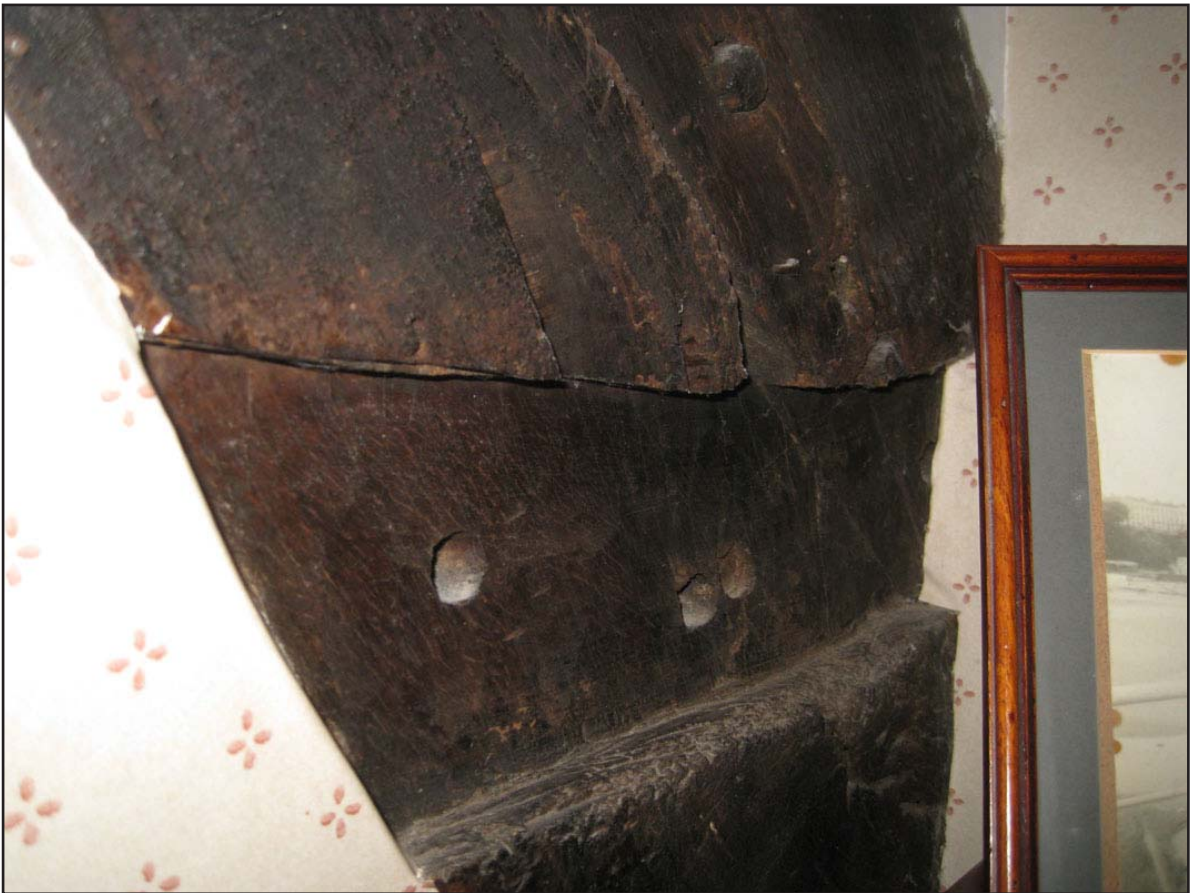
Plate 12: Close up of the housing for a tie beam on the eastern side of the southern face of the northern cruck, which forms the southside of the screens passage; view from the south.
