Mathern Palace Mathern MONMOUTHSHIRE

Archaeological survey of the roof.

**Mathern Palace, Mathern, Monmouthshire:
Archaeological Survey of the Roof, HAS 816 2009**

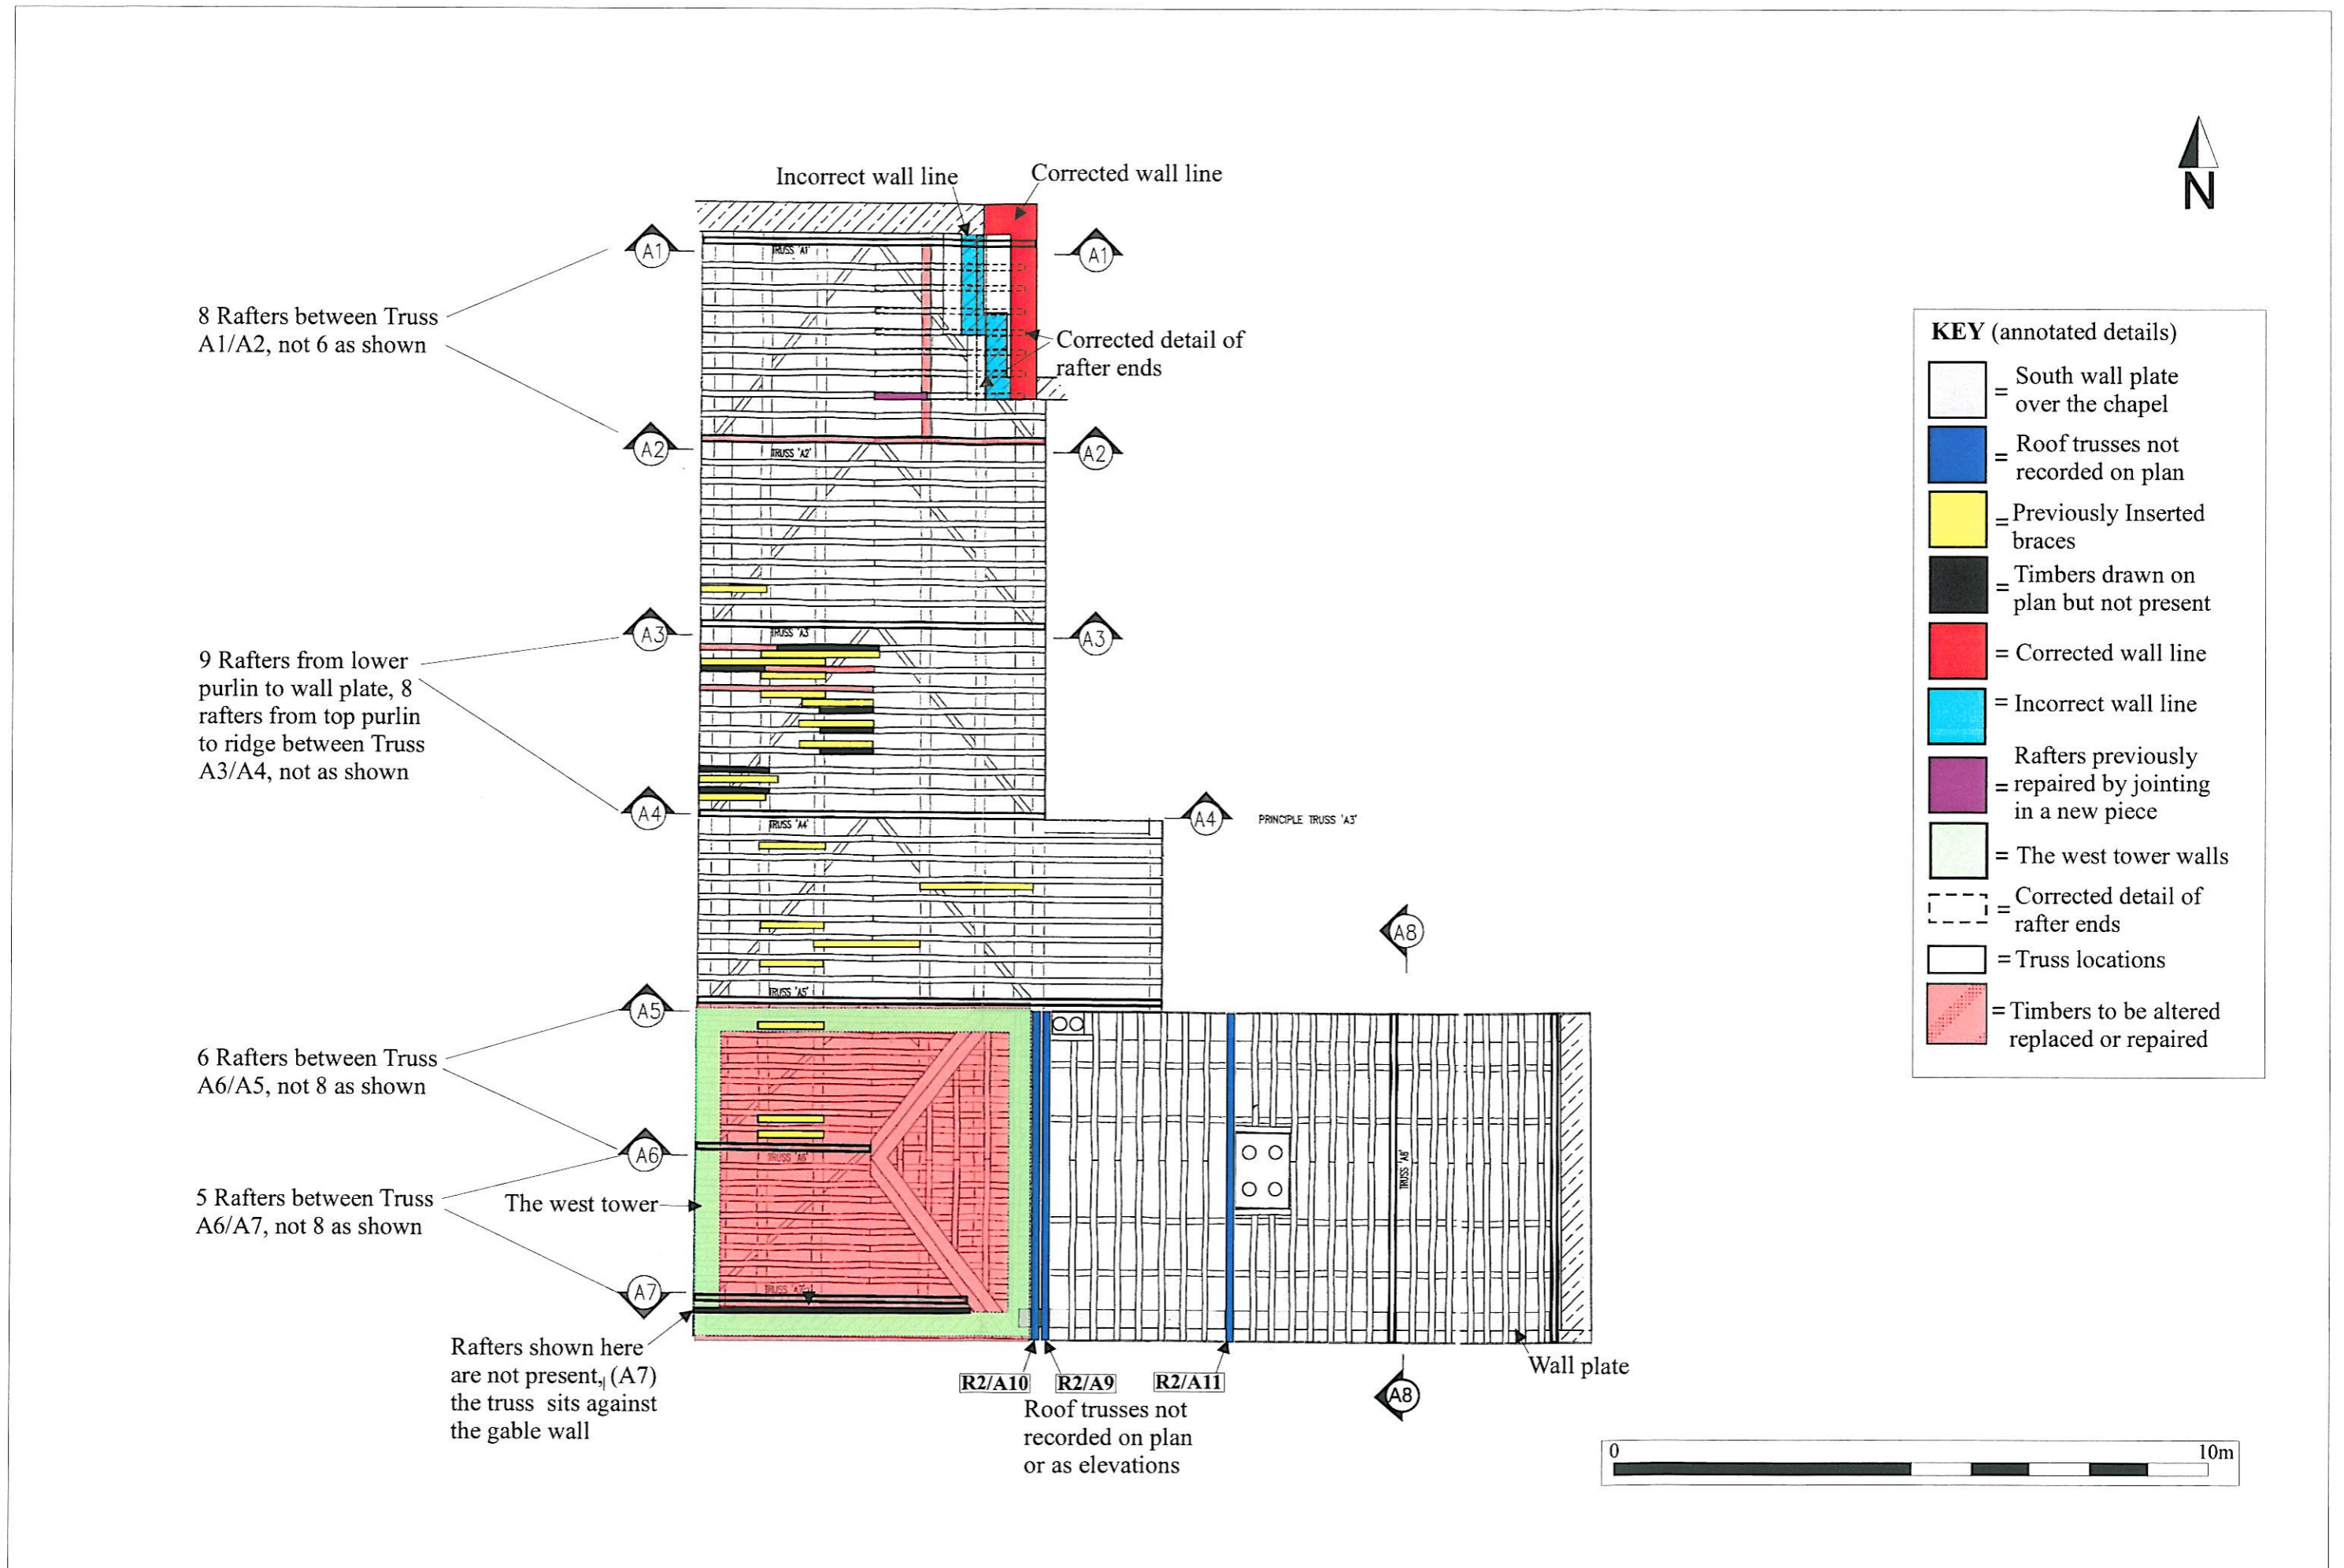
Mathern Palace, Roof 2, annotations to the architects drawings (at 1:100 scale), Figure 7.

Roof 2 was "L" shaped in plan (Figure 6) and covered the early 16th century chapel (thought to have been built by Bishop Miles Salley), and the wing on the adjacent north side. The recording of the roof involved looking for original or potentially early roof timbers, annotating any additional detail to the Architect's drawings (Figure 7), taking digital photographs and additional site notes as necessary.

Access to the roof space had to be gained through a hatch in the bathroom of the Directors suite. A few features had to be added to the Architect's drawings, there were for example too many or too few rafters in some of the roof bays. The short braces that had been added to the rafters as part of an earlier phase of repairs had not been recorded, and three roof trusses had been located on the roof plan, but had not been recorded (ie labelled or drawn in elevation).

Inspection of the exposed wall plate on the south side of the building showed that parts of the timber had either suffered from woodworm, or had rotted away and were crumbling to dust, leaving only the outer face of the timber intact.

The west end of the wall plate was rotten to 2.10m along its length. From inspection it was evident that the wall plate had consisted of two pieces of timber that had been jointed (mortice and tennon) and pegged together just to the west of the large early 16th century window on the south facing elevation of the chapel. The join in the wall plate was located at approximately 4.60m to the west of the east gable of the chapel.

The wall plate appears (superficially) to be possibly the oldest remaining timber in Roof 2 (that was available for inspection at the time of the survey). However, its poor condition could be due to water damage rather than age. It seems likely that this timber would have been replaced, or at least repaired during the post 1894 renovations of the building.

Examination of the rafters on the west side of the roof showed that they were generally in a reasonable condition, although some had woodworm, or were rotten at the bottom. Packers (also affected by woodworm) had been nailed to the bottom ends of rafters (some had two packers). The packers appeared to have been added to level the bottoms of the rafters in order to straighten out the roofline. Some of the rafters had bowed out of shape under the weight of the roof.

At the west end of the chapel there is a partly dismantled tower hidden in the roof space. Located against the east face of the tower was a truss, not drawn or numbered on the Architect's drawings (labelled A9, Figure 7), that had dropped by about 9" (23cm) on its south end. The drop in the truss was due partly to the rotten wall plate, and partly to the tie beam having rotted at the bottom. The dropped truss had affected the roof over the tower, pulling it slightly out of shape, meaning that the roof over the tower required attention to correct its position. The trusses were all open with tie beams, except Truss A2 which had a strut (a repair) supporting the principle rafter on the east side.

A second, newer truss (A10) was located immediately on the west side of A9 but was not visible from outside and therefore it was not possible to see whether this truss had also

moved, or whether it had been put in to alleviate the problem caused the movement of A9.

1.) The south wall plate of Roof 2.

The timber/s would require at least repair, if not complete replacement. As the wall plate was not accessible to record by drawing at 1:20 scale at the time of the initial survey, it was agreed that the wall plate would be carefully removed and set aside for detailed drawn records to be made at a later date. Unfortunately the three foot long section disintegrated on removal.

2.) Rafters on the west side of Roof 2.

Three rafters on the west side of the roof between trusses A3 and A4 needed to be replaced.

3.) Truss A2.

The east principle rafter of the truss needed replacing.

4.) The roof over the tower.

The whole of the roof over the west tower needed to be re-built to correct the twist caused by the truss (R2/A9) dropping.

5.) A purlin on the east side of the roof, between trusses A1 and A2 needed replacing.

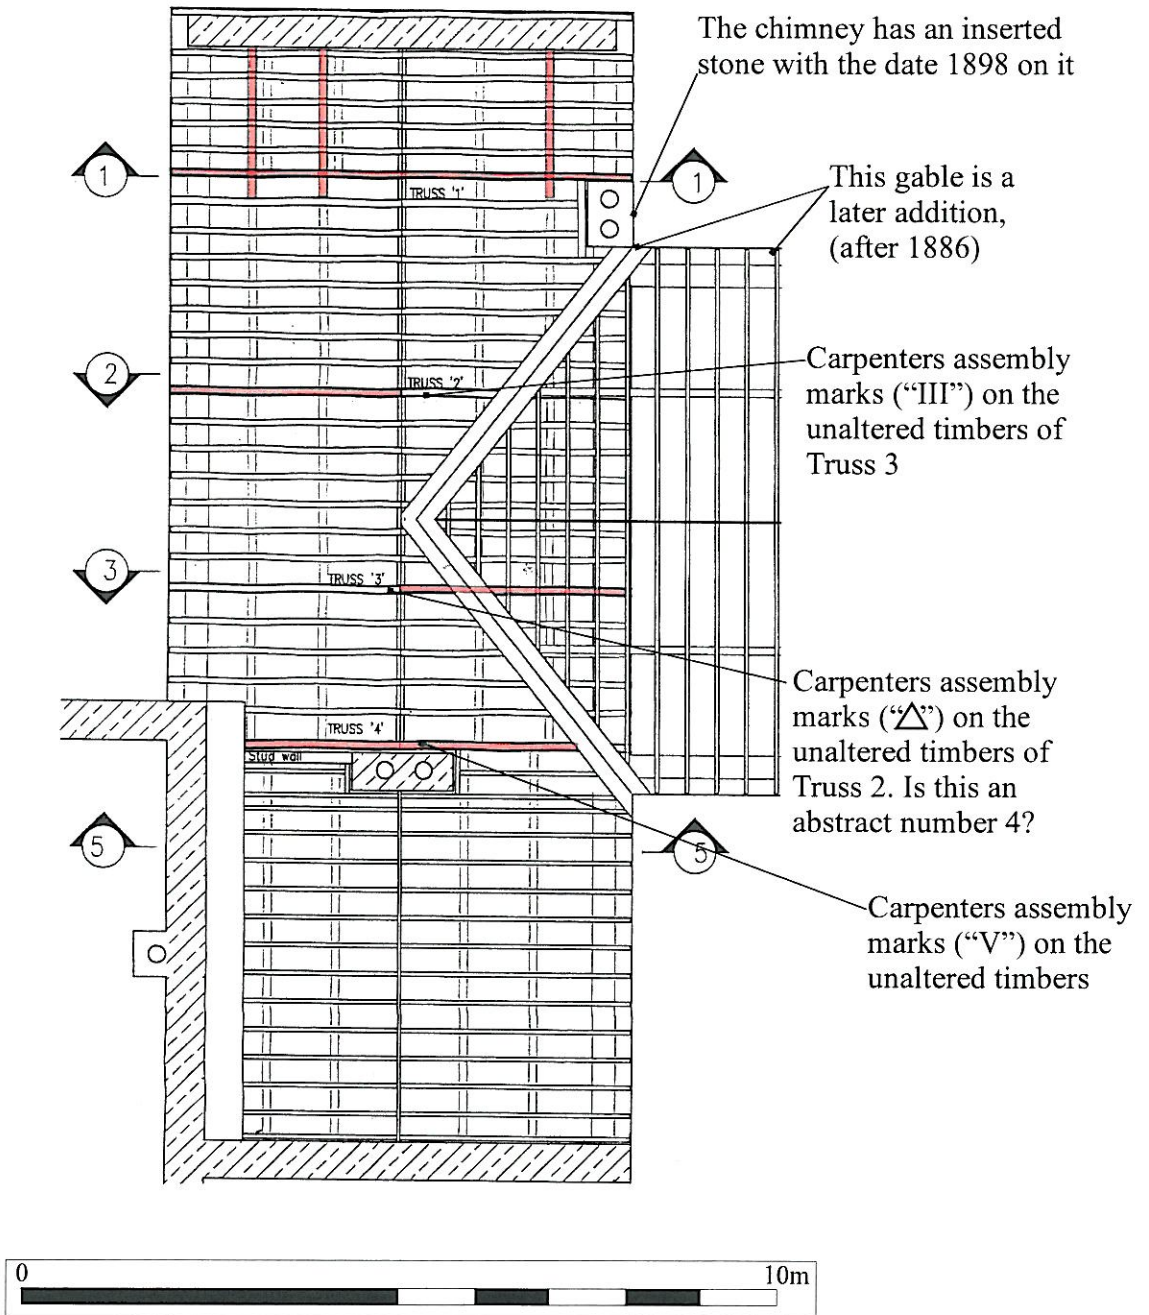
Mathern Palace, Roof 3, annotations to the architects drawings (at 1:100 scale), Figure 8.

A site visit was made to inspect roofs 3 and 4 after the necessary repairs had been carried out. The rafters, purlins and trusses were surveyed and on close inspection it appeared that parts of the roof structure may be original to this part of the building, or at least they appear to predate the 1890s restoration.

Four trusses (trusses 1-4) were located in Roof 3 between the west gable and a chimney in the roof space that appear to be possibly original. The four trusses were alike in style (collar and tie beam) and had sequential Roman numerals (Truss 1= "I", Truss 2= "II", Truss 3="△", Truss 4= "V").

Truss 5 was located on the eastern side of the chimney. The truss was modern and of a different style (low collar, no tie beam) to the others in Roof 3 (described above). The roof level beyond the chimney (including Truss 5) was lower than the roof on the west side of the chimney. No alteration was made to Truss 5. The entire roof structure in the east end of Roof 3 appeared to be of fairly new timber, and Truss 5 was the only truss in this end of the roof.

A now redundant purlin located low on the North side of the roof (Roof 3) must be original, or at least it predates the construction of the north gable as its position blocks access to that part of the roof, and would make no sense as being part of that phase of work. It seems reasonable to assume that some of the rafters in the main part of the roof are also original.

All the trusses in Roof 3 were repaired, (except for Truss 5) with new timbers as part of the present phase of works. Timbers of Roof 3 that were replaced (see Figure 8) included the following;

- 1.) **Truss 1**, located at the west end of the roof was entirely replaced with new timber, in the same style as the "original".
- 2.) **Truss 2**, Truss 2 had its west principle rafter and tie beam replaced. Truss 2 had carpenters assembly marks ("III") remaining on all the unaltered corresponding timbers.
- 3.) **Truss 3**, Truss 3 had its east principle rafter and tie beam replaced and had carpenters assembly marks ("II") remaining on all the unaltered timbers.
- 4.) **Truss 4**, located at the east end of the roof had been completely replaced (except for the collar) in new timber, the same as the "original".

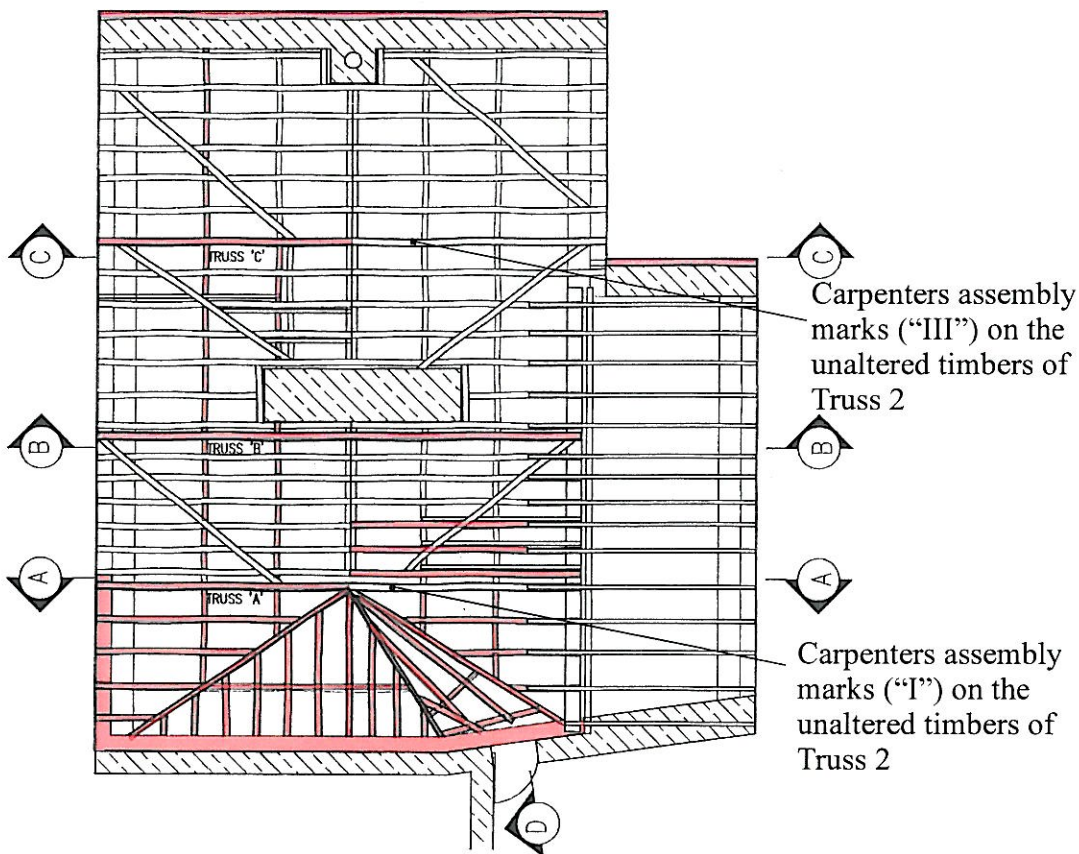
Mathern Palace, Roof 4, annotations to the architects drawings (at 1:100 scale), Figure 9.

The timber structure of Roof 4 was surveyed and recorded after the repairs had been carried out. There were three trusses in the roof space, all of similar style, with single collars and tie beam. The whole of the roof structure appeared to be modern, with the exception of trusses A and C (I and III), which possibly predate the 1890s renovation of the building.

The roof space in Roof 4 had been partly plastered, and whitewashed (perhaps it had been an attic room at some time). A horizontal edge to the whitewash across a central stone chimney implied a former ceiling level, there was also a vertical edge to a coat of plaster on one face of the chimney that appeared to indicate the position of a former partition. The configuration of the timber structure within the present roof did not appear to correlate with the whitewashed (ceiling?) line on the chimney.

All the visible timbers (except possibly trusses A and C) post dated the renovations of the 1890s. The roof space was recorded through annotations to the Architects plans and elevations and through digital photography.

Timbers of Roof 4 that had been replaced (see Figure 9) included the following;

- 1.) **Truss A**, located at the south end of the roof, had its west principle rafter replaced with new timber, to match the "original".
- 2.) The tie beam had already been replaced at an earlier, unknown date. The unaltered timbers (collar and rafter) had carpenters assembly marks ("I").
- 3.) **Truss B**, Truss "B" was entirely replaced with new timber matching the original.
- 4.) **Truss C**, Truss "C" had the principle rafter of the west side replaced. The unaltered timbers (tie beam, collar and rafter) had carpenters assembly marks ("III").

5.) **Wall Plate**, The wall plate in the south west angle of the roof had been repaired, this involved the complete replacement of the wall plate on the south wall and a partial replacement of the wall plate of the west wall, between Truss "A" and the south wall.

6.) **Rafters**, Most of the rafters between Truss B and the south wall were replaced with new timber. Rafters in the north gable were replaced, as was a short rafter adjacent to Truss C.
