Melingriffith Water Pump

Conservation and Refurbishment Works

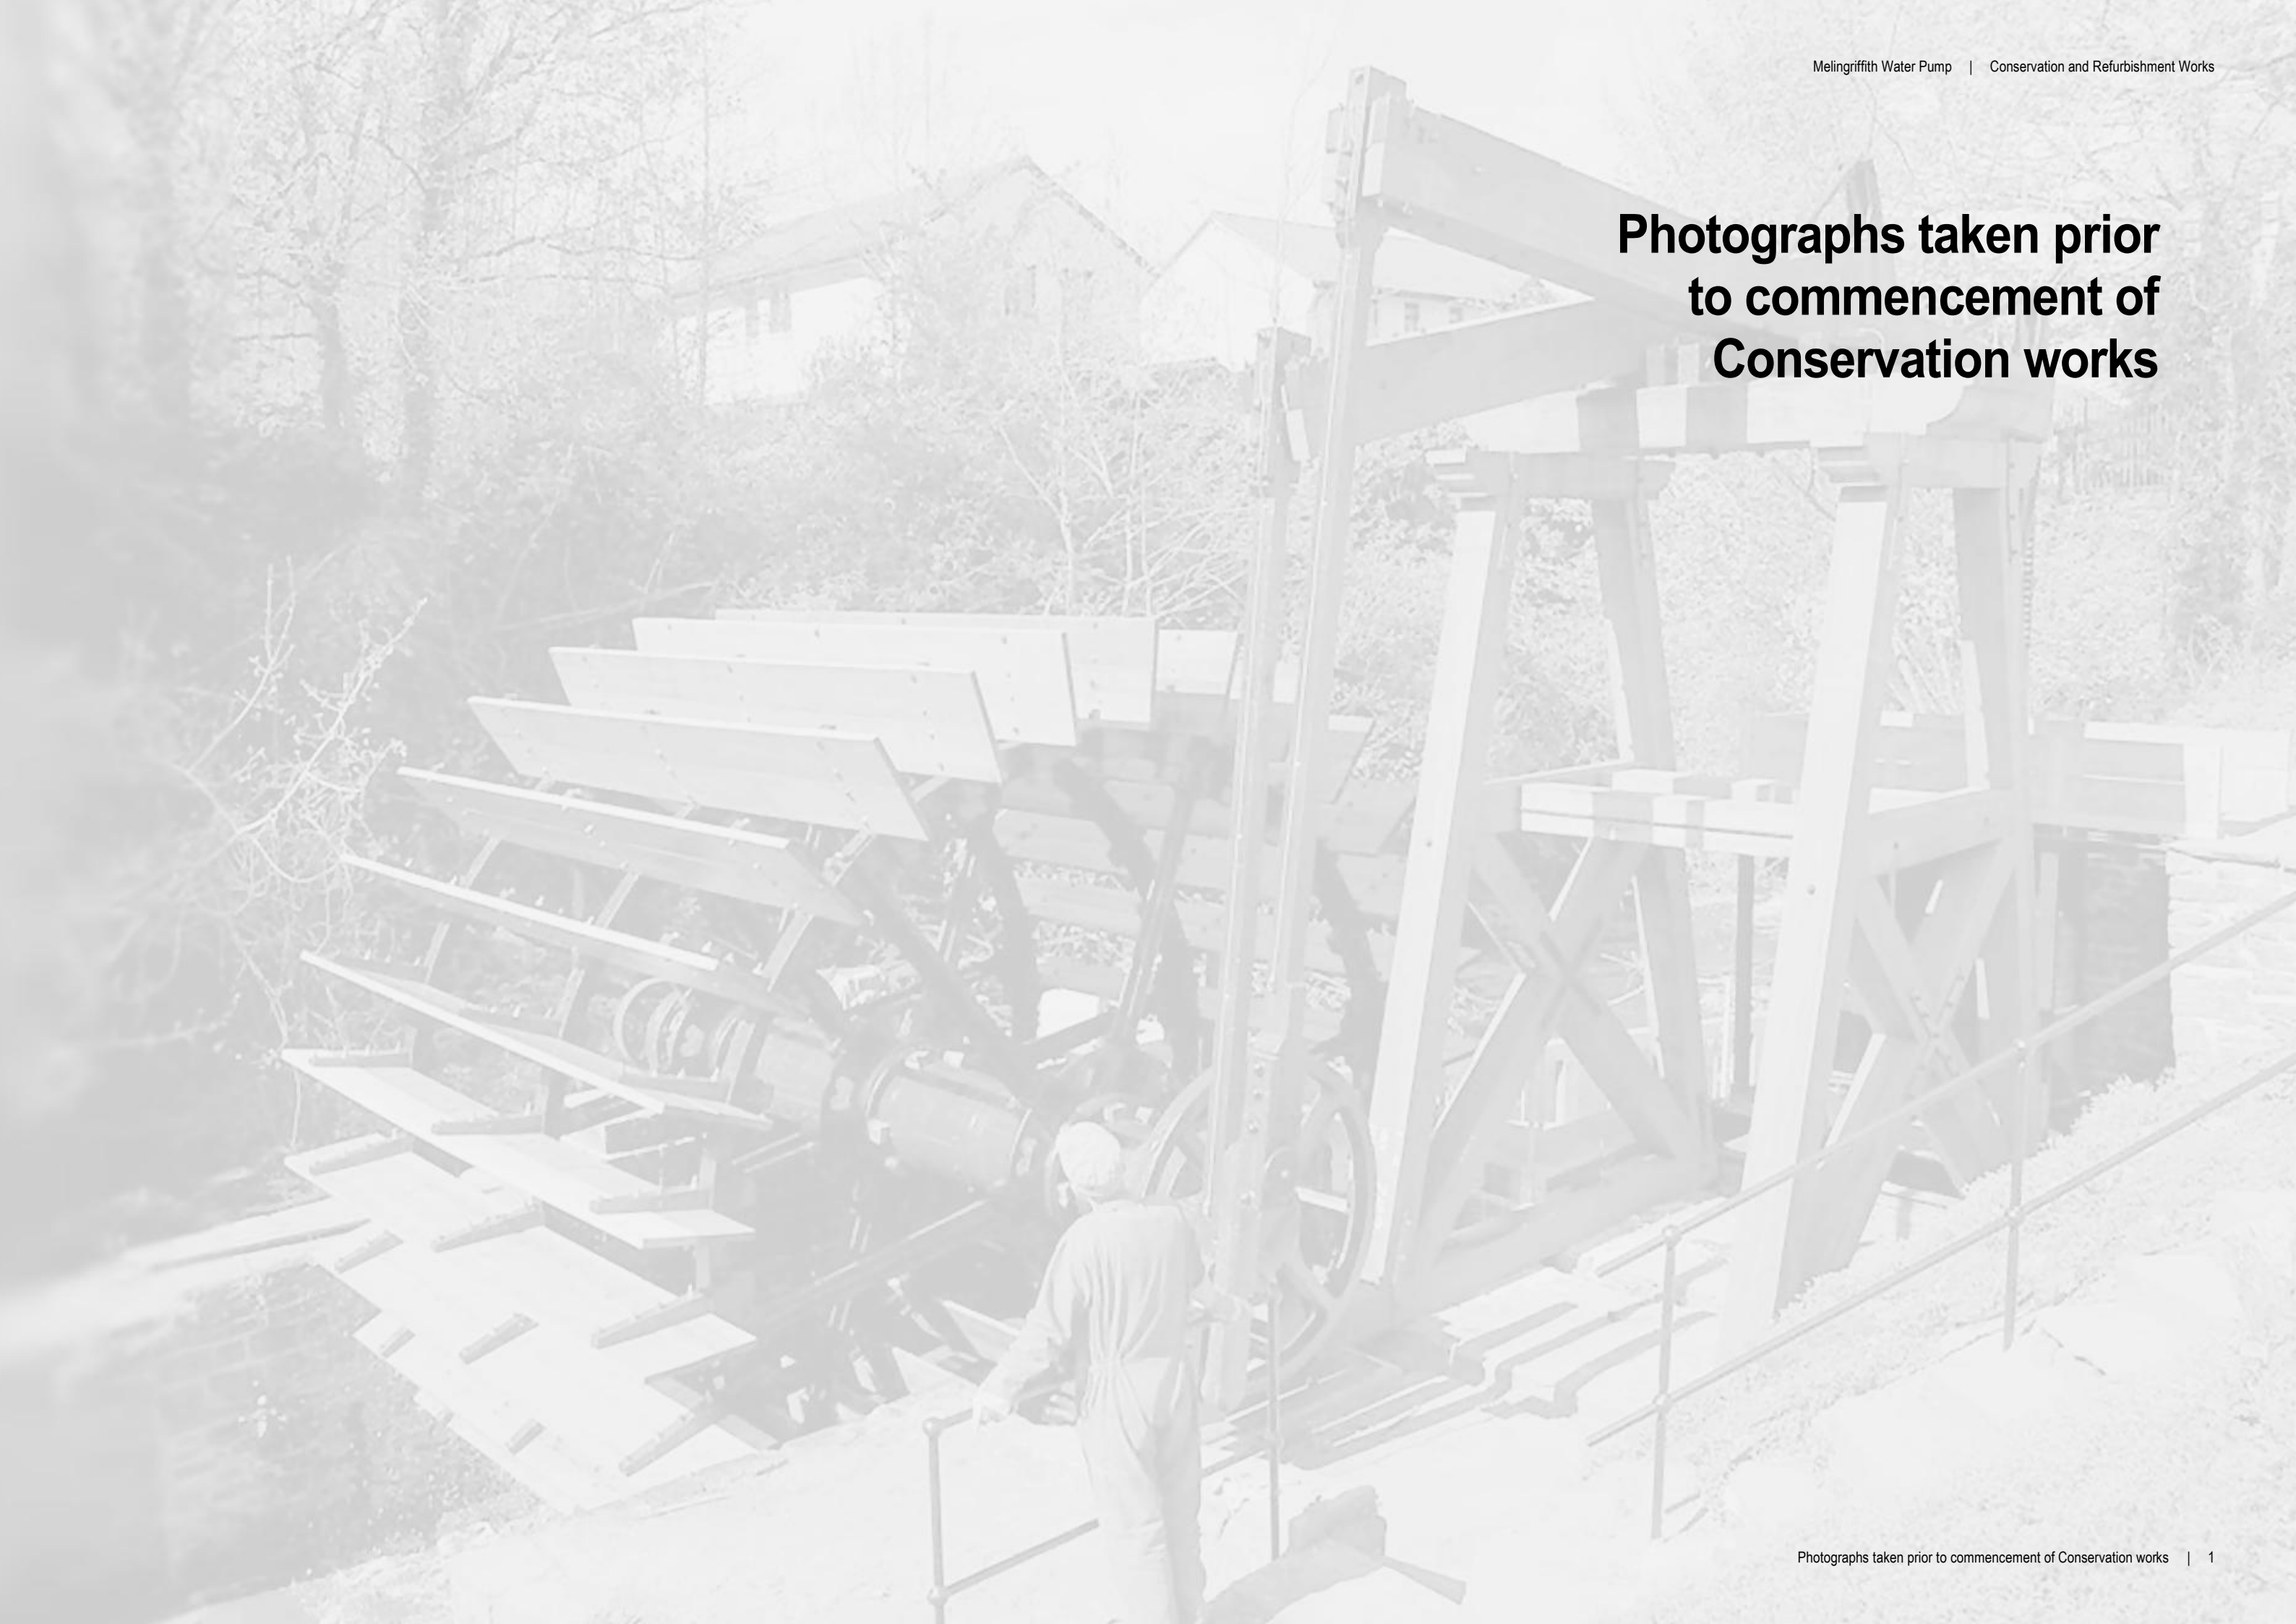
Photographs taken prior to commencement of Conservation works

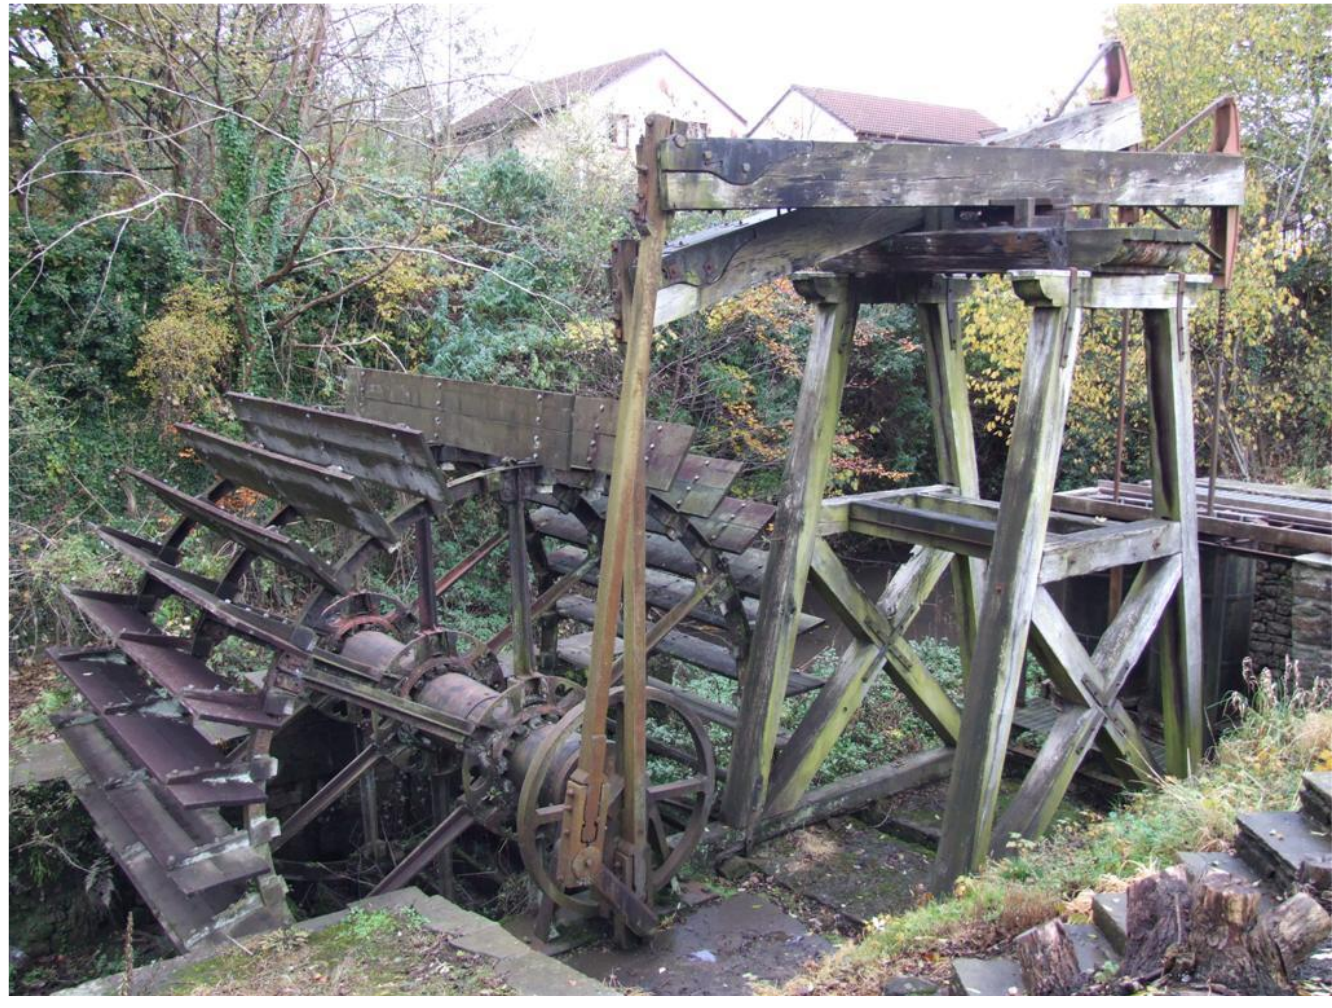
Fig 1 04/09/2008 View of the Wheel and Water Pump showing general dilapidated state of repair.

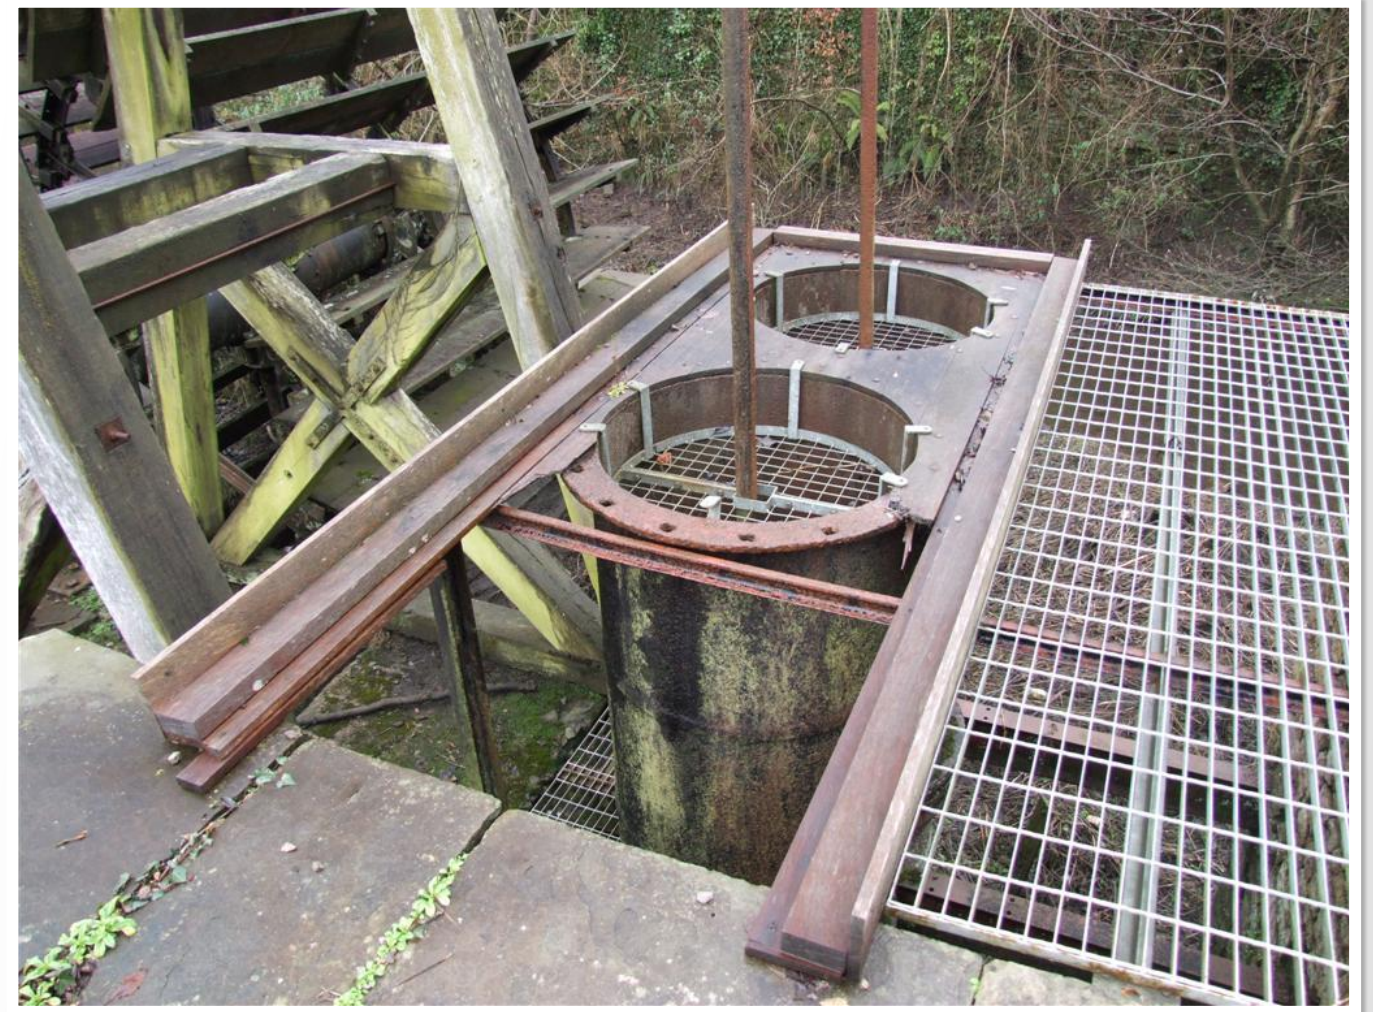
Fig 2 14/01/2009 Remains of the original timber Launder above the Pump cylinders.

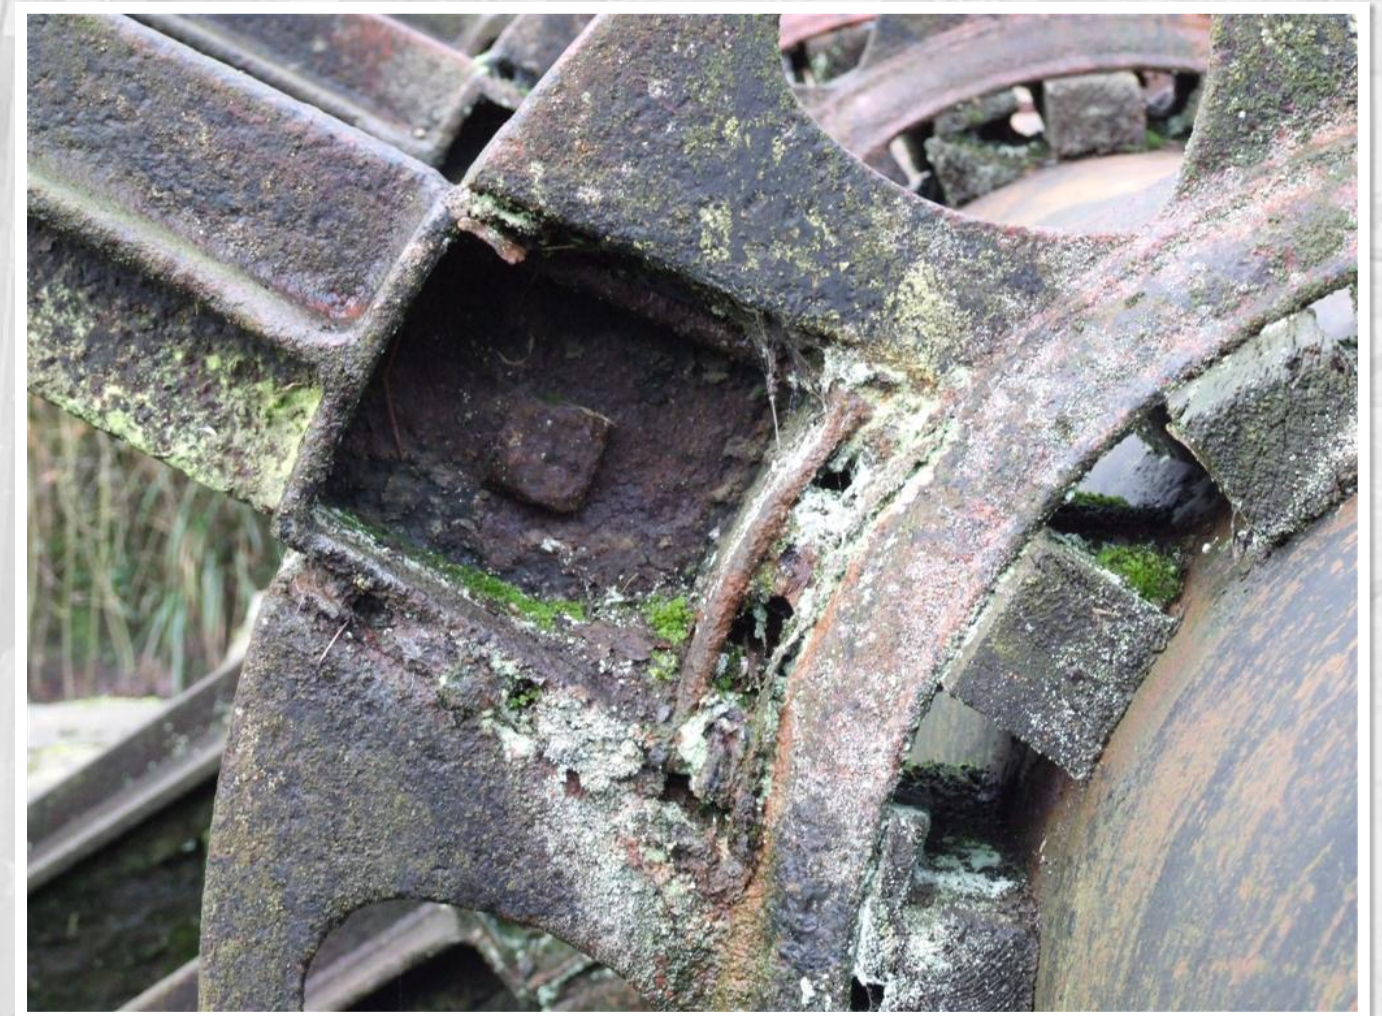
Fig 4 14/01/2009 Enlarged view showing the condition of the Wheel hub and shaft.

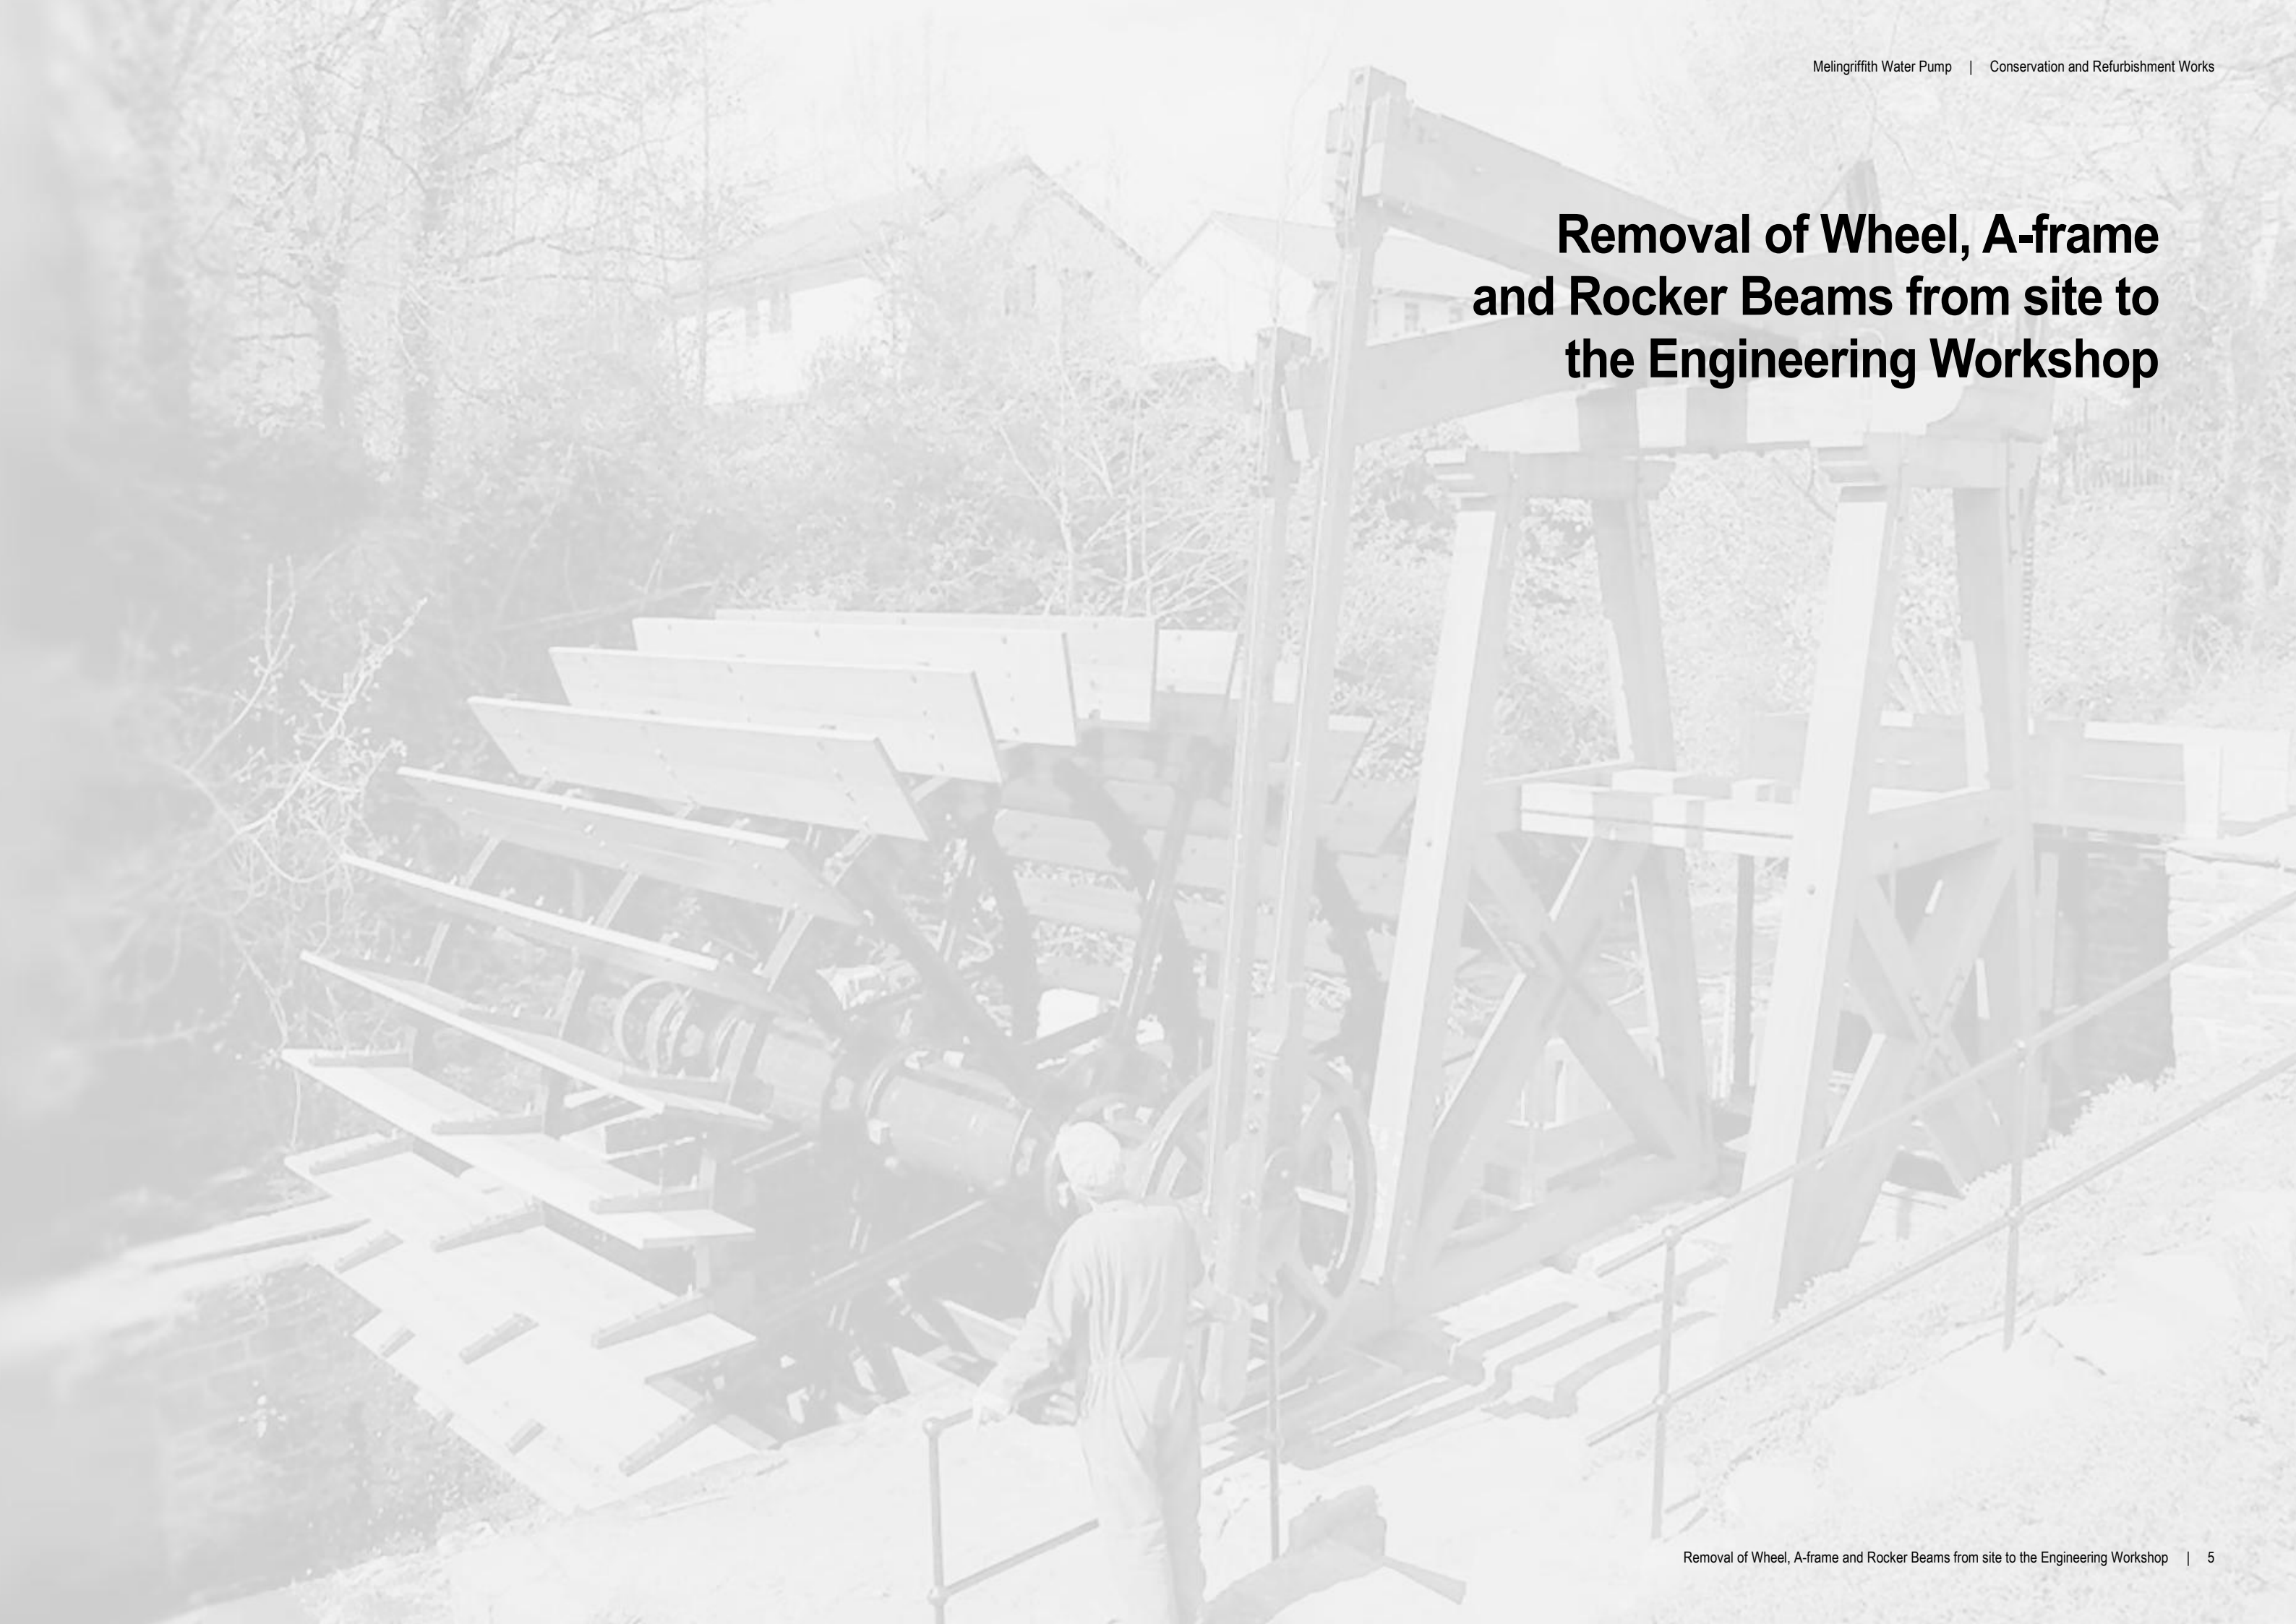
Removal of Wheel, A-frame and Rocker Beams from site to the Engineering Workshop

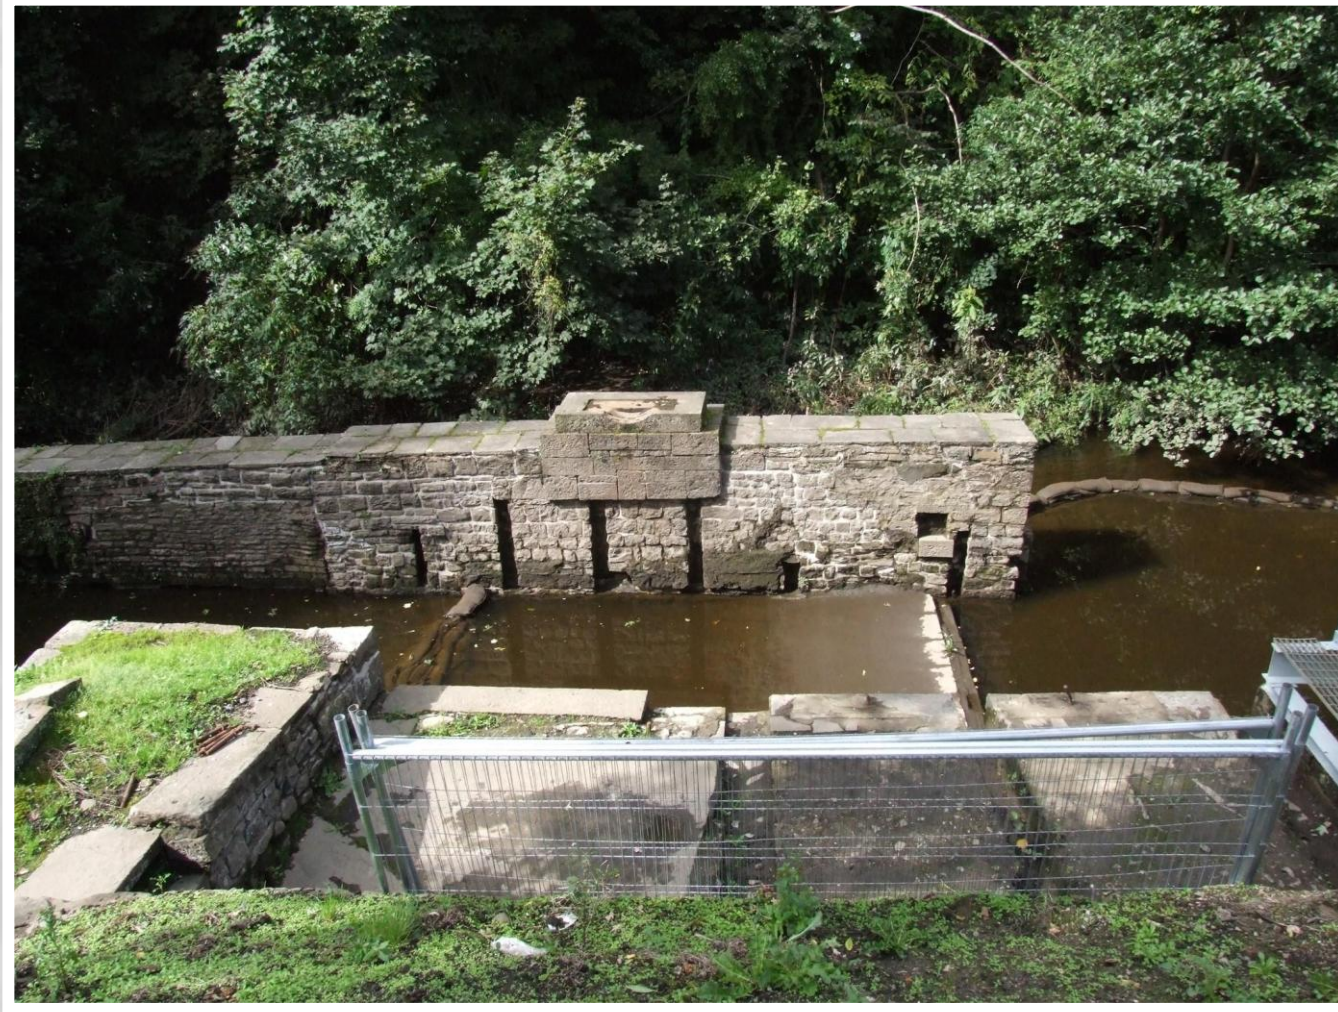
Fig 19 15/09/2010 View on Island wall following masonry conservation work to repair defective areas of original mortar pointing etc.

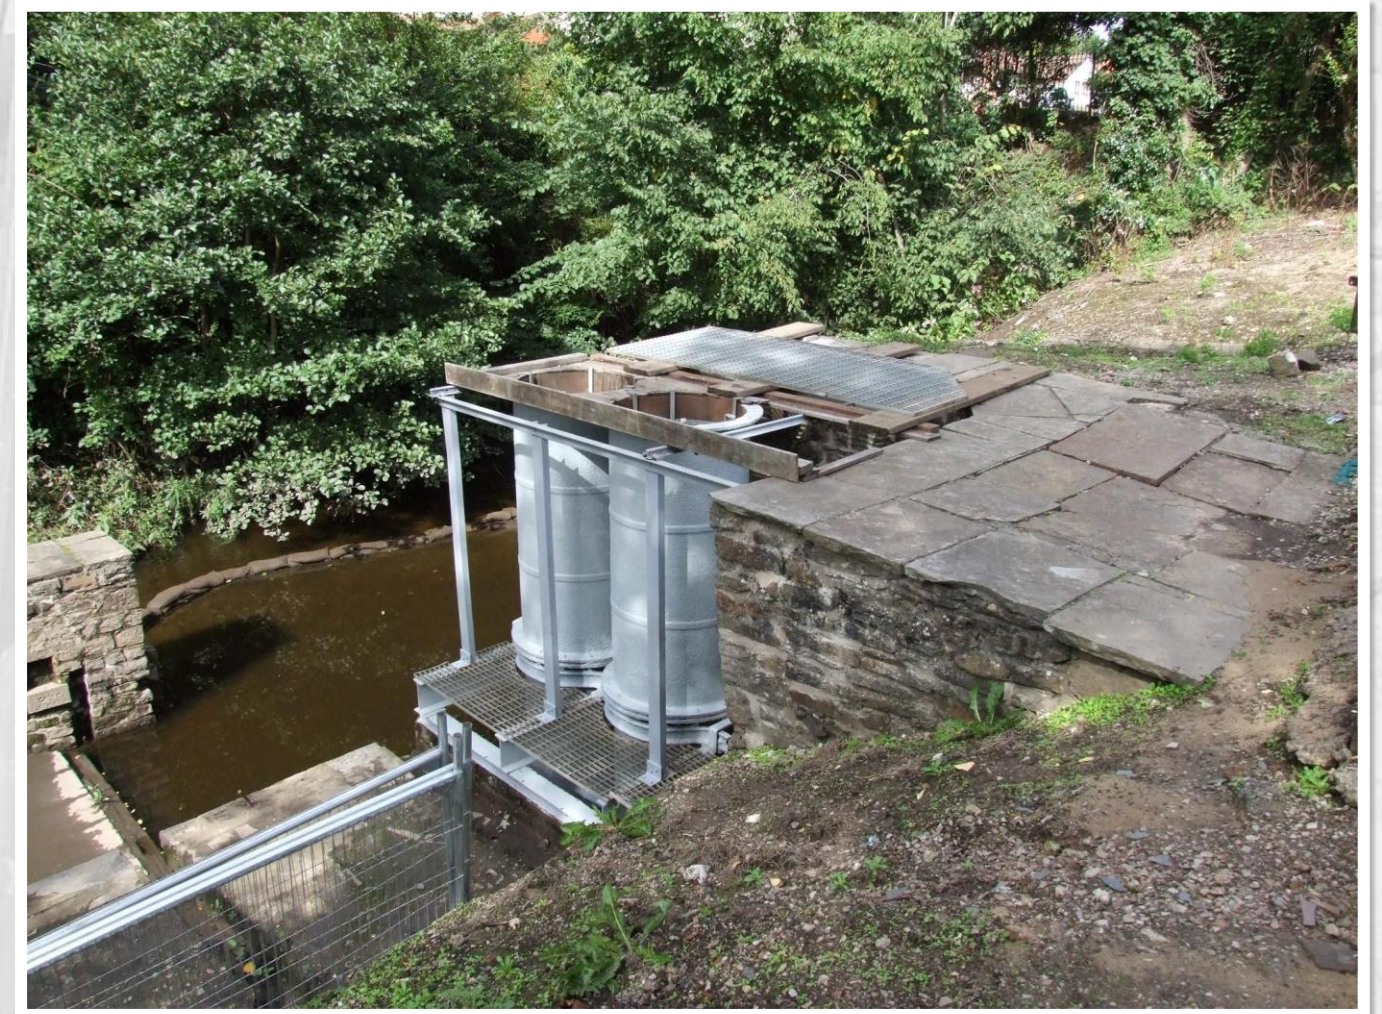
Fig 20 15/09/2010 Pump cylinders following cleaning by hand and coat of primer ready for decoration.

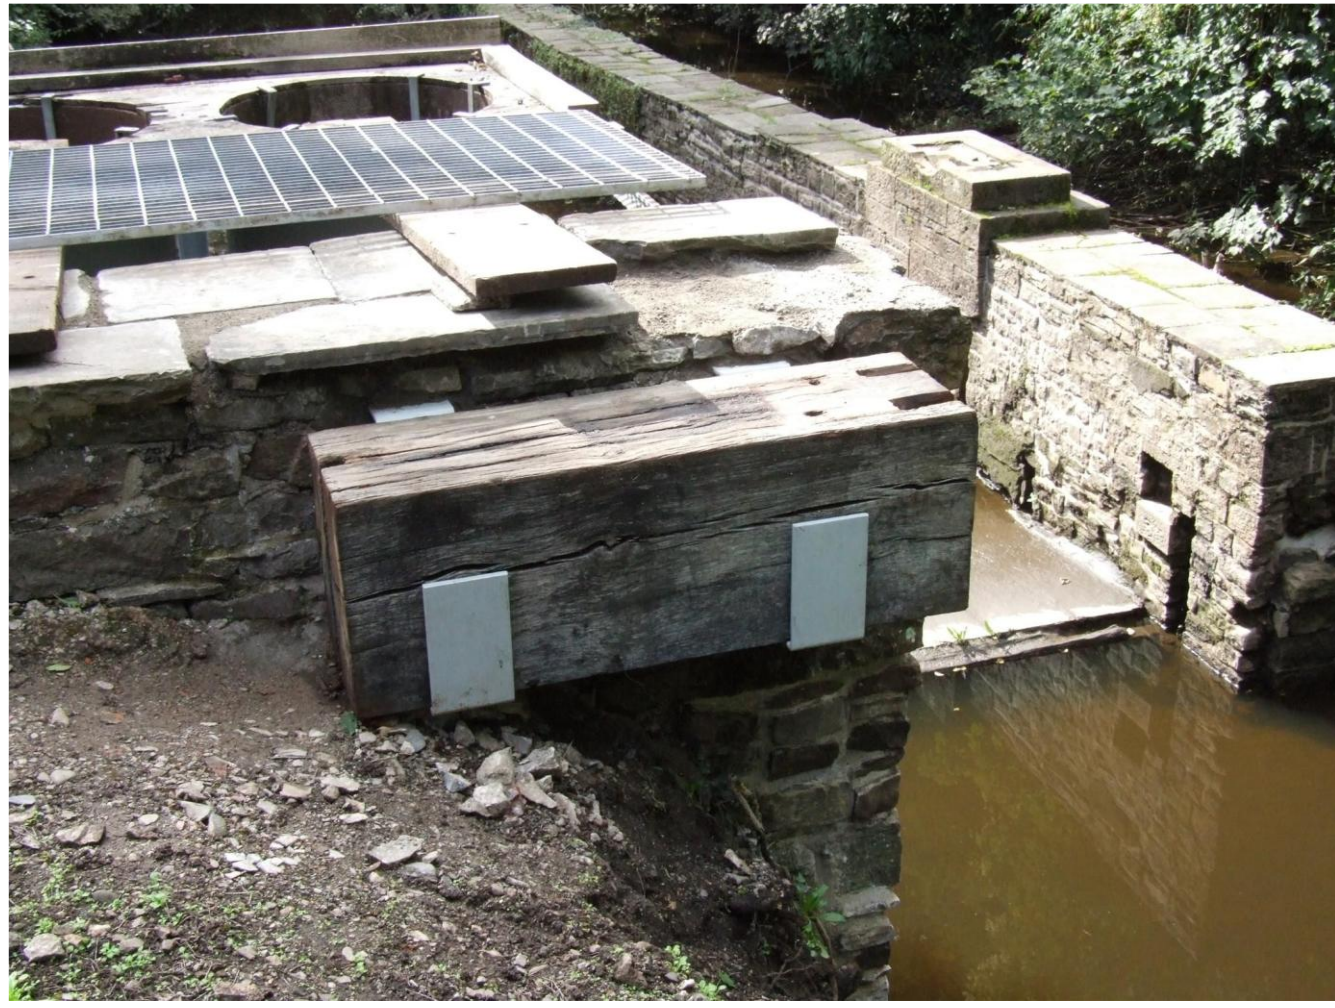
Fig 21 15/09/2010 Original Rocker Beams ends returned to site and mounted onto the wall adjacent the Pump cylinders. Metal brackets secured to the wall with resin anchors. Rocker Beams returned as part of the Bat Licence mitigation works. Beam ends also received replica metalwork to match original curved metalwork (not shown).

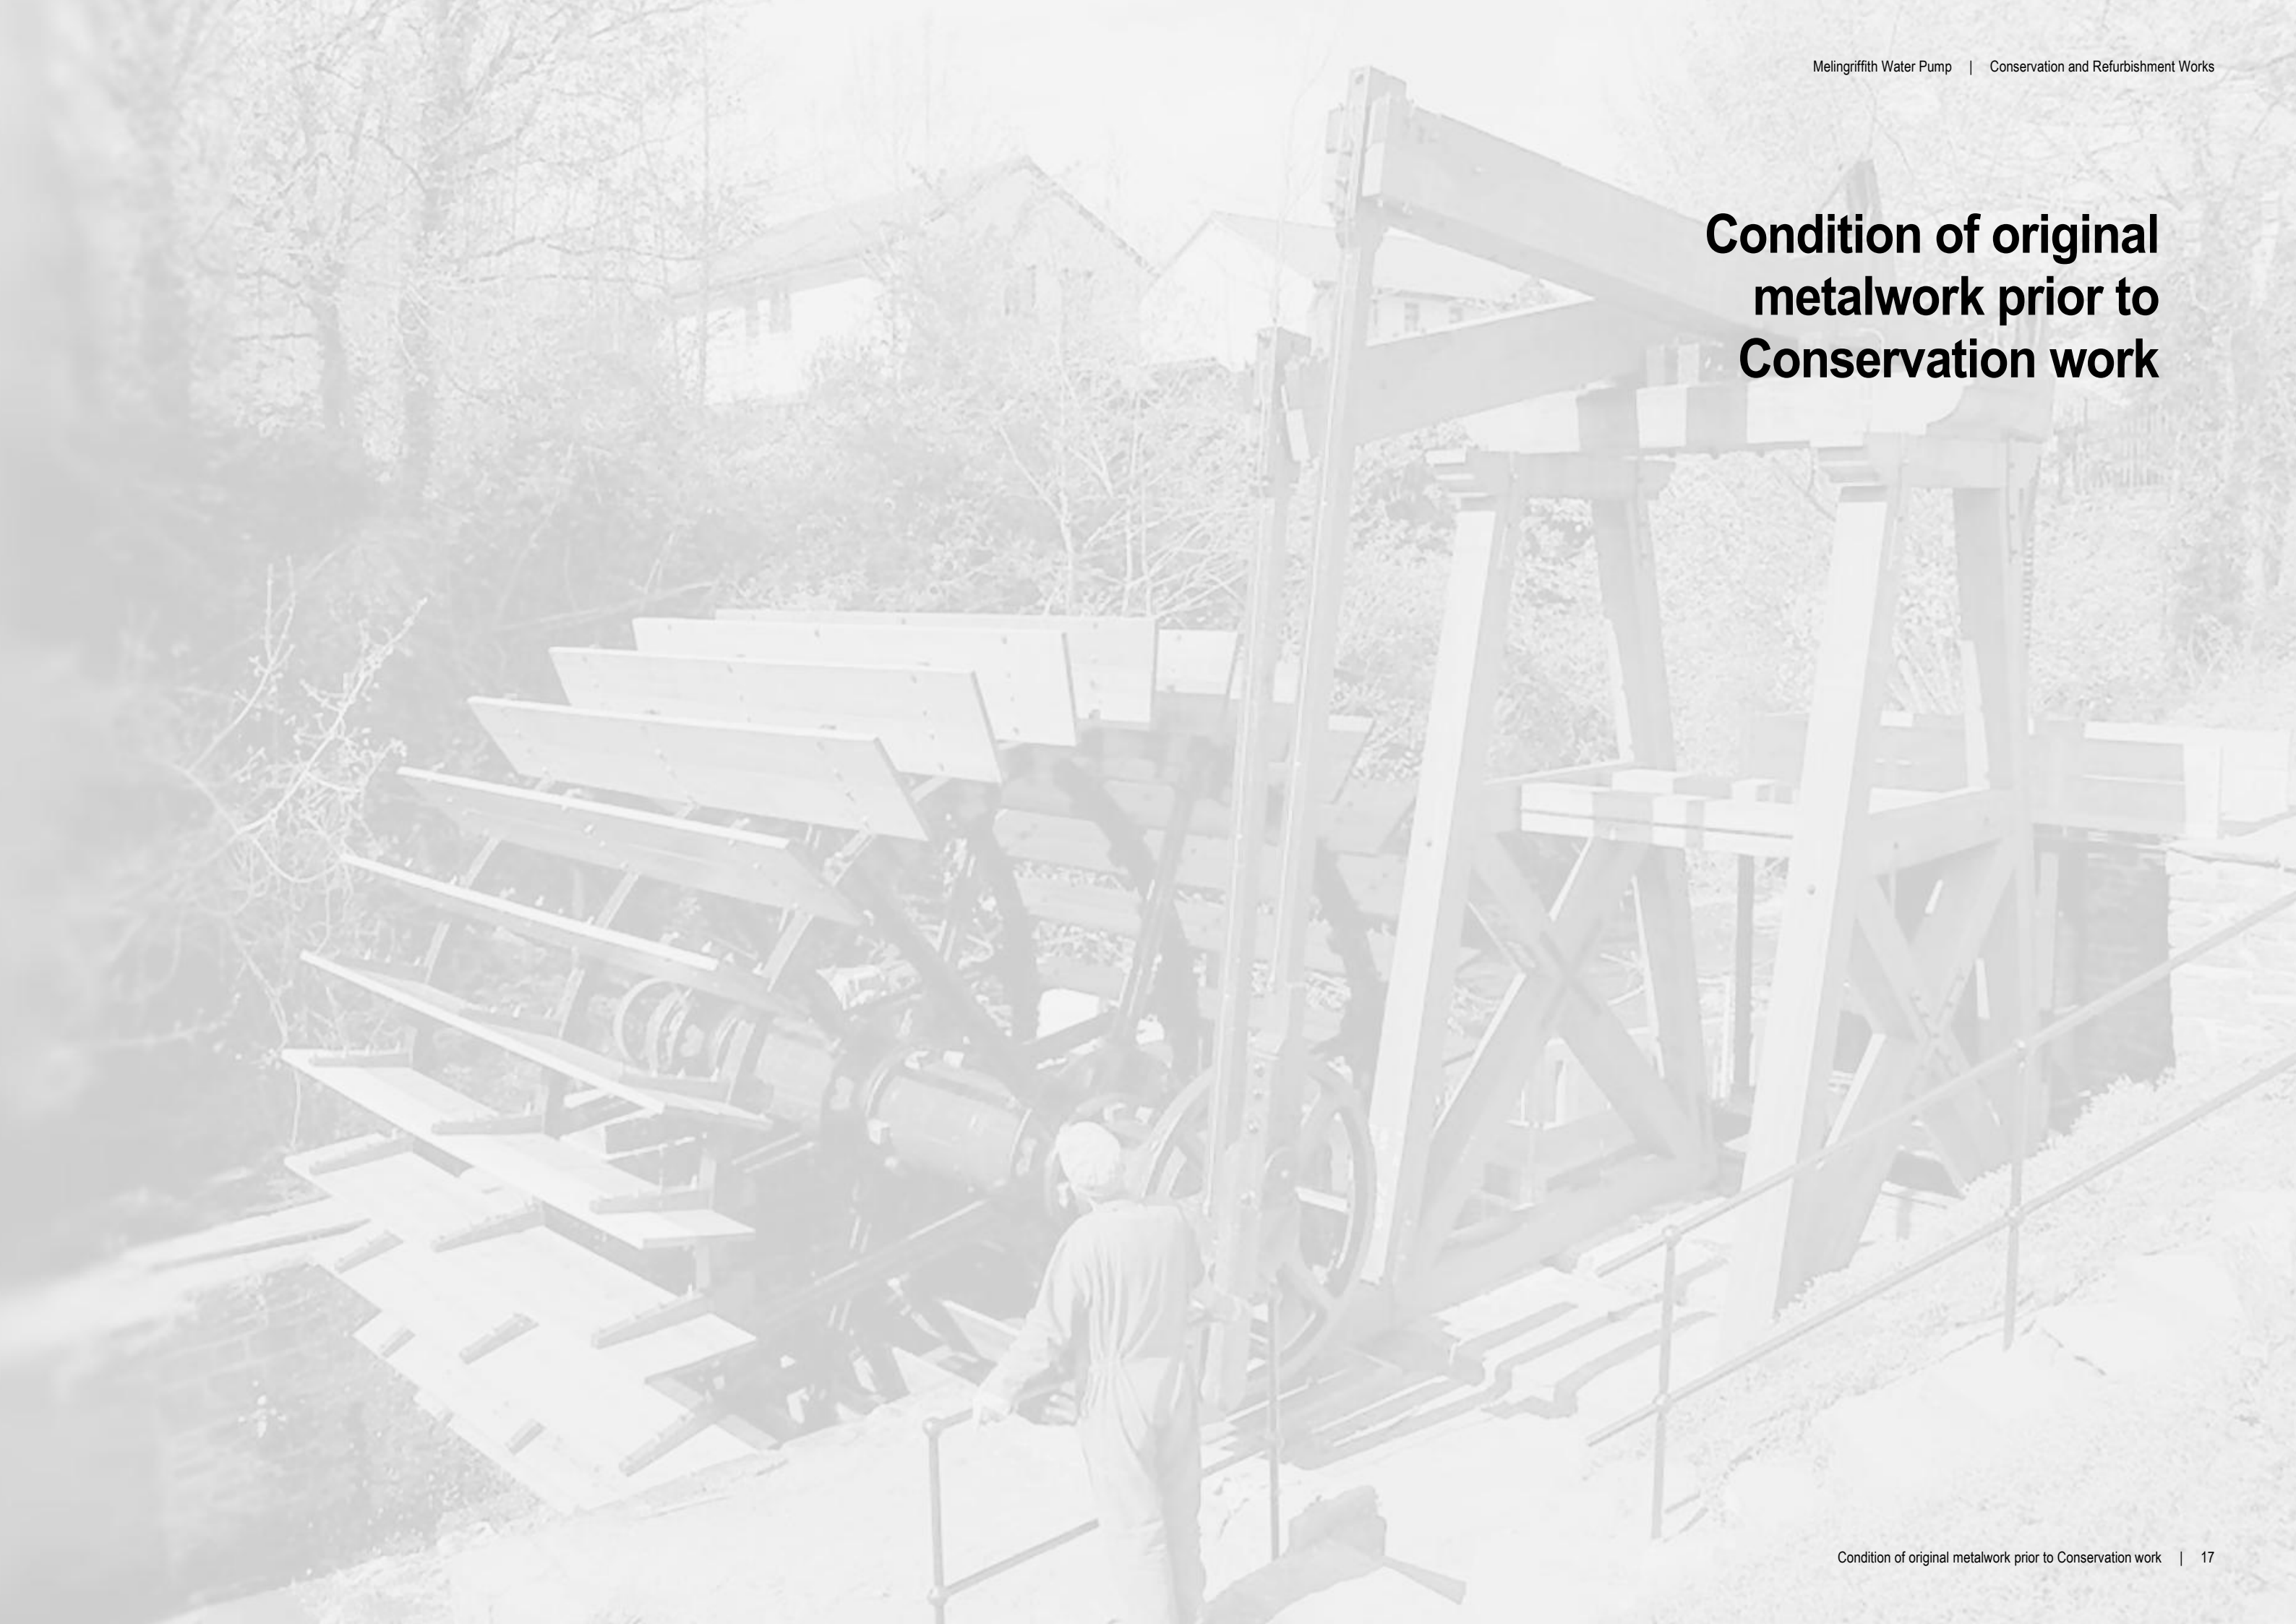
Condition of original metalwork prior to Conservation work

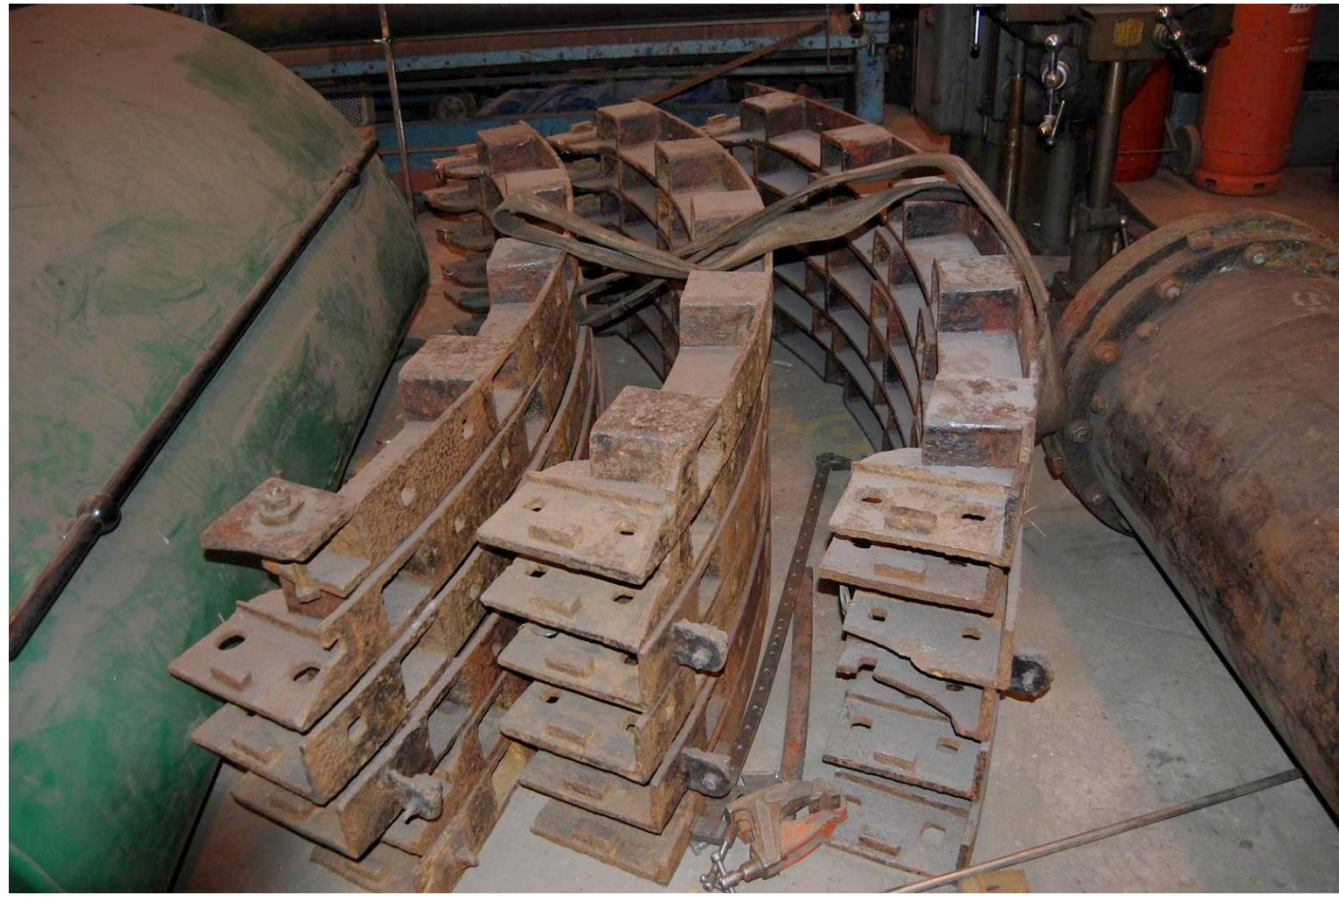
Fig 22 11/05/2010 Wheel Rim sections stacked ready for cleaning by hand.

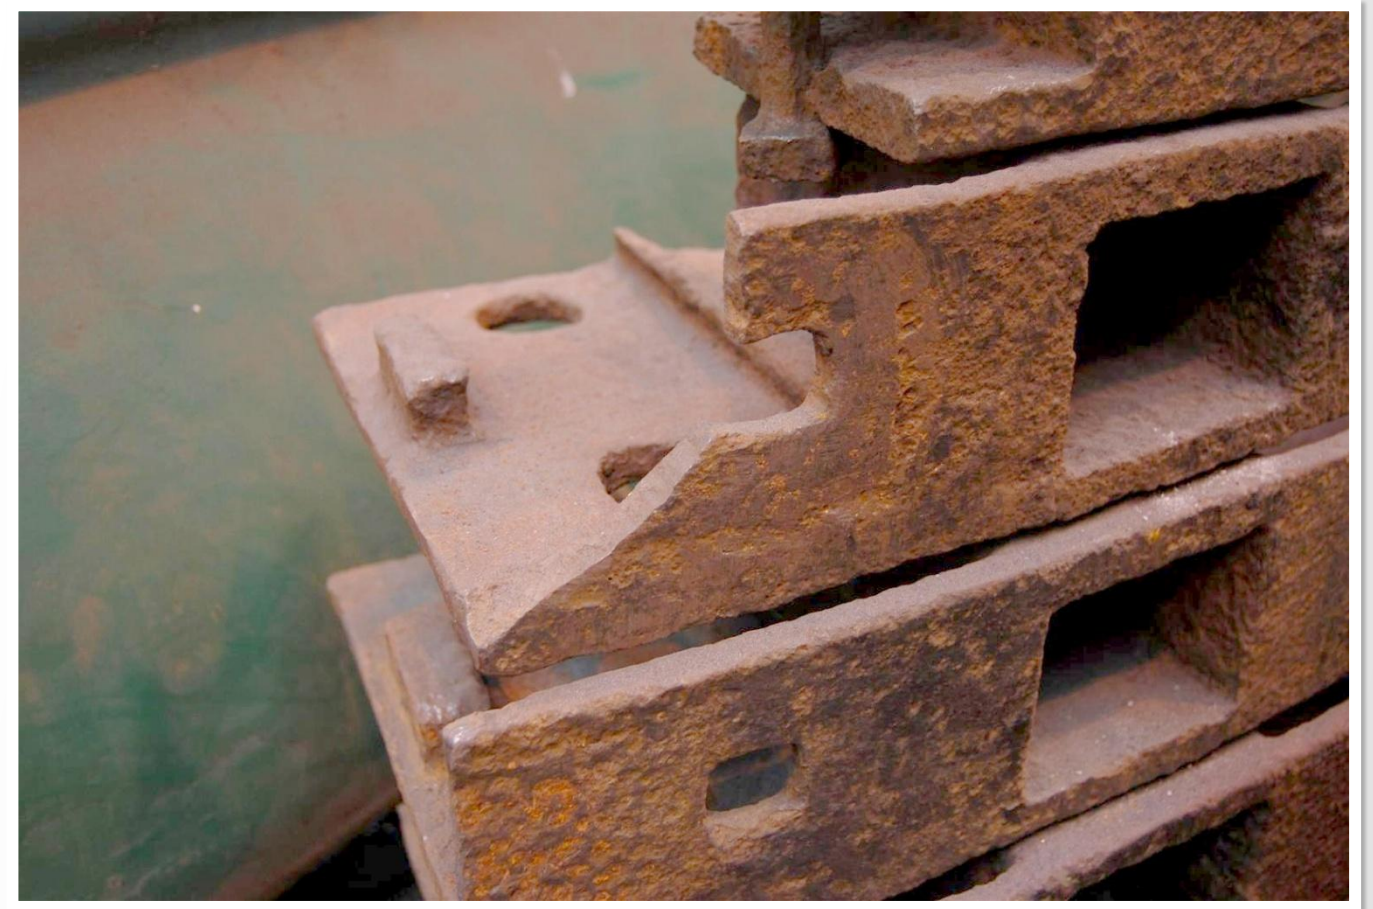
Fig 23 11/05/2010 Typical defect to Wheel Rim ends – fractures and loss of fabric where Wheel Rim segments are joined together. Repaired by splicing mild steel and welding.
