Melingriffith Water Pump

Conservation and Refurbishment Works

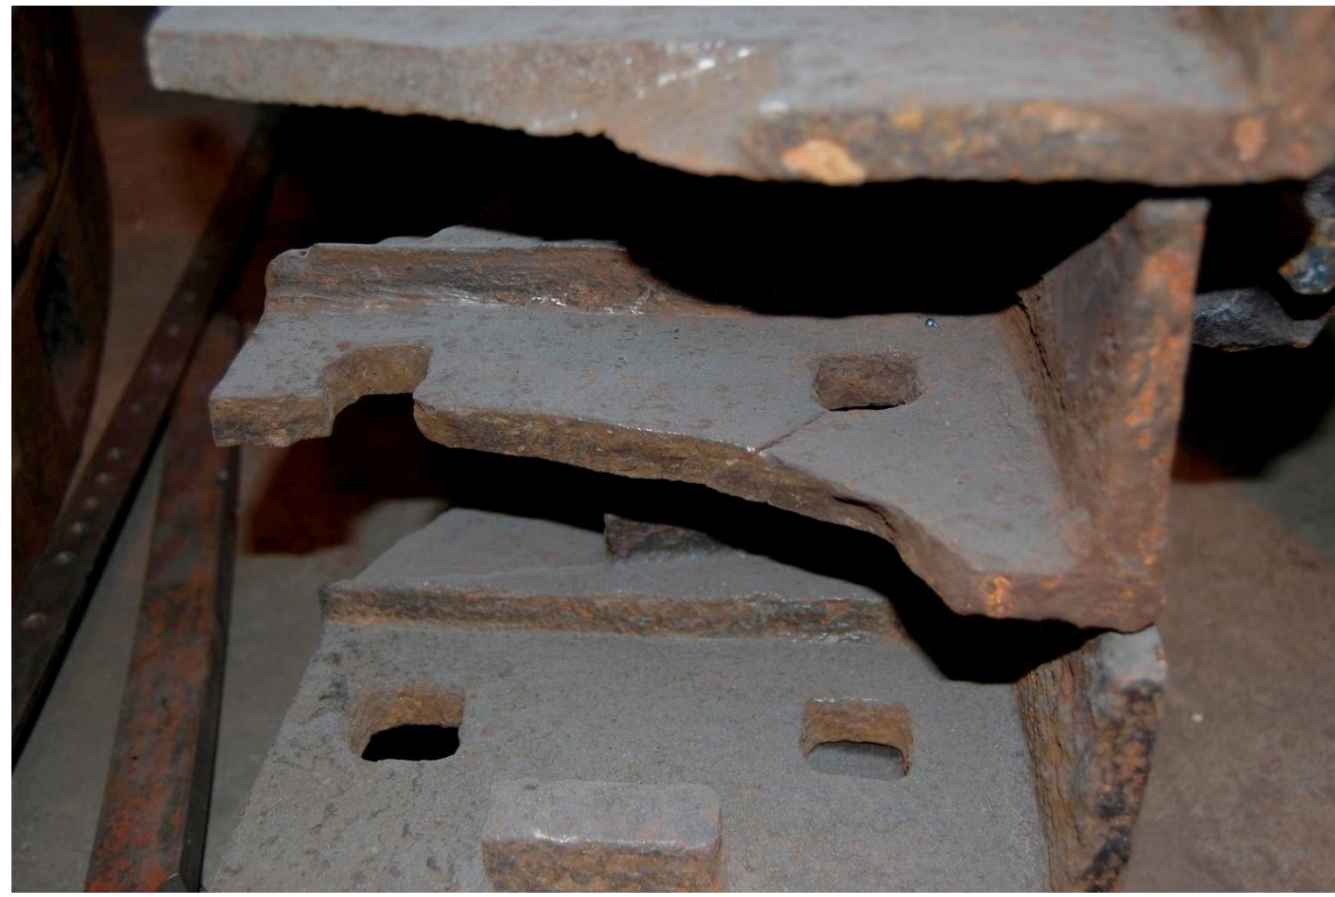
Fig 24 11/05/2010 Typical defects to Wheel Rim sections – fractures and loss of fabric where Spokes are connected to Wheel Rim segments. Repaired by splicing mild steel and welding.

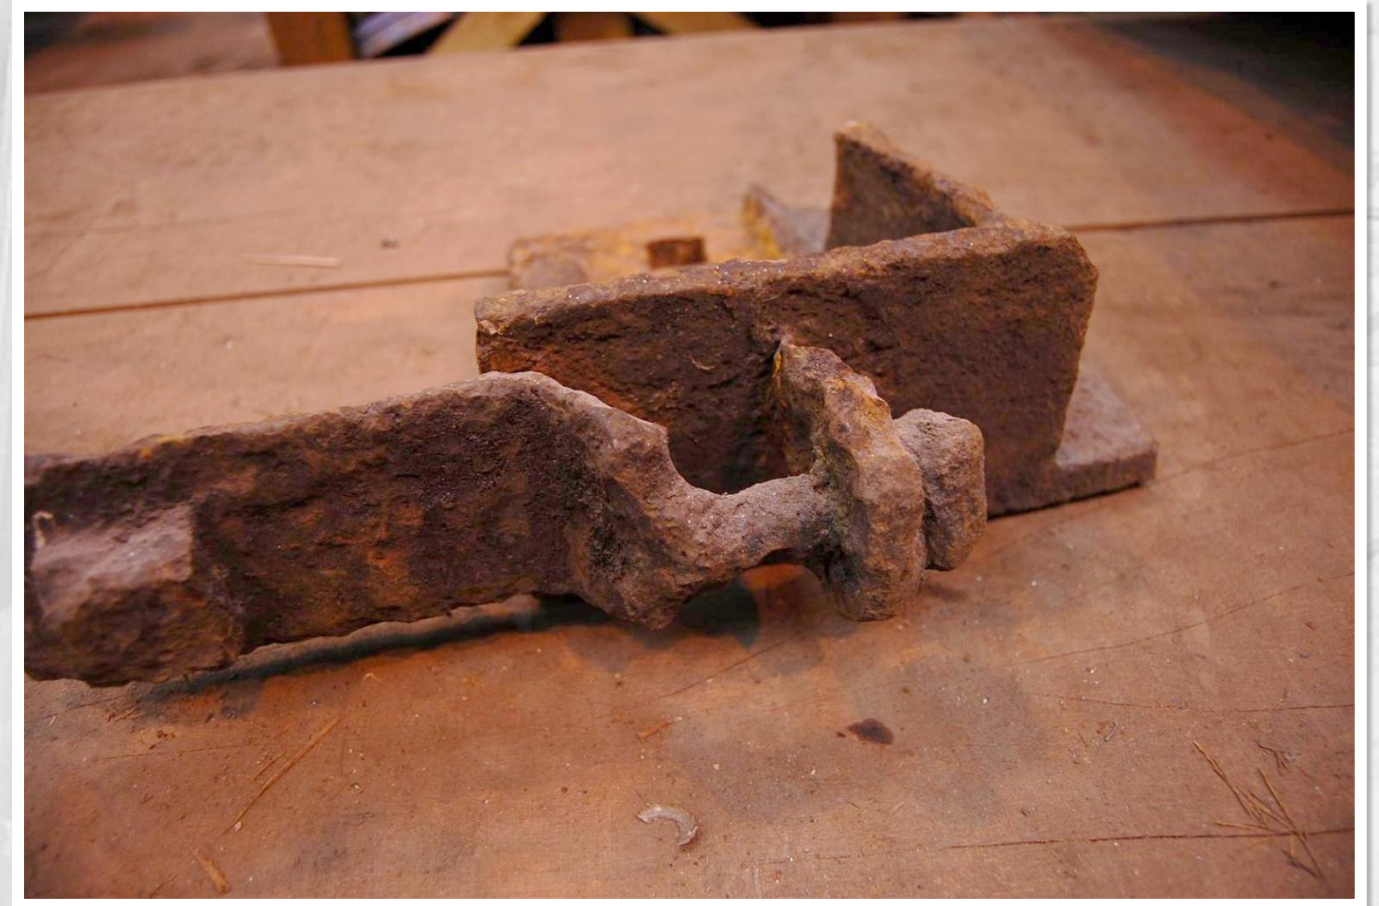
Fig 25 11/05/2010 Remains of Wheel Rim segment with original segment tie. Ties exhibit loss of section and heavy corrosion. Note part remains of original square-head bolt. All Ties subsequently replaced with new to match original details.

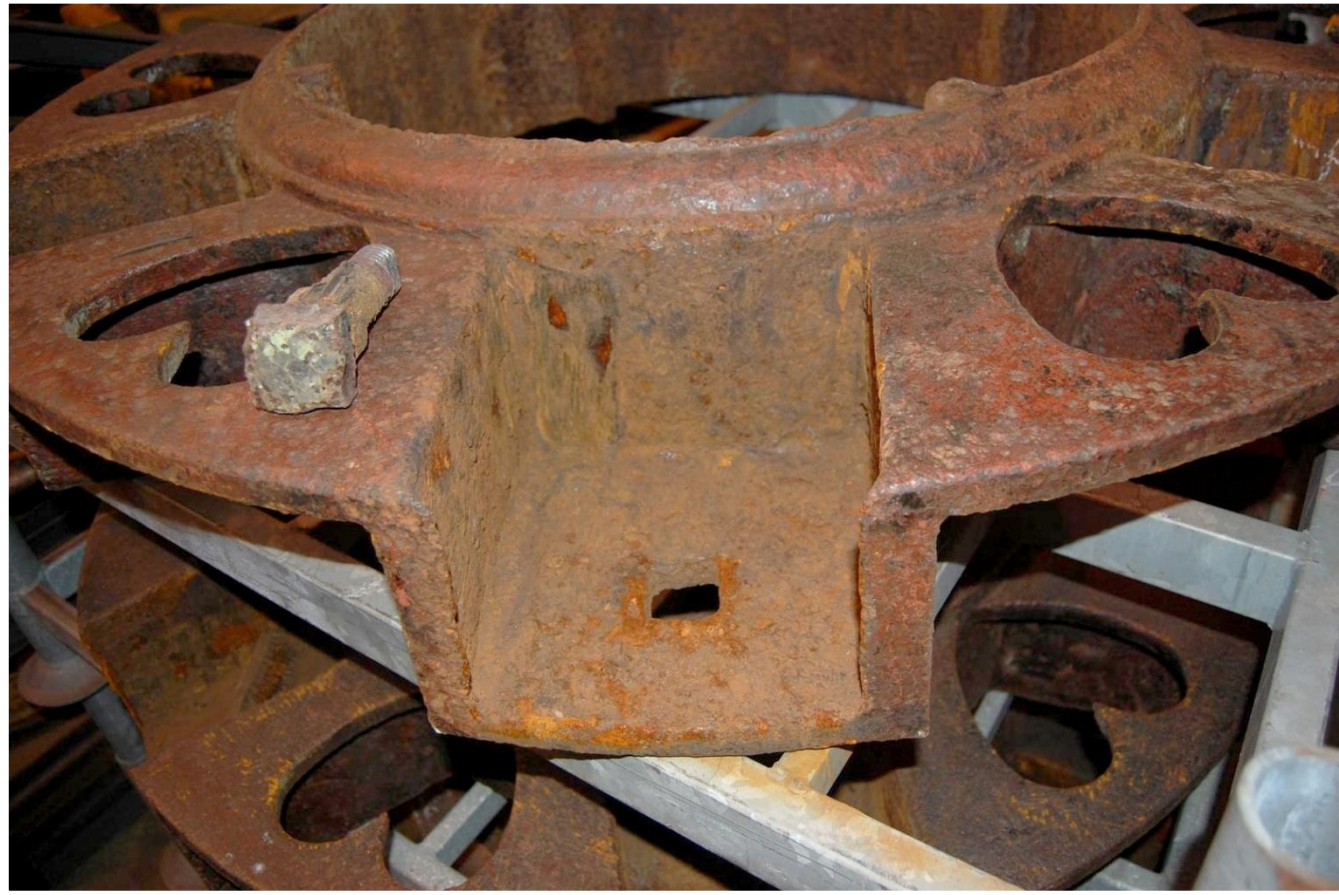
Fig 26 11/05/2010 Typical Wheel Hub. Found to be in good condition requiring cleaning by hand to remove loose metal and rust.

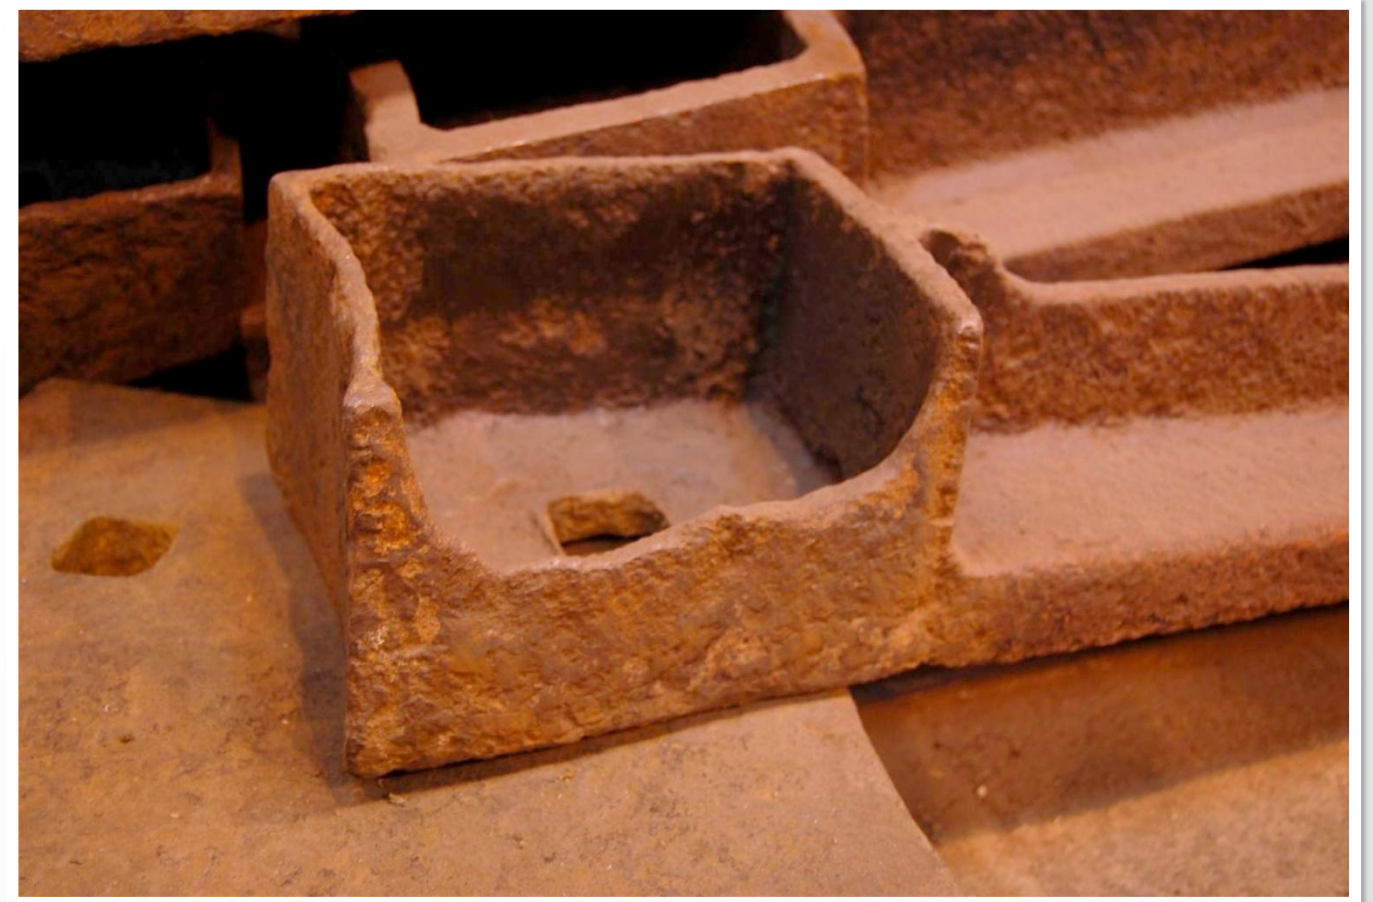
Fig 27 11/05/2010 Typical defects to Spokes (Wheel hub end) –loss of fabric due to corrosion.

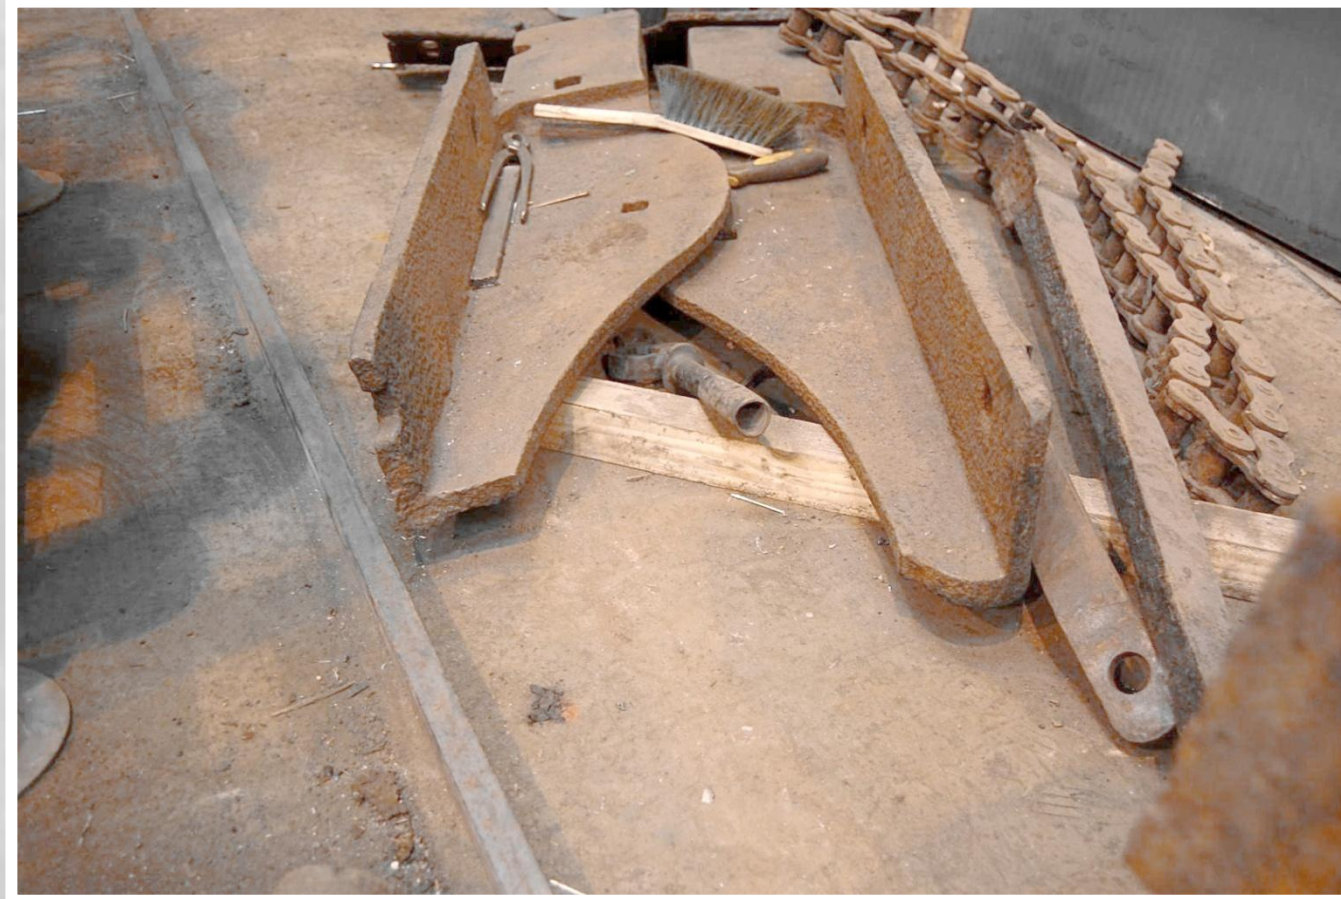
Fig 28 11/05/2010 Connection Rod upper housing plates (separated from sides of Rocker Beams). Loss of fabric where fractured around bolt hole.

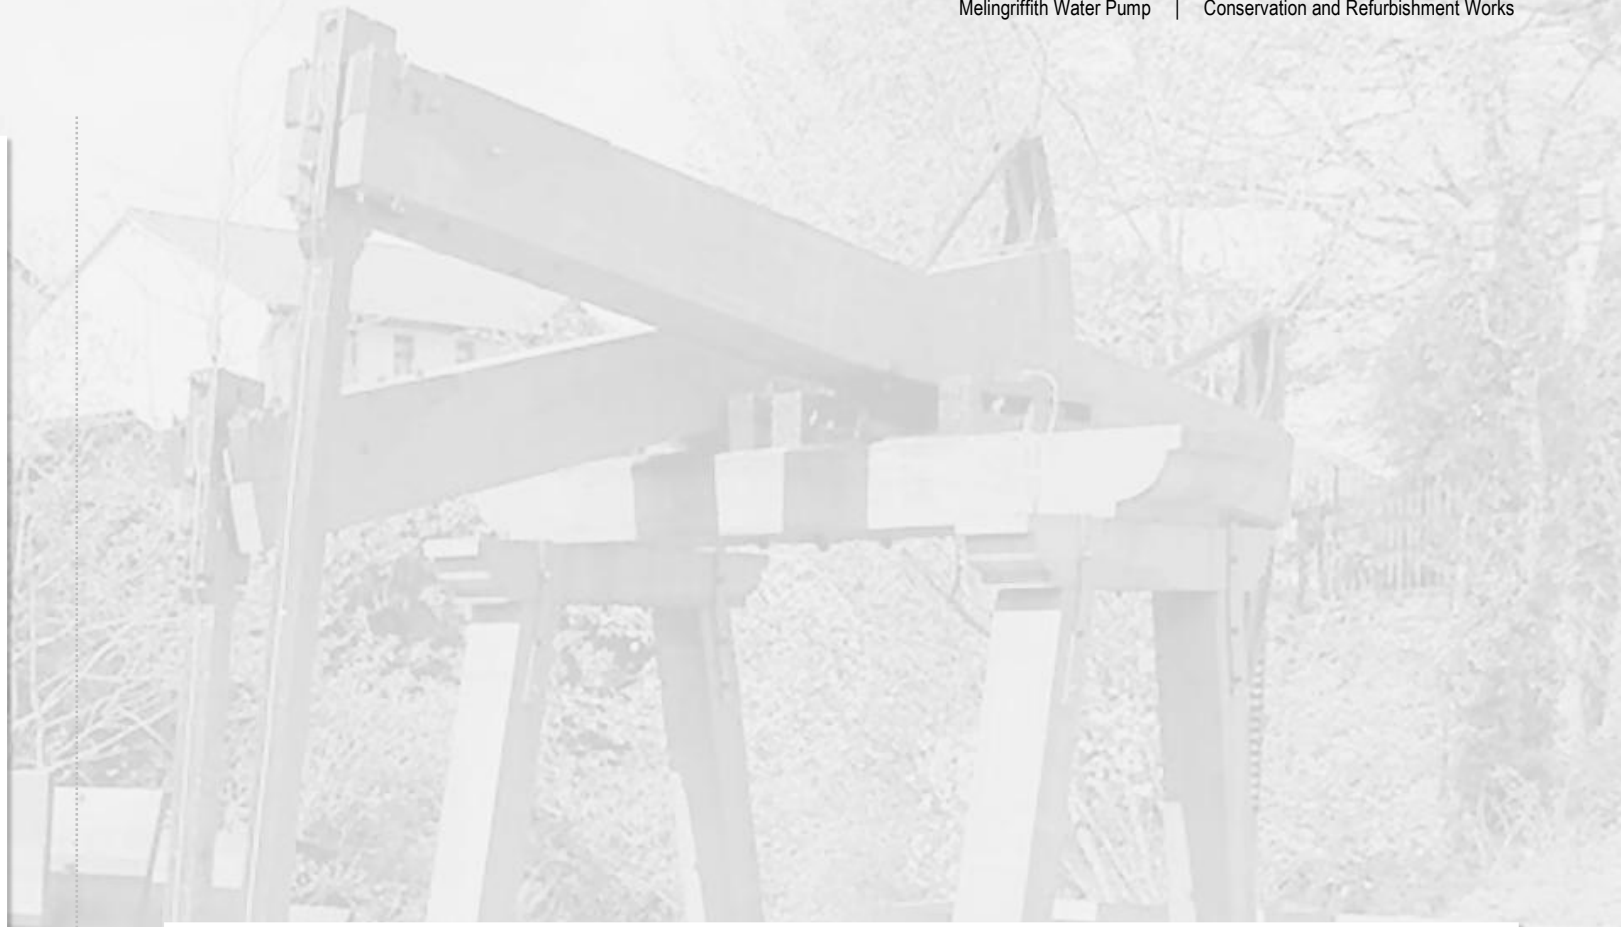
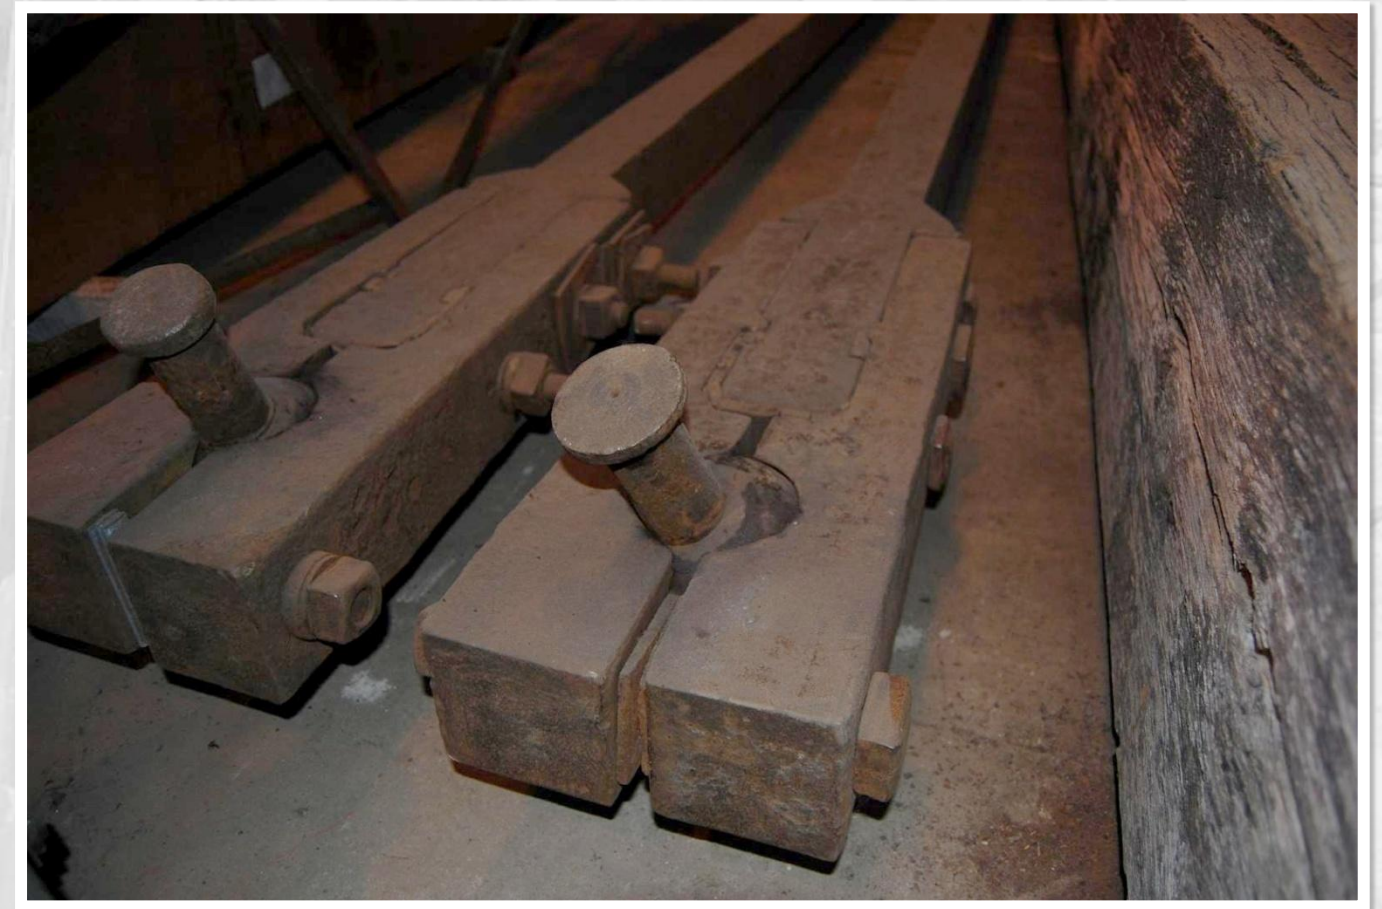
Fig 29 11/05/2010 Connection Rod ball joints (upper ends). Filing required by hand to achieve a smooth bearing surface.

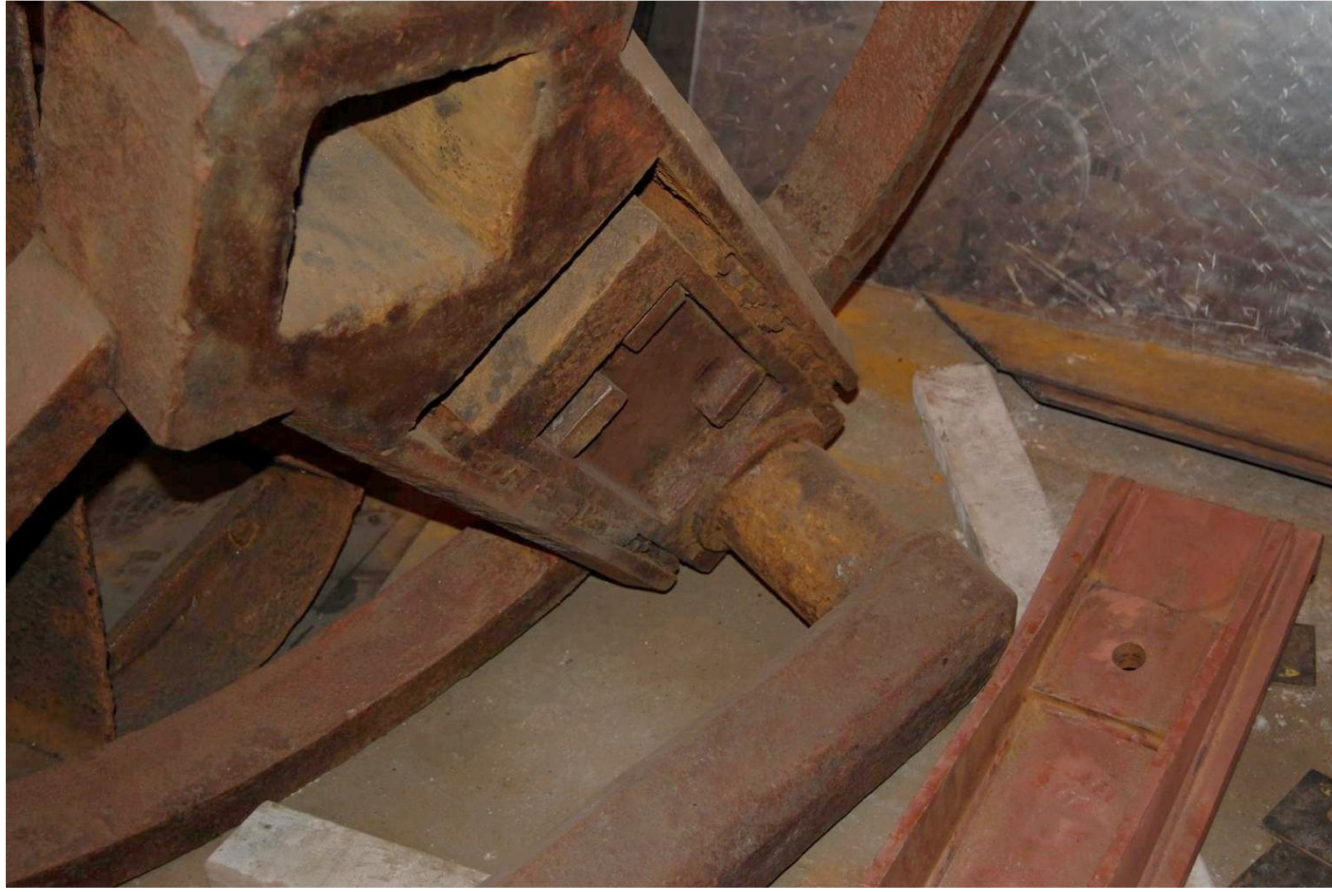
Fig 30 11/05/2010 Crank Arm found to be in good condition. Journals require filing by hand to achieve a smooth bearing surface.

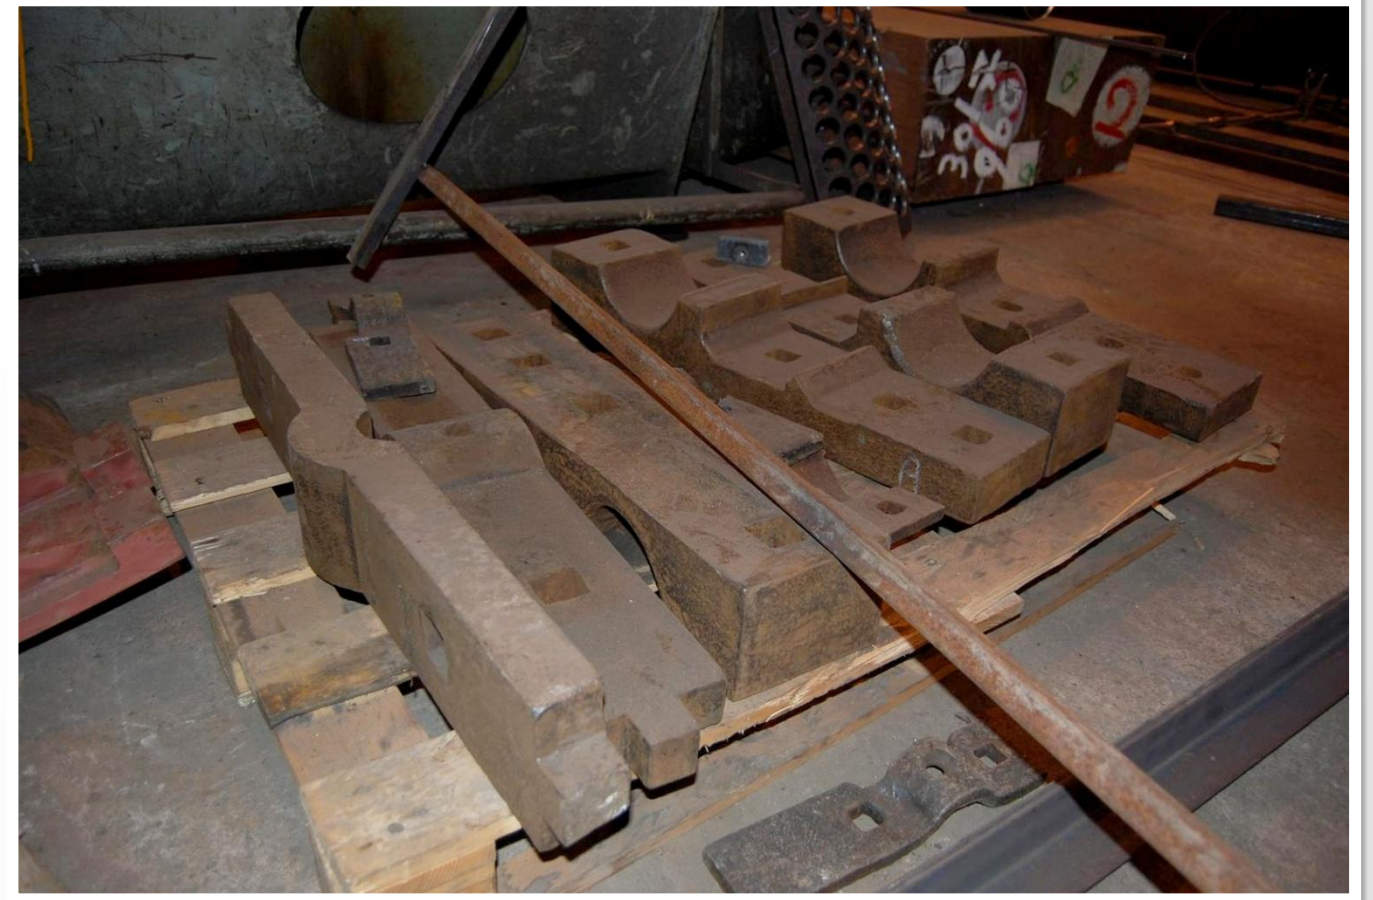
Fig 31 11/05/2010 Rocker Beam bearing caps (2 foreground pieces) – other pair was missing. Connection Rod bearing housings (4 background pieces).

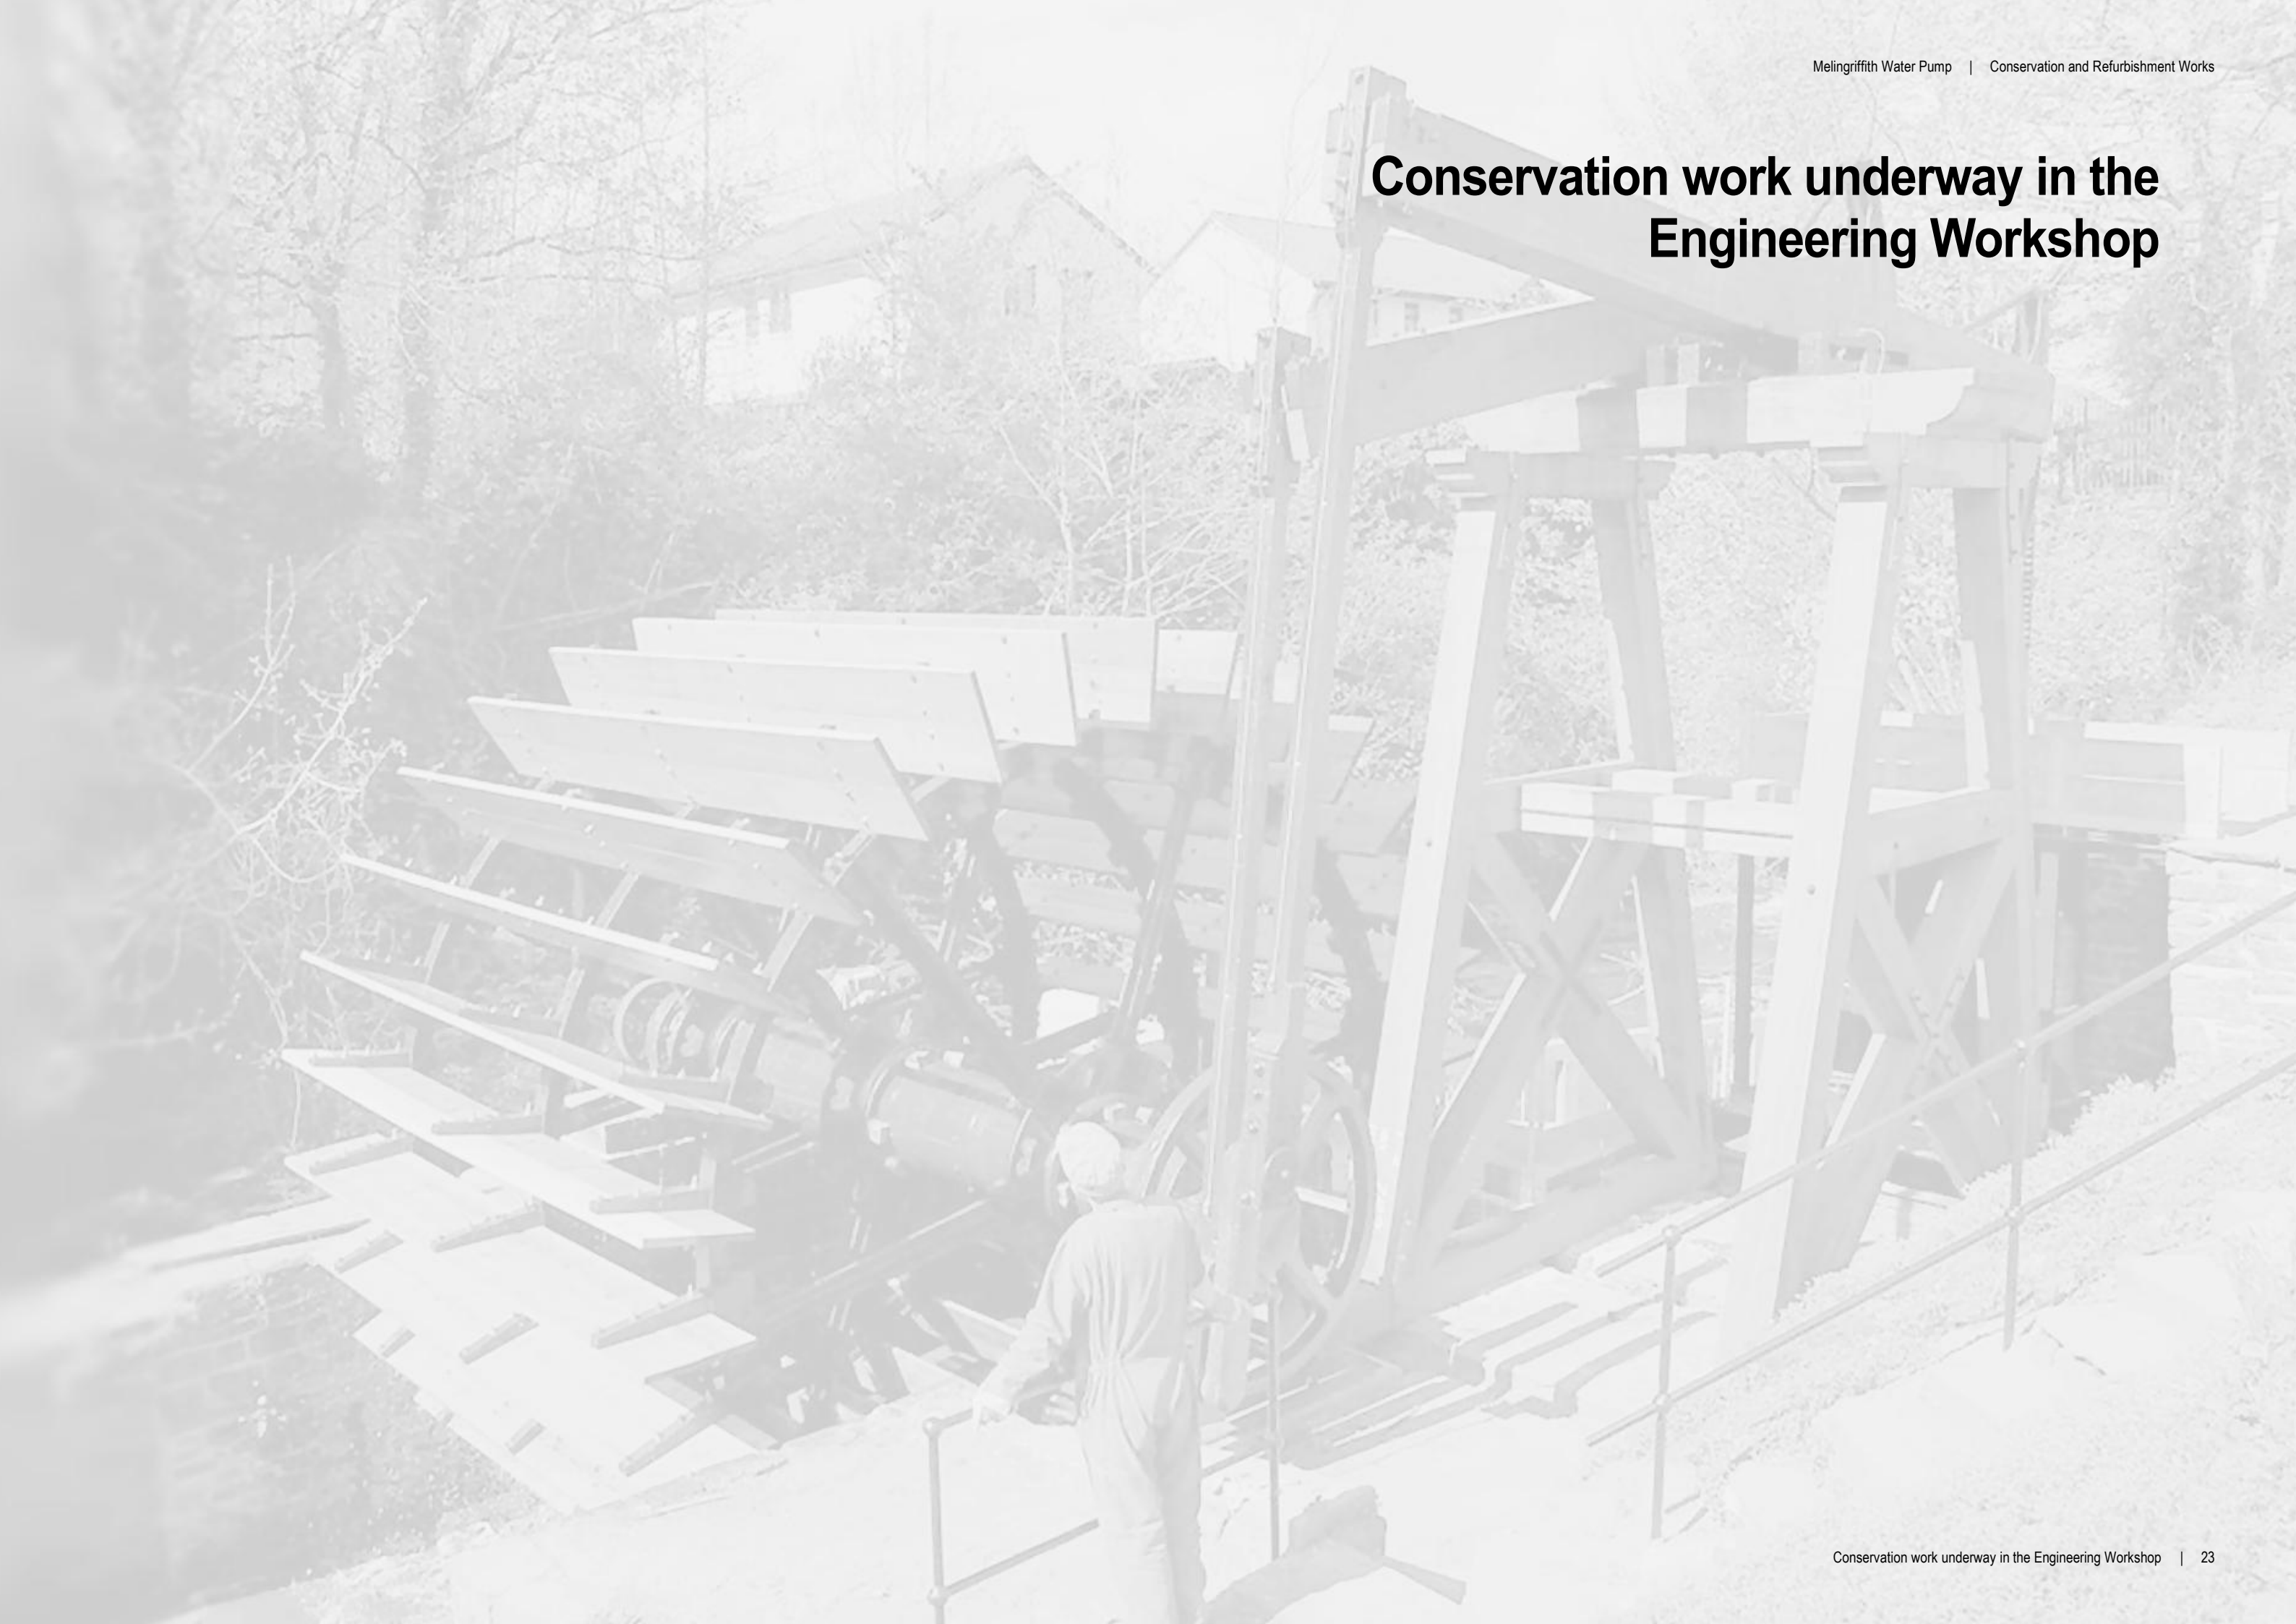
Conservation work underway in the Engineering Workshop

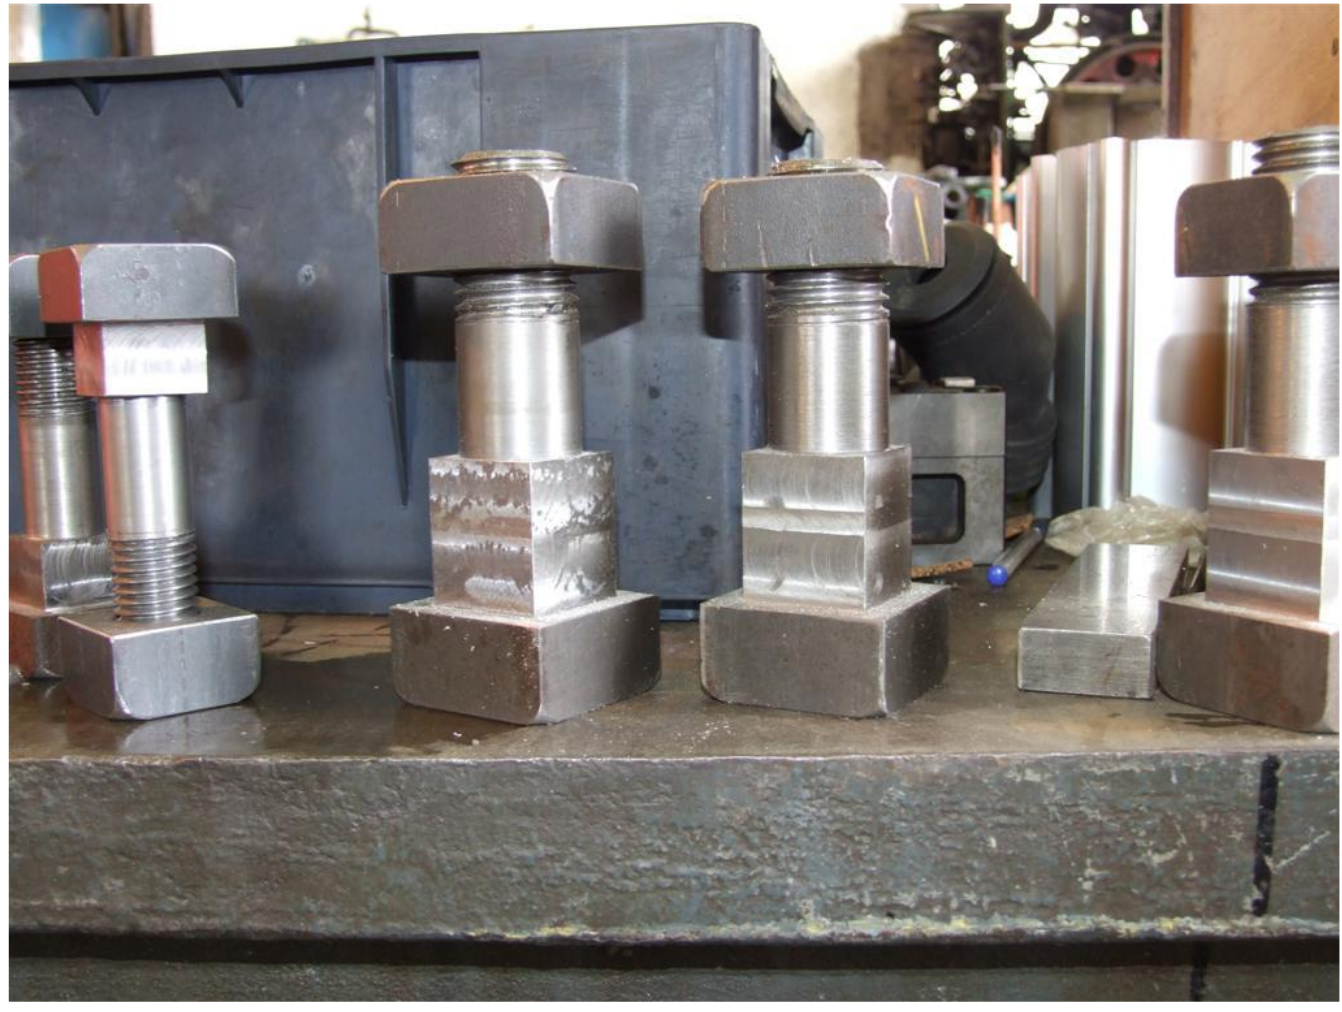
Fig 32 28/07/2010 Replacement mild steel square-head bolts and nuts to replace original (all damaged or destroyed during dismantling due to corrosion).

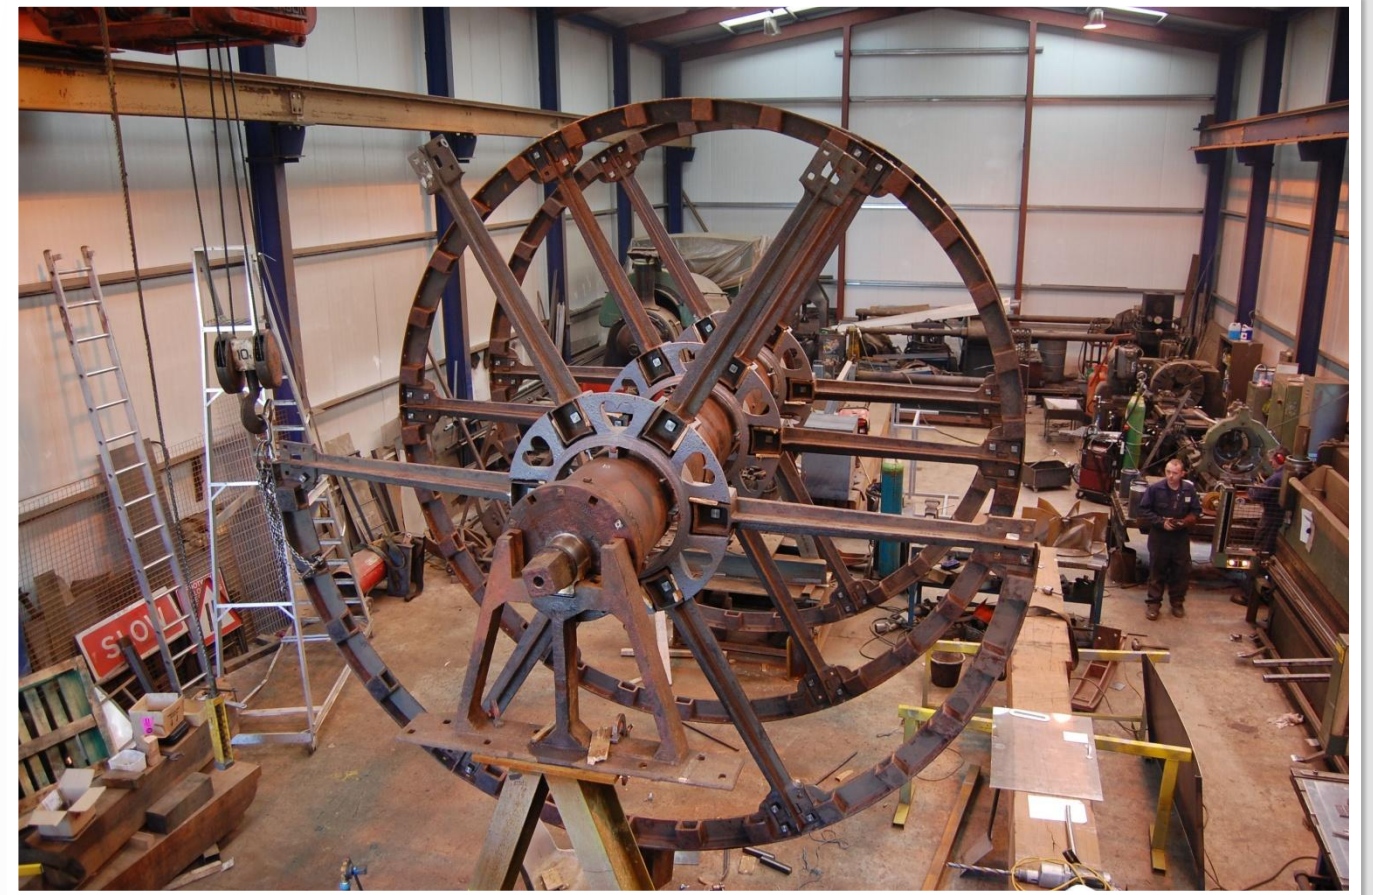
Fig 33 03/09/2010 Wheel being assembled following conservation and repair works.

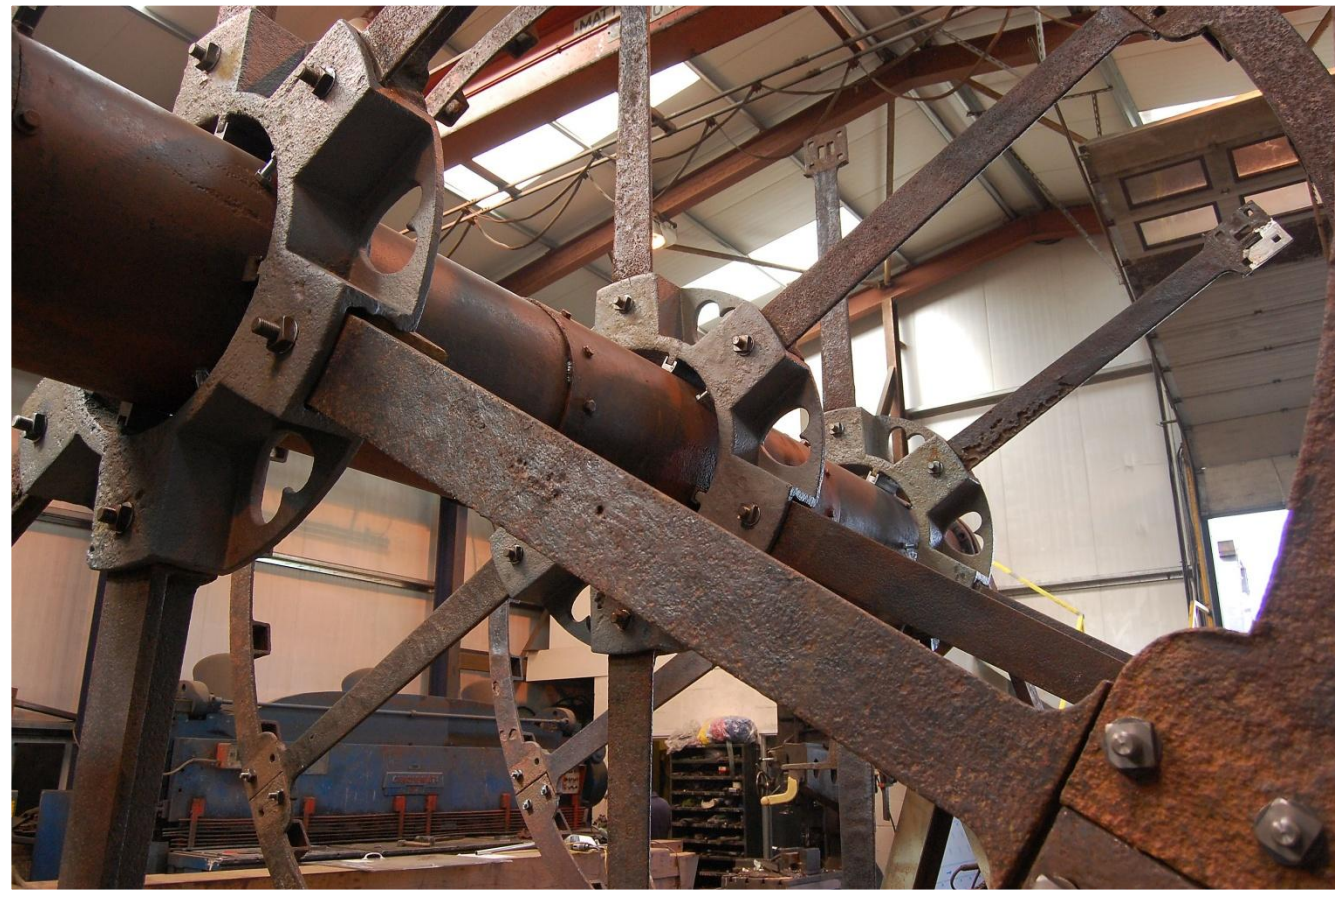
Fig 34 03/09/2010 Enlarged view on assembled Wheel. Note replaced square-head bolts and nuts and key-pieces welded to axle.

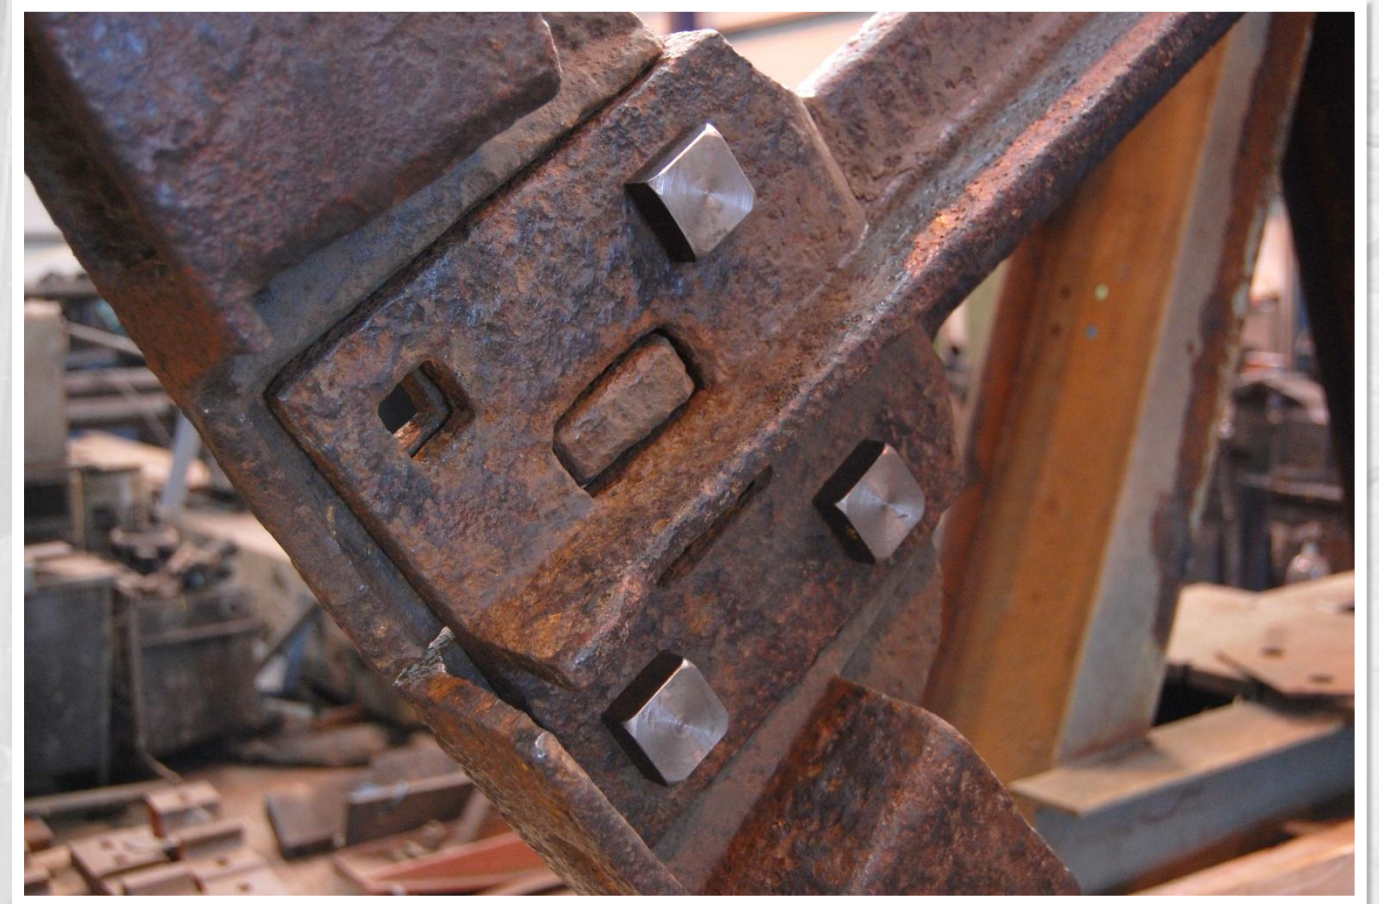
Fig 35 03/09/2010 Enlarged view showing replacement square-head bolts.

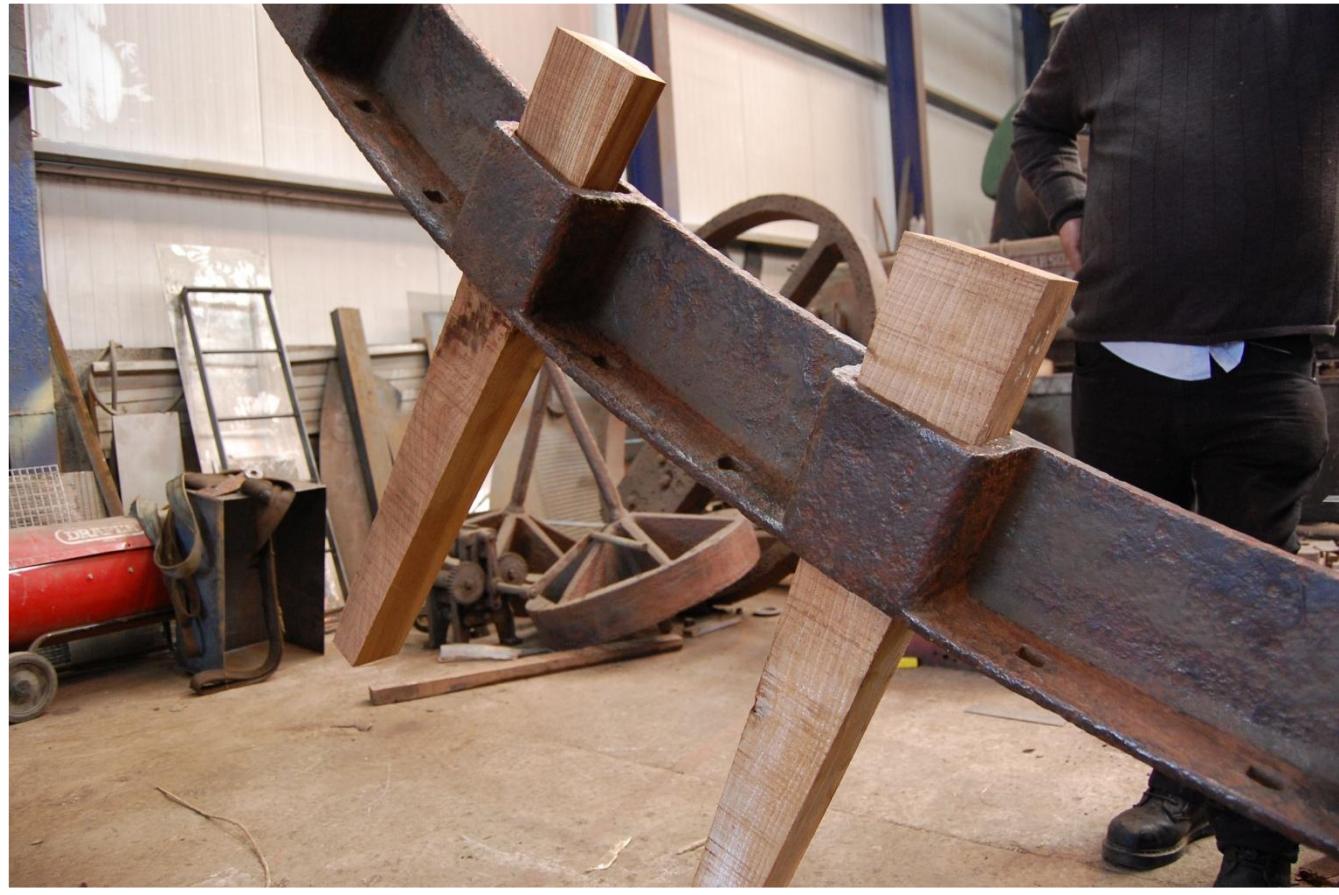
Fig 36 03/09/2010 Replacement Paddle Blade Brackets in Elm to match original details. Original Brackets were all defective, lost or rotten.

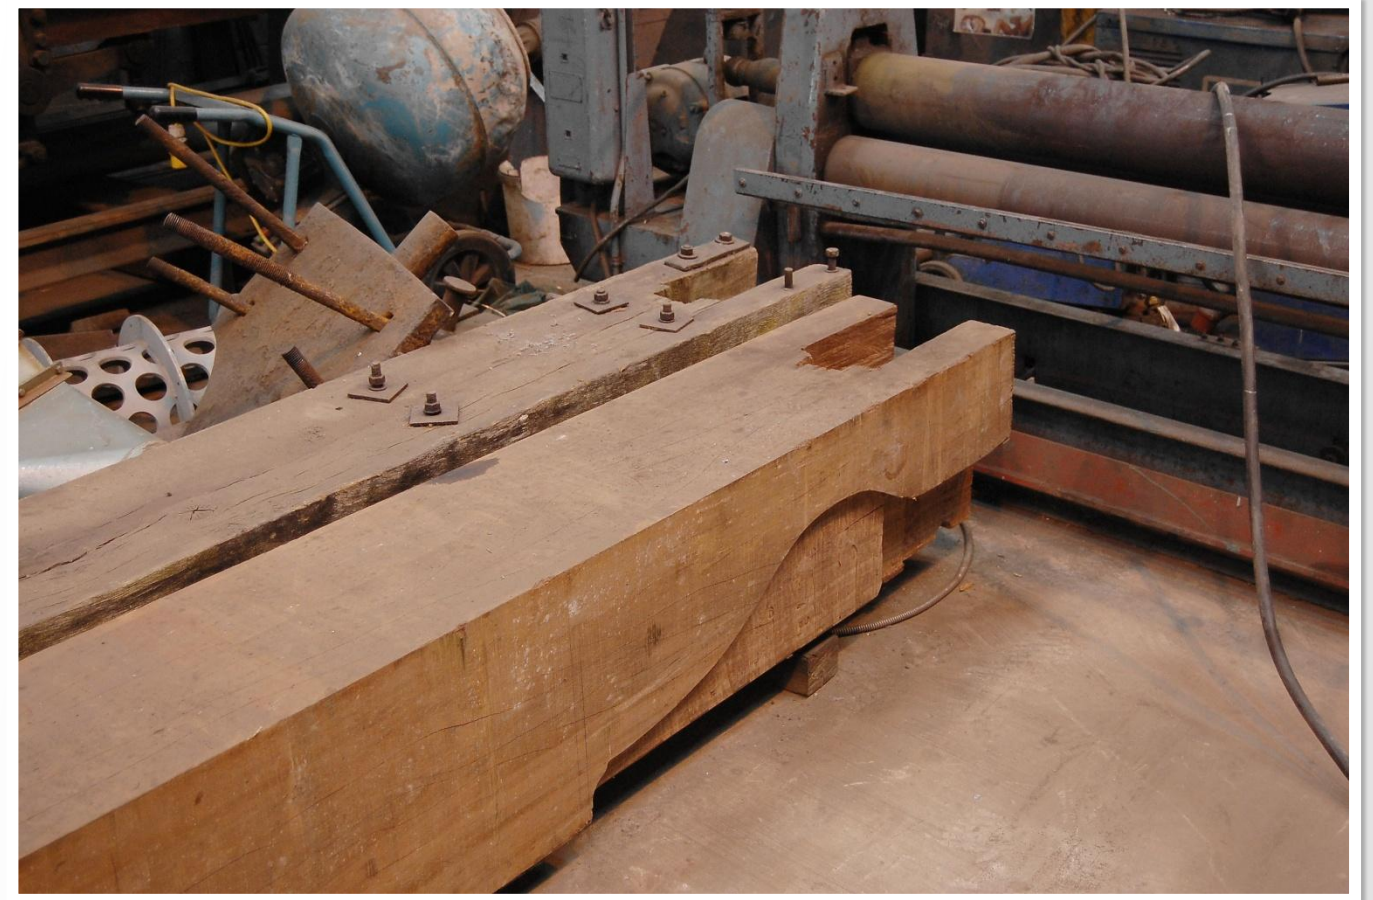
Fig 37 03/09/2010 Replacement Rocker Beams machined to accept Connection Rod bearing metalwork to original details.
