Melingriffith Water Pump

Conservation and Refurbishment Works

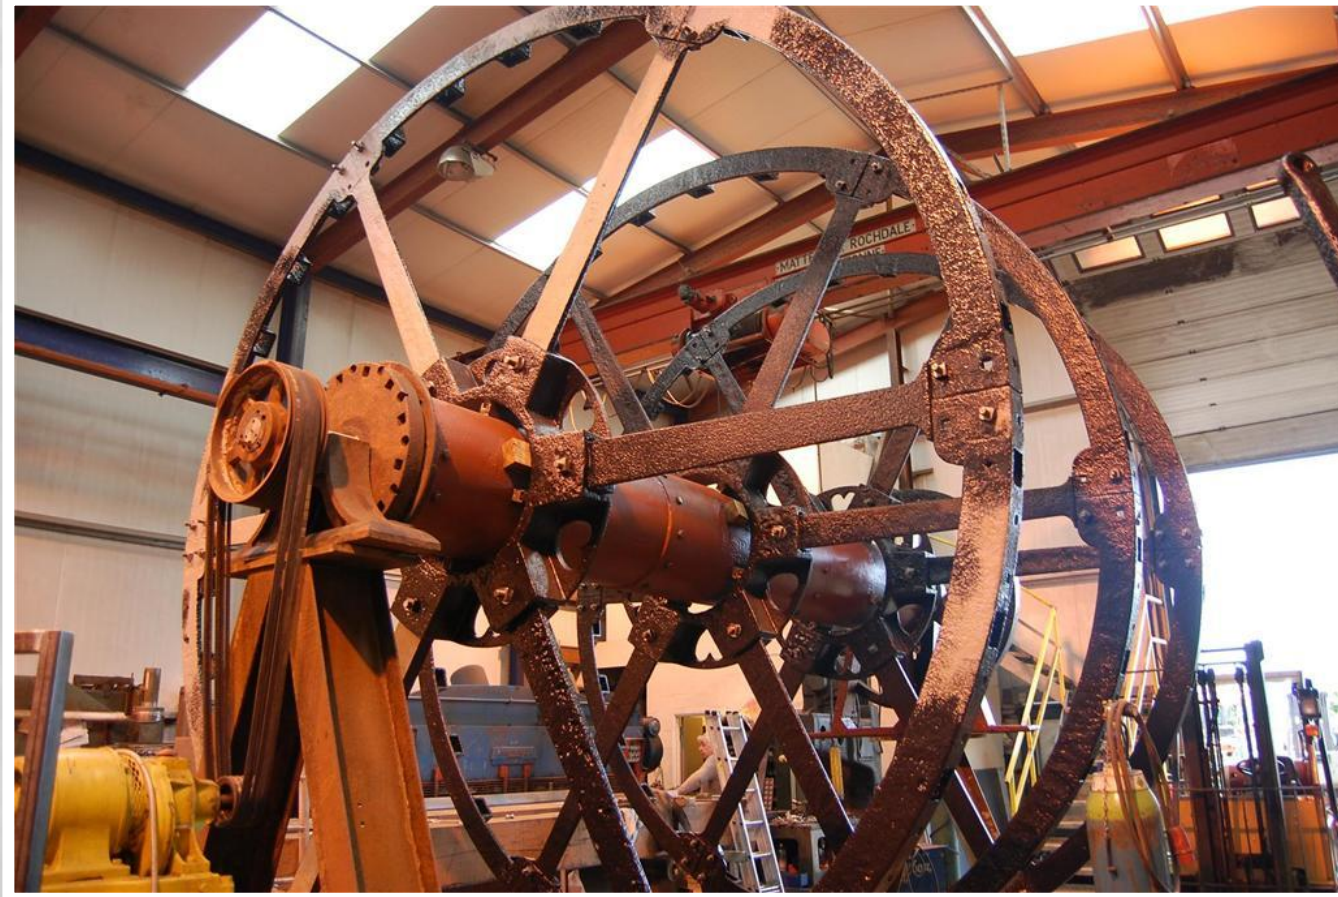
Fig 38 24/09/2010 Repaired Wheel in the workshop fully assembled with crank arms and bearings pedestals, mounted on temporary jig. Painting and decoration underway. Temporary motor drive attached to test alignment and rotation.

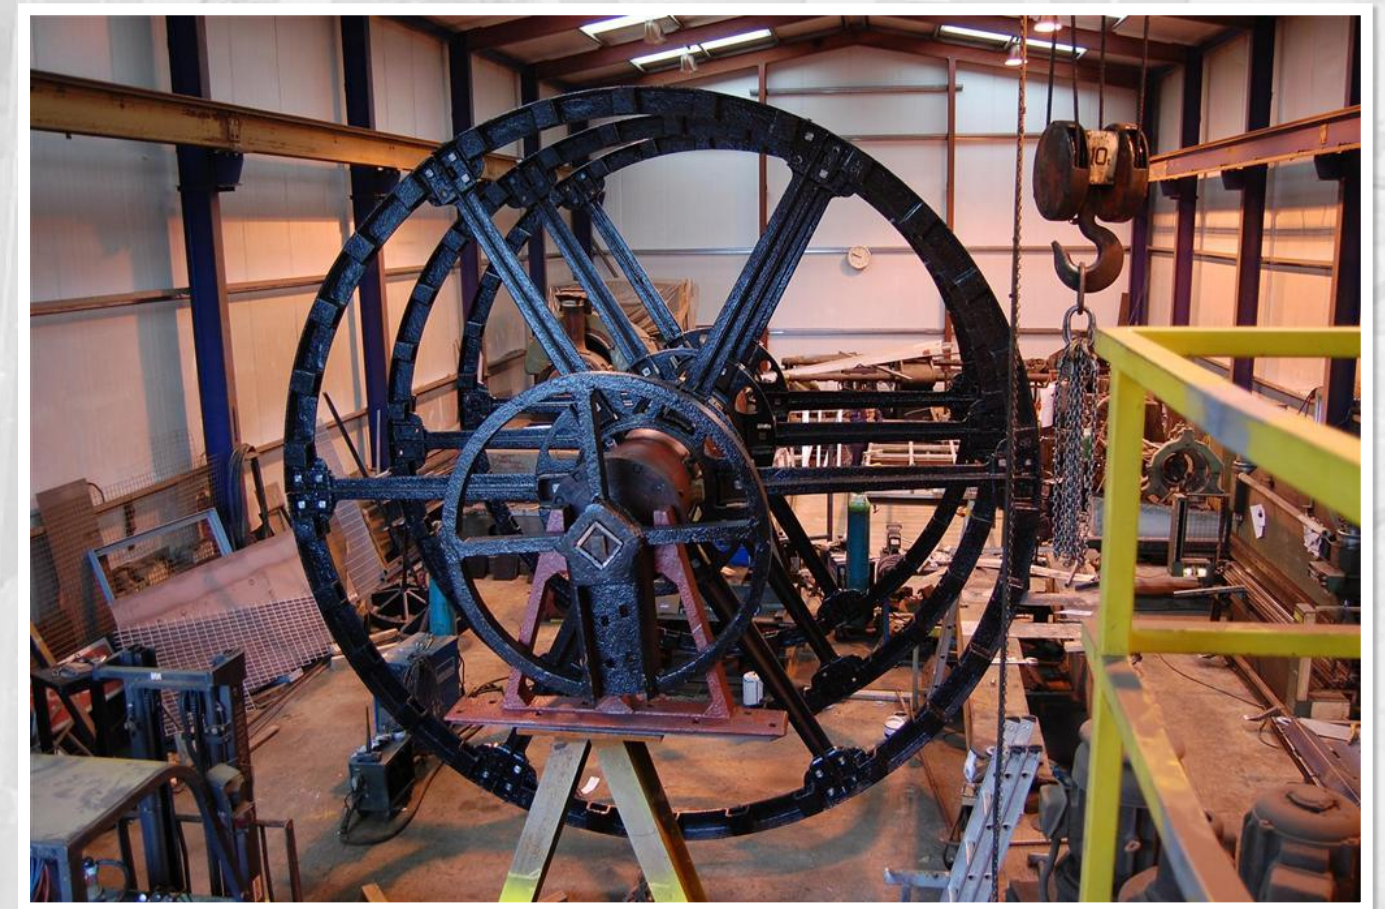
Fig 39 24/09/2010 Repaired Wheel in the workshop fully assembled with crank arms and bearings pedestals, mounted on temporary jig. Painting and decoration underway.

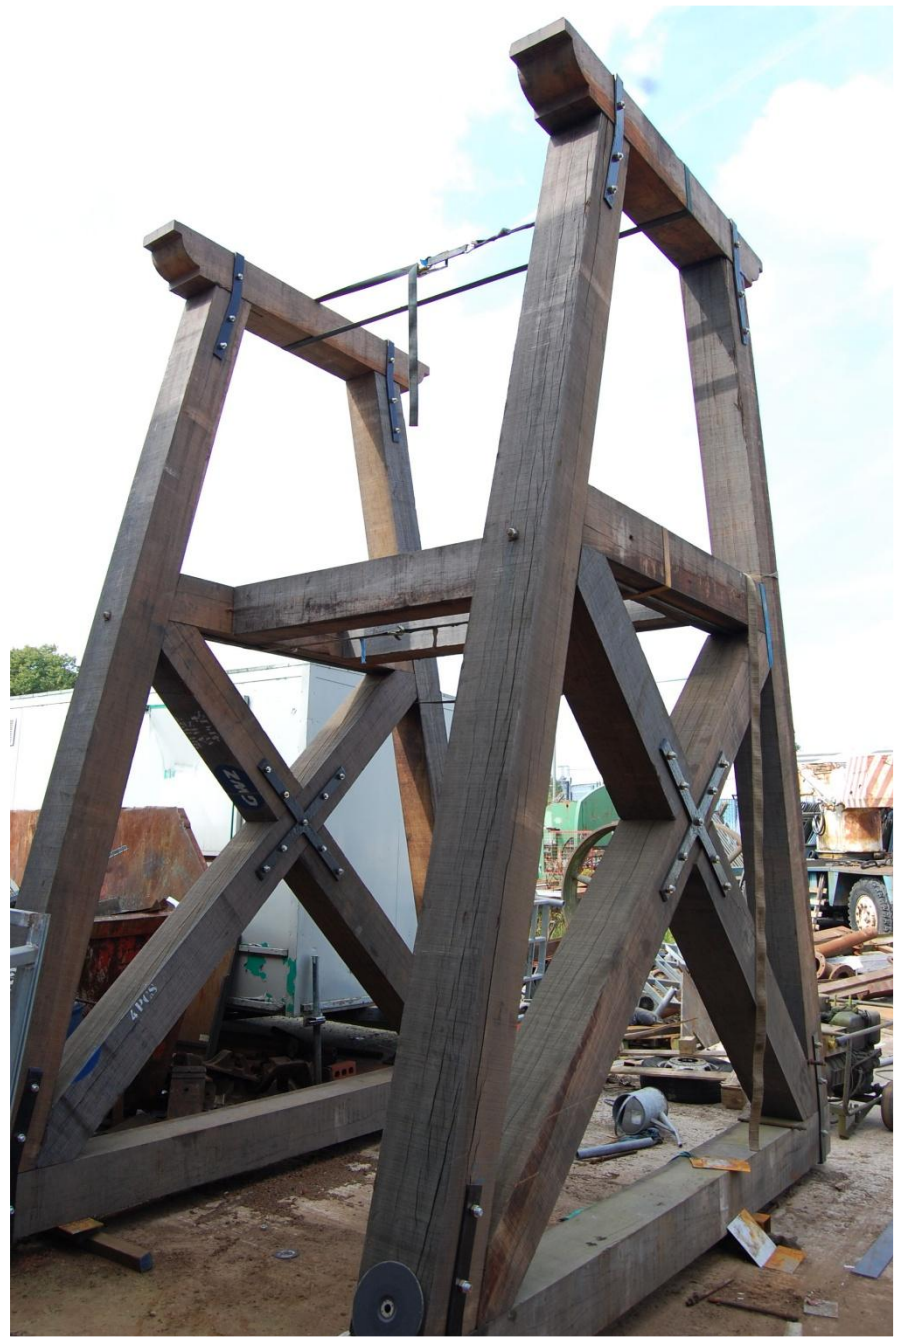
Fig 40 03/09/2010 Assembly of replacement A-frame in Ekki hardwood. Original metal braces reused and decorated.

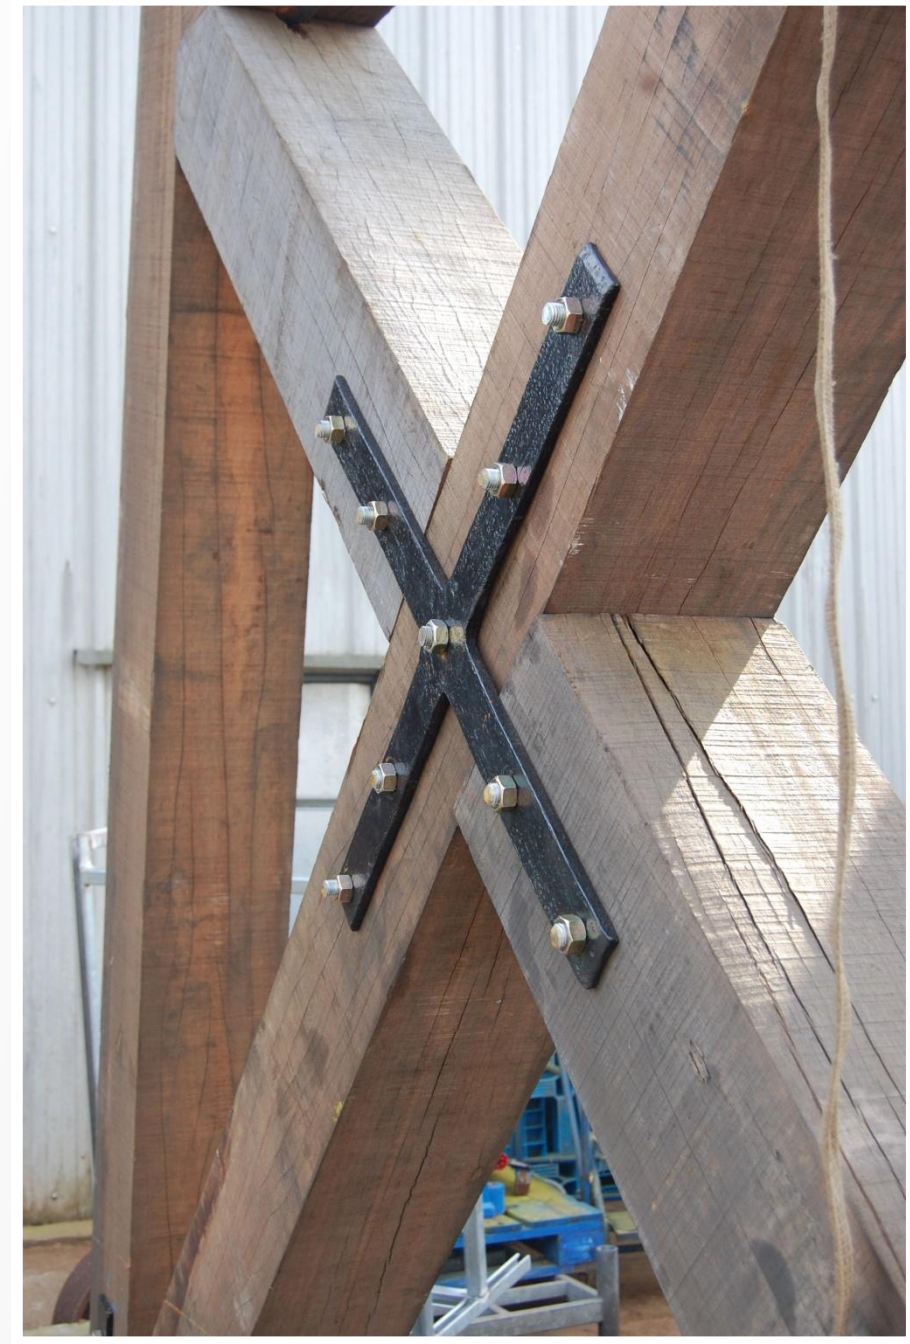
Fig 41 03/09/2010 Detail of new A-frame cross-brace.

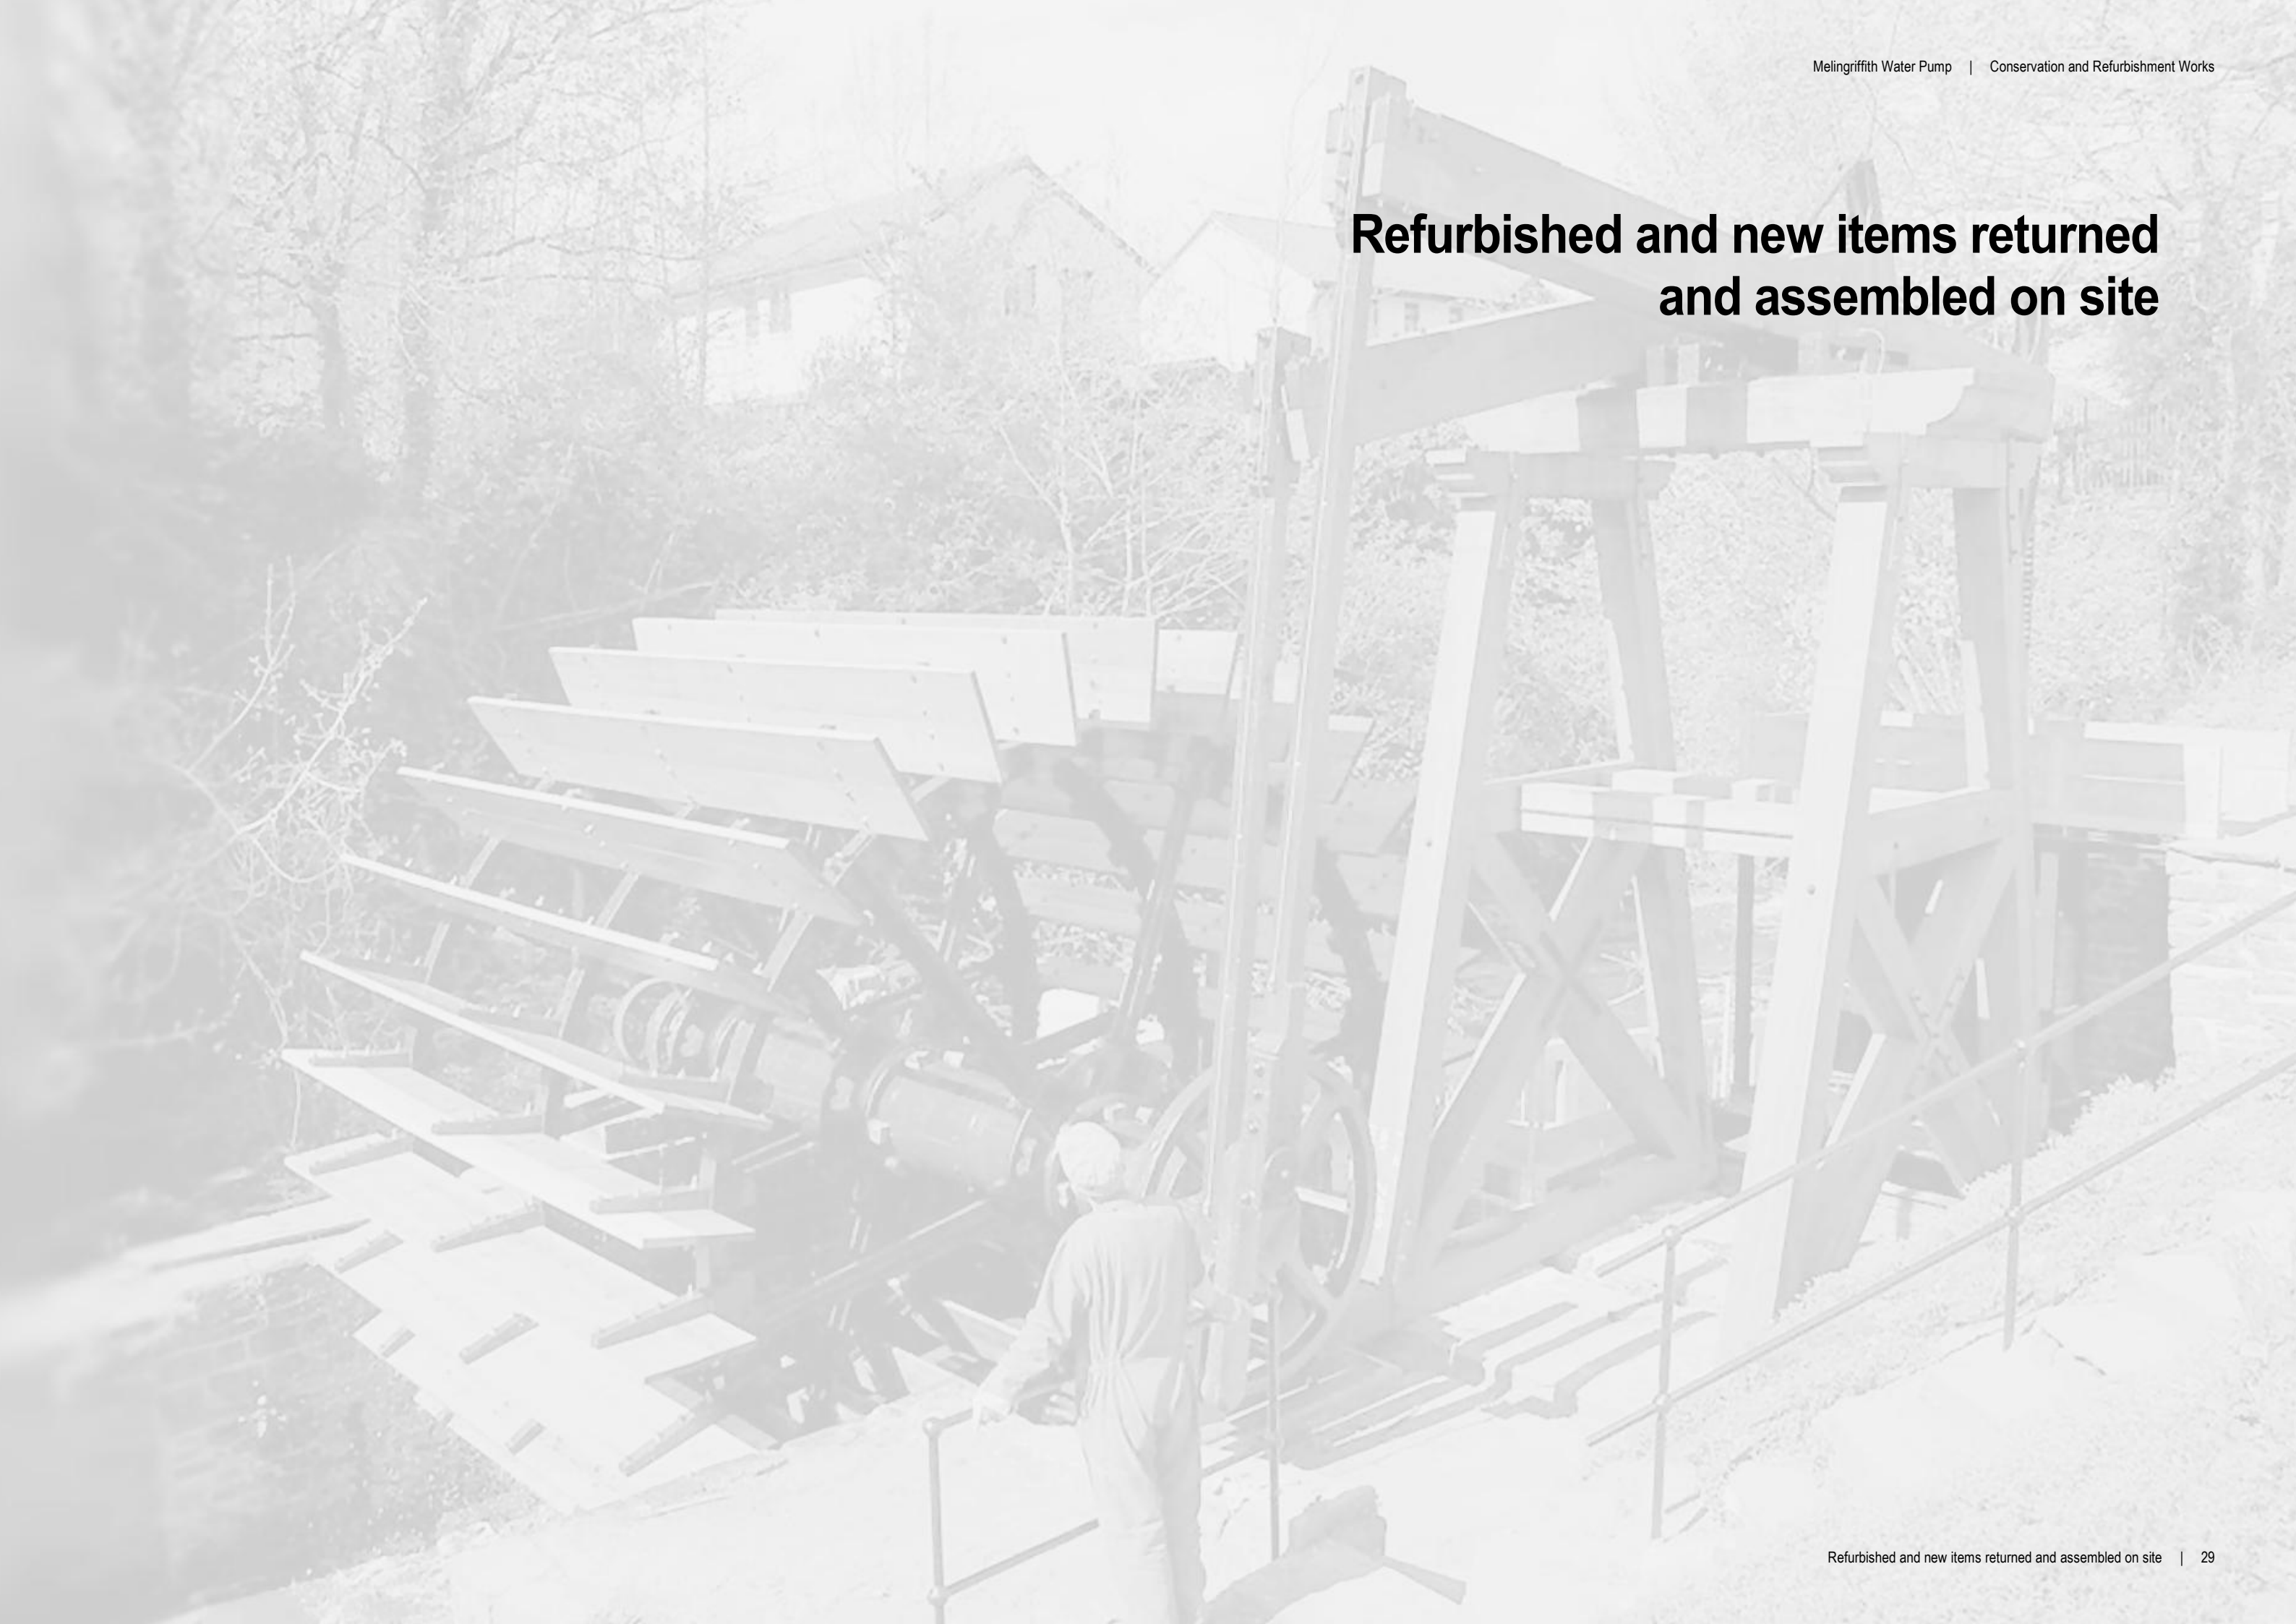
Refurbished and new items returned and assembled on site

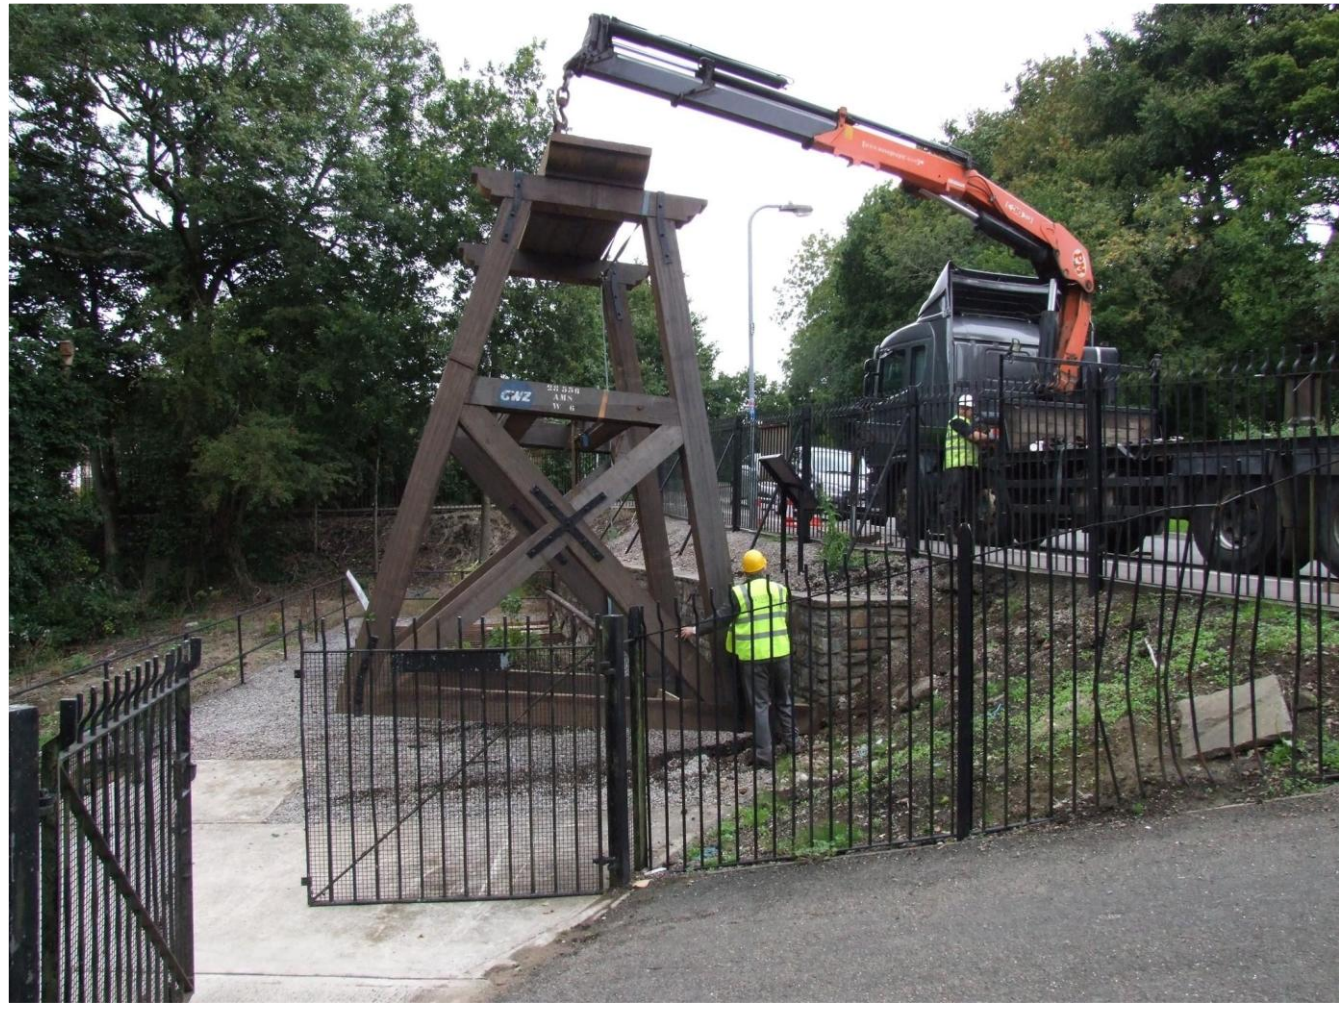
Fig 42 15/09/2010 Replacement A-frame lowered to temporary location in advance of main lift.

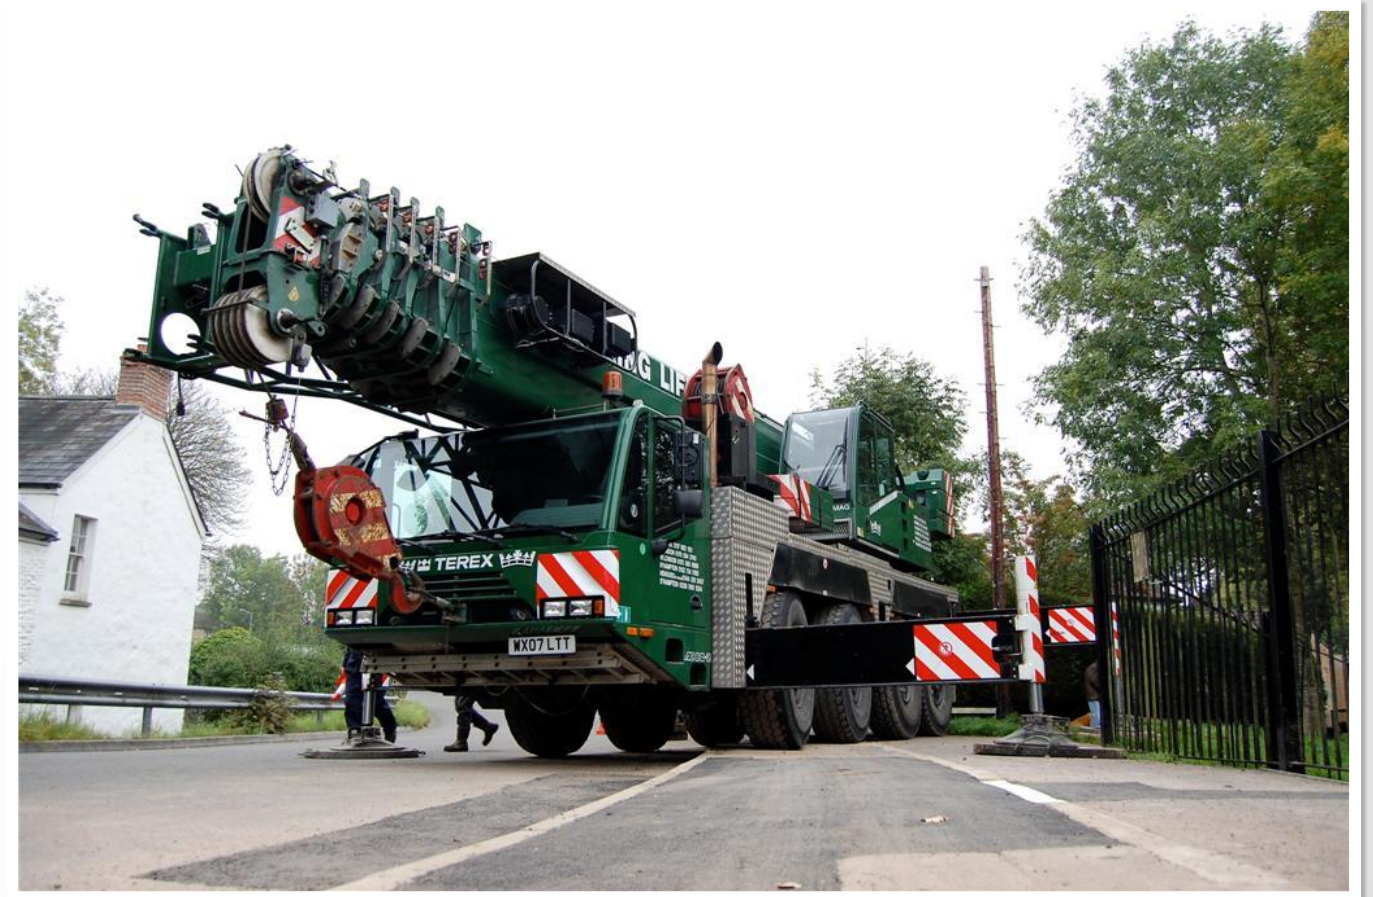
Fig 43 14/10/2010 Crane in position on Ty Mawr Road in preparation for main lifting operation.

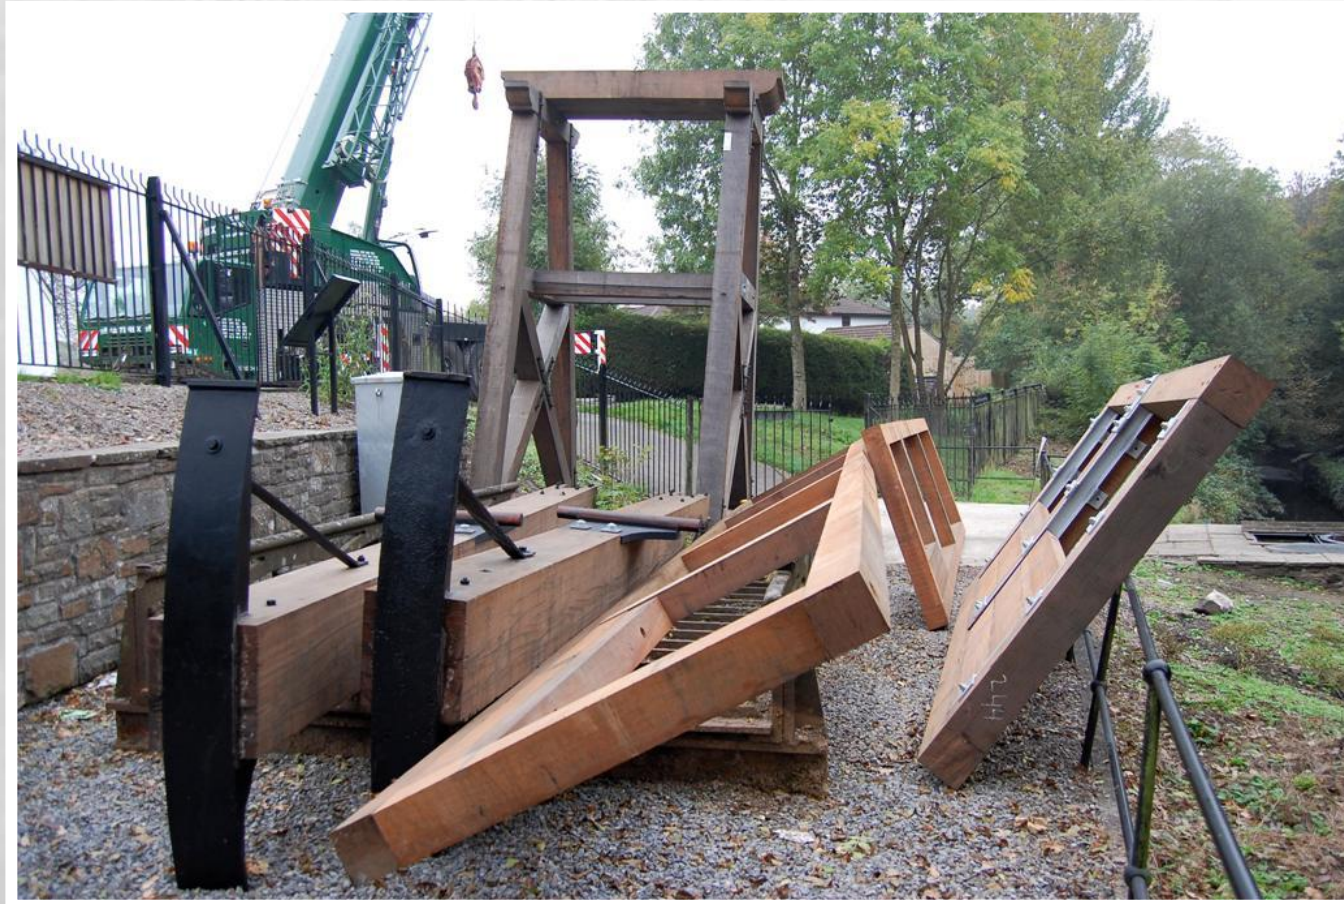
Fig 44 14/10/2010 Replacement Rocker Beams and associated metalwork, Sluice Gate and Filter Screen frames delivered to temporary location on site.

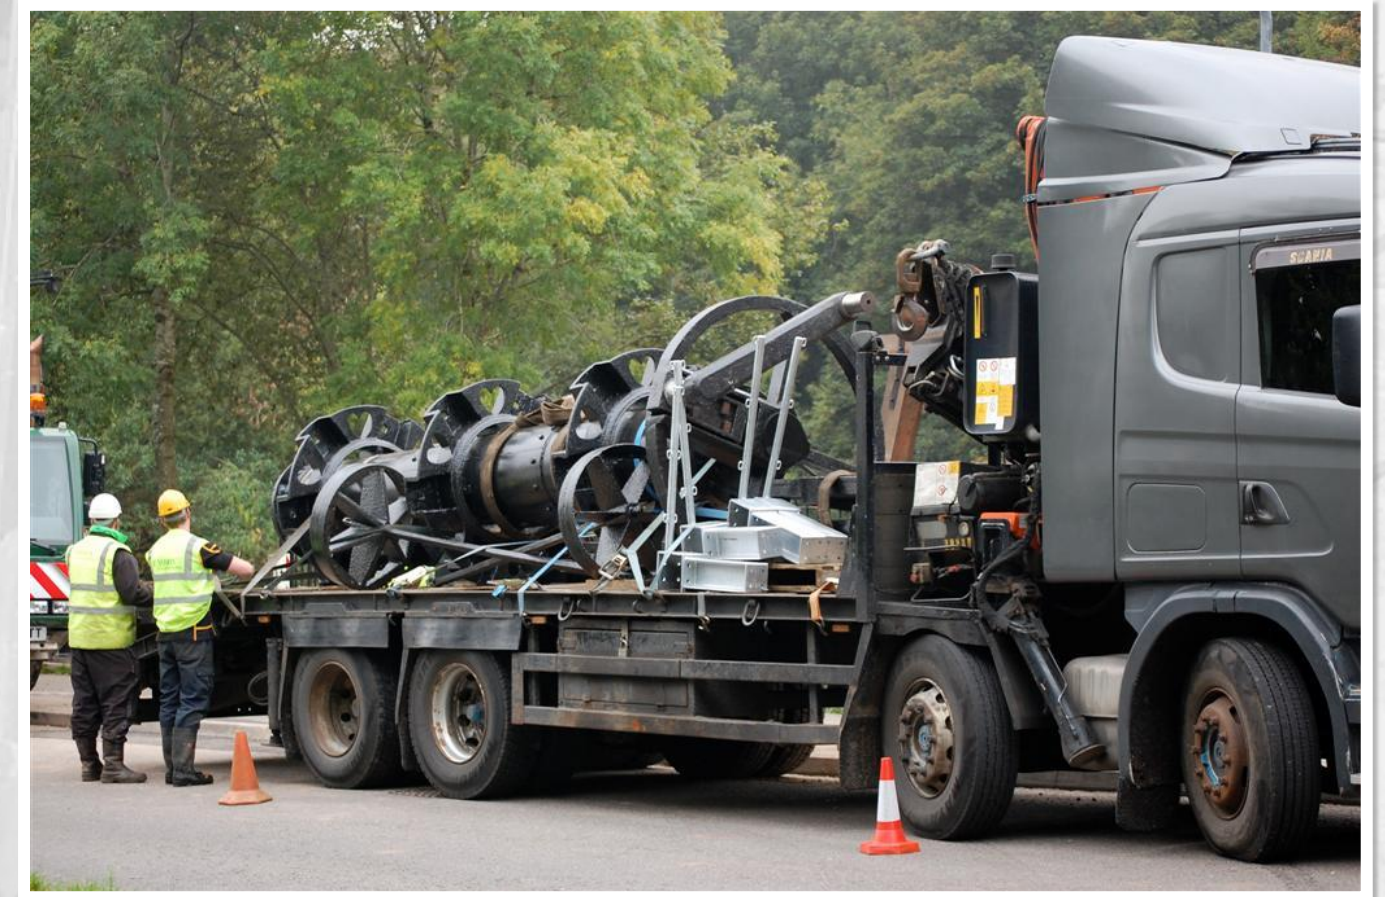
Fig 45 14/10/2010 Wheel components delivered to site to be lifted into position.

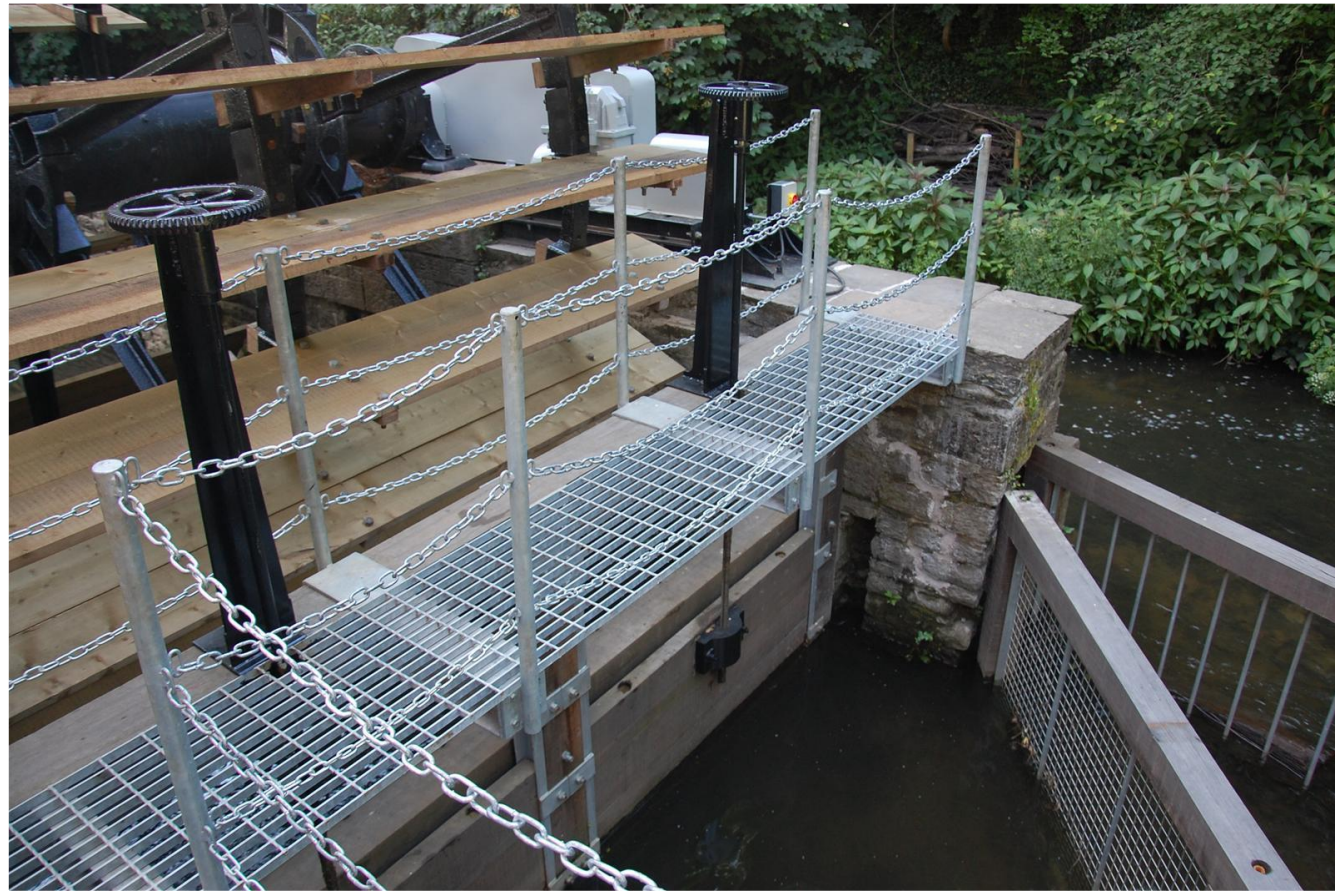
Fig 66 02/06/2011 View showing new galvanised mild steel access walkway fixed to replacement Sluice Gate frame. Sluice Gate lifting mechanism also shown, one for each Gate.

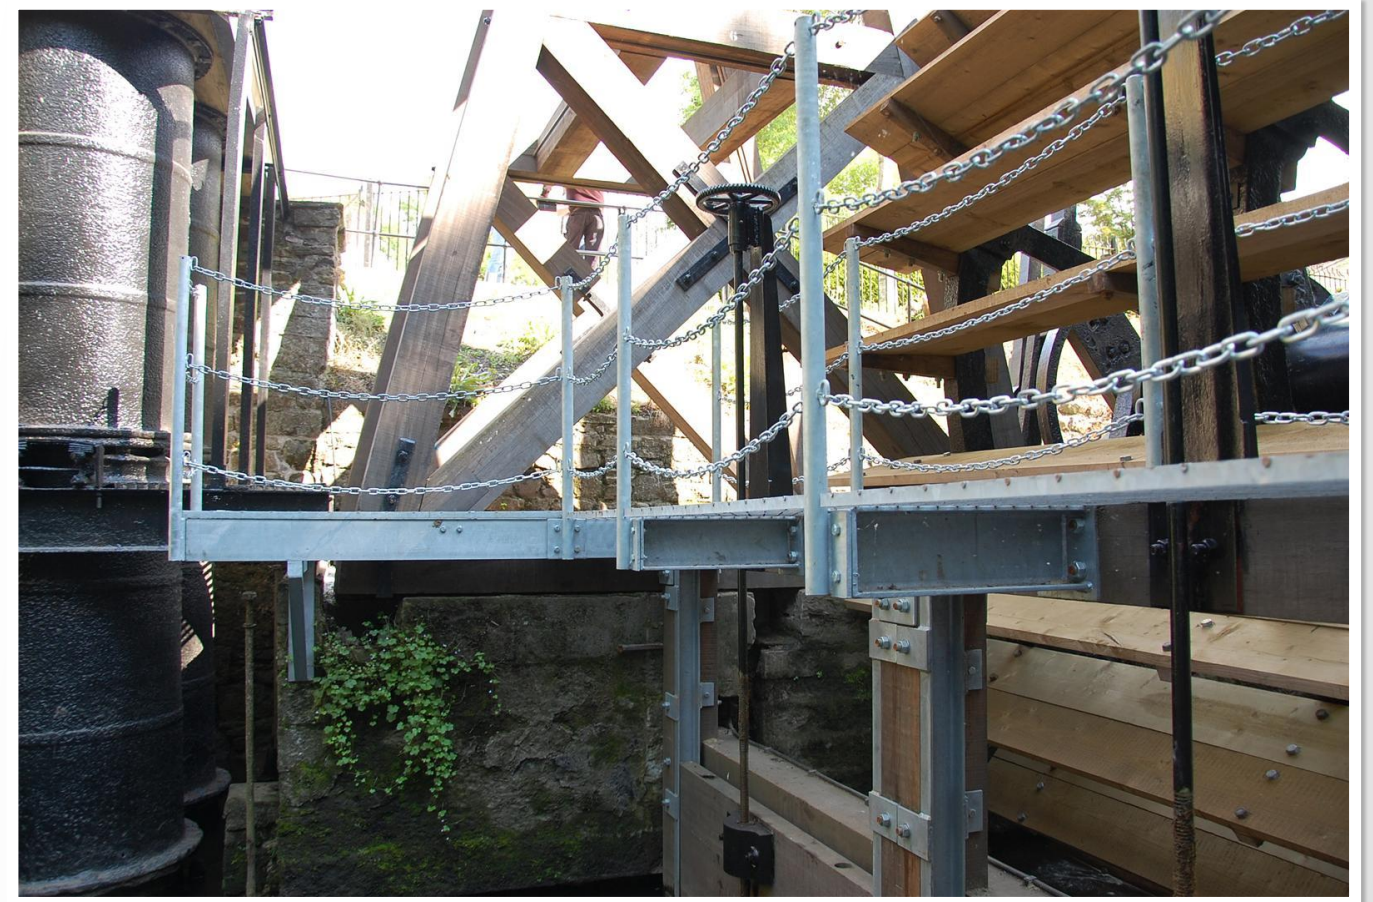
Fig 67 02/06/2011 Walkway support steelwork fixed to Sluice Gate frame and masonry wall.

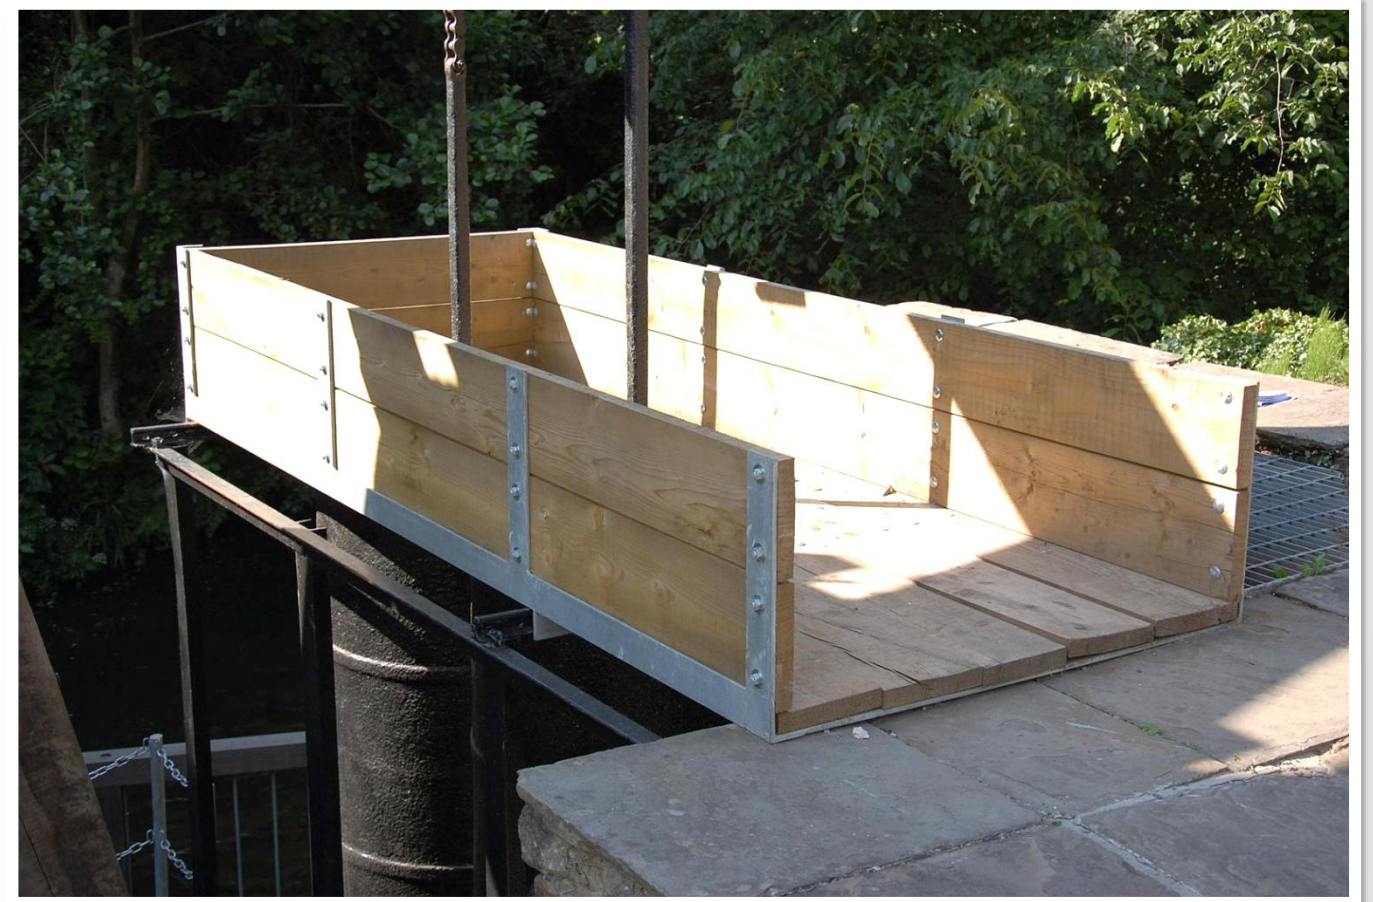
Fig 71 02/06/2011 View of the replacement timber Launder.

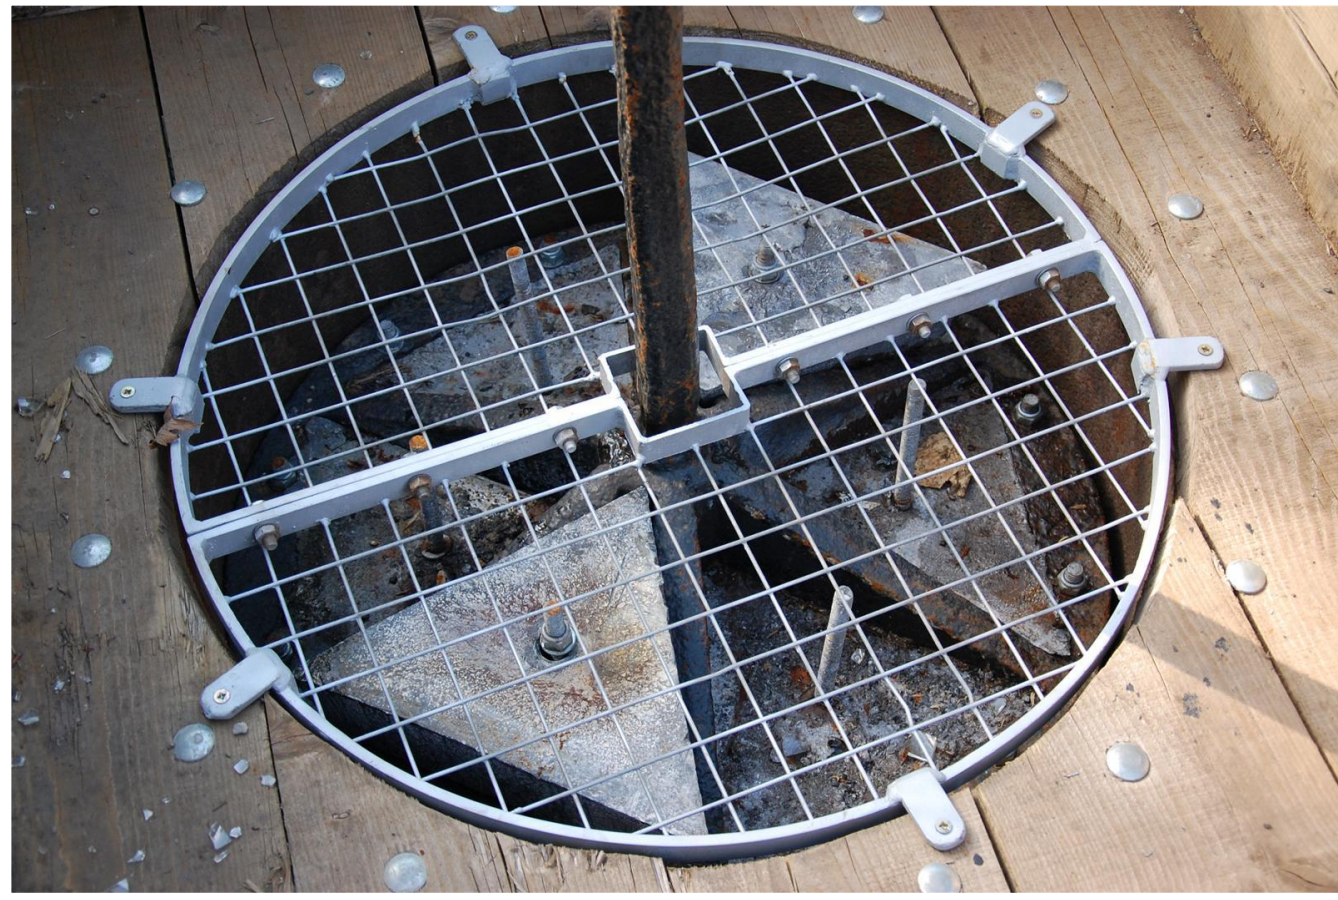
Fig 72 02/06/2011 Cast lead Counterbalance weight set within and on top of the original Valve Frames and Pump cylinders.
