REPORT OF AIRCRAFT ACCIDENT

ACCIDENT No. 13-5-5-504
9

(1) Place RAF Station, Llanbedr (2) Date May 5, 1943 (3) Time 1330
AIRCRAFT: (4) Type and model Lysander III A (5) A. F. No. V-9512 (6) Station Llanbedr, North Wales
Organization: (7) 8 A.F. & 8 F.C. (8) 6th F. W. (9) 2025th Gunnery Flight (Prov)
(Command and Air Force) (Group) (Squadron)

(56) Nature of accident Ground loop on landing.

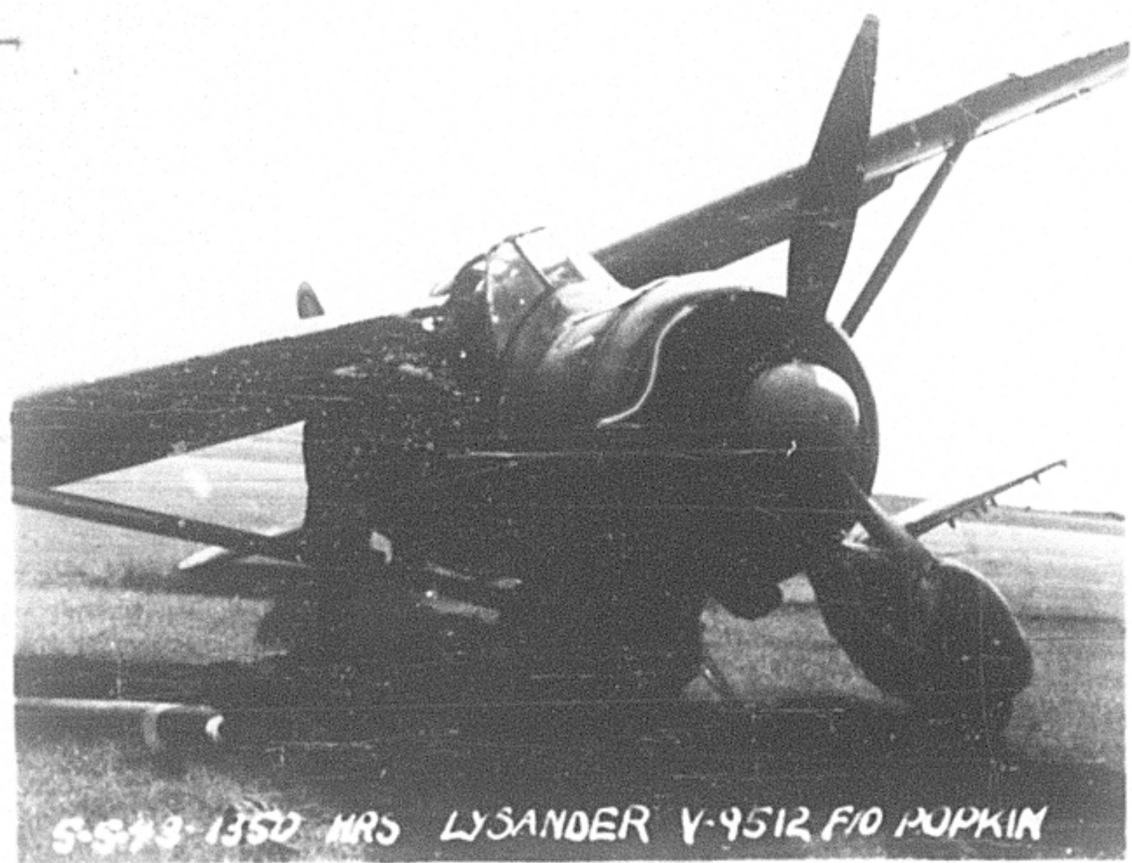
5-5-48 1350 MRS LYSANDER V-9512 F/O POPKIN

DAMAGE	(49) LIST OF DAMAGED PARTS
(46) Aircraft <u>W 4</u>	Starboard wing, landing gear, tail plane, fuselage belly.
(47) Engine(s) <u>O 4</u>	To be shock load tested.
(48) Propeller(s) <u>M 4</u>	One blade bent.

(57) Cause of accident Strong and gusty cross wind caused aircraft to swing violently upon landing. Tire blew and aircraft ground looped.
