APPENDIX 1

Photographic Record of Works

Client	Cadw
Job Title	Earl's Chamber
	Chepstow Castle, Monmouthshire
AS CONSTRUCTED

THE EARLS CHAMBER CHEPSTOW CASTLE

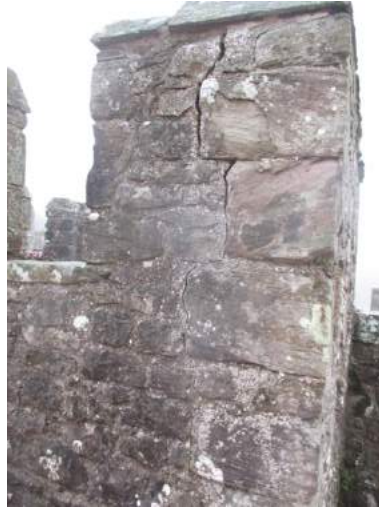
Figure 10: Pre-commencement
(note severe cracking and displacement)

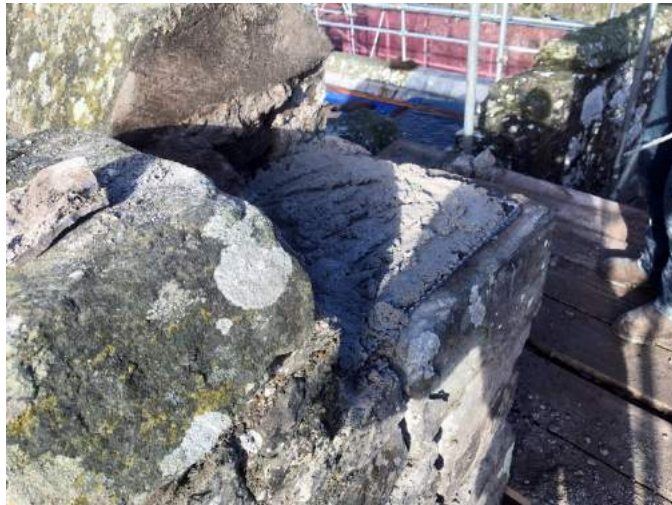
Figure 11: During contract works
(detail of bedding mortar and Helibar installation shown)

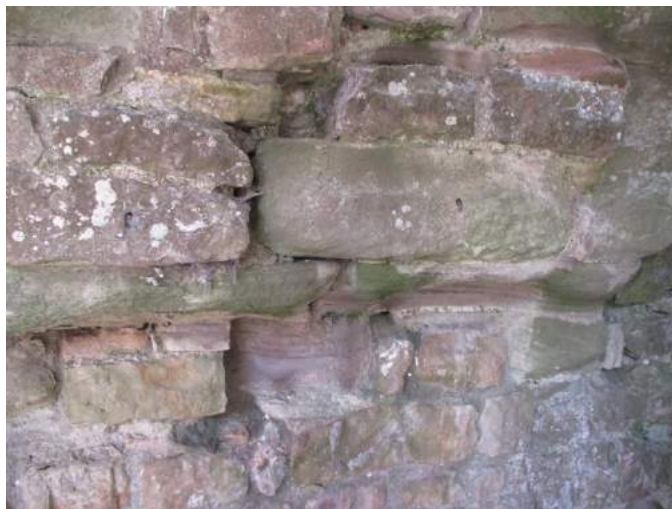
Figure 20: During contract works
(discreet holes from stainless-steel bar installation shown)

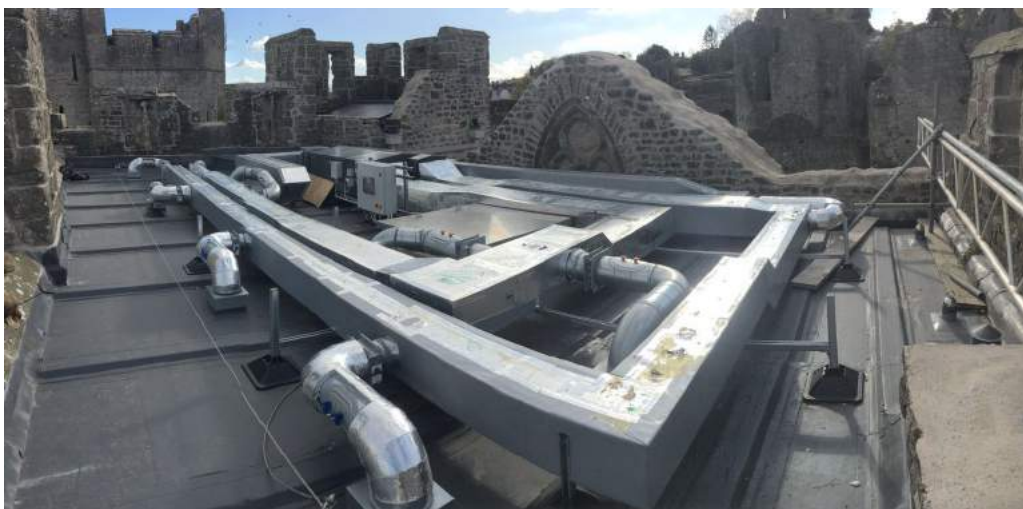
Figure 24: Nearing completion
(Entirety of roof plant configuration shown in 'fisheye' view)

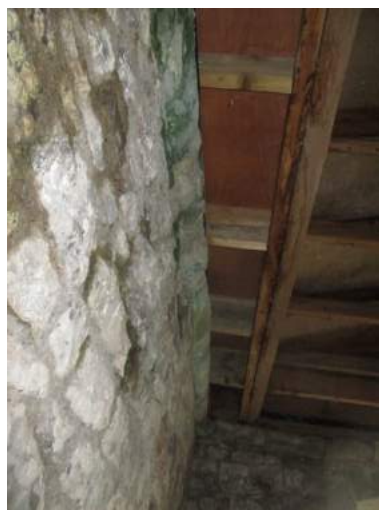
Figure 45: At completion
(wall noted to be visibly 'drying out')

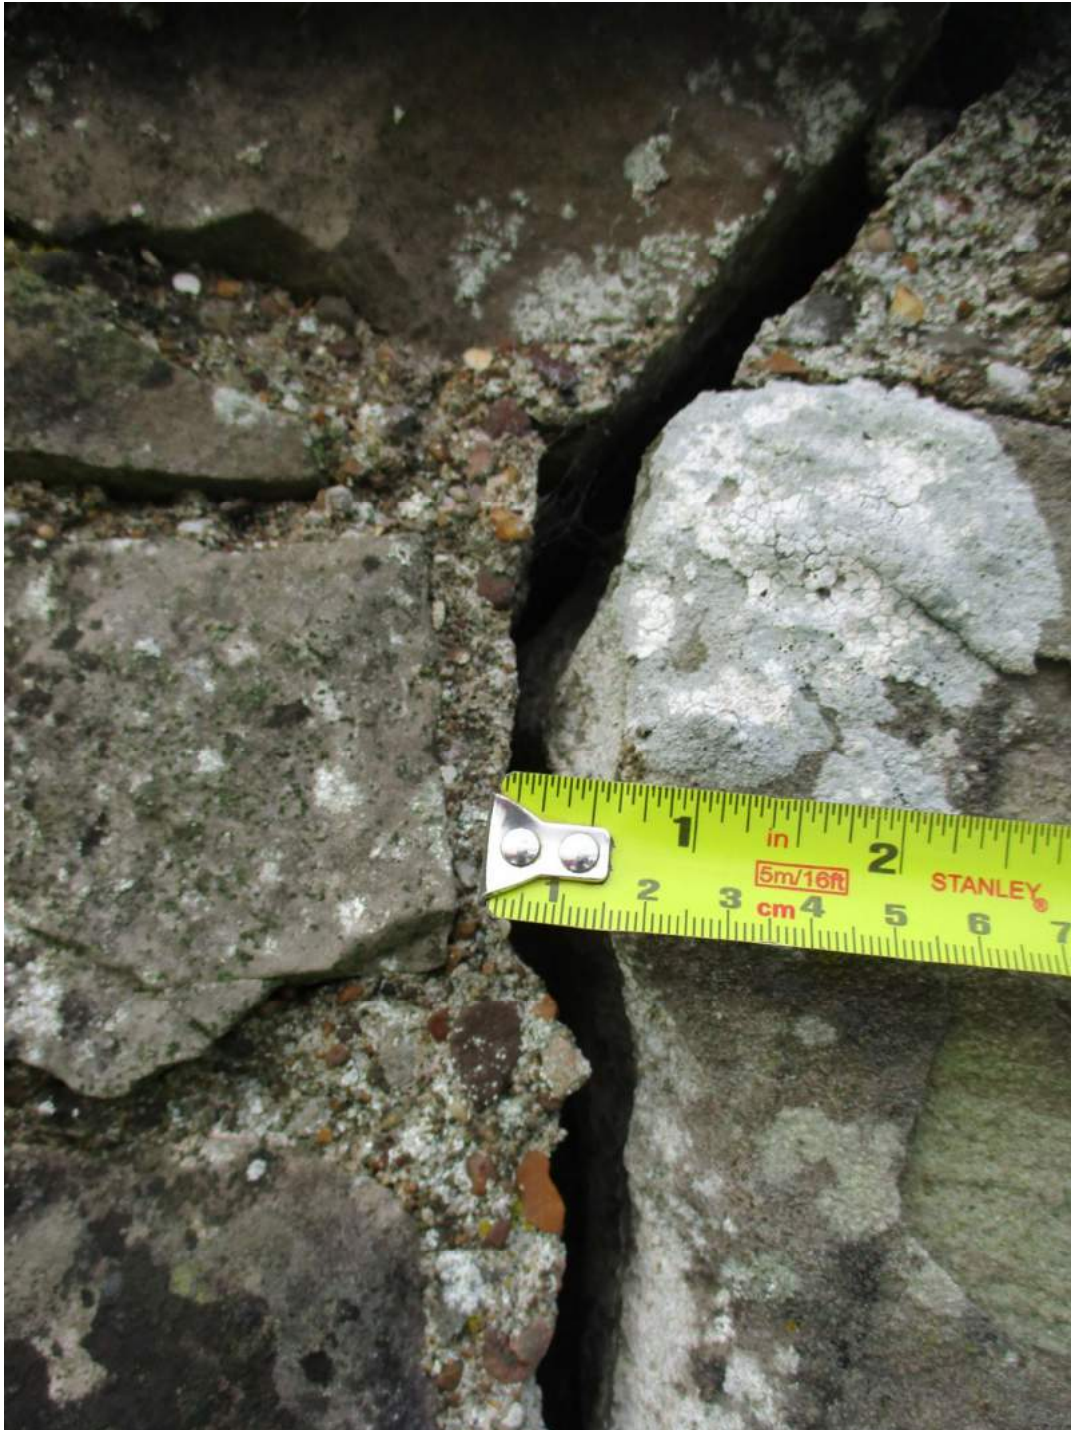
Photo 1: Widest point of crack in eastern elevation

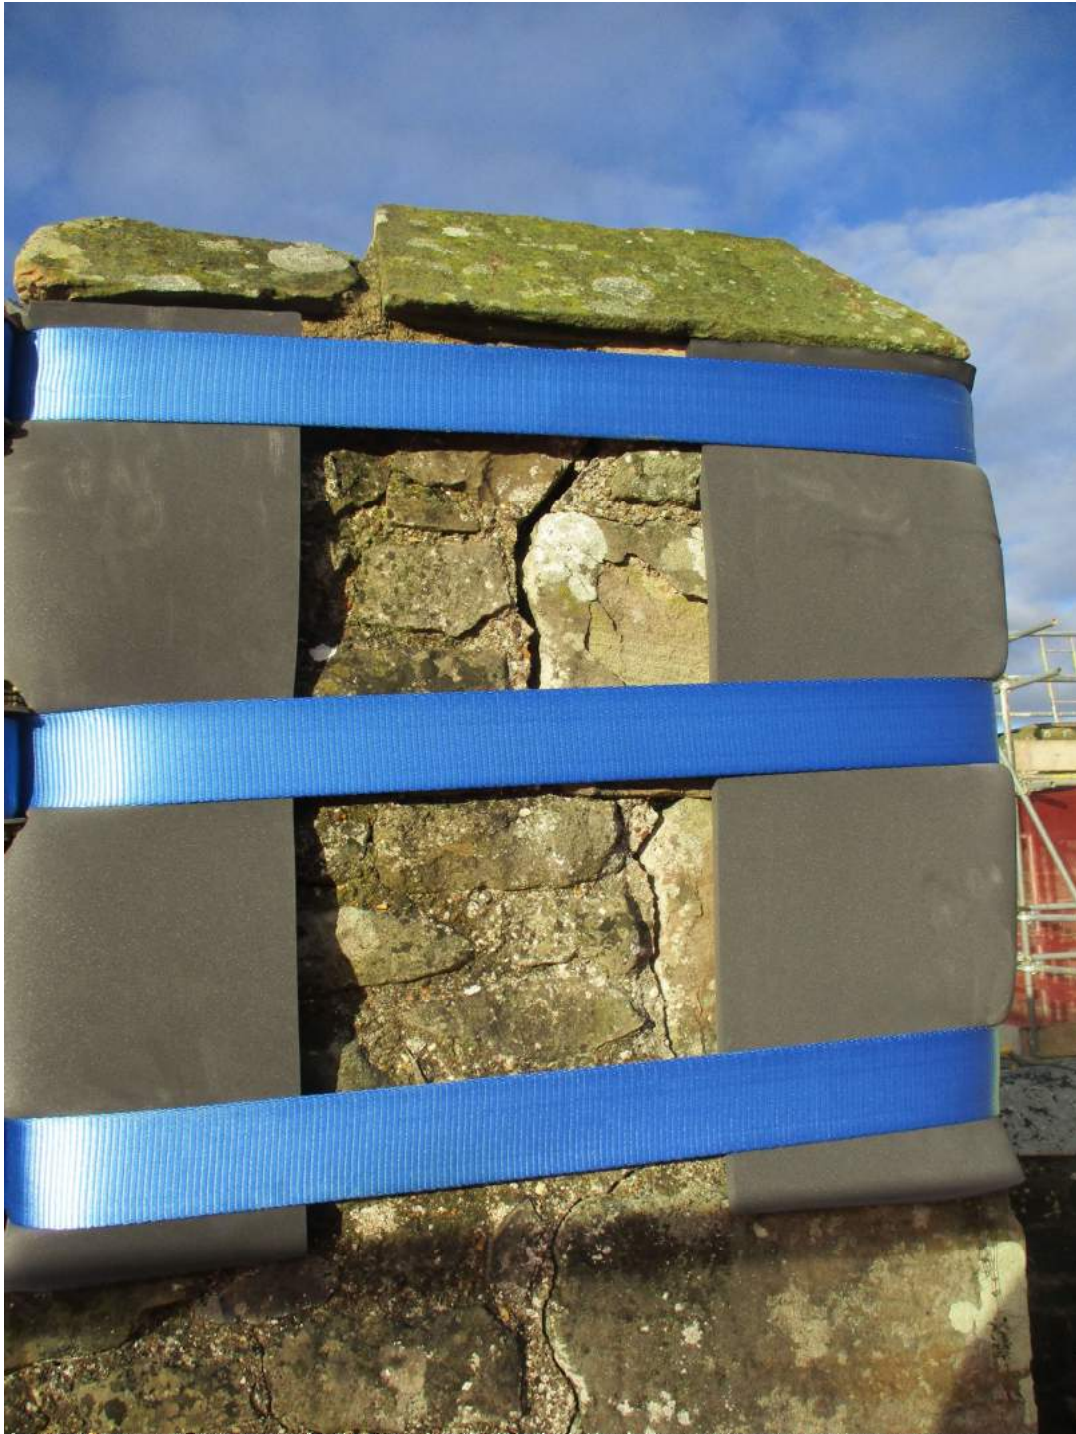
Photo 2: Crack visible in eastern elevation under temporary restraints

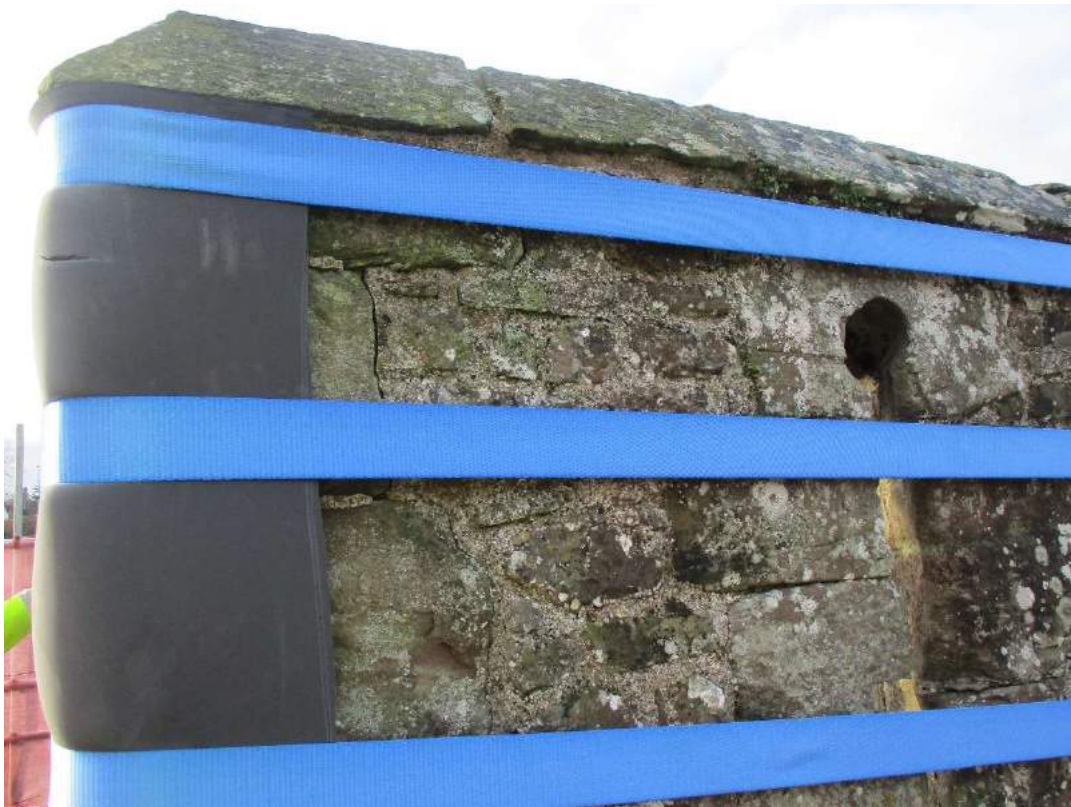
Photo 3: Crack visible in northern elevation under temporary restraints

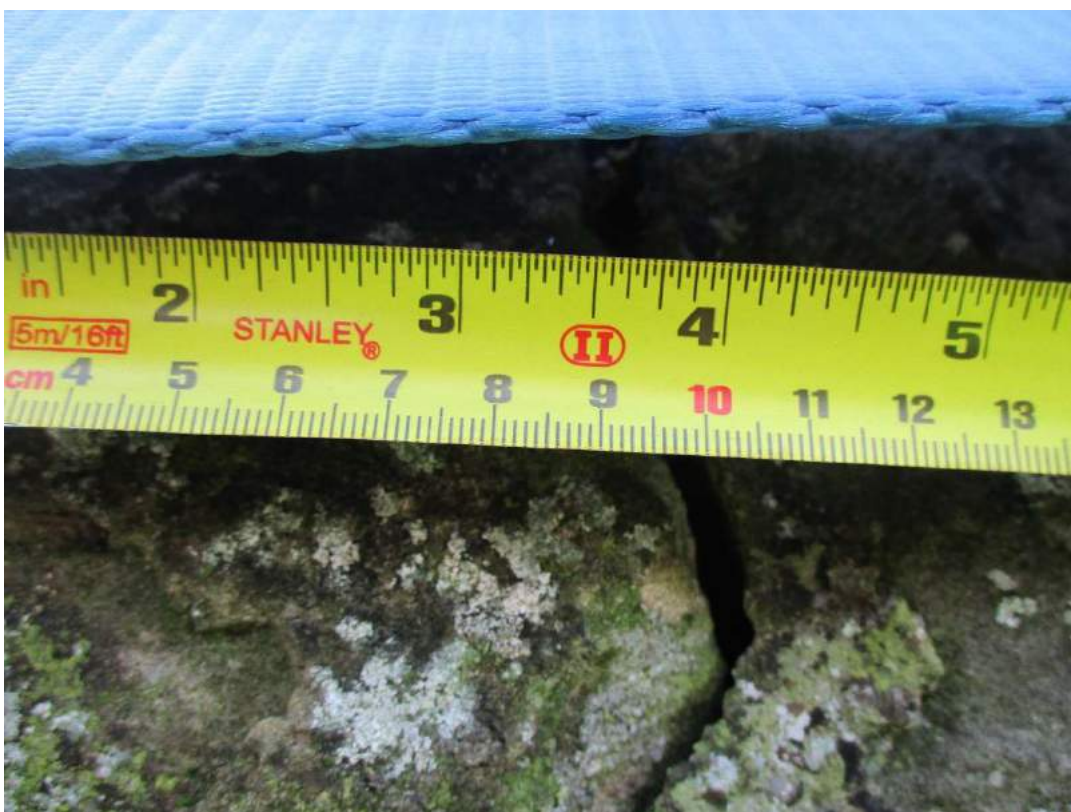
Photo 4: Widest point of crack in northern elevation

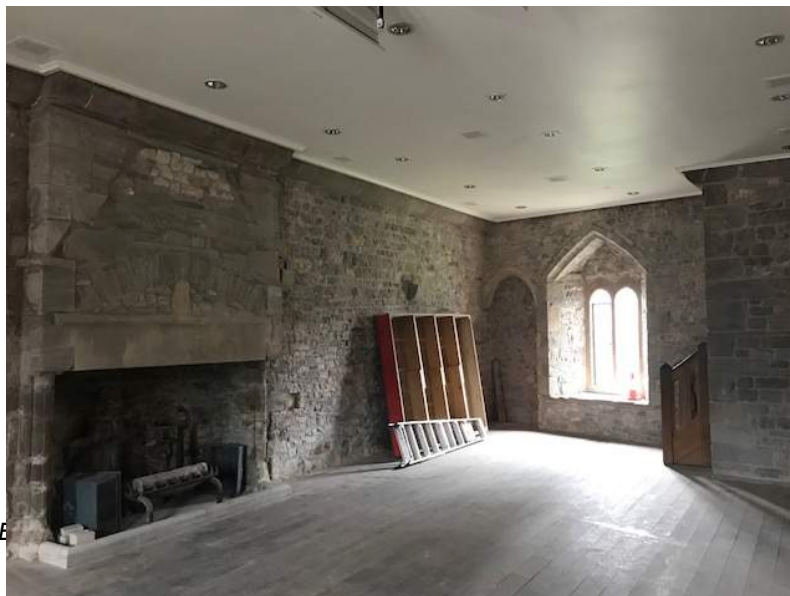
- 4.3 There was also a wet joint to the north west to the left side of the fire place in January 2018 where moisture was evident in the mortar joints - photograph 3. This joint has dried significantly by April 2018 with no moisture evident in the bedding joint - photograph 4. In January 2018 the moisture meter reading in the wet joint was 48% but this had reduced to 27% in April 2018, and therefore it could be concluded that the moisture penetration has stopped and the wall is drying out. We understand PDP Green have been investigating the cause of moisture penetration which is likely to be from the ledge above.

Photograph 3 - moisture penetration to bedding joint January 2018

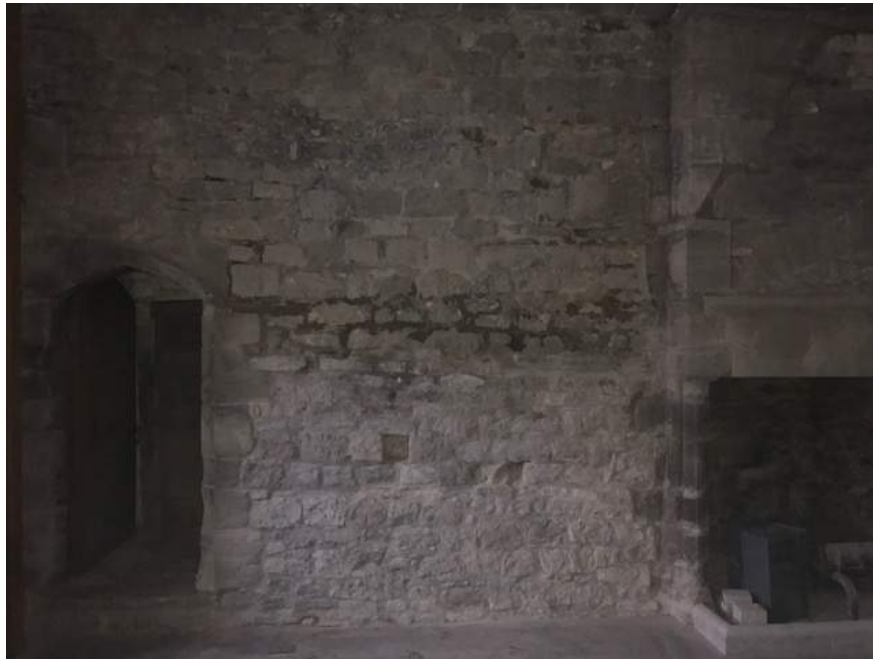
Photograph 4- reduced moisture penetration of bedding joint April 2018
