Fairbourne Flood Defences Renewal, Fairbourne, Gwynedd

Archaeological Building Recording and Watching Brief

Project No. G2315

Report No. 1209

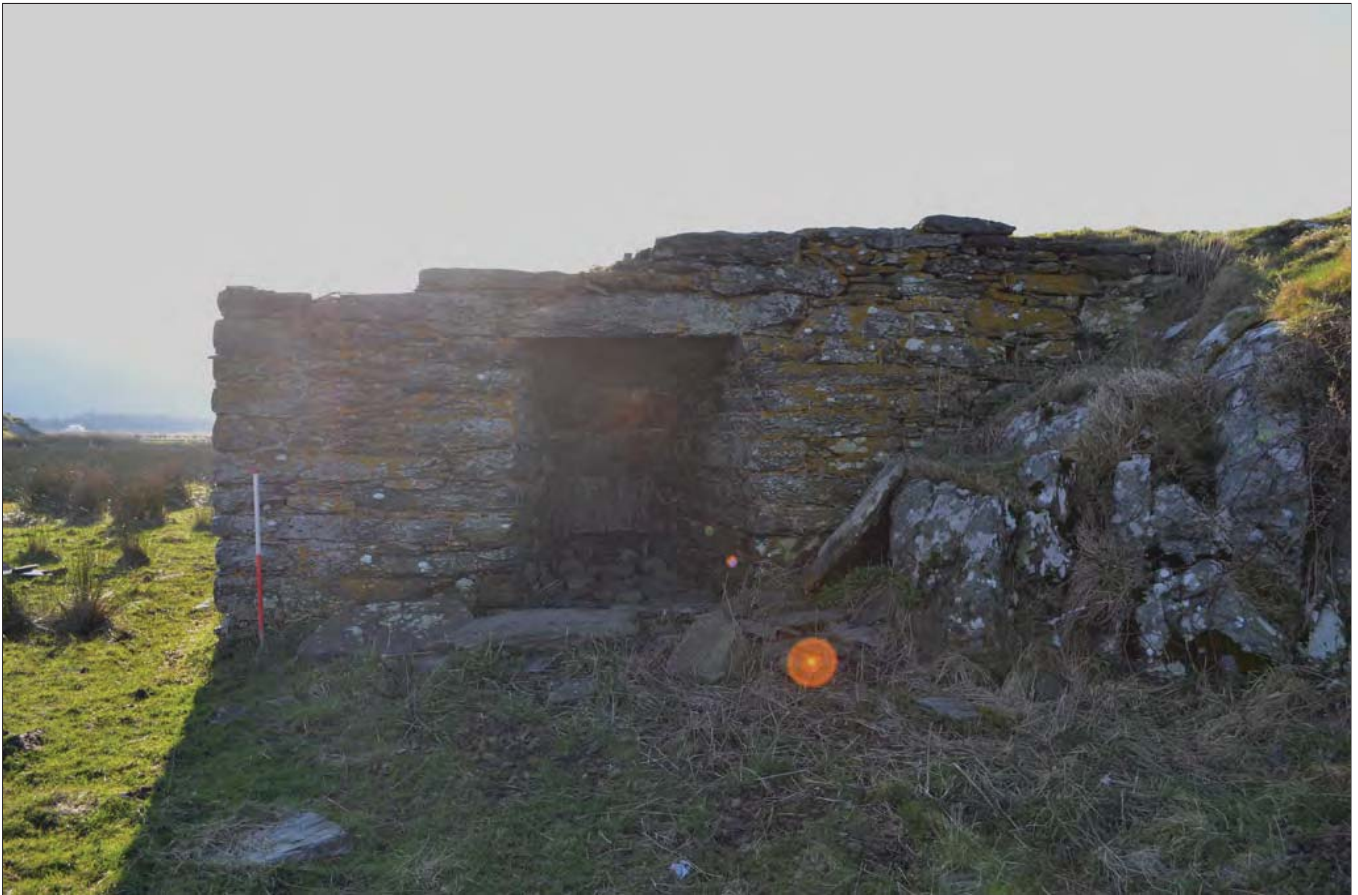
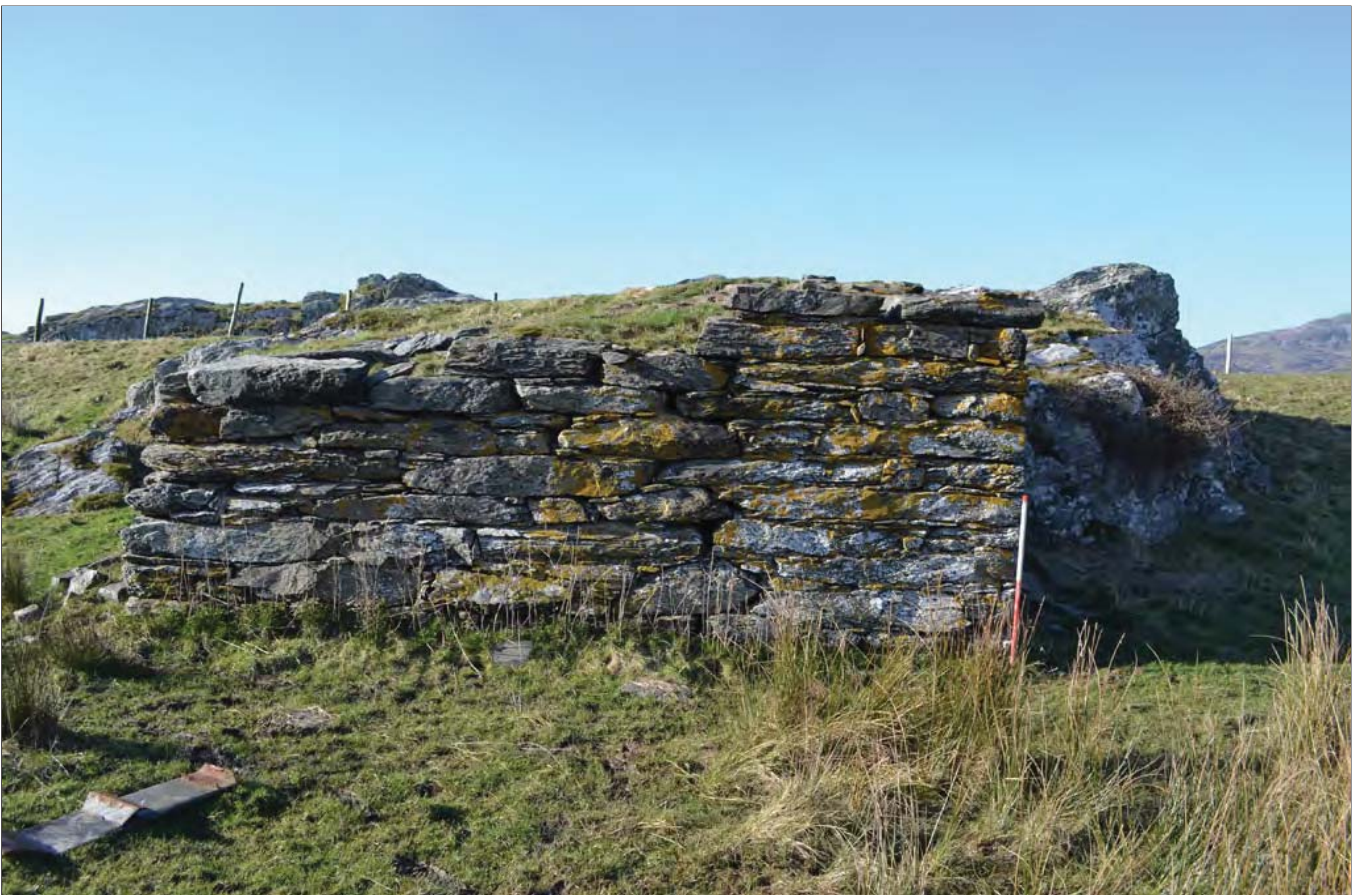
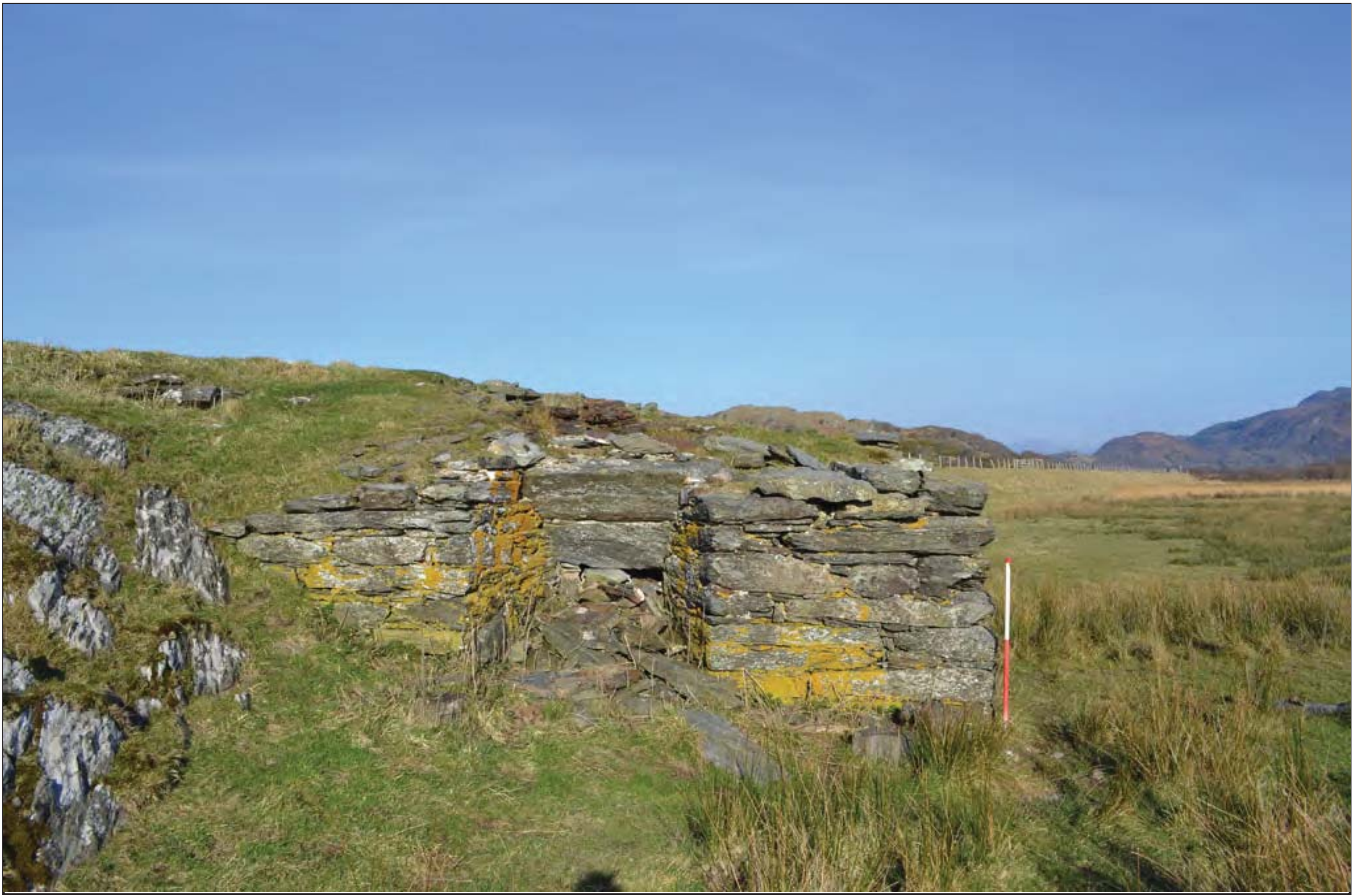
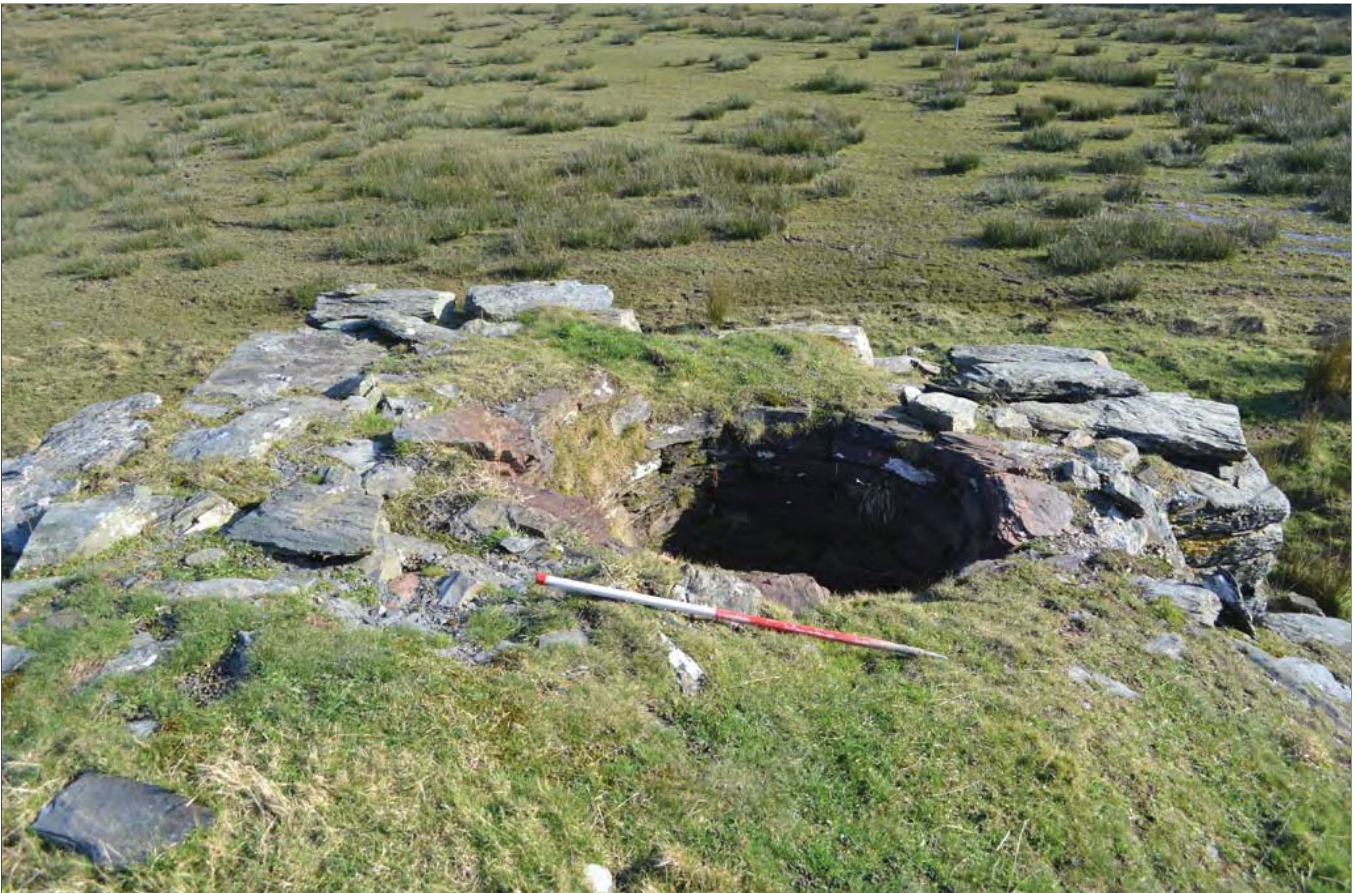
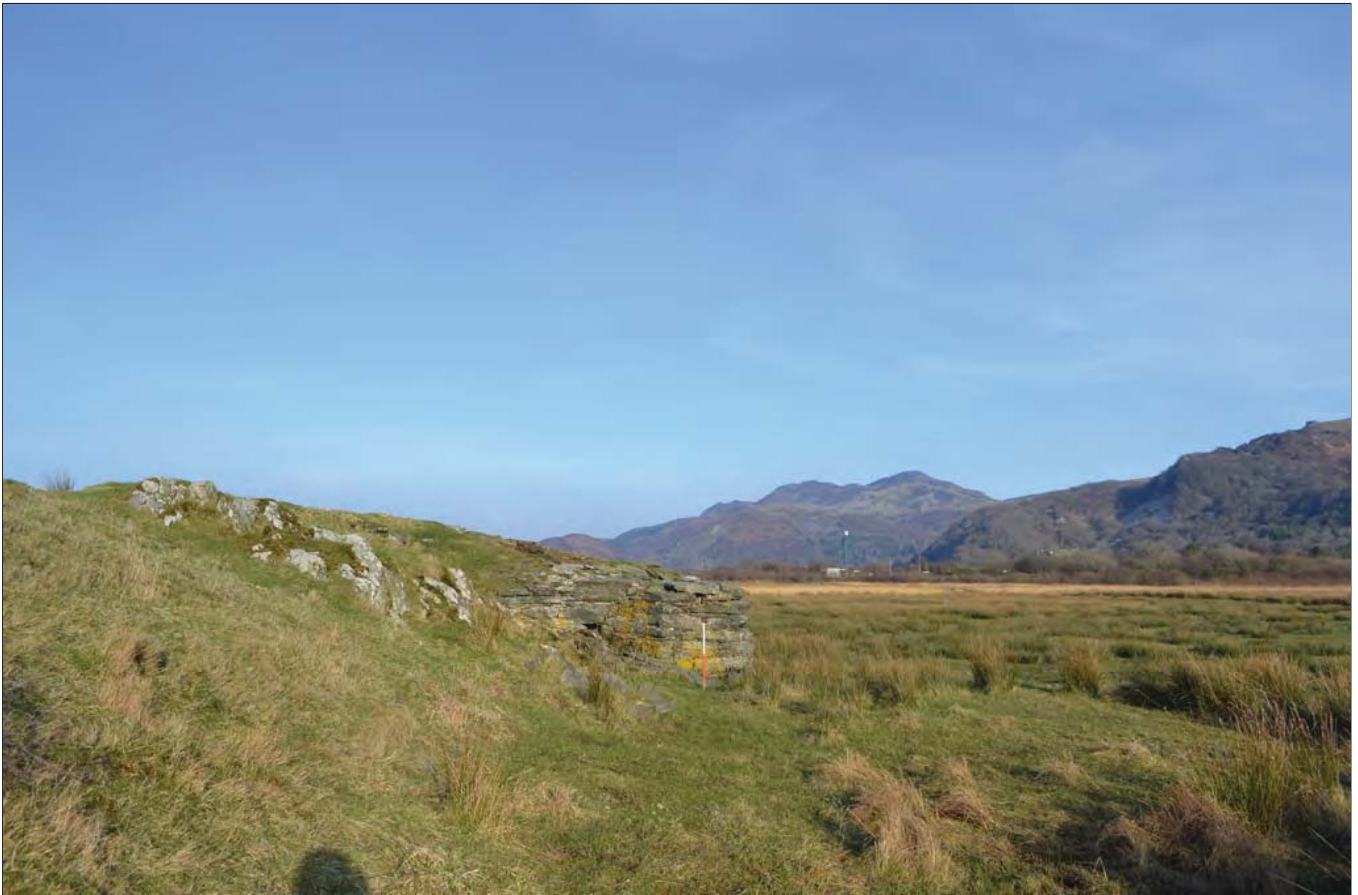
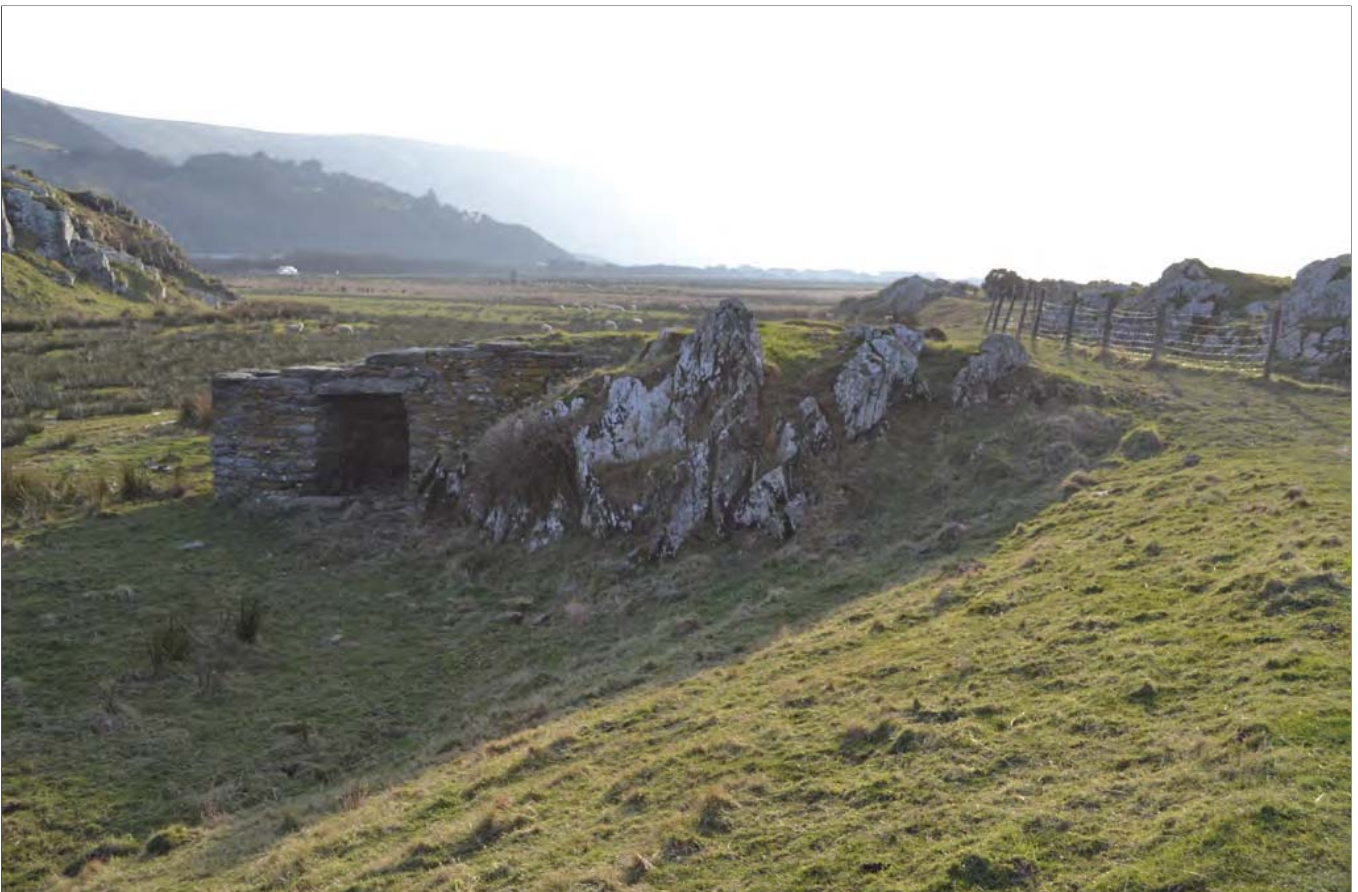
It is built of coursed rough shale fieldstone blocks (up to 1.2m by 0.6m), and is between 1.4m and 2.1m high and approximately 4.5m square (Plates 01-06). At no point does the overall height of the structure rise above the rock outcrop to the west of it (Plate 05). It is built into the east side of a rock outcrop which has in turn been built into the flood defence embankment, and is surrounded to the east by salt marsh. It has stoke holes to the north and south (Plates 02 and 04), and a circular entrance hole for the limestone above.

Plate 01: The Lime Kiln on the Fairbourne Embankment, viewed from the east. Scale 1m

Plate 02: The Lime Kiln viewed from the south. Scale 1m

Plate 03: The Lime Kiln on the Fairbourne Embankment, viewed from the west. Scale 1m

Plate 04: The Lime Kiln viewed from the north, showing hole into which the lime and fuel was shovelled. Scale 1m

Plate 05: The Lime Kiln on the Fairbourne Embankment, viewed from the west, showing relationship with the rock outcrop built into the Fairbourne embankment. Scale 1m

Plate 06: The Lime Kiln viewed from the east south east, showing hole into which the lime and fuel was shovelled. Scale 1m

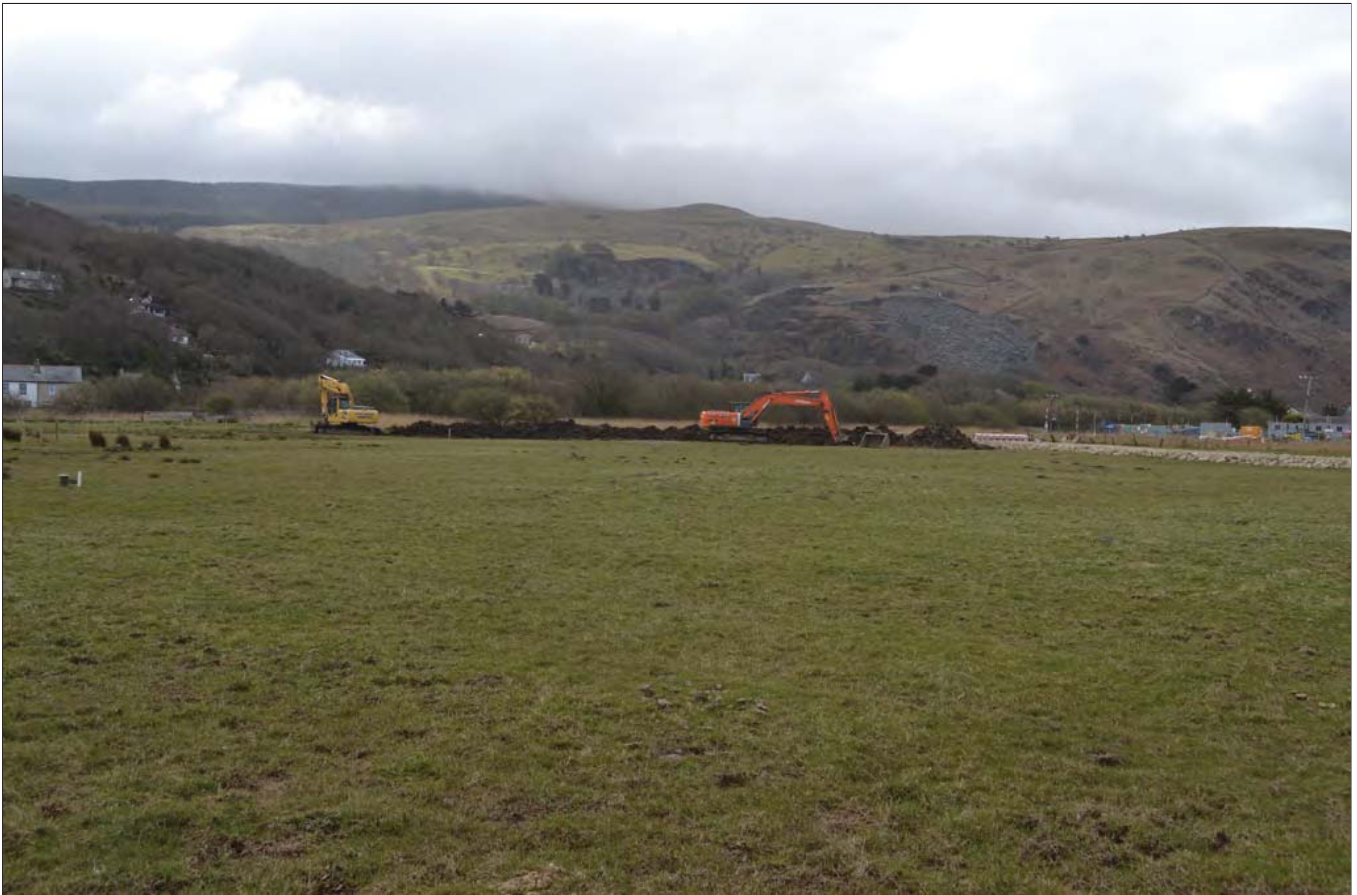
The remains of a former brickworks is noted on the 2nd edition 25 inch Ordnance Survey map of 1901 at NGR SH61781320, close to the areas of late 19th and early 20th century development in Fairbourne (Plates 7-10). Close to this area, but to the west of it, a borrow pit was excavated, covering an area of 8,000m². The main site of the brickworks, where the wooden and corrugated iron buildings were formerly located, and as shown on the 25 inch Ordnance Survey Maps, was avoided. During the stripping of this adjacent area a topsoil depth of up to 0.4m was noted, overlying rubble and brick at the east end, covering an area of about 24m by 40m, which was close to the location of the brickworks. This deposit was quite shallow (about 0.3m), and overlay a light yellowish brown clay about 0.25m thick which in turn overlay a blue grey waterlogged clay. Earlier geotechnical testing had indicated that at a depth of 0.6m a peat deposit would be encountered. These were not reached during the borrow pit excavation, which was restricted to the clay deposits above. These clay deposits overlying peat are consistent with natural estuarine deposits overlying earlier peat formation. The excavation work generally avoided the brickworks area, with clay excavated to the west of it (Plate 09). However a single course of brickwork, two bricks wide, running WNW-ESE was noted at SH61741315. The purpose of this is unclear, and it does not appear to have any foundations.

Plate 07: Excavation work on the borrow pit adjacent to the former brickworks site

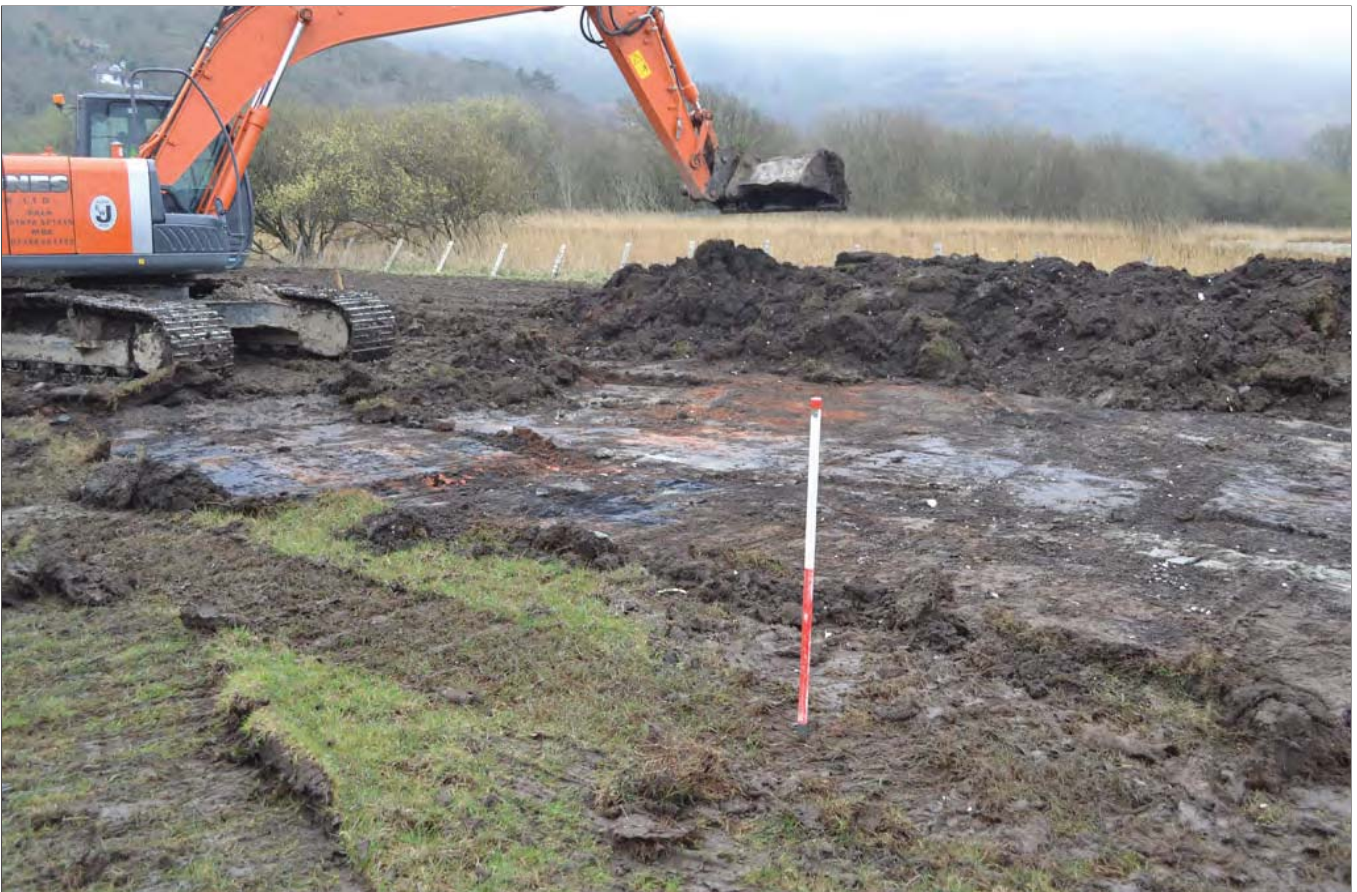
Plate 08: Evidence of brick rubble within the topsoil, presumably related to the works at the Fairbourne Brickworks. Scale 1m

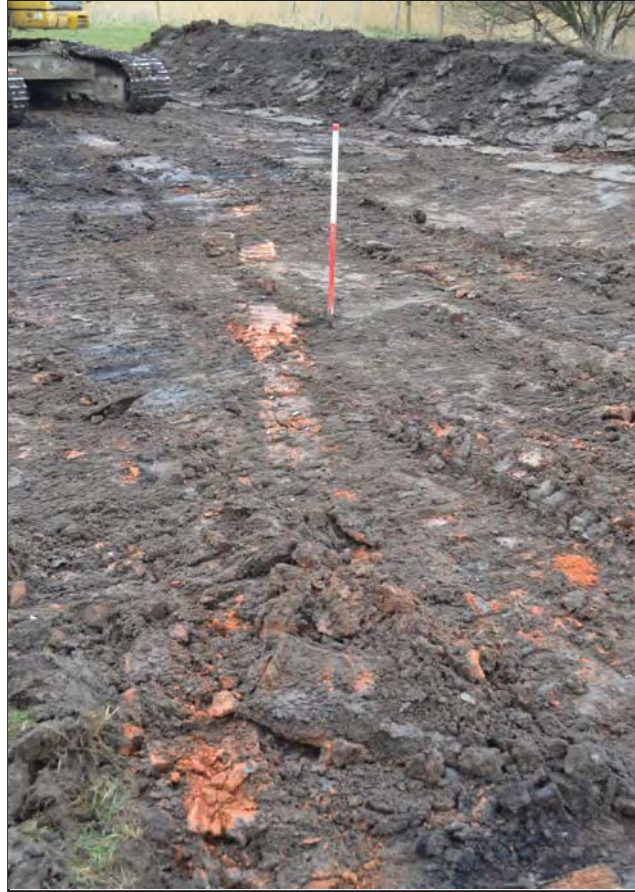
Plate 09: Excavation work on the borrow pit adjacent to the former brickworks site, showing double thickness of brickwork, which does not appear to be structural

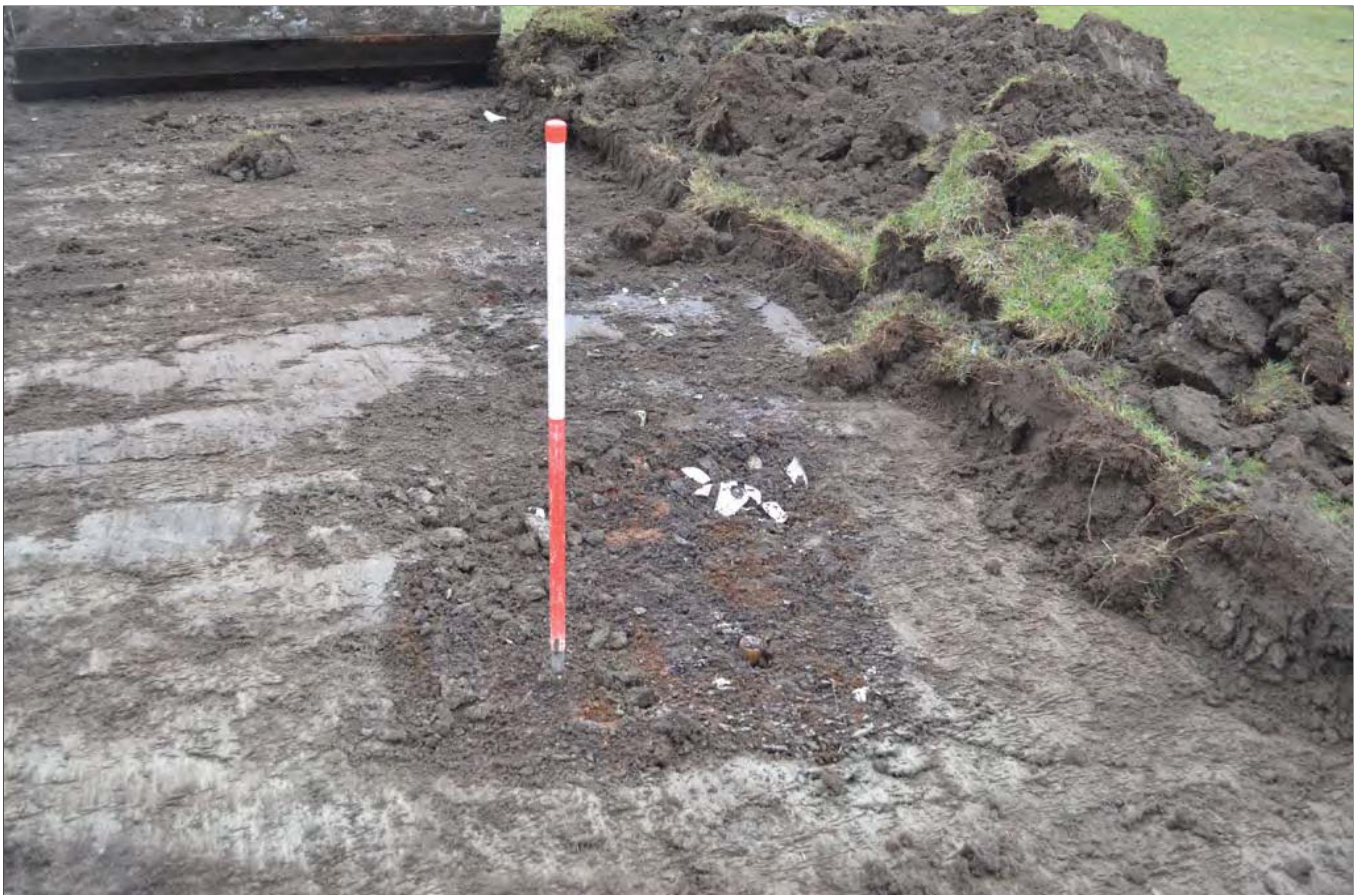
At the eastern end of the borrow pit excavation there was much late 19th century to early 20th century waste, consisting of glass, pottery and stoneware jars noted within the topsoil. This material although unstratified, is probably waste material from the time that the brickworks was in use (Plate 10).

Plate 10: Evidence of a rubbish pit at the former Fairbourne Brickworks site. Scale 1m

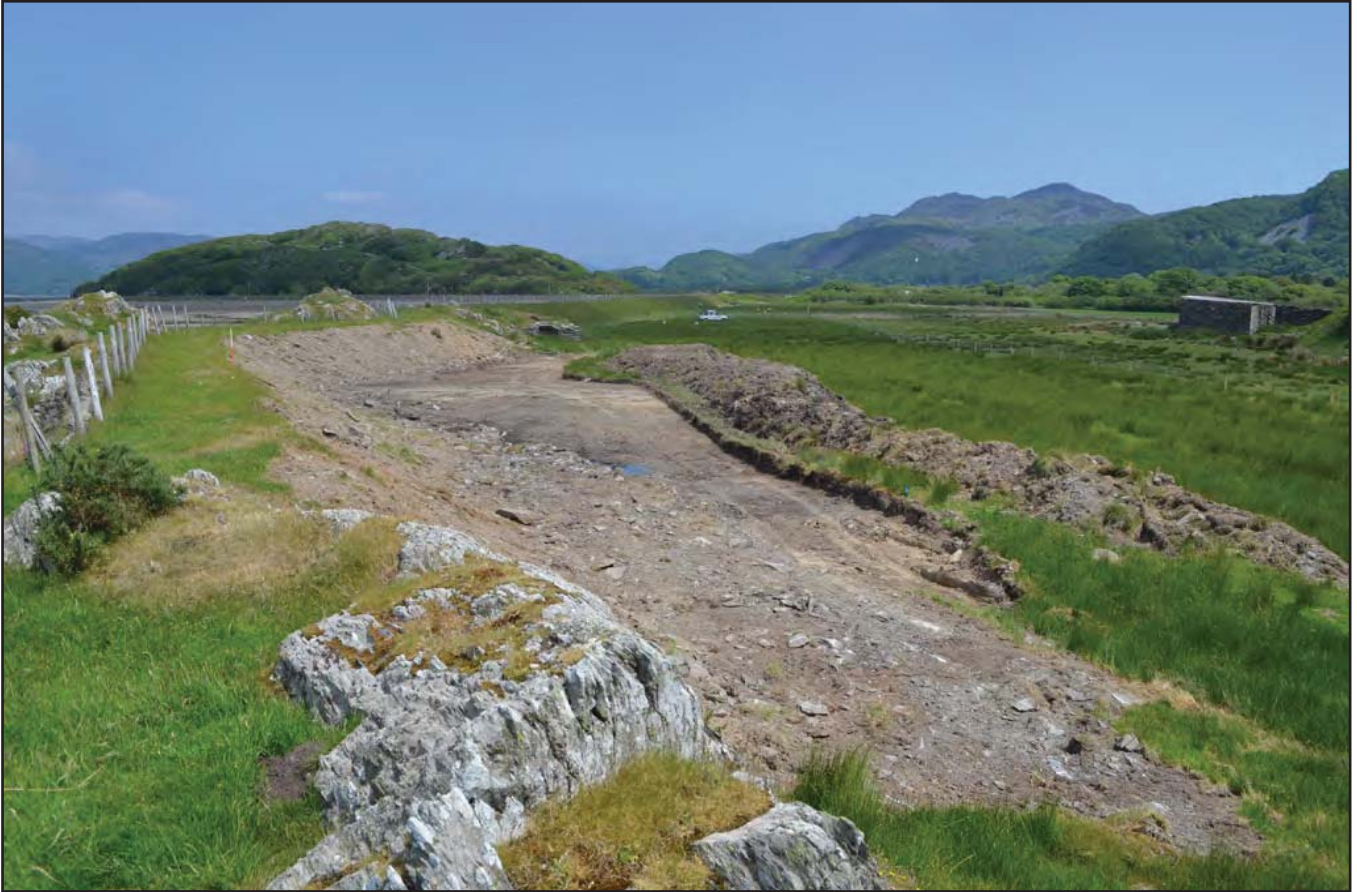
Plate 11: Topsoil strip adjacent to the embankment. View looking east

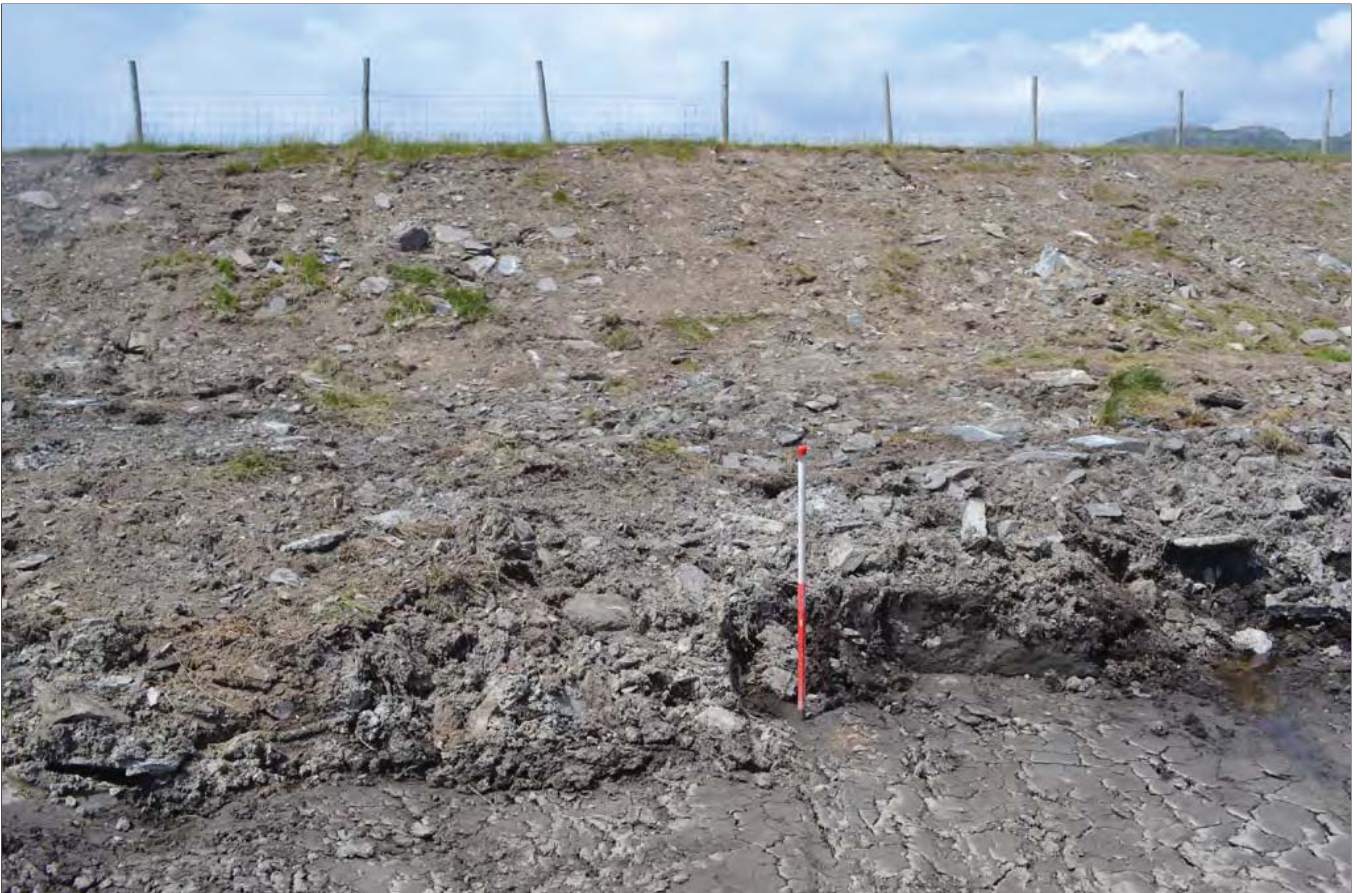
Plate 12: Fairbourne embankment, showing shale and clay make-up. View from the north. Scale 1m

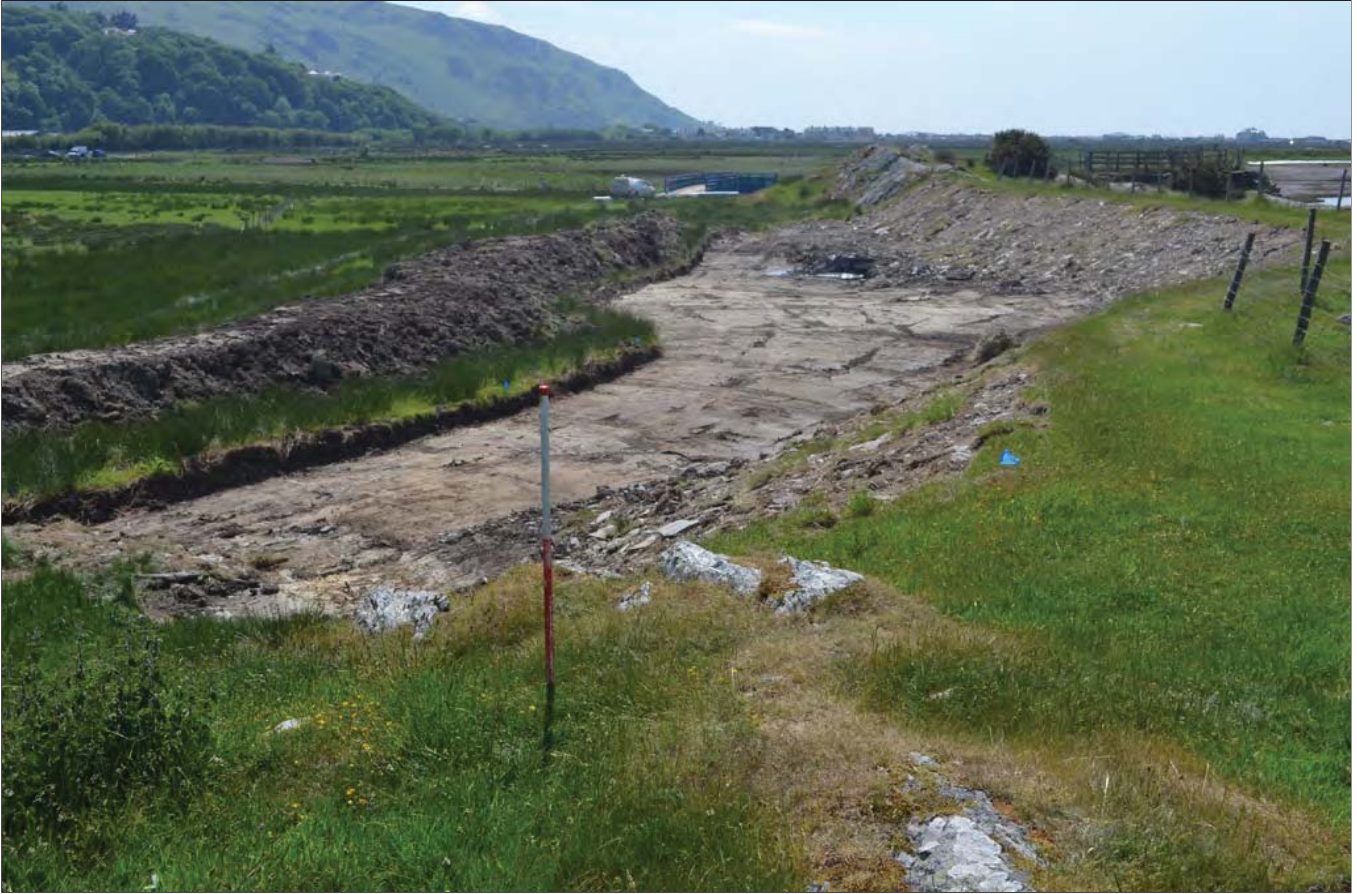
Plate 13: Topsoil strip of haul road east of the lime kiln. View looking west. Scale 1m

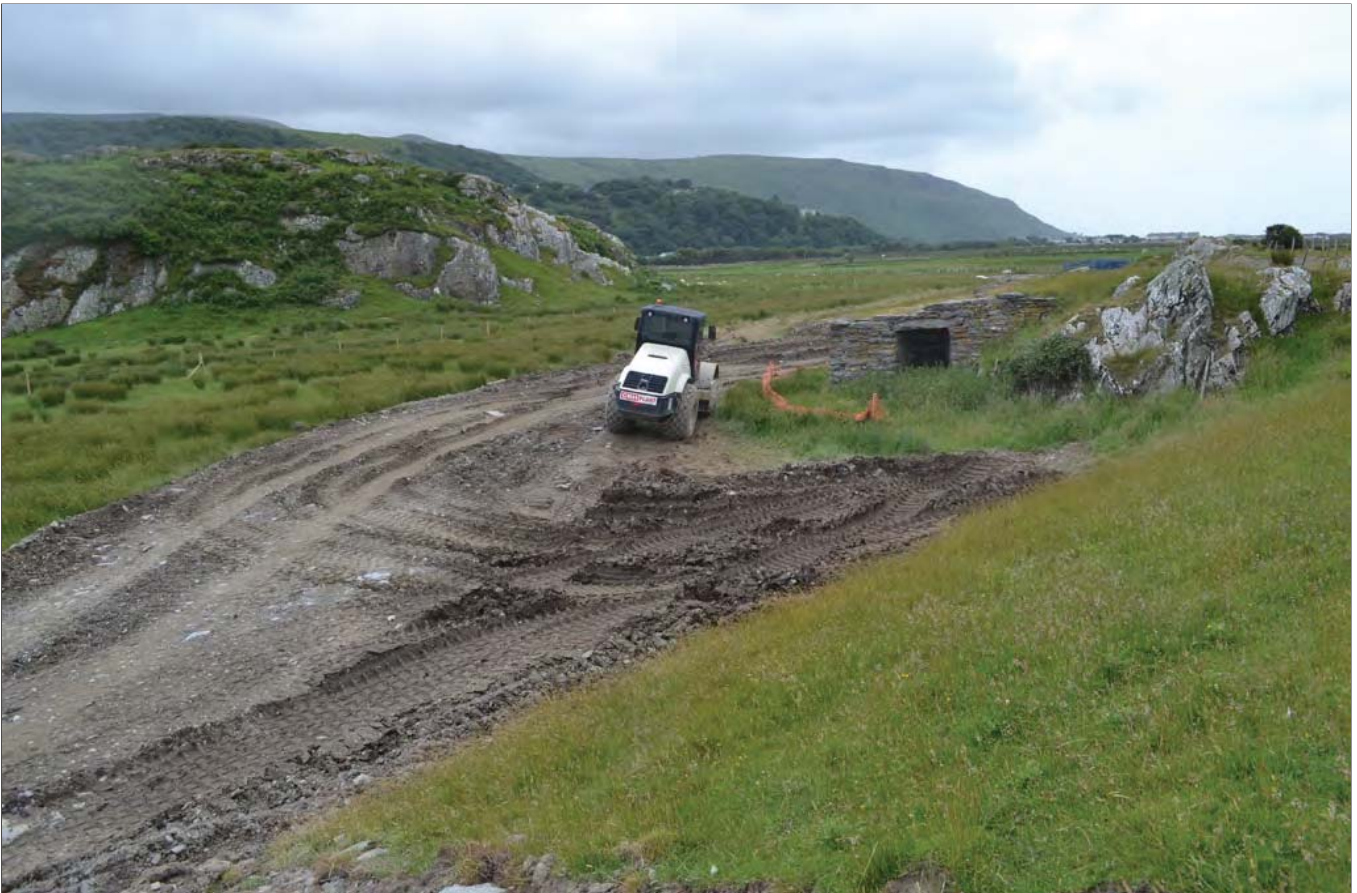
Plate 14: Use of the haul road adjacent to the lime kiln and Fairbourne Embankment. Scale 1m

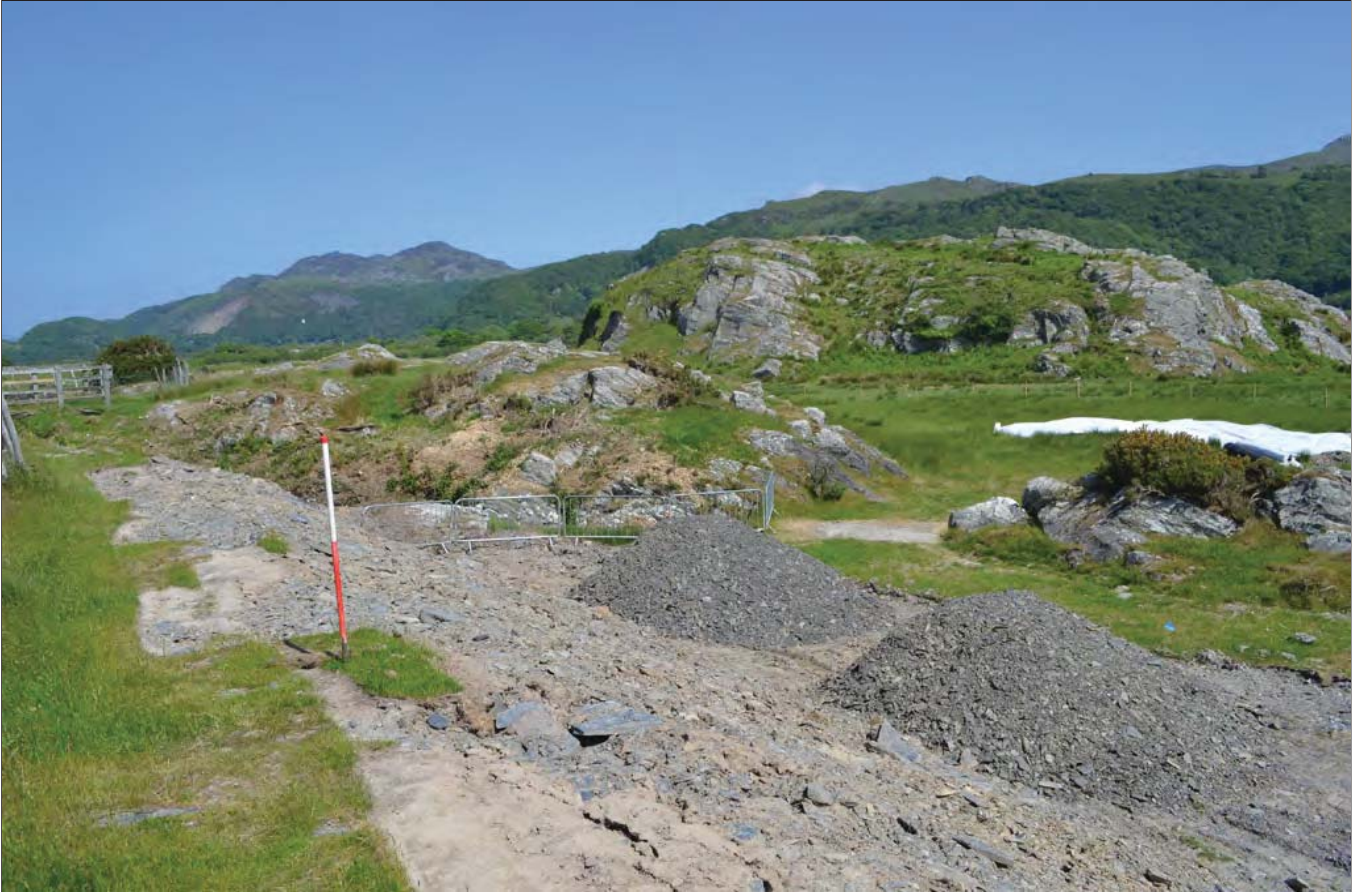
The stripped area consisted of up to 0.45m of silty clay below wet reeds/couch grass which overlay a mid orangy-brown natural clay and sand deposit. This was only visible in patches where the natural soils protruded at a shallow depth of about 0.25m. Rock outcropping was also noted in places.

Plate 15: Stripped Topsoil showing clay and shale make-up of the embankment. View looking west. Scale 1m

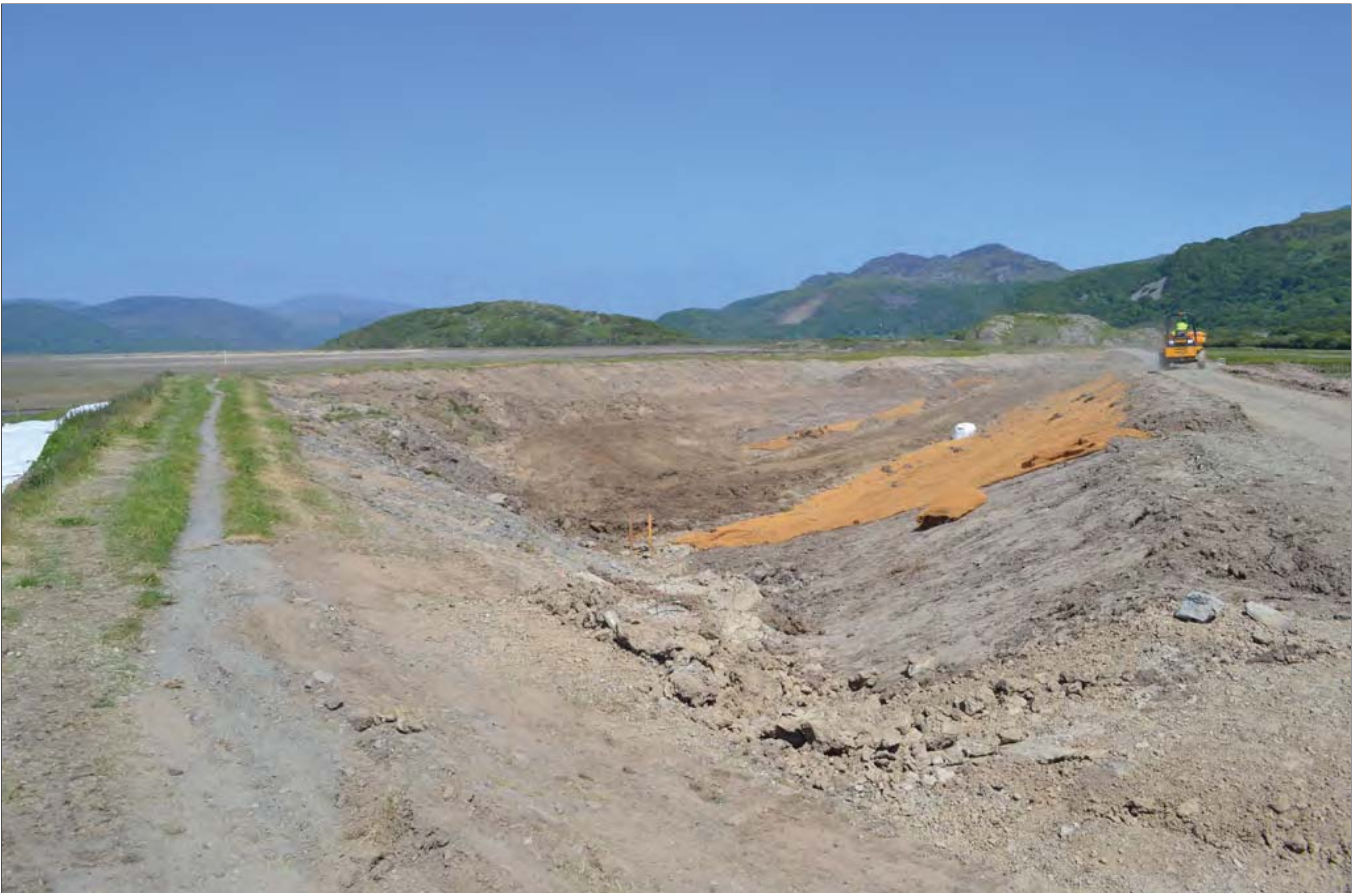
Plate 16: New section of Fairbourne Embankment removing the right-angled junction at the west end of the scheme.
