**Watching Brief**

**HAFOD ARCH (CLYDACH RAILROAD)**

**WB/BRY/10**

**Blaenau Gwent County Borough Council**

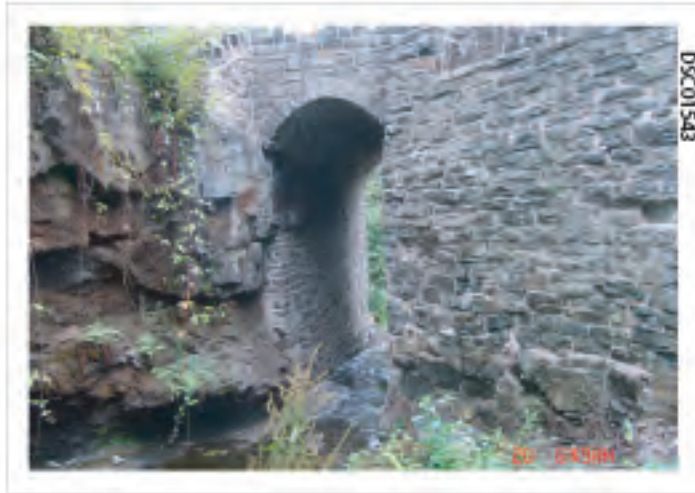
The Clydach railroad is cut into the rock face on its northern, uphill side, Plate 01 and embanked along its southern, downhill edge. Where it crosses the gully cut by the Nantmelyn stream, it is carried on a stone revetted causeway pierced by the Hafod Arch and a smaller storm arch, fig 02, Plate 02.

The Hafod Arch is towards the eastern edge of a raised causeway. The north edge of the causeway carries a later, cast iron service pipe on raised brick towers, Plate 04. Construction of these later towers had an impact on the arch possibly requiring alterations and repairs to be made. Plate 05, 00003 (AH) shows a set of steel lintels bridging a narrowed arch on the north side. The lintels were removed during consolidation work and not replaced, Plate 01.

Plate 01: Northern side of Hafod arch showing butt to rock face and finished work

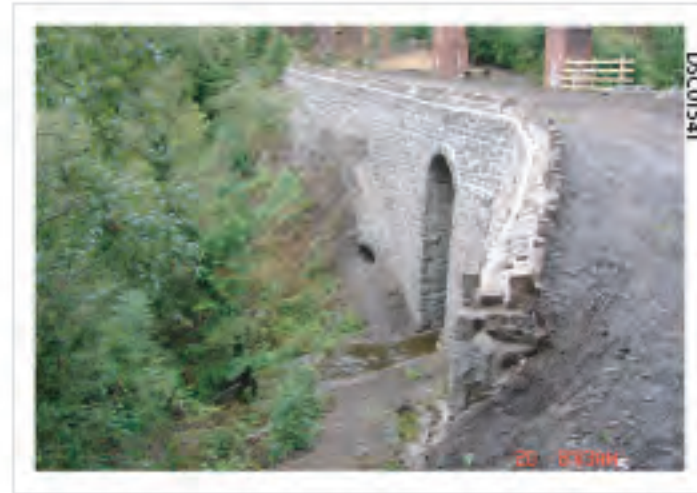
Plate 02: View over south revetment showing Hafod arch and storm arch

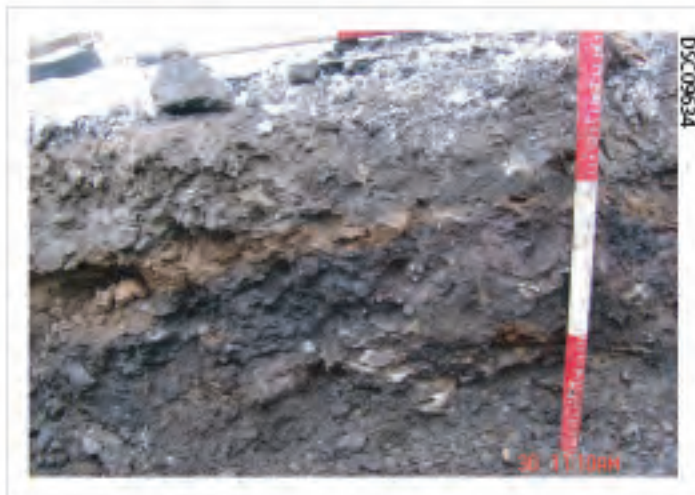
The causeway was constructed of rough dressed sandstone blocks with an earth and rubble infill. Plate 03 shows a 560mm deep section along the west edge during the excavation of the relief drainage channel, fig03.

Plate 03: Section 1

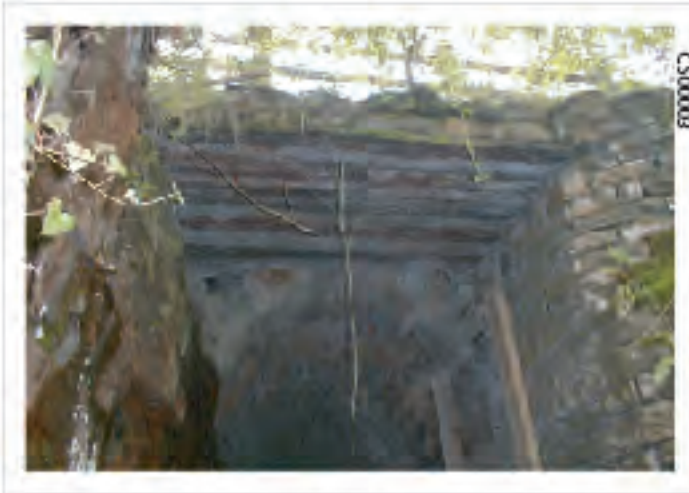
Plate 05: Earlier repair, Metal lintels.

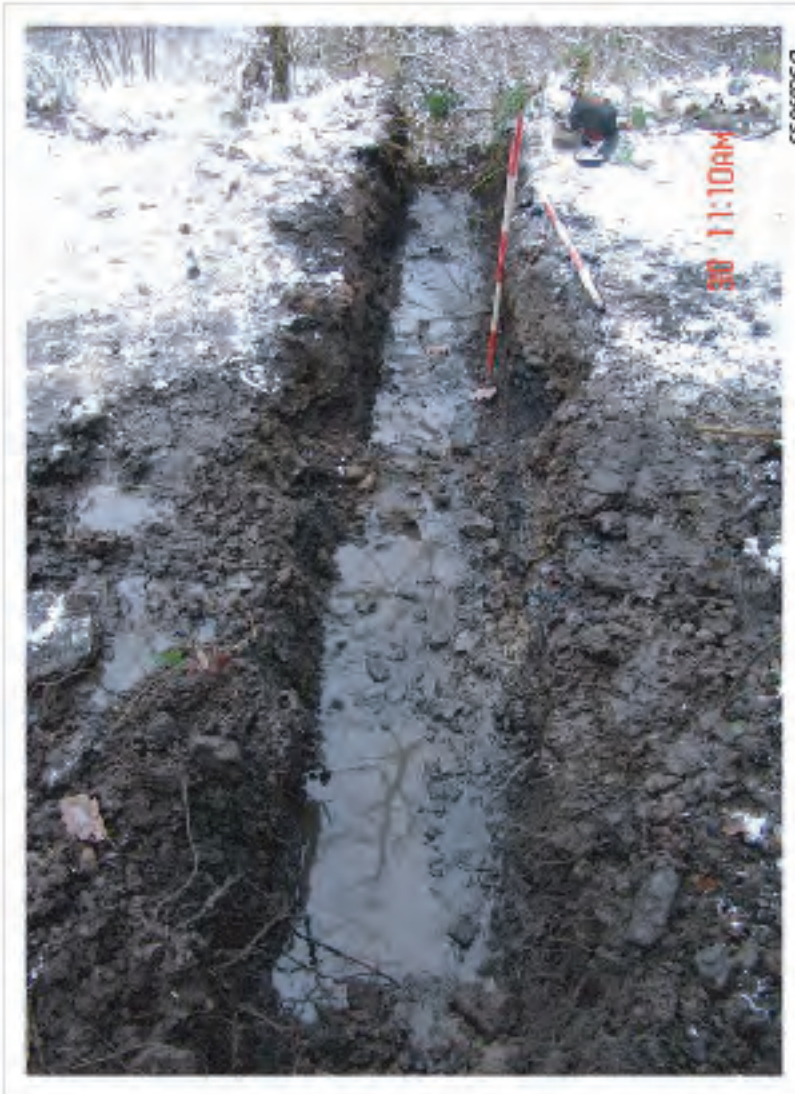
Plate 07: View across finished trench,  
water logging

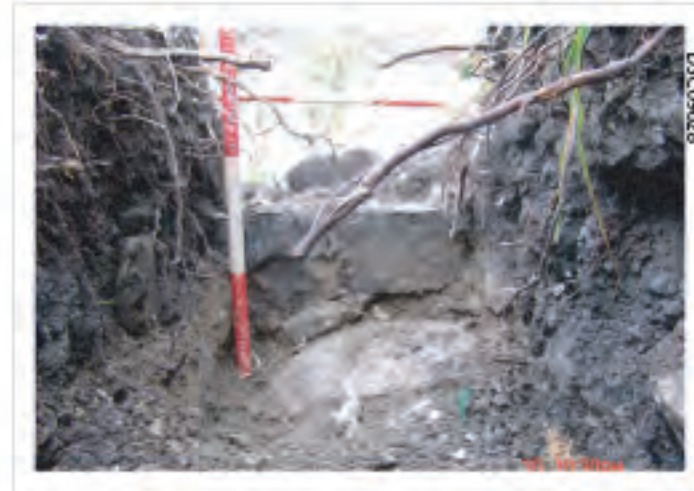
The southern edge of trench 1 abutted the revetment wall of the causeway, context [107], fig 03, Plate 09. As the revetment wall supports and contains the fills, contexts [101] – [106] it must obviously predate the later albeit during the same construction period.

Plate 09: Buried section of south retaining wall in trench

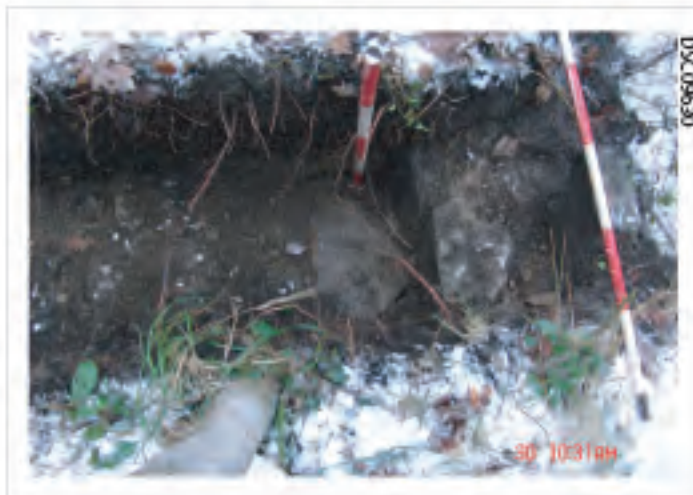
Context [108] is made up of a single dressed stone within the line of the southern revetment, fig 02, Plate 10. As stone [108] was beneath the limit of the excavation, it was not possible to further investigate its purpose.

Plate 10: Buried section of south retaining wall in trench vertical 2

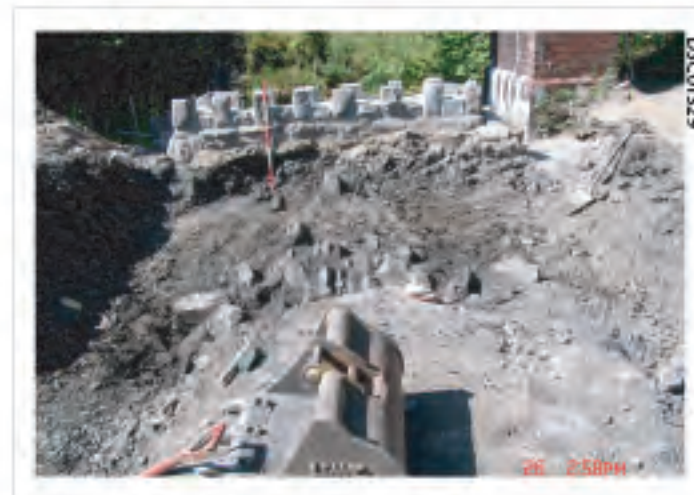
The platform itself [111] figs 04 & 05, Plates 11 & 15 did not extend over the full width of the track stopping some 2.6m shorts of the north revetment wall. Excavation in the un-concreted area north uncovered [112] the top of the barrelling for the arch.

Plate 11: View over TR2 showing concrete [111] and arch top [112]

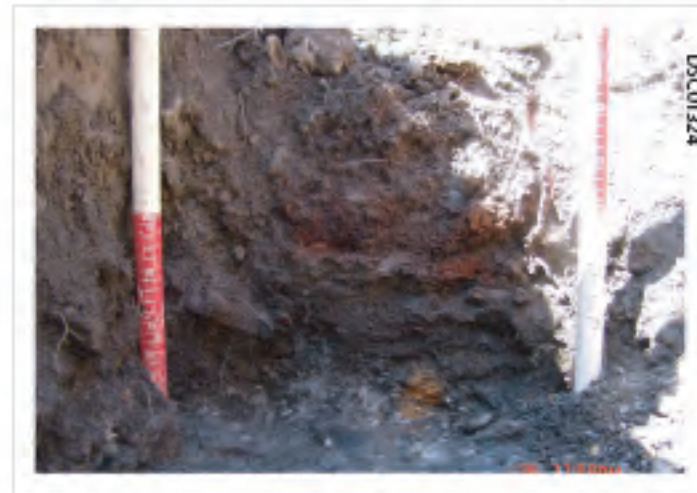
One other context [114] fig 05, Plates 13 & 14 was found under [110]. This lens of burnt material was only present in a narrow area along wall [107] but extended beyond the excavation; west. The lens of material was also on top of [106] which was the only recognisable context from trench 1 apart from the walls [107].

Plate 13: Section with beam [109] removed. Remains still in section cleared

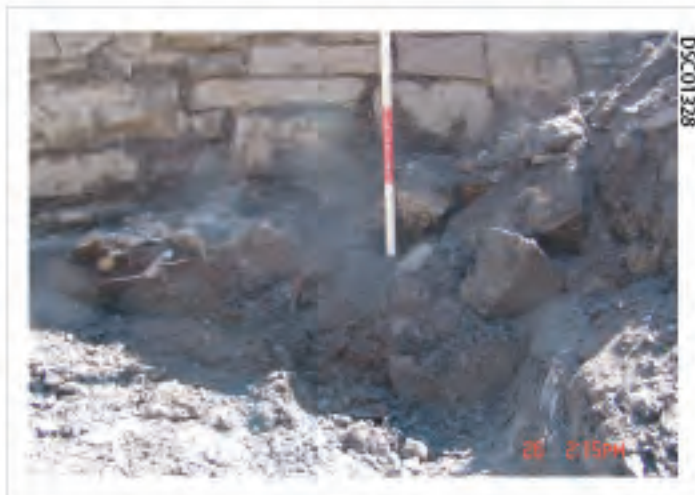
Plate 14: Detail of SW corner of TR2. [110], with [109] removed

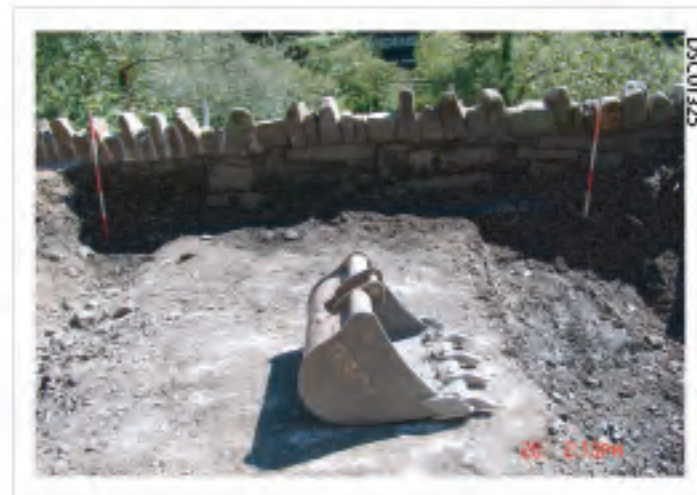
Within the second trench, there was a different sequence across the majority of the excavation, with a large expanse of concrete revealed over the arch section. The concrete did not however extend the full width of the causeway, fig 04, Plate 11. The north edge of the trench revealed a uniform rubble fill on top of the arch fabric [112], whereas the south edge included more humic material [109], [110], [113] and [114], figs 04 & 05, Plates 12, 13 & 14. It was not possible to reach context [112] along the southern half of the track bed because the area was covered by an earlier repair in the form of a concrete platform [111], fig 04 Plate 15.

Plate 15: Concrete [111] exposed

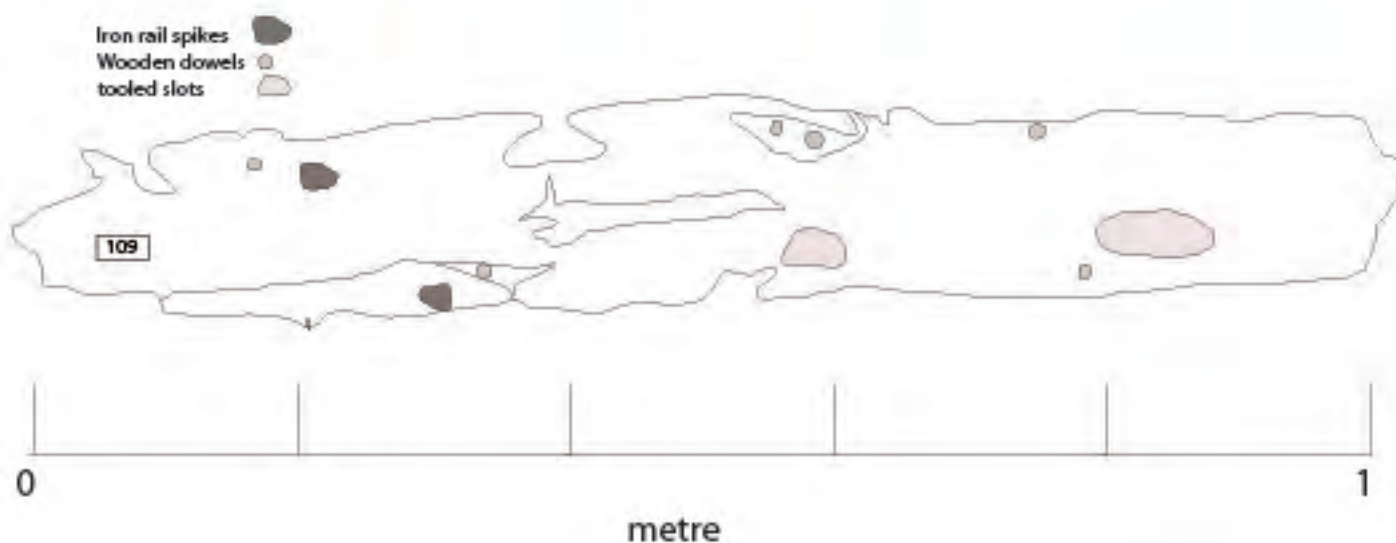
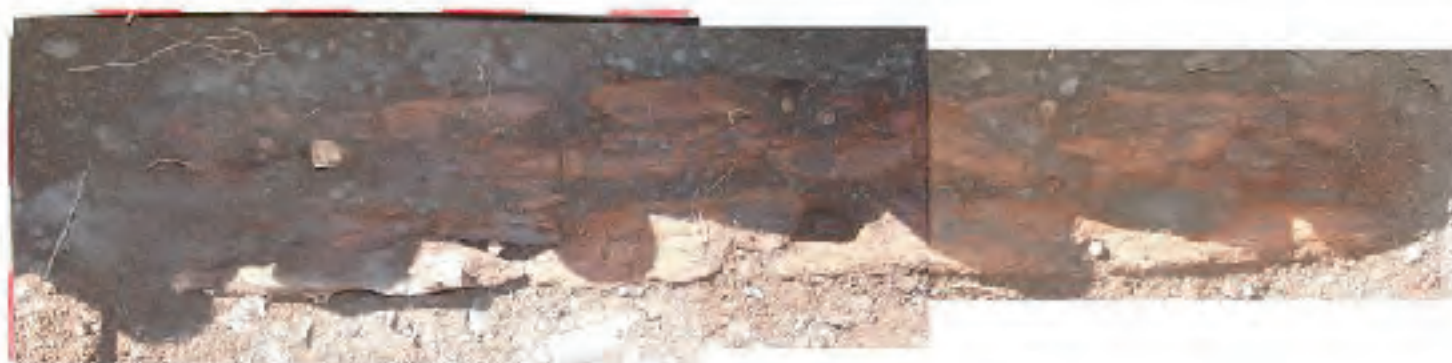
The beam, fig 05 Plates 16 & 17 was in a very poor state; completely saturated and very soft, becoming fibrous; its form almost entirely dependent on the surrounding soil, for shape. The exposed length measured just less than 1 metre in length with a width of 0.2m and a thickness of 0.13m. The wood had two identifiable, tooled slots passing right through the thickness. Three other holes may have been tooled but their irregular shape put into question their form.

The beam had 6 wooden dowels of varying diameter which also passed through the beam. The dowels were retained finds bag 02.

Plate 16: Beam [109]. Composite image

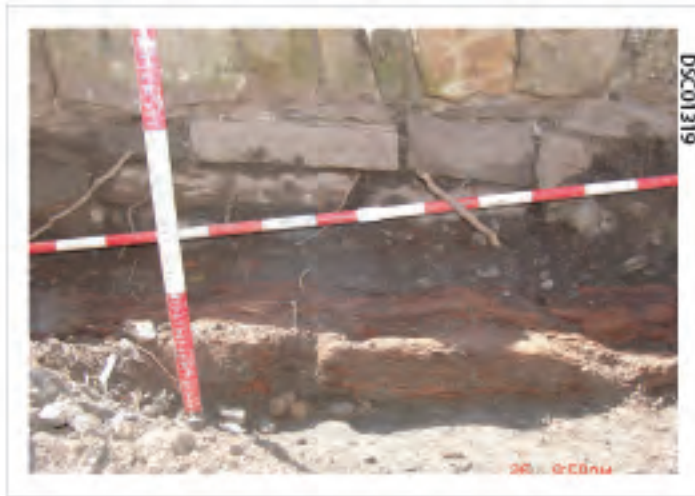
Plate 17: Beam [109] Sequence 1 detail of thickness (flash used)

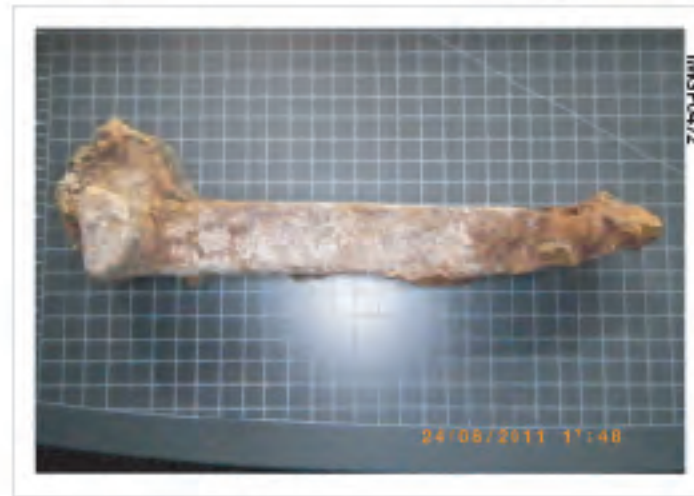
The beam also had two machine made iron rail spikes Plates 18 & 19, one of which was retained as find 01. The spikes measure 0.144m/5 inch in length. They are square section at 0.017m<sup>5/8</sup> inch and tapered from one side only to form the point. A head has been formed by folding the shaft over 0.039m x 0.029m. The folded head is then used to tie the rail in place.

Plate 18: Iron rail spike from [109] view 1

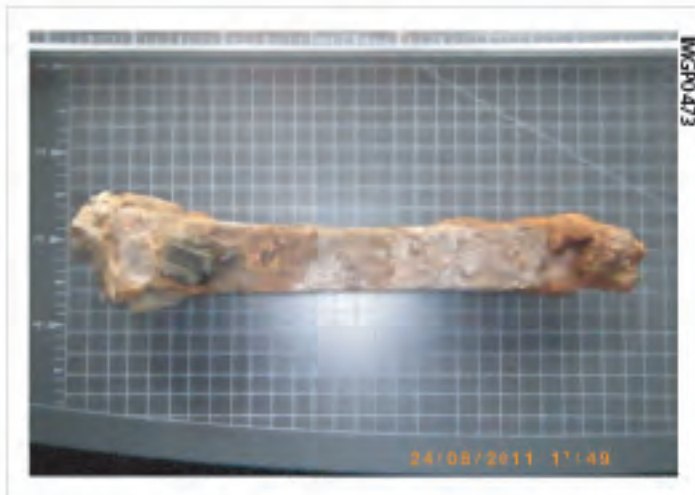
Plate 19: Iron rail spike from [109] view 2

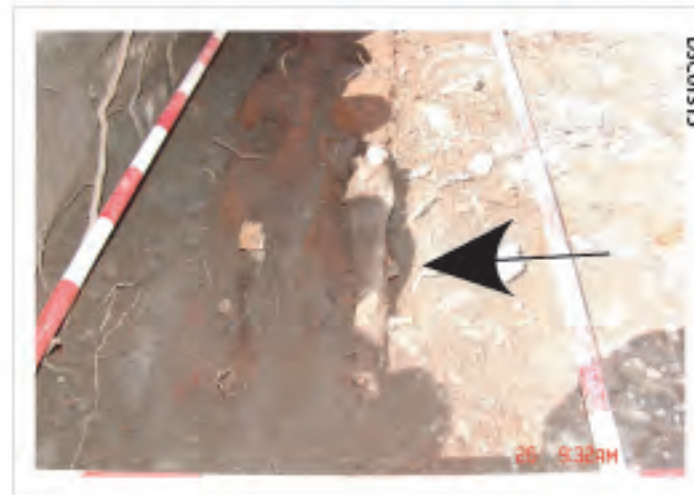
A further square section cut nail was recorded close to the two large versions but going into the beam from the side. Plate 20 *annotated*. The third nail had a smaller cross section at 0.005m, not retained.

Plate 20: Beam [109] measured photograph detail of iron rail spike

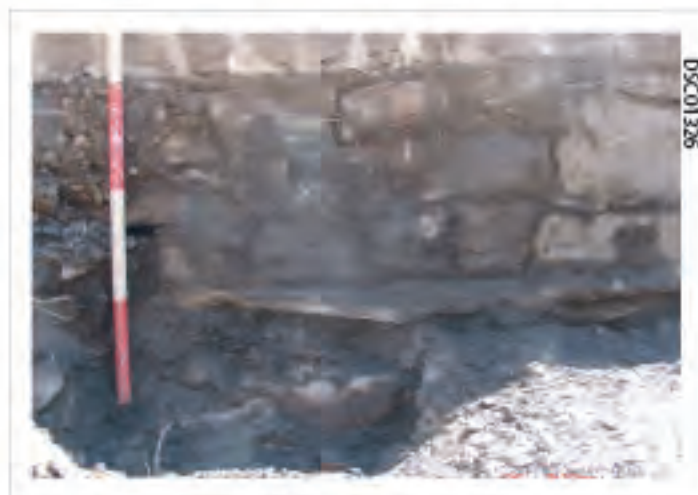
The beam itself sat partially on a ledge of yellow mortar [110], figs 04 & 05. The mortar layer can be seen in Plates 14 and 21 with a similar example on the north wall, Plate 11. It was assumed that this layer was cut through [115], at some time in the past to put in the concrete platform [111].

Plate 21: View of south wall [107] with [110] yellow mortar and possible [108]
