CPAT Report No. 1676

# Offa's Dyke Rd017 Reinstatement

Archaeological Mitigation

Client name: Richard Pugh  
 CPAT Project No: 2381  
 Project Name: Offa's Dyke Rd017 Reinstatement  
 Grid Reference: SO 2803 7081  
 County/LPA: Powys  
 CPAT Report No: 1676  
 Event PRN: 140304  
 Report status: Final

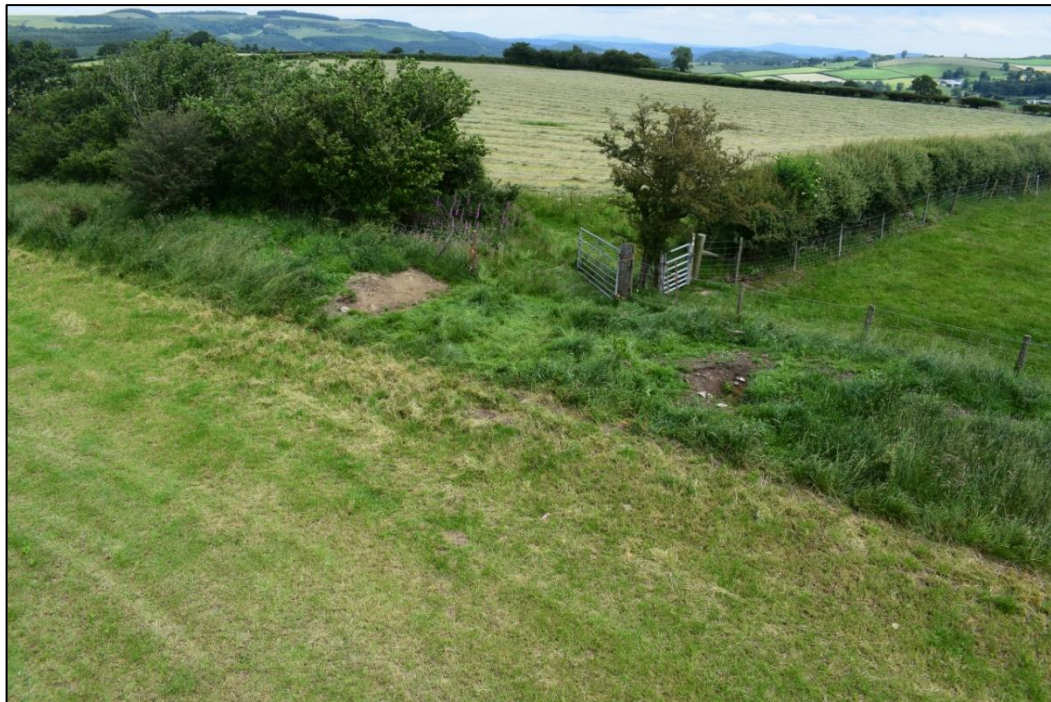
*Fig. 2 Extent of damage to the Dyke viewed from the west. Photo CPAT 4663-001*

- 2.4. The main area of damage consisted of a breach through the dyke bank from east to west located at NGR SO 2803 7081 (Fig. 1). The breach measured approximately 5m north-south, 7.5m east-west and 0.5m in depth. Immediately to the south of the breach the top of the bank was broken up and disturbed, although it was unclear what had caused this. A sheep scrape (Fig. 2) had been dug into the western side of the dyke within this area.

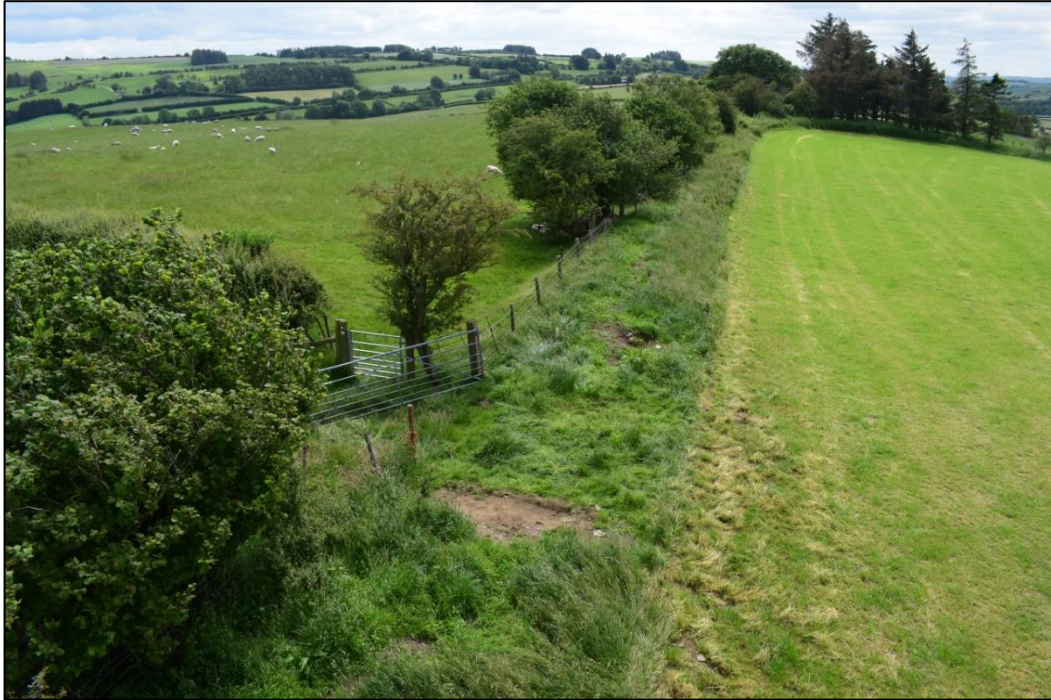
*Fig. 3 Extent of damage to the Dyke viewed from the north. Photo CPAT 4663-004*

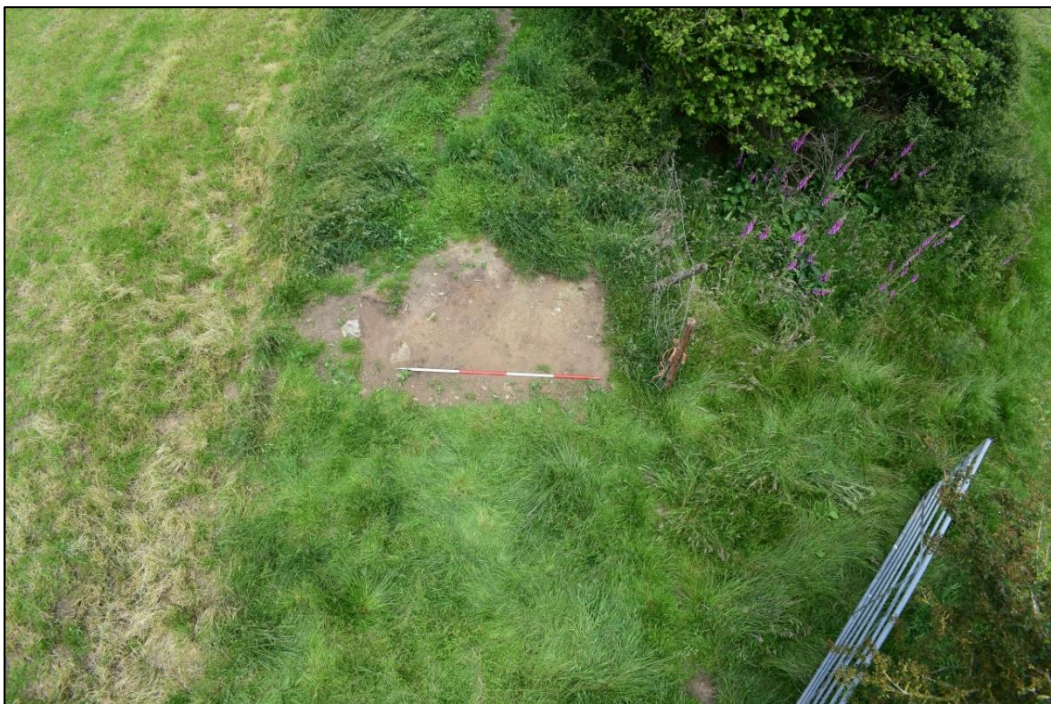
*Fig. 4 Exposed section through the core of the Dyke bank viewed from the south. Photo CPAT 4663-007*

- 2.5. The damaged area was largely grassed over at the time of the survey, although a surviving section through the core of the Dyke bank was visible to a thickness of 0.3m and comprising

a compact light brown silt containing moderate rounded stones. Shortly after the damage was done a gravelly core was noted by Cadw at the base of the north-facing section, although this was no longer apparent when the survey was undertaken.

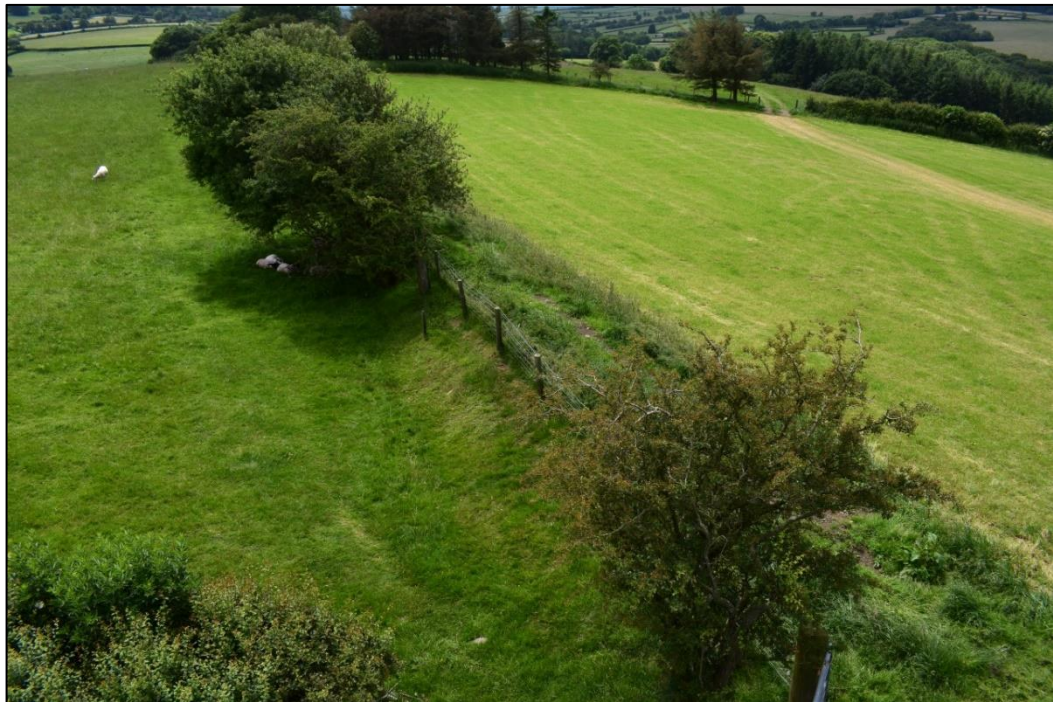
*Fig. 5 View from the north-east showing the ditch running along the eastern side of the Dyke. Photo CPAT 4663-005*

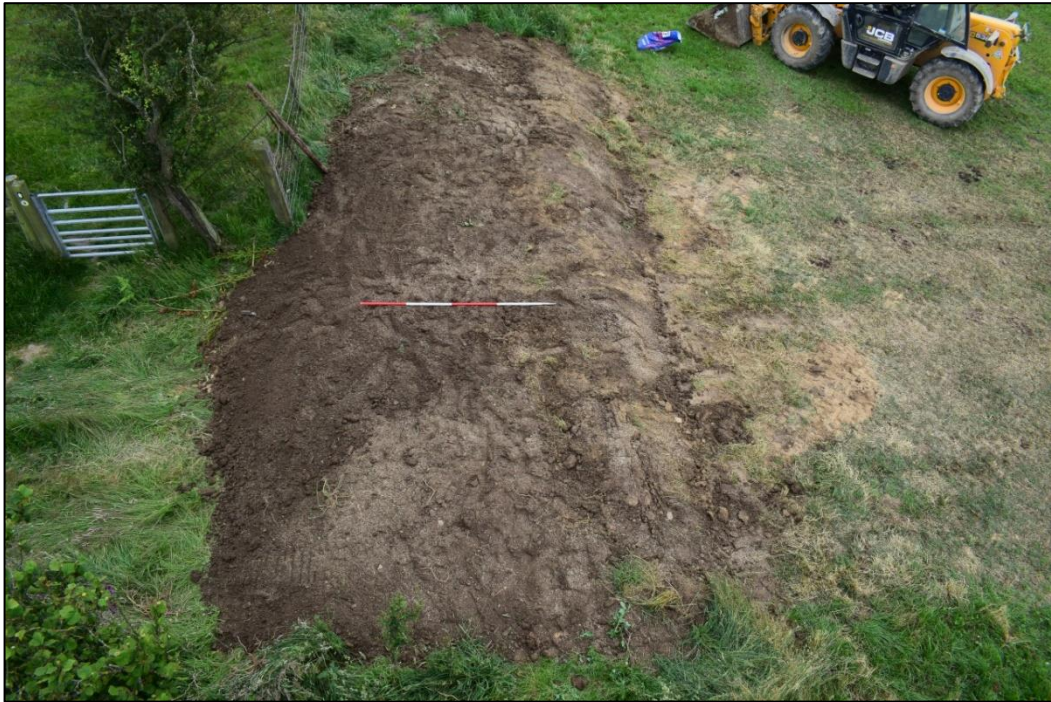
*Fig. 6 The reinstated section of the Dyke viewed from the north. Photo CPAT 4663-012*

- 2.6. The reinstatement was carried out using locally sourced subsoil of a similar composition to the existing fabric of the Dyke. It was conveyed to the site and placed into position by machine. Care was taken to avoid any damage to the existing bank by the use of hand tools to form the profile of the reinstated material where it met with the existing fabric. Once the form of the reinstated bank had been established it was covered with topsoil to a thickness of approximately 0.1m. The topsoil was sown with grass seed and covered with Geocoir biodegradable matting in order to stabilise the reinstated form of the bank.

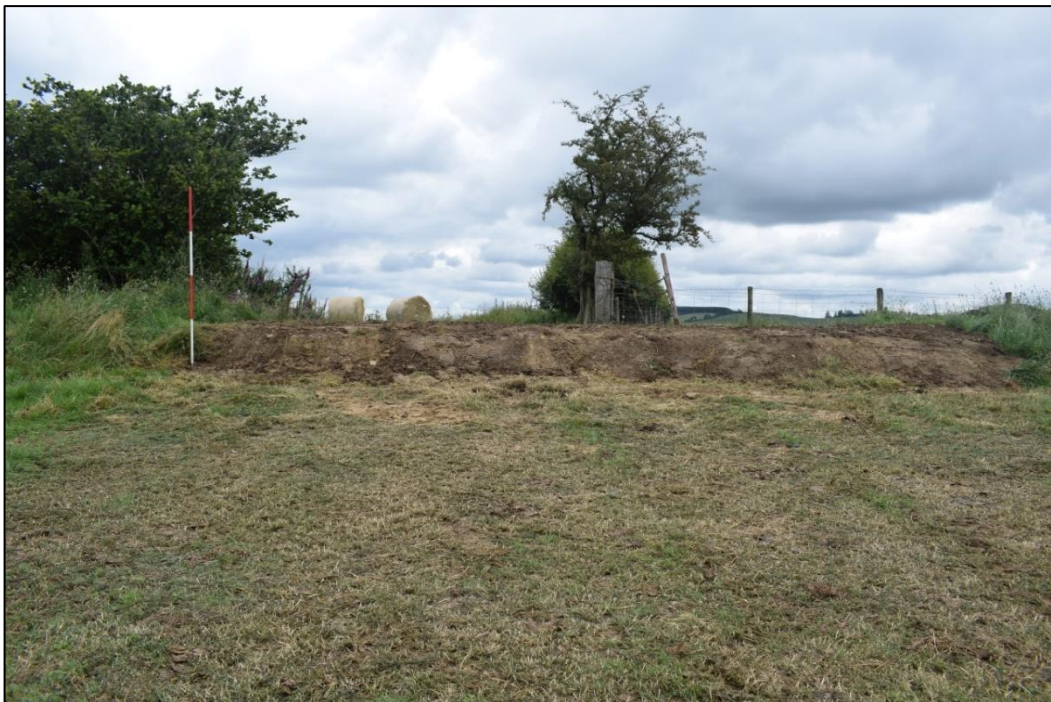
*Fig. 7 The reinstated section of the Dyke viewed from the west. Photo CPAT 4663-018*

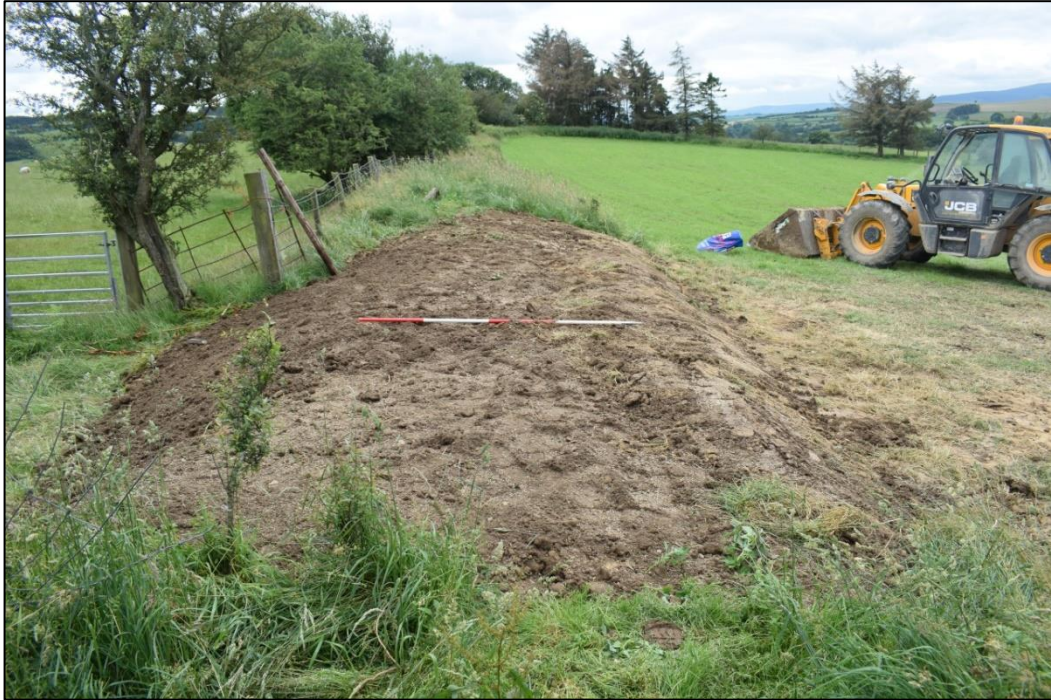
*Fig. 8 The reinstated section of the Dyke viewed from the north. Photo CPAT 4663-019*

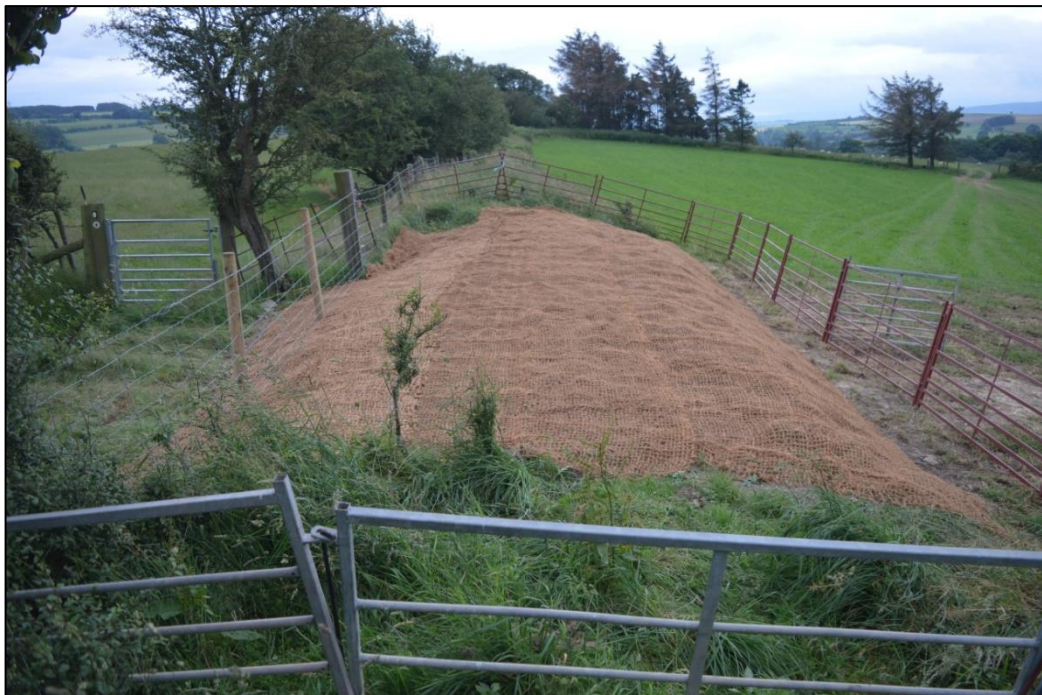
*Fig. 9 The reinstated section of the Dyke following laying of the stabilising matting, viewed from the north. Photo CPAT 4663-039*

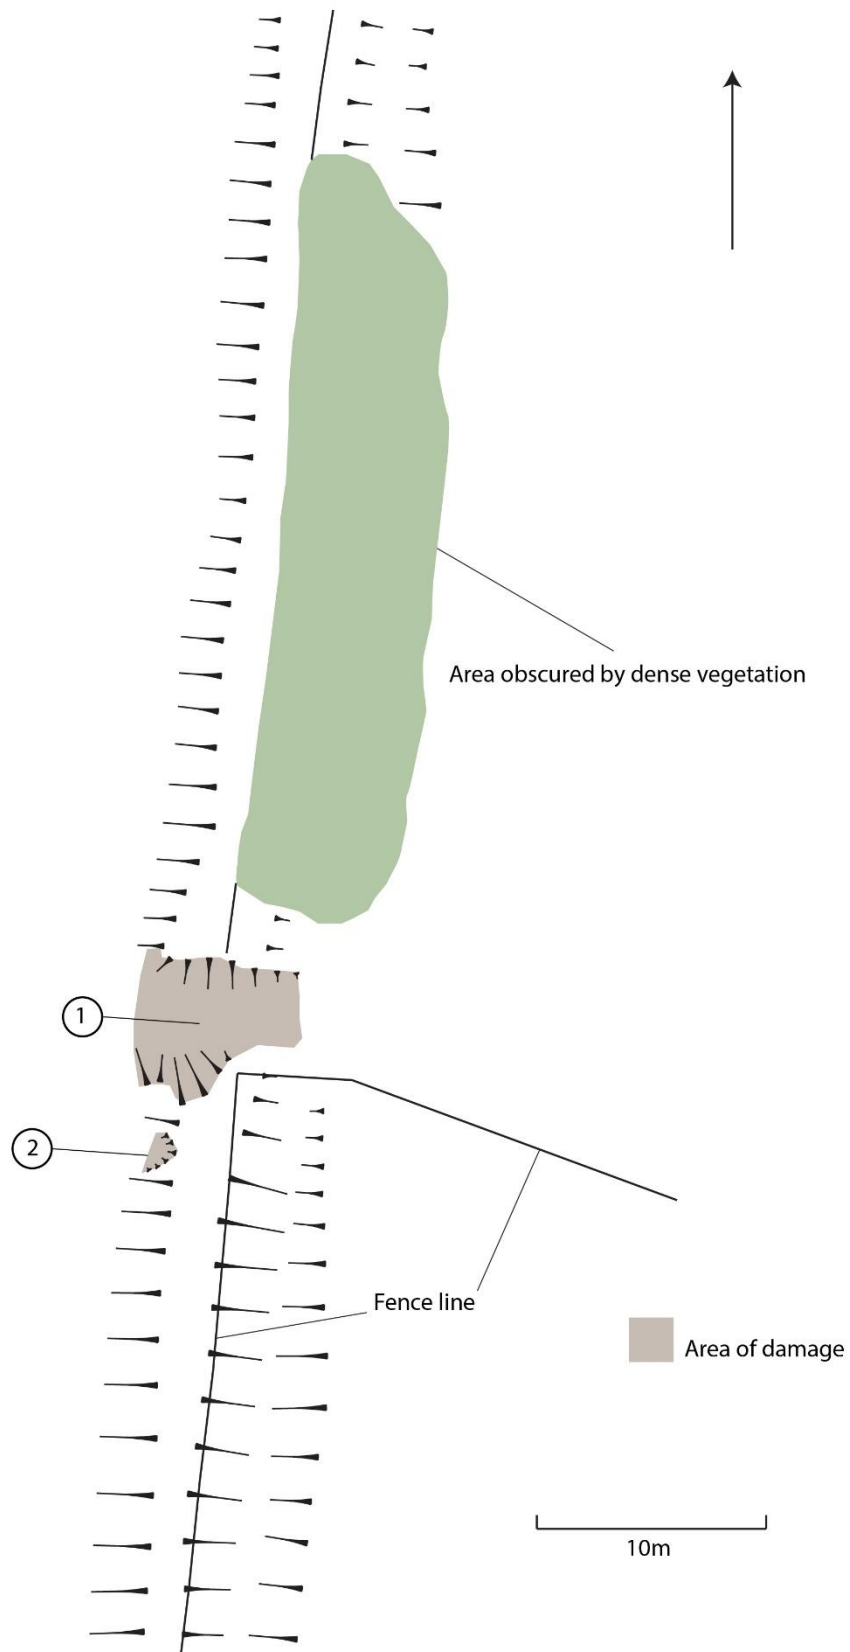
*Fig. 10 Plan of the dyke prior to reinstatement*

- 2.2. Prior to the commencement of reinstatement works a photographic record was made of the damaged section, which was also recorded through total station survey, recording the surviving extent and profile of the monument in relation to the existing boundaries. A Total Station survey of the undisturbed parts of the dyke to either side of the damaged section was also carried out during this phase of the works (see Fig. 10).

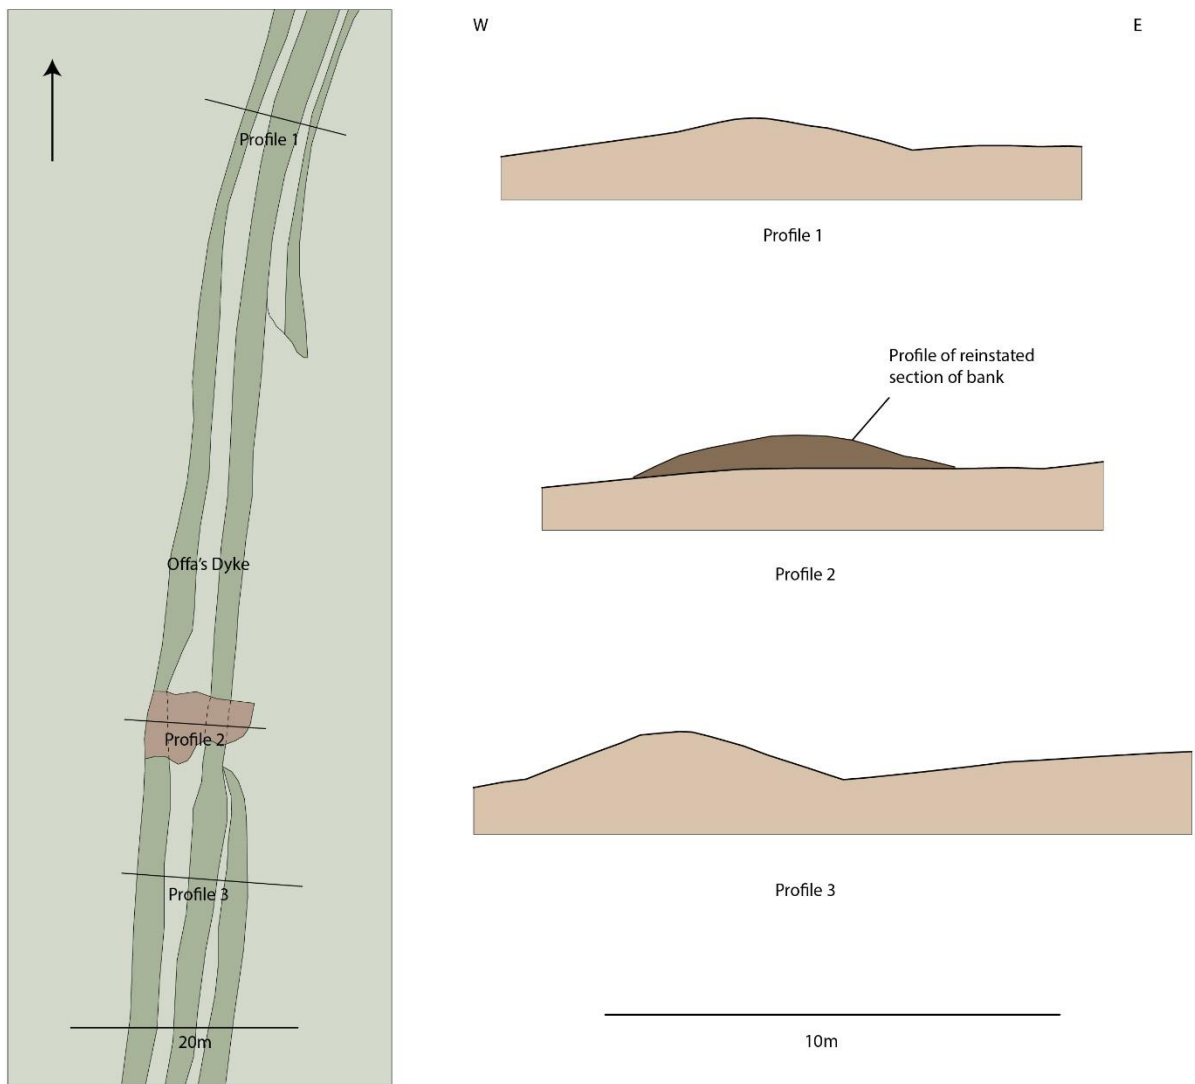
Fig. 12 Profiles across the bank of the dyke

- 2.3. An analysis of survey data determined that this section of Offa's Dyke Rd017 was 7m to 8m in width, and between 0.5 and 1.2m in height. The profile comprised a sharply defined steeply sloping western bank, a flattish bank top up to 5m in width and a moderately sloping eastern bank (see Fig. 12). A ditch was intermittently visible along the eastern side of the Dyke. There was no discernible trace of the defensive ditch which was located to the west of the Dyke.
