CPAT Report No. 1441

Castell y Blaidd, Powys

Topographical survey

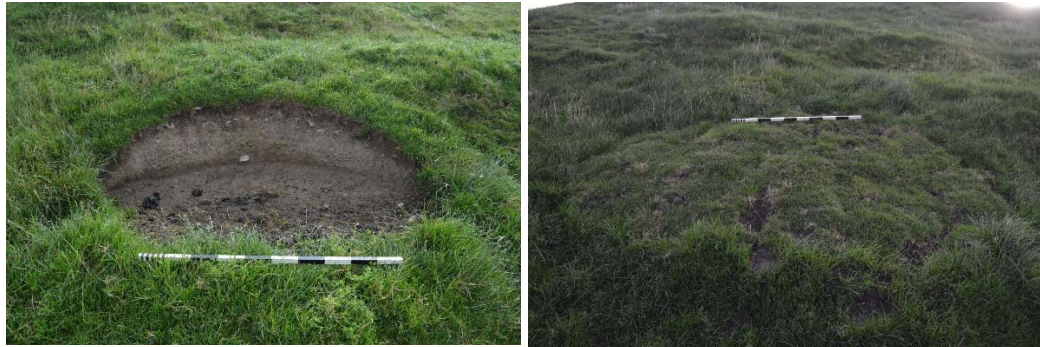
- 5.2. Most of the damage was caused by sheep scrapes, where sheep have dug into the bank in order to shelter from inclement weather. A large flock of sheep were present in the field where the enclosure is situated at the time of the survey.

Figs 2 and 3. Sheep scrape on south-west extent of monument before and after repair work. CPAT 4224-0001 and CPAT 4224-0090

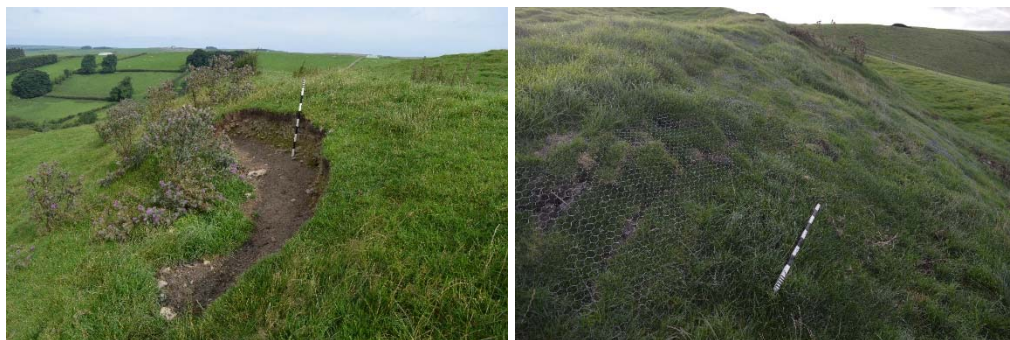
- 5.3. There was some very minor burrowing activity visible on the south-west bank of the monument, caused by rabbits (Fig. 5). No tangible evidence of rabbits, besides the burrows themselves was evident at the time of the survey.

Figs 4 and 5. Large sheep scrape on south-west extent of monument before and after repair work. CPAT 4224-0008 and CPAT 4224-0093

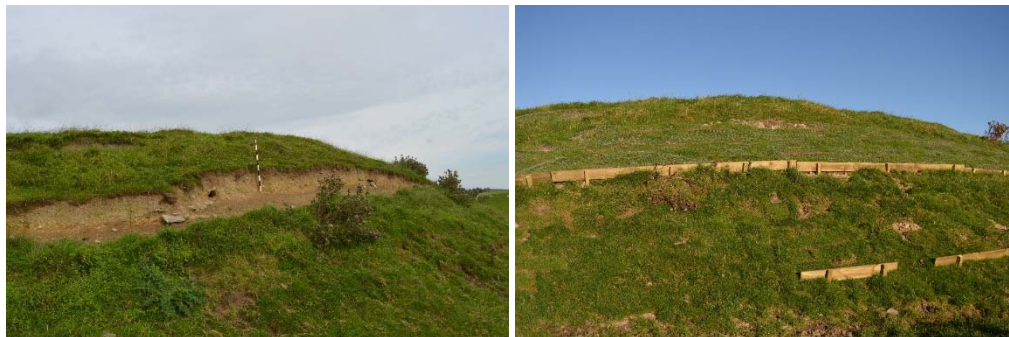
Figs 6 and 7. Extensive livestock and burrowing damage along south-east extent of monument before and after repair work. CPAT 4224-0028 and CPAT 4224-0133

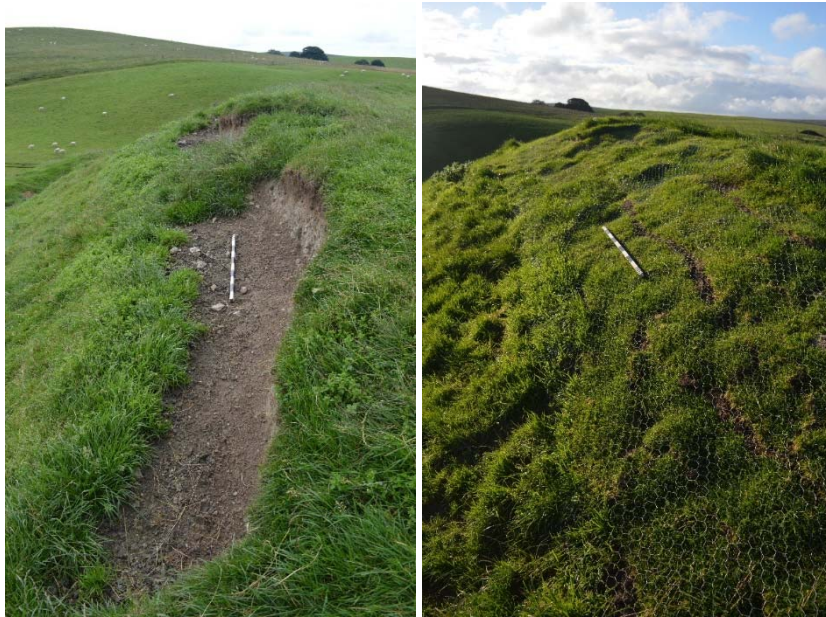
Figs 8 and 9. Sheep scrape on north-east side of monument before and after repair work. CPAT 4224-0040 and CPAT 4224-0113

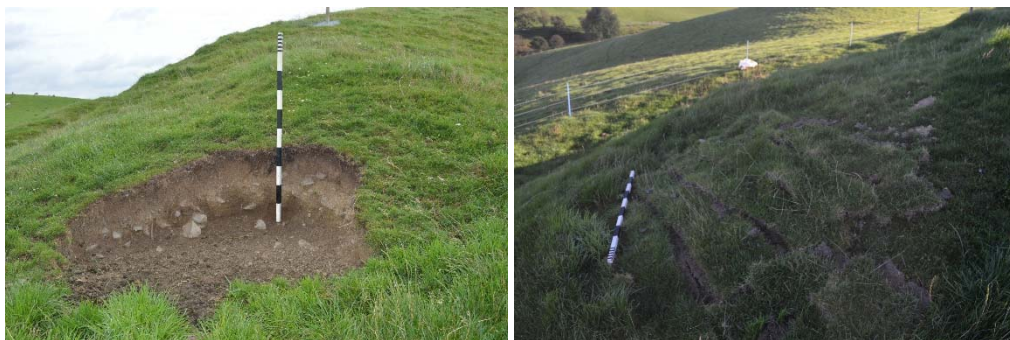
Fig. 10 and 11. Sheep scrape on north-west extent of monument before and after repair work. CPAT 4224-0046 and CPAT 4224-0115

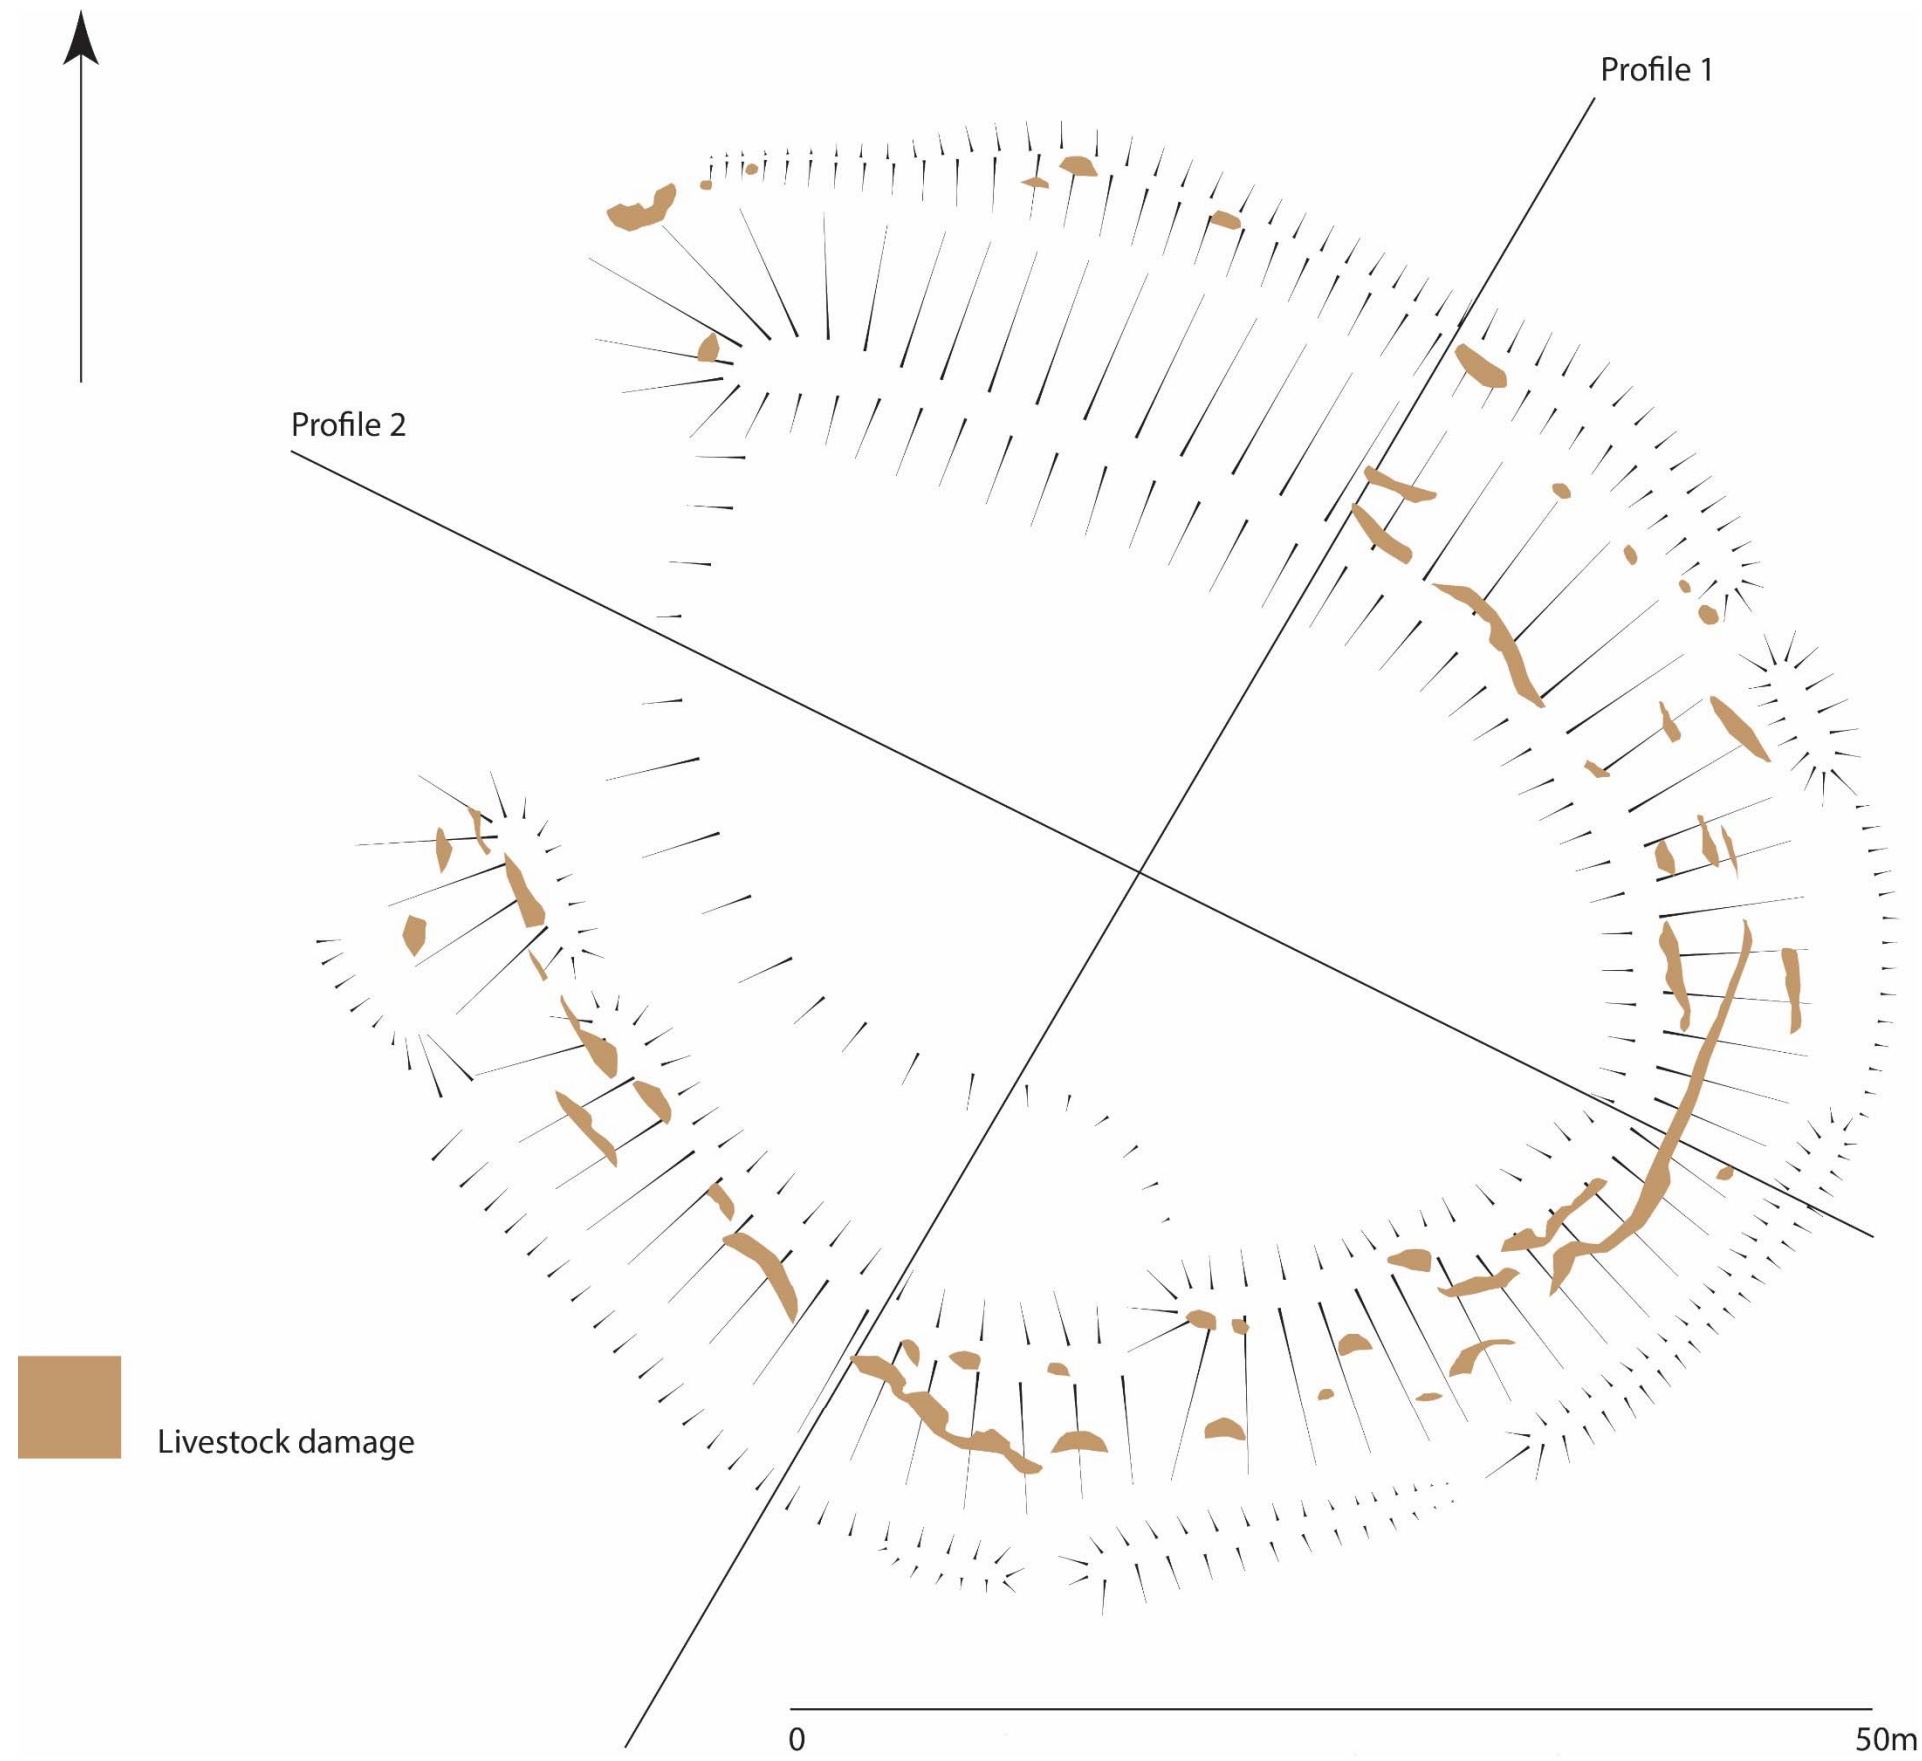
Fig. 11. Plan of Castell y Blaidd showing damage caused by livestock

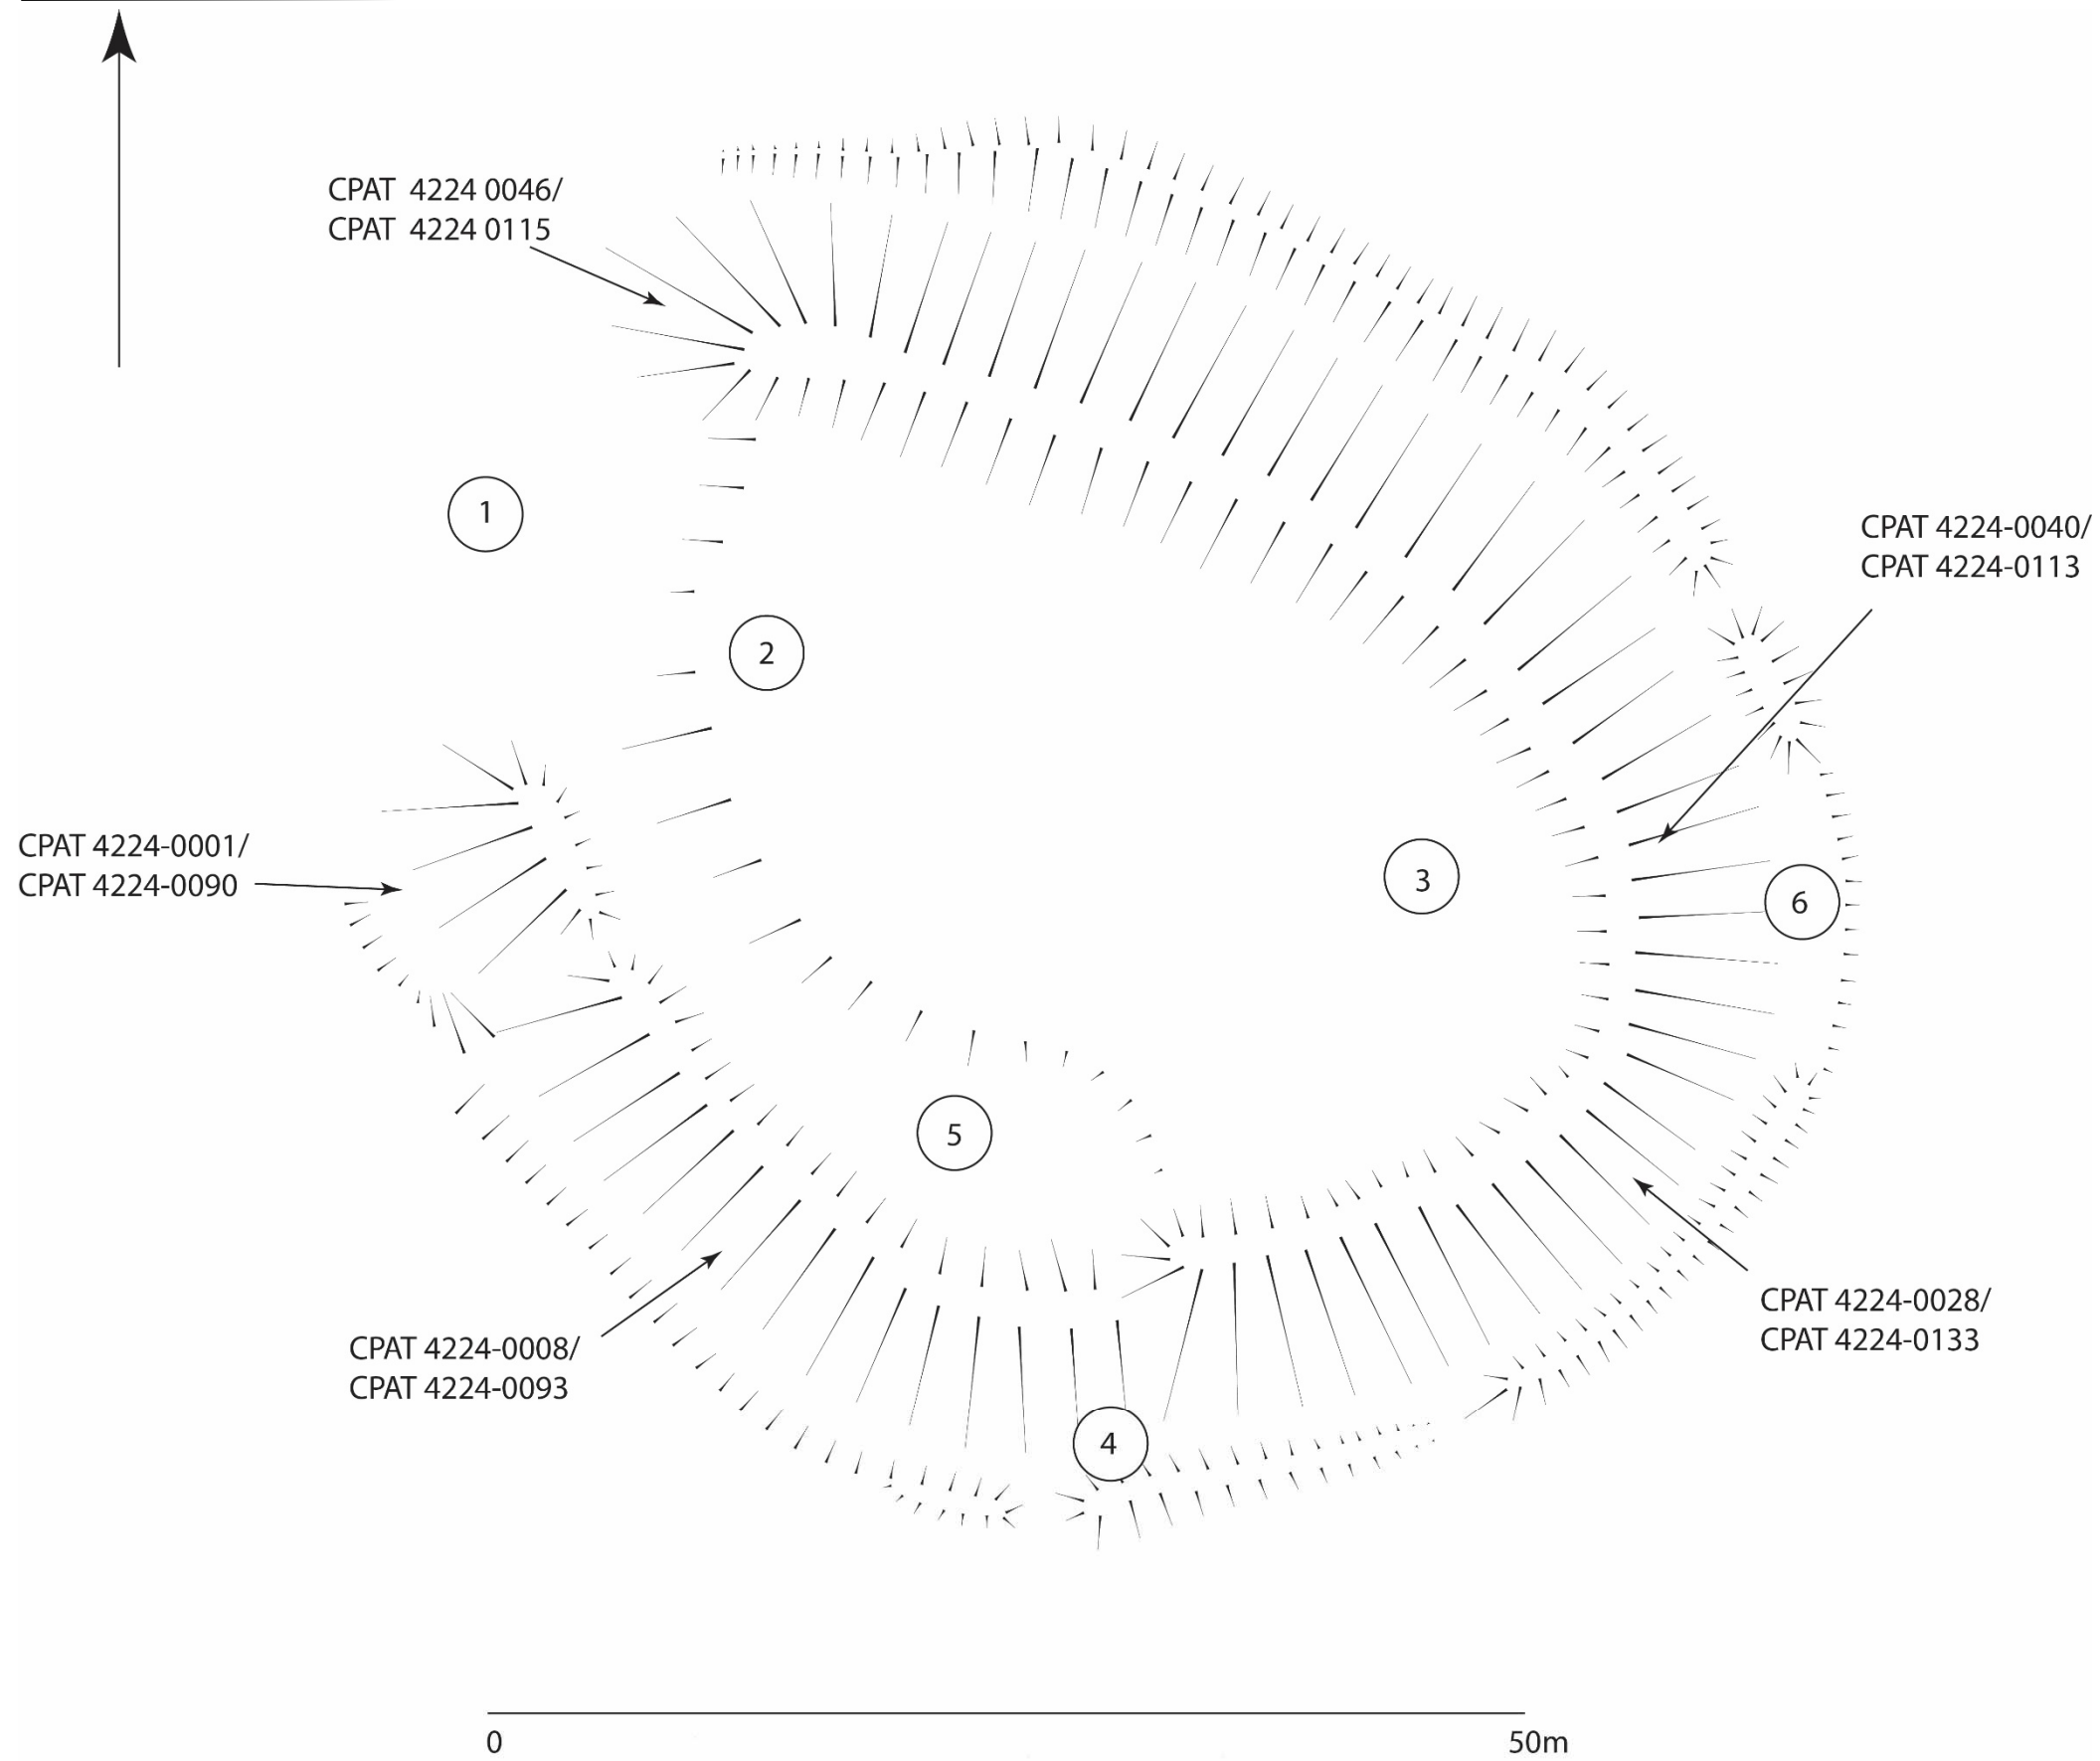
- 4.1. The enclosure measures approximately 50m north-west to south-east by 35m internally. It comprises an inner enclosed area, sloping to the north-west, surrounded on three sides by a steep earthen bank approximately 4m in height. At the base of the inner bank is a shallow ditch surrounded by an upcast bank approximately 0.6m in height. The bank was incomplete on the east extent (Fig. 12, 6) and several narrow gaps in the bank were recorded.

- 4.2. The defences are completely absent to the north-west (Fig. 12, 1), apparently having never been completed as the site has never been ploughed and there are no obvious signs of disturbance. A gentle but clearly discernible change in the slope (Fig. 12, 2) running into a depression on the south-western inner bank (Fig. 12, 5) may have been the basis for an inner defensive line, possibly temporary whilst the enclosure was being constructed.

- 4.3. There is a break in the upper and lower defensive bank at the south extent (Fig. 12, 4). The break in the lower bank is distinctly offset to the one in the upper bank.

- 4.4. The inner enclosed area slopes away to the south-west. At the east extent a flat or gently concave circular raised area, 21m in diameter was discernible (Fig. 12, 3).

Fig. 12. Plan of Castell y Blaidd showing features and photographs showing damage to monument and repair work
