CPAT Report No. 1488

Offa's and Wat's Dykes in Wrexham

Monument Condition Survey

Client name: Cadw
 CPAT Project No: 2102
 Project Name: Wrexham Dykes
 County/LPA: Wrexham
 CPAT Report No: 1488
 Event PRN: Offa's Dyke - PRN 140167; Wat's Dyke - PRN 140168
 Report status: Final
 Confidential: Yes

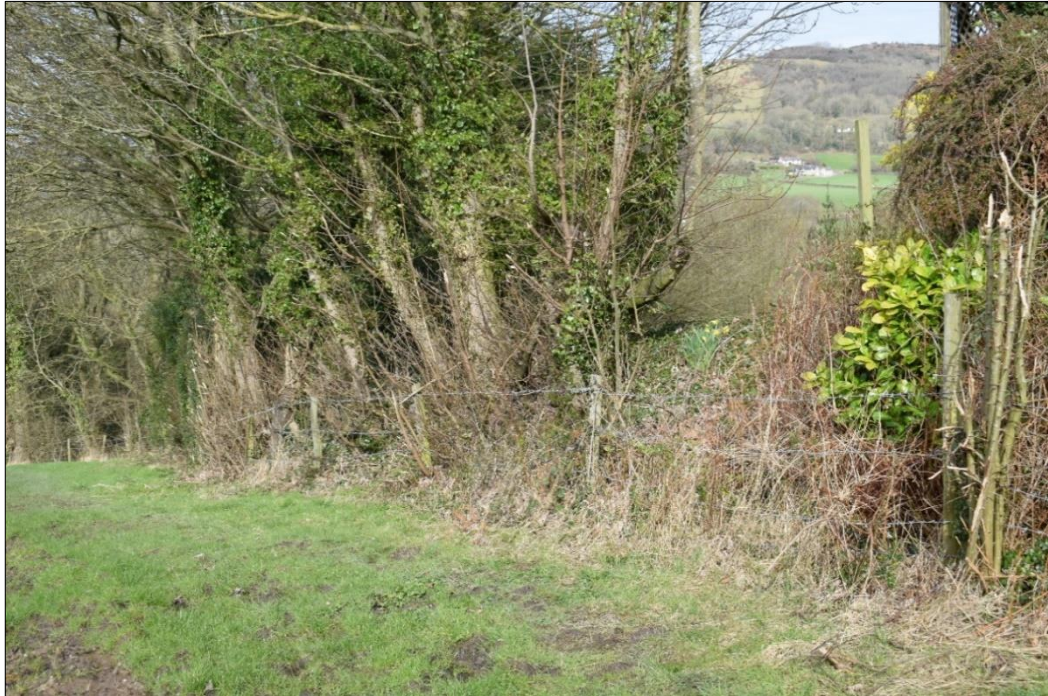
- 3.2. This section is in a favourable condition and is not under any active threat, although there is a boundary along the line of the bank.

Offa's Dyke Unit 1: View from the south the escarpment with fence and trees CPAT 4315-0005

Actions: Maintain in present condition.

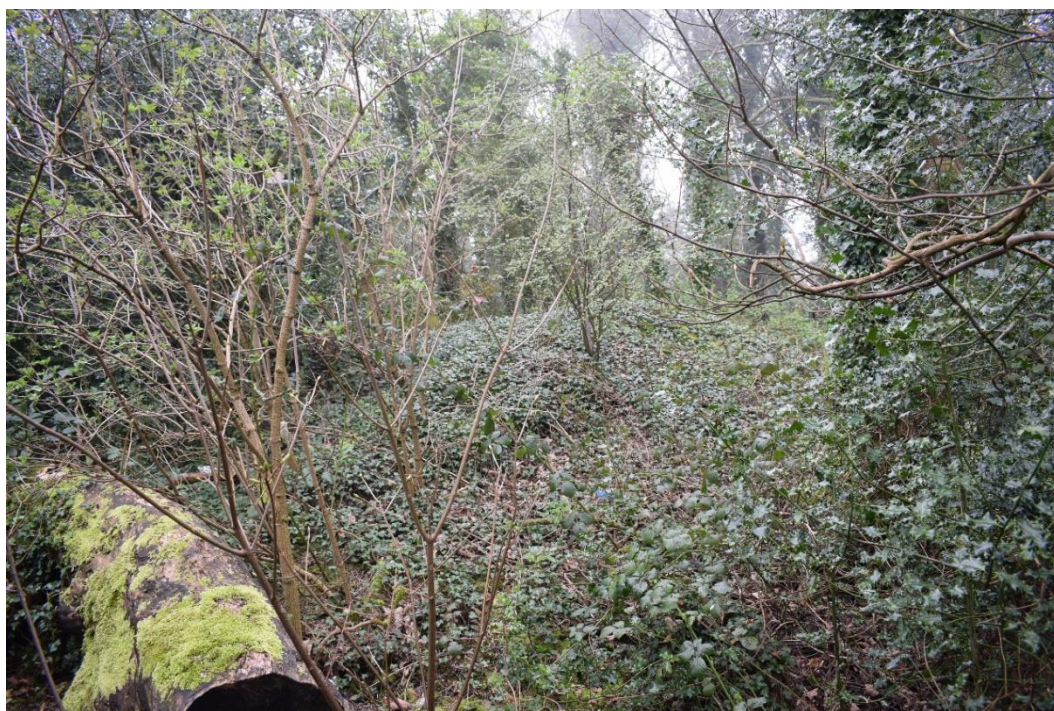
- 3.27. The whole of the section is heavily overgrown with trees and scrub, making it difficult to appreciate the upstanding earthwork, while there is also the potential for damage from tree roots and wind-blown trees.

Offa's Dyke Unit 6: view from the south showing the overgrown bank within woodland. CPAT 4326-0007

- 3.28. The upstanding remains are not currently afforded statutory protection. Clearance of scrub would improve the visibility of the bank and enable it to be appreciated by the public.

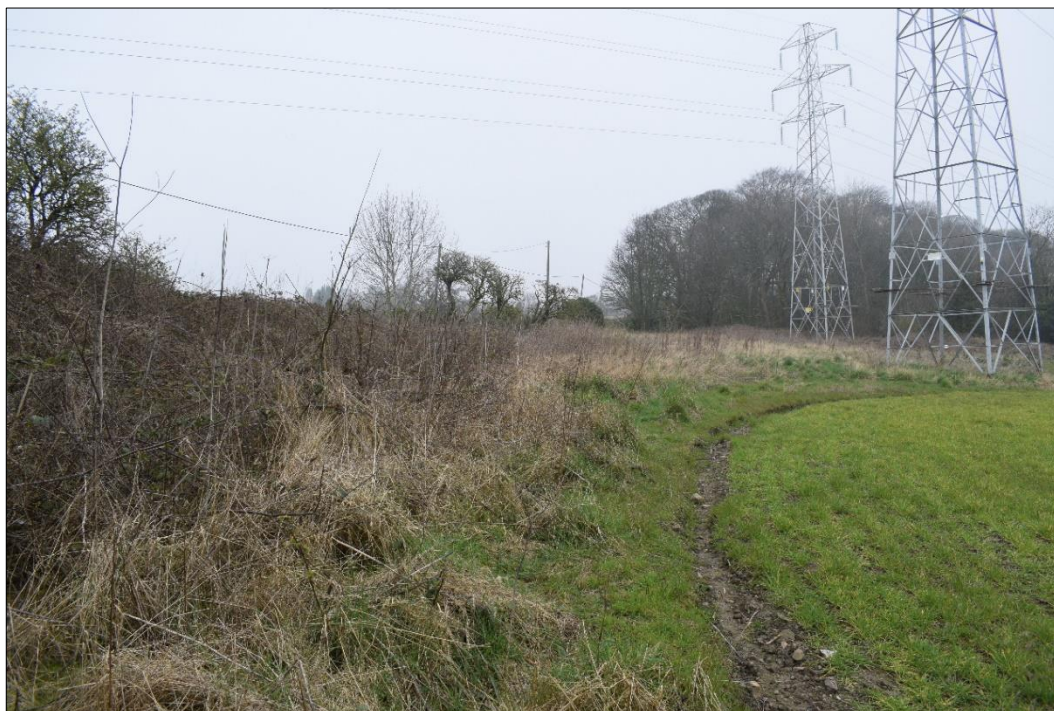
Offa's Dyke Unit 7: view from the south showing the upstanding bank obscured by scrub (Issue 1). CPAT 4326-0014

- 3.32. The low upstanding remains are not currently afforded statutory protection. Clearance of scrub would improve the visibility of the bank and enable it to be appreciated by the public.

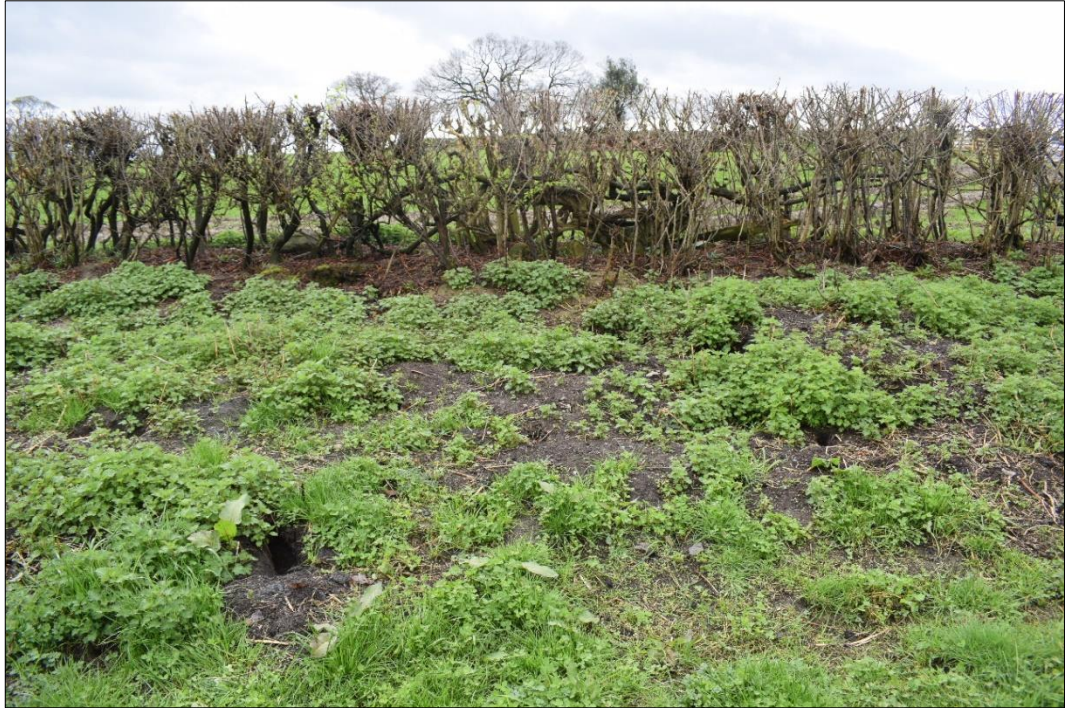
Offa's Dyke Unit 11: Animal burrowing (Issue 2) and bracken (Issue 3) along the north-west side of the bank. CPAT 4326-0034

- 3.53. Control of the bracken would likely to help reduce the issue of burrowing animals.

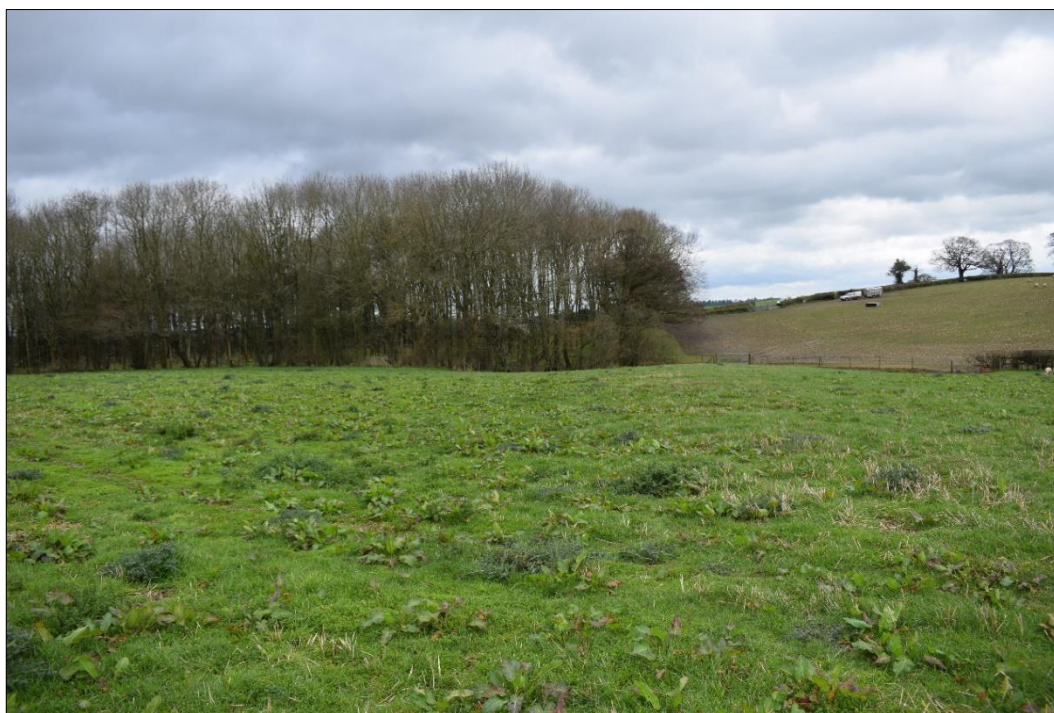
- 3.61. The bank is almost entire plough-levelled and while currently under pasture the condition of the vegetation suggests that the field is subject to at least occasional ploughing.

Offa's Dyke Unit 13: View from the south-west showing the slight earthwork of the bank heading to the right of woodland in the distance. CPAT 4326-0045

- 3.63. Address the agricultural regime to prevent further ploughing.

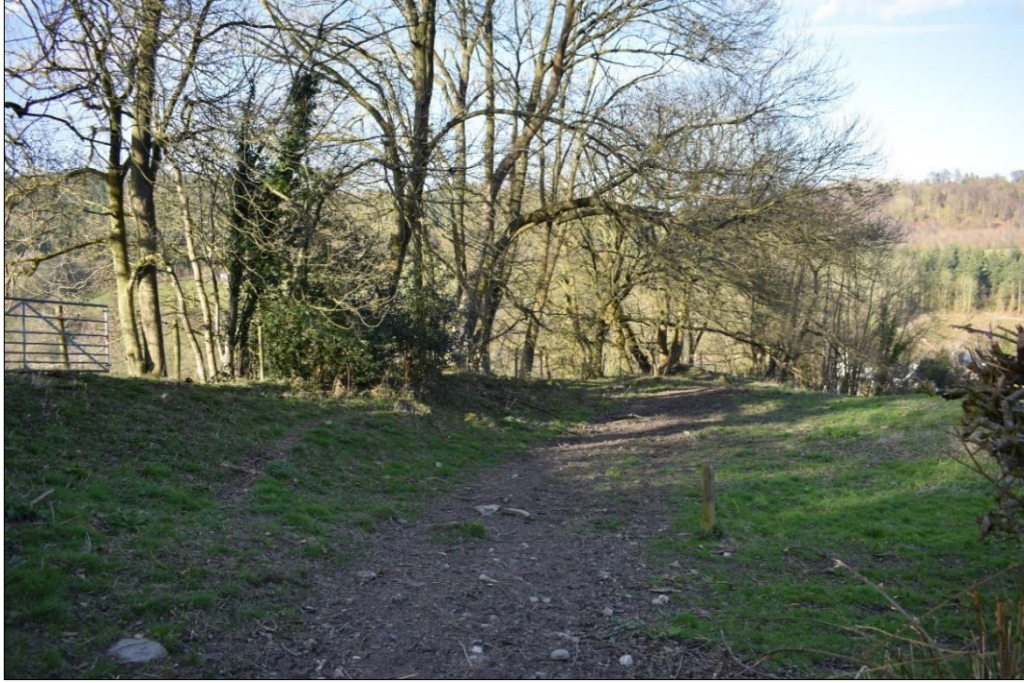
- 3.76. A fence follows the crest of the bank which has led to minor stock erosion alongside, and also has the potential for further damage when it is replaced.

Offa's Dyke Unit 17: View from south of the stock erosion (Issue 1). CPAT 4315-0014

- 3.80. All but the north-east end is scheduled with an English designation (list 1006265) which crosses the border into Wales. Active management issues may require management of livestock, while potential issues resulting from development and vehicles should be managed through the scheduled monument consent process.

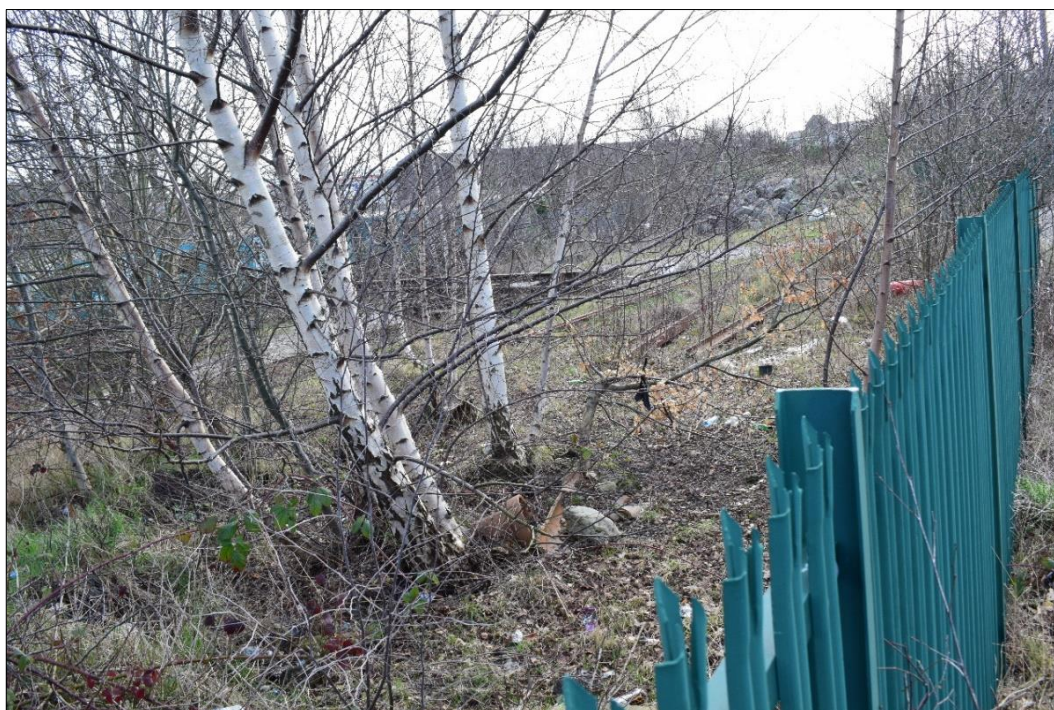
Wat's Dyke Unit 2: View from the north along the route of the dyke, showing tree growth (Issue 1). CPAT 4317-0020

- 4.9. The upstanding remains extend slightly to the south of the scheduled area of SAM De286. The control of scrub growth would enhance the scheduled section.

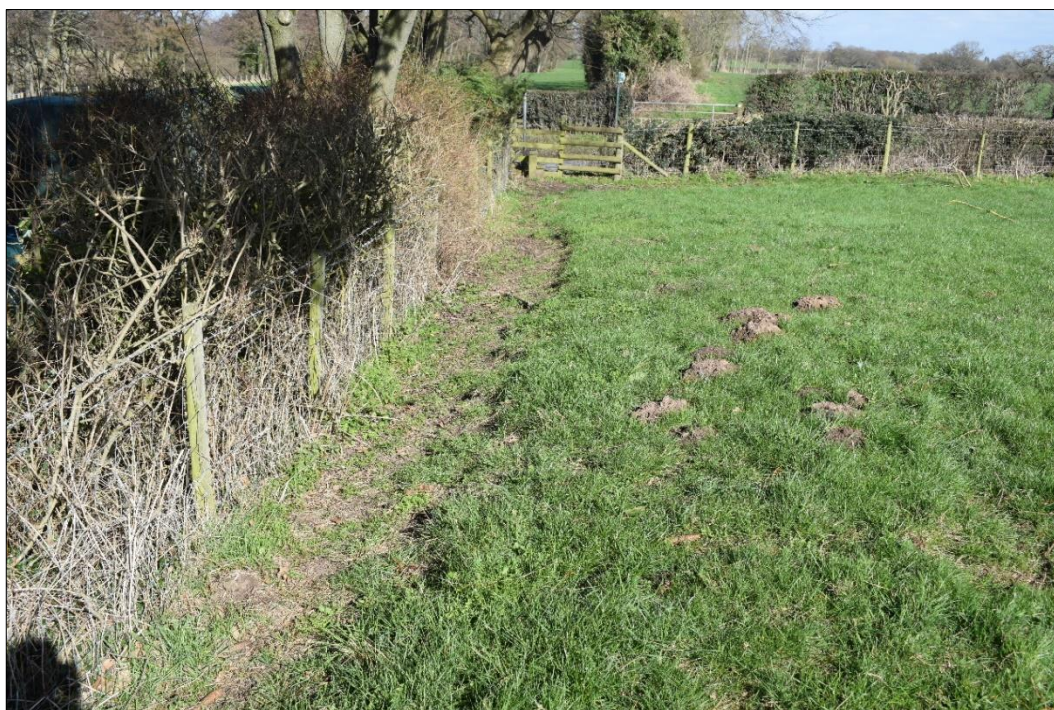
Wat's Dyke Unit 12: View form south of stock erosion (Issue 1) alongside the boundary. CPAT 4317-0069

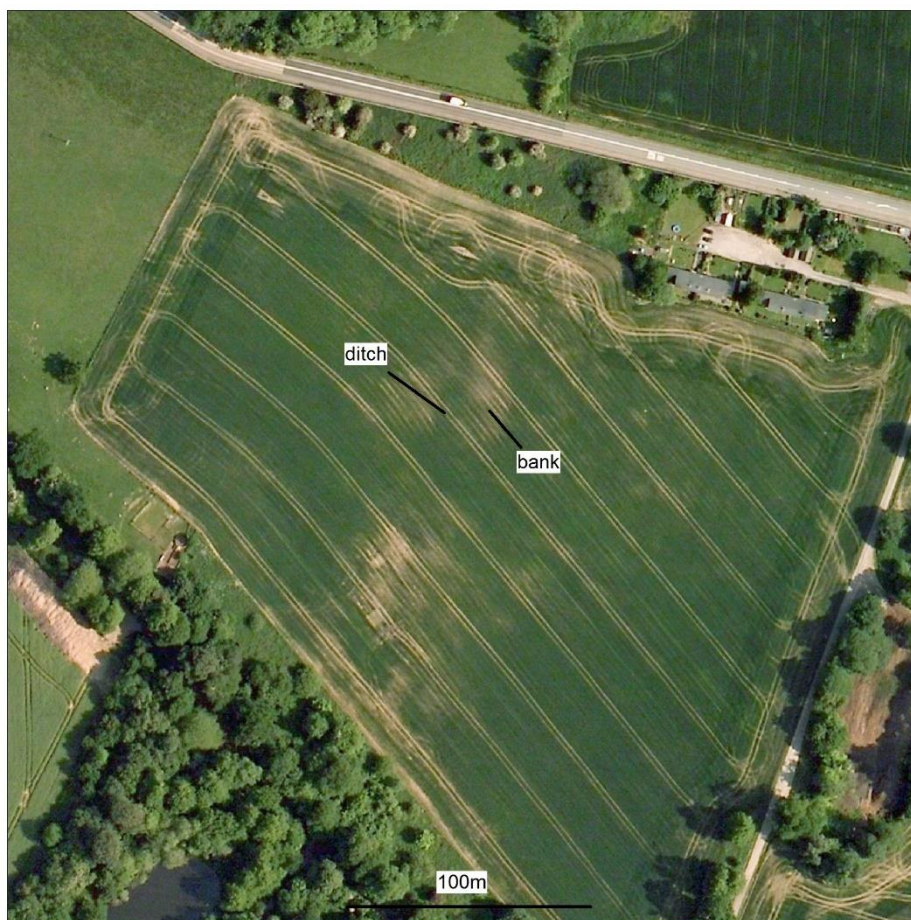
Wat's Dyke Unit 13: cropmarks recorded in 2015

- 4.54. The slight earthworks are extremely vulnerable to further ploughing which can only be addressed by a change in the agricultural regime to either pasture or direct drilling of crops.

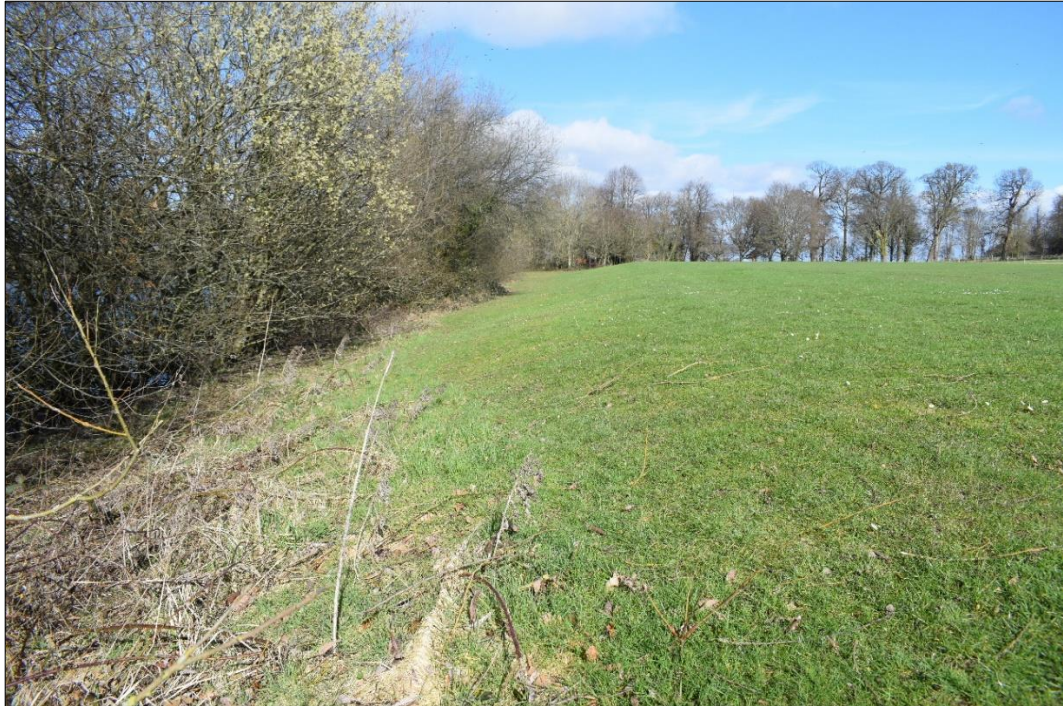
Wat's Dyke Unit 14: View from the south showing the west-facing scarp along the approximate line of the dyke, with the lake to the left and the levelled area to the right. CPAT 4317-0070

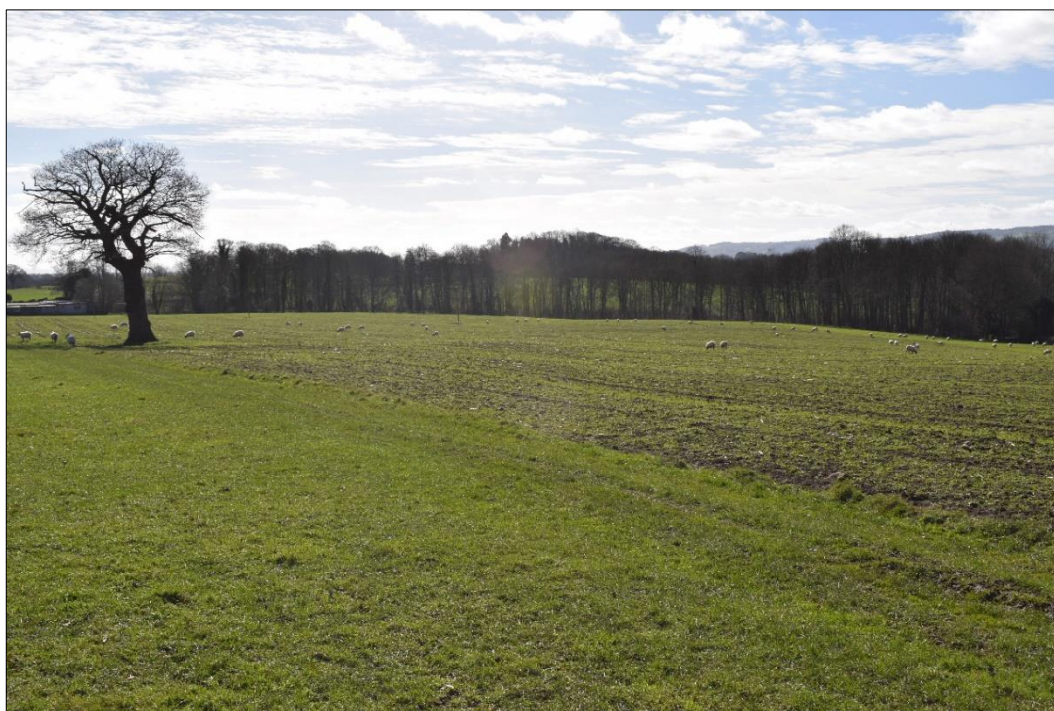
- 4.59. Poor, almost worn/truncated away as an extant feature, no start or end point clearly distinguishable. Field had been chain harrowed but this did not appear to have damaged the dyke.

- 4.60. The dyke lies in fields subject to arable rotation and the earthworks have already been reduced to a point where they are barely visible. Further ploughing will continue to erode any upstanding earthwork and has the potential to damage buried archaeology.

Wat's Dyke Unit 15: View to the south-west along the line of the dyke. CPAT 4317-0074

- 4.61. Exclude the dyke from future ploughing.
