Meifod Church Archaeological Watching Brief

The following discussion relates to an archaeological watching brief carried out at Meifod Church on 19th June 2018 in connection with groundworks relating to the installation of path lighting. The work was the subject of a Faculty (No 1810) granted by the St Asaph Diocesan Advisory Committee.

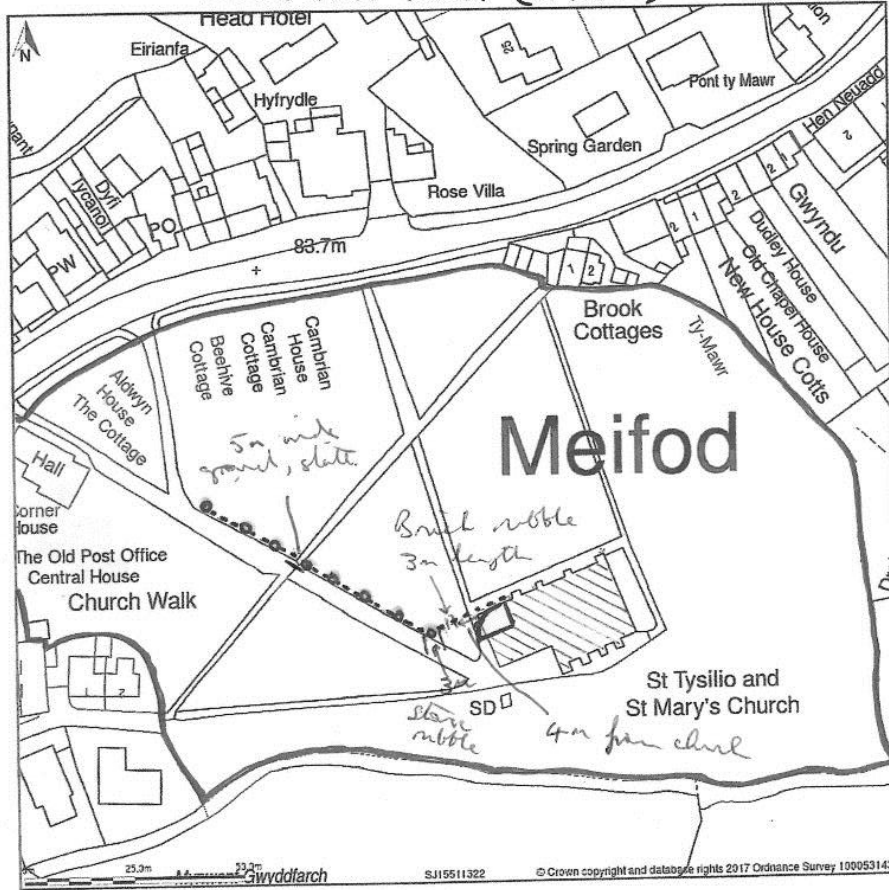
The watching brief examined a machine-dug trench, running east-south-east along the main access path from the point where two paths join and leading towards the church, in which a cable for the path lighting was laid (see Fig. 1). The cable passed into the church via a blocked door on its north side, where a pre-existing hole had been drilled for the main electricity supply cable for the church.

Fig. 1: Plan of the path lighting route (courtesy Meifod Church Committee)

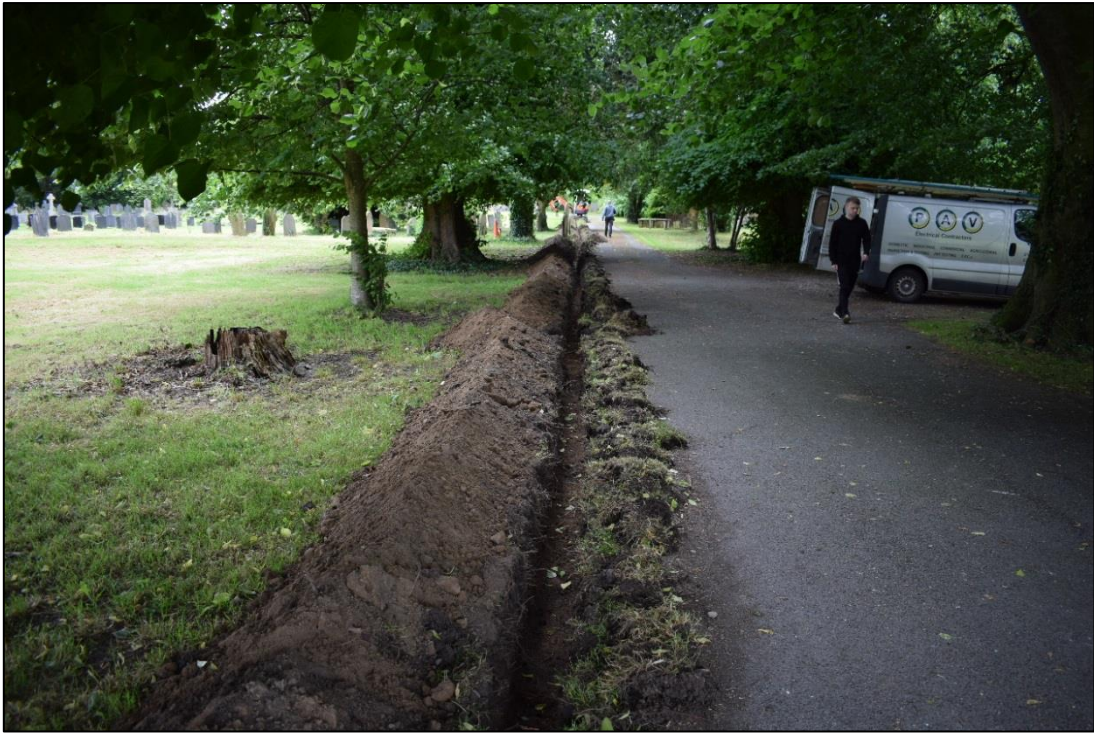
In the churchyard, the trench in which the cable was installed averaged 0.25m wide and 0.5m deep, with wider sections measuring 0.6m by 0.6m and to the same depth, created to allow the siting of lighting bollards at intervals along its course. The soils observed in the trench showed that there was 0.2m of dark grey silt overlying yellowish-brown clay silt where the trench ran parallel to the church access route; the clay silt appeared to be of natural origin and seemed to represent ground undisturbed by burials.

Fig. 2: Main section of trench alongside access path

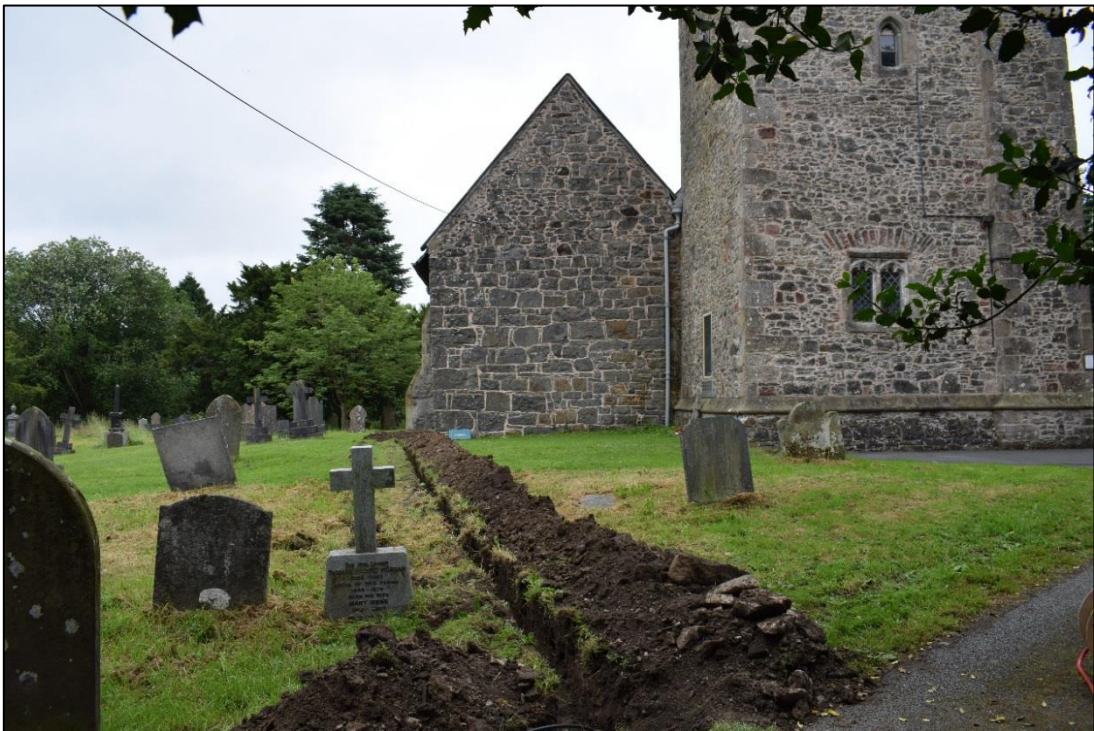
Fig. 3: Section of trench leading to church

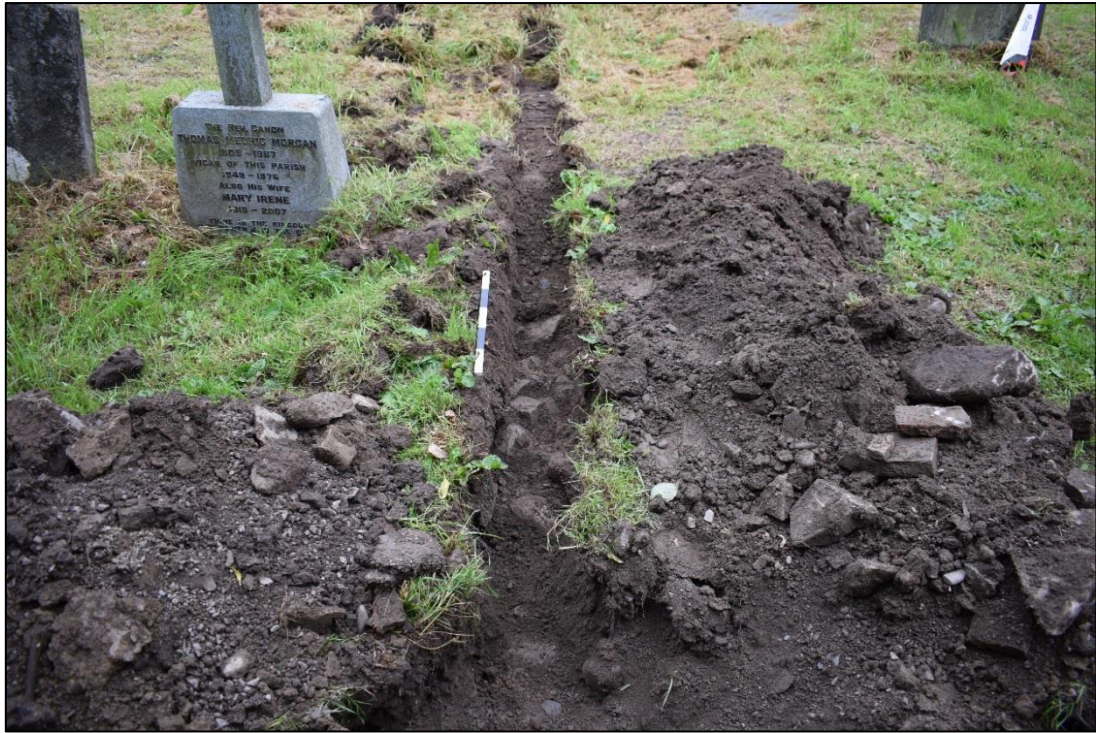
The line of the trench left the path to the west of the church tower and proceeded east-north-east to the point where the new cable passed into the church. Where the trench changed direction, an area of stone rubble was encountered at a depth of about 0.3m, continuing to the east-north-east for 3m. Some brick fragments were present in this material and it can therefore be assumed to be no earlier in date than the 19th century. A collection of brick fragments, also presumably of 19th-century date, was identified between 4m and 7m from the corner of the church and extending below the base of the trench.

Fig. 4: Stone rubble at the change in direction of the trench

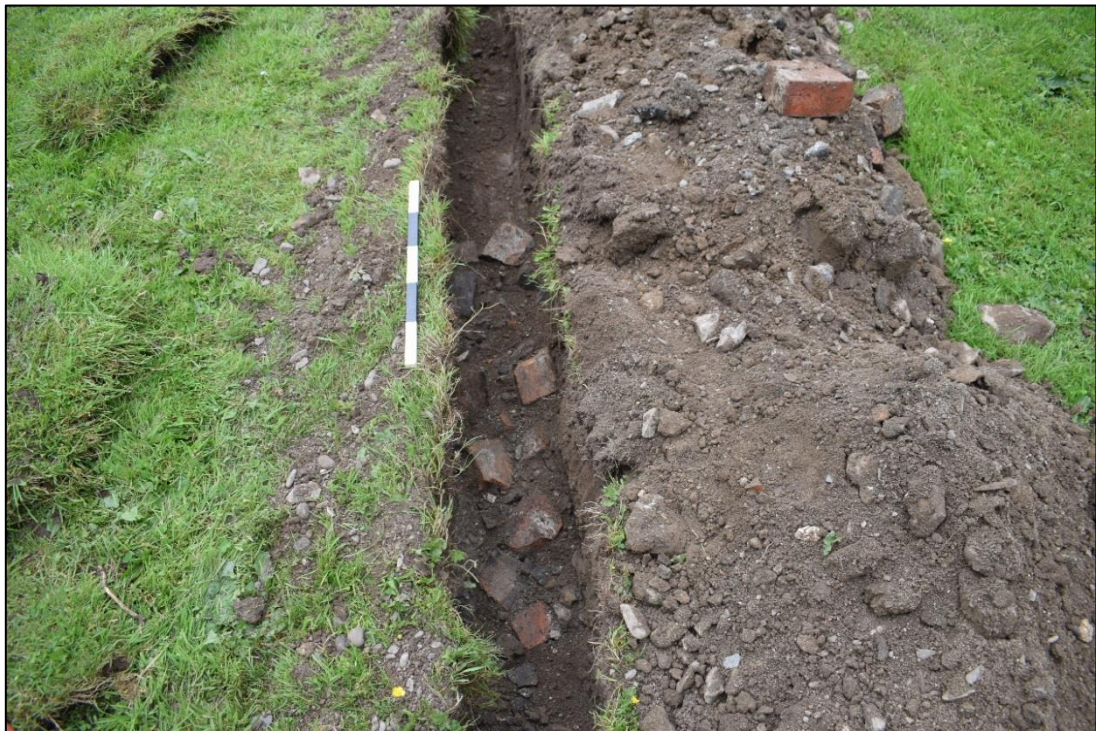
Fig. 5: Brick rubble between 4m and 7m from the corner of the church

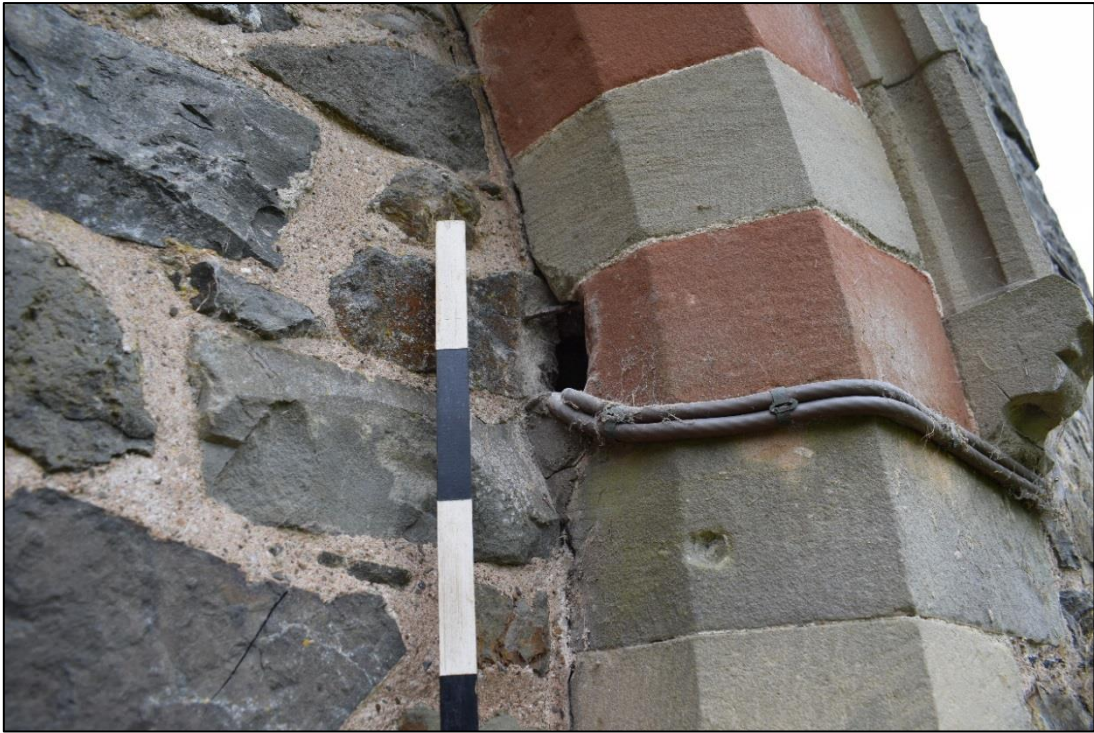
There was no effect on the structure of the church as an existing aperture was used to link the path lighting cable to the mains electricity supply.

Fig. 6: The existing aperture in the blocked doorway, which was reused for the path lighting cable
