CPAT Report No. 1487

Brecon Gaer (Br001)

Archaeological investigation and recording

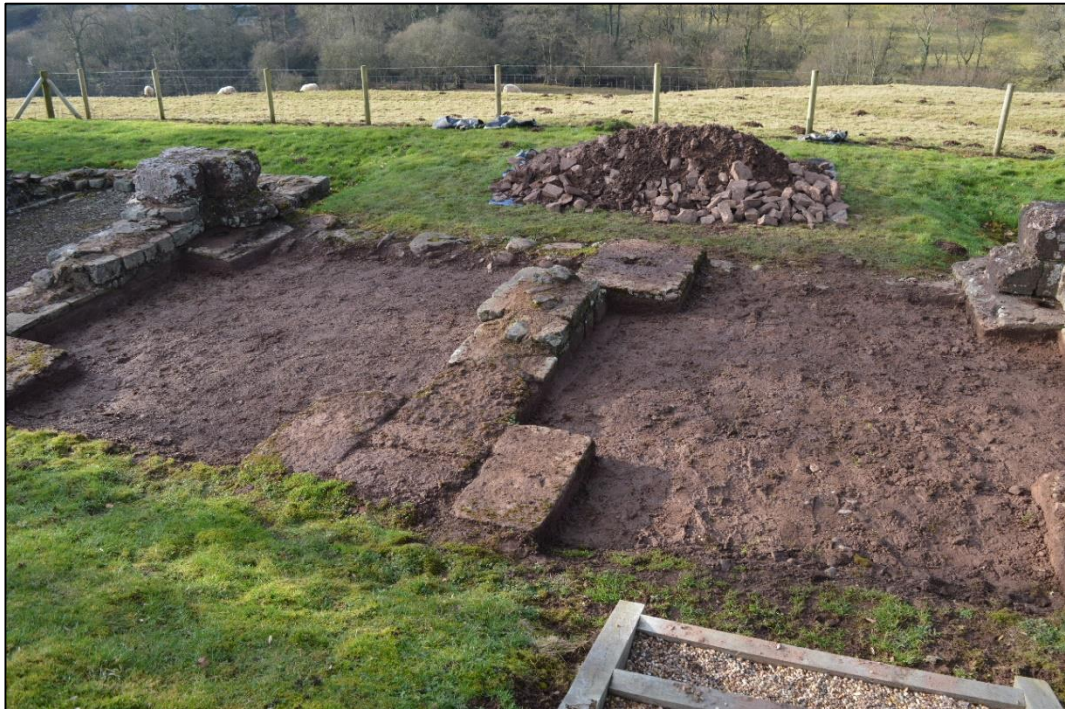
- 3.6. The ground level within the central part of the west gate was reduced by 100mm to expose more of the structural remains of the gate to facilitate reconsolidation. All of the material which was removed had been placed there by the Ministry of Works and comprised a layer of reddish sandstone gravel, 50mm thick, covering a layer of well-set, pitched sandstone cobbles, up to 0.2m thick. To allow the ground to be reduced by the requisite amount the cobbles were removed and the gravel re-used to provide a level surface. Examination of Wheeler's photographs demonstrated that the ground level following his excavations was roughly equivalent to the level prior to the recent excavations, suggesting that the level had been reduced further by the Ministry of

Fig. 3: Investigations within the West Gate, viewed from the east. Photo CPAT 4291-0034

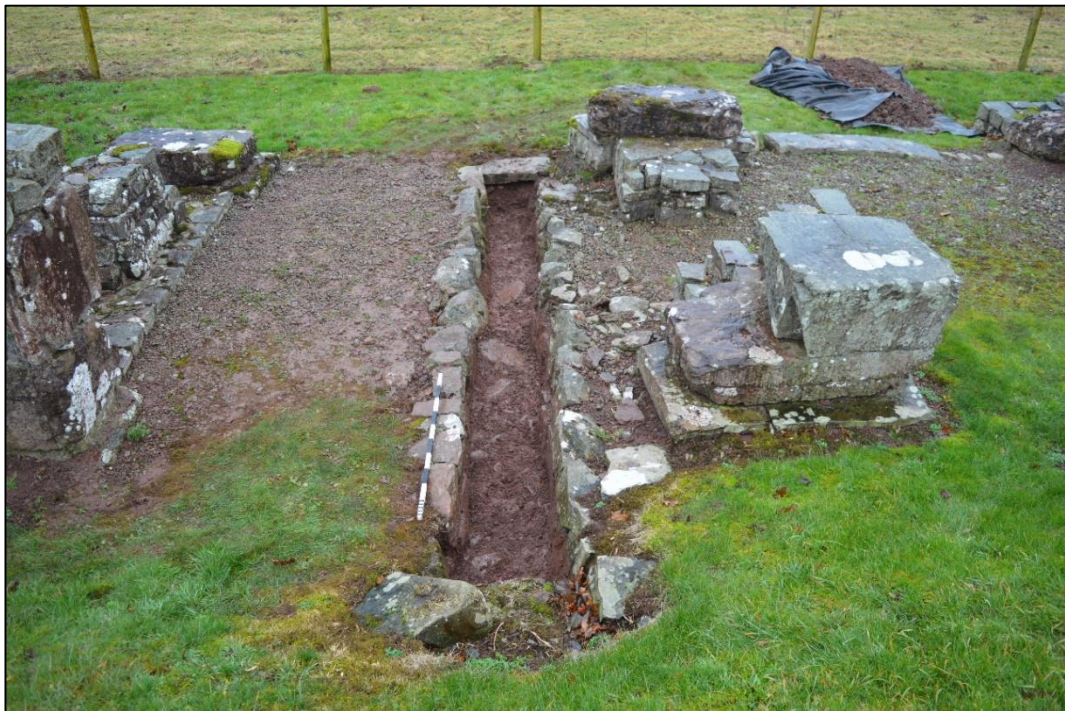
- 3.8. Within the South Gate the excavations were restricted to emptying a stone-lined Roman drain (Figs 4, 14-15) running along the length of the gate passage, which was cleared of debris to enable its conservation. The section of the drain that was exposed measured 4.8m long and up to 0.55m wide. An average thickness of about 0.3m of grey-brown silt was removed down to its base of reddish clay silt and occasional flat stones, indicating an original depth for the drain of about 0.6m.

- 3.10. The central pier of the gate, lying parallel to and between the two roadways, can be clearly seen on the right side of Fig. 4, below. If the modern images are compared with Wheeler's photographs from the 1920s (see Figs 15 and 16) it is evident that the current stonework is a fairly close approximation to the original, including the projecting walls that define a lateral doorway linking the two roadways.

Fig. 4: The excavated drain within the South Gate, viewed from the north. Photo CPAT 4291-0004

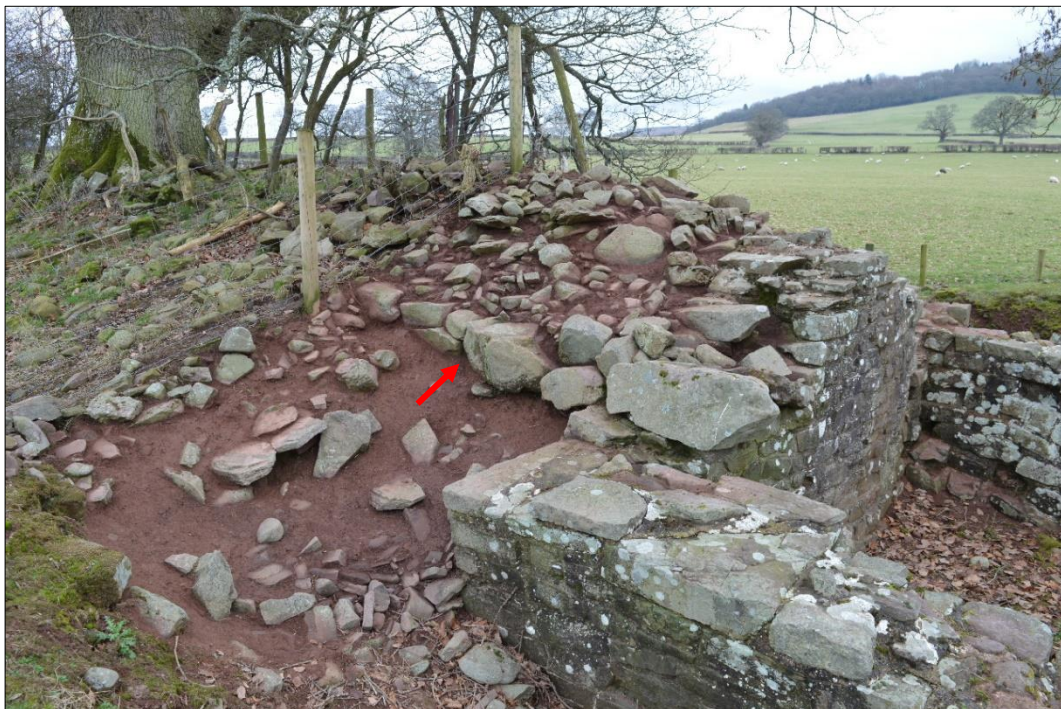
- 3.13. On the top and the west side of the rampart a stone rubble deposit thought by Wheeler to represent post-Roman rebuilding was evident, defined by a simple stone revetment on its west side (Fig. 5). Although this was left in place by the Ministry of Works, it is known that the material had originally covered the guardroom on the north side of the gate and had been removed during Wheeler's excavations in the 1920s; the few stones that were found to overlie the north wall of the guardroom may have been placed there by the Ministry to signify this relationship. The surviving rubble deposit appeared to be relatively thin and capped the earlier earthen rampart, composed of reddish clay silt, which was visible to the east. It appeared that the earlier rampart had been cut back and the north wall of the guardroom built against its edge to act as a revetment when the stone structure of the east gate was built.

Fig. 5: The investigation of the rampart adjacent to the East Gate. Note the stone revetment (arrowed) thought be Wheeler to represent post-Roman rebuilding.

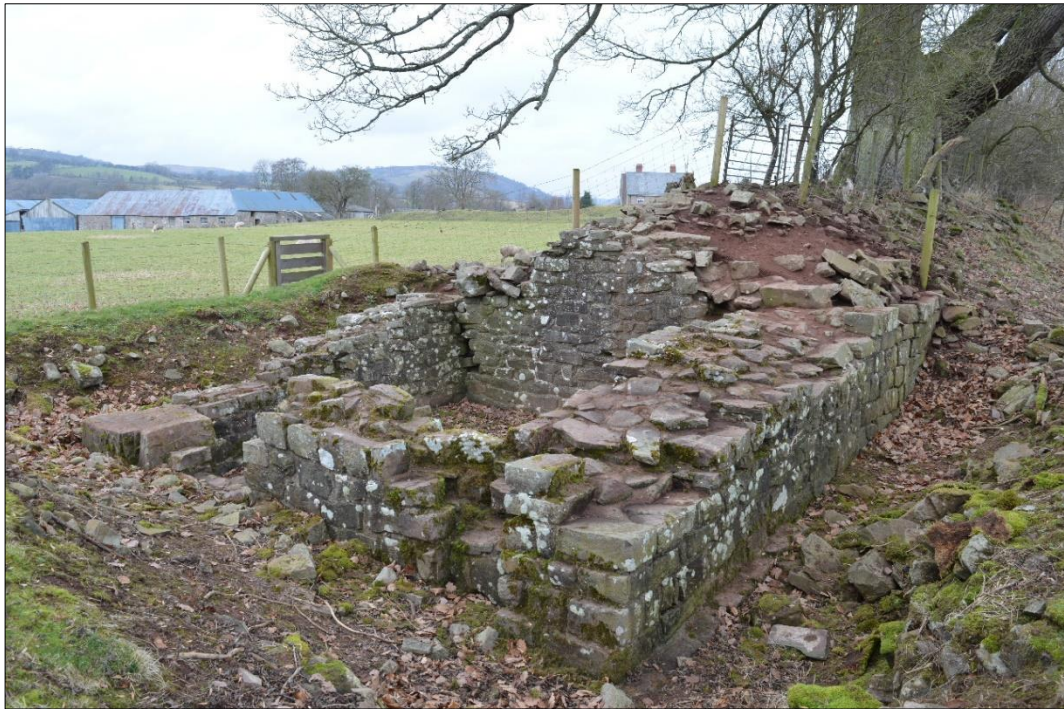
Fig. 6: The investigation of the rampart adjacent to the East Gate. 4291-00 15

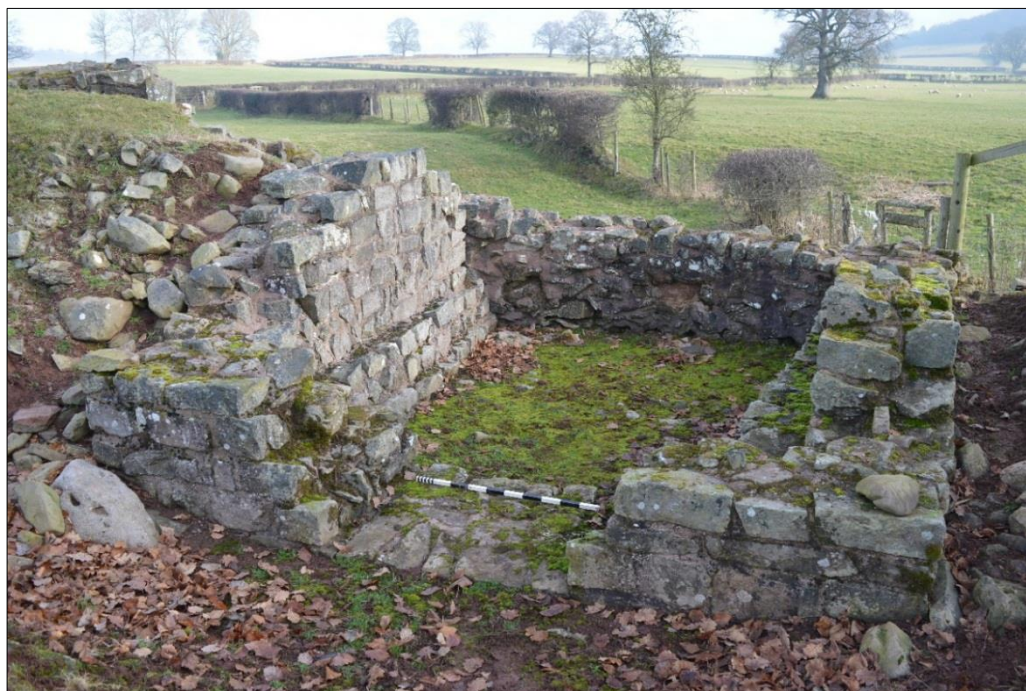
- 3.17. At first view the fabric of the tower appeared to be basically unaltered, although the MoW recorded comprehensive rebuilding of the north elevation and 50% of the east elevation of the tower in June 1970; they noted that the walls were completed in July. The remaining elevations of the tower had been repointed and the exposed upper faces of the structure sealed to prevent weather damage, which has served to mask the extent of the repaired masonry, but there seems to be no reason to suppose the team altered their usual practice of taking down the walls to remove roots and other vegetation and then rebuilding them to the same overall appearance using new mortar. It does, however, appear that the work here was completed to a slightly less rigorous standard than had previously been the case.

Fig. 7: The north-east turret, viewed from the south-west. Photo CPAT 4291-0029

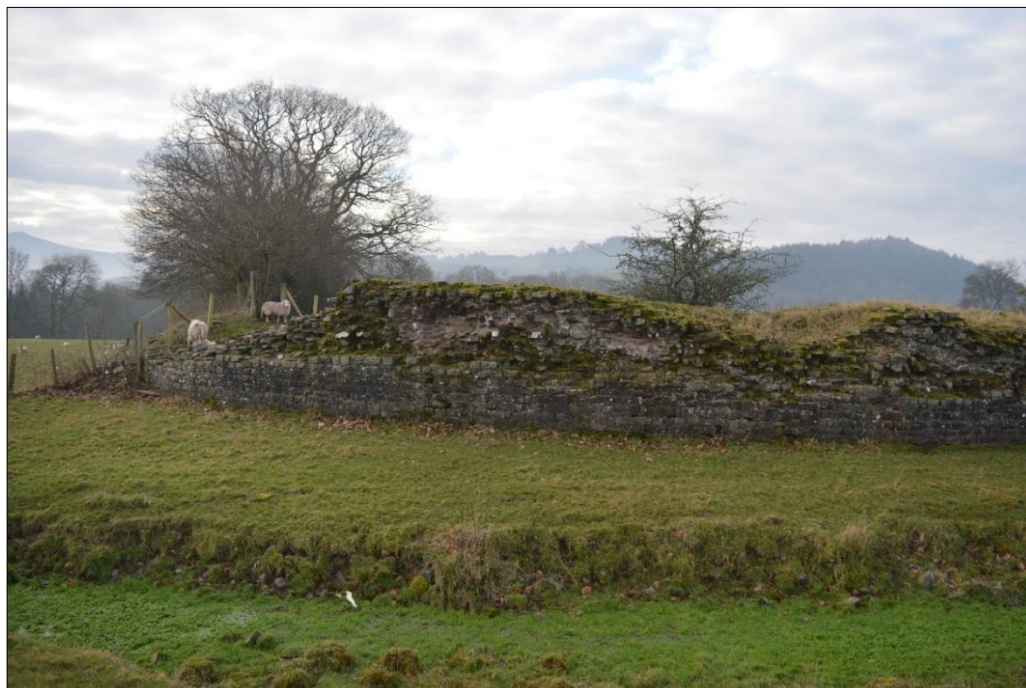
- 3.19. The MoW reports refer to work carried out on the north wall between August 1967 and November 1970. This work comprised cleaning, consolidating and pointing the masonry and the removal of scrub and trees from the earthen bank overlying the wall. The bank was also regraded. It seems likely that the structure had collapsed in several places, as the MoW reports referred to trial trenching to determine the original line of the wall. In the north-east corner the footings of the wall were underpinned. The exposed core of the wall and the wall top were sealed to prevent any further weather deterioration.

Fig. 8: A section of the north wall adjacent to the north-east turret. Photo CPAT 4291-0028

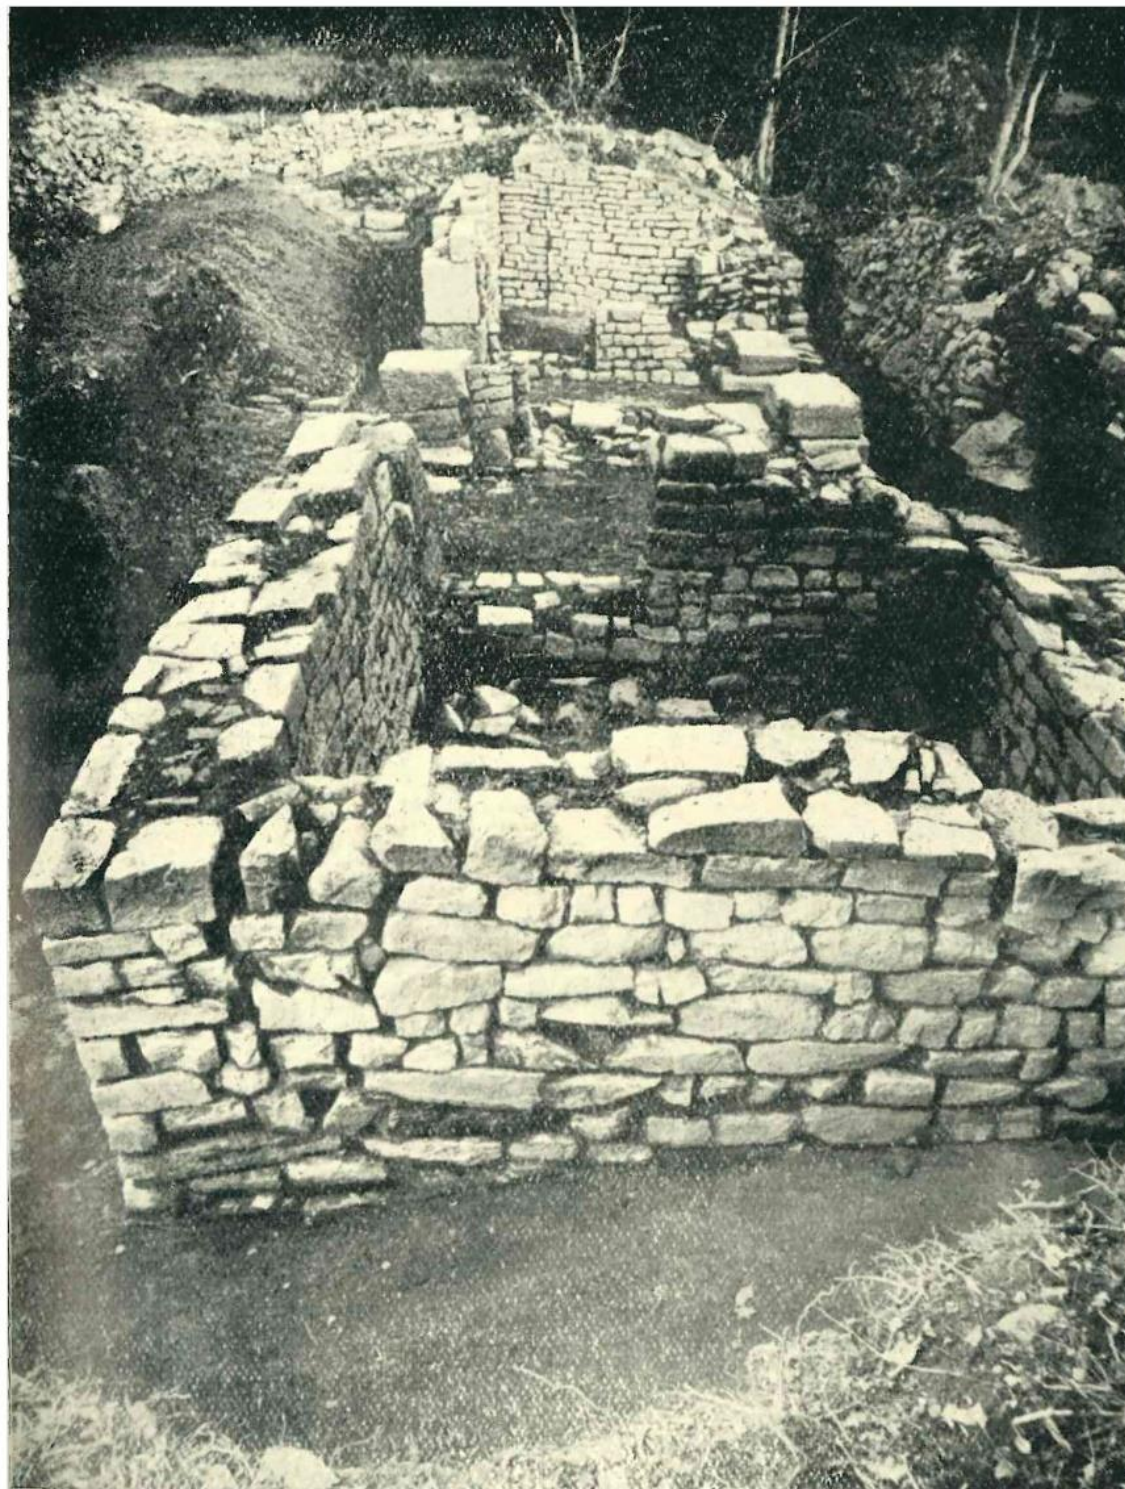
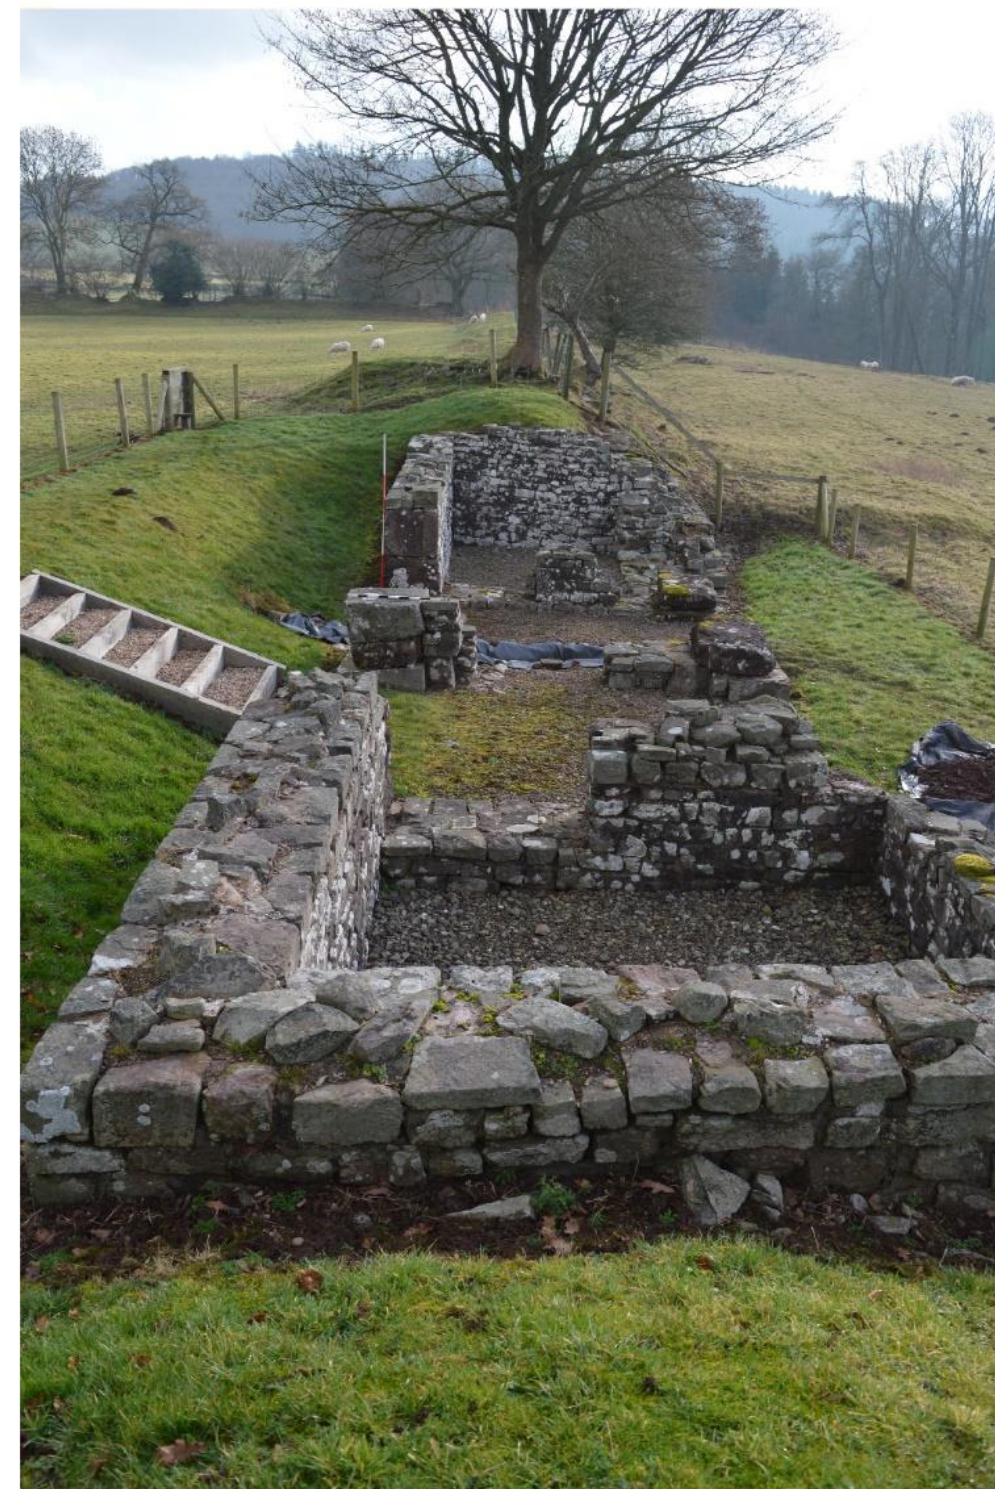
- 3.9. The building survey initially suggested that there had been little dismantling or rebuilding work, although the entire visible structure had been extensively repointed and sealed on the exposed masonry. The east elevation of the west guardroom (Fig. 15) had evidently been rebuilt, possibly having collapsed in the 25 year interval between the original excavation and the Ministry of Works repair programme. The MoW site report for March 1961 refers to this work being carried out, the adjacent fort wall (south elevation) was also rebuilt at this time. A report from July 1966 refers to 'rebuilding walls and foundations continuing' and later in that year to the consolidation of masonry having been completed. Comparative analysis of the 1920s excavation photographs reveals that this rebuilding had been carried out sympathetically and to a high standard.

Fig. 15 South Gate: view from the west c. 1925 (Wheeler 1926) and 2017 (Photo CPAT 4291-0054)

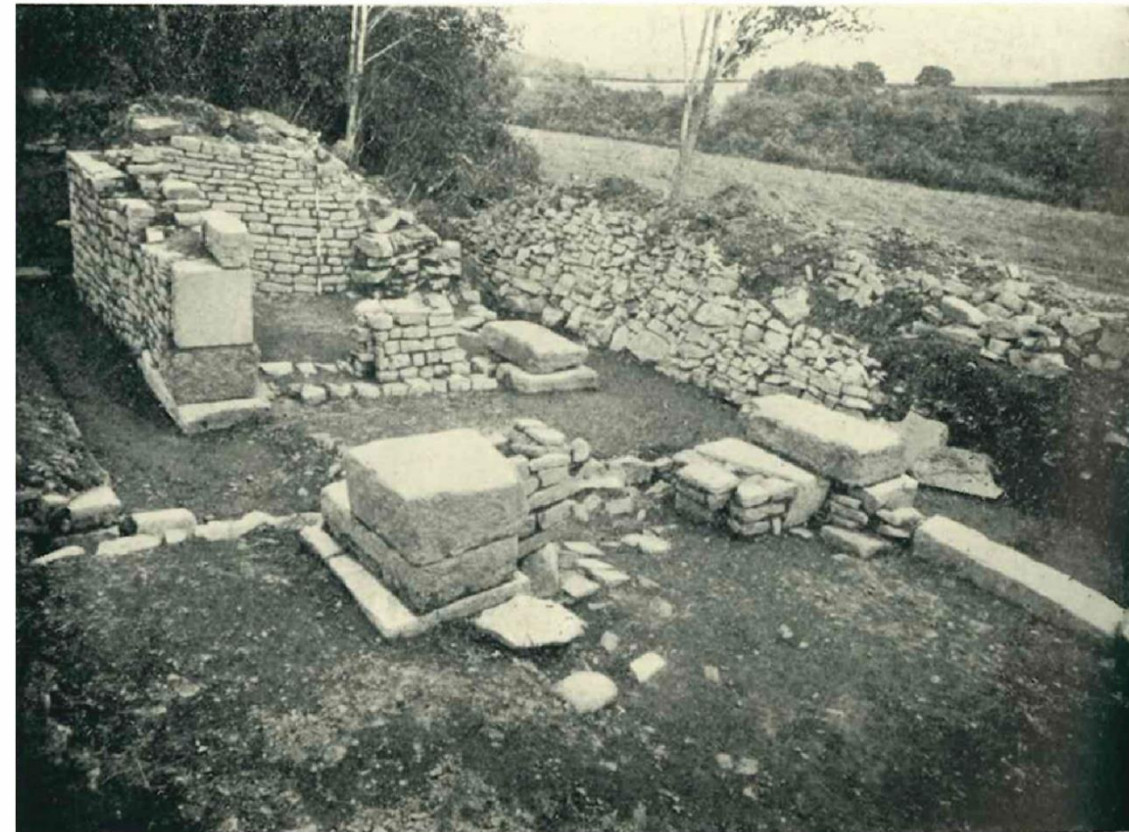
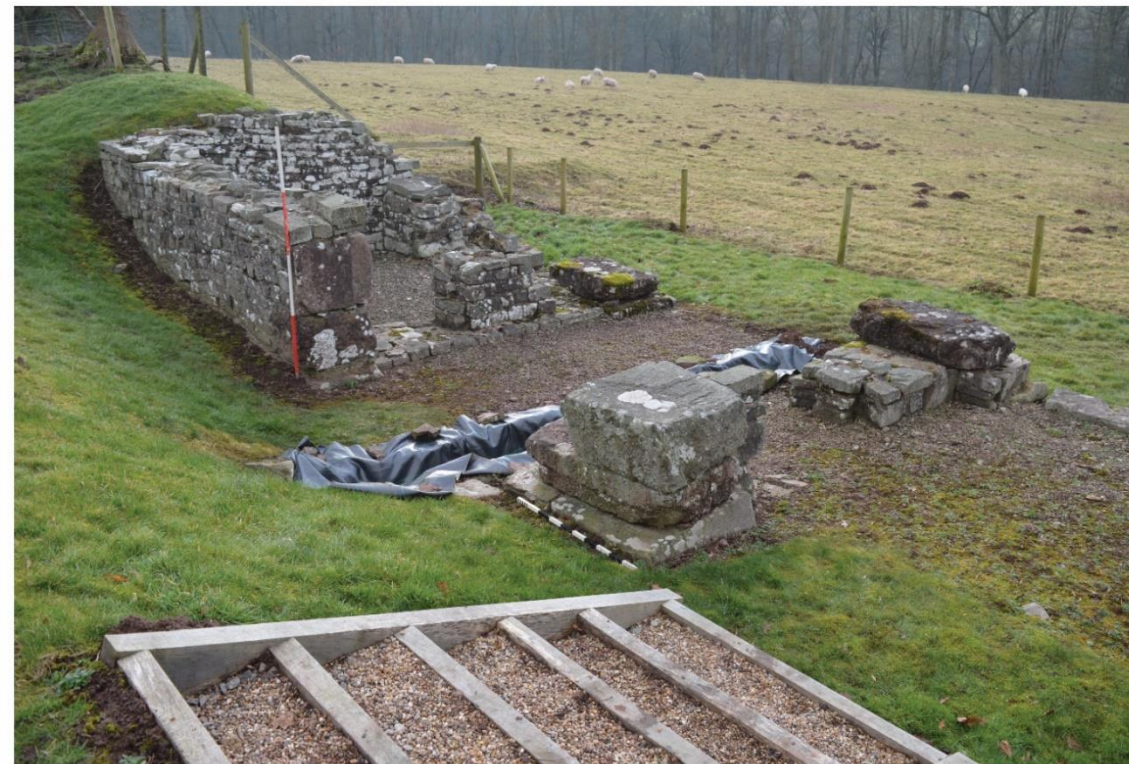
- 3.11. Some discrepancies between the original stonework and the Ministry rebuilding have been identified at the north-west corner of the east guardroom, where the near square stone that forms the third course up from ground level on the 1920s photograph (see Figs 16 and 20, elevation B) appears to have been turned through 90 degrees to rest on what was formerly its side. It is also evidently the case that the Ministry workmen added a course of stone on this part of the north wall of the guardroom to even out its upper surface.

Fig. 16 South Gate: East Guardroom, view from the north-west c. 1925 (Wheeler 1926) and 2017 (Photo CPAT 4291-0056)

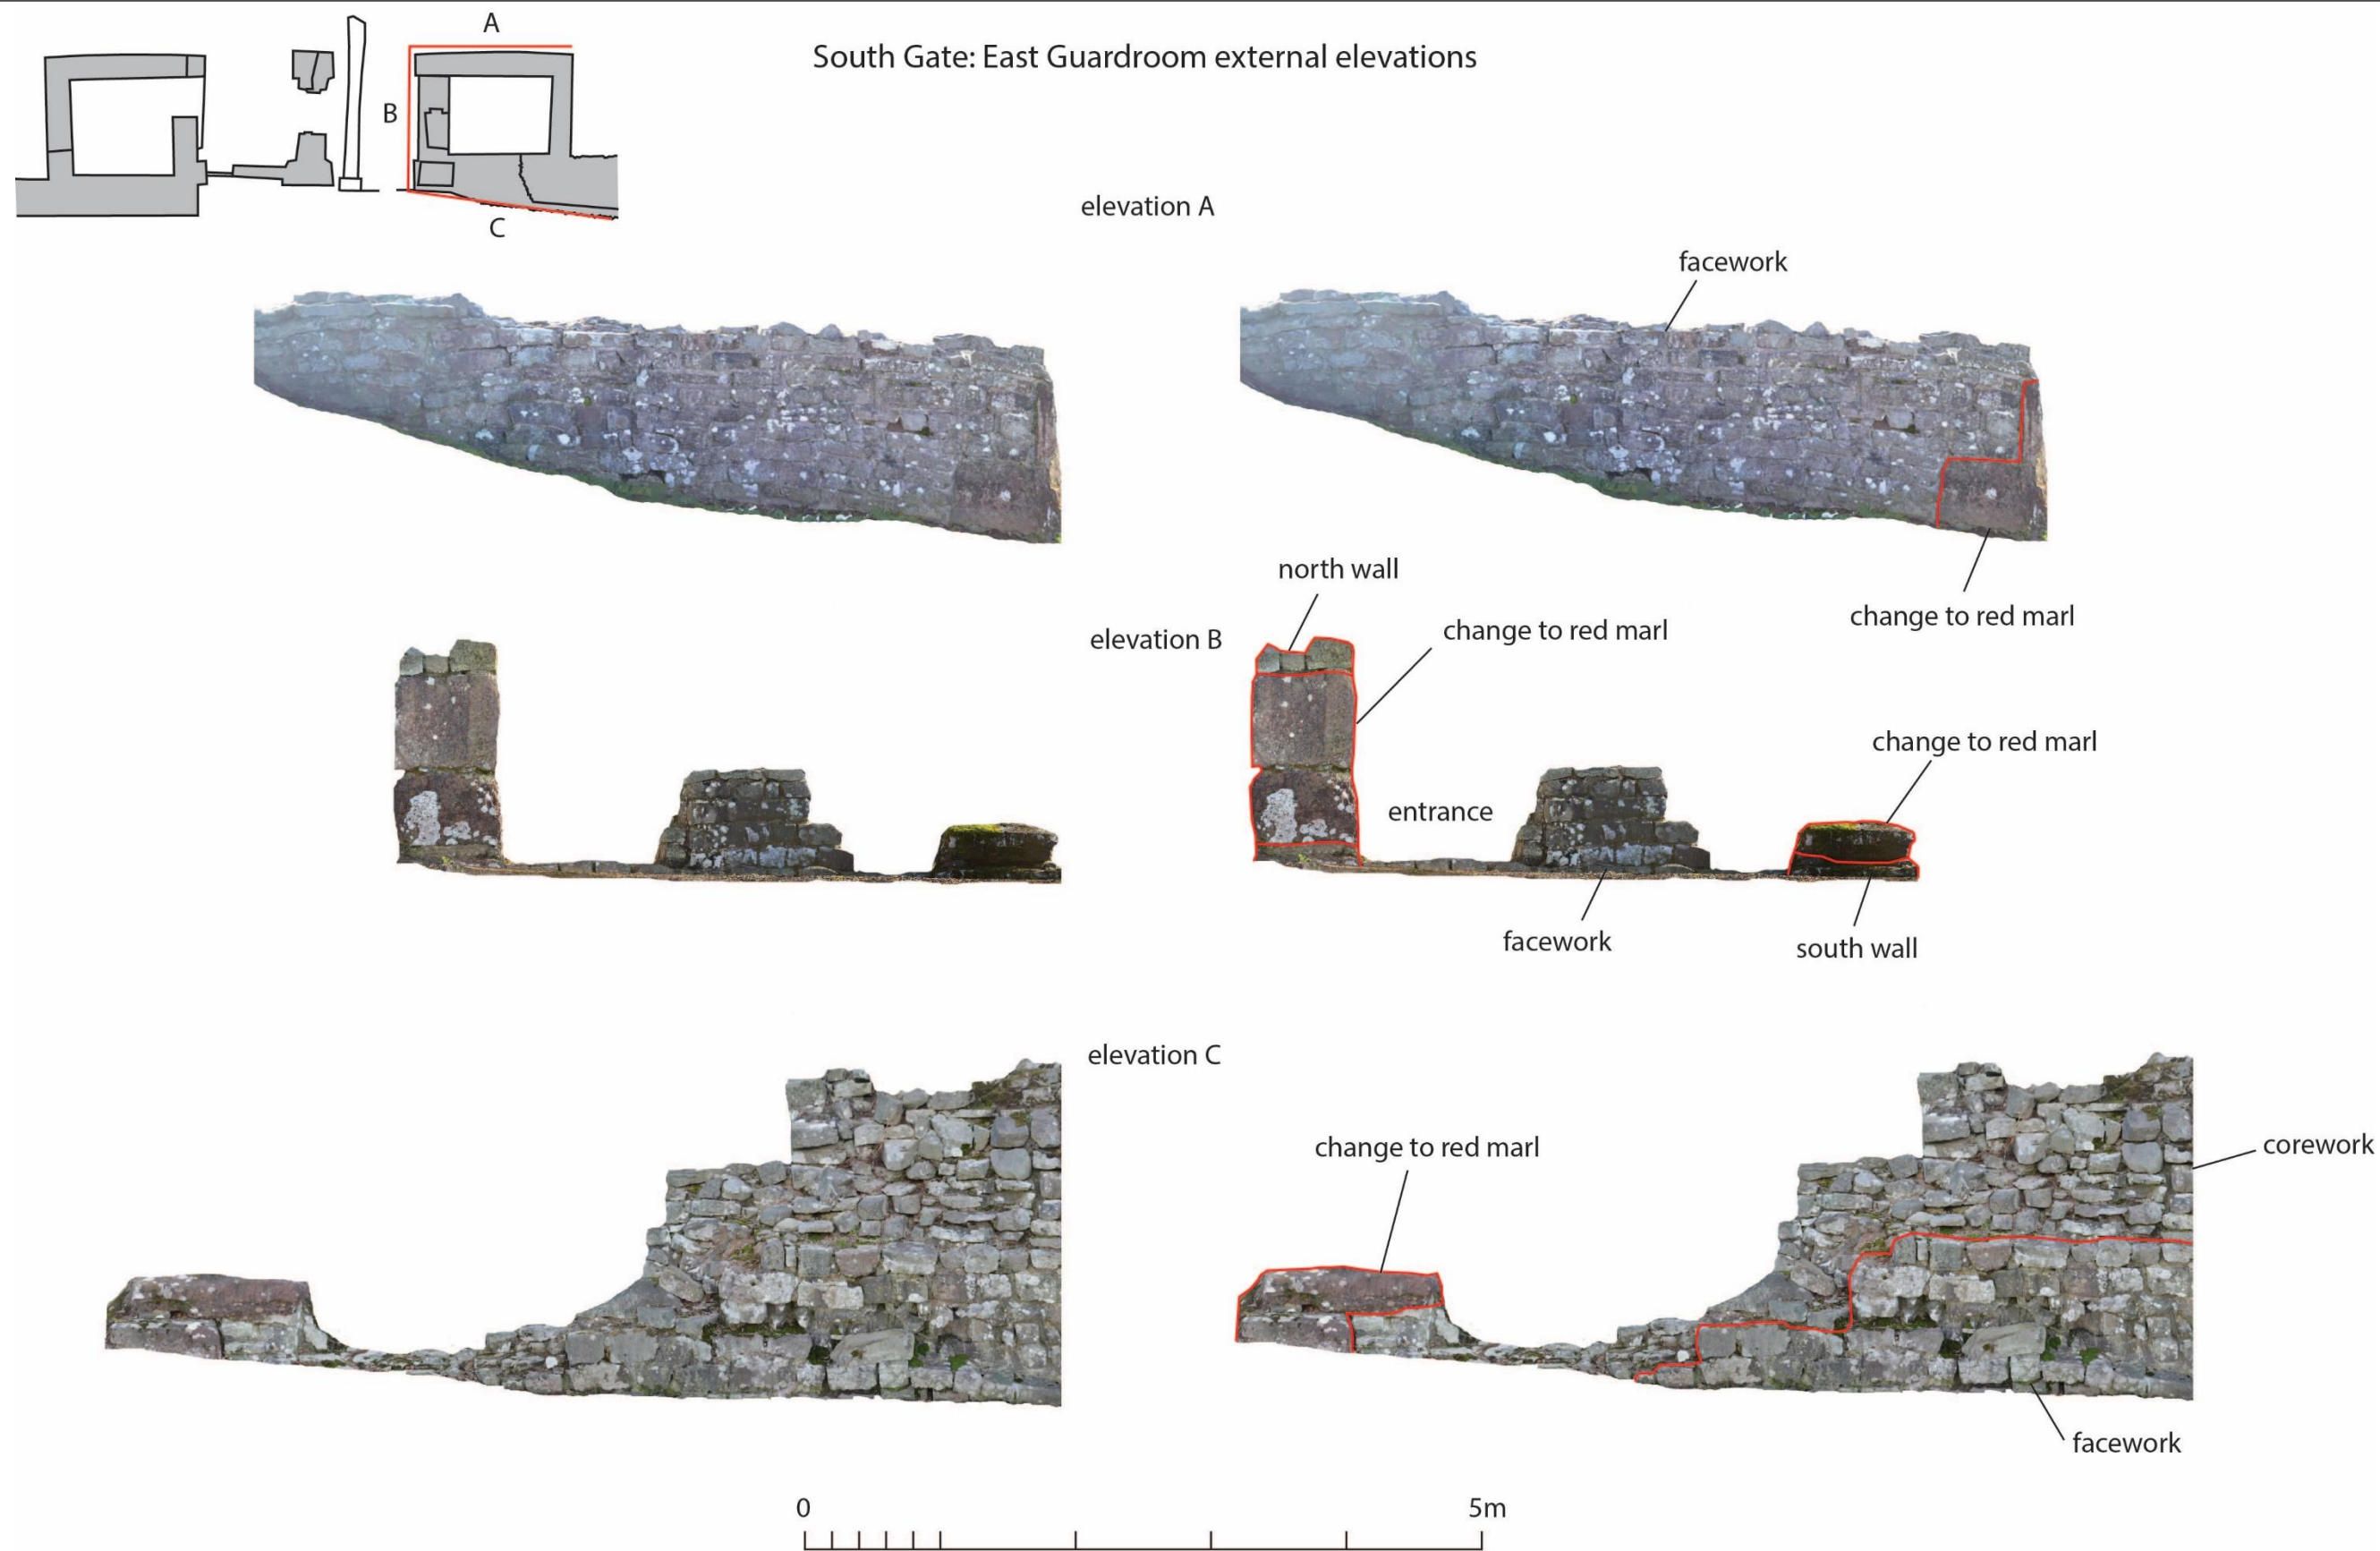
Fig. 20 South Gate: East Guardroom, external photogrammetric elevations

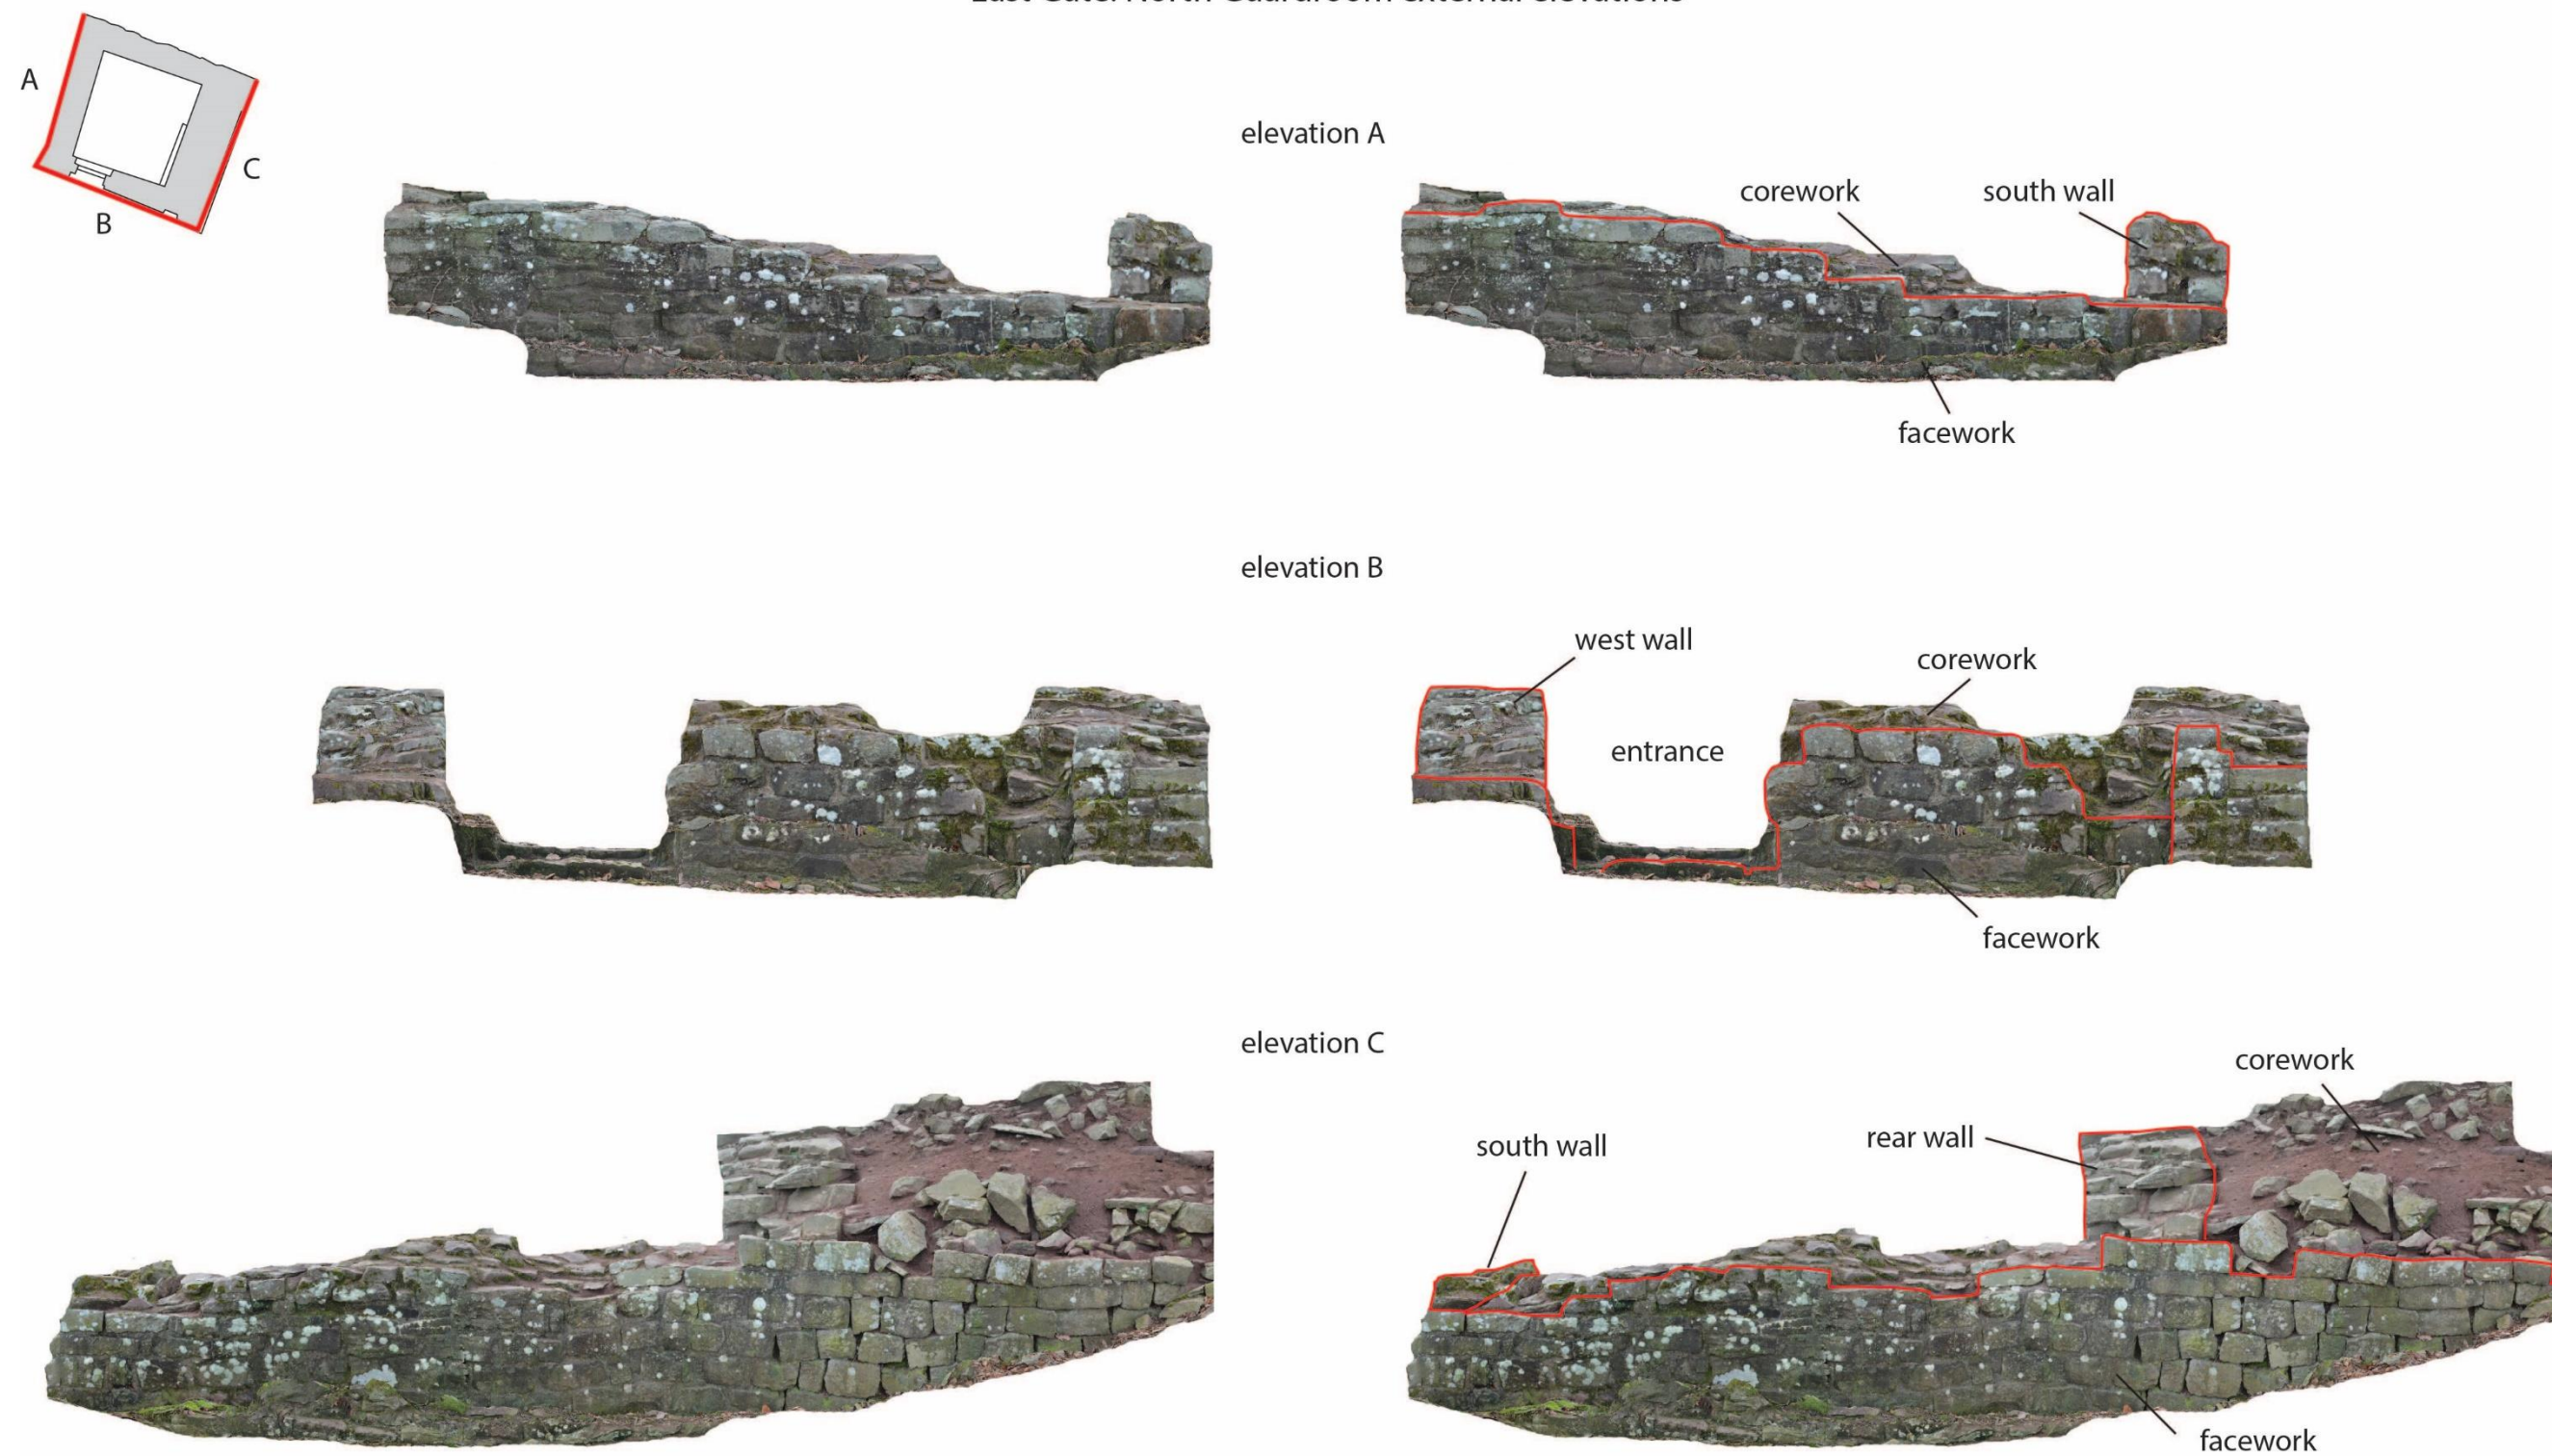
- 3.15. A short section of the outer face of the east wall of the fort is evident to the north of the guardroom (see Fig 27, elevation C), although this has curiously been left in an unfinished state, without pointing. The most probable explanation is that work on the site was closed down for the winter in November 1969, immediately after scrub was cleared from the east wall of the fort; when the team returned in June of the following year they concentrated their attention on the structures forming the north side of the fort. There appears to have been no further consolidation work following the 1970 season.

Fig. 27 East Gate: North Guardroom, external photogrammetric elevations
