CPAT Report No. 1604

Stanage Park Lake, Knighton, Powys

Archaeological Evaluation

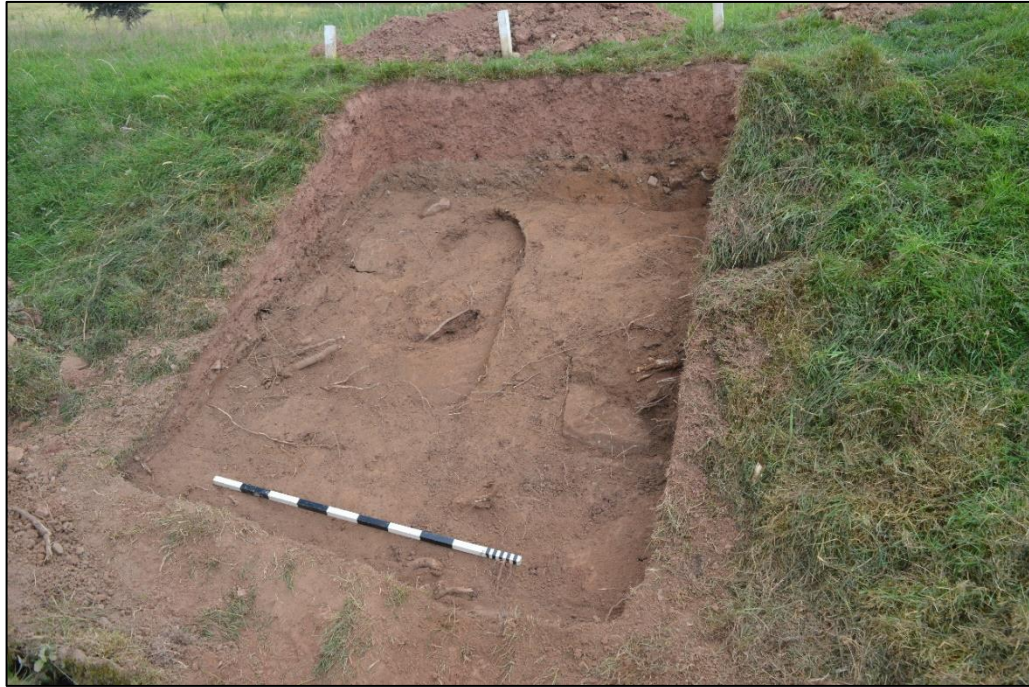
- 3.3. Trench 1 (Fig. 7, 1) measured approximately 1.2m by 1.5m and was positioned to locate an outlet recorded on the 1928 Ordnance Survey 25" map, but also inferred by the shape of the channel located to the east of the dam. Underlying the topsoil (101) was a firm reddish silt 0.2m in thickness. Underlying 102 a compact, light grey silt deposit (103) was revealed extending across the entire trench but also appearing to fill a steep sided cut [104], >0.2m deep and >0.9m in width, broadly orientated north-east. The south-east side of the cut fell outside of the excavated area. The fill contained a number of very large pieces of sandstone and part of an iron door hinge. Underlying 103 and cut by 104 was a light orangey brown silt (105) containing moderate sub-angular stones.

Fig. 8 Trench 1 viewed from the north. Photo CPAT 4523-0007

- 4.1. Excavations in Trench 1 confirmed the position of the outlet ditch suggested by the Ordnance Survey 25" map of 1928, as well as revealing the shape of the disused channel to the east of the dam, at the north end. This channel, which was presumably an open U- or V-shaped ditch running across the upper dam, apparently superseded an earlier outlet located immediately to the north.

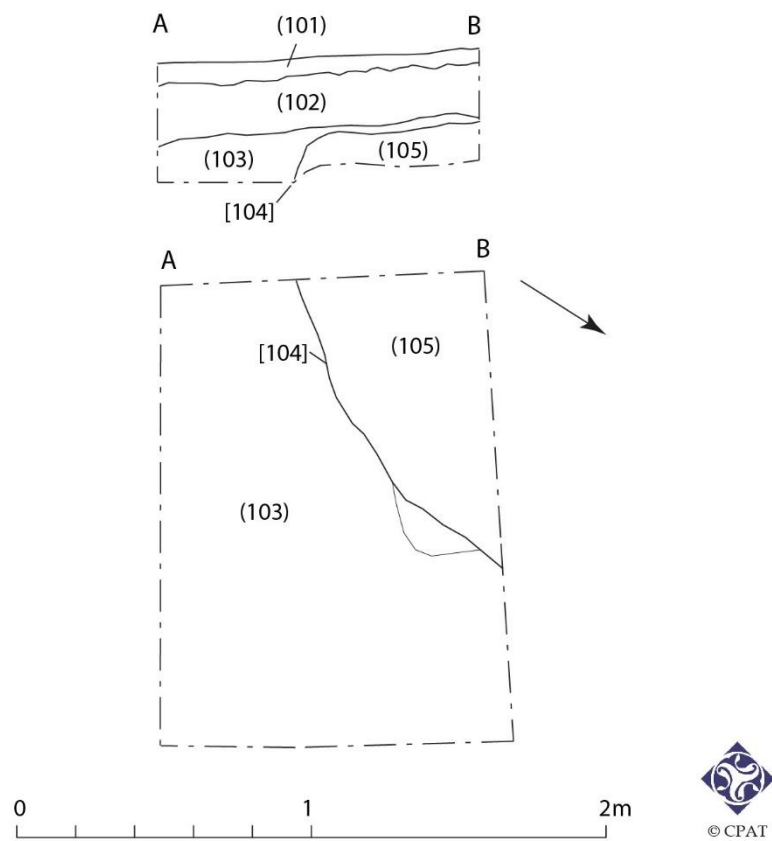
Fig. 9 North-north-east facing section and plan of Trench 1

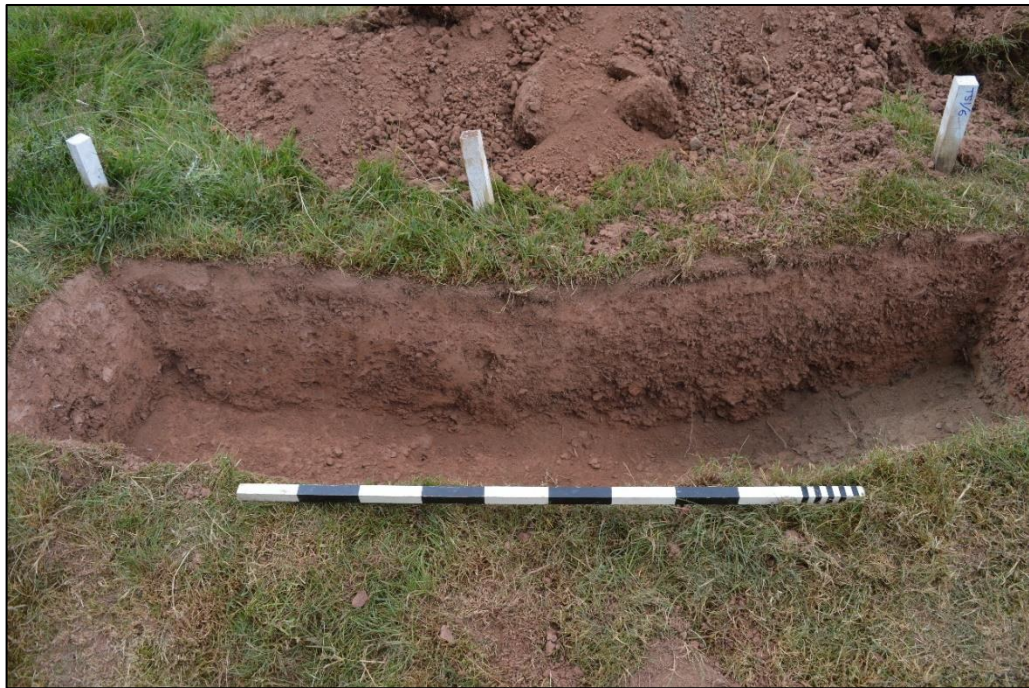
3.4. Trench 2 (Fig. 7, 2) measured 2m by 0.5m and was located approximately 5m to the north of Trench 1 in order to determine the form of an outlet recorded on the Ordnance Survey 25" map of 1889, but also inferred by the shape of the channel to the east. Removal of the topsoil (201) revealed a compacted, friable reddish brown silt (204) and degraded sandstone deposition. Cutting this was a V-shaped ditch [203] 0.9m in width and 0.37m deep, oriented broadly east-west and running across the north end of the dam. The line of the ditch was also discernible as a faint depression in the top of the dam structure. Within the ditch was a firm mid-reddish brown clayey silting fill (202). Underlying 204 was a buried soil horizon composed of a greyish clayey silt, which formed the line of the natural slope underneath the dam.

Fig. 10 East-facing section of Trench 2 Photo CPAT 4523-0004

- 4.2. Trench 2 revealed a V-shaped ditch, interpreted as an open outlet, running across the top of the dam. This feature was recorded on the Ordnance Survey 25" map of 1889, and also fed into the channel later used by the outlet identified in Trench 1.

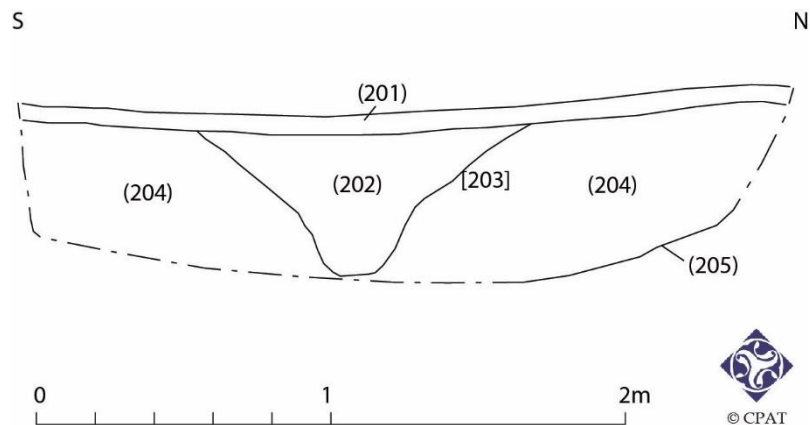
Fig. 11 East-facing section of Trench 2

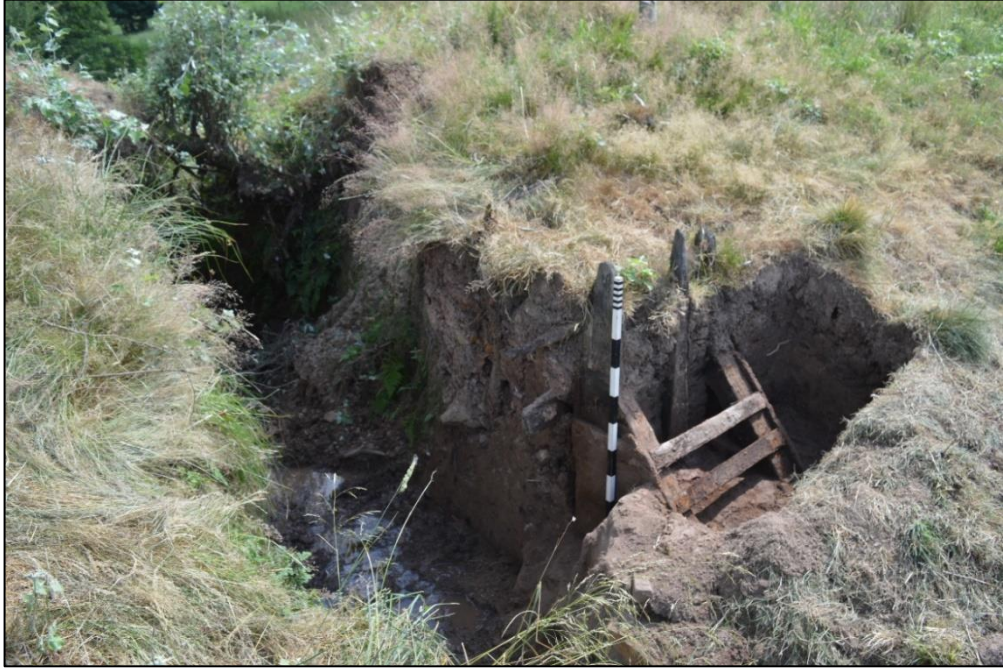
Fig. 12 View from the north-west of the breach and the wooden bank retaining structure south of the sluice. Photo CPAT 4523-0021

- 3.6. The sluice mechanism and presumably the retaining structure to the north of the sluice had been destroyed by the breach. A section of ceramic pipework recorded by Mike Garner in 2016 in the north-west facing section of the breach was not present at the time of the survey, although a similar section was noted on the east side of the breach having apparently been dislodged by water erosion.

- 4.4. The sluice mechanism located on the centre of the dam had been washed away by the breach in the earthen bank. Analysis of the construction of a wooden retaining structure, and the structure of the dam itself where it was revealed in section, suggests that the sluice was an original feature of the dam construction. The undisturbed natural subsoil upon which the dam was constructed was revealed at depth of approximately 1.6m below the top of the dam. The position of the sluice pipe was difficult to ascertain but was probably 1.2 metres below the top of the dam.

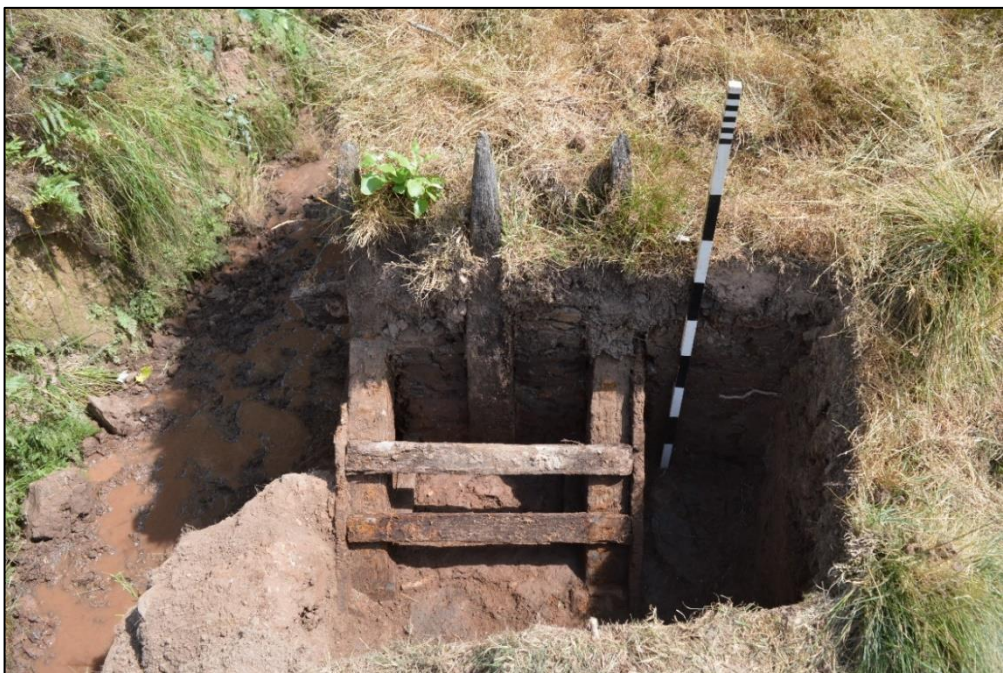
Fig. 13 View from the west of the bank retaining structure. Photo CPAT 4523-0017

- 3.8. The structure broadly comprised four structural elements; three posts (303) retained by two angled supports at either end (306) with boards attached to the sides (307) and rear (305) of the posts. The structure measured >1.2m in height, >0.7m in width and 0.67m in length.

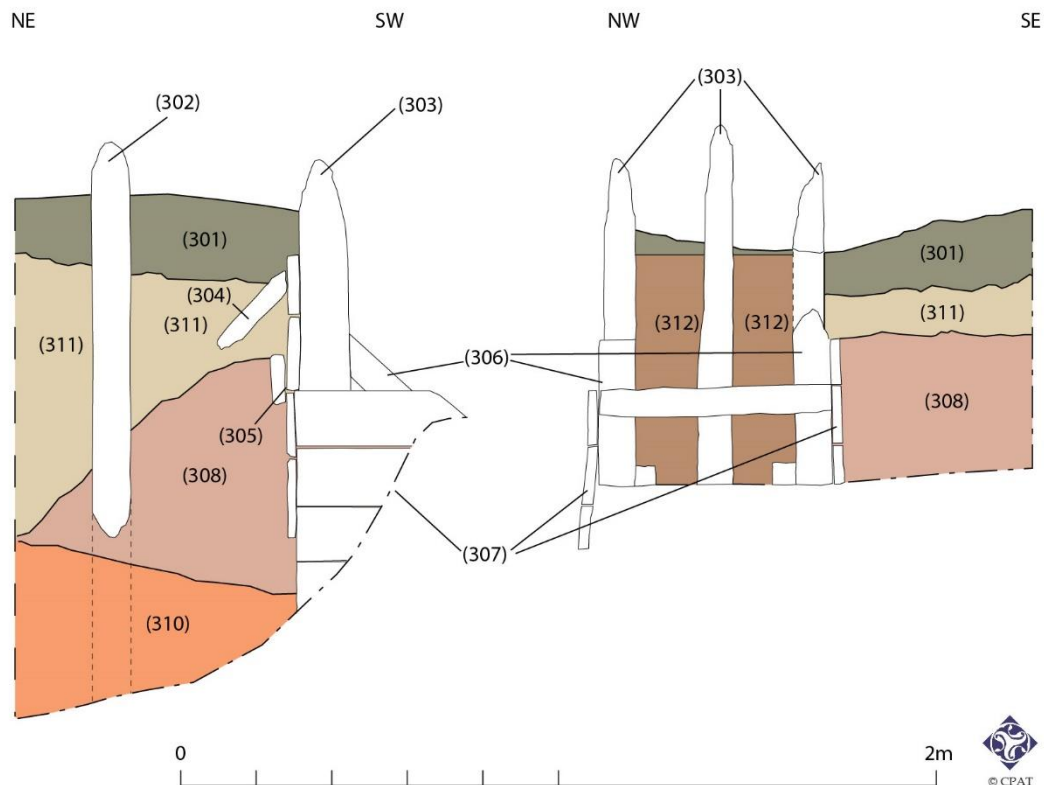
Fig. 14 North-west and south-west facing section showing the dam construction and wooden retaining structure to the south of the breach

- 3.7. The retaining structure was covered by a soft, mottled silt deposit (312), 0.5m in thickness, overlying the uppermost layer of the dam construction, which comprised a friable mid-greyish brown sandy silt (301), 0.22m thick. A partially displaced timber arranged horizontally above the sluice (304) was revealed at this level. Underlying layer 301 was a friable stony clay silt (311), 0.75m thick, containing frequent angular stones, representing the main deposit of material forming the dam. Underlying 311 was a hard, compacted, reddish silt (308), 0.63m thick, containing degraded stone, which lay directly above the natural subsoil, a clay silt.

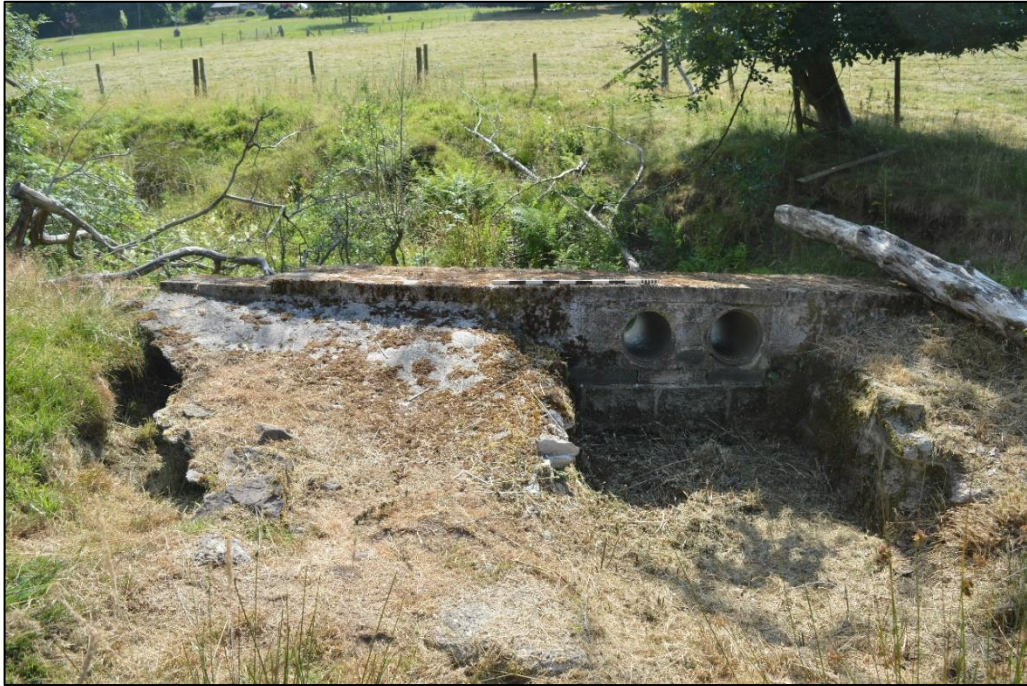
- 3.10. The outlet located on the south end of the dam was cleared of vegetation and examined to determine if any trace of the earlier outlet had survived. The outlet was late 20th-century in date and built in concrete blockwork with two outlet pipes. Water flow had eroded away the dam construction around the sides of the concrete.

Fig. 15 View from the north-west of the southern overflow showing the erosion of the dam construction on the north-east end. Photo CPAT 4523-0015

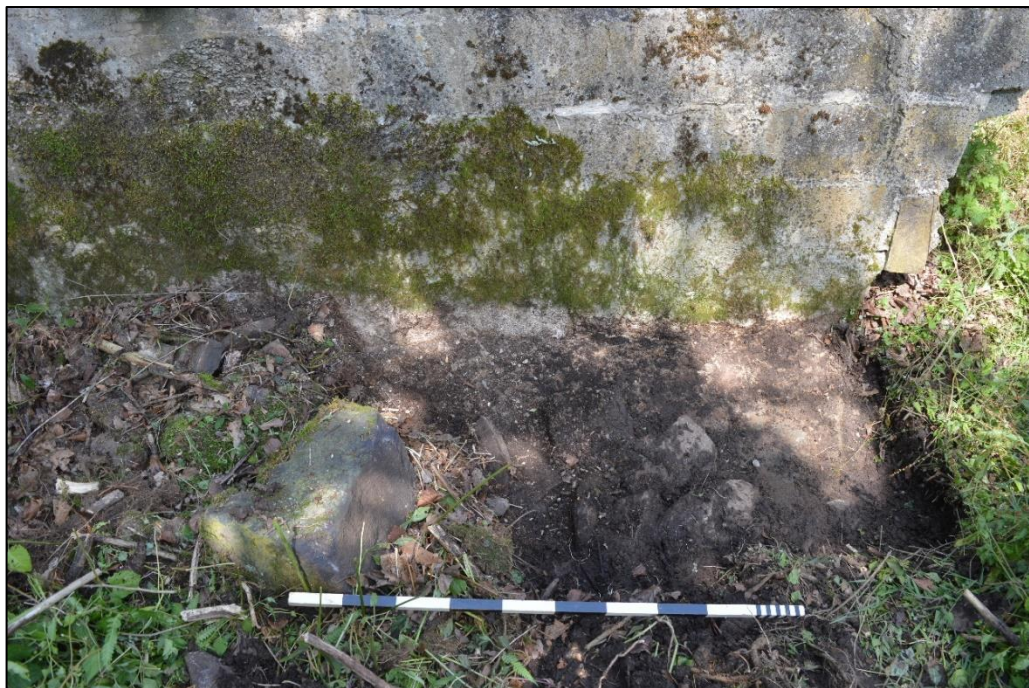
Fig. 16 Stonework in the outlet channel south of the southern channel. Photo CPAT 4523-0013

- 3.11. The base of the outlet channel and the sides of the outlet were examined to see if any trace of an earlier outlet, first depicted on Ordnance Survey 25" mapping in 1815 had survived. No in situ remains of an earlier structure were discernible, although a number of sandstone blocks were identified in the outlet channel including some incorporated into the concrete foundation of the extant structure.

- 4.5. An examination of the modern concrete outlet located on the south end of the dam revealed no in situ remains for an earlier feature, which was first depicted on the Ordnance Survey 25" map of 1815. It is unclear, based on the available evidence, what form this may have taken, although the presence of a number of roughly worked sandstone blocks in the base of the outlet channel suggests it may have been constructed from stone.
