A470 BLAENAU FFESTINIOG  
TO CANCOED IMPROVEMENT

ARCHAEOLOGICAL RECORDING REPORT

Report number : 621 part 1

Prepared for  
White Young Green plc and Gwynedd Consultancy Environment Directorate  
December 2005

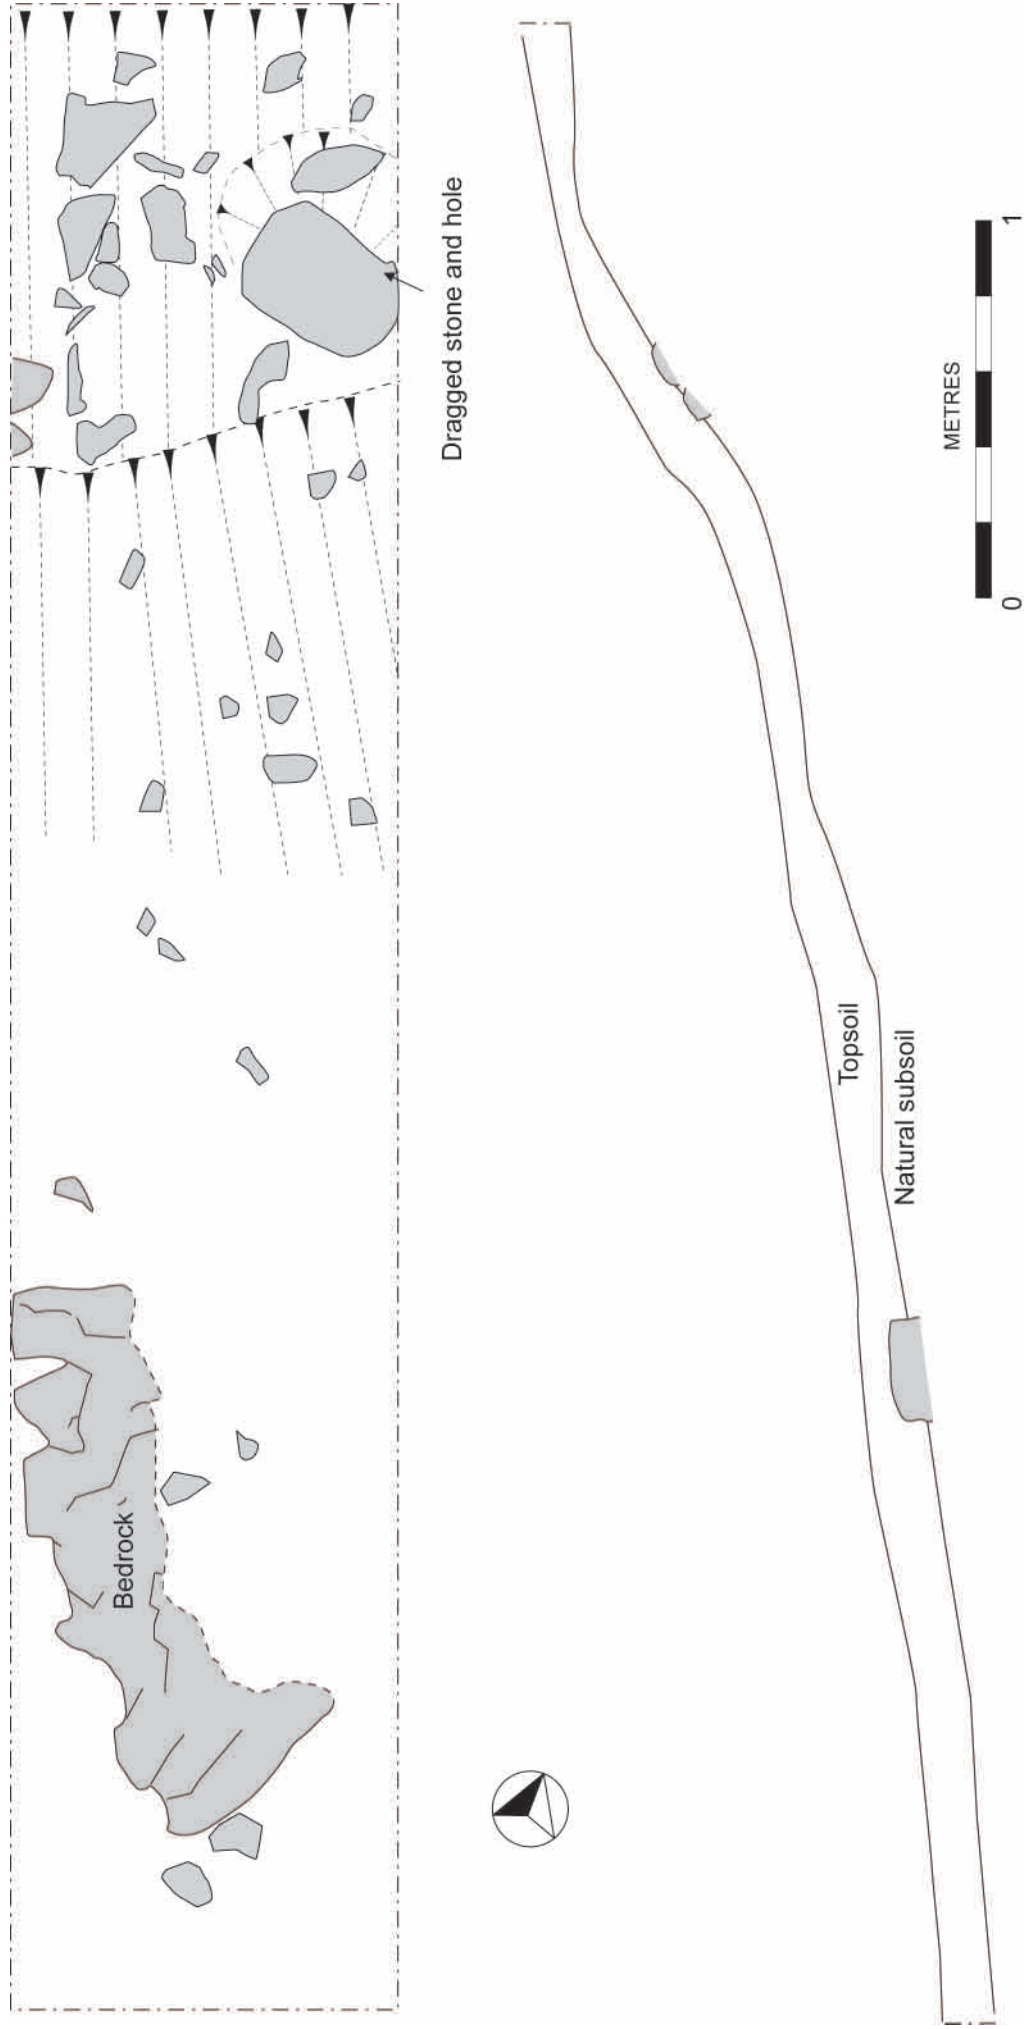
Fig 10 Site 17, subrectangular scoop. Plan and north-east facing section

A 5m x 1m trench was hand dug along the northern half of the feature (Fig. 10 and Plate 2). The turf and topsoil was 0.15m deep and contained frequent modern finds including broken glass, tin cans and plastic wrapping. One sherd of 19<sup>th</sup> century Buckley ware was also recovered from the same context. The finds were distributed throughout the context indicating modern disturbance. This was overlying typical subsoil of the area: mid-reddish-brown silt containing slate fragments. Shattered bedrock was visible on the north-western end of the trench along with one larger stone that had been partially dragged from the subsoil, leaving a hole. The subsoil level dropped gradually to the south-eastern end where bedrock was exposed.

It seems likely that this area was cut back during one of the later 20<sup>th</sup>-century programmes of road improvements. The single 19<sup>th</sup>-century find was almost certainly re-deposited from a nearby location. The lay-by is a sheltered location that has probably been used as a stopping point for many years. This site can now be reallocated to Category D - Minor and damaged sites.

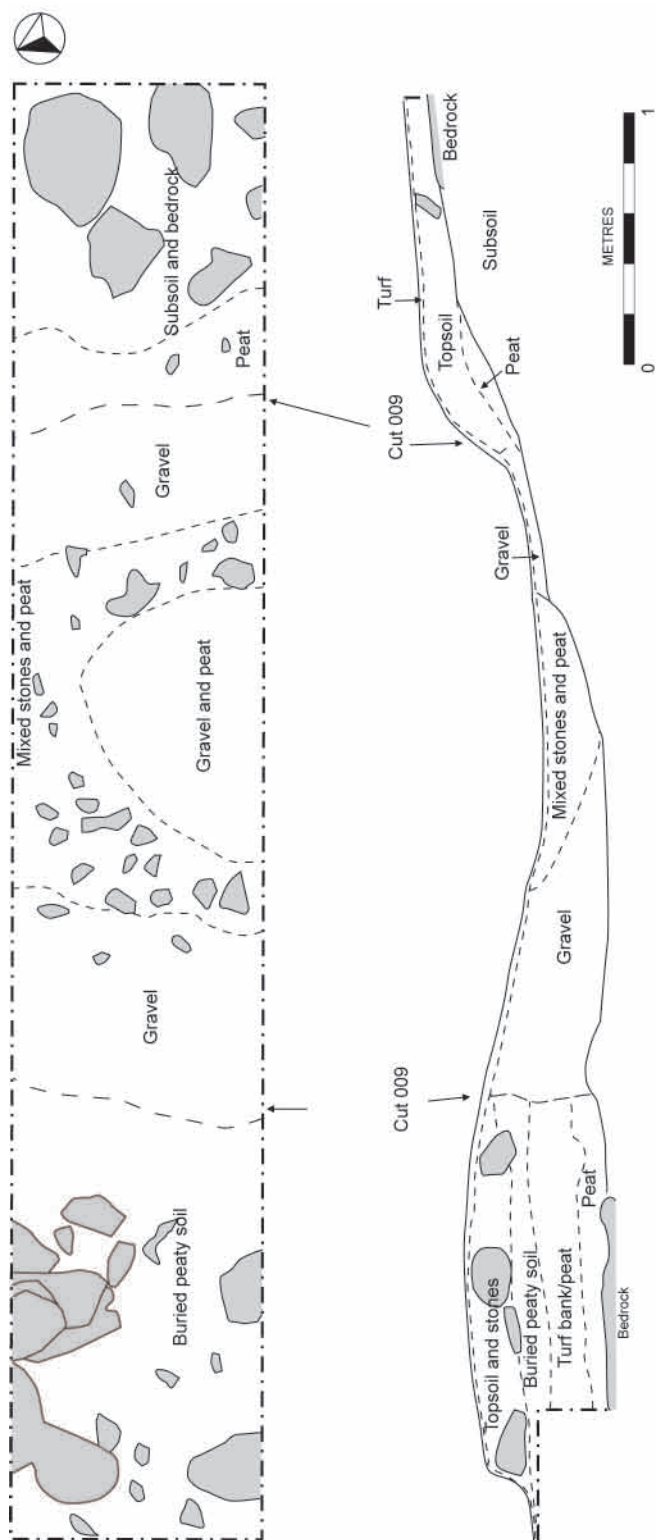
Fig. 12 Site 25 Small circular feature. Plan and south-west facing section

A 5.8m x 1m trench was excavated across the centre of the feature (Fig. 12 and Plate 4). The turf and peaty topsoil were removed revealing stones and peat at the north-western end of the trench and subsoil and bedrock at the south-east. A mixture of gravel, peat and stones filled the central part of the hollow. Upon further excavation it was found that the earliest feature was a turf and peat bank covered by a buried peaty topsoil. There was no dating evidence from this feature but it seems likely that it was a continuation of the low bank that runs along the lower side of the pre-turnpike road.

This was truncated by a vertical cut (009) that marked the edge of the gravel, small stones and peat deposits and defined the edge of the hollow. The gravel and other fills appeared to be a mixture of tipped horizons. The gravel was very well sorted and, in places, very clean, suggesting that it was from a quarry. The remains of a small fire of brushwood were found low down in the gravel. Some un-burnt wood was still extant. The deposits were not waterlogged so this confirms that the feature is of no great antiquity. A long, slate slab was sitting close to the bottom of the feature. No other finds were recovered from the feature. A jumble of stones, on peaty topsoil on top of the bank at the north-west of the feature, appears to be up-cast from the hollow.

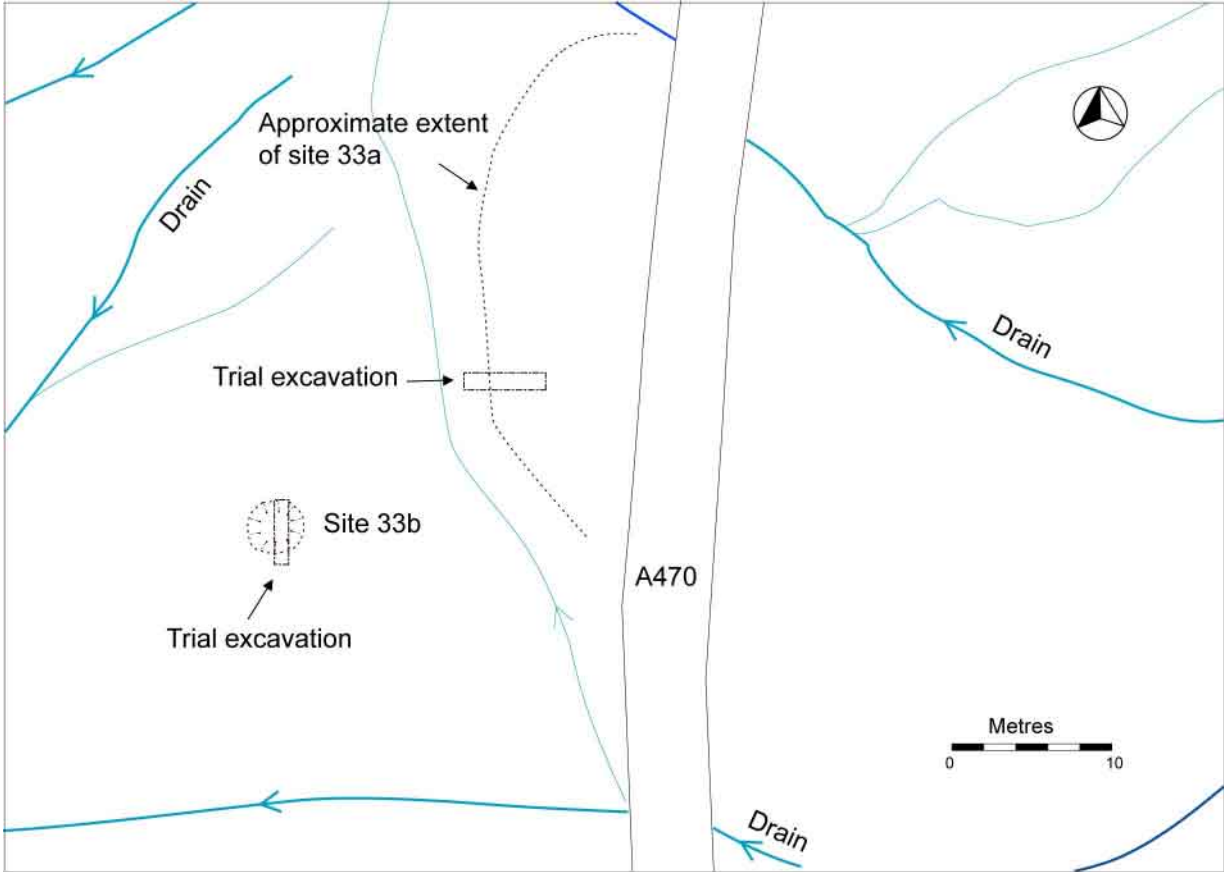
Fig. 13 Sites 33a and 33b, Embanked curvilinear feature and possible cairn

The feature is no longer visible. A level working platform of compacted slate waste was built over it during repairs to the A470 revetment wall during the last 5 years (Fig. 13). Plates 5 and 6 show the site in 1992 and 2005.

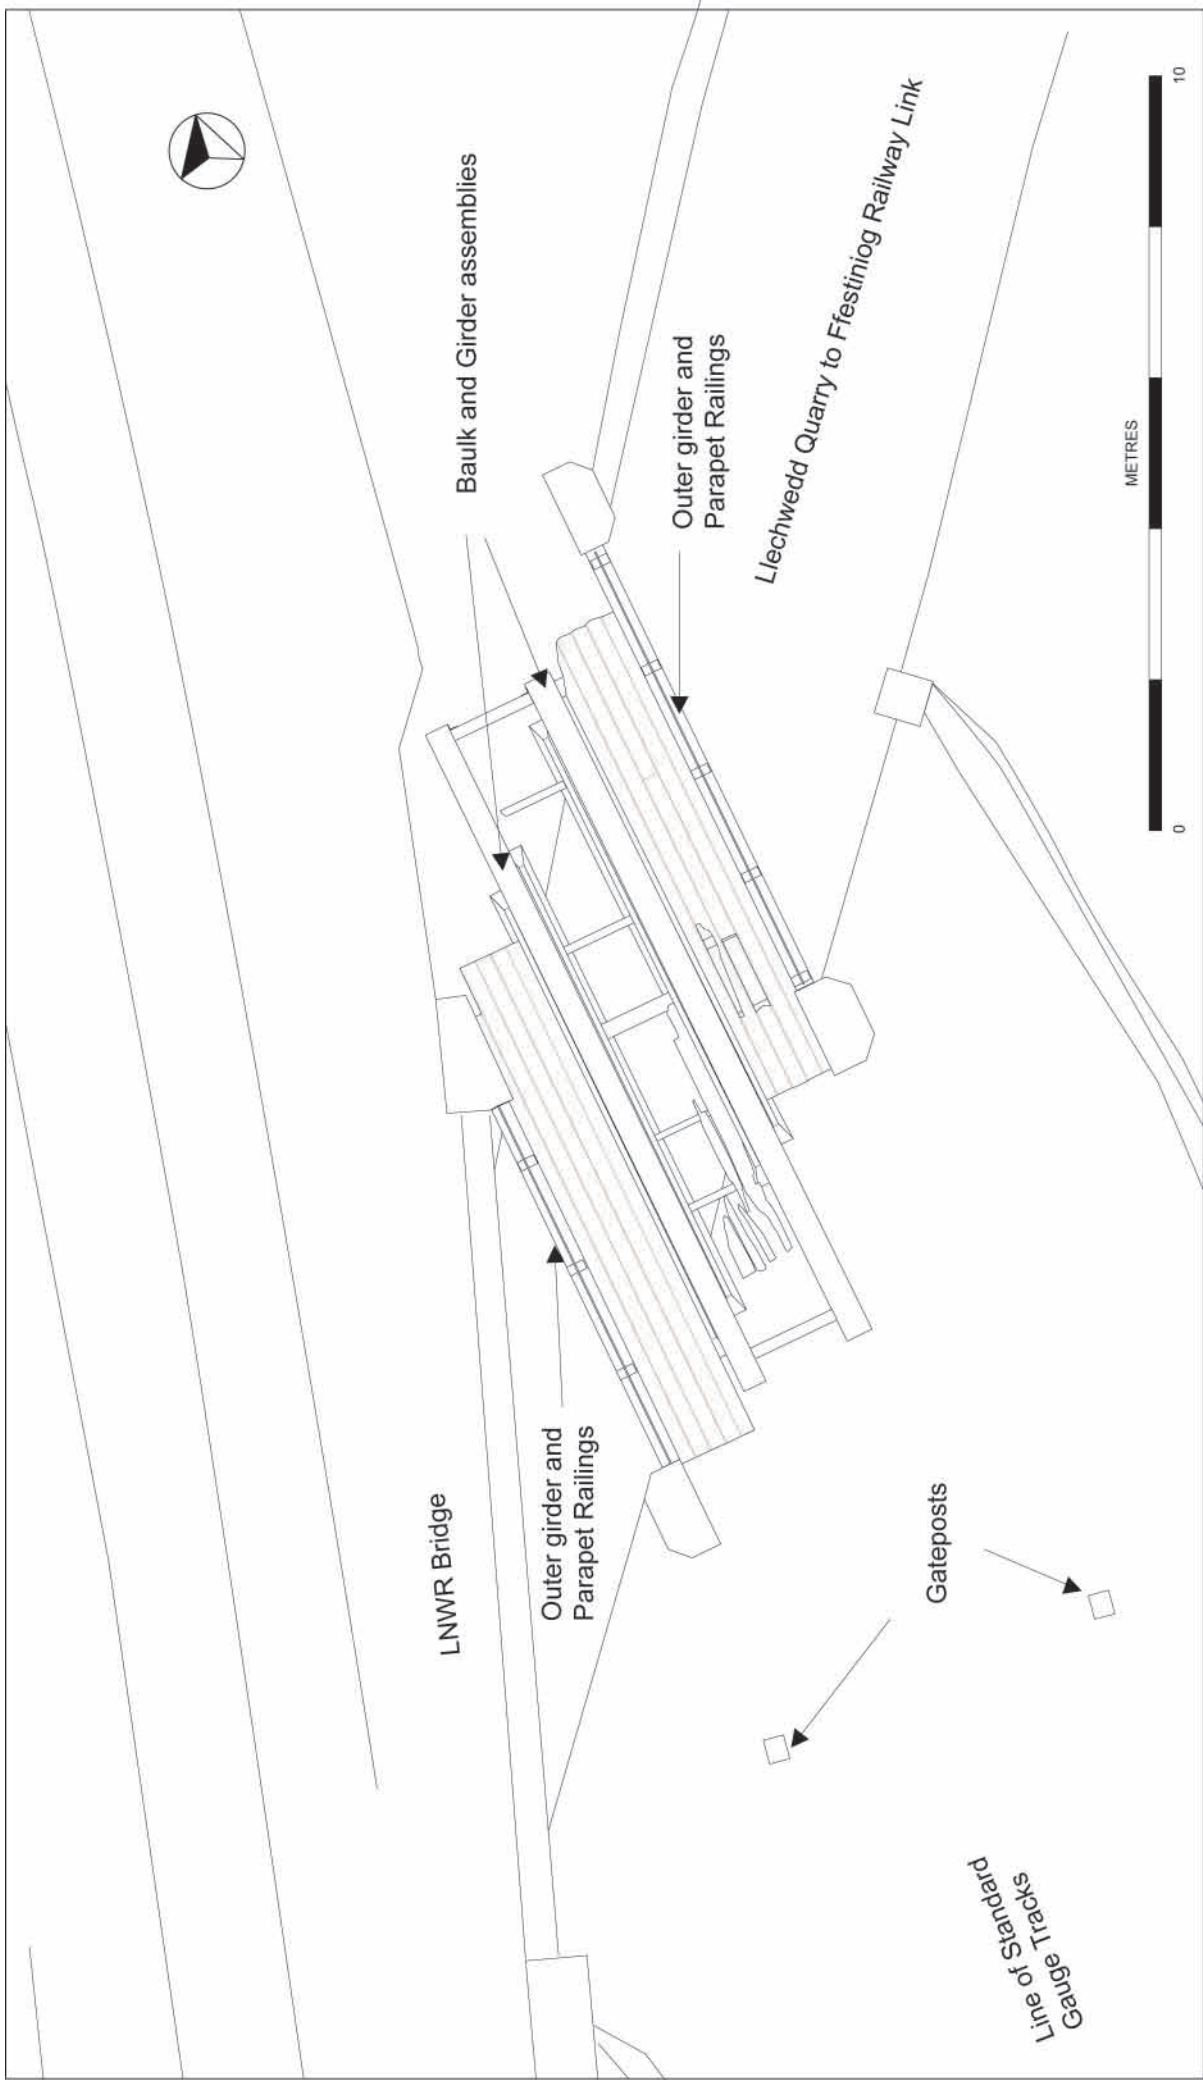
Fig. 19 Site 3(25) Plan of Girder Bridge 67

The four central cast iron girders are the live load bearing elements of the superstructure. Each girder is 7.01m long and 0.42m deep. The lower flange is 0.31m wide and 0.076m deep and the upper 0.079m wide and 0.025m deep. This inverted T shape is termed a Hodgkinson Section (Fitzgerald, c.2005 and Tower 1874). The upper flange is extended down to the lower at the ends of the girders producing a distinctive chamfered termination (Plate 19). Most of the rest of the superstructure is of wood, much of which is now in a poor condition (Plate 11). This does however allow further constructional details to be seen. A single track passed across the bridge and each rail was laid on a continuous longitudinal timber baulk (Fitzgerald, c.2005) set between each pair of main load bearing girders and resting on the lower flange. Each girder/baulk assembly is held together by three transverse tie bars running through the girder web and the timber baulk. The rest of the width of the bridge is infilled with three plank walkways supported by transverse timber joists. The central walkway has now largely collapsed.

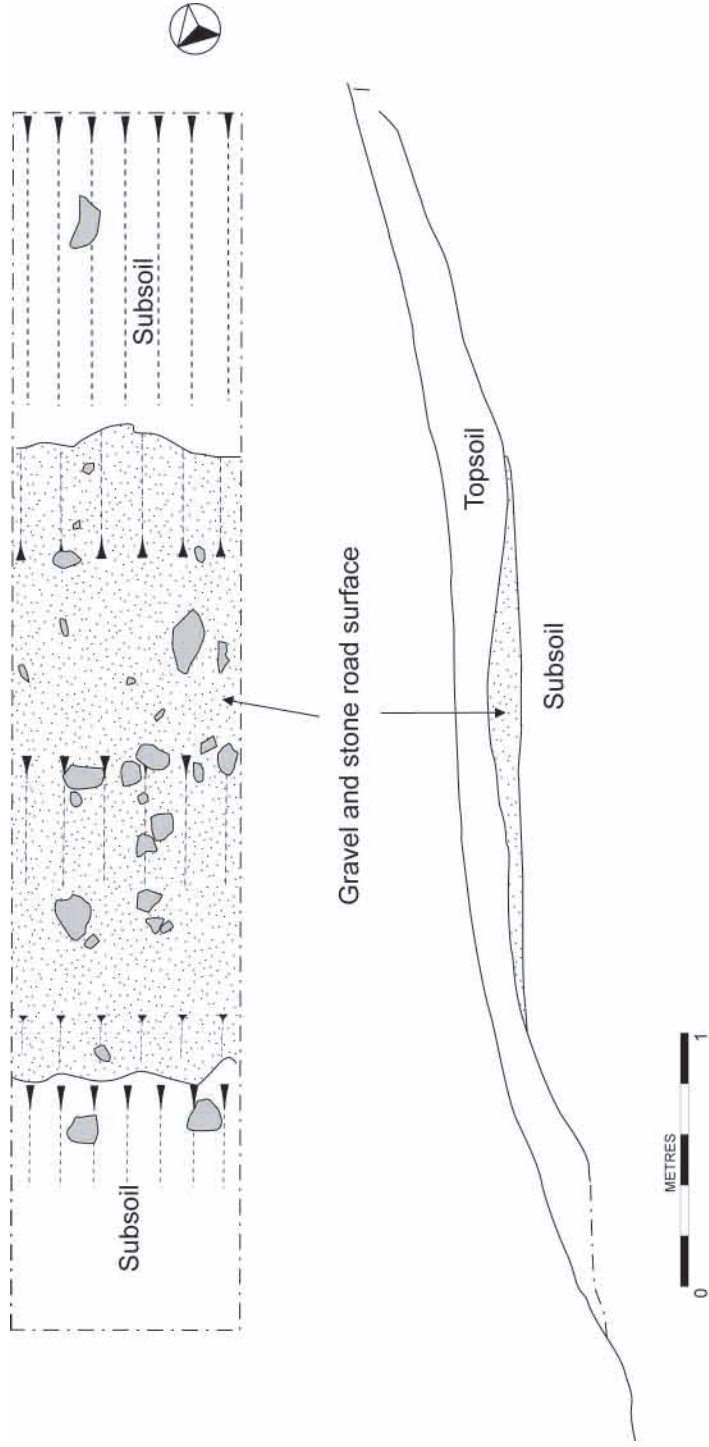
Fig. 17 Site 39b road. Plan and south-west facing section

A 5m x 1m trench was excavated across the feature (Fig. 17 and Plate 12). A 2m wide road surface was found to lie directly beneath the shallow topsoil. This was slightly cambered and 0.2m thick in the centre. The metalling consisted of compact gravelly silt containing occasional larger stones and was almost certainly derived from the local subsoil. This site can now be reallocated to Category C – Sites of district or local importance. The road is discussed in a wider context below.
