Tudno Castle Hotel, Vaughan Street, Llandudno

Level 2 Building Survey

Report No. 1532

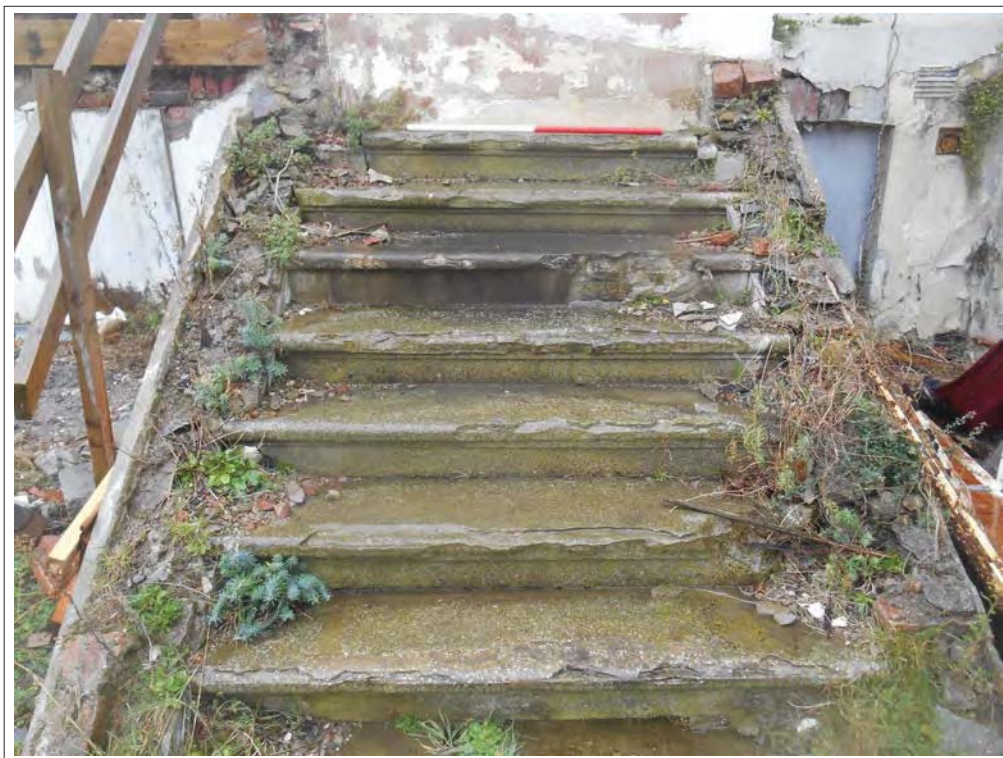
A close view of the extension allows defining multiple events of alteration. The oldest evidence is found with a flight of stairs. These stairs appear depicted in historical maps dating to the 1890s. However, this entrance was blocked at the time in which the extension ceased to be defined by a rectangular space to be defined as T-shape in plan. At this point, a window and a door are cut through the main wall. These elements still are visible to date however are currently blocked by wooden boards. The flight of stairs leading to the existing door is no longer in place. However, it may be noted that these stairs existed, at least, until the time in which the latest drawings for the side were made (see Figure 5).

Plate 12. Detail of staircase leading to extension 1, looking W.

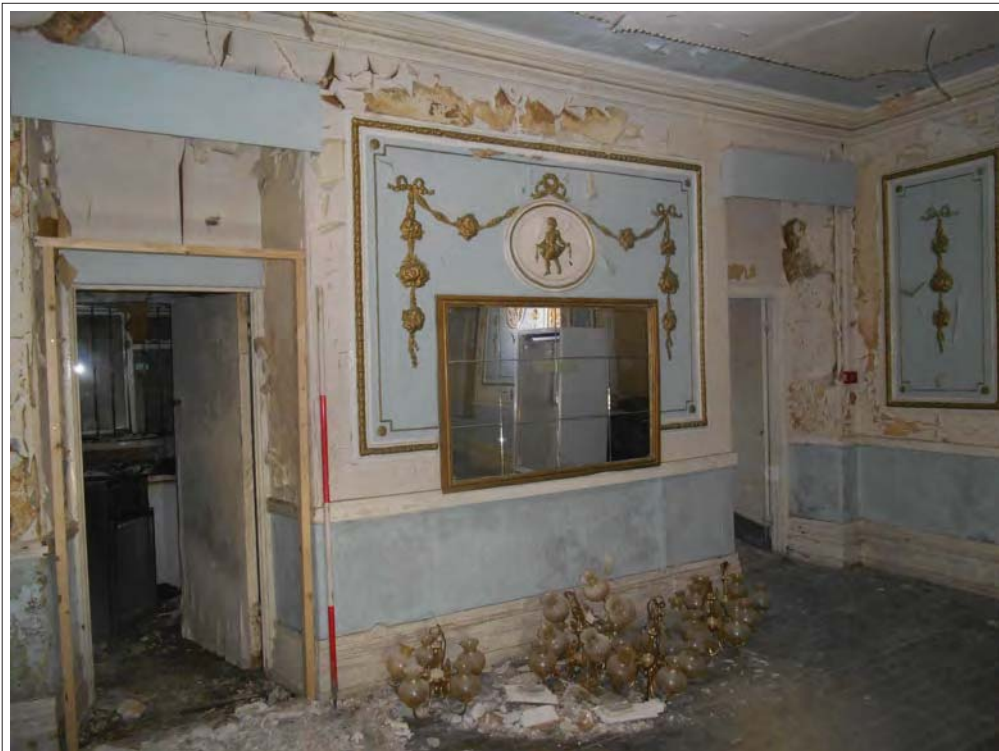
Plate 18. View of altered wall. Fireplace replaced for panelled wall. Looking E.

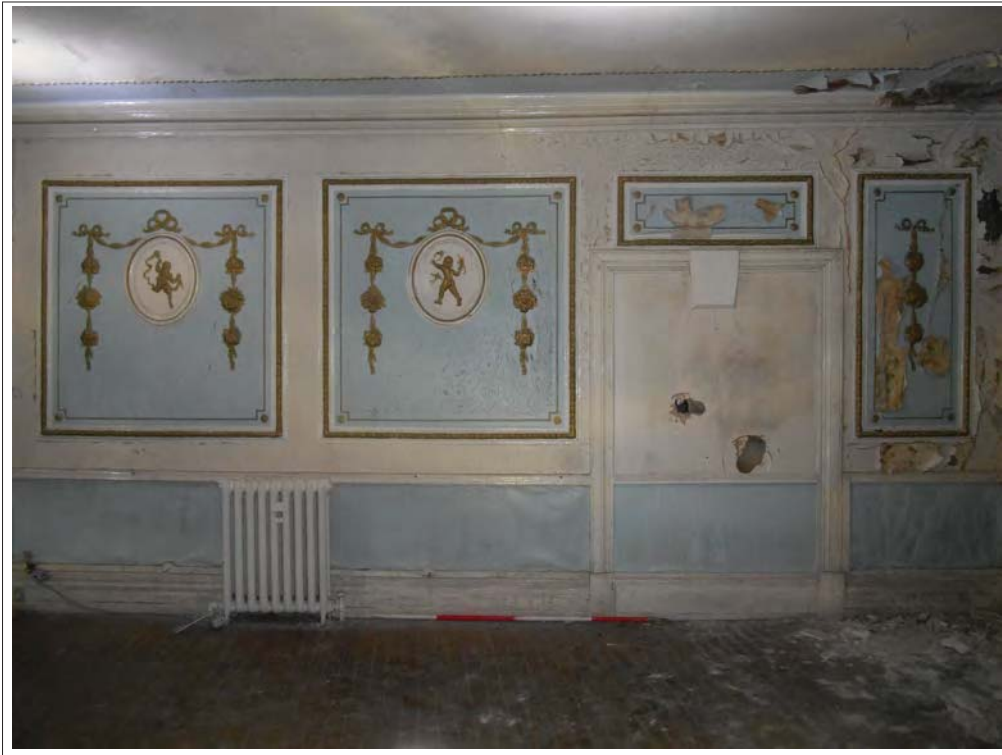
Plate 19: This photograph illustrates another even of alteration within the ballroom area. In contrast with the alteration described on Plate 18, this event seems to postdate the decoration found on the wall. On this occasion, a doorway appears to have been blocked and subsequently decorated to follow existing patterns on the wall. This suggestion gains support by noting that the chair railings and skirting boards used in this area are of different style than those used elsewhere.

Plate 19. Blocked door, subsequently decorated, looking N.

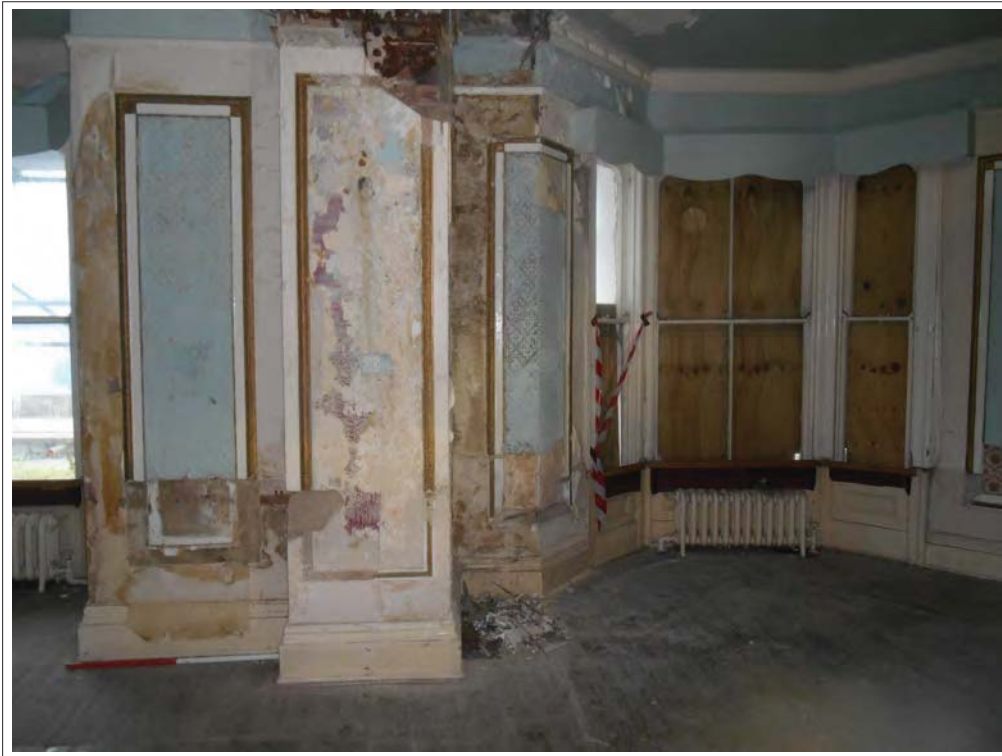
Plate 31: The decay of some of the decoration found within the bar area allows documenting earlier decoration events. Before painted following rococo style, the rectangular panels found on walls appear to have been covered with wall paper with floral geometric patterns. Moreover, this image also illustrates the existence of panel mouldings under canted three-light windows and scalloped curtain mouldings. A similar situation is portrayed in Plate 32 and 33.

Plate 31. Projected wall evidencing different layers of decoration. Looking NW.

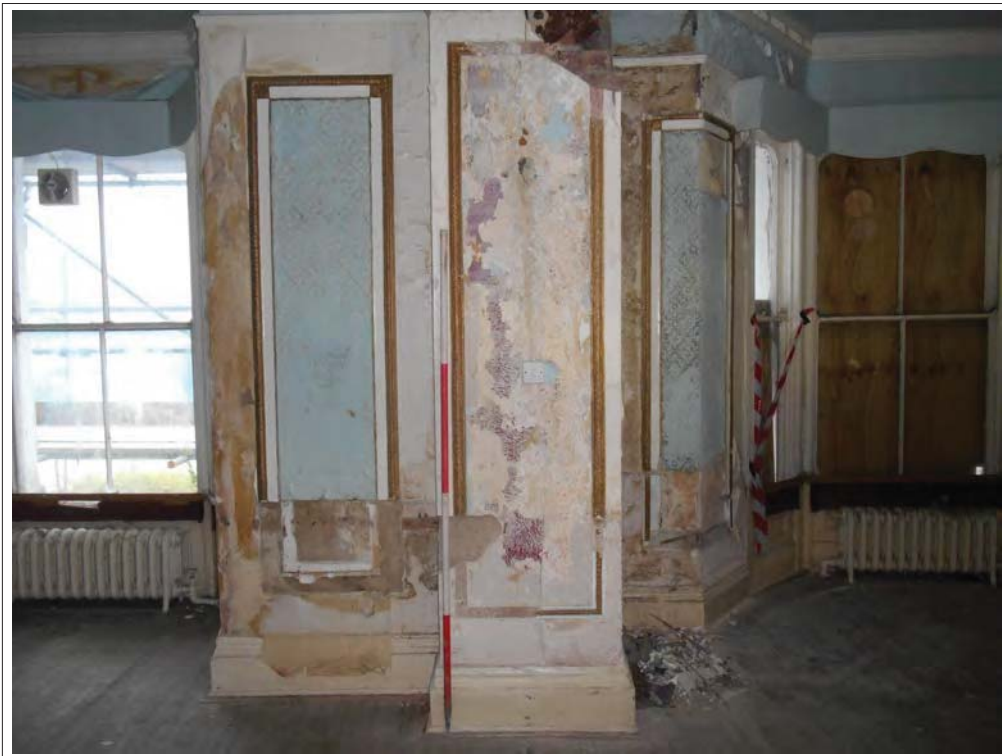
Area A (Plates 32 and 33): As already noted, this area appears to respect the general decoration encountered throughout the ground floor. However, it is noted that, in contrast to the ballroom and bar, this area contains the characteristic rectangular panels on the walls without any further decoration within the panels. Moreover, similarly to that stated in Plate 31, resulting from decay, it is possible to observe previous decorative episodes characterised by wall paper floral geometric patterns.

Plate 32. Projected wall evidencing different layers of decoration. Looking NW.

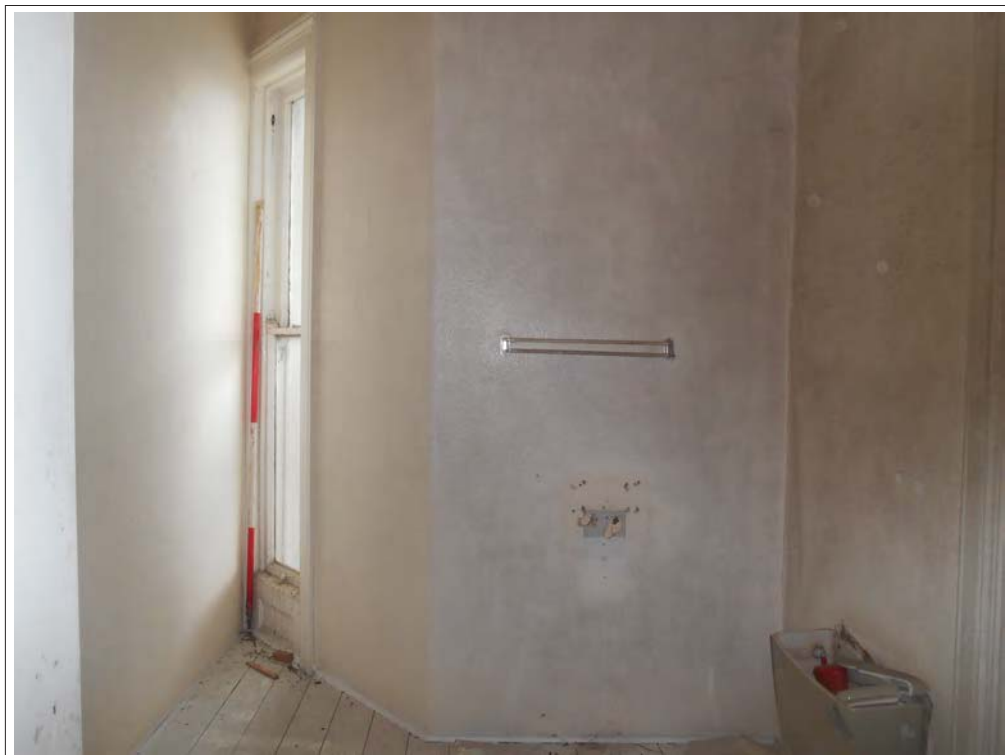
Plate 74. View of Room 7. Ensuite bathroom. Door blocked, looking NE.

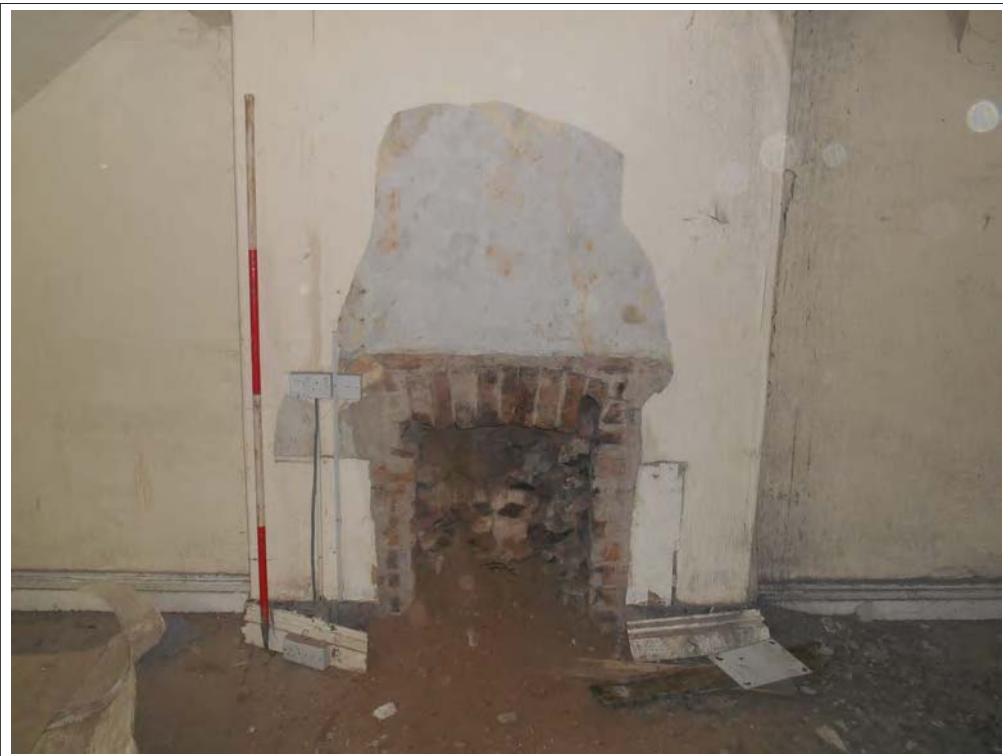
An original fireplace was encountered during the survey (see Plate 102). The fireplace was badly damaged but it was possible to observe its brickwork. Moreover, all rooms contained the original pedimented windows observed during the study of the building's elevations.

Plate 102. View of original fireplace, looking W.

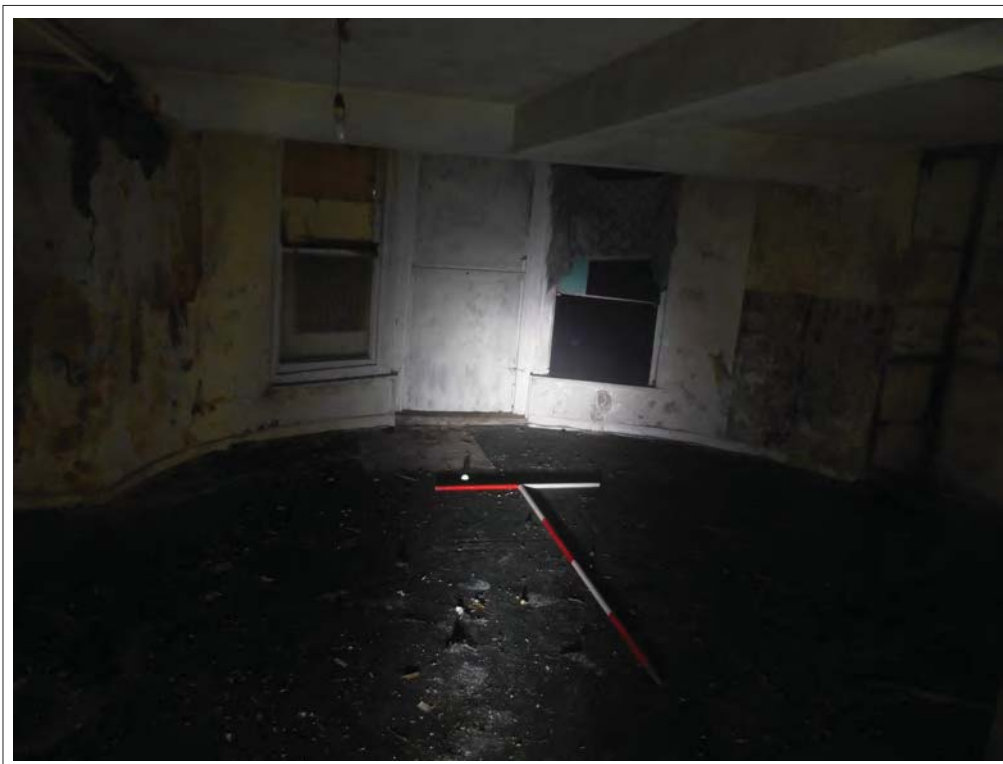
Plate 110: This image illustrates one of the canted five-light windows located within the area of the basement. This window is currently blocked off by wooden boards. While the room appear to have been painted white during its last stages of use, resulting from decay, it is possible to observe different events of wall paper decoration.

Plate 110a. Canted five-light window currently blocked, looking NE.

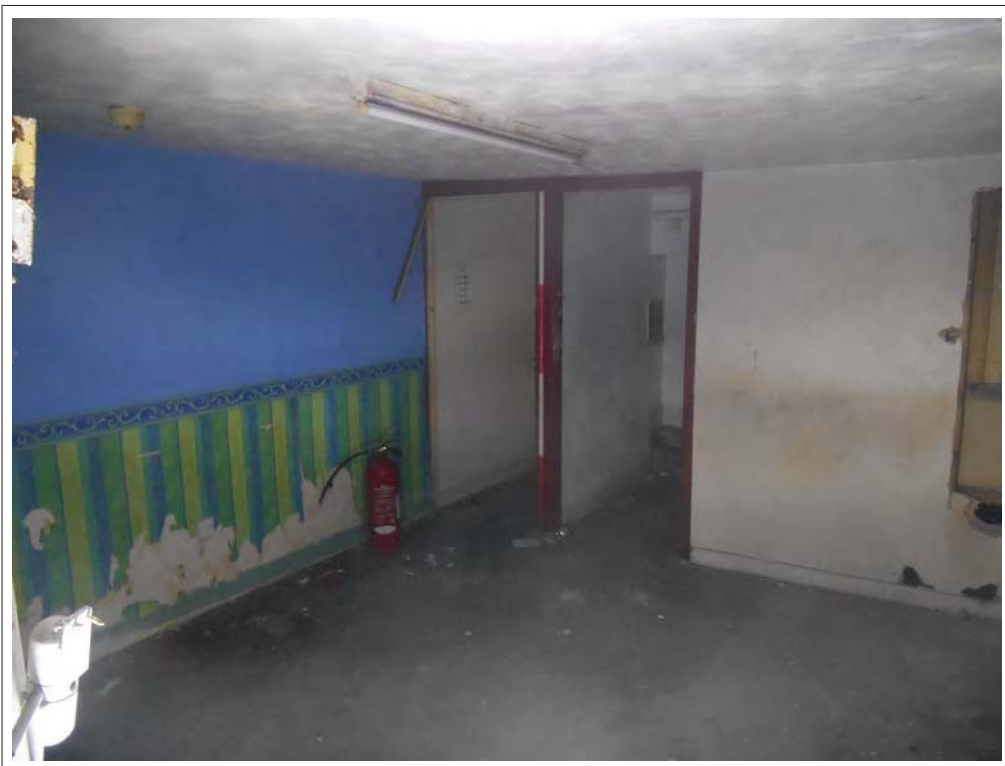
Plate 111 and 112: This image illustrates two spaces confined to communal toilet facilities. The only original element found within these spaces is a blocked centre bar sash window (see Plate 112). Plate 111 illustrates the first of these spaces. The walls of this toilet facilities have been decorated with striped wall paper. A horizontal band with floral patterns is located half way up the wall. During the visit, it was determined that this space had been created sometime during the late 20th century. Plate 112 illustrates the second of these spaces. While badly damaged, this space retains some of the original tiles.

Plate 111. Toilet facilities, looking N.

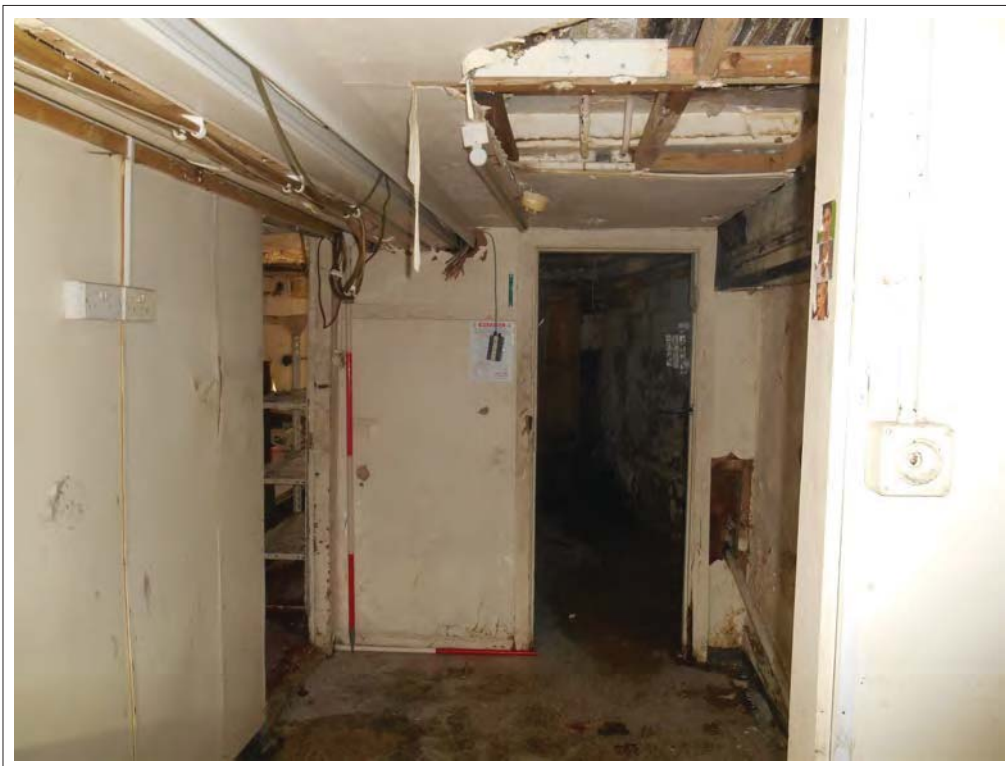
Plate 119 and 120: These images illustrate a number of spaces of a bar area. The only original element found within this space is a canted three-light window currently blocked off by wooden boards. All fitting and appliances found within the bar area appear modern. While the walls of this space are covered by white wall paper, it is possible to see an earlier phase of decoration consisting of light blue paint, similar to that found on the adjacent bar area (see Plate 122).

Plate 119. From kitchen, view to cellar. Looking S.

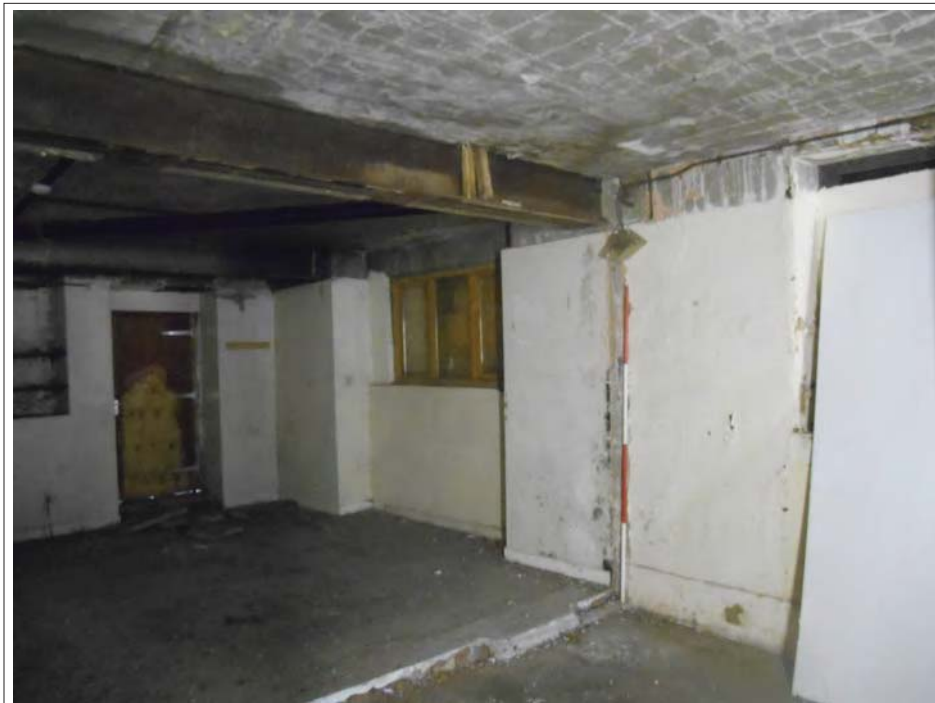
Plate 135. East facing wall. 1960's Window subsequently repaired. North facing wall with back entrance. Not original. Scale 2m

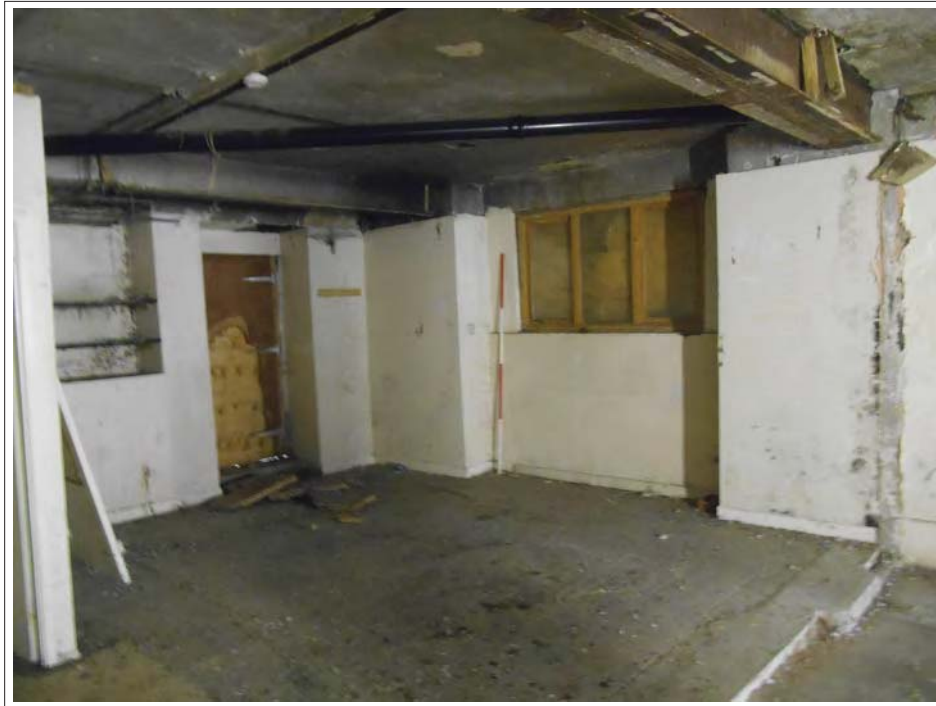
Plate 136. East facing wall. 1960's Window subsequently repaired. North facing wall with back entrance. Not original.

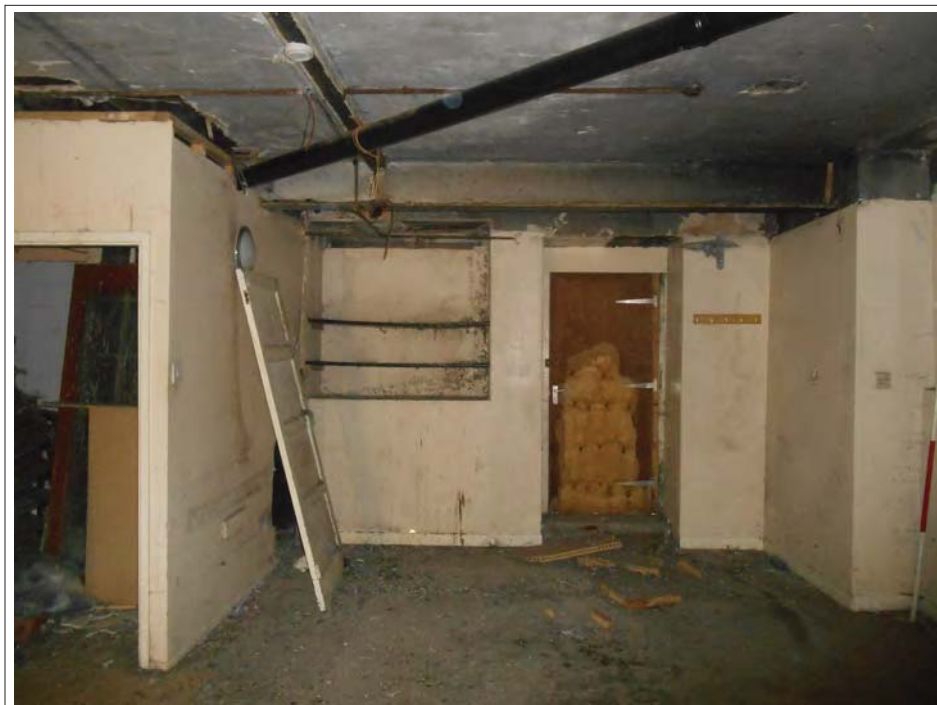
Plate 137. North facing wall. Inset blocked window transformed into shelving.

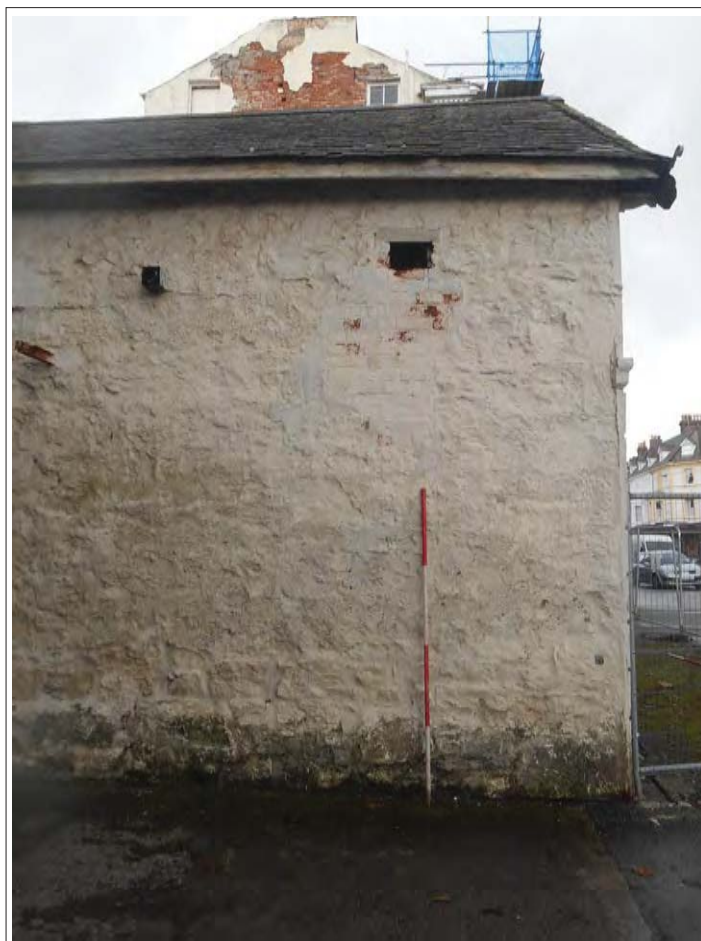
Plate 149. Detail of repair or alteration of possible window or vent.
