**A.P.A.C. Ltd.**

WATCHING BRIEF

WB/AONB3/10

**Angiddy Ironworks, Tintern.**

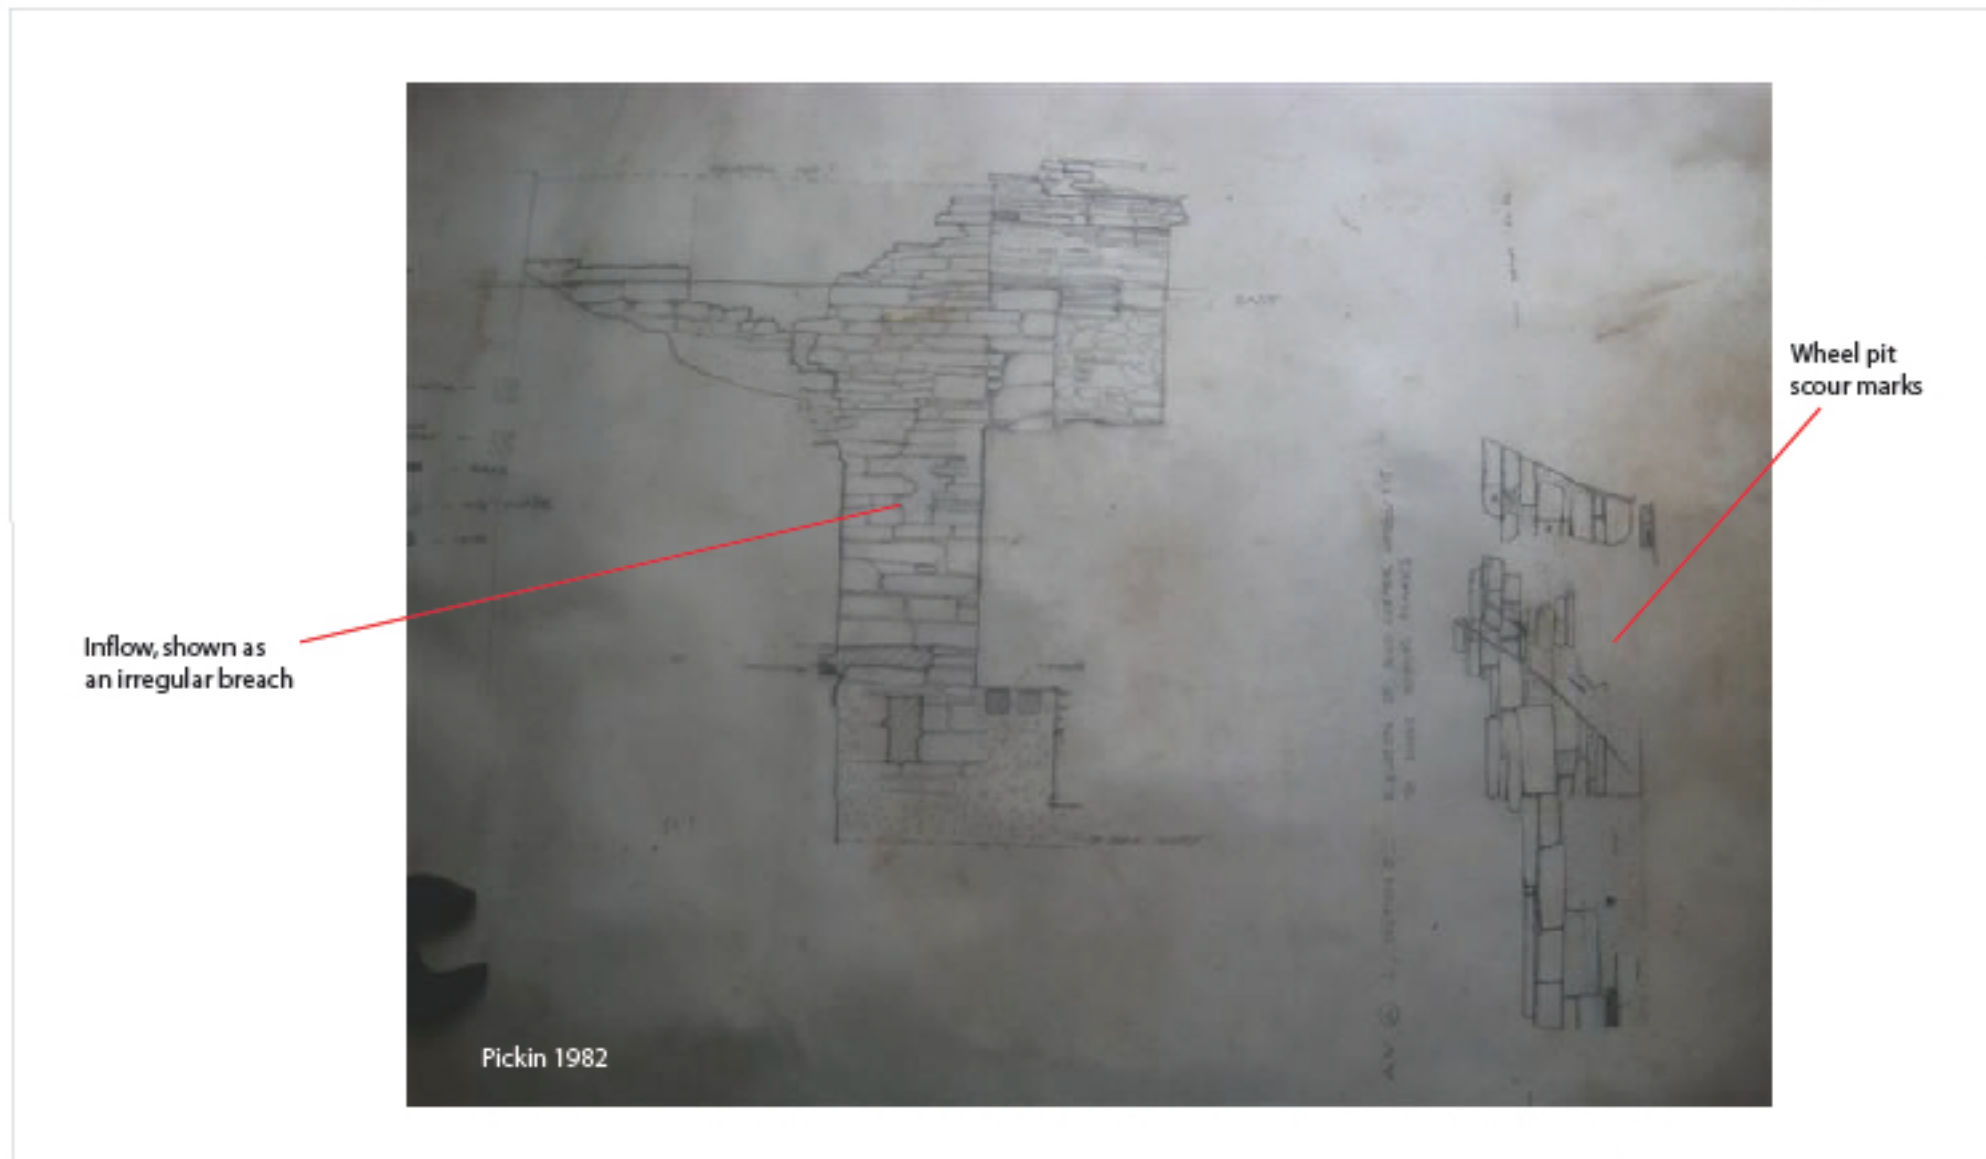
Fig 10: East wall of wheel pit 1979/81.

One casualty of the consolidation work has been the loss of some of the scouring detail caused by the water wheel to the wall of the wheel pit. Fig 10 shows the amount that was recorded during the 1979/81 excavations; bourn out in Plate 58 SC043. After consolidation work, some of the detail has been lost as can be seen by comparing Plates 58 and 59.

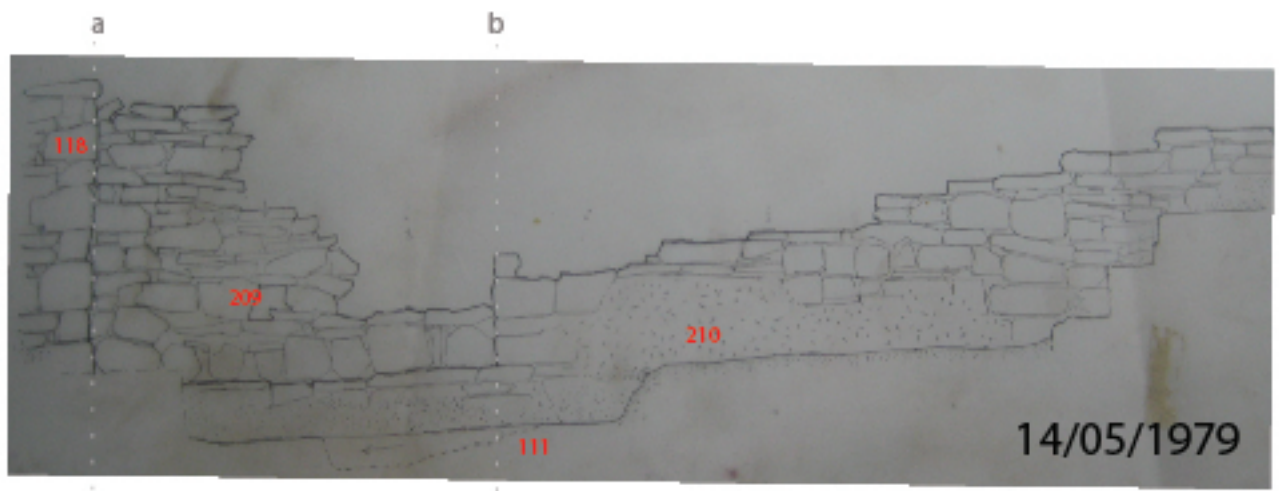
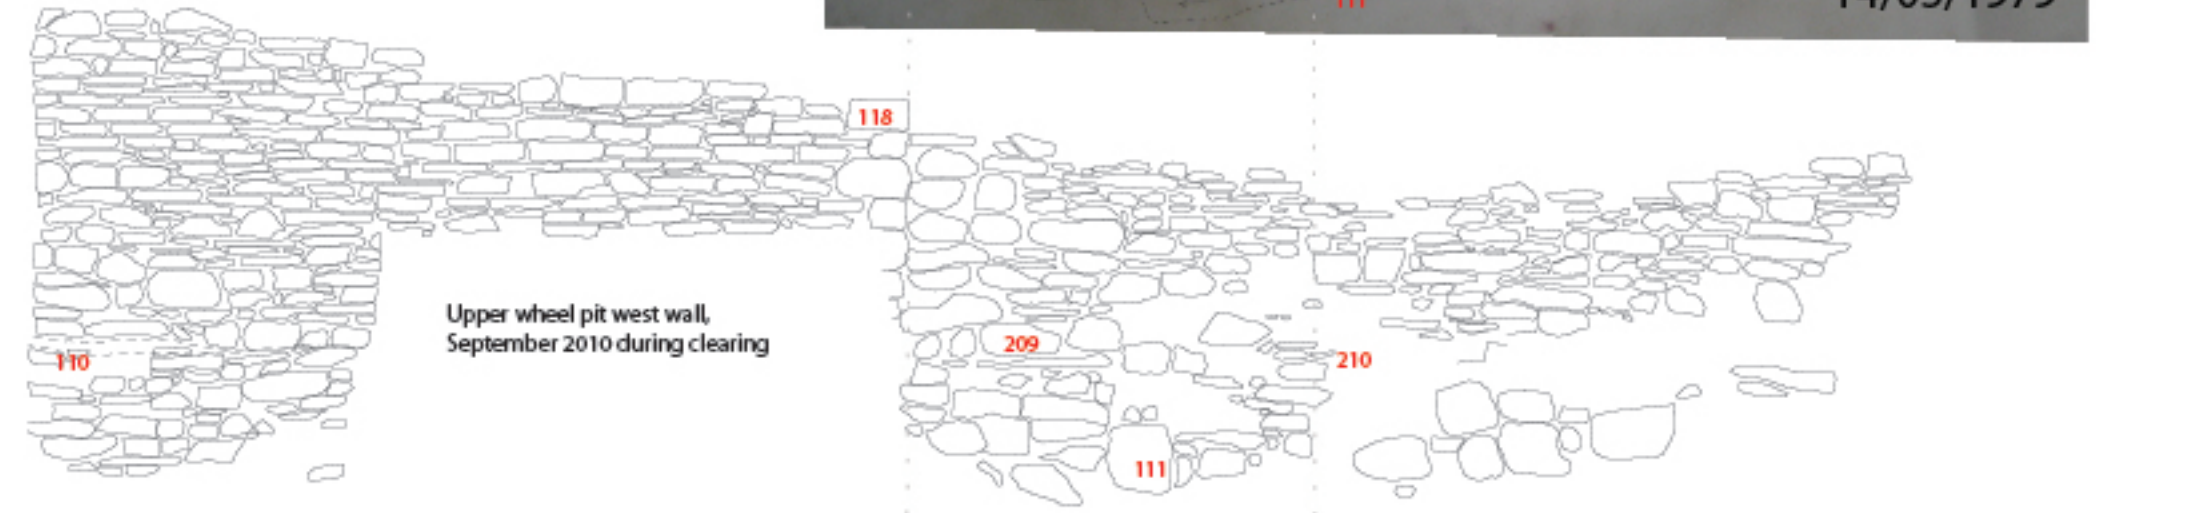
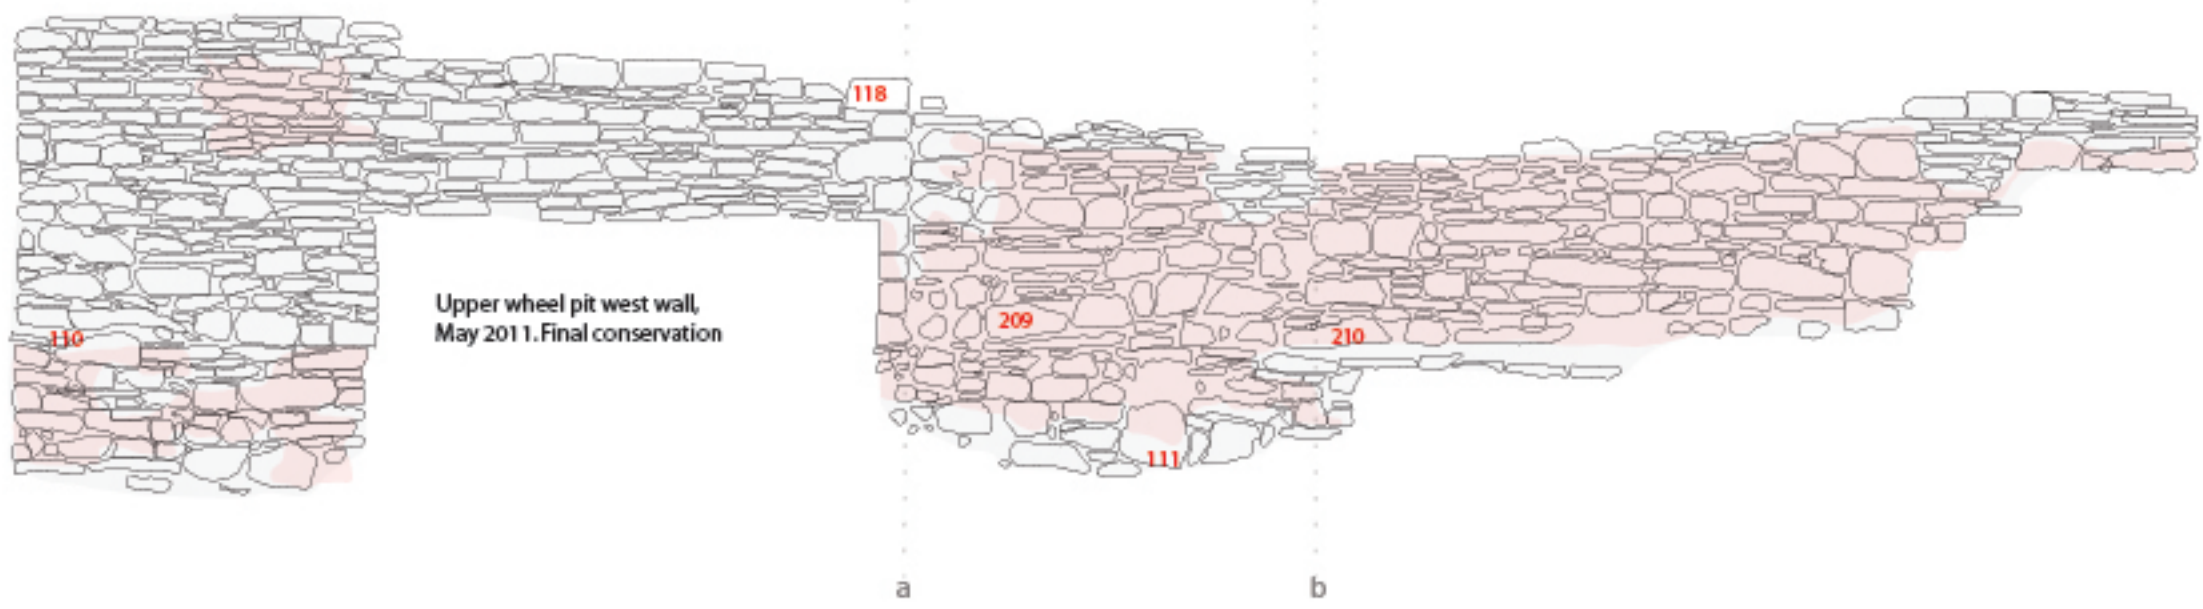
Fig 12: Upper west wall of Wheel pit: 1979/82, pre consolidation 2010 & final state 2011

Site drawing Upper wheel pit west wall 1979/81

Upper wheel pit west wall, September 2010 during clearing

Upper wheel pit west wall, May 2011. Final conservation

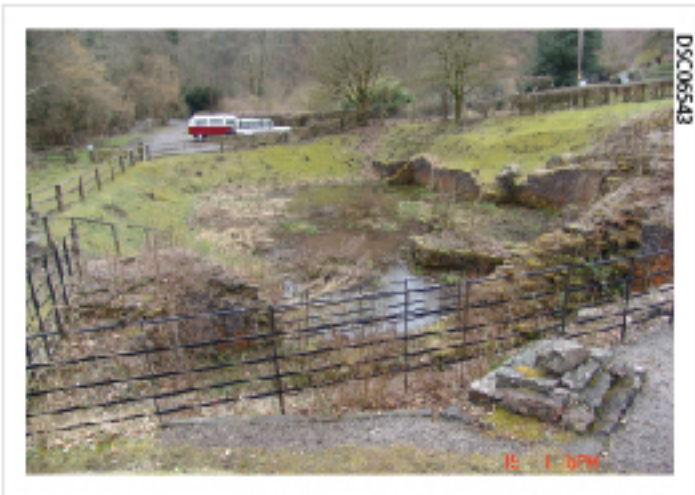
Plate 03: Overview of site showing water logging

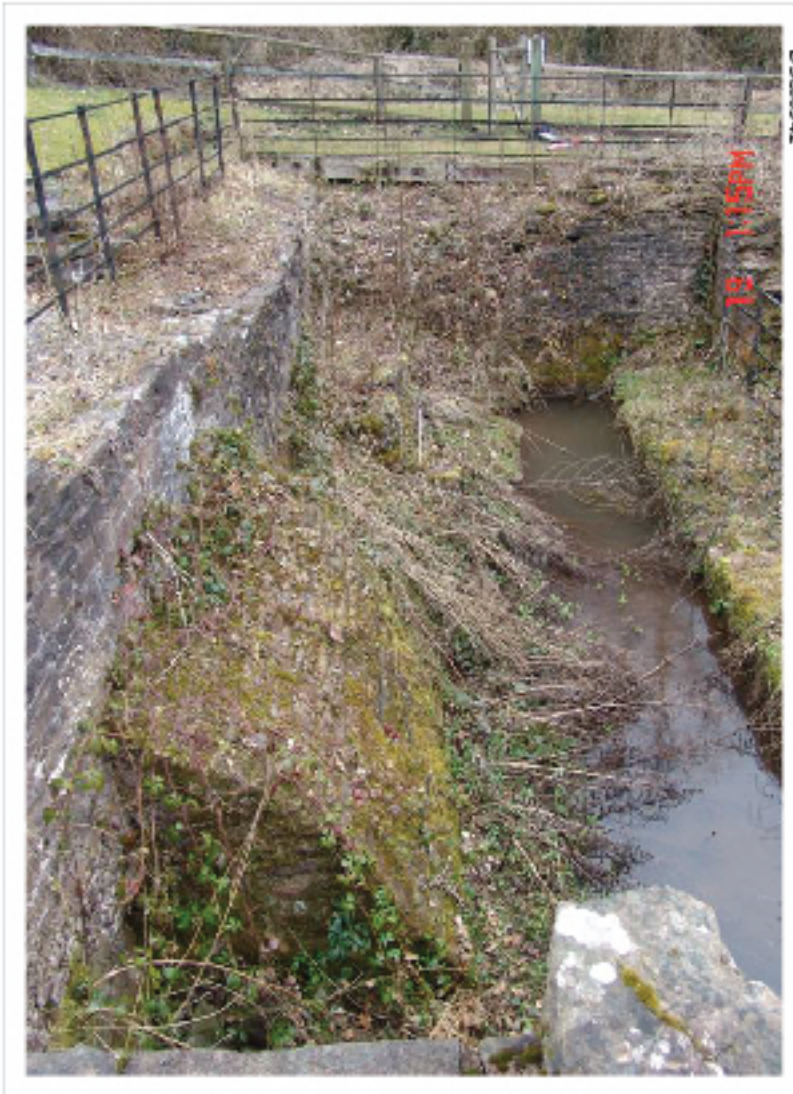
The upper surrounds of the wheel pit before the present work began was in a very bad state of repair, as has been shown in Plates 07, 22 & 49. Once clear of vegetation a comparison can be made between the excavation photographs of 1979/81, Plate 60 and 61. Such a comparison identifies areas where restructuring had been undertaken; particularly along the wheel pit edges and the construction of the barrelled buttress Plate 62.

Plate 07: Wheelpit waterlevel, mid March 2010.  
Inflow submerged

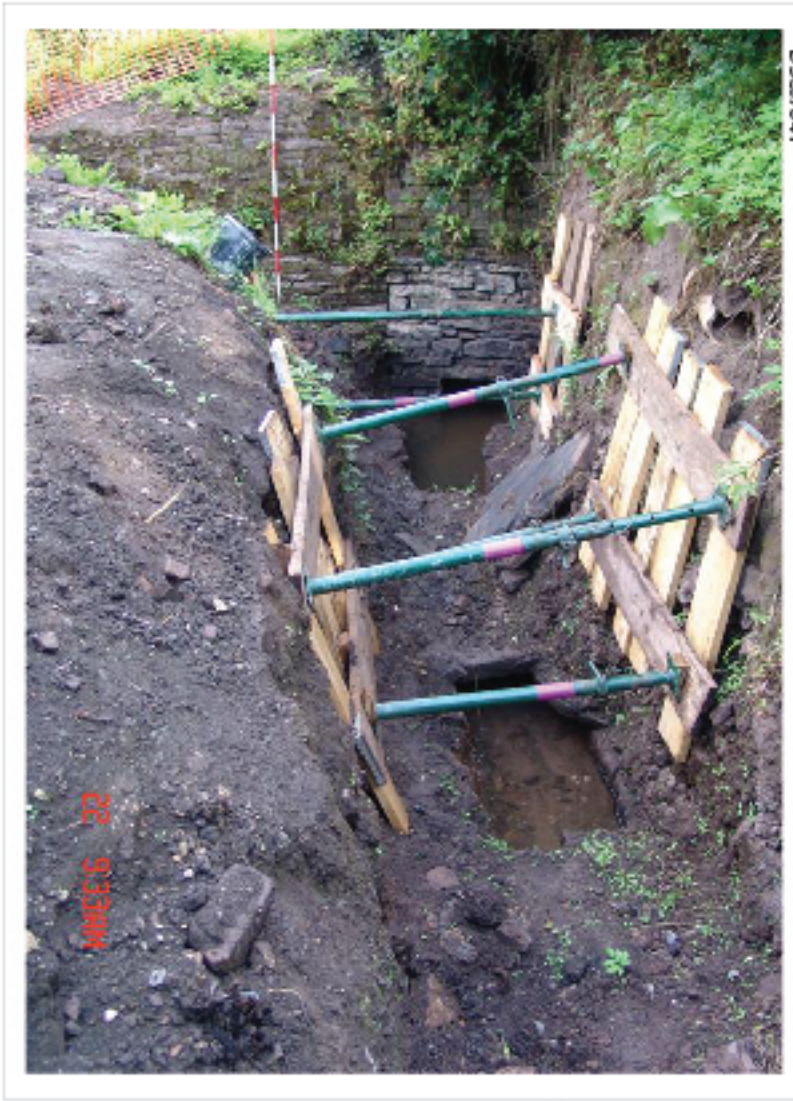
Another reduction in culvert width can be seen at the outflow by the cottage, Plate 31. A whole section of culvert wall can be seen to butt up to the cottage wall. The outfall itself is the small square hole, bottom centre of the wall; effectively narrowing the culvert to around half width. The adjacent cottage wall was found during earlier excavation to be rendered at this level, therefore presumably, originally above ground (Phillips 2007).

Plate 31: Later view along culvert at cottage, prior to jetting

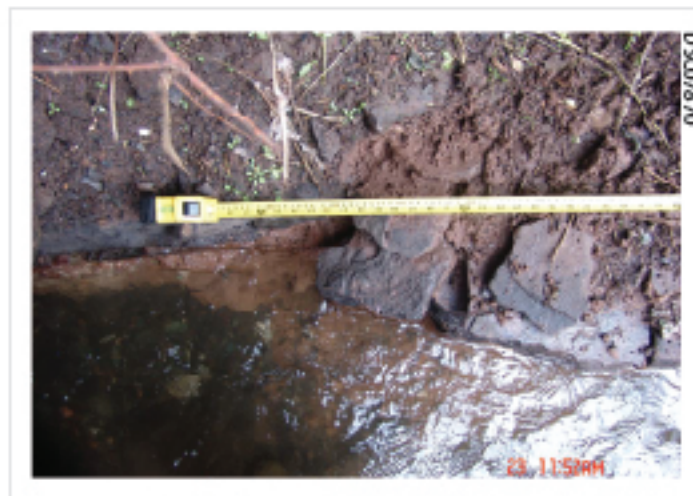
The other side of the culvert bulge referred to in Plate 31, can be seen in Plate 34. The view shows the bulge 'just in front of the outflow beside the cottage wall'. In this instance, the butt joint has been constructed with size graded stone to form a curve and thereby reduce any impediment to the flow of water which would cause turbulence leading to erosion of the structure. Further evidence that this is an addition to, rather than an original construction.

Plate 34: Upstream butt joint to culvert below outflow. Curved construction to reduce turbulent water flow and erosion.

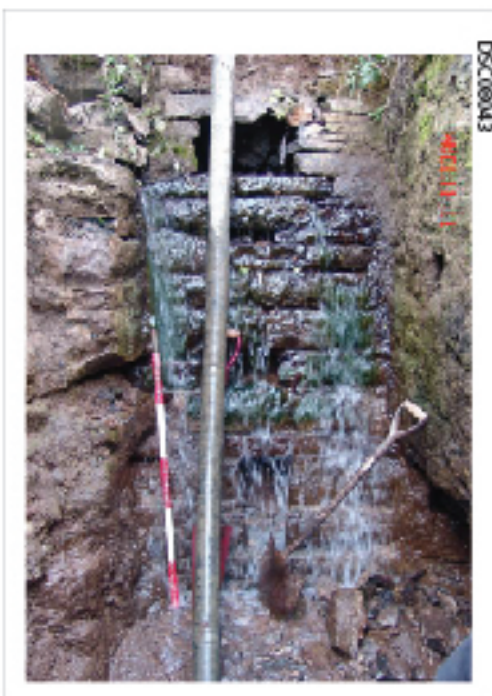
Plate 52: Stream side of wheelpit showing water ingress, river sandbagged

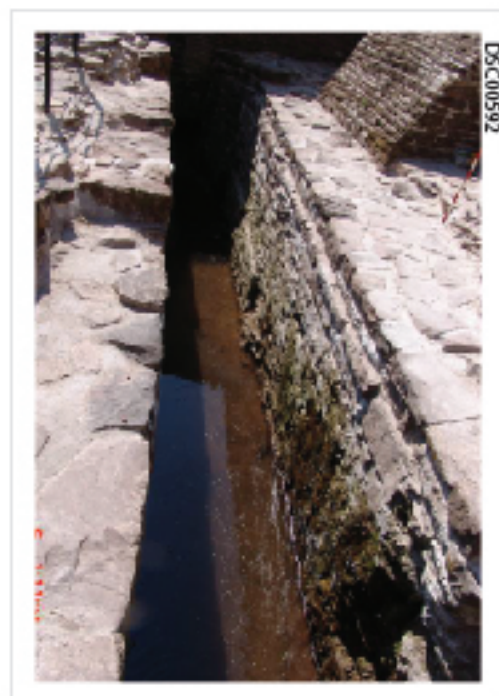
A general view of the wheel pit after the consolidation and conservation work had finished shows a very much more coherent structure with a noticeably lower water level, Plate 53. The top of the wheel pit has been squared off and an inset row has been added to the west edge, clearly identifying the new repair work.

Plate 53: Final Wheel pit Recessed edge

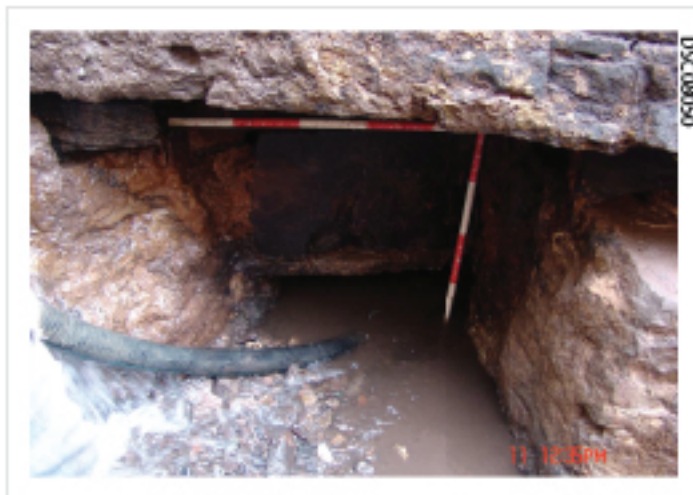
At the north west corner of the wheel pit it was possible to confirm that there had been no change to the outflow hutch. Plate 55, shows its condition during the original excavation and Plate 56, shows it during de-silting with the pressure jet. One of the wooden beams recorded on fig 10 can be seen *insitu* top left, Plate 56. A probable return jam for the post can be seen top right of the photograph. At the bottom, the pressure jet hose can be seen running under the capstone to the culvert.

Plate 56: Eastern hutch in drained wheelpit showing wooden lintel and socket.

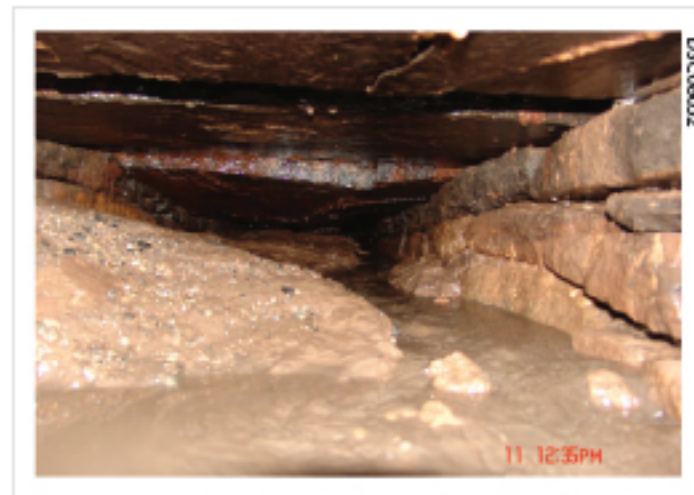
Plate 57,, shows a view along the hutch culvert under the capstone shown in Plate 56. The silt at this point is around 1m deep. The capstone roof to the culvert can be seen to be in a poor state of repair which can only be expected to get worse, if not attended to.

Plate 57: Eastern culvert from the wheelpit hutch. Silt level and broken capstones

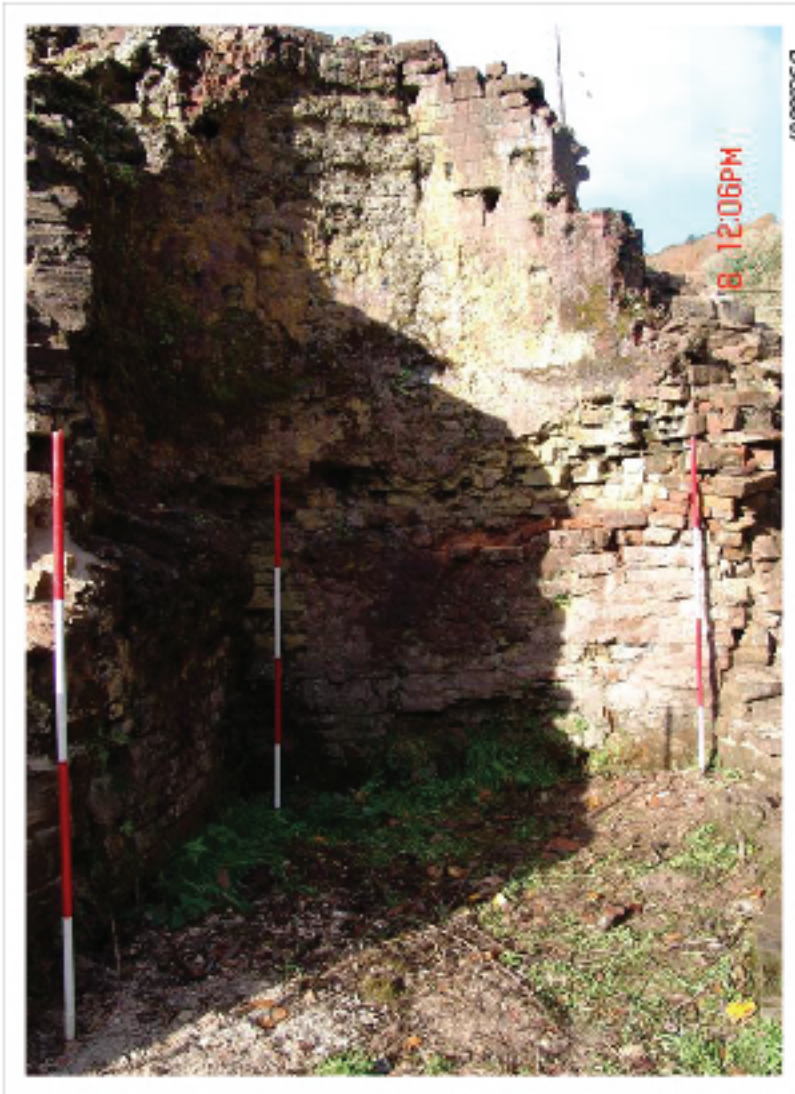
Photographs taken at the end of clearance work illustrate some changes, although, it is not clear if these are a result of consolidation work or weathering. Plate 87 is taken in almost the same direction as Plate 86. Comparison shows that the blue/green glassy slag is no longer present neither is the burning to wall 148. There also seems to be a more defined line of repair brick, which did not exist on the earlier photograph.

Plate 87: 2nd Close up of furnace shaft after clearing
