Stabilisation Works at Ruperra Castle, Glamorganshire

Historic Buildings Record

Project #: AD042

March 2019

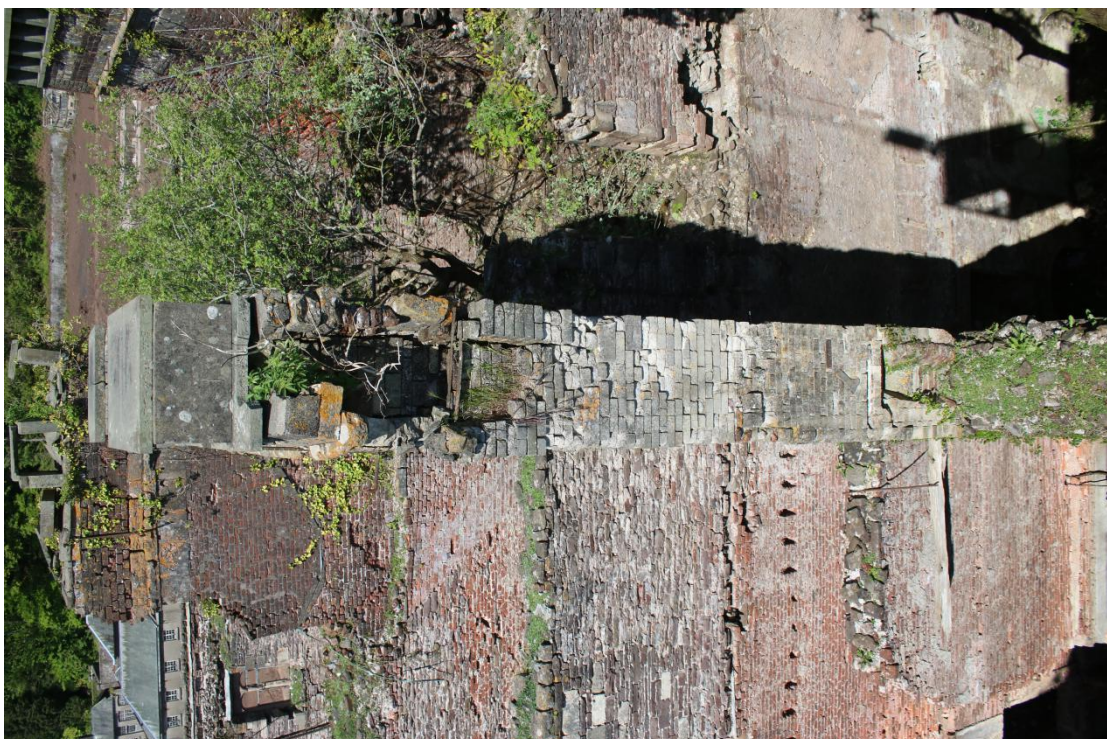
Plate 3 - AD042_WB_003 - South chimney elevation, showing top of flue, caused by partial collapse of brickwork.

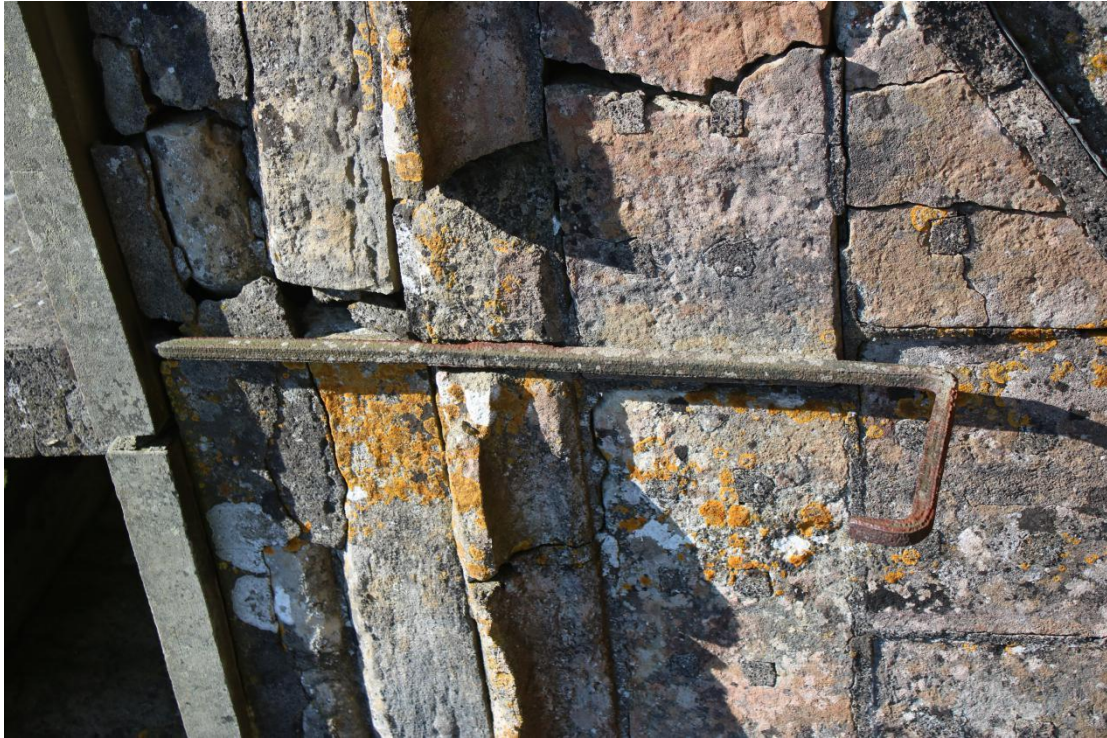
Plate 8 - AD042_WB_008 - West elevation, showing damaged sandstone ashlar.

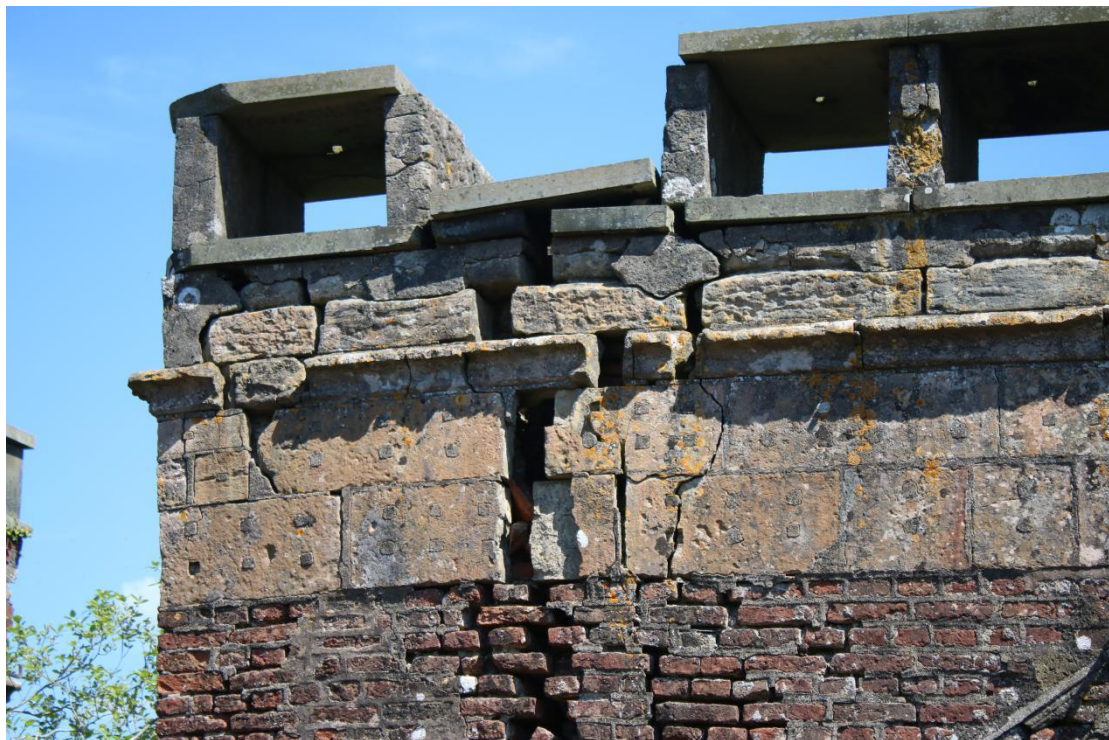
Plate 15 - AD042_WB_015 - West elevation, showing crack, caused by northern flue falling away.

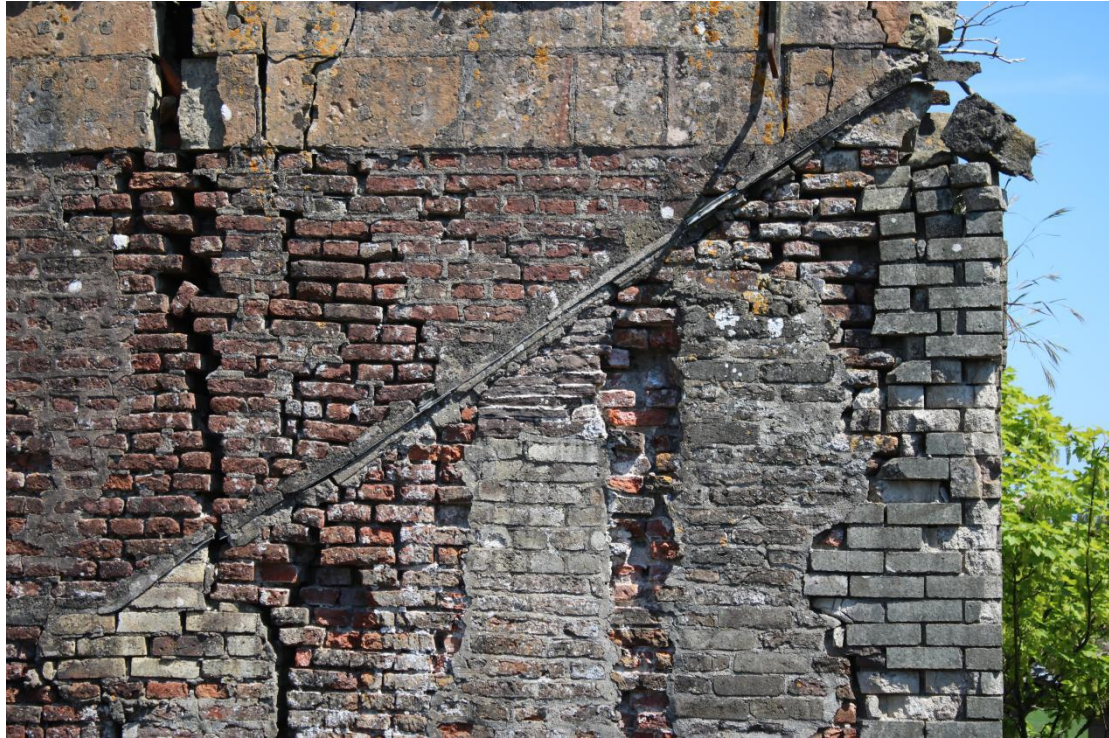
Plate 16 - AD042_WB_016 - West elevation, showing crack, caused by northern flue falling away.

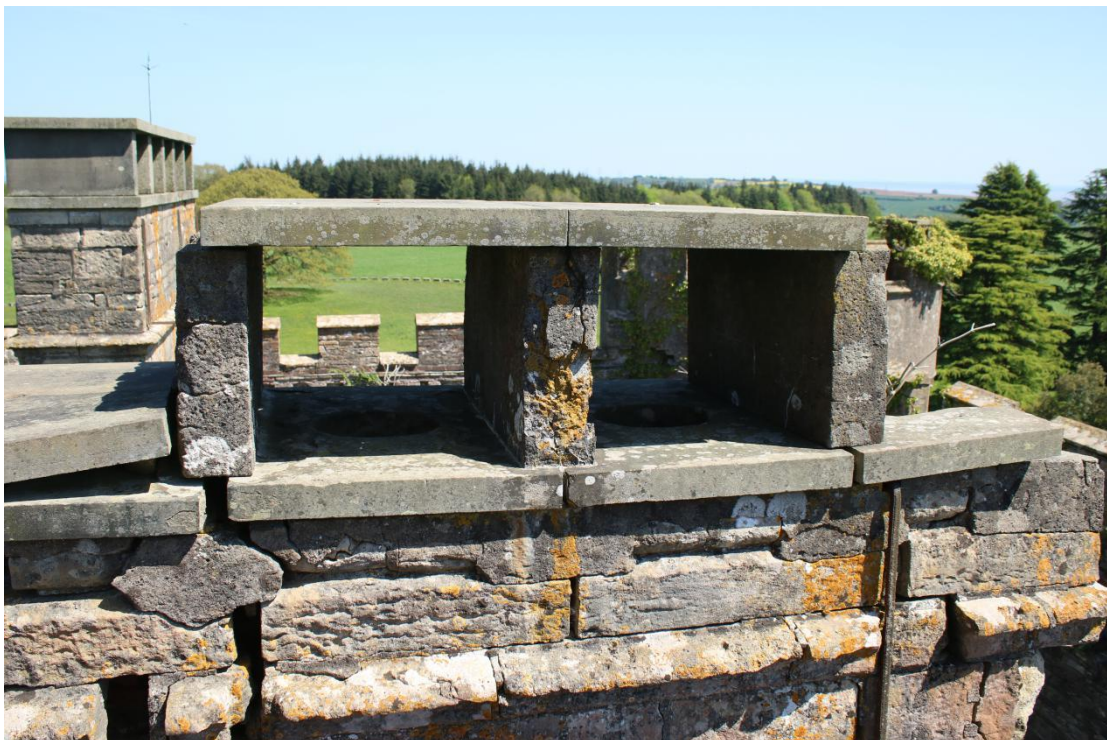
Plate 19 - AD042_WB_019 - West elevation, showing crack to sandstone ashlars opening through to east elevation.

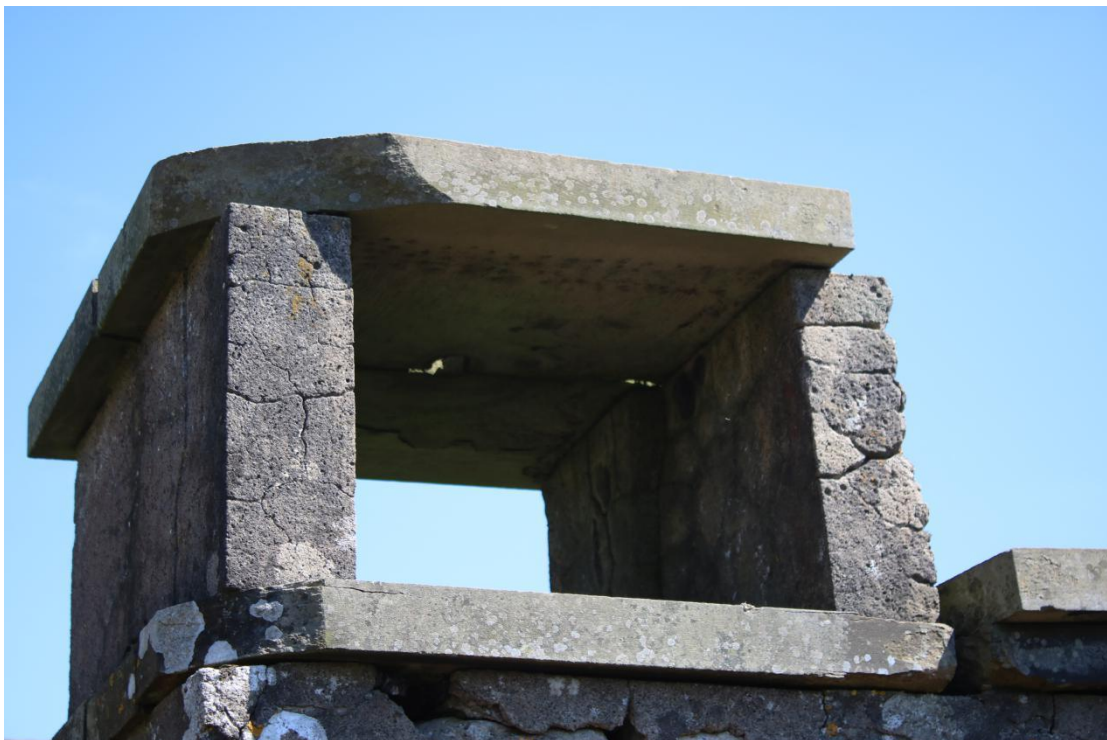
Plate 23 - AD042_WB_023 - West elevation, showing dropped capstone.

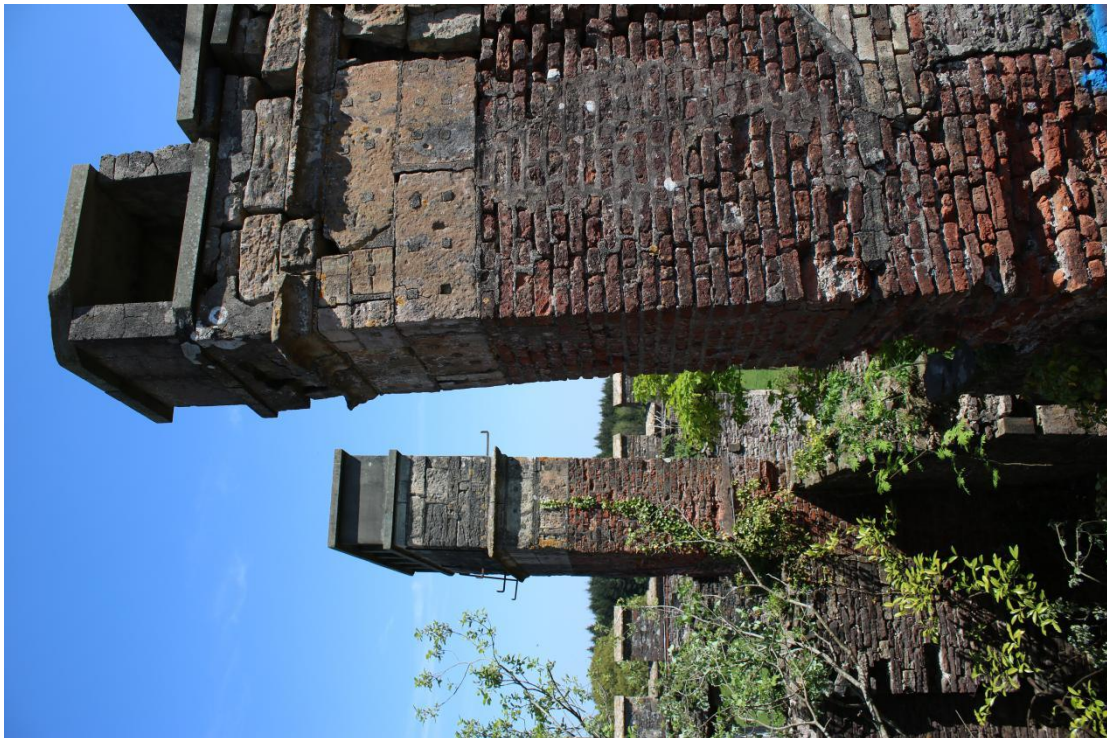
Plate 25 - AD042_WB_025 - West elevation, showing pinch spalling.

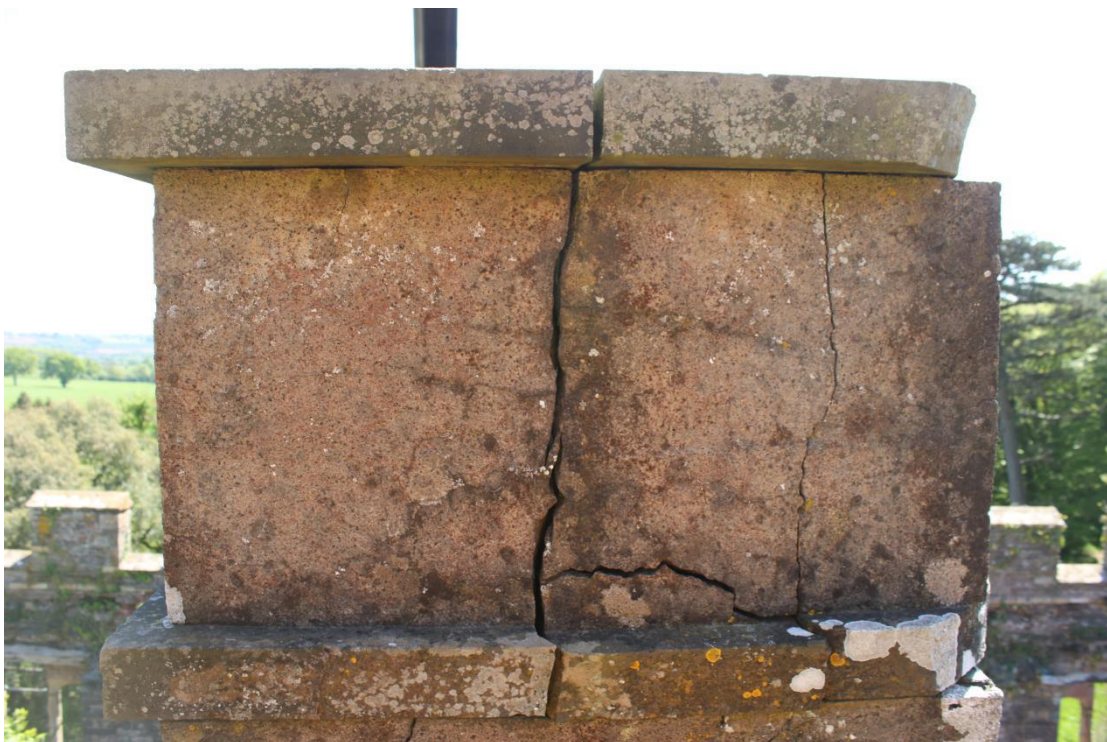
Plate 31 - AD042_WB_031 - North elevation, showing decayed sandstone ashlar with cementitious mortar above.

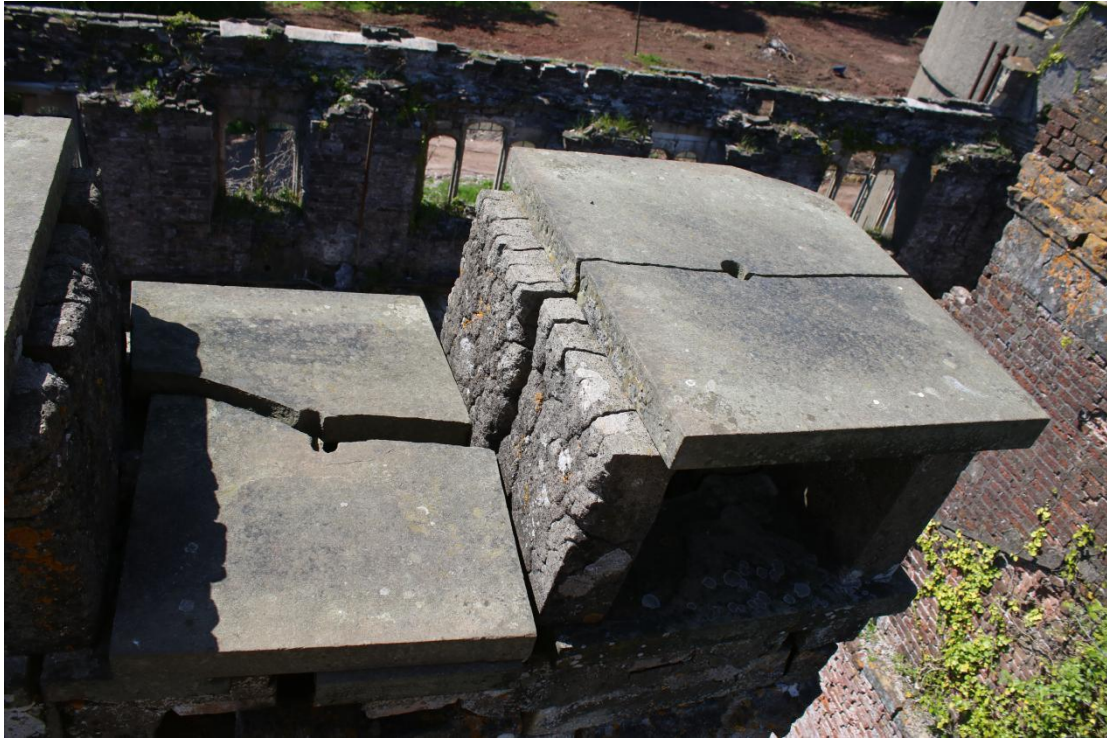
Plate 36 - AD042_WB_036 - 3/4 view of north and east elevations, showing pinch spalling and flashing line to former roof.

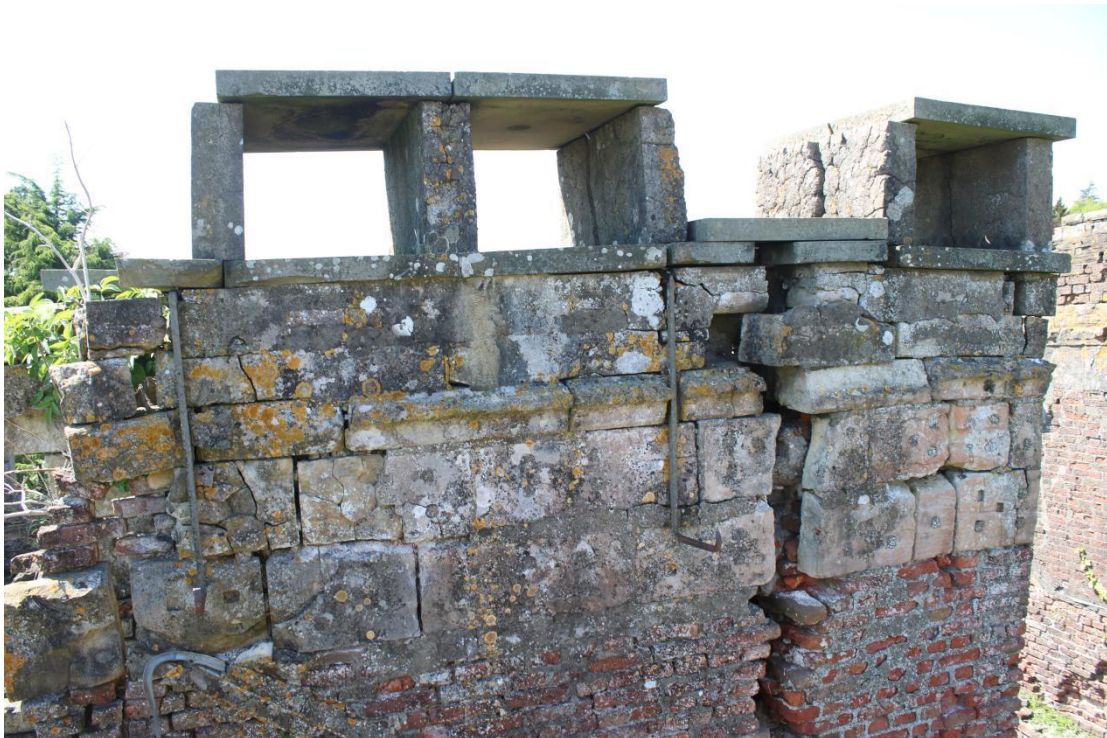
Plate 43 - AD042_WB_043 - East elevation, showing crack.

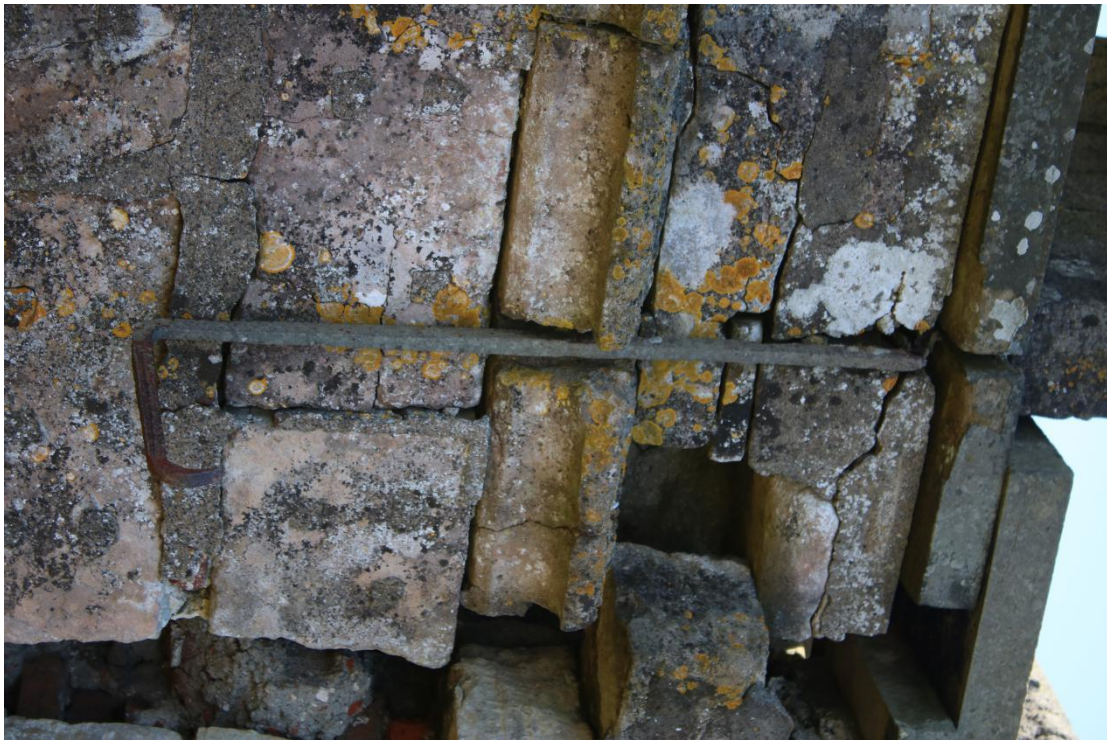
Plate 47 - AD042_WB_047 - East elevation, showing crack and flashing line to 1783 roof.

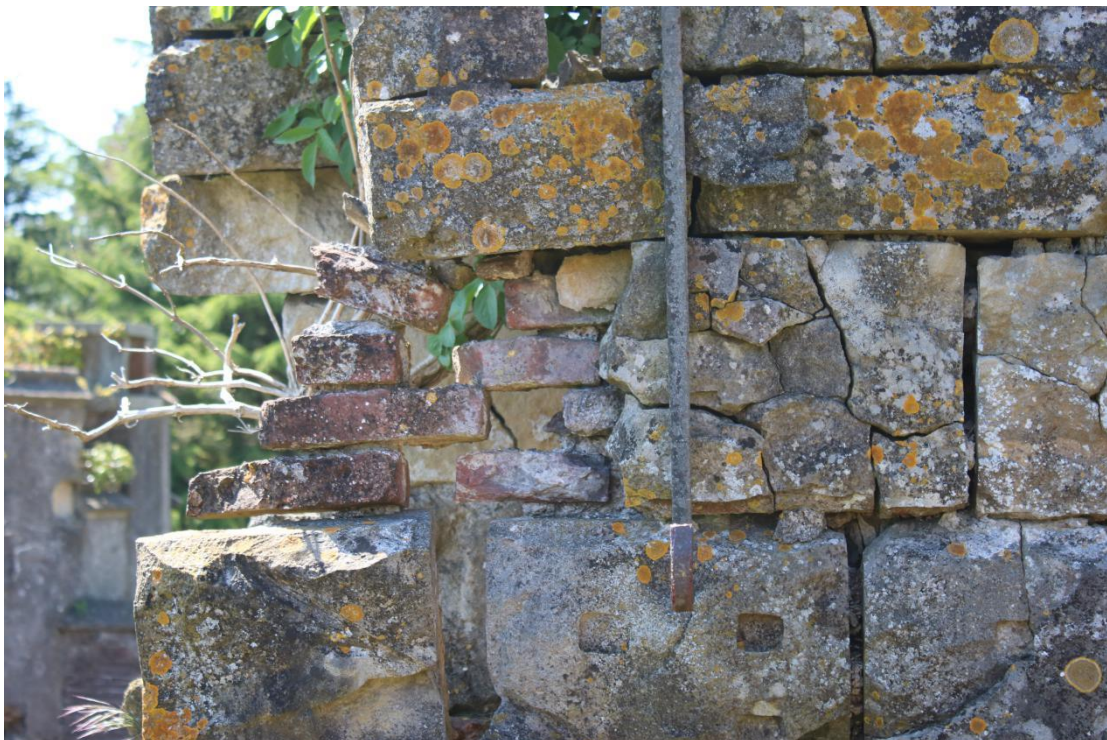
Plate 49 - AD042_WB_049 - East elevation, showing collapsing masonry and later lead flashing to 1783 roofline.

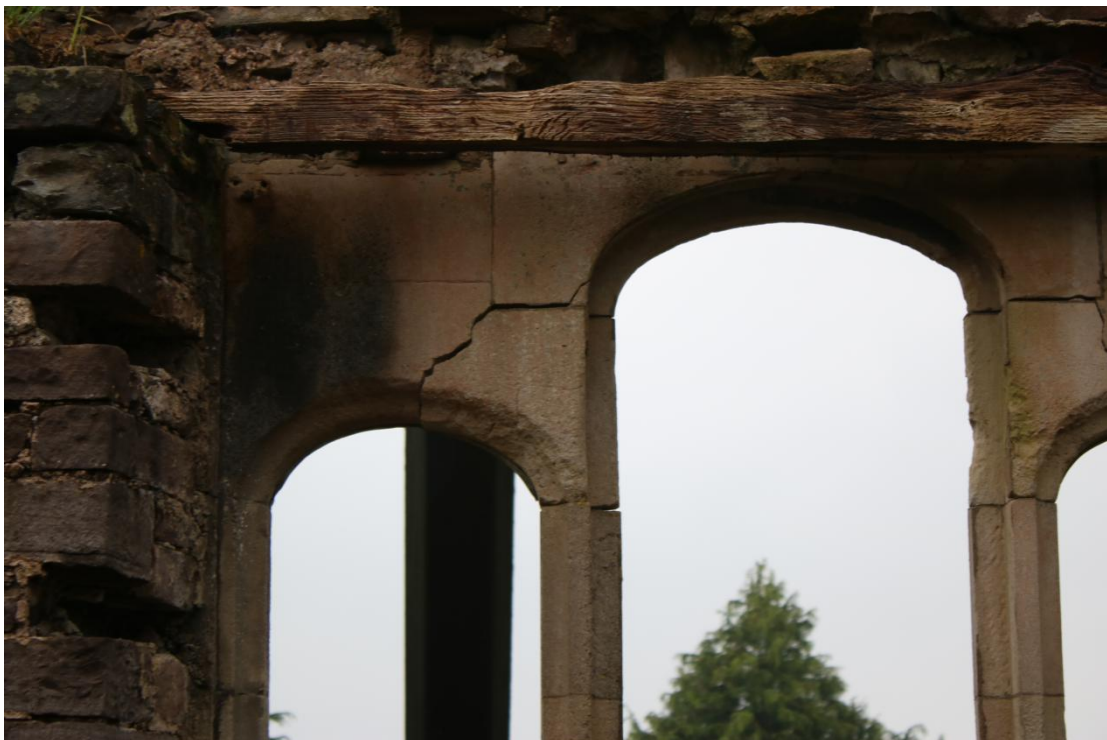
Plate 129 - AD042_WB_129 - South window interior, showing hanging masonry.

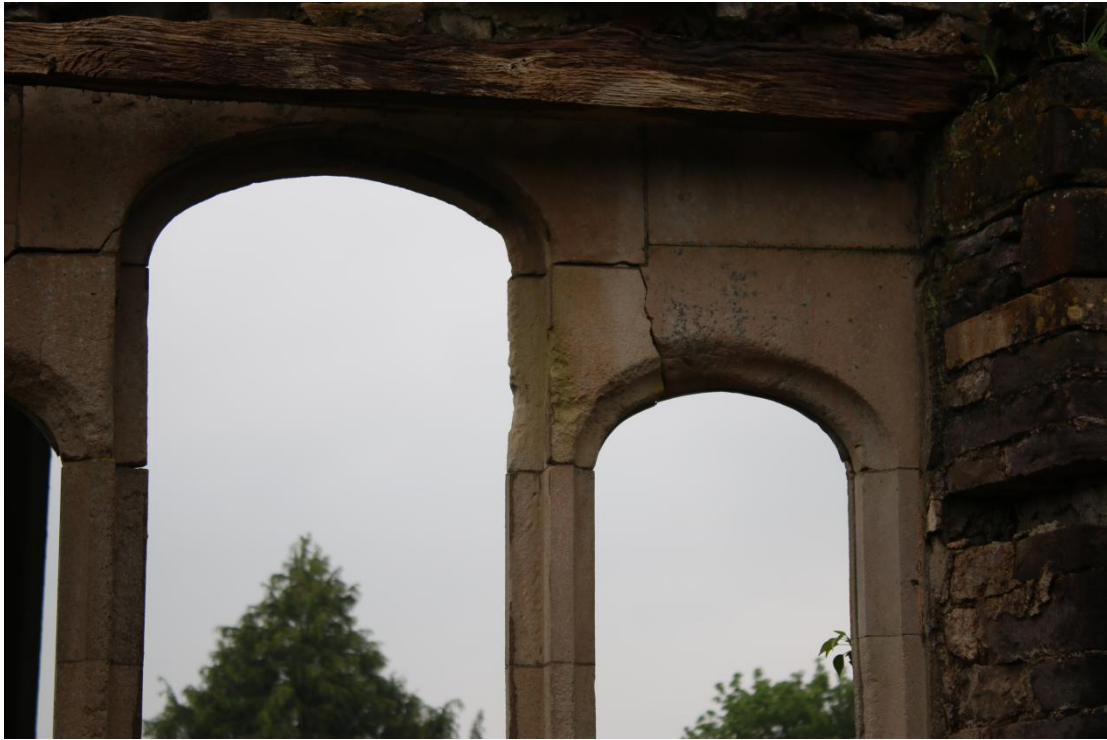
Plate 130 - AD042_WB_130 - South window interior, showing deteriorating sandstone window head, east.
