Former Coach House, Newport, Pembrokeshire

Archaeological Buildings Record & Watching Brief Report

Project #: AD010 25th May 2016

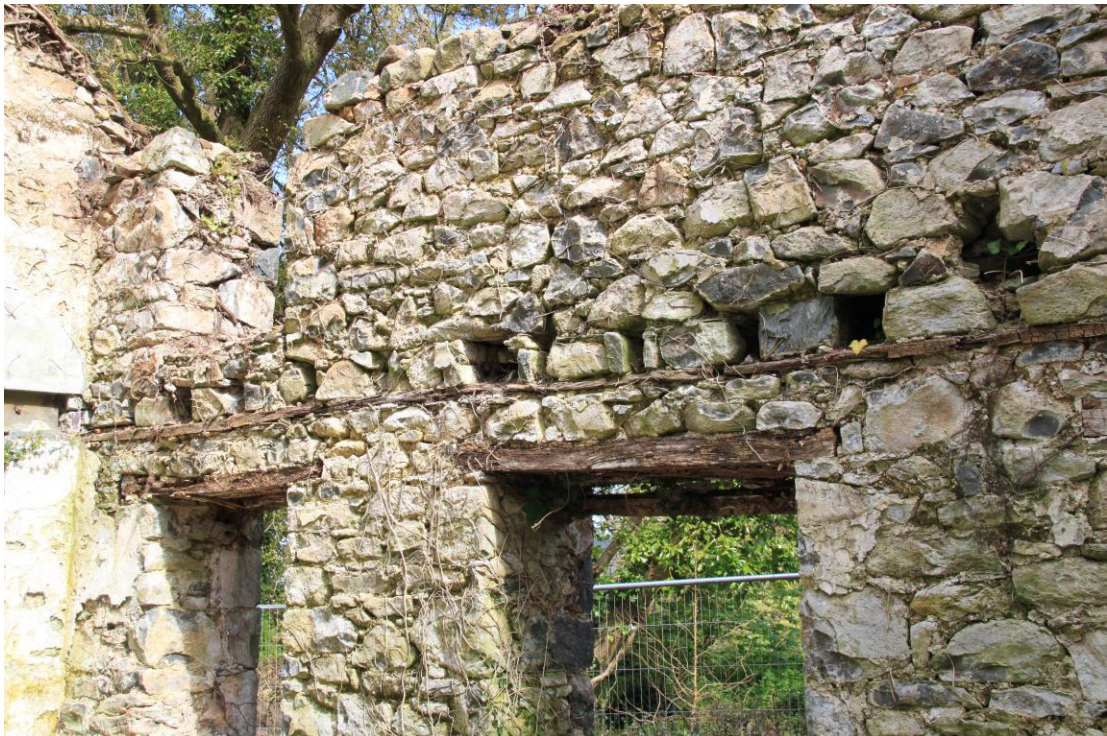
Plate 18 - AD010-BR-018 - Joist sockets, internal, north wall.

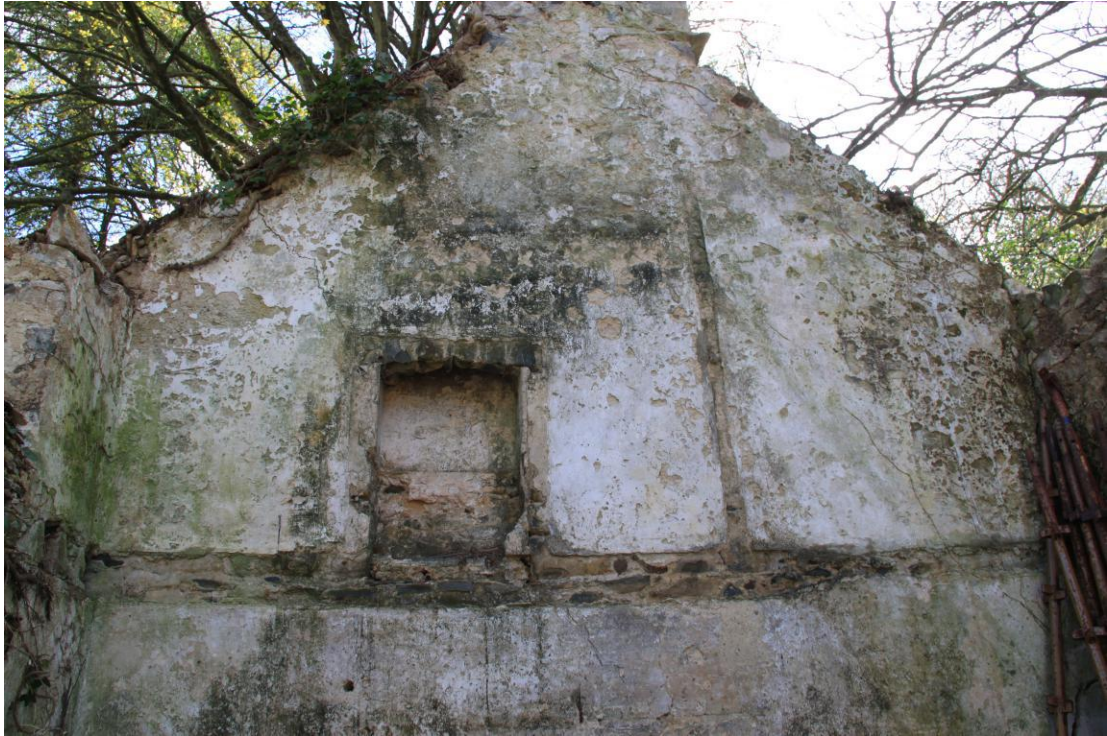
Plate 25 - AD010-BR-025 - First floor fireplace, internal east wall, Former Coach House. N.B. Partition division mark to plaster.

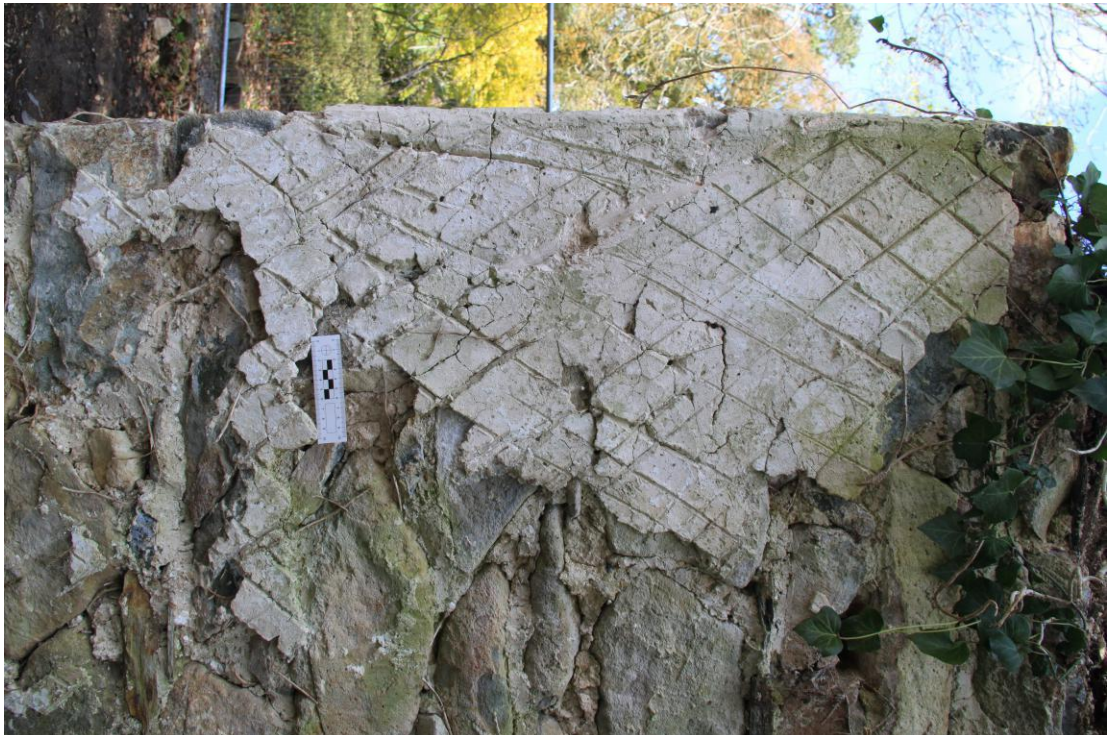
Plate 26 - AD010-BR-026 - Scoring to plaster base coat, internal north wall, Former Coach House.

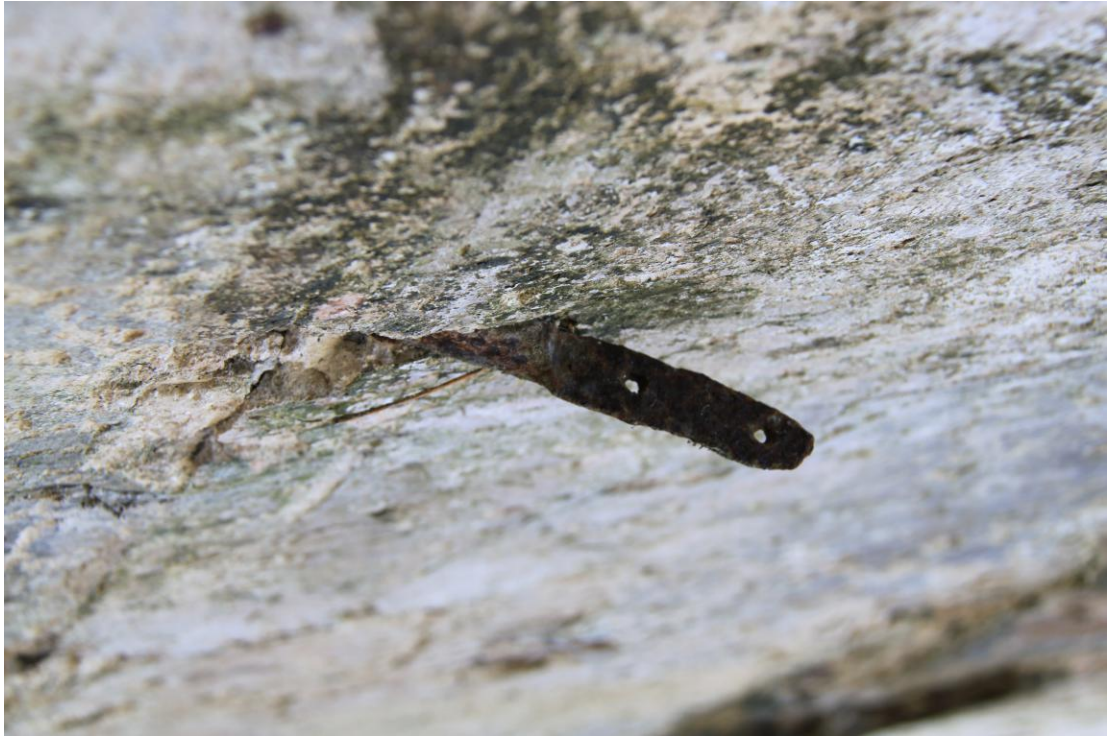
Plate 27 - AD010-BR-027 - Misc metal bracket, internal, north wall.

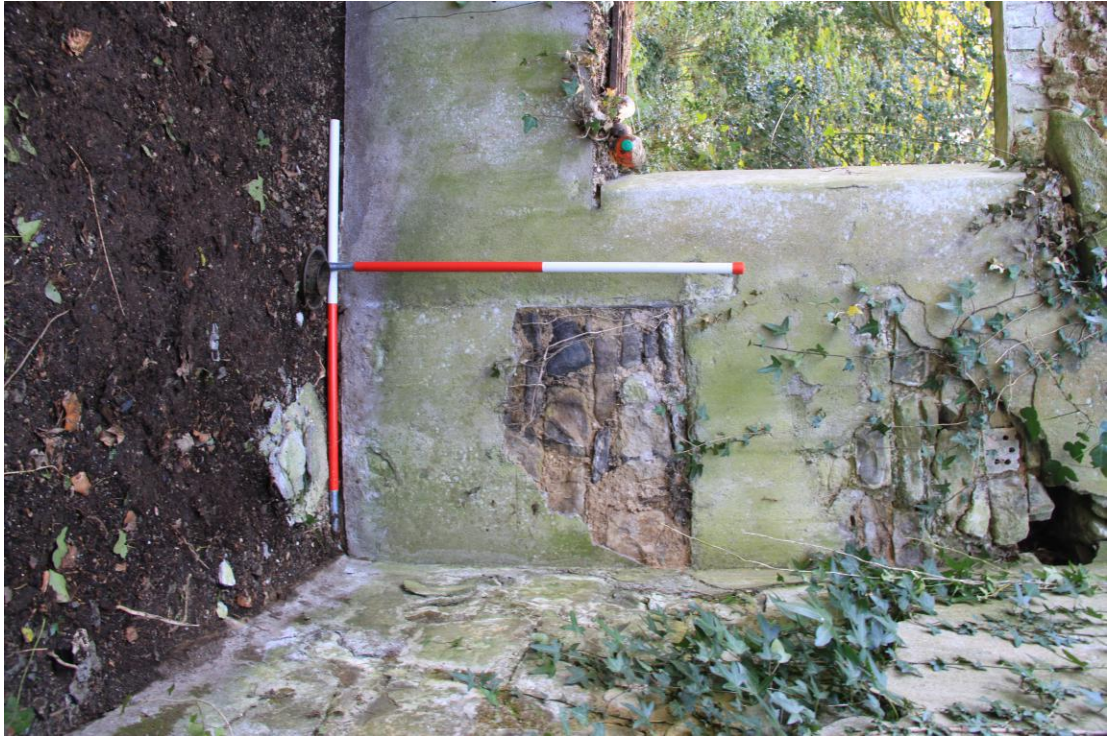
Plate 33 - AD010-BR-033 - Blocked fireplace, Extension B internal, east wall.

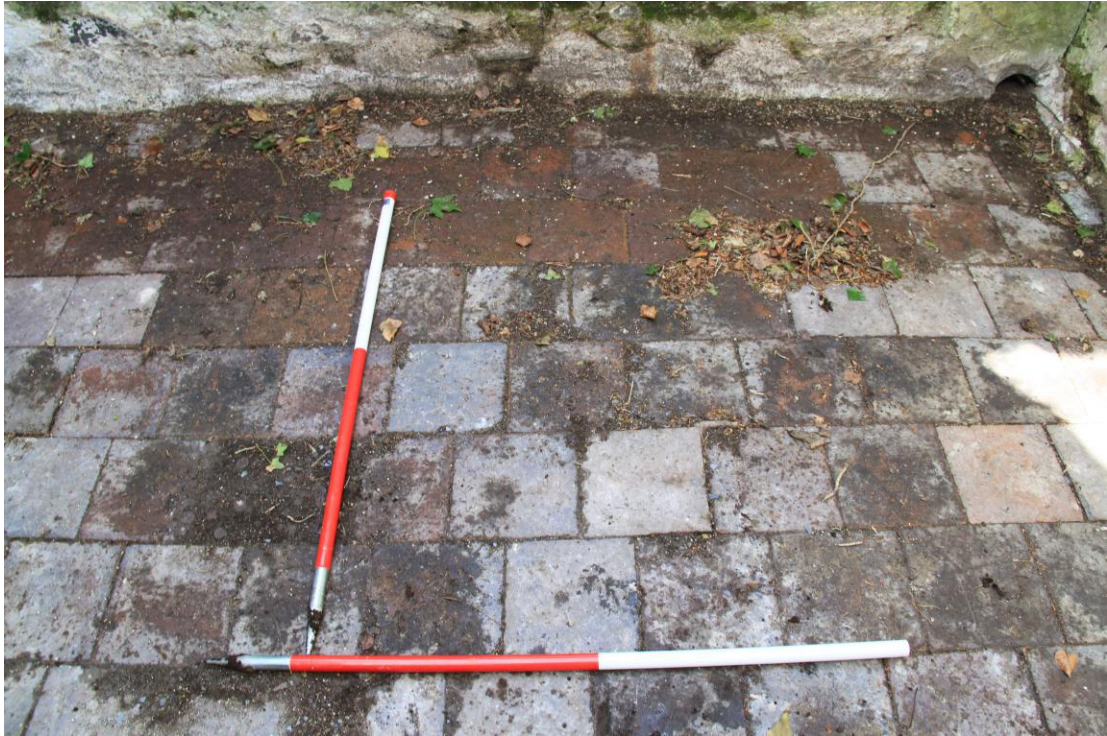
Plate 37 - AD010-BR-037 - Quarry tile floor to Extension A.

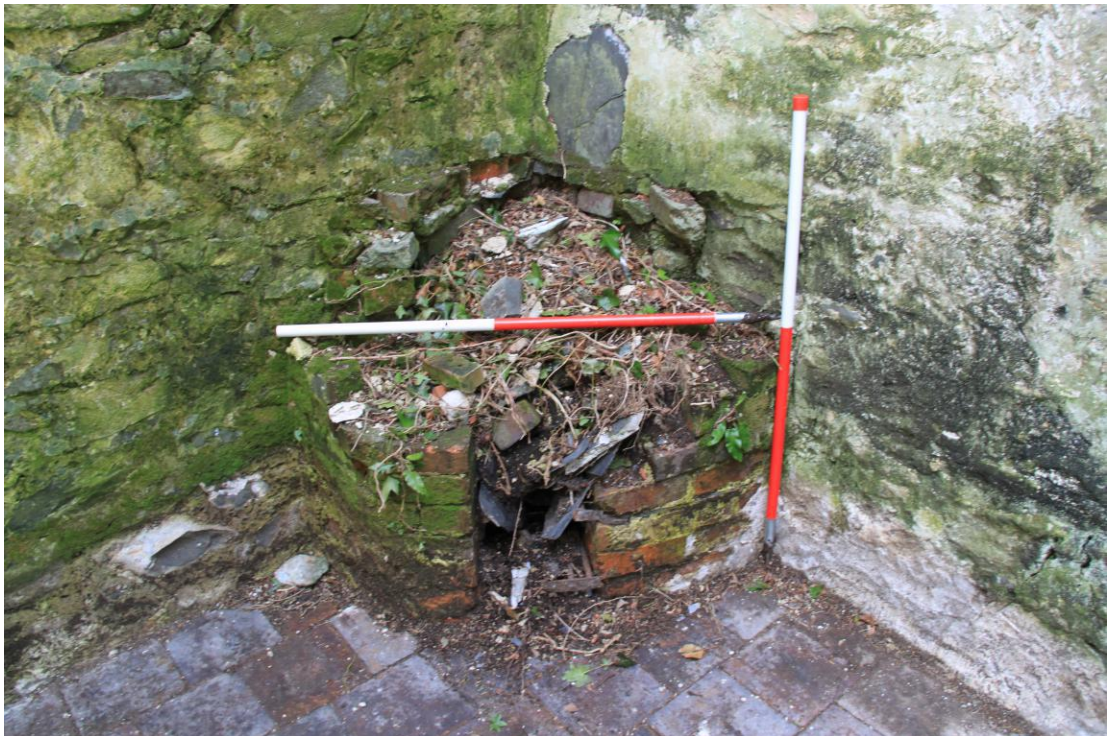
The remains of a small boiler occupies the north-east corner of the room (**Plate 38**) and red quarry tiles cover the floor (**Plate 37**). The two windows and door all have oak lintels internally (**Plates 39-40**). A four light sash window frame remains, but de-glazed and damaged in the east elevation (**Plate 47**).

Plate 38 - AD010-BR-038 - Remains of small boiler/copper.

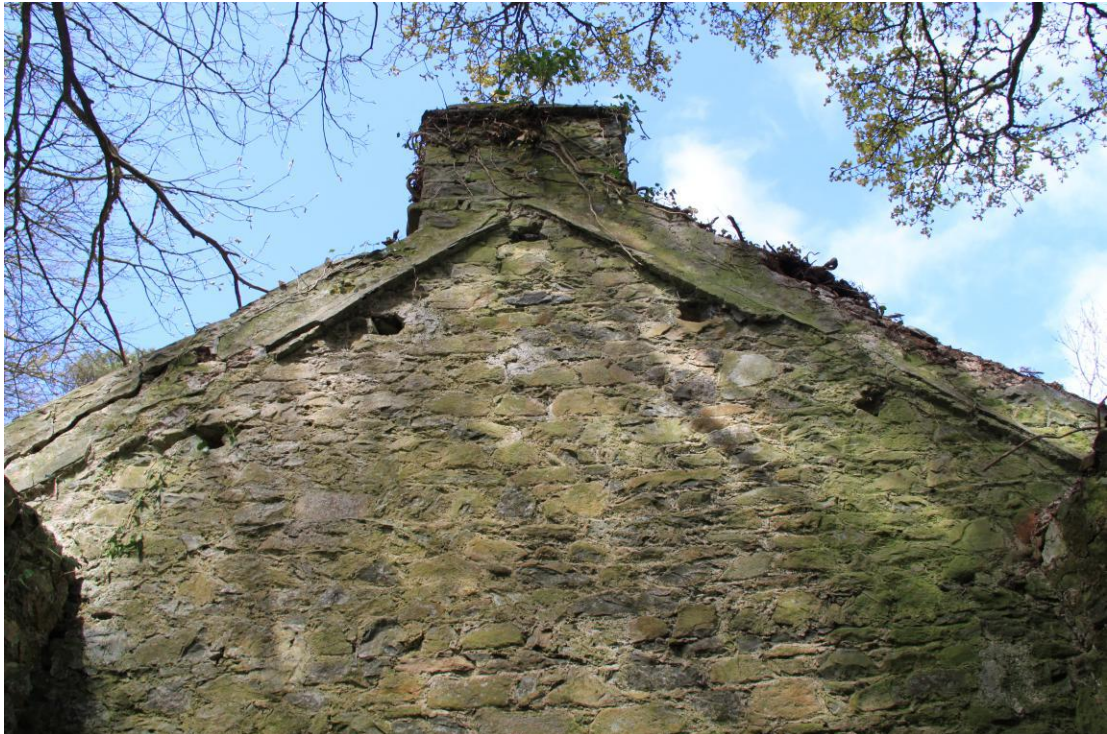
Plate 44 - AD010-BR-044 - Gable wall between Former Coach House and Extension A, showing two purlin and one ridge sockets.

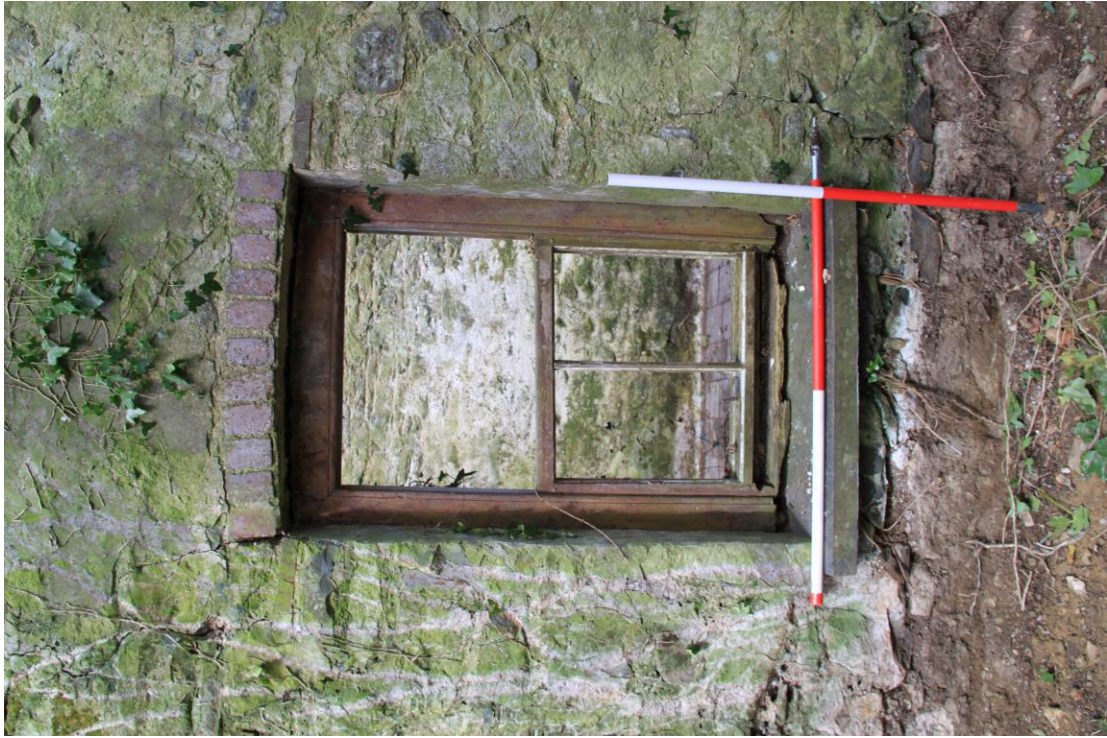
Plate 47 - AD010-BR-047 - Remains of four light box sash window, Extension A east elevation.

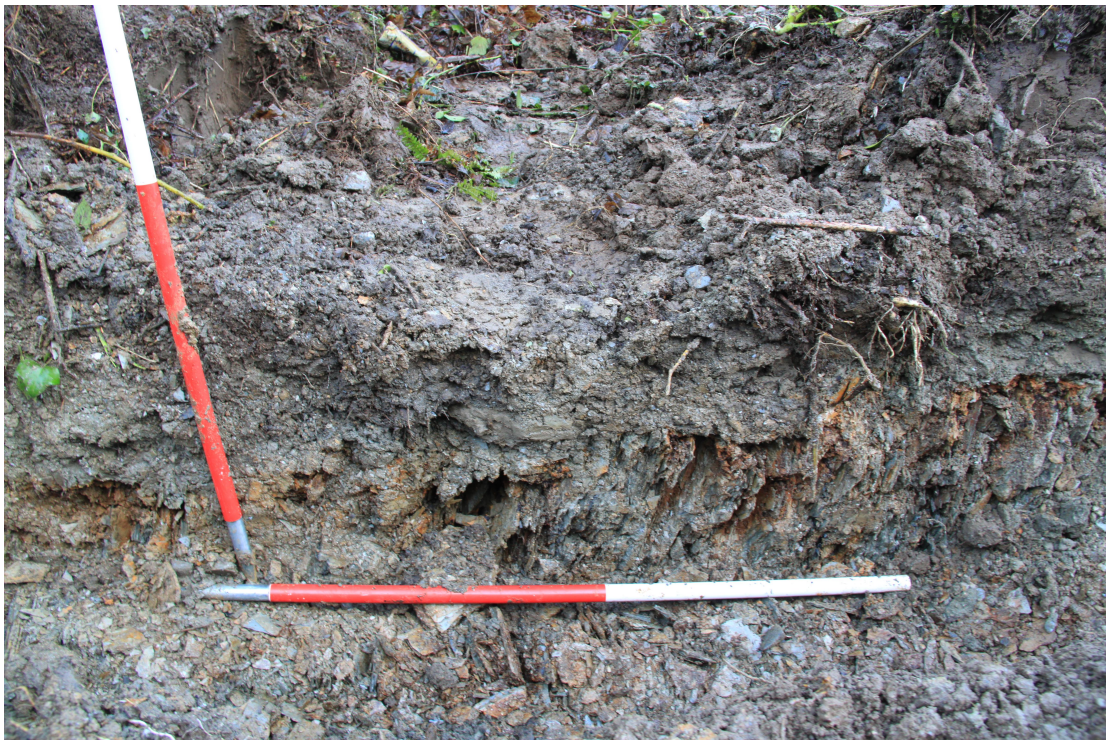
8.2.2 The former leat was originally excavated to a depth at which the parent bedrock was reached, no lining material could be identified; a grey silty deposit was identified. Subsequent disuse caused the tumble of the earth banks into the waterway.

Plate 63 - AD010-D2-016 - Section of service trench 1 showing leat.
