CPAT Report No. 1886

Bailey Hill, Perimeter Wall

Archaeological Watching Brief

Project Name: Bailey Hill perimeter wall, Mold

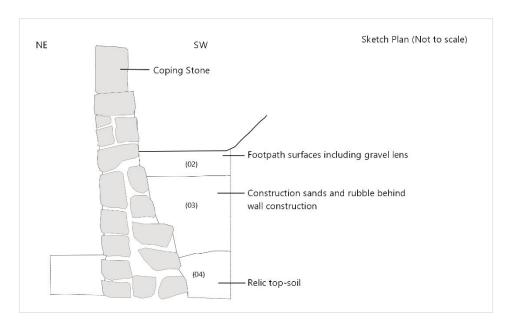
Fig. 4. Sketch plan showing the profile of the south-eastern section of perimeter wall

- 3.3. The coursing within the removed section of wall consisted of roughly dressed, mixed irregular and rectangular blocks, with 'cock and hen' coping stones. The upper section of the wall was only a single course thick but widened out to 0.75m at its base (Figure 4).

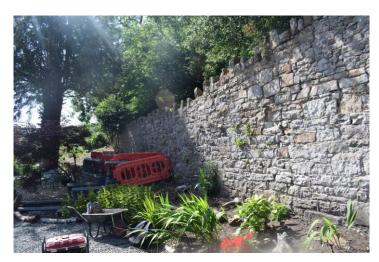
Fig. 5. Pre-removal shot of damaged section of perimeter wall CPAT Photo 5003_3

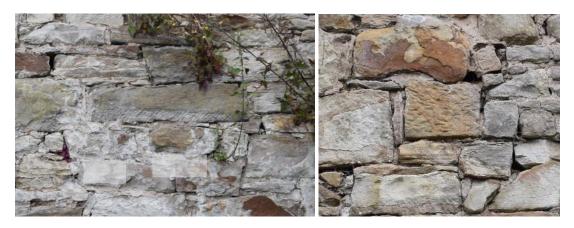
3.5. Built within the mostly undressed blockwork of the wall section nearest 'The Mount', are several blocks of worked stone displaying clear tool marking, one of which was finely dressed. The inclusion of these stones within the wall could indicate the reuse of masonry, likely from a nearby structure that comprised in part finely dressed worked stone (figure 6).

Fig. 6. Dressed stonework within the perimeter wall between near 'The Mount' CPAT Photo 5003_25 and 26

- 5.3. Contained within the wall section nearest 'The Mount', were some dressed stones that could indicate the reuse of masonry from a nearby structure. It is possible that these could be associated with the castle site, but too little is known of the site's construction to draw a more evidenced comparison.

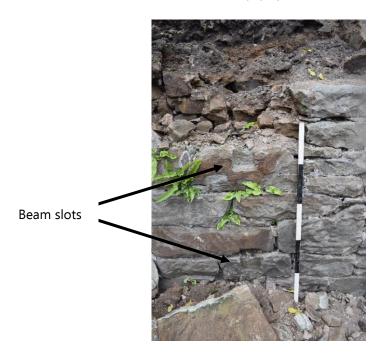
Fig. 7. Beam slots carved into the stonework near 'The Mount' CPAT Photo 5003_15

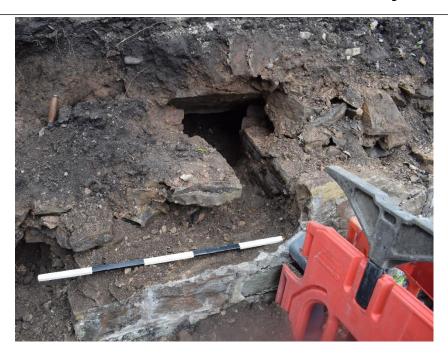
3.6. Built within the perimeter wall at the north-western end of the removed section was a redbrick lined culvert that has been subsequently blocked up on the outer face of the wall (Figure 8). The interior comprised of a 0.4m wide slot built into the stone coursing which then continues as an unfrogged and un-mortared redbrick wall that fans out towards the southwest. The structure is capped with a sloping stone slab and is still relatively hollow inside. Within the construction cut of this feature, set behind the bricks, was a dense deposit of largely intact ceramics. These included an Asiatic Pheasant type willow pattern plate, stamped with HL & Co (Handcock, Leigh & Co of Staffordshire) c. 1860-2. The other vessels are of a similar date, indicating that the wall has likely been remodelled during the construction of 'The Mount' or soon after.

Fig. 8. Culvert built into perimeter wall, CPAT Photo 5003_8

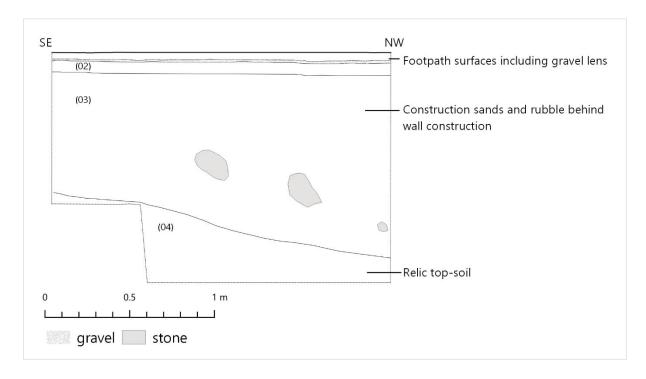
3.7. The soil exposed behind the wall (Figures 9 and 10) displayed predominantly made-up ground, comprised of an upper pathway layer with lenses of organic material and gravel (02), overlying a mixed sand and rubble, up to 1m thick, that forms made-up ground infilling the space between the perimeter wall and the natural hillside (03). These seal a relic organic topsoil that sits at a similar level to the topsoil on the northern side of the wall and slopes off towards the northwest.

Fig. 9. Northeast facing section of soil behind the removed wall.

- 5.2. The soil deposits exposed behind the wall indicated that the pathway on the southwestern side of the wall has been significantly built up, sealing an original organic topsoil at a depth of up to 1.1m. This suggests that this section of perimeter wall has not been cut into the natural hillside that forms Bailey Hill.

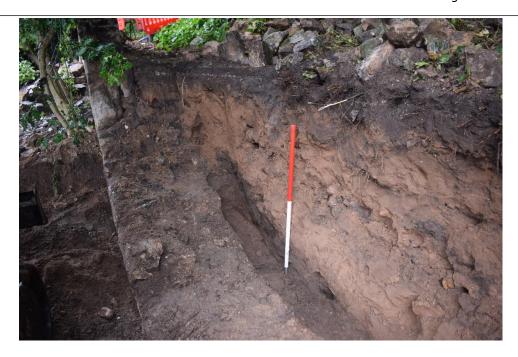
Fig. 10. Soil deposits behind perimeter wall CPAT Photo 5003_29

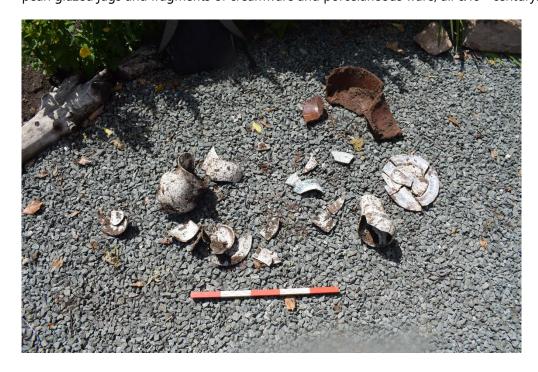
4.1. A cache of nearly intact ceramic vessels was recovered from within the construction backfill of the culvert built into the perimeter wall. Most of these vessels were not retained except for a single willow pattern plate stamped with HL & Co (Handcock, Leigh & Co of Staffordshire) c. 1860-2. The other vessels included a large glazed red earthen ware dish (Buckley ware), two pearl glazed jugs and fragments of creamware and porcelaneous ware, all c.19th century.

Fig. 11. Cache of ceramic vessels within construction of culvert CPAT Photo 5003_22
