CPAT Report No. 1728

St Grwst's Church and Gwydir Chapel, Llanrwst, Conwy

Archaeological Watching Brief

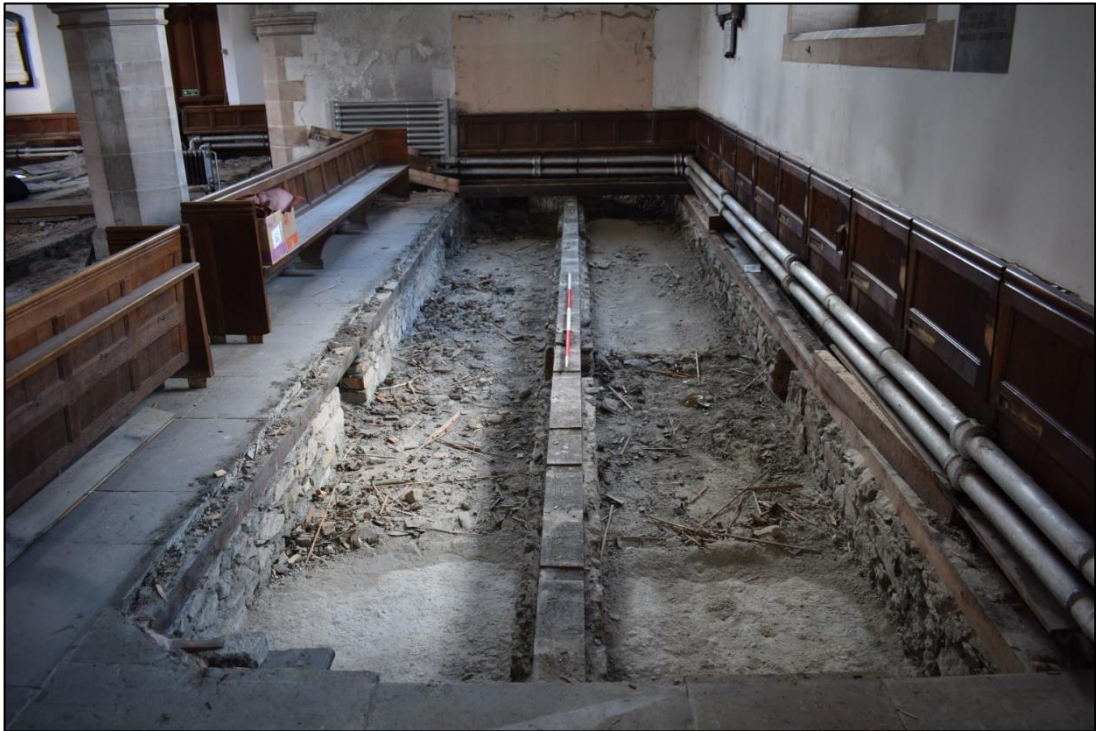
- 3.2. The main part of the work within the church which had the potential for significant archaeological impacts involved the lowering of the floor level and the subsequent construction of a new floor slab to support the new structures. This was carried out in the nave, north aisle and tower. The reduction of the floor level revealed sections of an earlier floor which was clearly in use in the 18th century, and perhaps also the beginning of the 19th century to judge from the ledgers that were revealed. Some of the ledgers were taken up as they were too close to the surface and were placed between the sleeper walls of the floor in the north aisle after the wooden and stone slab flooring there was removed and before the new floor had covered them. Apart from these walls, no archaeological features or structures were seen in the floor of the north aisle (Fig. 2). No evidence was revealed for grave cuts or

Fig. 2: The north aisle floor, showing the sleeper walls, from the east. CPAT 4679-0001

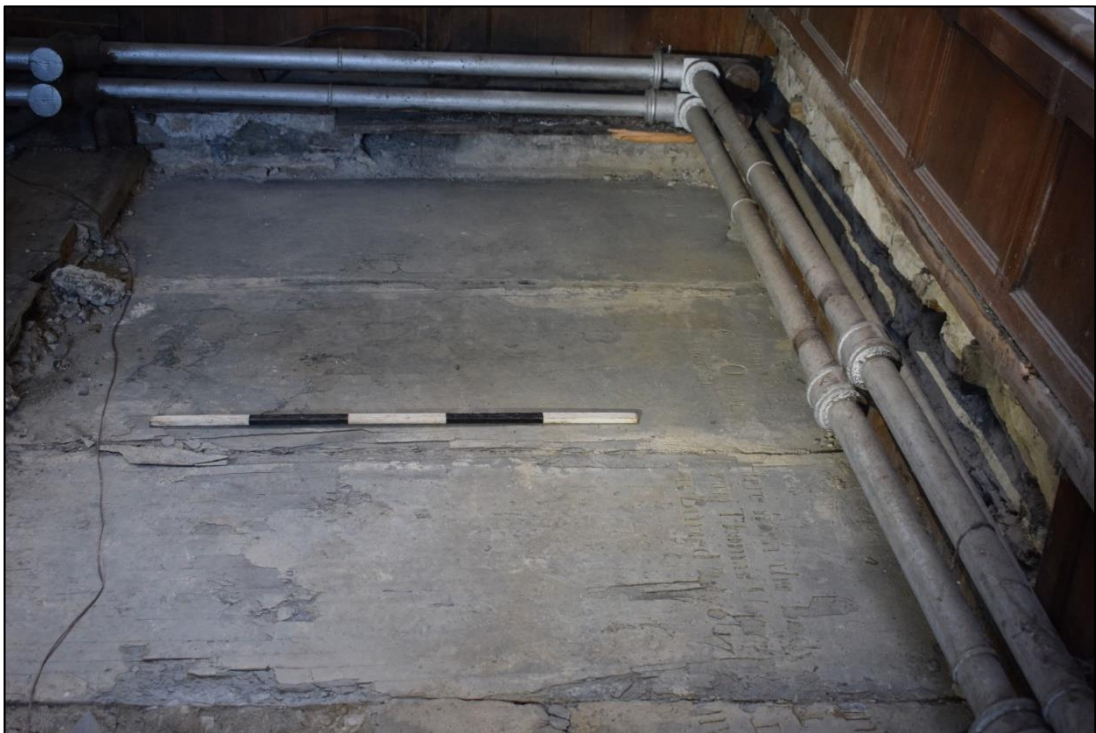
Fig. 3: The ledgers in the south-west corner of the nave, from the north. CPAT 4679-0012

- 3.3. At the west end of the nave, the removal of the modern flooring in the south-west corner of the church, where the font had been sited, revealed four ledgers and other slabs which had been used as flooring (Figs. 3 and 4). The ledgers were dated to between 1751 and 1801; all had to be taken up to give sufficient depth for the new floor to be installed. These were positioned so closely together that they may represent the reuse of ledgers as flooring.

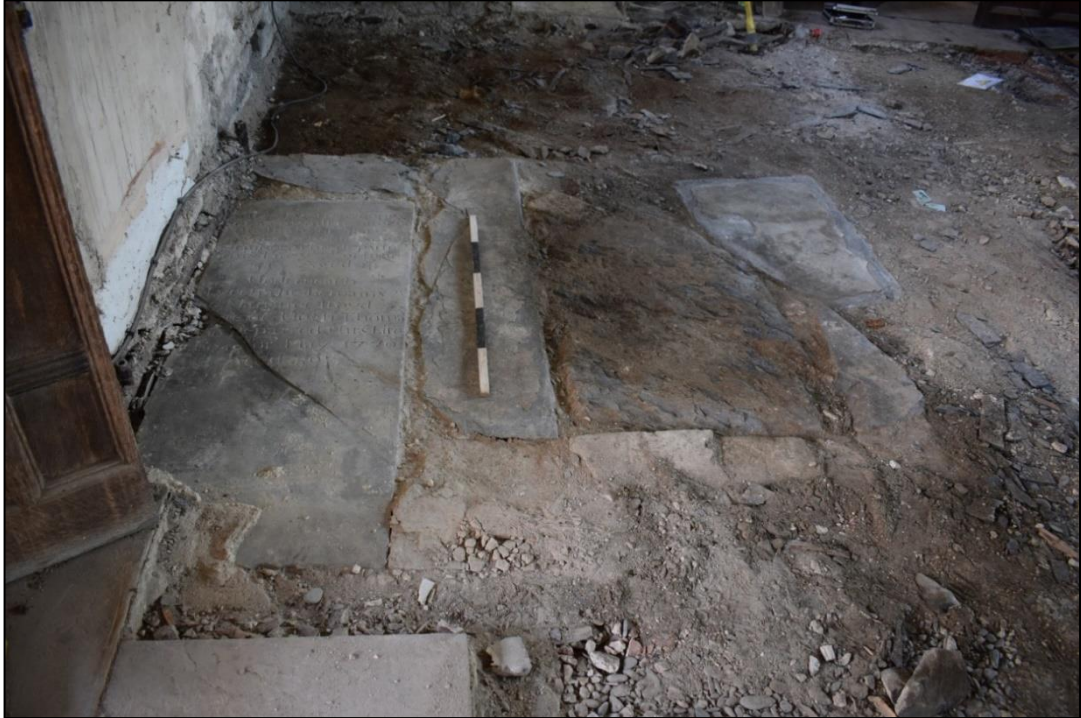
Fig. 4: The 1751 ledger (left) and floor slabs to the west of the main entrance to the church, as revealed by the taking up of the font, from the east. CPAT 4679-0102

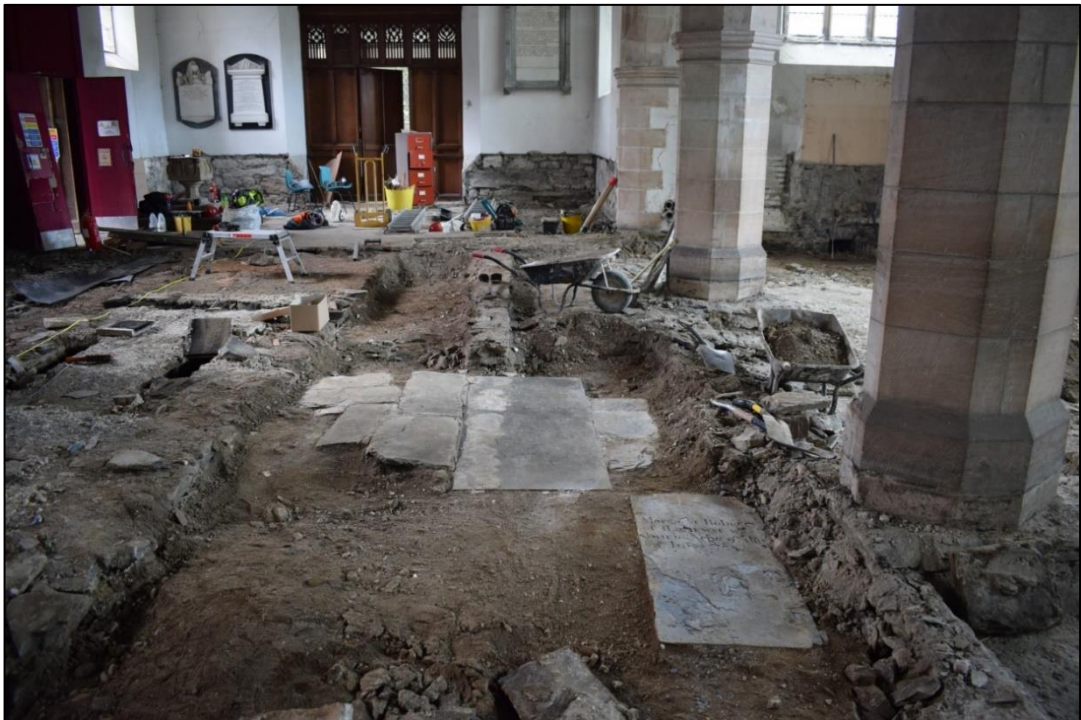
Fig. 5: The remains of the 18th-century floor within the nave, from the east. The John Williams ledger is the more distant of the two large slabs. CPAT 4679-0033

- 3.4. Further to the east within the nave, another area of this early floor was found in-situ (Fig. 5) though its surface was uneven. Two dated ledgers were revealed, of 1728 and 1767, and it seems likely that these were part of the same floor level identified in the corner of the church.

- 3.6. This section of the old floor was fairly uneven and the higher portions had to be removed to allow the new floor to be installed. The ledgers were slightly lower and this enabled them to be retained in their original positions.

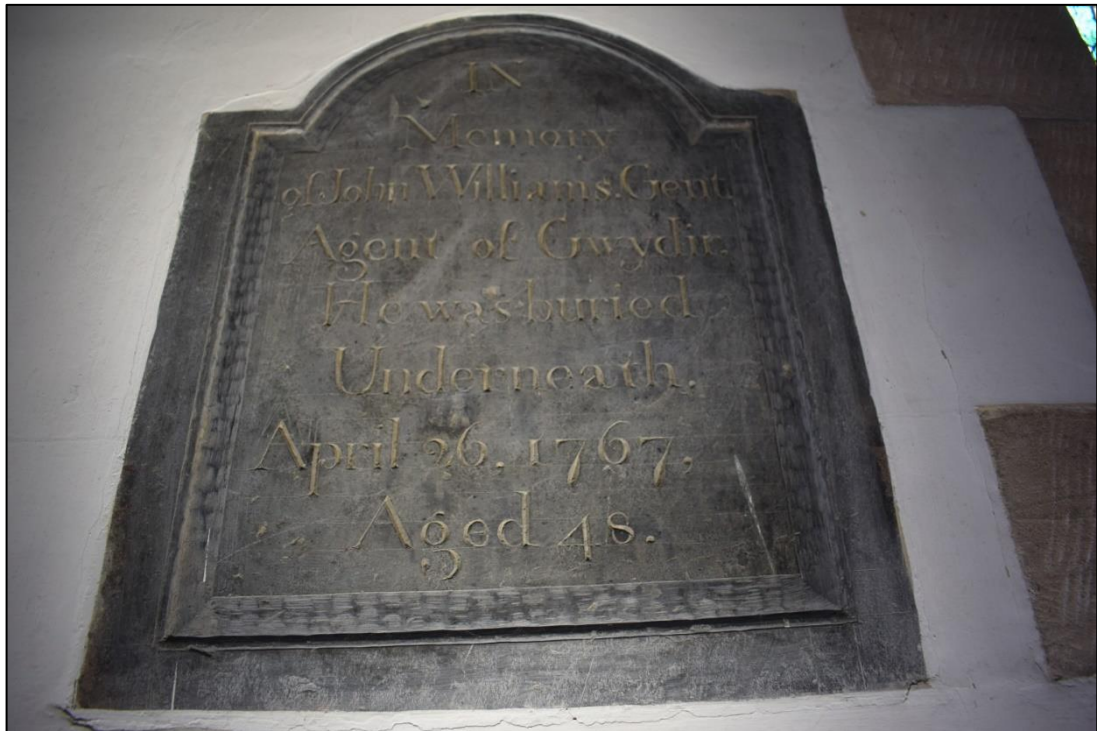
Fig. 6: The John Williams memorial plaque on the wall of the north aisle. CPAT 4679-0075

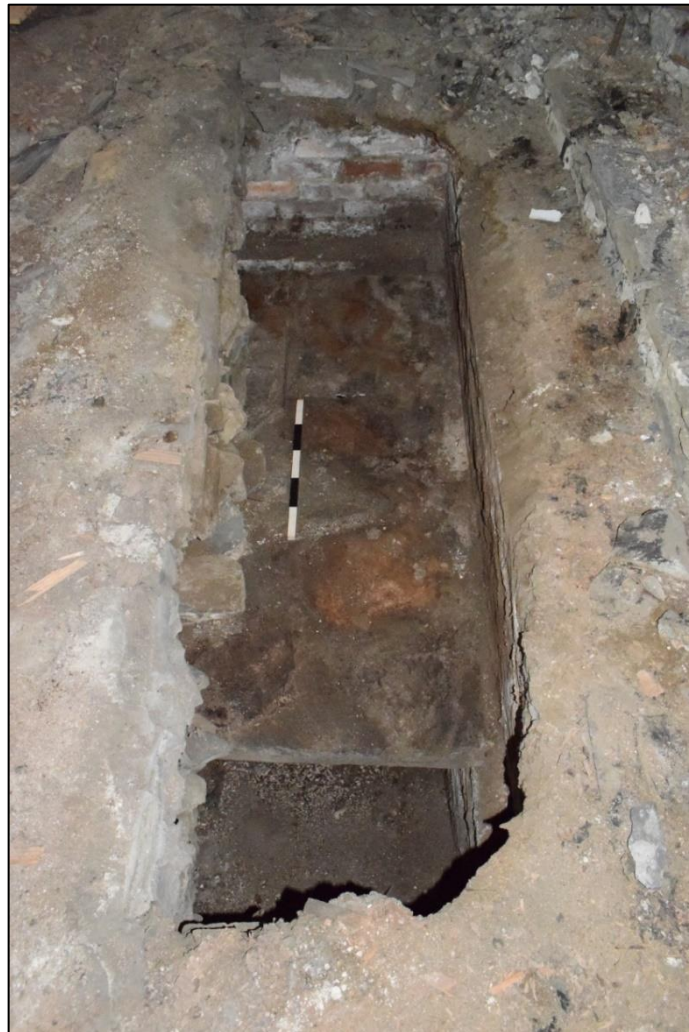
- 3.7. On the south side of the nave and almost opposite the John Williams ledger was a brick-lined vault (Vault 1; Fig. 7), aligned east/west. Its presence had been appreciated at an early stage owing to some subsidence of the overlying soil and the investigation of this structure had therefore been made a priority to ensure that the new floor was placed on a secure footing. It was partially overlain on its north side by a sleeper wall for the same type of wooden flooring that was taken up in the north aisle.
- 3.8. The reason for the subsidence was readily evident in that the slabs sealing the vault had not all been replaced, leaving the east and west ends open which had admitted soil into the interior of the vault. It was interesting to note the remains of a fabric covering (the brown-

coloured patches on Fig. 7) which had no doubt been placed on top of the slabs when the vault was last used.

Fig. 7: Vault 1, showing the incomplete slab and covering material, from the west. Partially overlying the north (left) side is a sleeper wall for the 20th-century floor of the church. CPAT 4679-0048

- 3.9. Although the vault was only large enough in plan for a single coffin, the likelihood is that it was of sufficient depth to allow for at least two and possibly three burials. This was demonstrated by a monument on the south wall of the nave to the likely occupants, Jane Hughes, her husband Thomas, and their daughter Jane, who died in 1729, 1733 and 1767, respectively. The inscription is given in full in Appendix 2 and its location is marked on Fig. 49. New slabs were used to seal the vault, which was then covered with a protective membrane before being filled. The outer walls were left untouched by the floor preparation works.

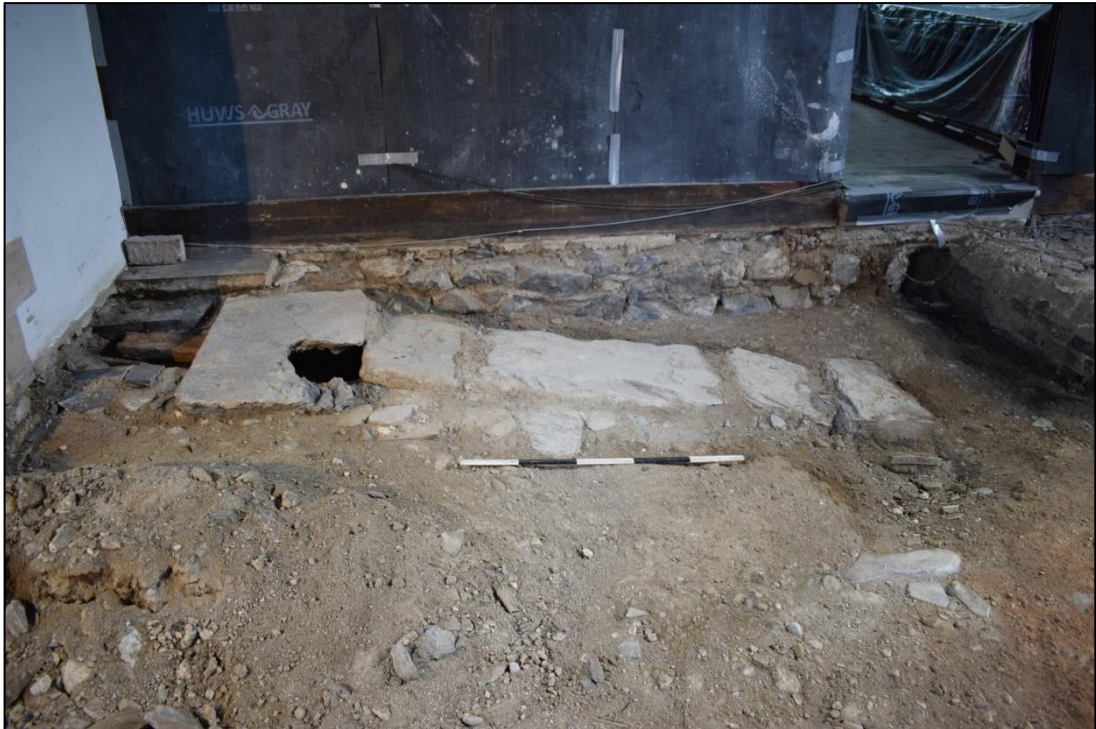
- 3.10. As the floor level was being lowered on the north side of the nave at its east end, a second vault (Vault 2) was revealed. This was of completely different character, comprising two approximately parallel stone sleeper walls running north/south with a covering of slabs (Fig. 8). Previous disturbance was evident as one slab was missing and another had been damaged, this could have taken place when the north aisle was built.

Fig. 8: Vault 2, running parallel with and adjacent to the rood screen, from the west. CPAT 4679-0072

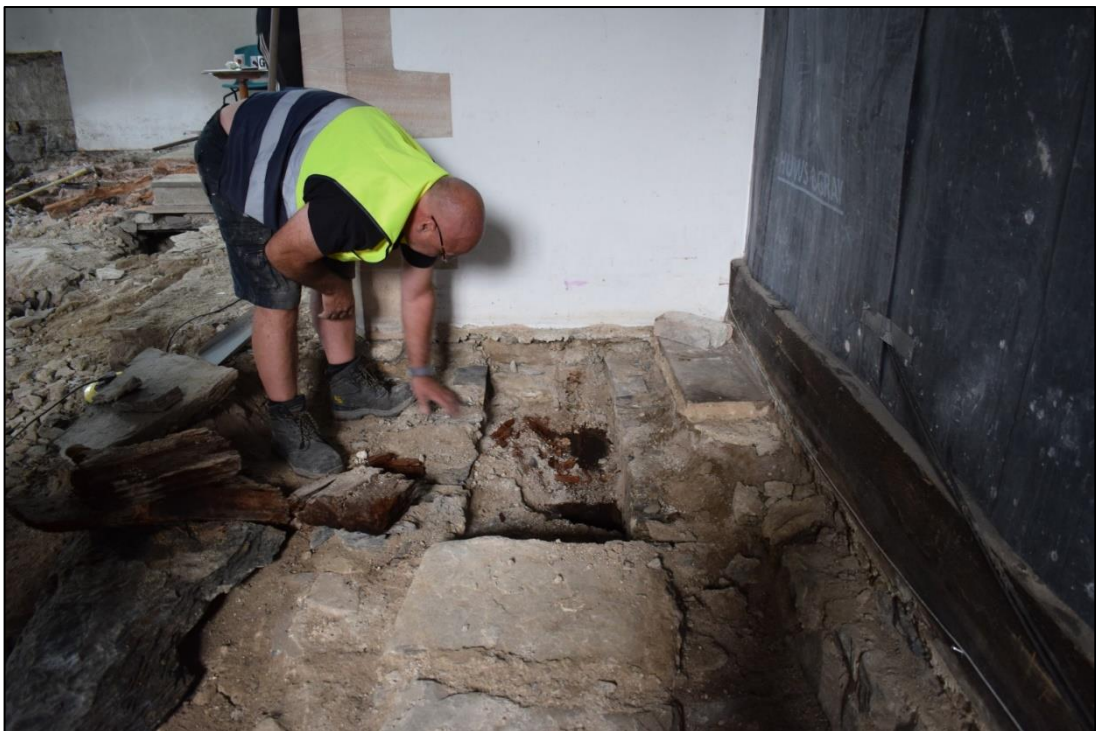
Fig. 9: The reduction in the height of the sleeper walls of Vault 2, prior to the setting in place of new covering slabs, from the south. CPAT 4679-0082

- 3.11. The vault had to be modified (see Fig. 9) as its upper surface was too high to allow the new floor to be of sufficient thickness. Accordingly, the two northernmost covering slabs were removed, the sleeper walls were lowered by about 0.2m and the vault was then capped with

three reused slabs from elsewhere, the old slabs being in poor condition. The interior of the vault was examined after the slabs had been removed and human remains were observed, though whether these were in-situ could not be determined. They were left in position. No evidence regarding the date of the vault or the potential occupant was observed.

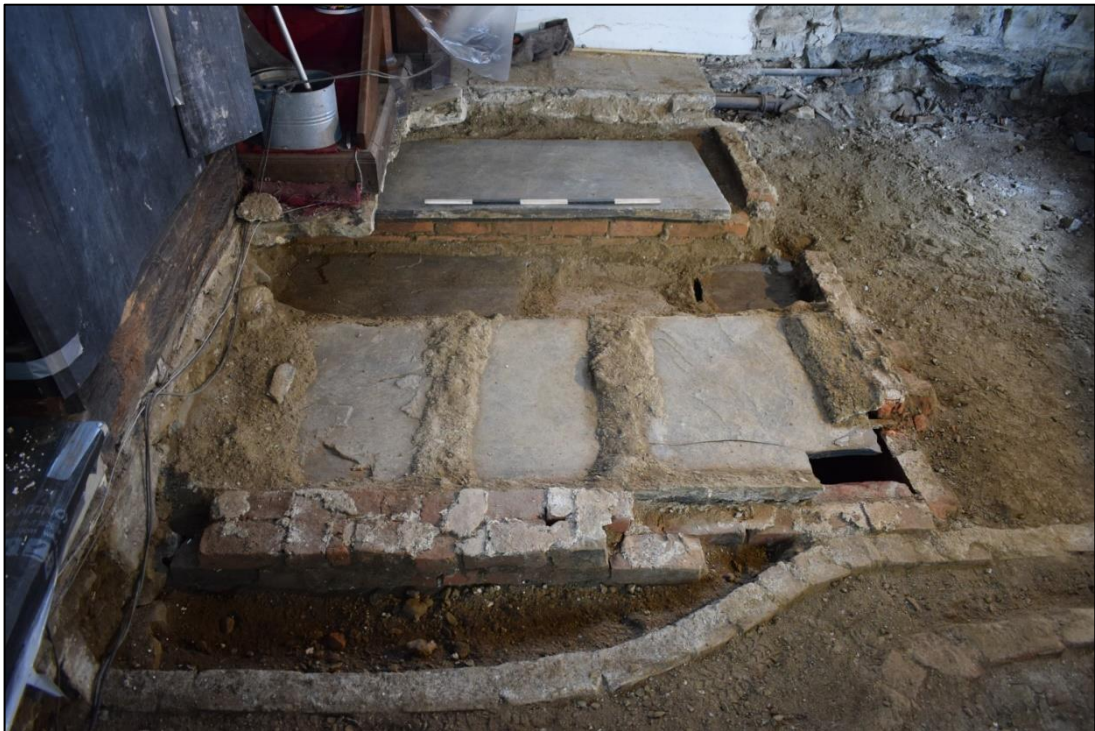
- 3.12. Also at the east end of the nave, but to the south of Vault 2 and partly beneath the pulpit, was a third vault (Vault 3). This was a large subterranean brick structure, capped by a number of slate slabs (Fig. 10). Immediately to the south was a displaced ledger (No. 22) supported on what seemed to be a brick extension of the vault; the ledger inscription dated to 1822. The slabs covering the northern part of the vault were removed, as they were insecure, revealing an iron supporting bar. Once the slabs were removed, it could be seen that the northern part was divided from the southern part by a brick wall running east/west at the surface but approximately 1.1m below there was a space which meant the two sections were interconnected. At least three lead coffins were seen within the northern part of the vault, in varying states of disrepair, and further coffins could be seen in the southern part. Red paint had been applied to the interior.

Fig. 10: Vault 3, adjoining the rood screen on the left, from the north. The ledger at the rear was as found, before it was lowered to allow the new floor to be installed. Note also the curved brick wall in the foreground, which is part of a duct associated with a 19th-century heating system (see Fig. 13 and para 3.15). CPAT 4679-0091

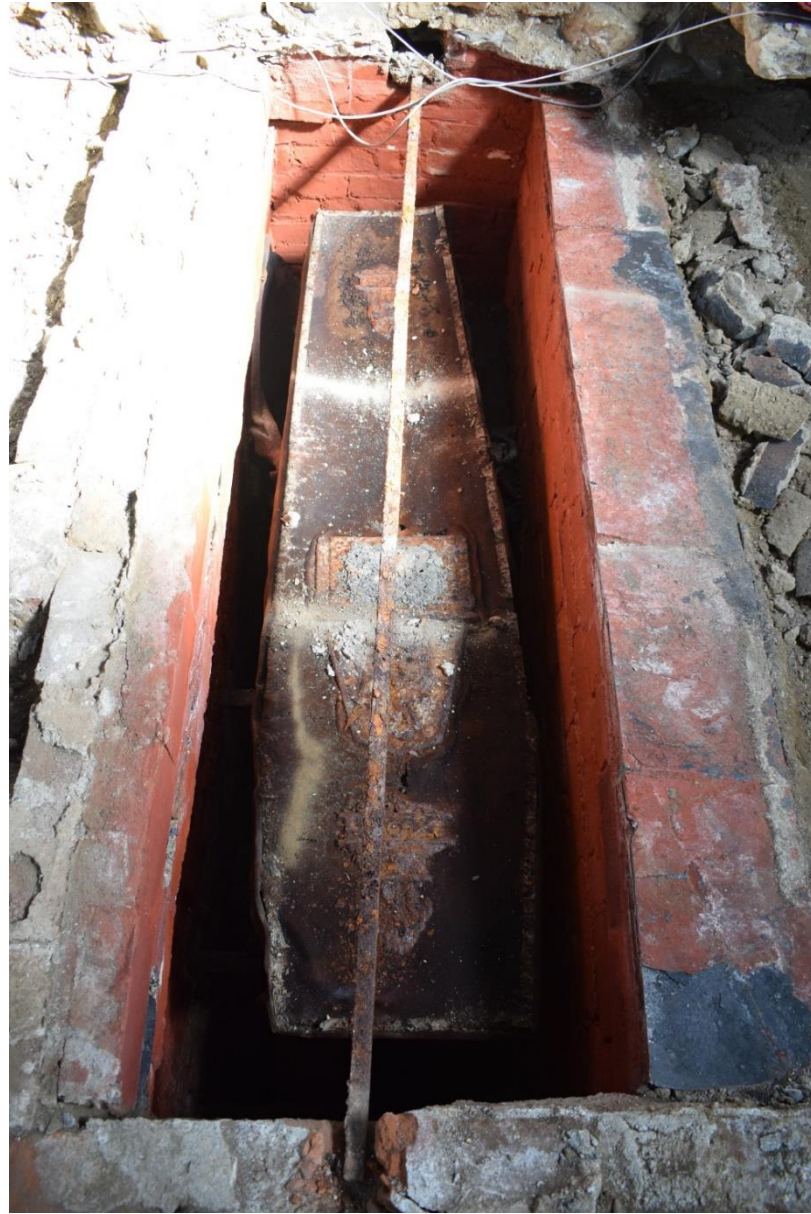
- 3.13. The uppermost coffin (Fig. 11) seemed to have had a fabric covering and a number of decorative plaques were applied to its upper surface; these were not decipherable but examination of a number of brass plaques attached to the rood screen nearby suggested that the burials represented were those of the Owen family of Pencraig and Hendre, dating between 1719 and 1852. The ledger inscription matched that on one of these plaques (these are included at the end of Appendix 2 for information). Another set of plaques relate to the Ellis family of Cyffty, the dates covering the middle of the 18th century to the early years of the 19th century. The bricks used in the vault were manufactured by Hancocks of Buckley, who operated in the 18th and 19th centuries.

Fig. 11: The uppermost coffin in the north part of the vault showing the iron supporting bar, from the west. CPAT 4679-0100

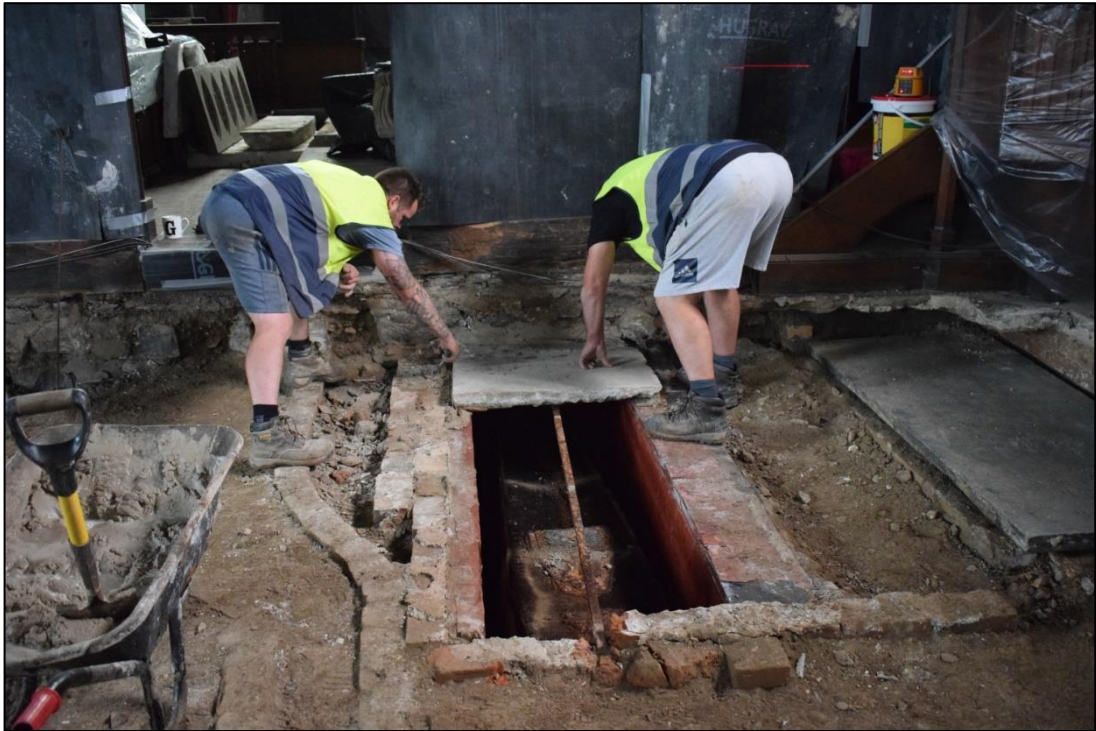
Fig. 12: The placement of the new capping stones over the north part of the vault. The ledger is in its lowered position. CPAT 4679-0105

- 3.14. In order that the new floor could be installed safely, the thin slabs capping the north side of the vault were replaced with thicker material (Fig. 12). The ledger on the south side also needed lowering and to this end it was moved out of the way, a number of brick layers were removed and the ledger then replaced in its correct position. No grave contents were revealed or disturbed.

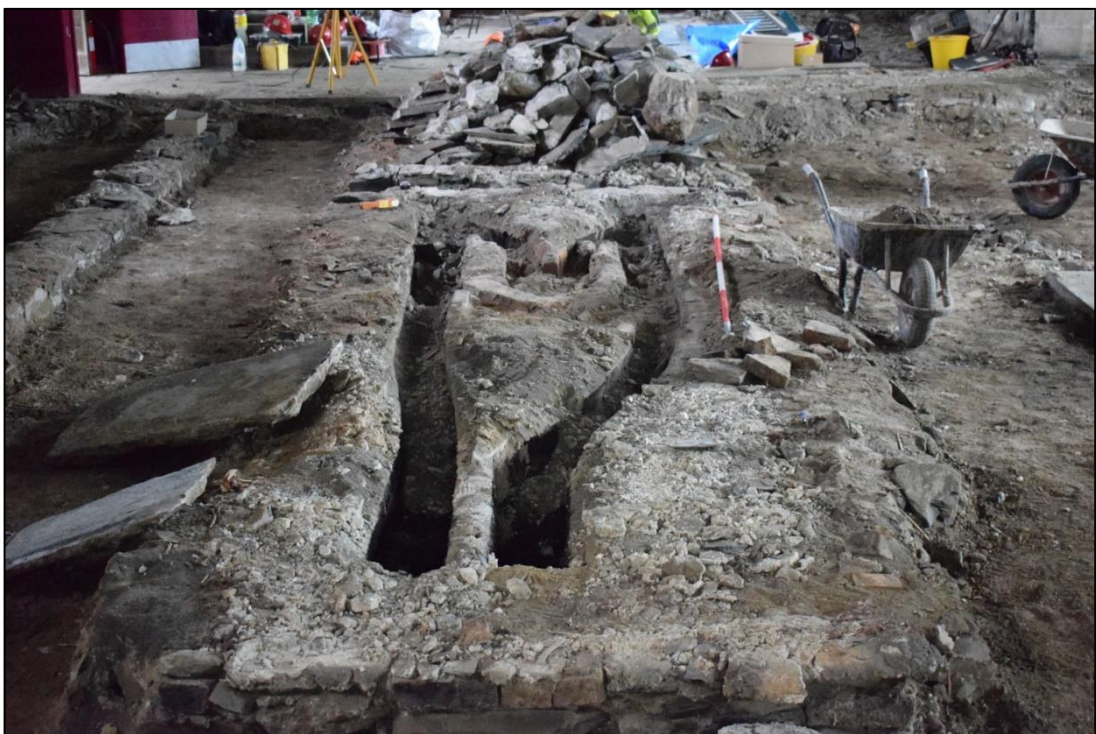
- 3.15. The only other feature of interest in the floor was the remains of a series of underfloor ducts (Fig. 13) likely to relate to a 19th-century heating system. These originated in the area of the tower and passed under the floor of the nave, continuing beneath the rood screen and into the chancel. The structural remains of these were retained in-situ, where possible; they have only been recorded in plan where they relate to earlier features of the church interior.

Fig. 13: Underfloor ducts in the nave, most likely from a 19th-century heating system. CPAT 4679-0057

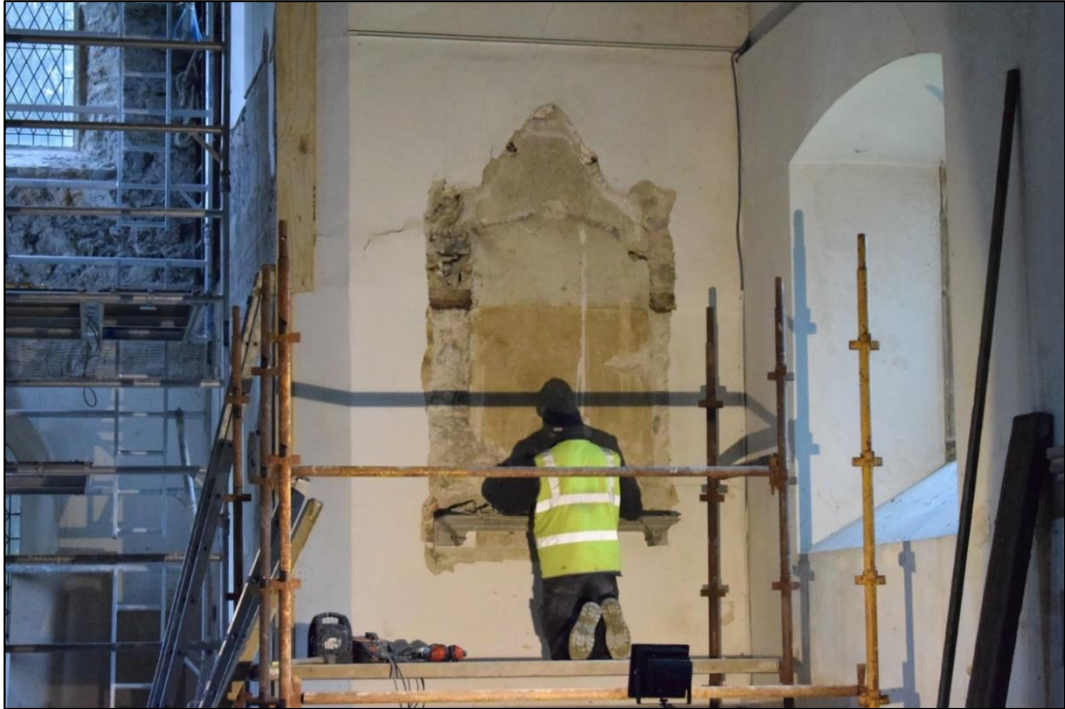
Fig. 14: The wall monument on the west wall of the nave, to the north of the tower in the process of being taken down, and moved to the north wall of the north aisle. CPAT 4679-0115

- 3.16. A number of wall monuments needed to be moved from their existing positions to allow for the reorganisation of the internal space of the church. Two, on the south side of the tower at the west end of the nave, were placed higher on the wall (Fig. 15). Another, on the north side of the tower (Fig. 14) was removed and attached to the north wall of the north aisle. As far as the writer is aware this work was accomplished without damage to the monuments.

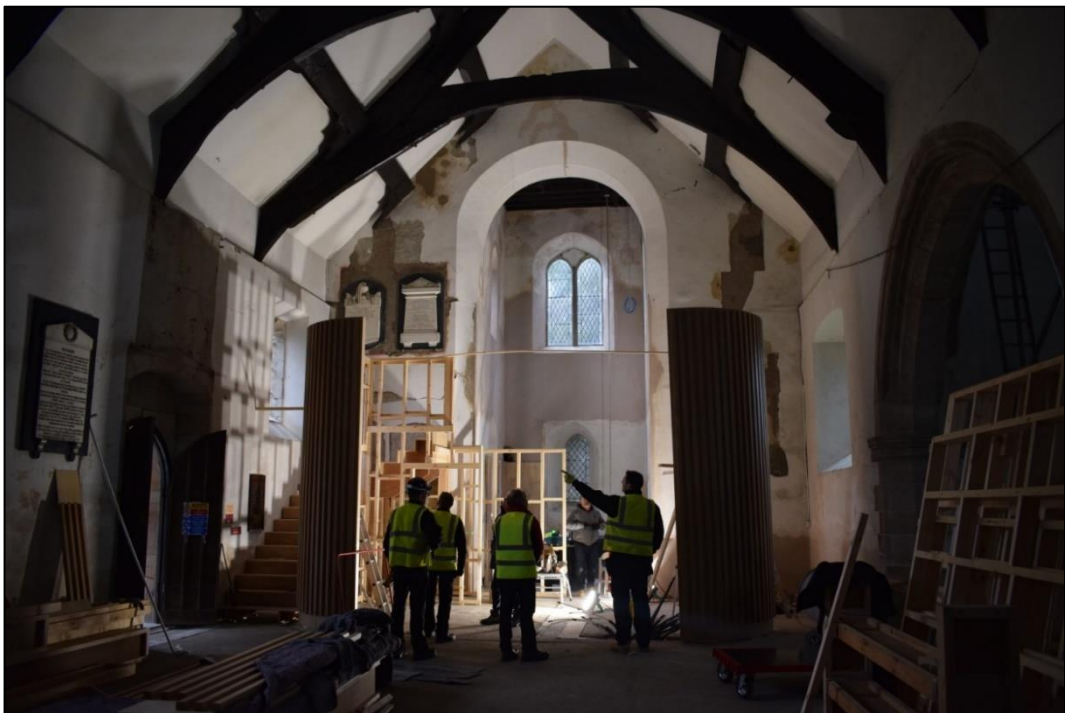
Fig. 15: The west end of the nave after the monuments were repositioned. CPAT 4679-0179

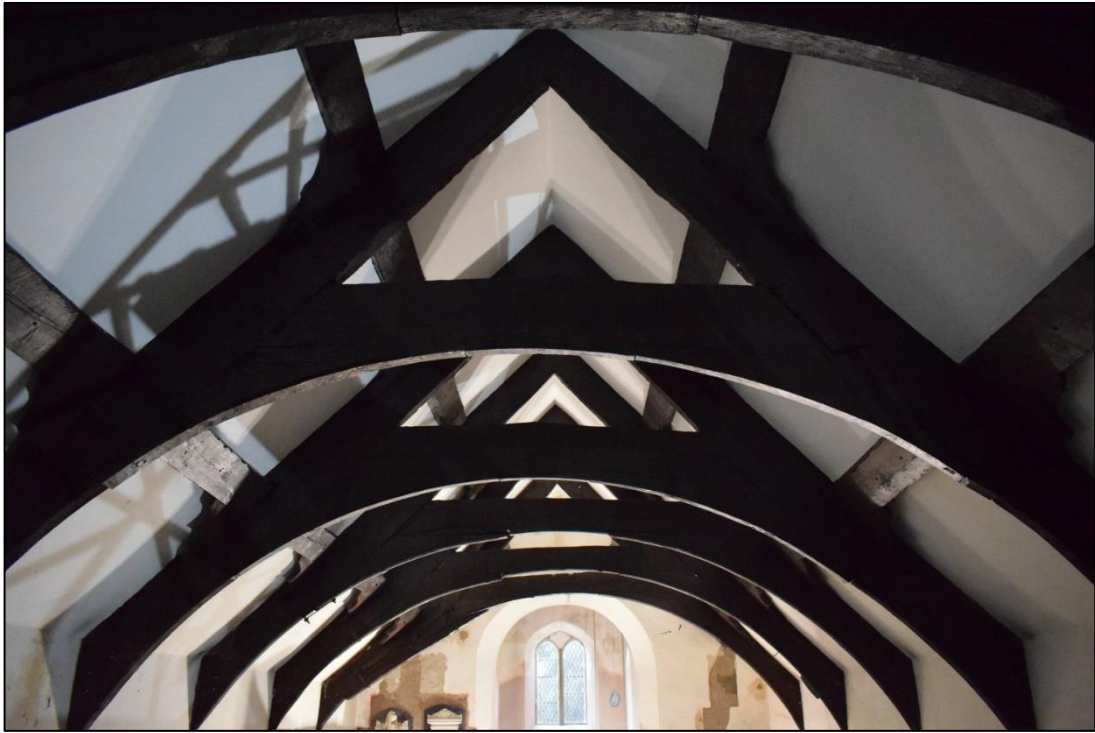
Fig. 16: The roof trusses in the nave taken from the top of the rood screen, from the east. CPAT 4679-0181

- 3.18. Access was possible to the walkway on the top of the rood screen via the spiral staircase on its north side, where pencil graffiti of 1928 was noted in passing. This allowed for scrutiny of the corresponding roof truss, but little of significance was observed. It was interesting that there was some evidence of probable repairs where timbers had been bolted together (Fig. 17), though when this had been done could not be determined, and the less formal nature of the carpentry than that in the north aisle was readily apparent. It was not possible to examine any of the other roof trusses.

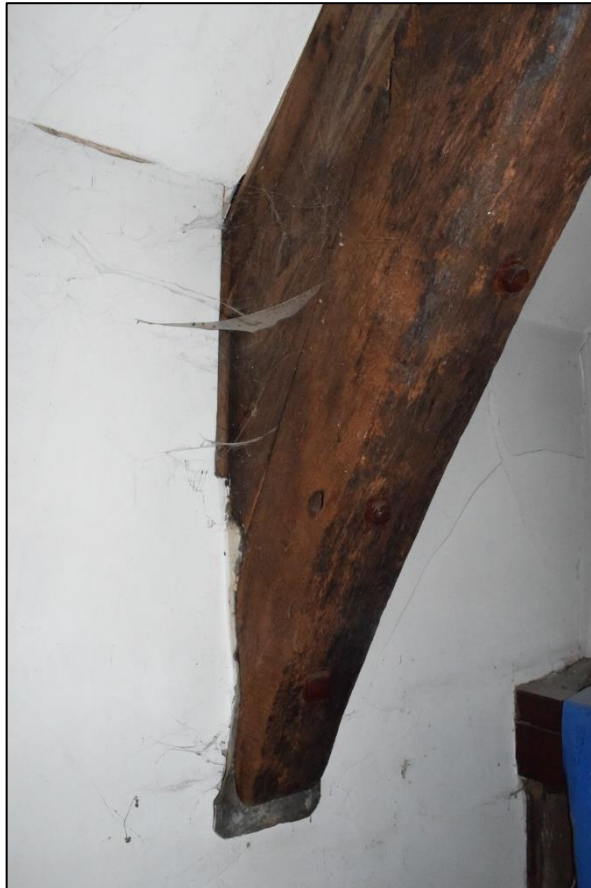
- 3.19. It is widely agreed by previous sources that the roof of the nave and chancel dates to the late 15th century and the visible features gave no reason to doubt this attribution. It was evident that the pattern of the original roof timbers and windbraces (Fig. 18) was copied to provide the roof structure of the 19th-century north aisle (Fig. 19).

Fig. 17: The south side of the roof truss crossing the rood screen, showing bolted repair, from the north-east. CPAT 4679-0183

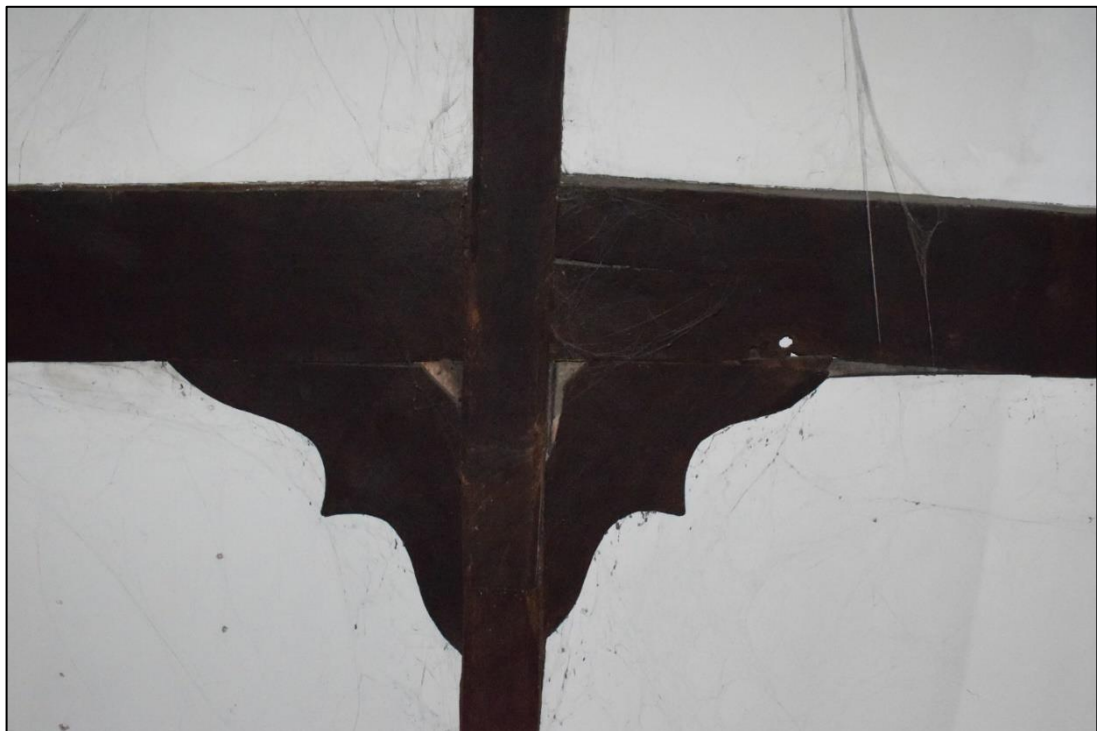
Fig. 18: Windbraces on the roof truss crossing the rood screen, which most likely provided an overall appearance copied to shape those in the north aisle (see Fig. 19). CPAT 4679-0182

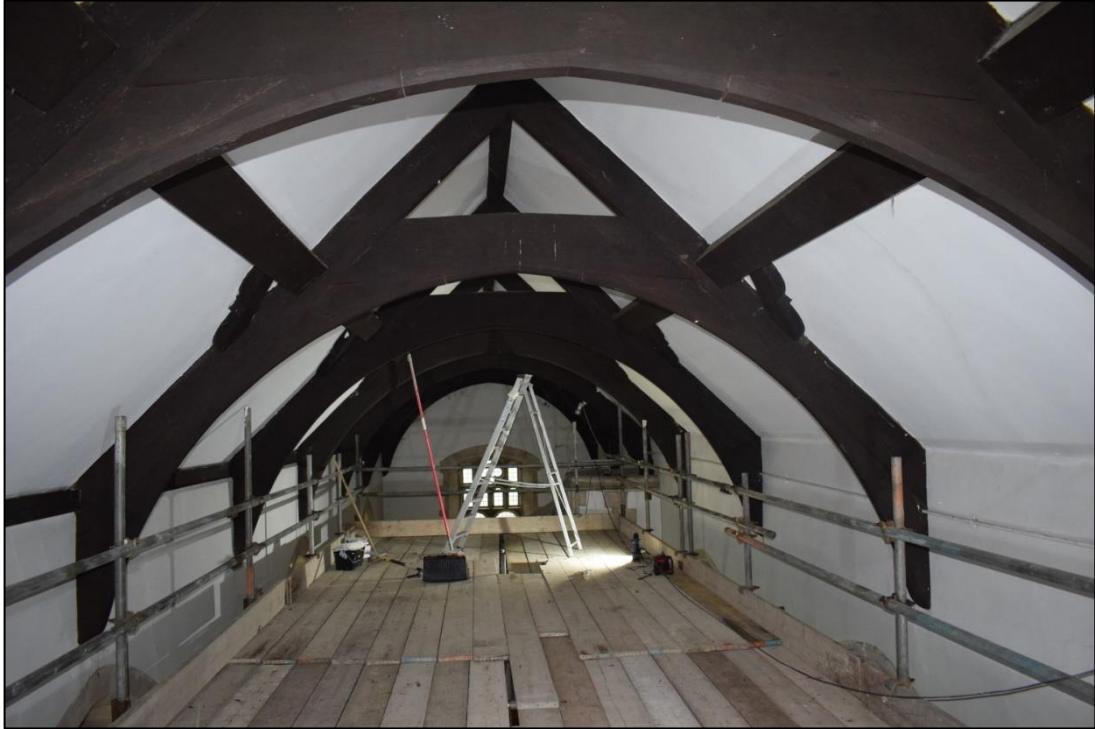
- 3.20. Scaffolding was erected in the north aisle to allow the ceiling to be painted, which allowed close scrutiny of the timbers; these all appeared to be machine sawn and very much made to a pattern. No reused timber was found and there were no carpenter's marks. The timbers were evidently all created at the same time for use here, something highlighted by the similarity between these windbraces and trusses and those in the original roof of the nave. The roof almost certainly dates to the end of the 19th century, when the aisle was constructed.

Fig. 19: The roof trusses of the north aisle. CPAT 4679-0173

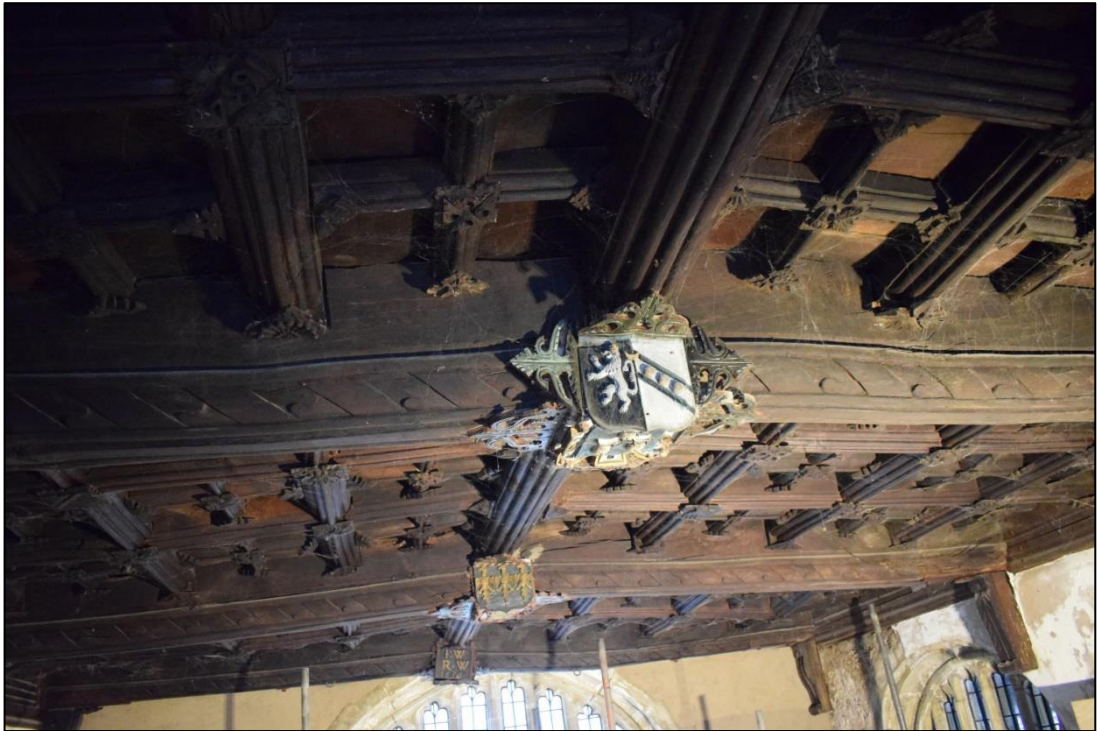
- 3.22. Close observation demonstrated that the roof of the chapel (Fig. 20) had been subject to fairly extensive repair, probably owing to deterioration of the timbers. The places where major beams rested on wall brackets seemed to have been particularly susceptible, the beams often having metal reinforcement added to their ends to support the roof structure (Fig. 21).

Fig. 20: The chapel roof. CPAT 4679-0156

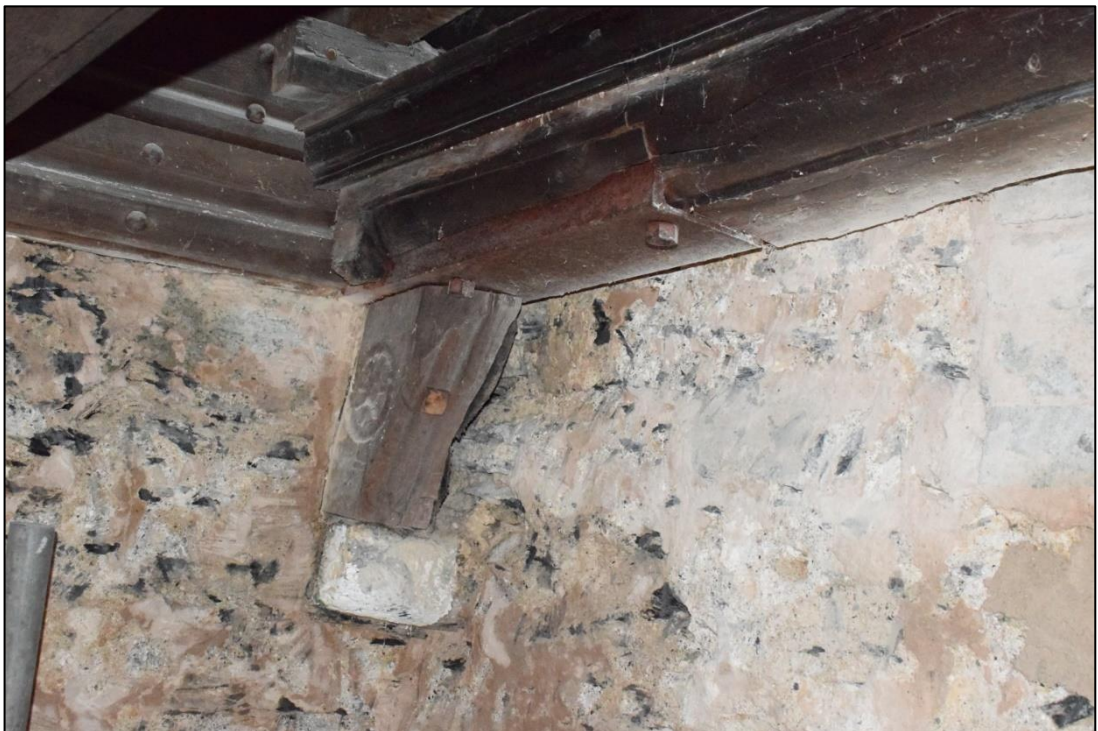
Fig. 21: Repairs at the south-west corner of the chapel roof. CPAT 4679-0162

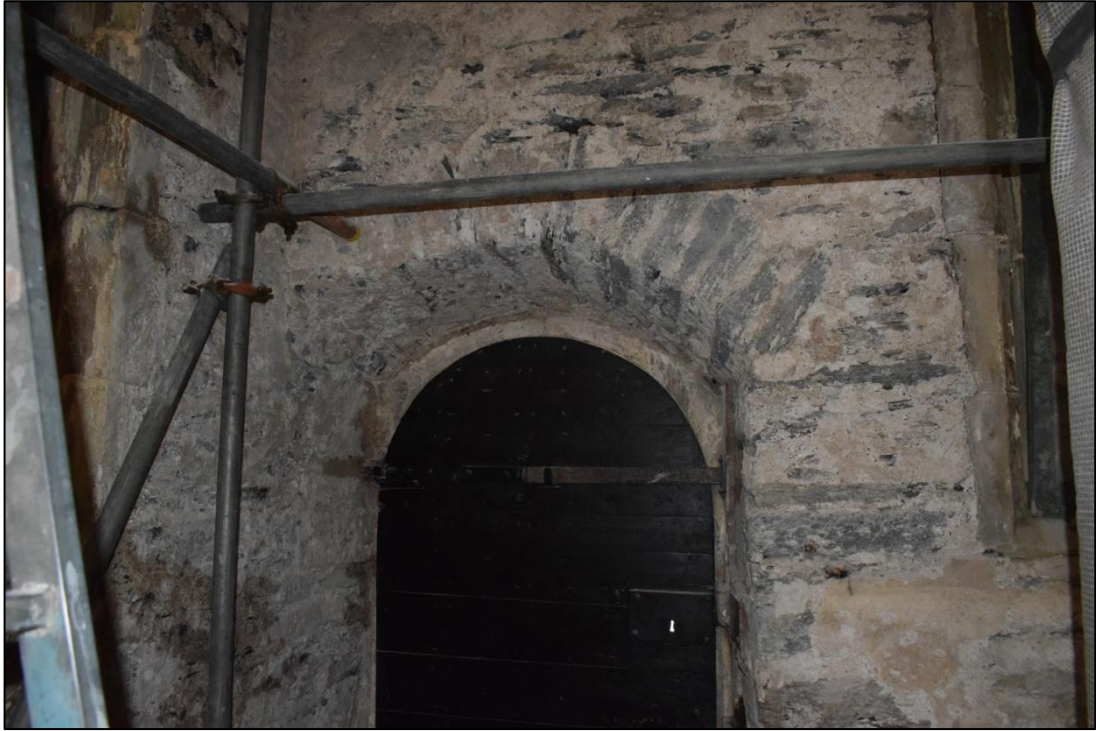
- 3.23. Little additional information was forthcoming from the repointing, the only evidence that had not been recognised related to the west (external) doorway of the chapel, where the stone arch (Fig. 22) forming the doorhead was exposed and a slot in the wall was identified which seems to have been used to permit a wooden bar to be inserted in the wall which could then be drawn across the internal side of the door to secure the entrance (Fig. 23).

Fig. 22: The stone arched doorhead at the external door at the south-west corner of the chapel. CPAT 4679-0169

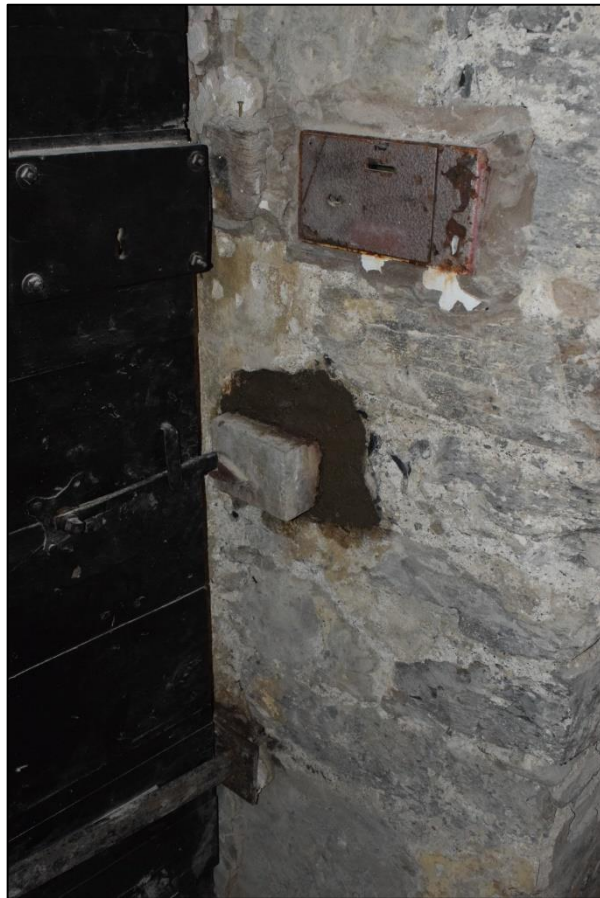
Fig. 23: The location of the (repointed) wooden drawbar slot on the external door of the chapel. CPAT 4679-0171

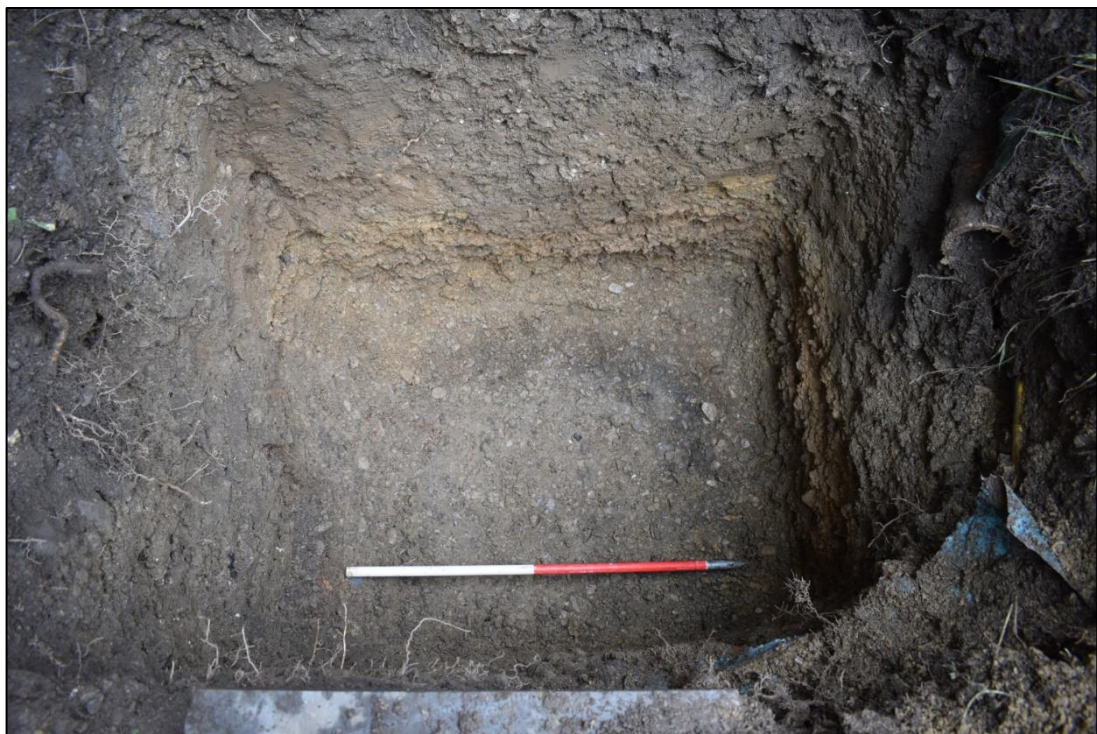
- 3.25. Immediately to the south of the tower, a trench was excavated to place a new sewage treatment plant, measuring 1.2m by 1.2m and 1.4m deep, which necessitated the moving of a ledger (No. 15) a short distance to the south-west. The outline of the east end of a grave and traces of a wooden coffin presumably relating to the ledger could be seen in the base of the trench (Fig. 24). The dates on the ledger were from 1844 to 1911, though the appearance of the grave suggested it was earlier than the latest of these dates.

Fig. 24: The trench excavated to place the new sewage treatment plant, showing the outline of the grave, from the west. The end of the repositioned ledger 15 is visible in the foreground. CPAT 4679-0120

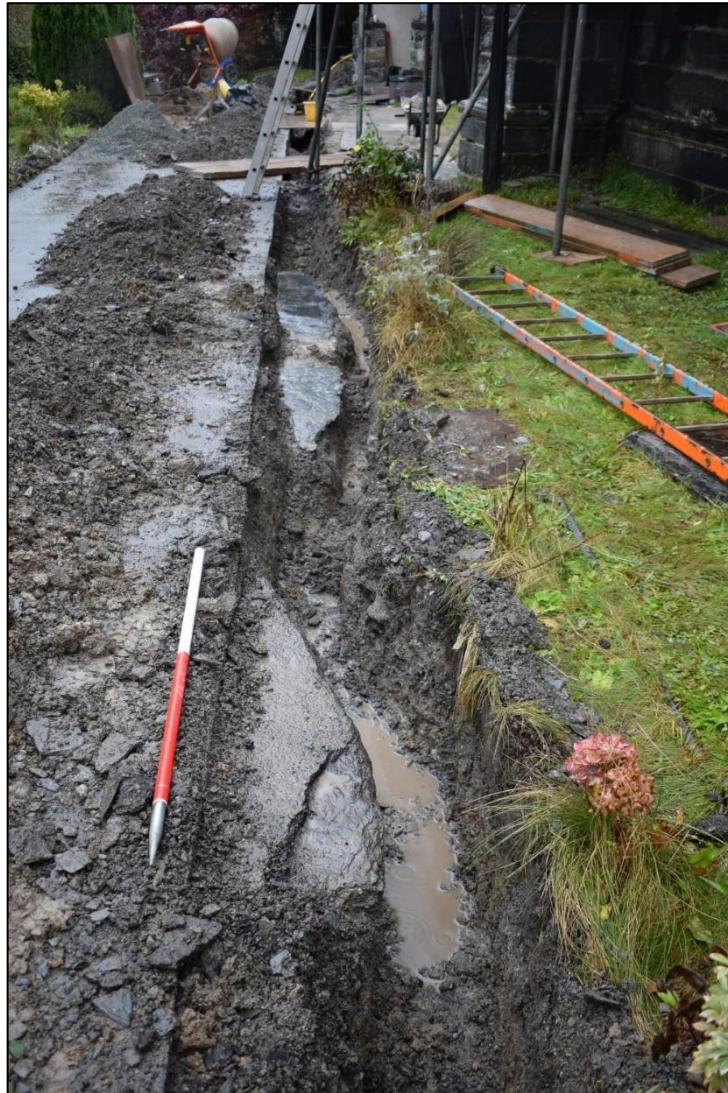
- 3.26. A narrow trench, no more than 0.5m wide, was then excavated from the treatment plant, following the church path towards the ornamental gates to the east. As noted above, a number of ledgers were revealed beneath the path, some of which had 18th-century dates. As the trench neared the gates, it turned across the path to run south to its outlet into the local sewage system. A number of ledgers were seen in the sides of the southern section of trench but these were left in-situ and no search for inscriptions was made.

Fig. 25: Ledgers visible in the side of the trench for the waste pipe leading from the sewage treatment plant and following the line of the church path. CPAT 4679-0138
