CPAT Report No. 1728

St Grwst's Church and Gwydir Chapel, Llanrwst, Conwy

Archaeological Watching Brief

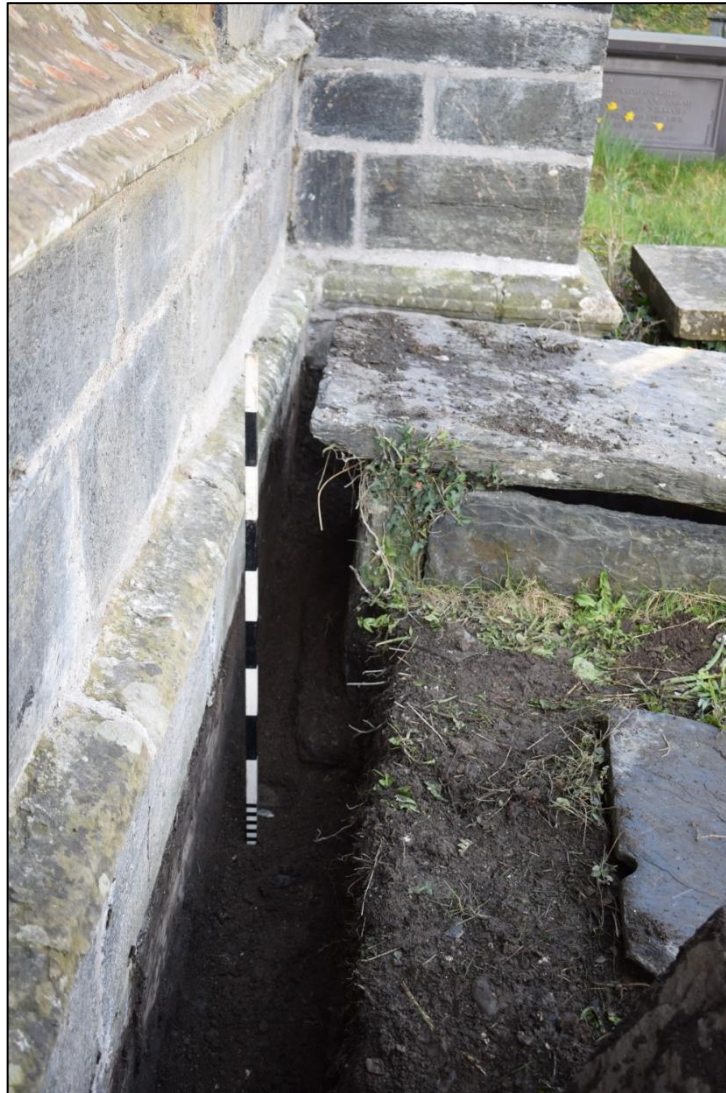
- 3.27. A 'French' drain was installed against the outer walls of the chapel to reduce the levels of damp in the interior, this involved the excavation of a narrow trench, 0.3m wide and 0.4m deep, on the east and south sides of the chapel, to prevent the build-up of moisture against the outer wall.
- 3.28. One additional ledger (No. 23; Fig. 47) was revealed close to the south-east corner of the chapel but it had no visible inscription. Otherwise, the only structure revealed was the buried portion at the western end of a chest tomb (Fig. 26) that lies on the east side of the chapel; this is readily visible above ground and has not been specifically recorded.

Fig. 26: The end of the chest tomb on the east side of the chapel, from the south. CPAT 4679-0194
