Monmouth School House Stair 2 Works

Photographic Record | 30/01/2024

Job name
Monmouth School - School House

Job number
3502E

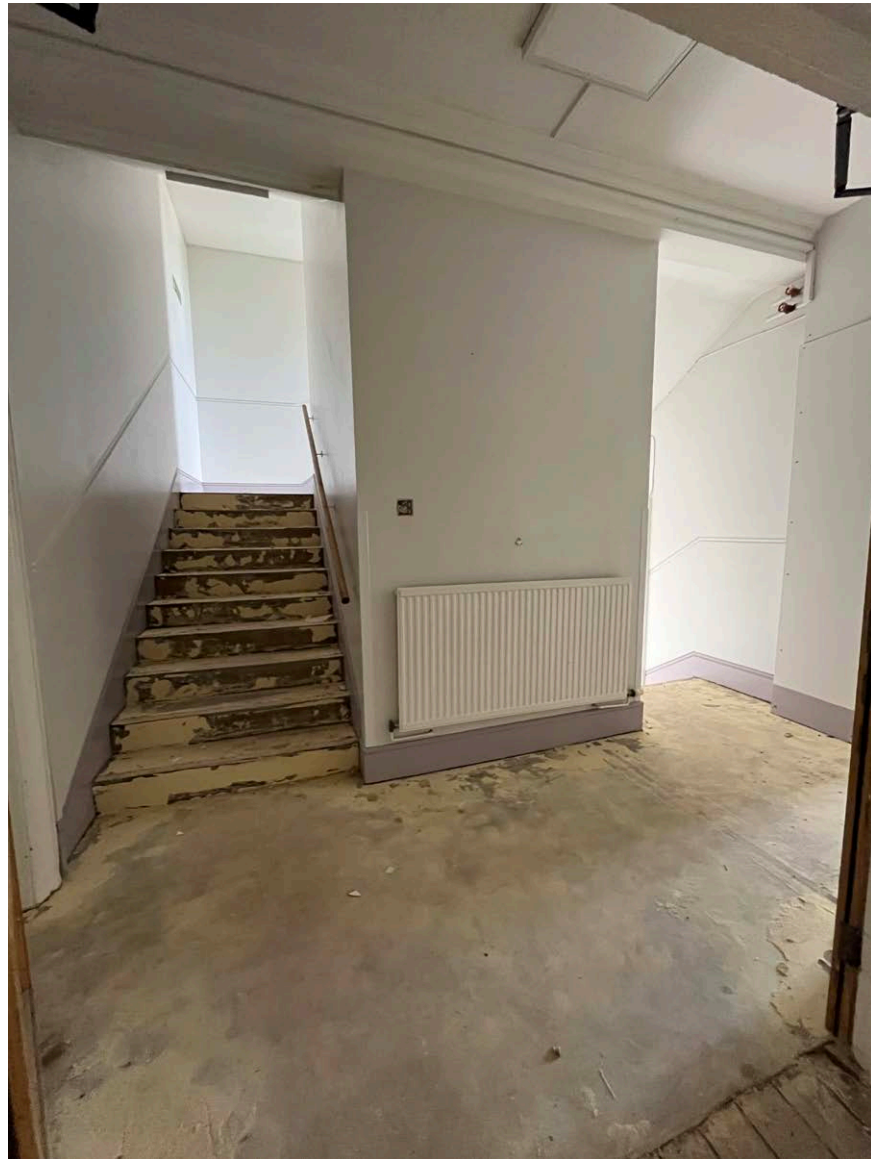
View of existing Stair

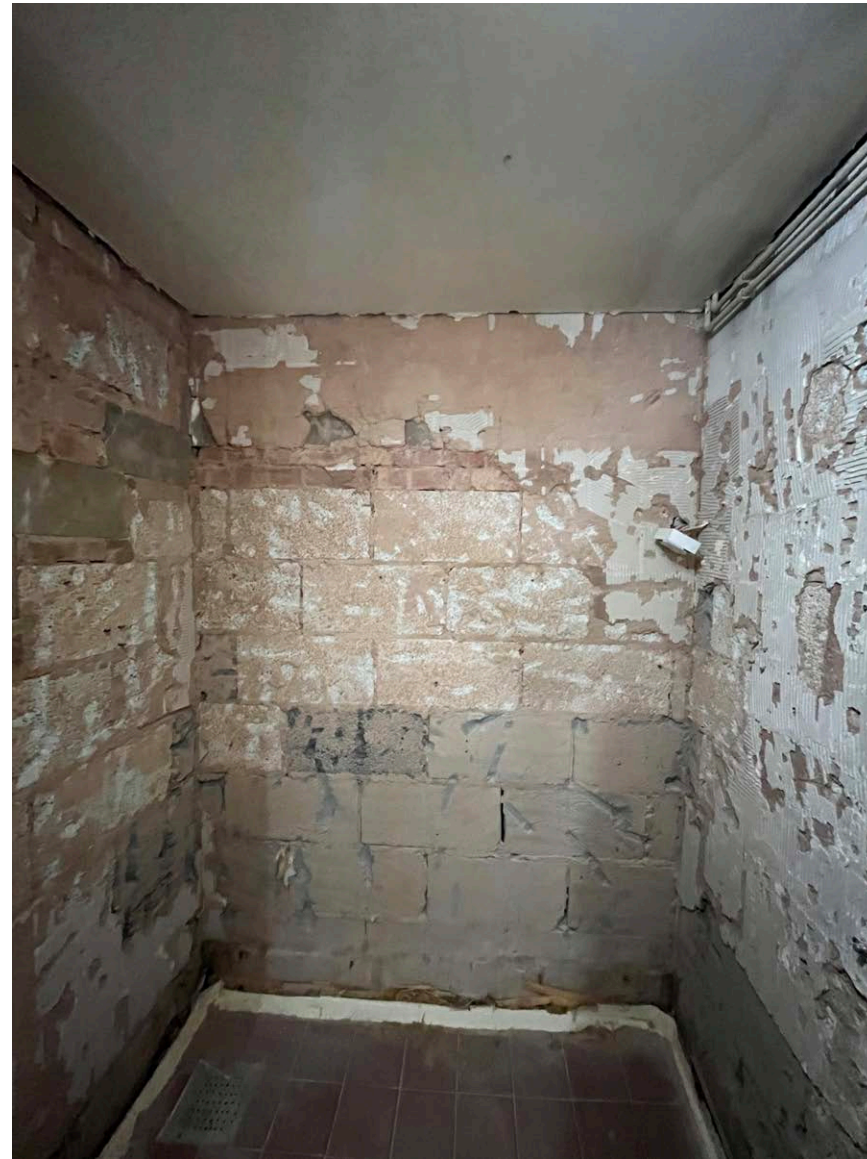
View of existing blockwork in bathroom

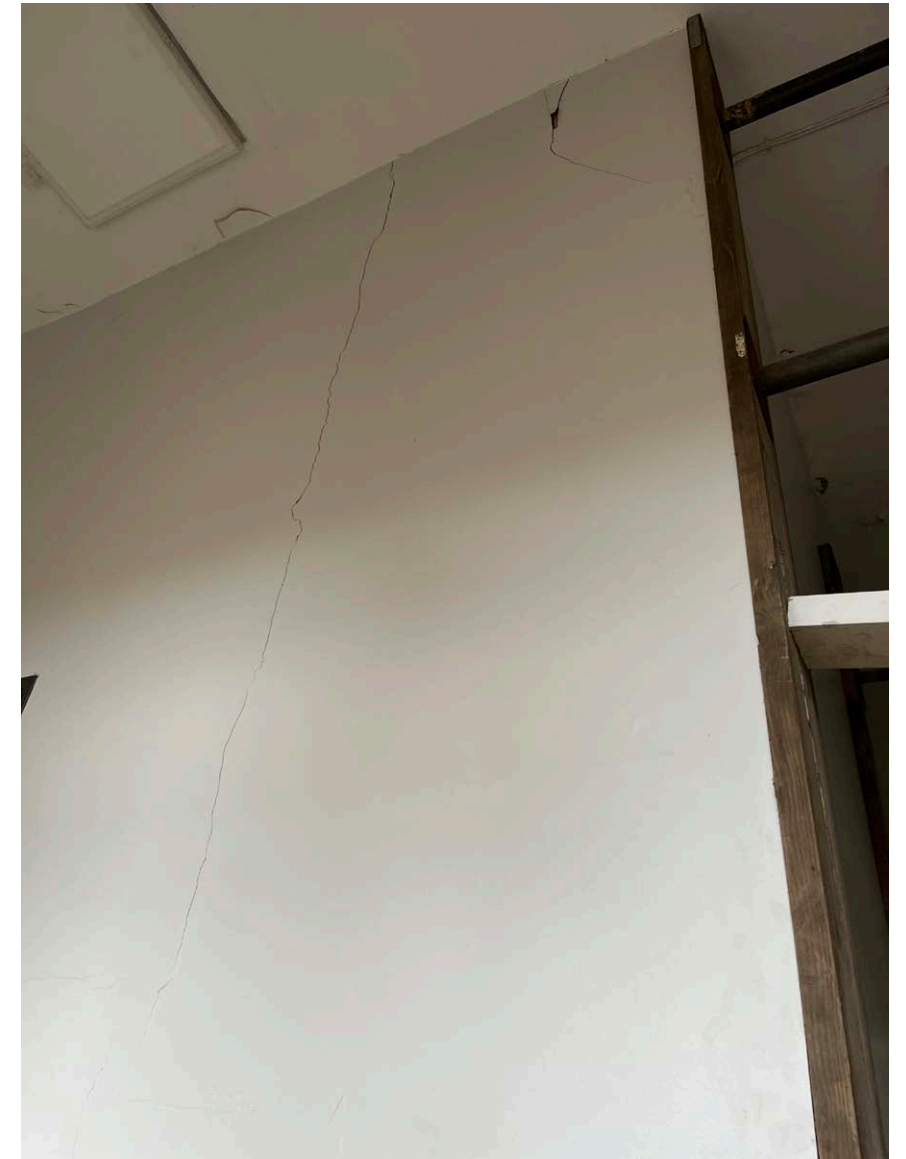
View of existing cracks to blockwork wall
