Airbus Building 058, Broughton

Level 3 Building Survey

Report No . 1975

May 2021

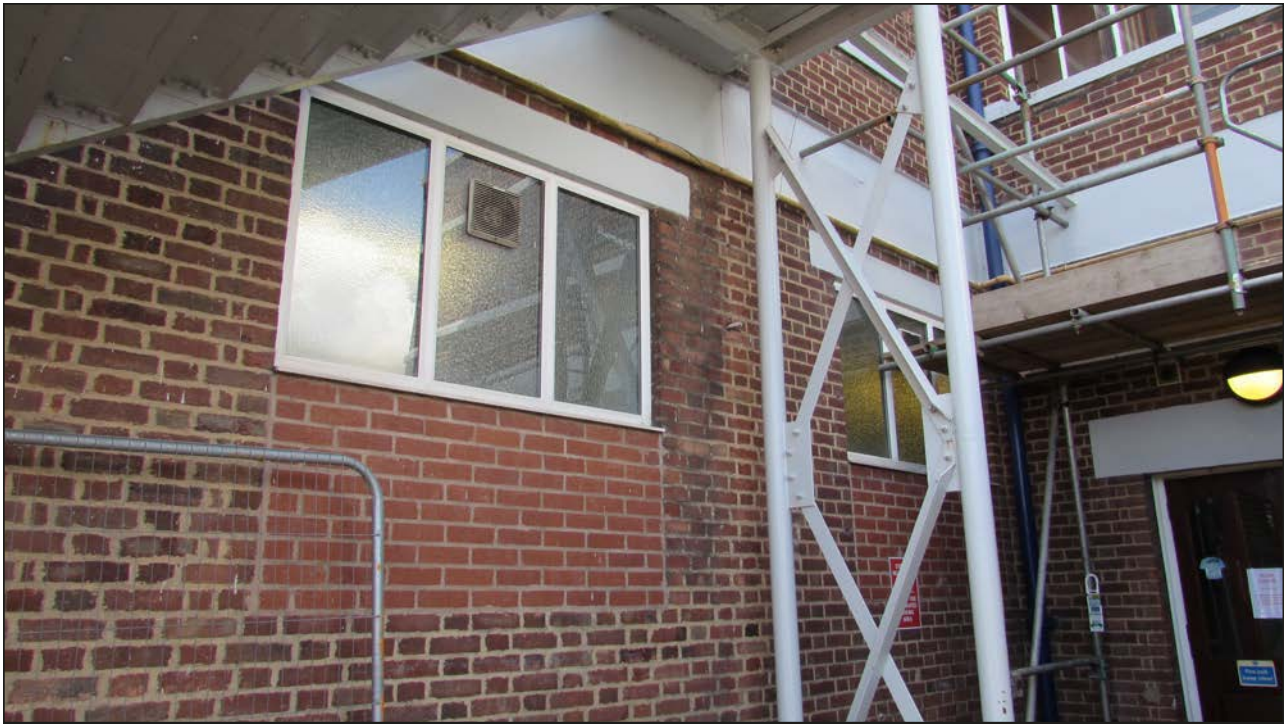
Plate 3. Repair details, NW facing elevation.

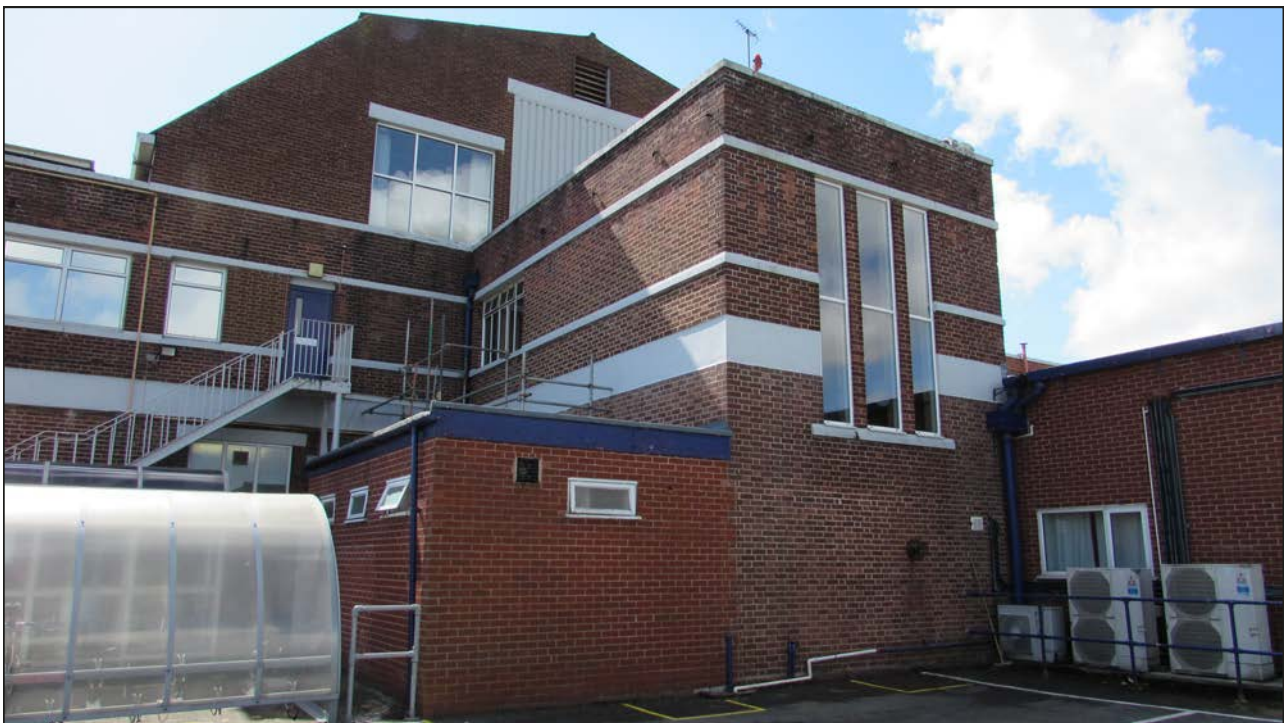
Plate 4. Repair details, NW facing elevation.

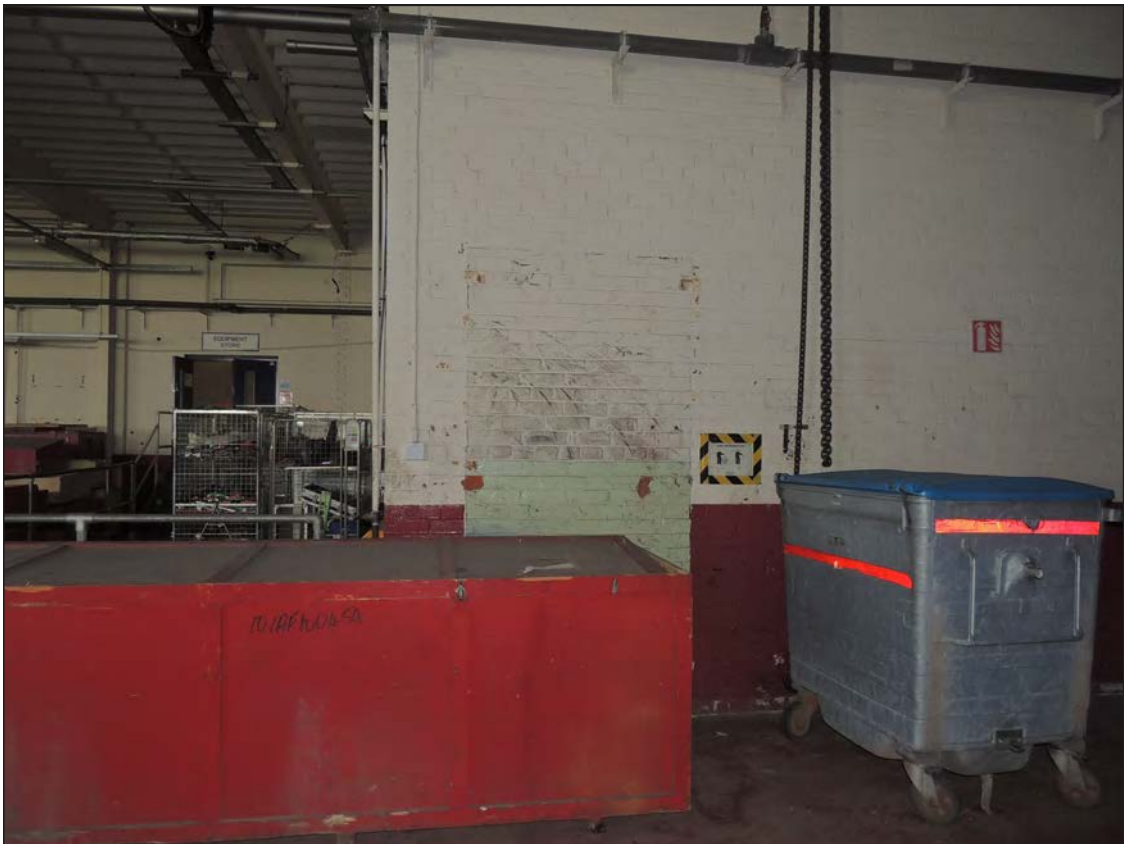
Plate 107. View of a blocked doorway in the garage looking NW

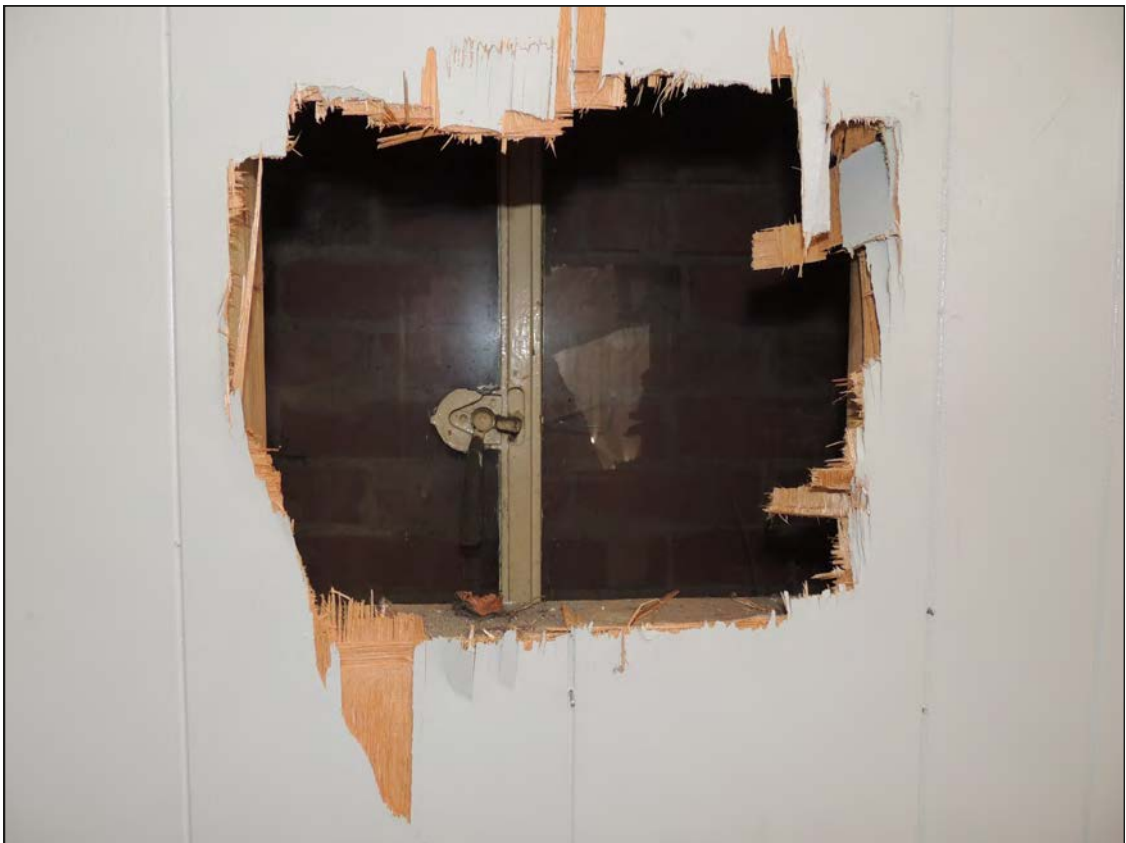
Plate 112. View of possible original windows behind wooden panels looking NW

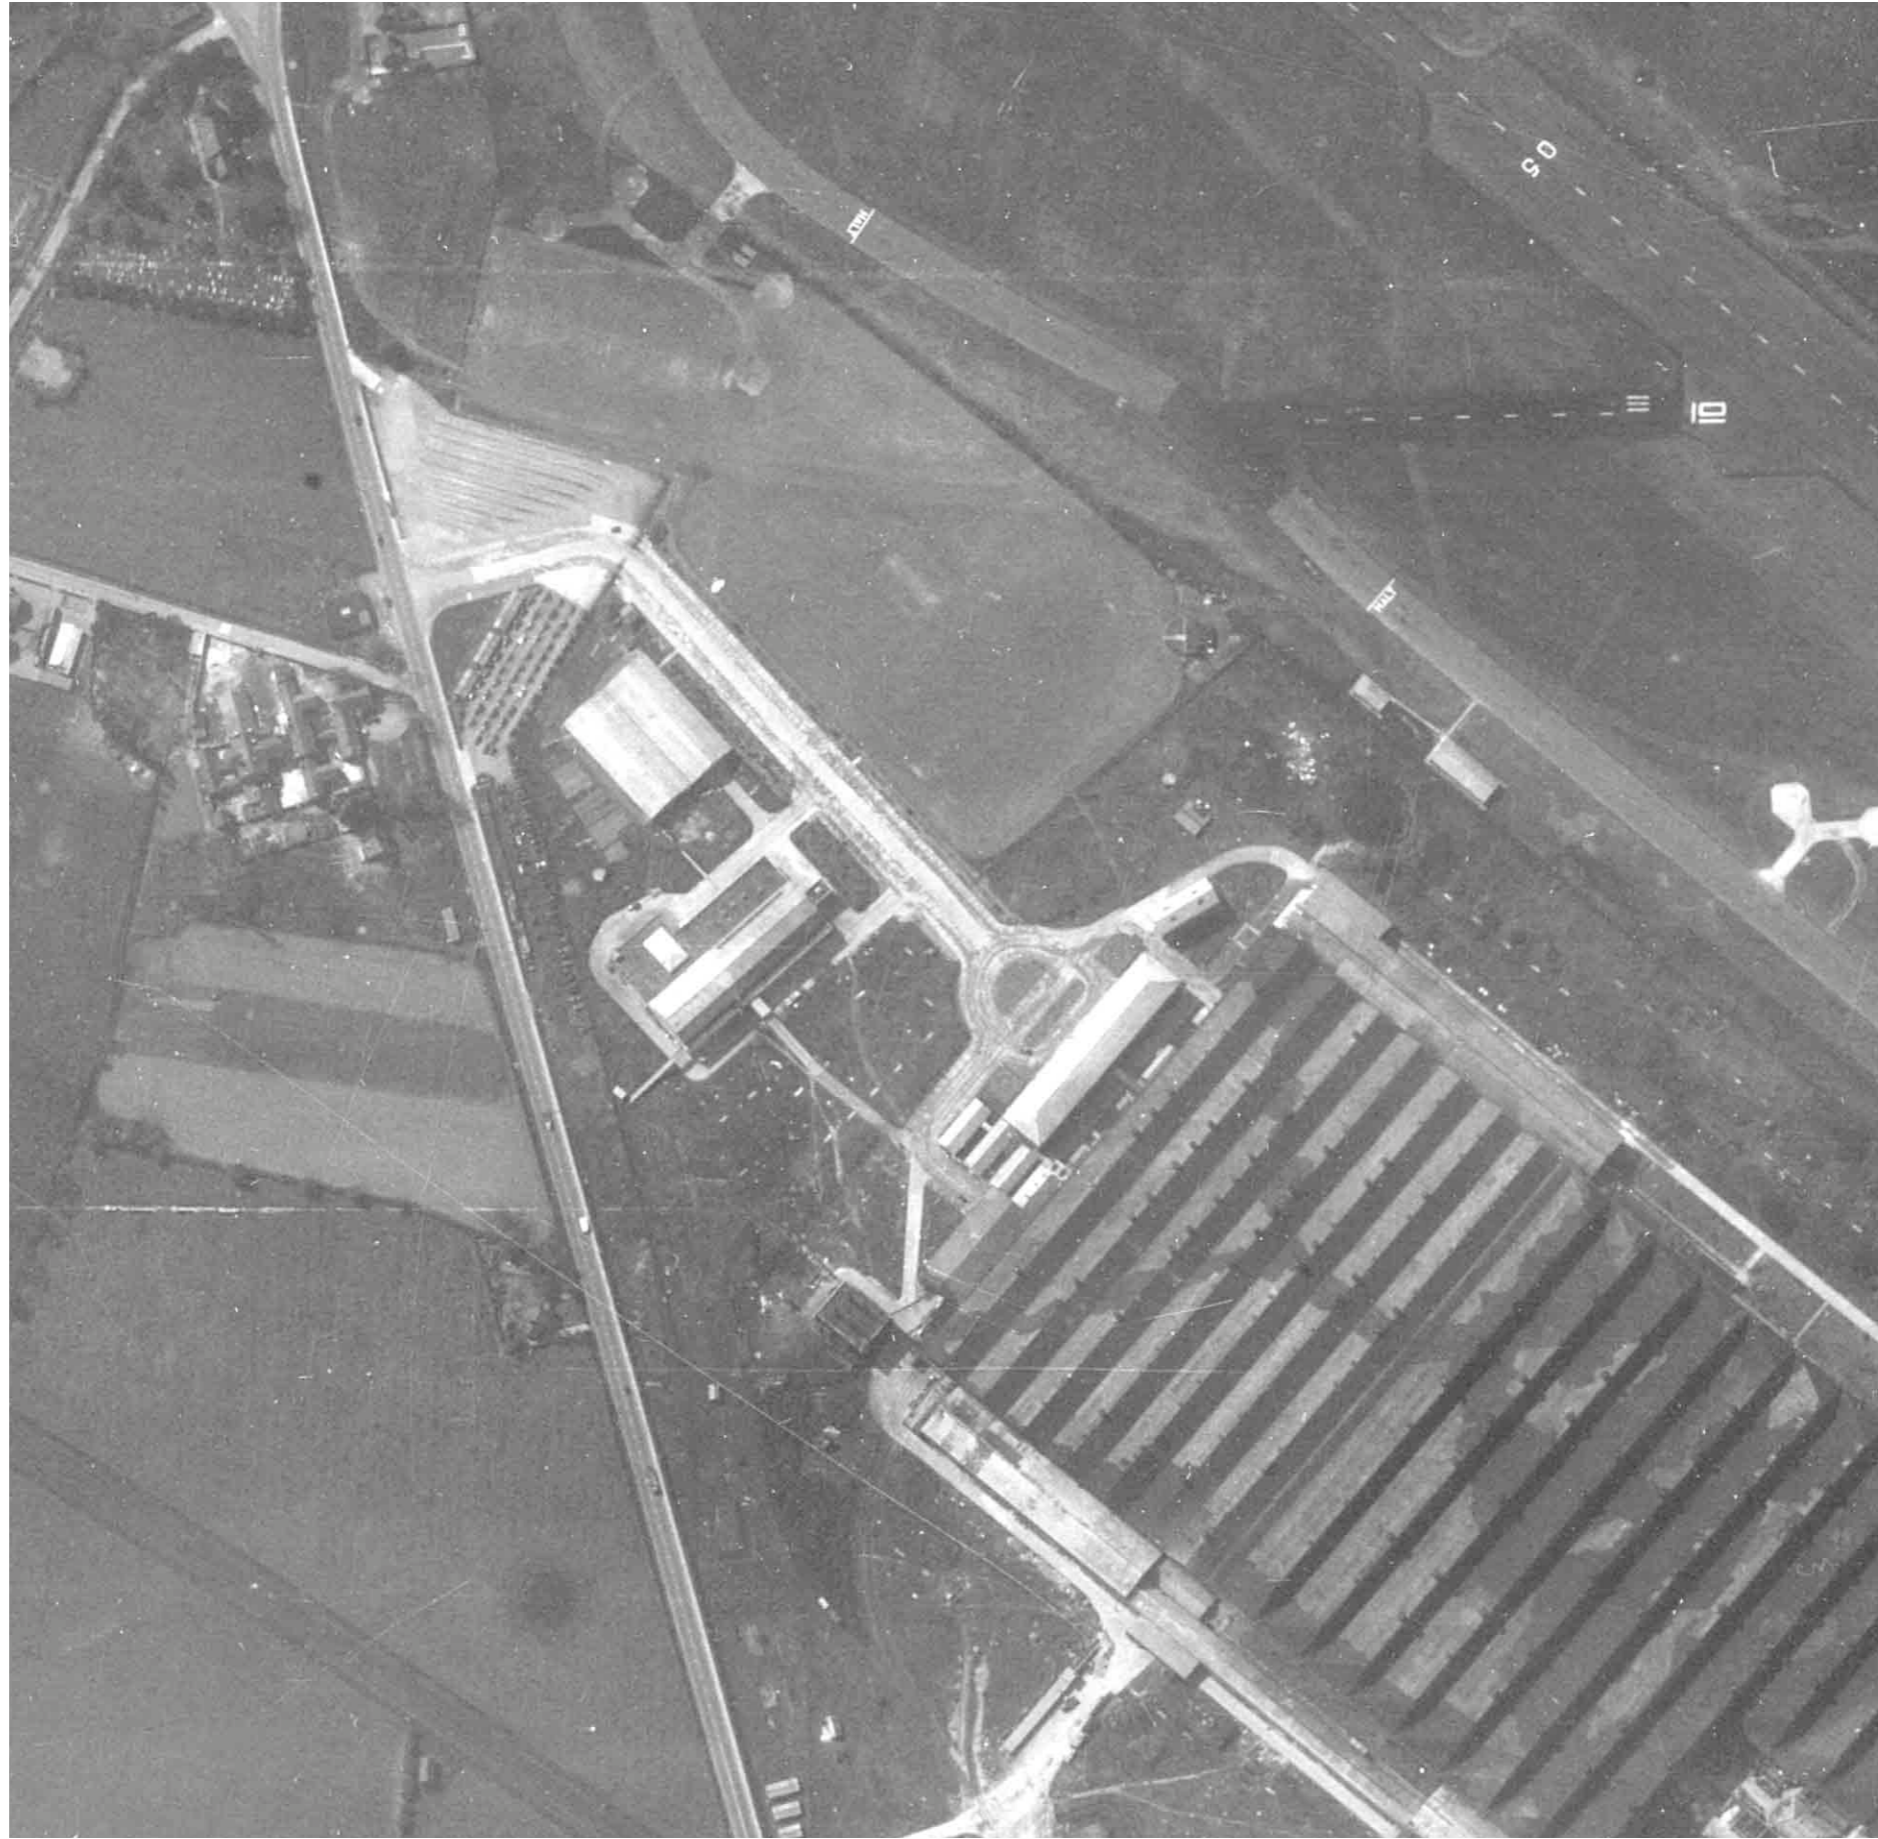
Plate 159. Fragment of 1951 5107 RAF540 491 3189.

site and those who worked there. It does, however, denote the location of a small engineering works and train station at the location of RAF Hawarden. Map SJ36, published 1951, was consulted and found the airfield was not located on the map. However, aerial photographs from 1951 show the airfield in existence as well as building 058 with a corrugated sheeting roof (Plate 159).

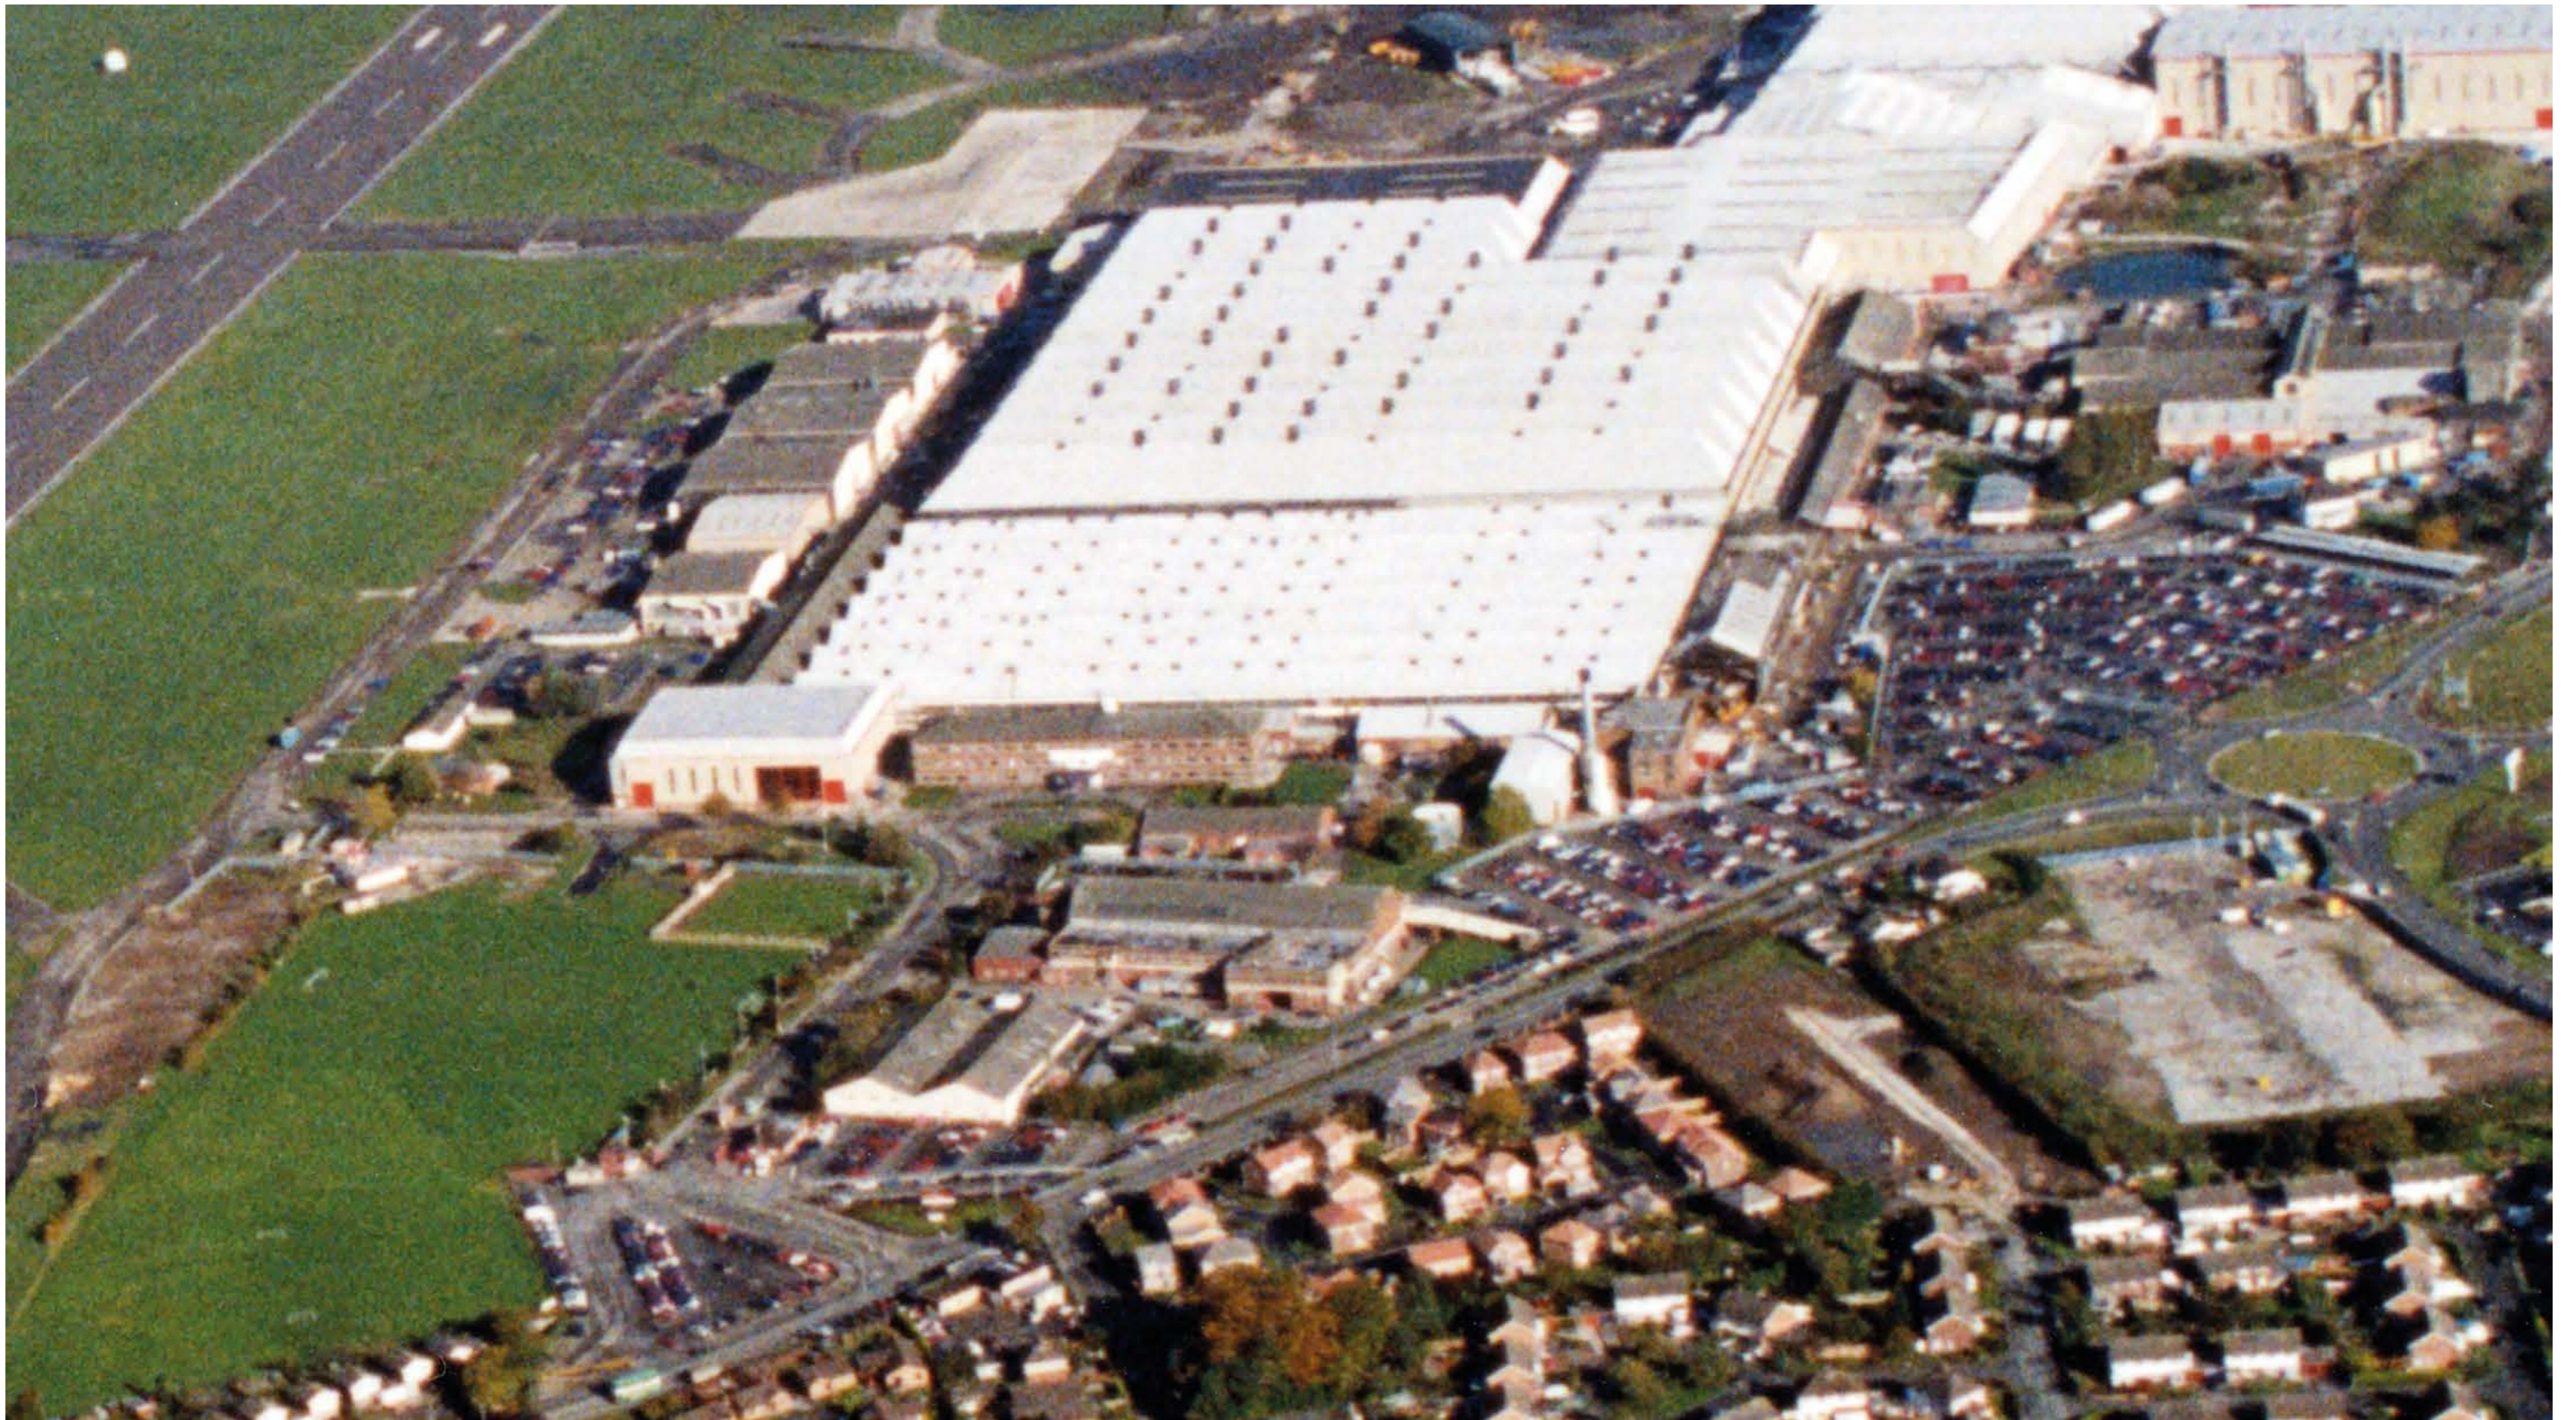
Plate 161. Fragment of 1999 WDA 99139 F38 20A

- 4.11. Cartographic sources dating to 1990 depict the plan of building 058 with an extension to the NW elevation. Otherwise, the shape and form of the building had not changed from the 1960's map to this map. Aerial photographs from 1999 corroborate the presence of the extension to the NW elevation, meaning that the extension comprising of the ground floor artists changing rooms, backstage area and ladies' toilets must have occurred by 1999 (Plate 161).
