**St. David's Church,  
Blaenporth, Cardigan,  
Ceredigion Cardigan SA43 2AP**

*Archaeological Watching Brief*

August 2023

HRSWales  
Report No: 245

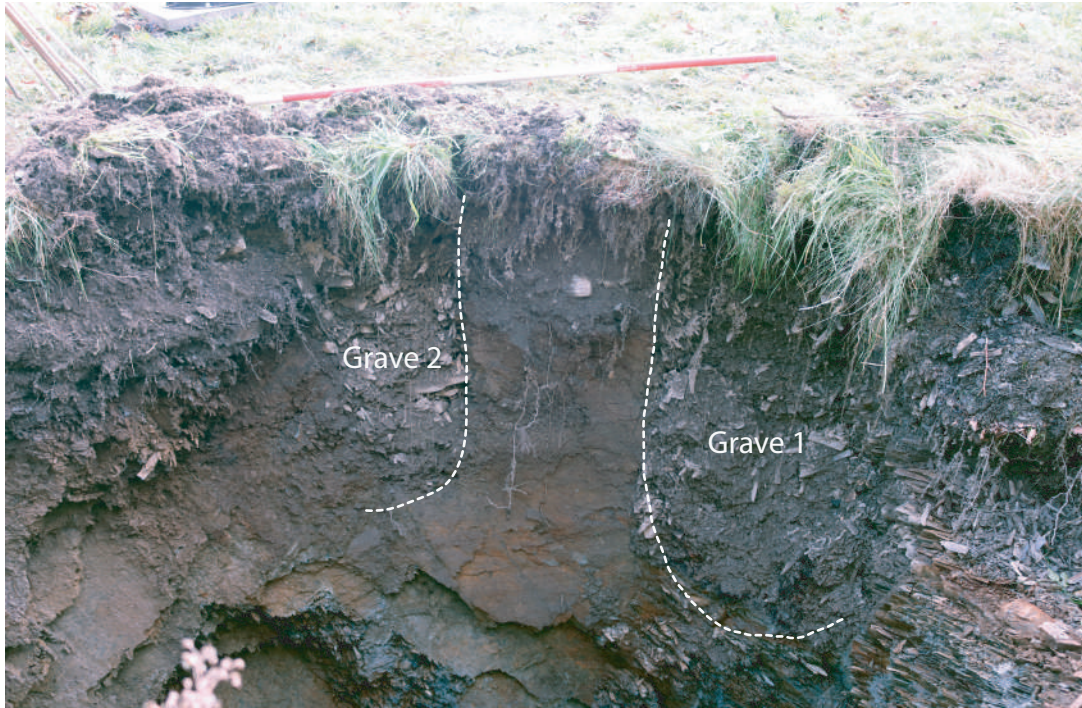
Plate 08. St. David's Church, Blaenporth - West facing section of pit for septic tank. Shows edge of two early unmarked grave cuts. Looking E.

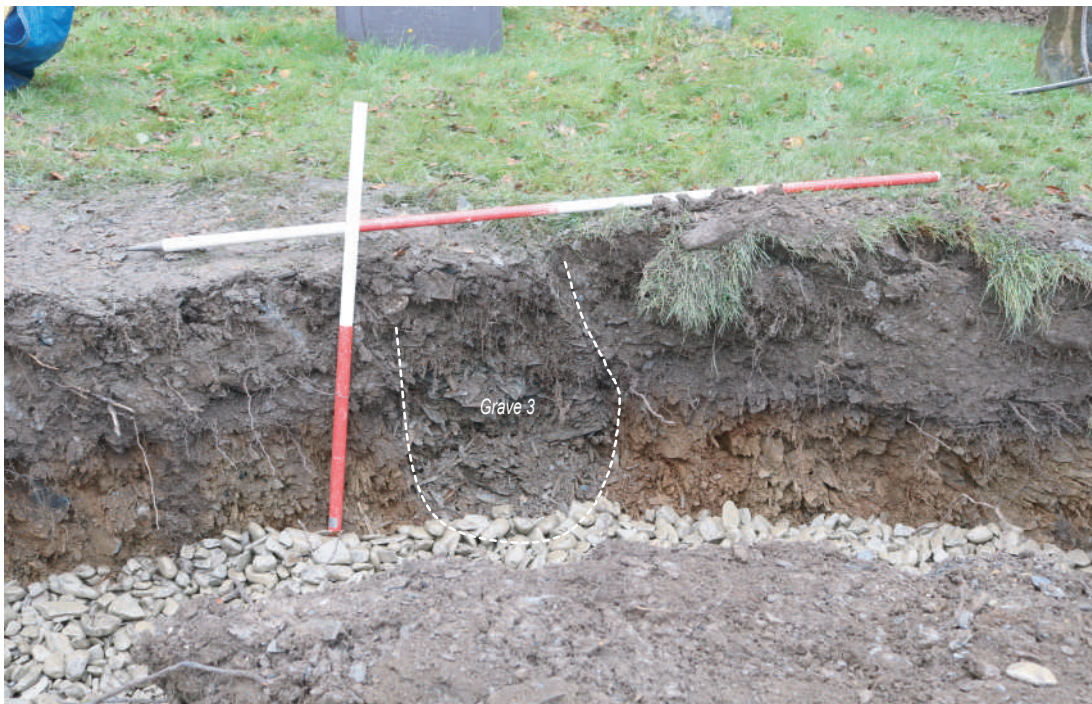
Plate 13. St. David's Church, Blaenporth - View of early grave cut in east facing section of drainage cut. Looking west.

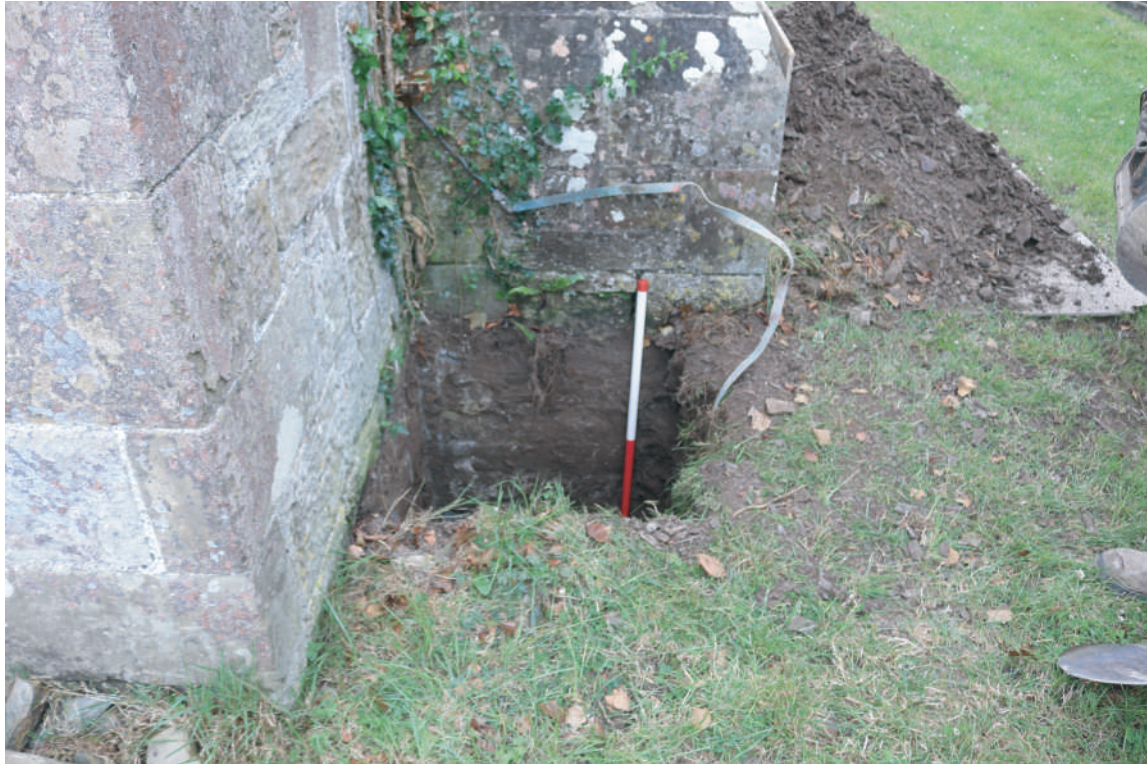
- 5.12 *i)* The trench for Lightning Conductor Plate 1 (L1) was positioned at the far northwest corner of the church. Deposits encountered were the turf (100), top soil (101) and loose shale (102). No significant finds, features or deposits were encountered in this trench, other than the existing copper cable and rod for the pre-existing lightning conductor.

Plate 26. St. David's Church, Blaenporth - Completed Trench for Lightning Conductor Plate 1. Looking S.

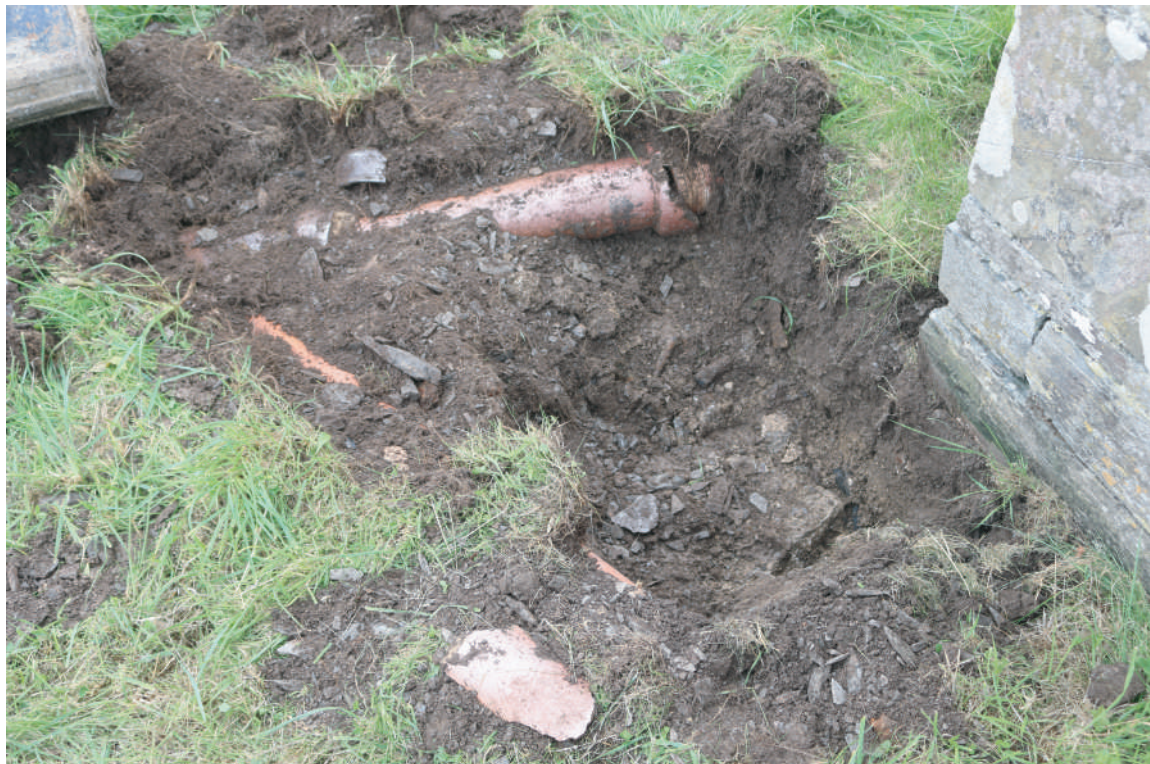
Plate 29. St. David's Church, Blaenporth - Working shot during cutting for Lightning Conductor Plate 2. Note 1930s/50s stone drainage pipe. Looking E.

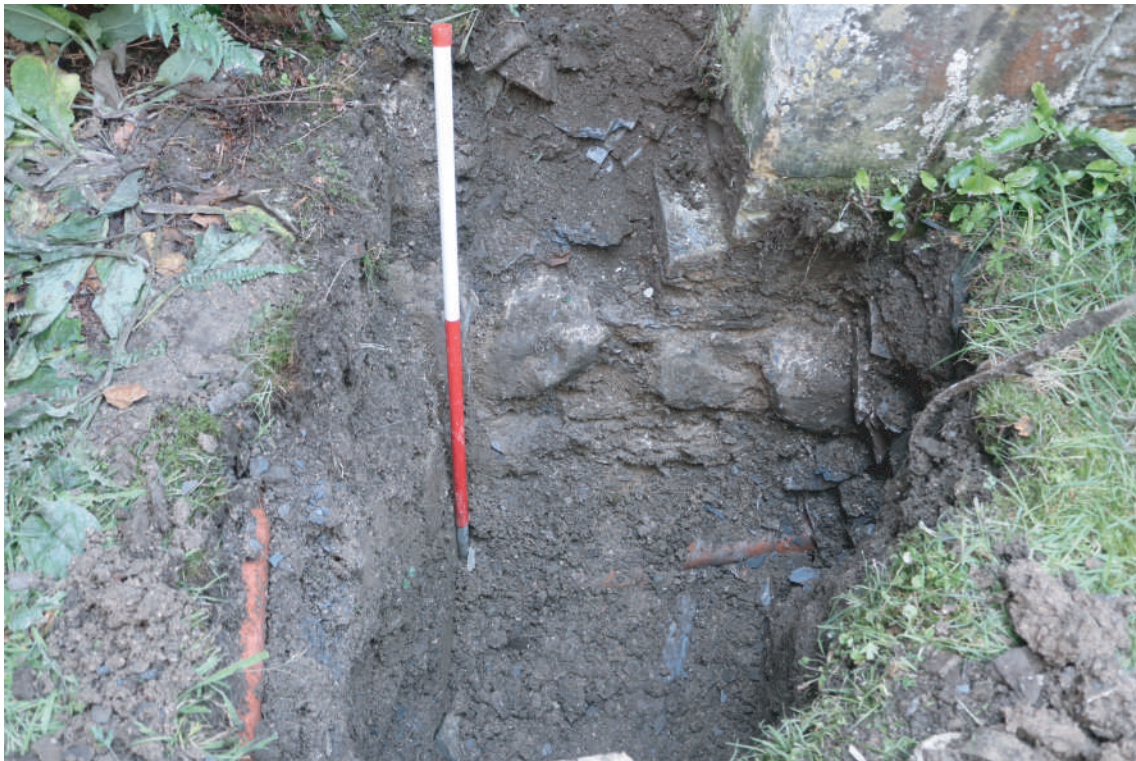
- 6.2 As well as the early unmarked graves, the other interesting find was what appeared to be a small section of the earlier church foundation in one of lightning conductor plate trenches (LT3) positioned beneath the north wall of the church, which implies that the 19<sup>th</sup> Century church was built directly over the earlier foundation.

Plate 33. St. David's Church, Blaenporth - Completed Trench for Lightning Conductor Plate 3 on west side of Vestry. Note foundation for earlier church becoming exposed and 19th Century clay drainage pipe at base of trench.. Looking S.

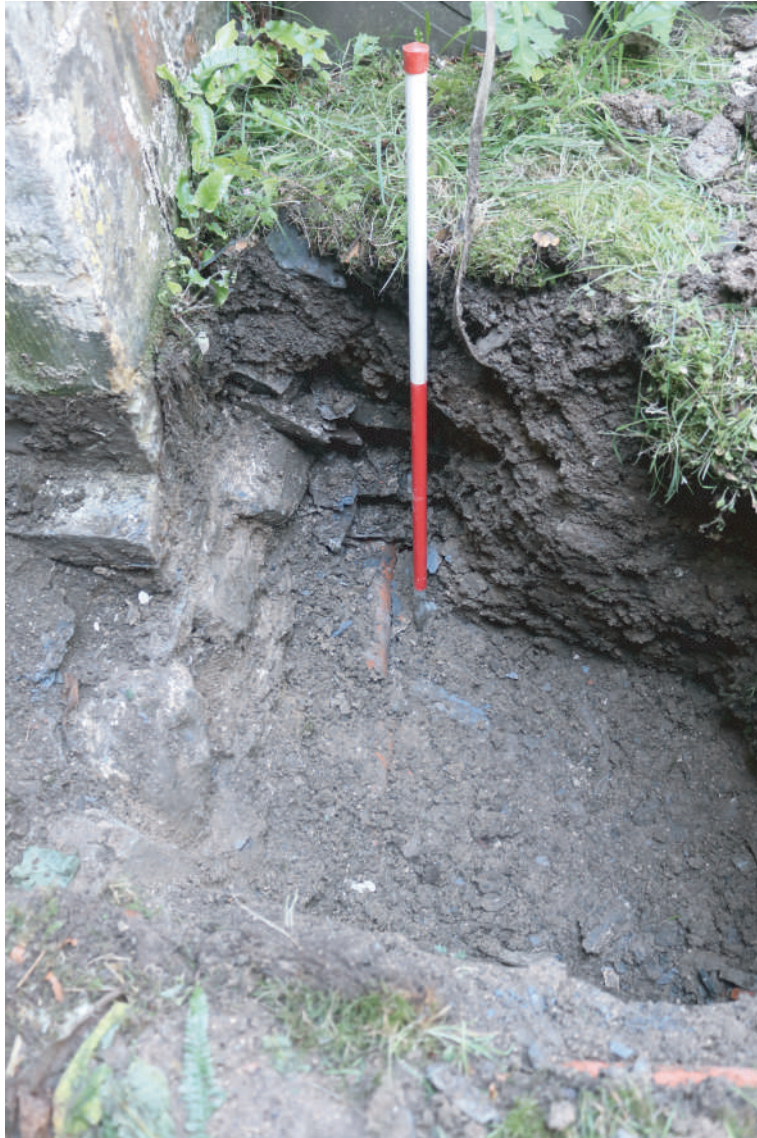
- 5.14 *iii)* The trench for Lightning Conductor Plate 3 (L3) was positioned between the Vestry and the Boiler house, on the eastern side of a tall Victorian gravestone to one James Thomas. In order to avoid potential damage to the grave beneath the gravestone as well as the groundwork possibly compromising the gravestone, the trench was moved, approximately 0.50m further east. Following the removal of the turf (100) and top soil (101) a loose mid brown soil deposit intermixed with shale and

Plate 34. St. David's Church, Blaenporth - East facing section of completed Trench for Lightning Conductor Plate 3 on west side of Vestry. Looking W.
