Llanwnwr Farm, Goodwick Pembrokeshire

Archaeological Watching Brief

Report No. 1312

December 2014

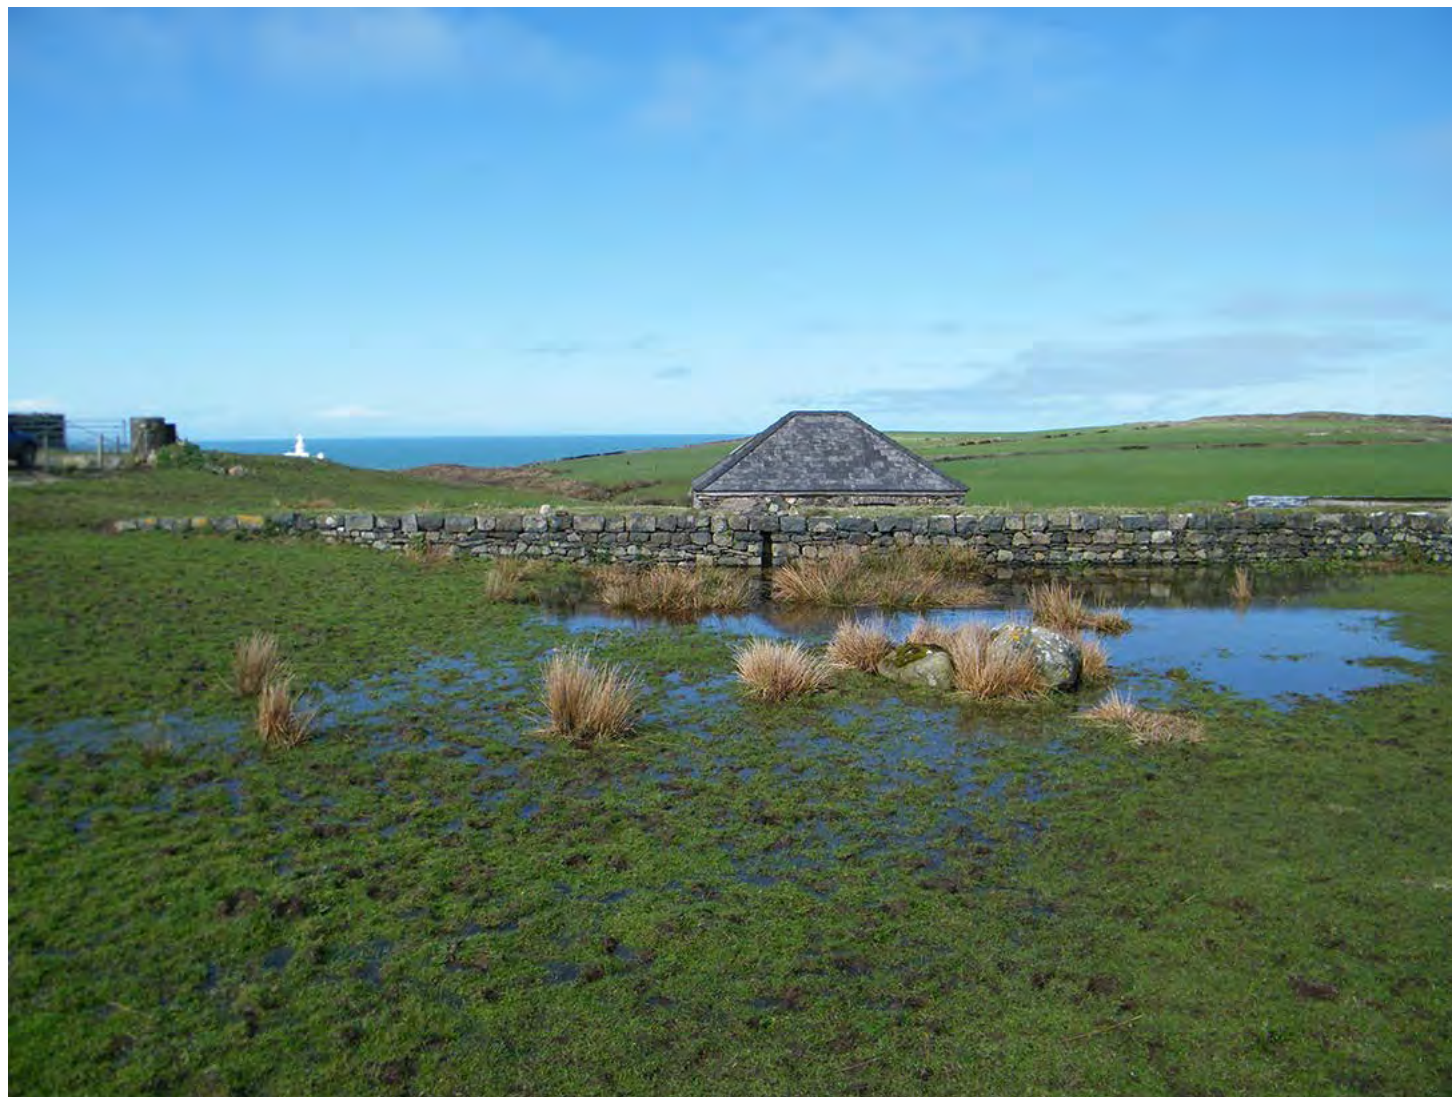
The former waterwheel building [104] is located on the eastern side of the farm, immediately north of the sluice pond. The building and pond date from the late nineteenth century and were used to house and drive a waterwheel that powered agricultural machinery in the nearby farm buildings. The wheel had gone out of use by the 1950s and the building was converted into a pig sty (G. Richards *pers comm*), with an extension on the northern side of the building for the pens. The sluice pond remains intact, although has partially silted up (fig. 3).

Fig. 3
View north over sluice
pond towards the
waterwheel building

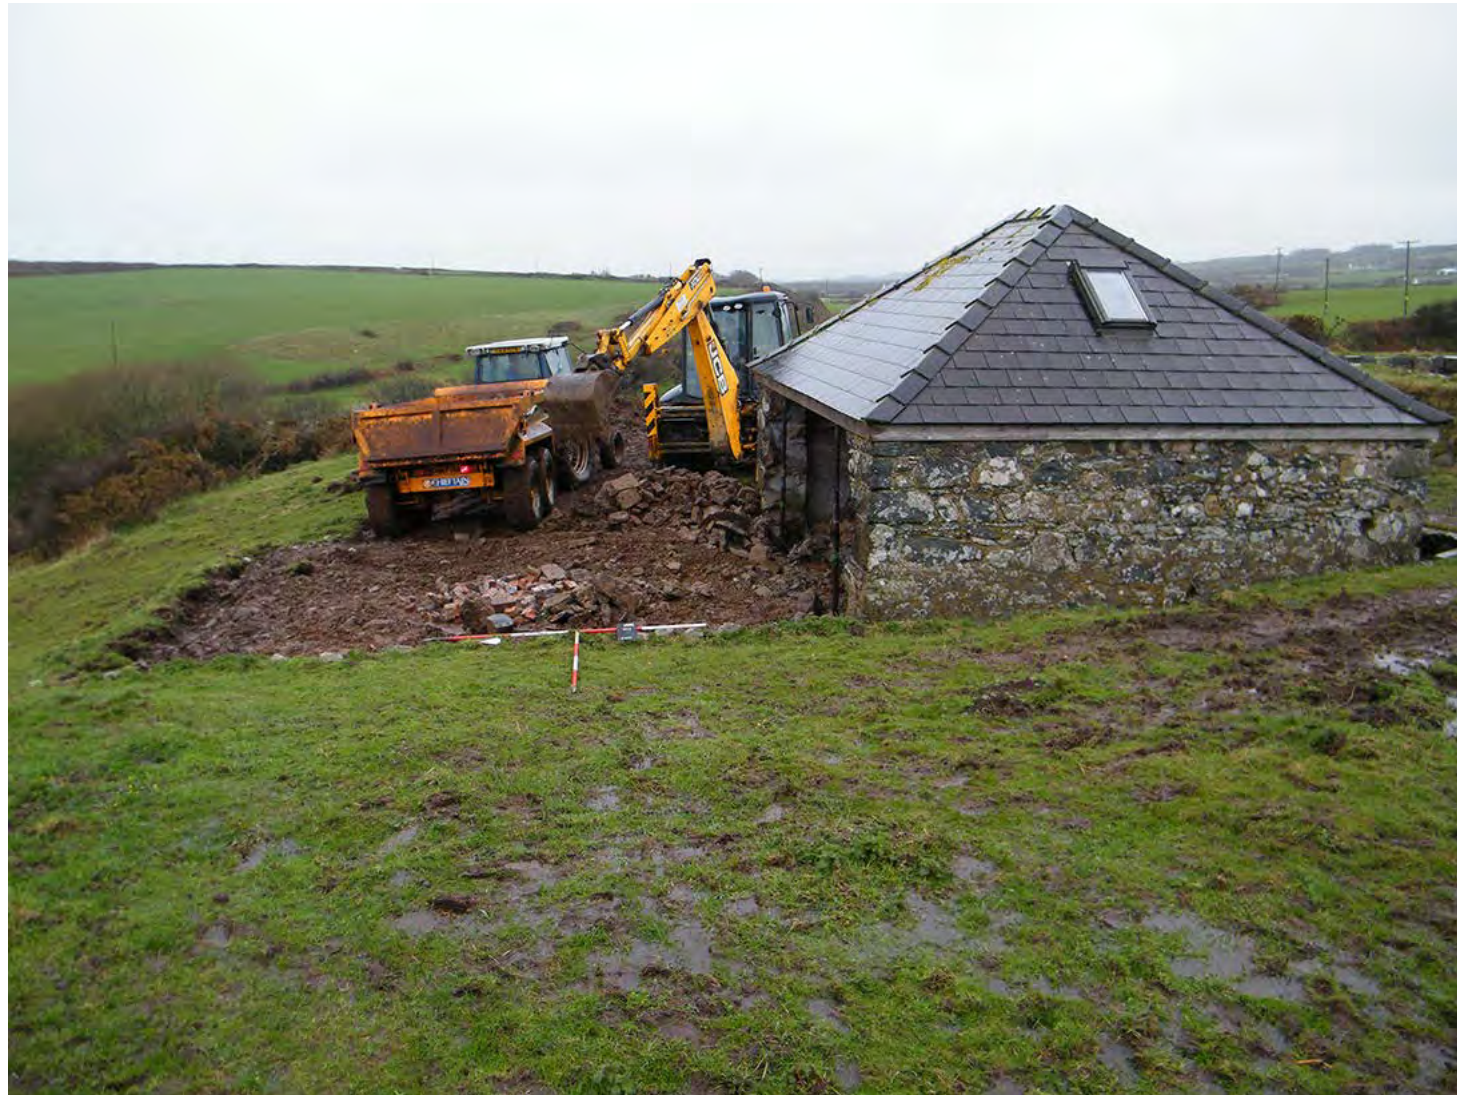
Prior to the watching brief starting, the modern extension to the building had been removed and the concrete floor outside the building broken up and removed (fig. 4). The concrete (100) within the building was removed under archaeological supervision and was shown to be 0.1m deep and overlying a loose rubble deposit (101) (fig. 5). The rubble filled the whole of the interior of the building and varied from 0.22m deep on the eastern side of the structure to 1.8m deep on the western side. The rubble overlay a further deposit of soil and rubble (102), 1.5m deep, which contained lumps of clay and twentieth century artefacts including glass and brick fragments (not retained).

Fig. 4
Concrete extension being
removed from northern
end of building

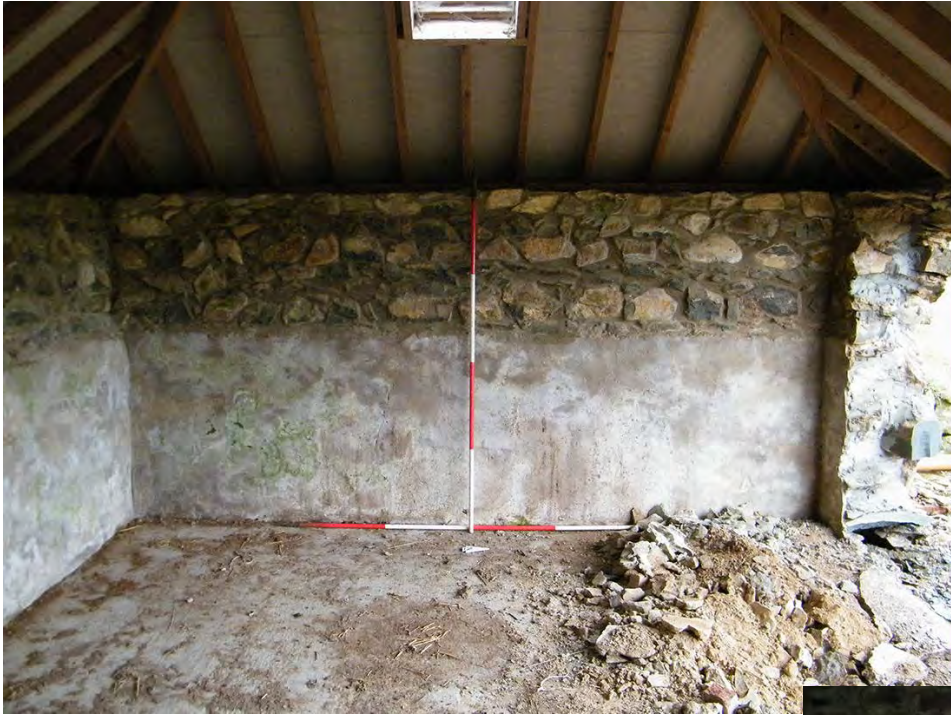
a. Intact concrete floor and wall covering

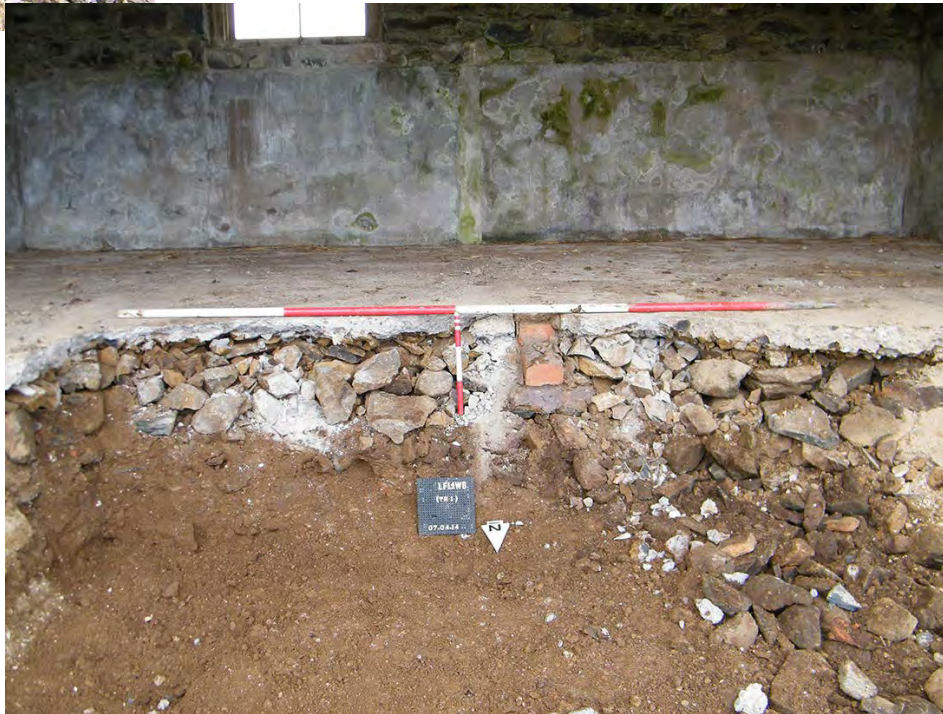
b. Section through concrete floor and underlying rubble deposit

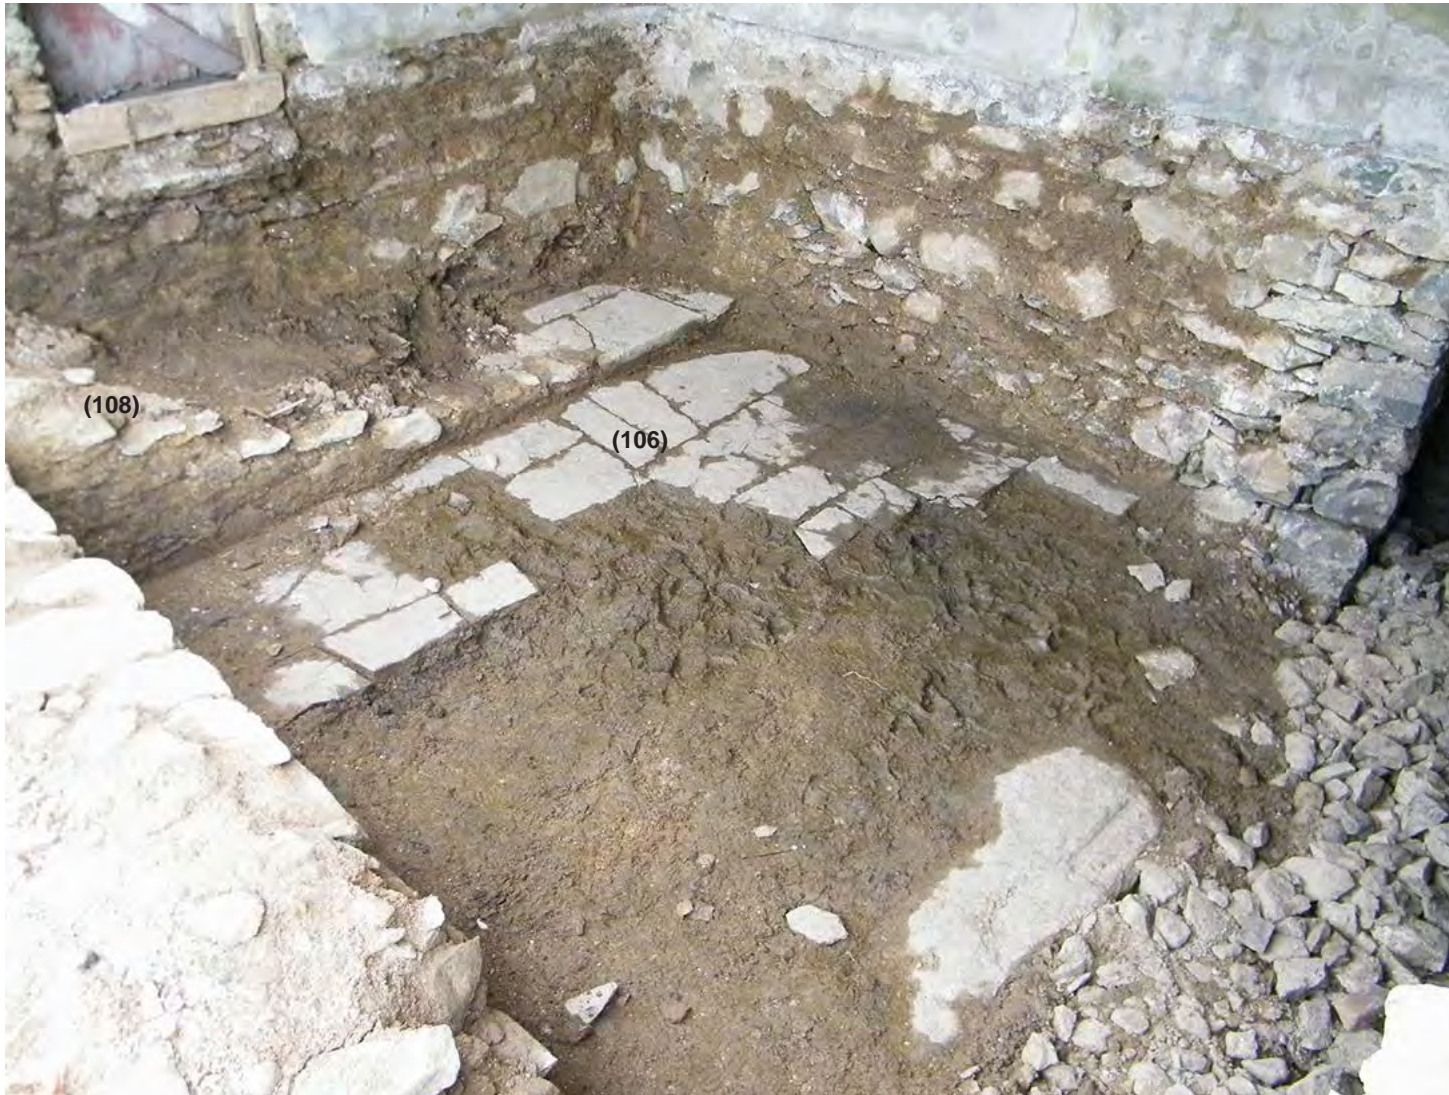
The soil and rubble deposit (102) overlay the original floor of the building, which comprised loose laid stone slabs (106) (figs. 6 and 9). The floor slabs had been laid partly onto the natural geology (103) and partly onto a patchy deposit of dark brown silty clay (112). The floor slabs had been disturbed prior to the infilling of the building with rubble, with much of the western section lifted. Several slabs were also lifted during the removal of the rubble fill. Along the eastern wall of the structure a flight of stone steps (108), leading from the door on the eastern side of the building to the sunken floor, survived in a fragmented state. The stone steps (108) were built on top of the bedrock, which had been excavated out to form the sunken building, and built using stone rubble bonded with a pale off white lime mortar (figs. 6 and 9).

Fig. 6
Intact floor slabs (106)
and remains of steps (108)

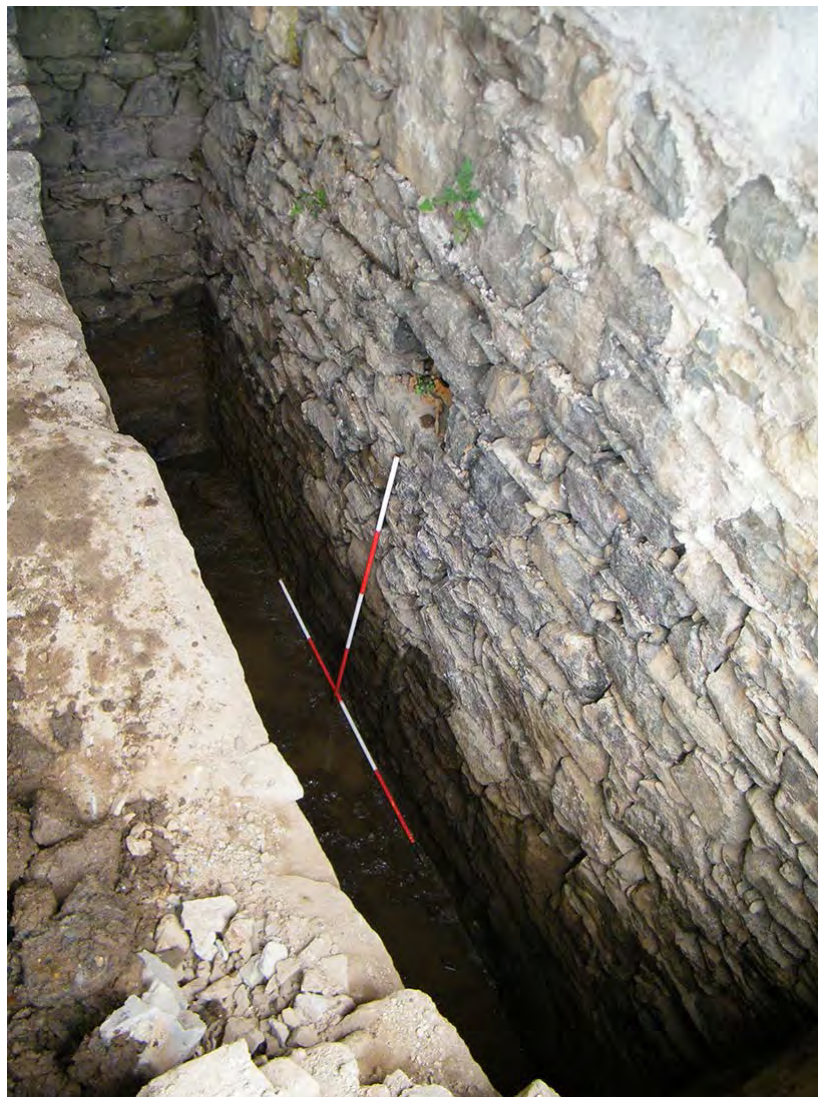
The wheel pit (105) was located on the western side of the building, orientated north/south (figs. 7, 8 and 9). It measured 1m wide by 2m deep (from the floor of the building) and was filled with loose rubble (101). A number of twentieth century artefacts were identified within the rubble in the wheel pit, predominantly broken metal tools and unidentified lumps of rusty iron. Sherds of twentieth century pottery and two leather boots (both left feet) were also identified. Due to the modern nature of the finds none were retained for analysis. The wheel pit was dug into the bedrock and had a thin layer of patchy silty clay covering the base (no context number assigned). Metal fixings, to hold the wheel in place, were built into a recess in the western wall of the structure and a granite slab containing holes for fixings was located on the eastern side of the pit. The inlet, to feed the wheel from the sluice pond, was located in the south-western corner of the building, approximately 4m above the base of the wheel pit (fig. 8 and 9). This would have fed the wheel at its mid-point, making it a breast shot wheel system. The water outlet was located in the north-western corner, at the base of the wheel pit, and fed the water into a channel which took it northwards away from the building (fig. 8 and 9).

Fig. 7
Wheel pit following
removal of rubble

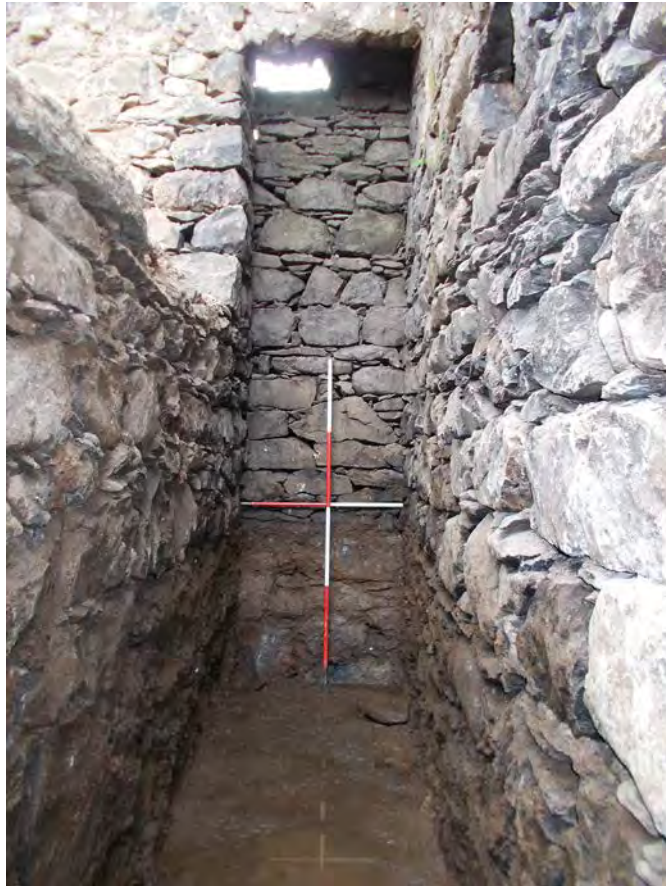
a. Water inlet

Fig. 8
Wheel pit following
removal of rubble

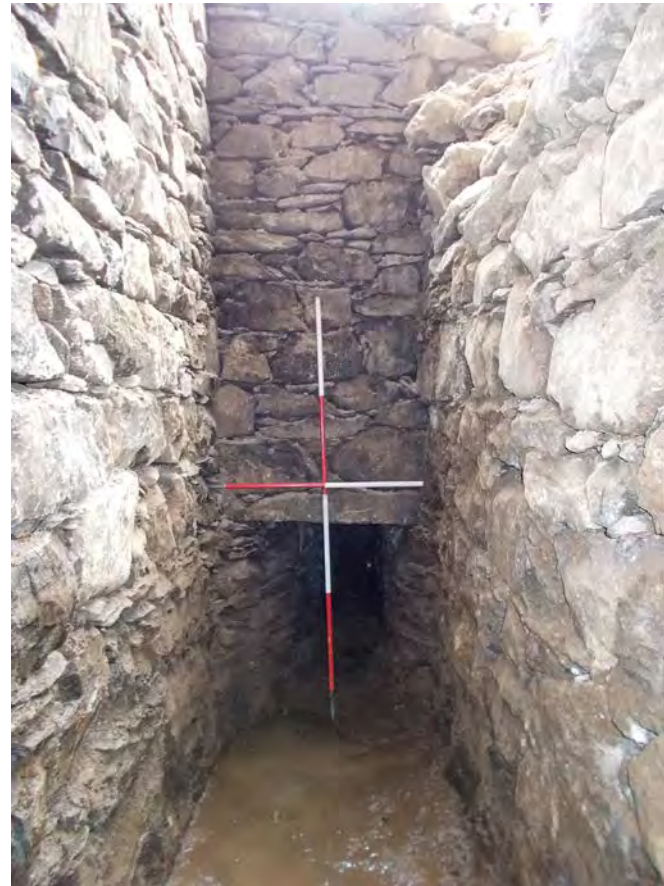
b. Water outlet

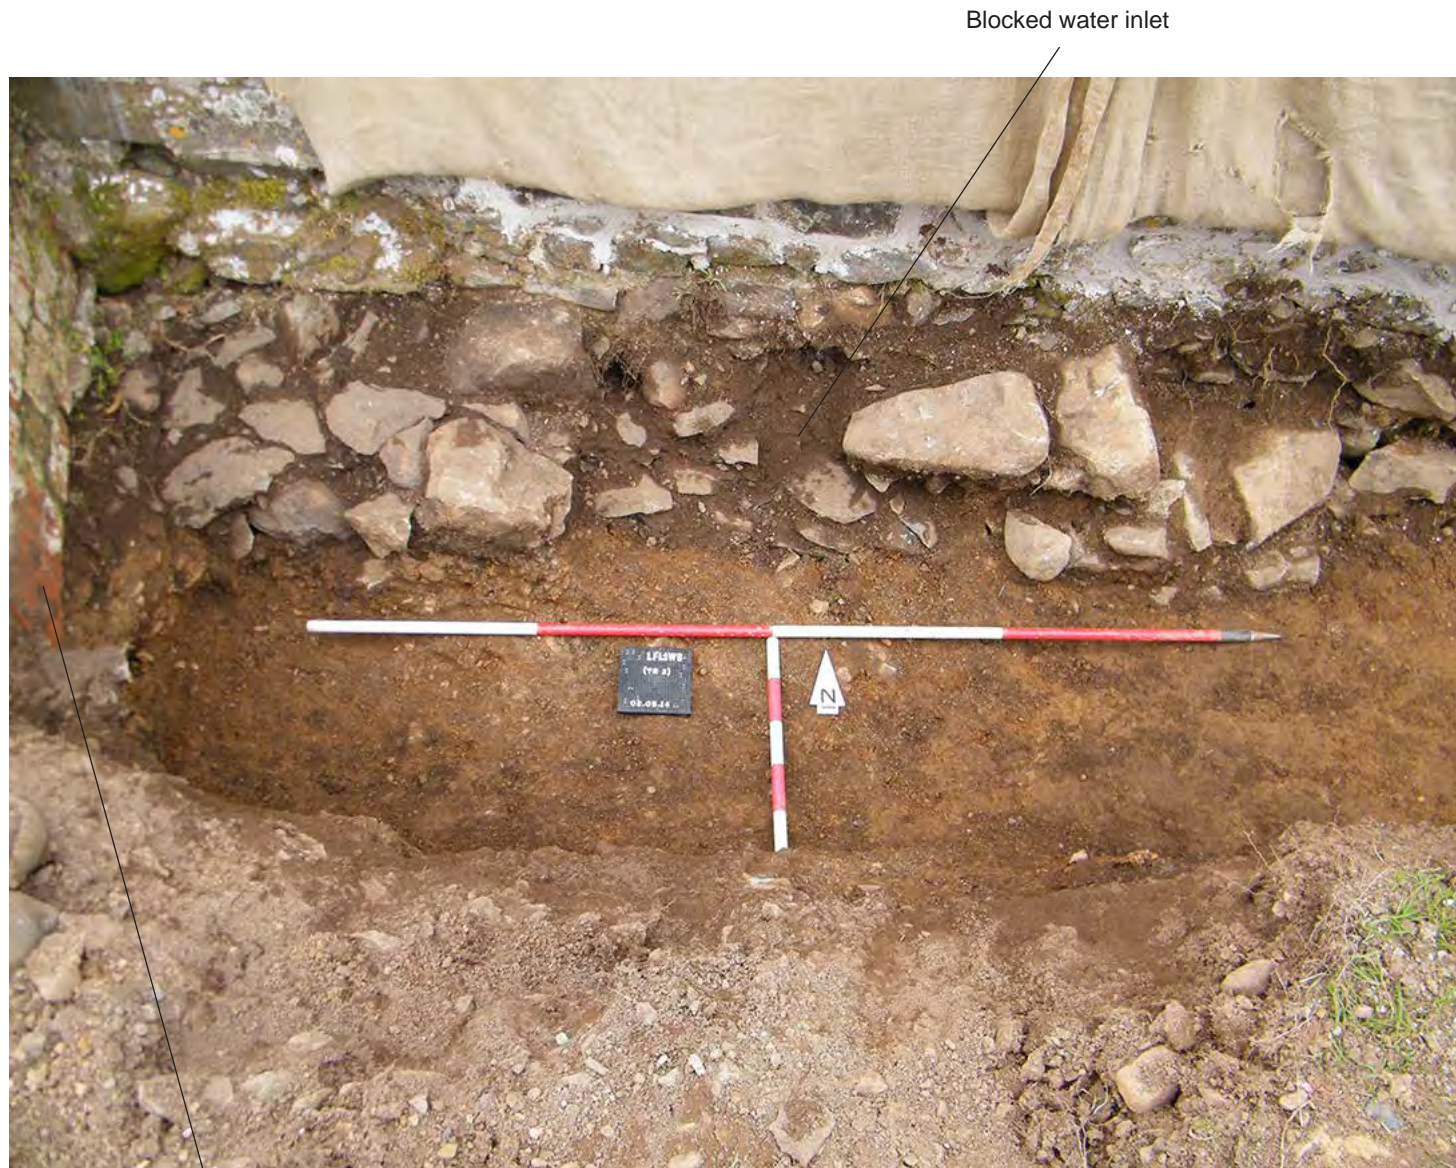
The ground on three sides, west, south and east, of the waterwheel building was reduced to expose the walls of the structure and allow them to be consolidated and repointed. This work exposed the external side of the water inlet, which had been blocked, and a channel diverting the water from the sluice pond around the building (fig. 10). The inlet blocking is likely to have occurred at the time that the building was converted into a pig sty, while the diverter channel may have been in use throughout the life of the waterwheel, used to allow water to flow from the sluice pond when the wheel was not in operation. On the western wall a large stone was identified that had traces of metal fittings on it. It is likely that this stone and its fittings were related to the take-off drive that was associated with the wheel.

Blocked water inlet

Diverted water channel

Fig. 10
View of blocked water inlet

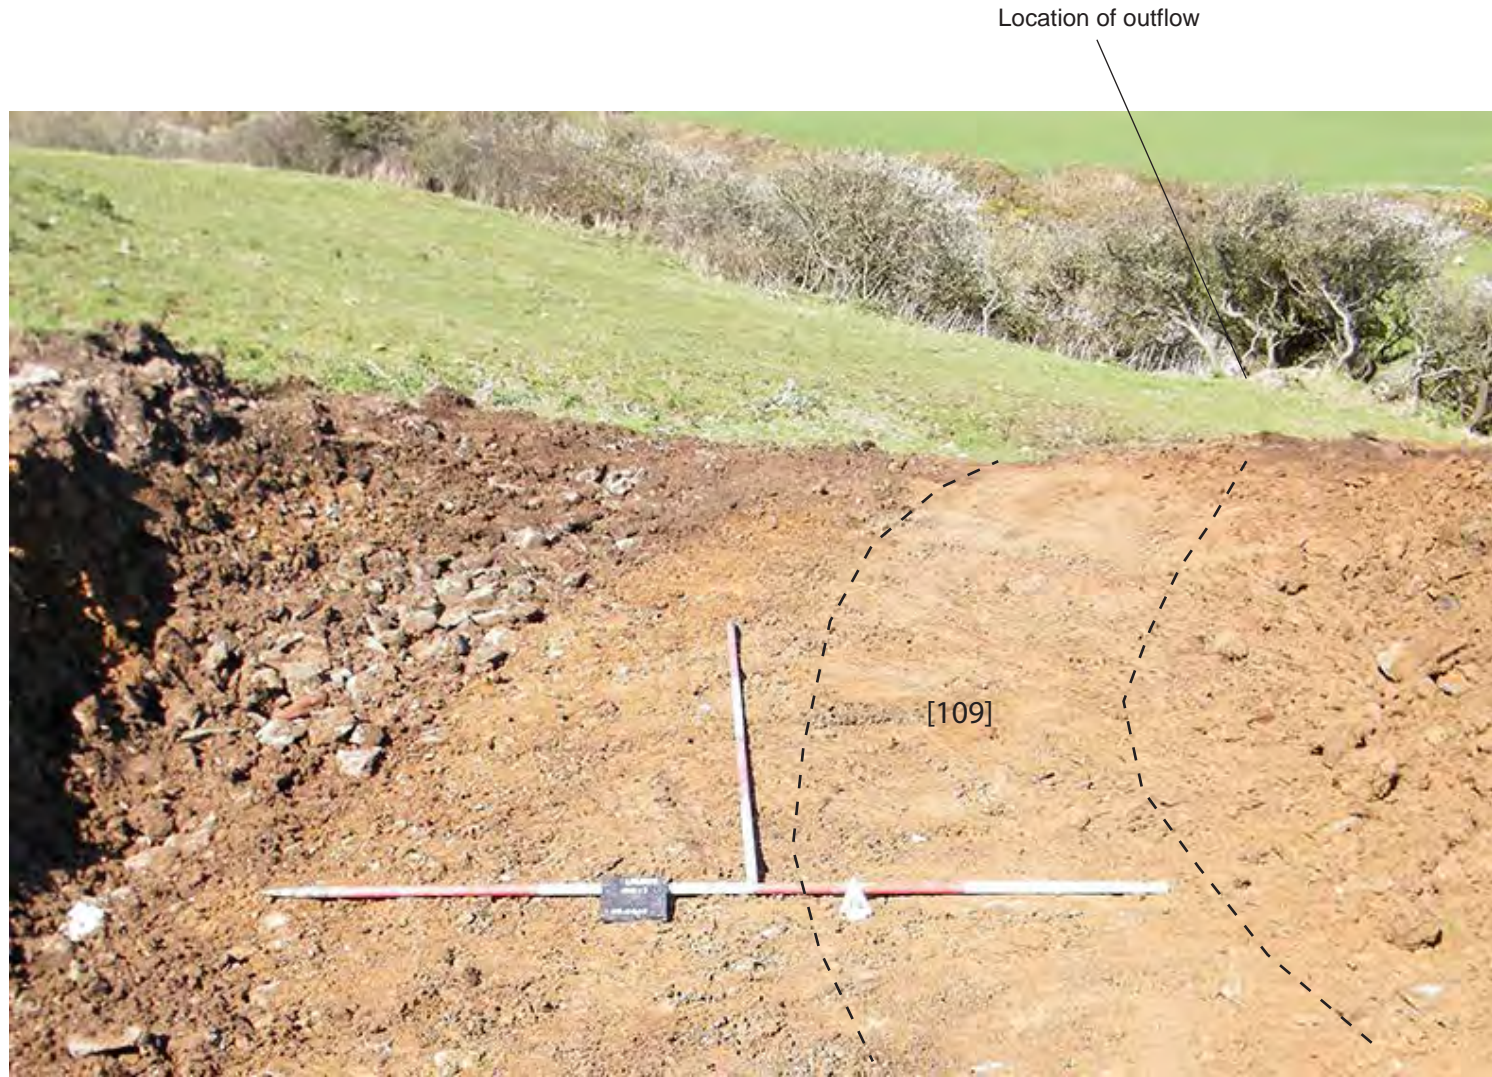
The ground to the north of the structure was reduced to reveal the line of the water outlet channel [109], which flowed northwards from the building to an outflow around 15m to the north-east (fig. 11). The channel was fed from the water outlet in the north-western corner of the building, and had been dug into the bedrock. The outlet channel was not excavated.

Fig. 11
Line of water outlet
channel

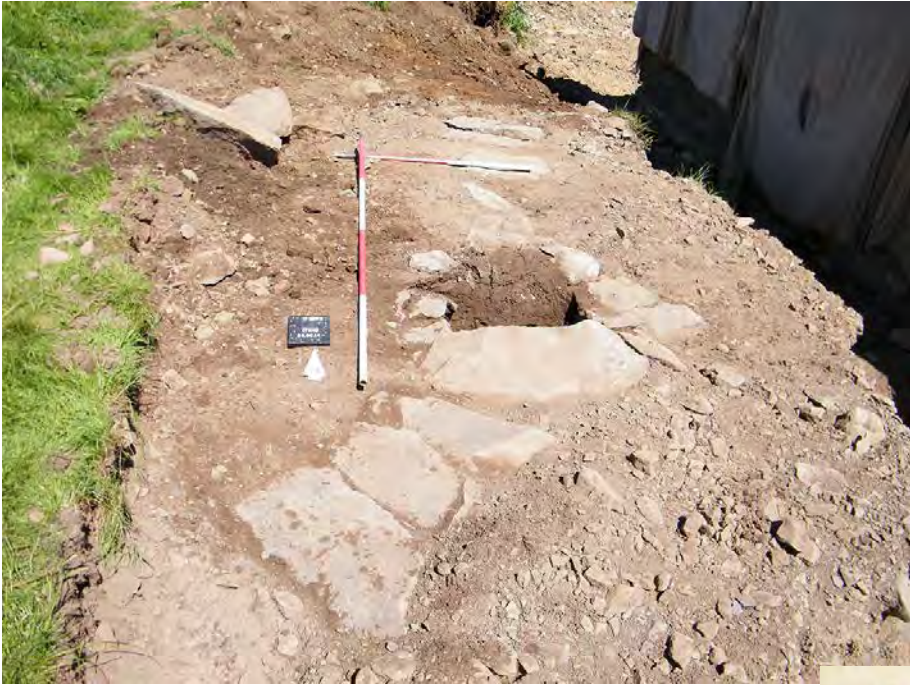
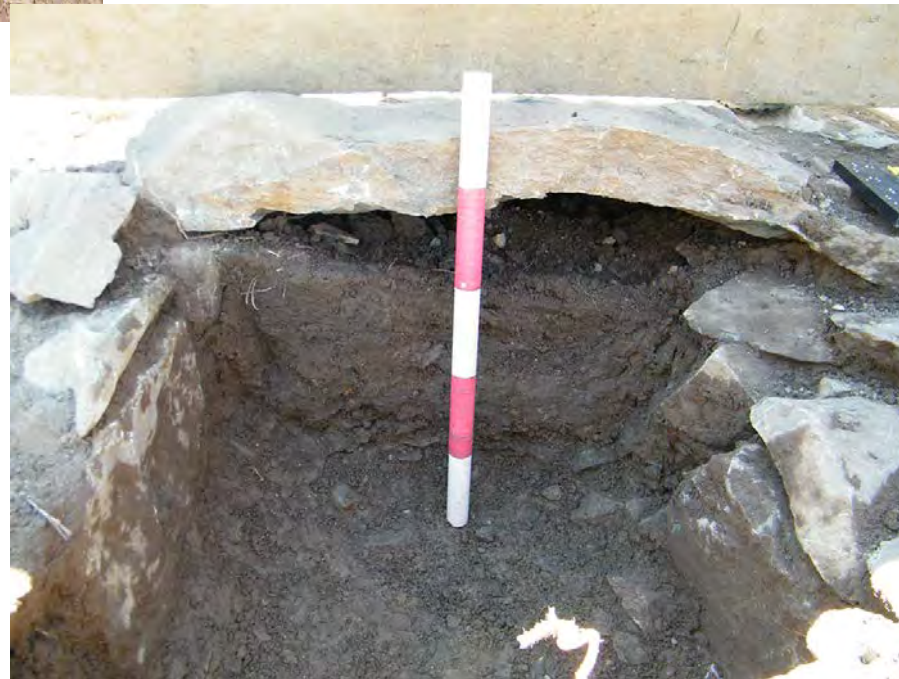
On the western side of the structure a stone built box culvert [113] was identified. This ran roughly parallel to the structure and drained into the diverter channel (fig. 12). The culvert was well built, slab lined with a slab covering, and was filled with a fine dark brown silty deposit (114) from which sherds of modern ceramics were recovered. This is likely to be a drain associated with the farm yard and buildings to the west that was routed into the outlet channel to facilitate drainage.

Fig. 12
Stone built culvert on
western side of structure

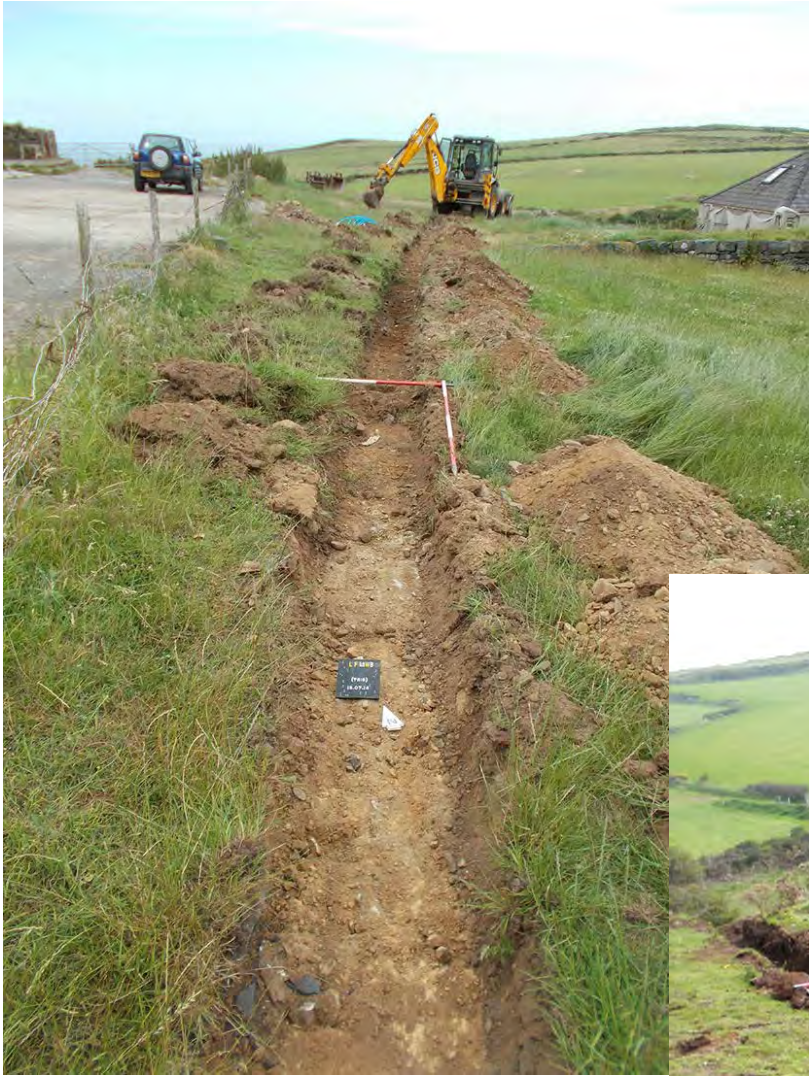
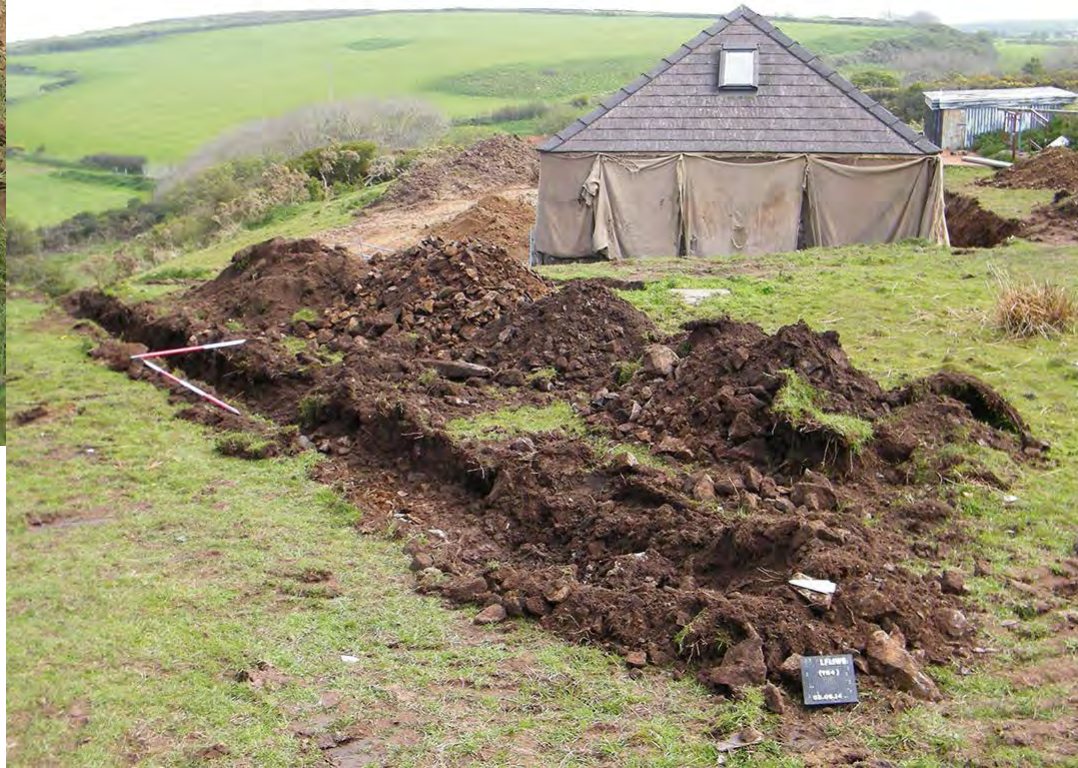
A number of service trenches were excavated to the west and north-west of the structure (figs. 13 and 14). All the trenches were around 0.7m wide and cut to the natural, which was identified immediately below the topsoil. No finds or features of archaeological significance were revealed.

Fig. 14
Service trenches around
the structure
