Stack Cottages, Blaenafon Iron works

Archaeological Evaluation

Report No. 1032

Date: **September 2011**

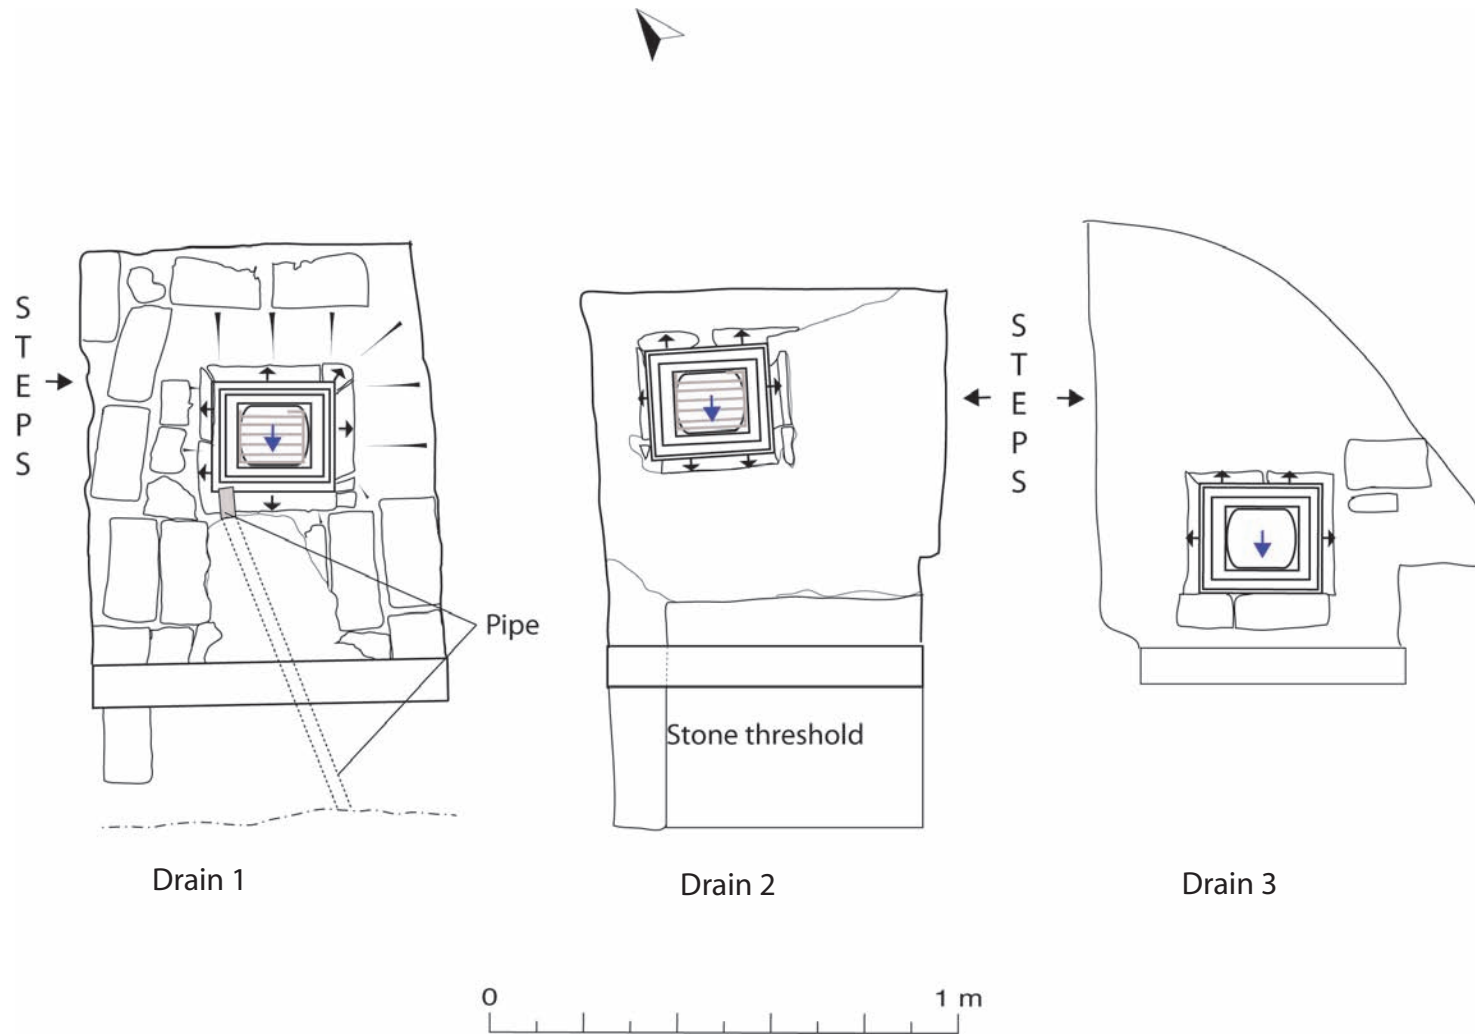
Fig. 2
Drains 1, 2 and 3
post excavation

An 0.74 x 0.80m area outside the northernmost rear door was located 1.13m below the rear path level at the foot of 4 steps leading down north-south (fig. 3). Approximately 15 cm of soil and wind-blown debris had been deposited over an indeterminate length of time and was cleared down to a brick tiled and mortar base floor (see fig. 4). A square 0.24 by 0.24m centrally located ceramic drain with a 0.13 by 0.13m opening was discovered 0.37m from the current doorway timber frame. The sunken square opening to the drain was lined on all four sides with bricks, some of which had been cut to fit. The drain opening possessed a removable degraded and damaged metal grill. The 0.25m deep drain was full of soil and consequently unlikely to function as an effective drain. After clearing the drain an attached outlet pipe was found midway down the drain that appeared to lead towards and under the rear doorway (fig. 2, blue arrow). A later pipe outlet possibly from an interior sink appears to have been inserted and covered with cement near the corner of the exterior drain (fig. 2).

A similar soil filled area was located outside the rear of the next house (to the south). This 0.75m by 0.75m space was also located at the base of a staircase 1.13m below the rear path (fig. 3). 6 steps descend from the rear pathway south to north. A square ceramic drain of identical proportions to Drain 1 was again located under 0.15-0.20m of soil and debris and 0.44m from the door threshold (see fig. 3). The drain was northeast of centre and inserted into a sunken brick or tile lined hole in a mortared surface. Other than the sunken drain surround no other bricks were visible on the floor surface. A damaged and degraded removable metal grill was also present over the drain (fig. 5). The drain was found to be full of soil and was cleaned to its base. An identical outlet was located on its eastern side leading towards and under the house doorway.

This soil and debris covered drain was located near the rear door outside the final southernmost house in the row (fig. 3). The area (0.90m max x 0.85m max) enclosed by a curved wall on its southern end was 1.50m below the rear path and was accessed via 8 steps descending north to south. The 0.25m deep ceramic drain, again identical in proportions to Drains 1 and 2, was found sealed by a square cut wooden cover which had been inserted sometime after it had been filled with soil. It was cleared and found to function in exactly the same way as the previously excavated drains; an outlet drained towards and under the house floor (fig. 5). This drain was very close to the rear door, only 0.12m from the wooden frame.

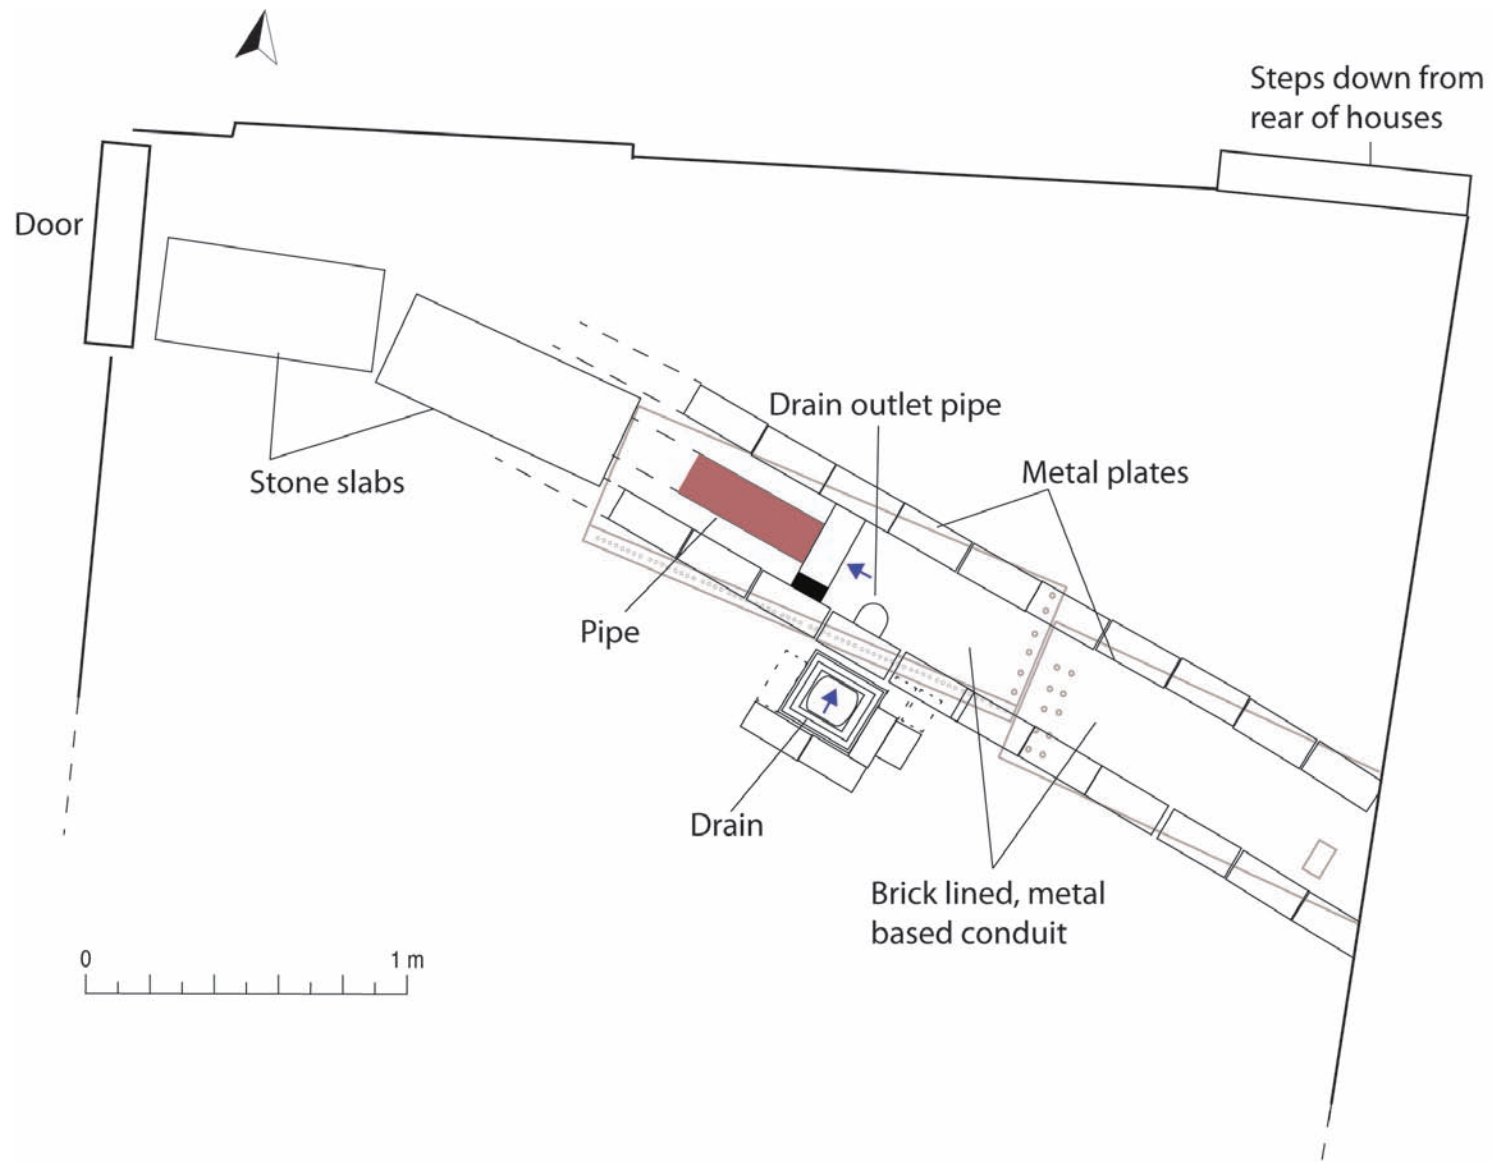
Fig. 3
 Drain 4 post
 excavation

In contrast to the previously described drains this was located bisecting an exterior enclosed space at the southern end of the north-eastern row, incorporating the gable end of the house associated with Drain 3 (see fig. 3). The original location of the drain in relation to its current location is unclear as the space appears to have been much altered.

The square ceramic drain appears to be very similar to Drains 1, 2 and 3 but the end of the identically located outlet pipe was, in this case, discovered. The drain was emptied of soil and was found to be 0.25m deep. Excavation of the soil immediately to the north of the drain revealed two rusty riveted metal sheets (1.42m by 0.44m and 1.15m by 0.44m) that acted as covers for a three brick deep (0.35m) lined 0.32m wide conduit with a metal base. The conduit contained approximately 0.10-0.15m of soil and some modern pottery sherds. The connected drain outlet protruded 0.10m from the brick lined wall and drained to the base of the conduit. This conduit appeared to be brick sealed under the eastern wall and had one further pipe draining into it under the eastern metal sheet. The easternmost metal sheet cover appeared to underlay or had been inserted under the eastern wall of the possible yard. It was not possible (or desirable for safety reasons) to fully remove this sheet to enable further investigation.

The conduit leads in a north westerly direction towards the western doorway of the enclosed space. Adjacent to the ceramic drain a brick archway supports the opening of a 27cm diameter pipe which appears to drain water out of the conduit towards the north-west. The course of the pipe may be indicated by the presence of two flagstones leading towards a threshold and an associated entrance, although this would need to be further investigated to confirm.

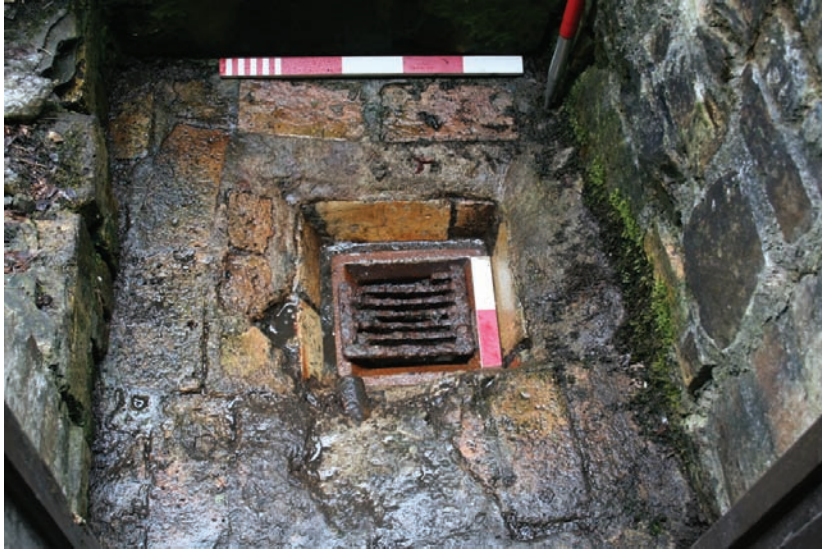
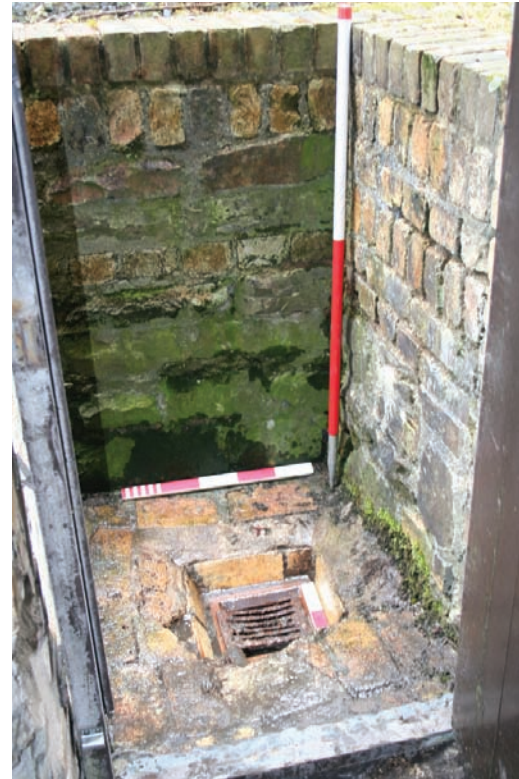
Fig. 4
Drain 1

Viewed from inside the adjacent house
