Blaenavon Forgotten Landscapes Project

Conservation Management Plan

Report No. 1046

Date: **March 2012**

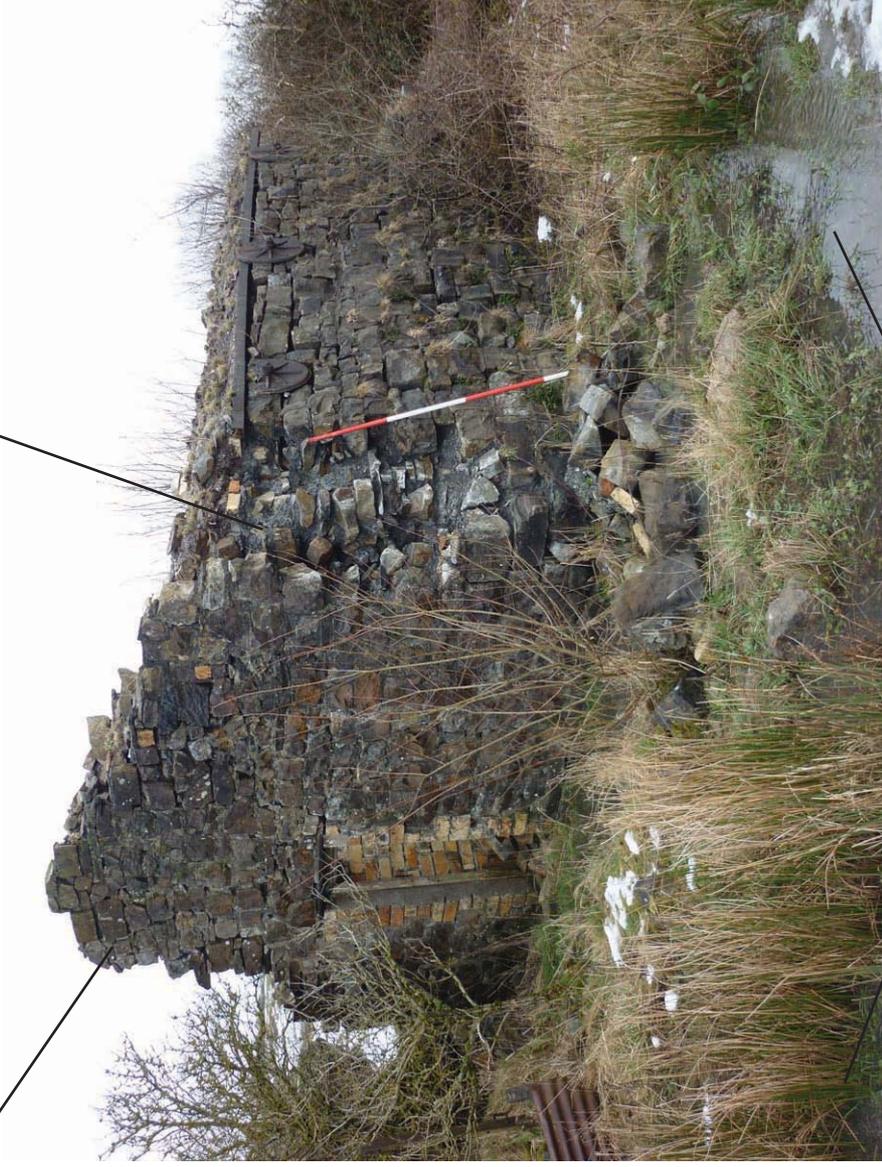
Fig. 12
The Powder House

The structural elements of the site are in an extremely poor state of repair. The site is largely overgrown with brambles, and water has pooled at the north-western end of the structure and flows down the western side (fig.12 and 15). Collapsed rubble, bricks and tiles fill the main powder house, obscuring the lower courses of walling,

Bowing and leaning north wall

Collapsed north-west corner

Water around structure

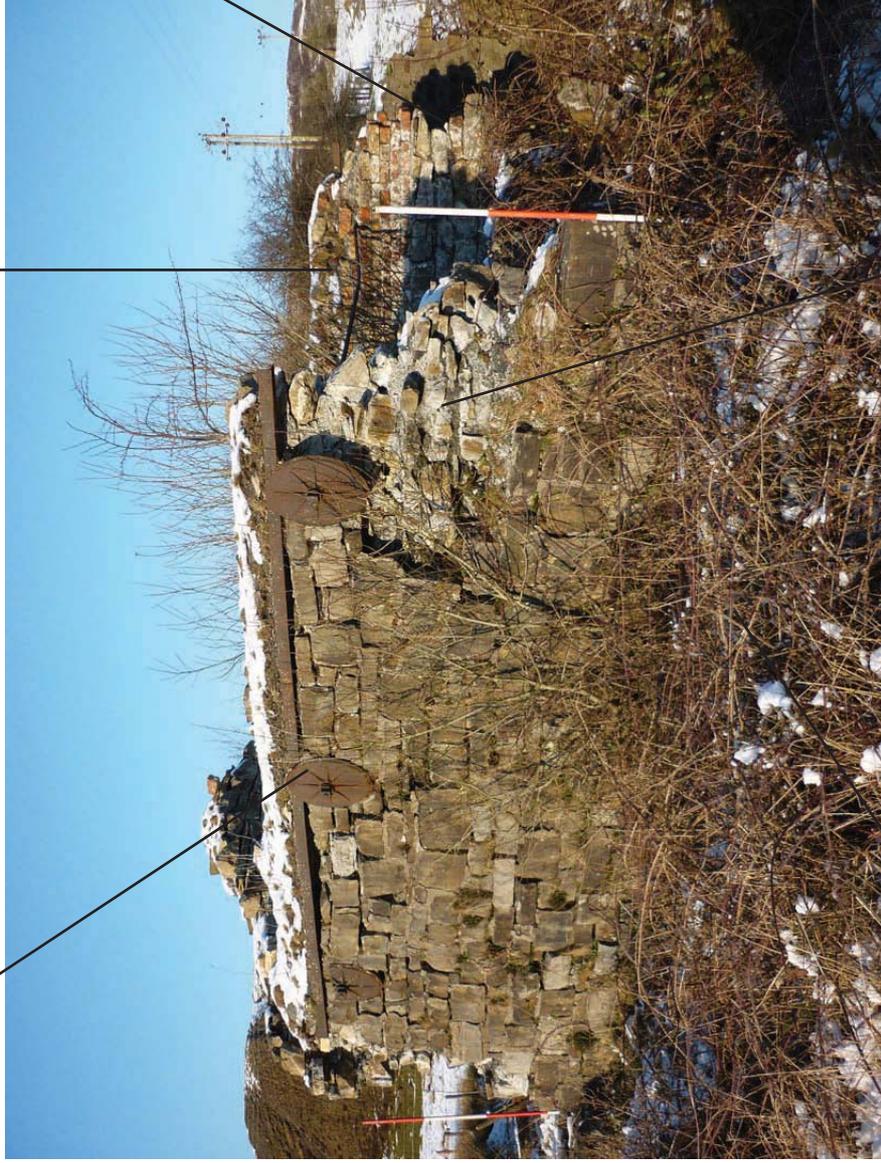
Corroded ironwork

Collapsed southern wall

Overgrown vegetation

Missing facing on western wall

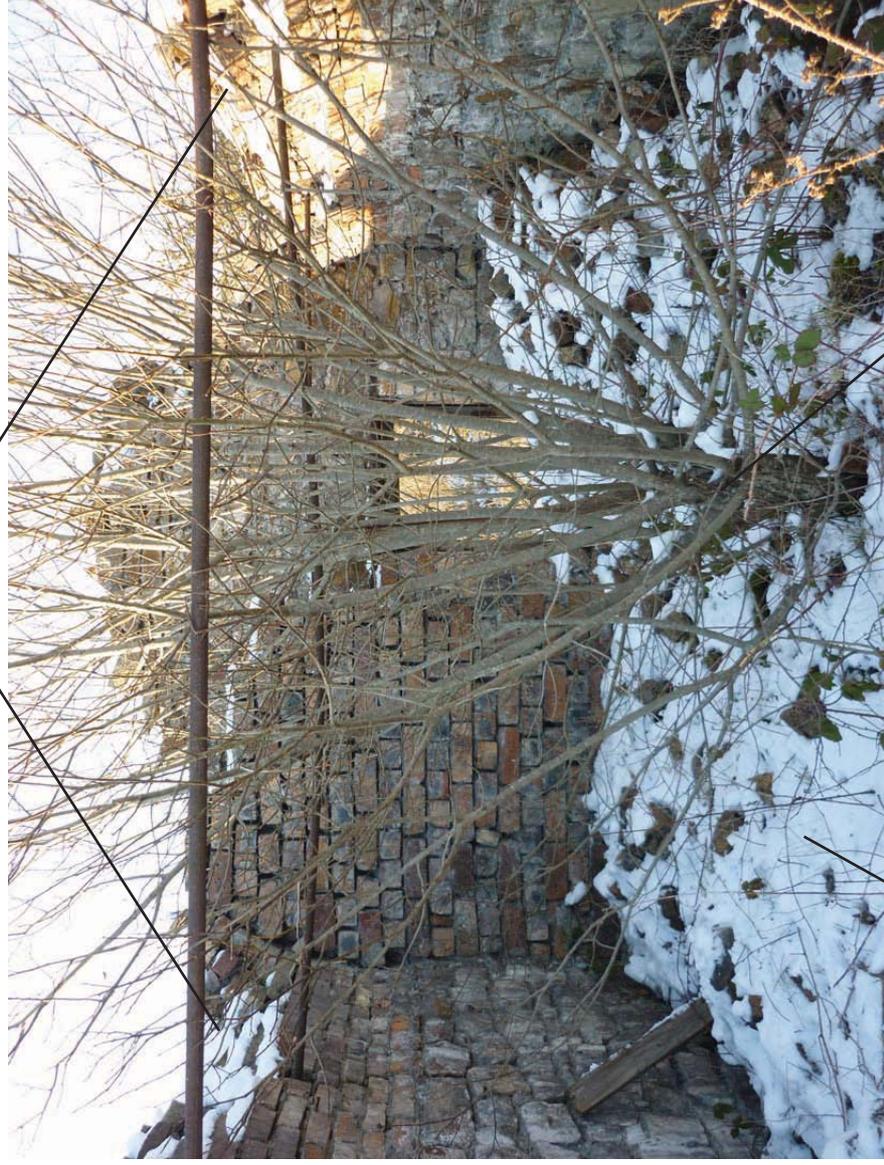
and a tree has seeded within this rubble (fig. 16). More rubble fills the area to the south of the main structure, surrounding the smaller brick building. The quantity of rubble masks much of the lower sections of the walls of both the main powder store and the smaller building. The northern wall of the main powder store is bowing inwards and leaning outwards, and the north-western corner has collapsed exposing the inner rubble core of the wall (fig. 11 and 12). The southern wall of the structure is largely missing and the barrel-vaulted internal roof has collapsed. The western wall has partly collapsed at the southern end, while the eastern wall is missing most of the facing stones resulting in the core of the wall being exposed (fig. 11). The smaller, brick-built structure survives only as the northern and southern walls. The wall that once enclosed all the buildings on the site now only survives on the eastern side, although a section of it has also collapsed. It has undergone some repair in recent years, and has been partly re-pointed using cement (fig. 17).

Collapsed barrel-vaulted roof

Rubble-filled interior

Seeded tree within rubble

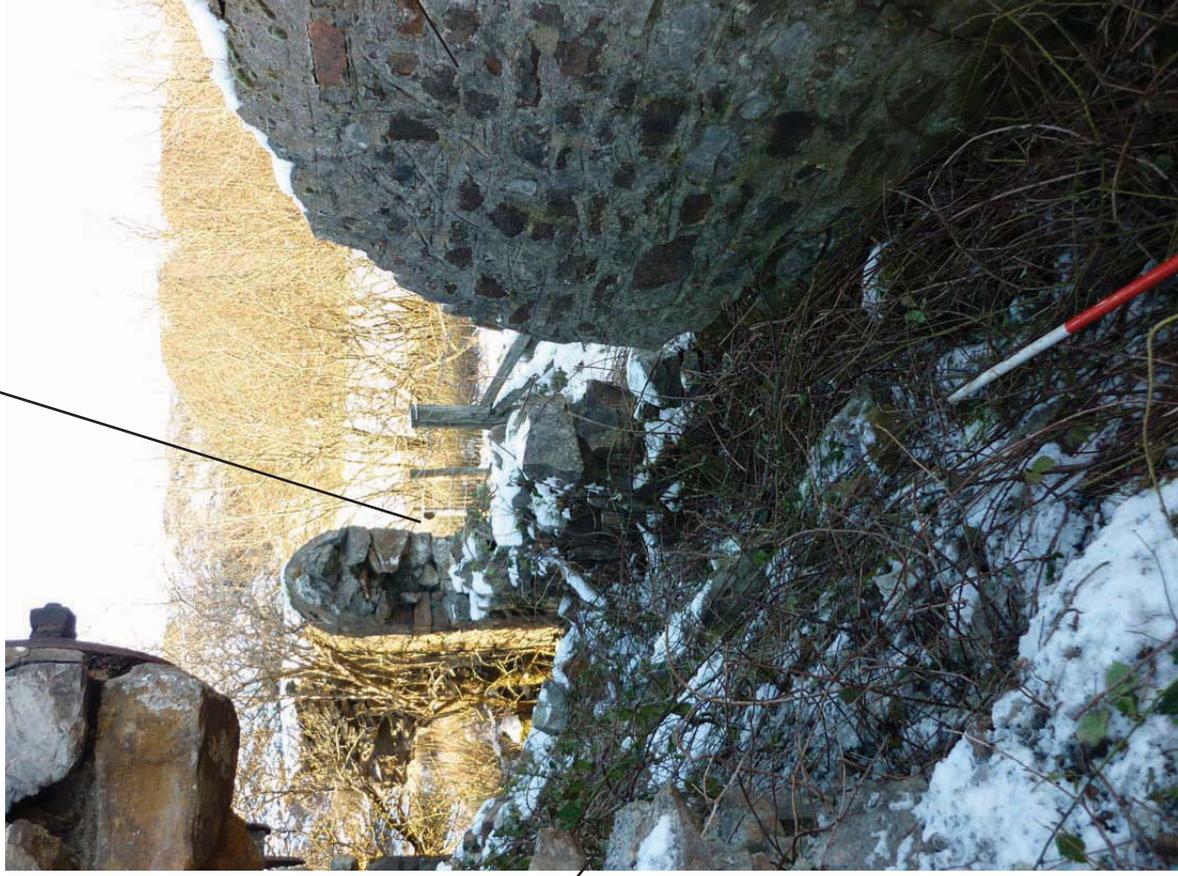
Collapsed section in external wall

Partly re-pointed external wall

Facing missing from east wall

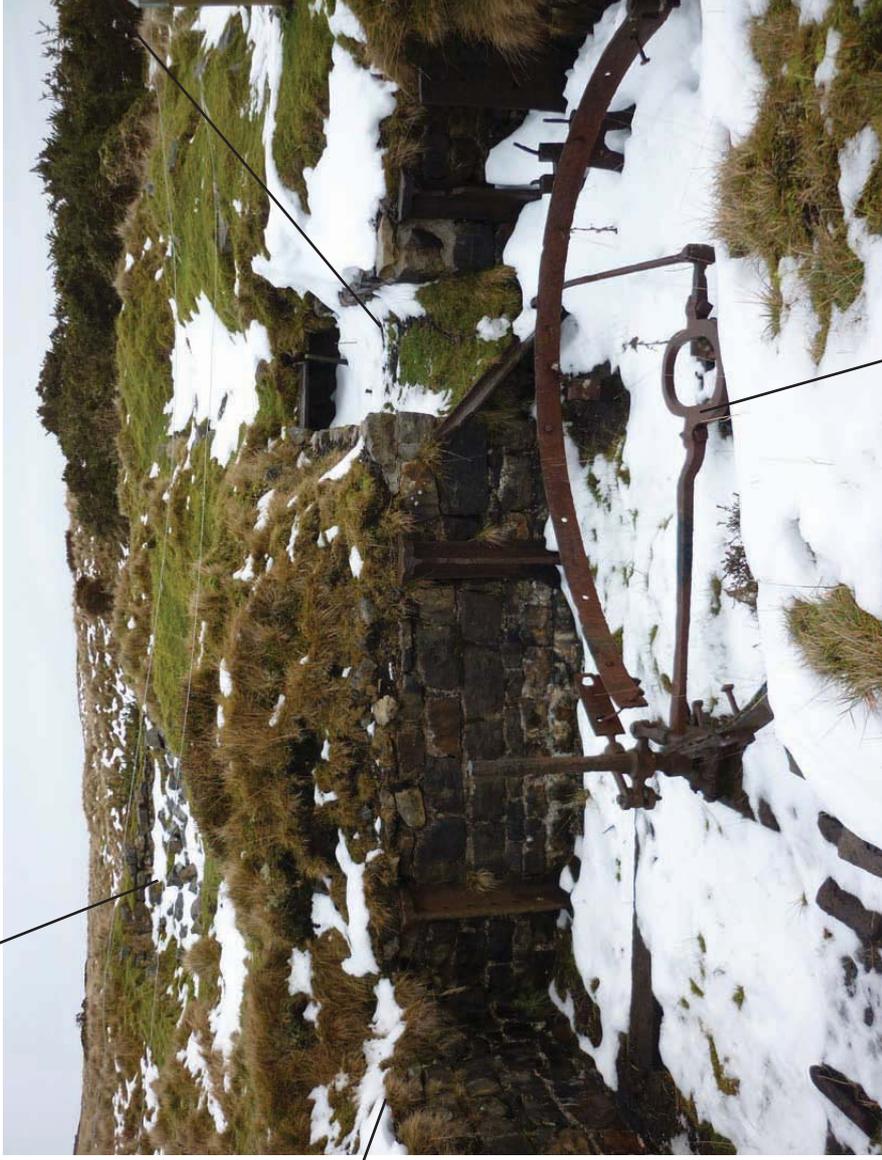
Rubble filled brakeman's house

Rubble and vegetation filled gully linking mechanism with brakeman's house

Encroaching vegetation

Corroding brake mechanism

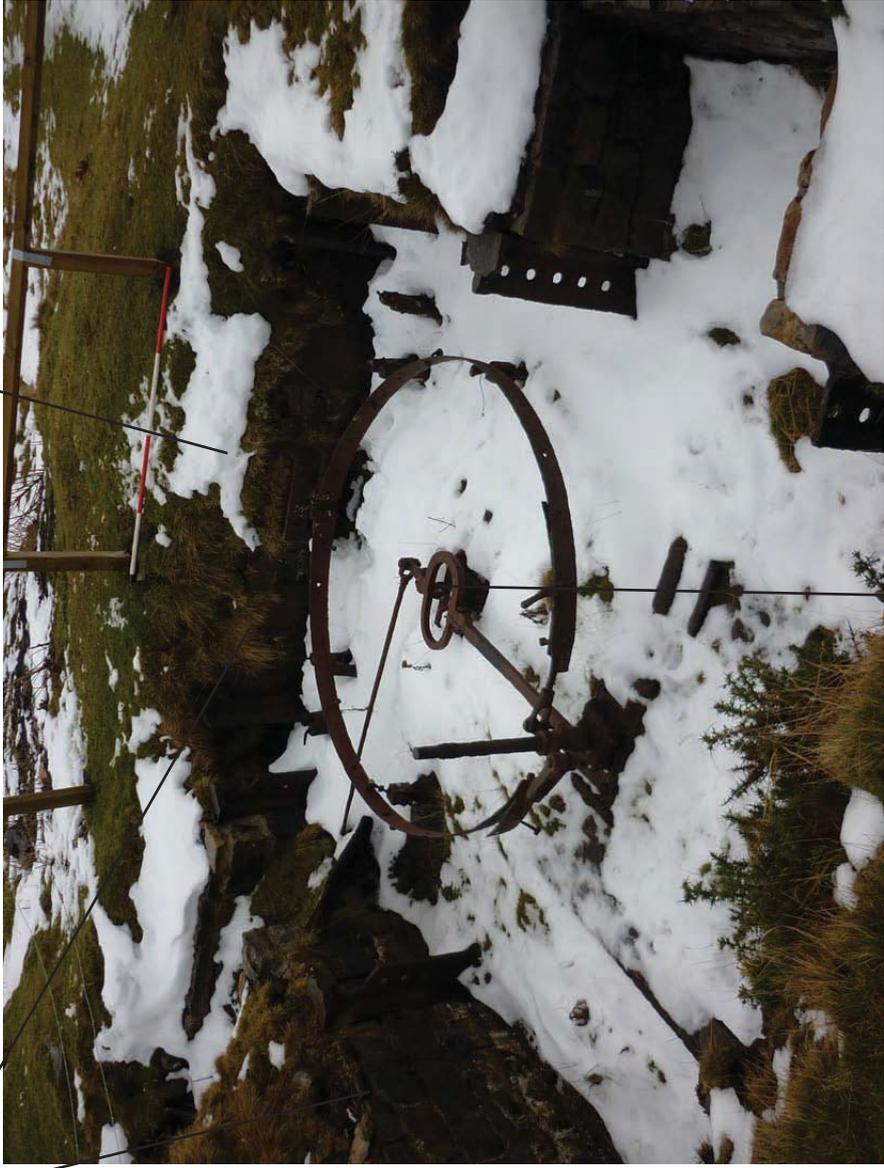
Fig. 20
The Tramway
Incline Brake

The structure housing the brake mechanism is largely sound, having undergone repairs in 2010. This included repointing of sections of the stonework and vegetation removal. The top of the walls are, however, starting to come loose again, and sections of the mortar are crumbling. The metalwork is continuing to corrode, and sections of it have been lost since the 1970s. Vegetation is encroaching on the top of the sunken walls, and weeds are growing in the base of the structure. The gully linking the mechanism with the brakeman's house is partly filled with rubble and vegetation, which has buried the brake rod. The brakeman's house is largely rubble filled and overgrown with vegetation.

Encroaching vegetation

Loose walling

Corroded metalwork

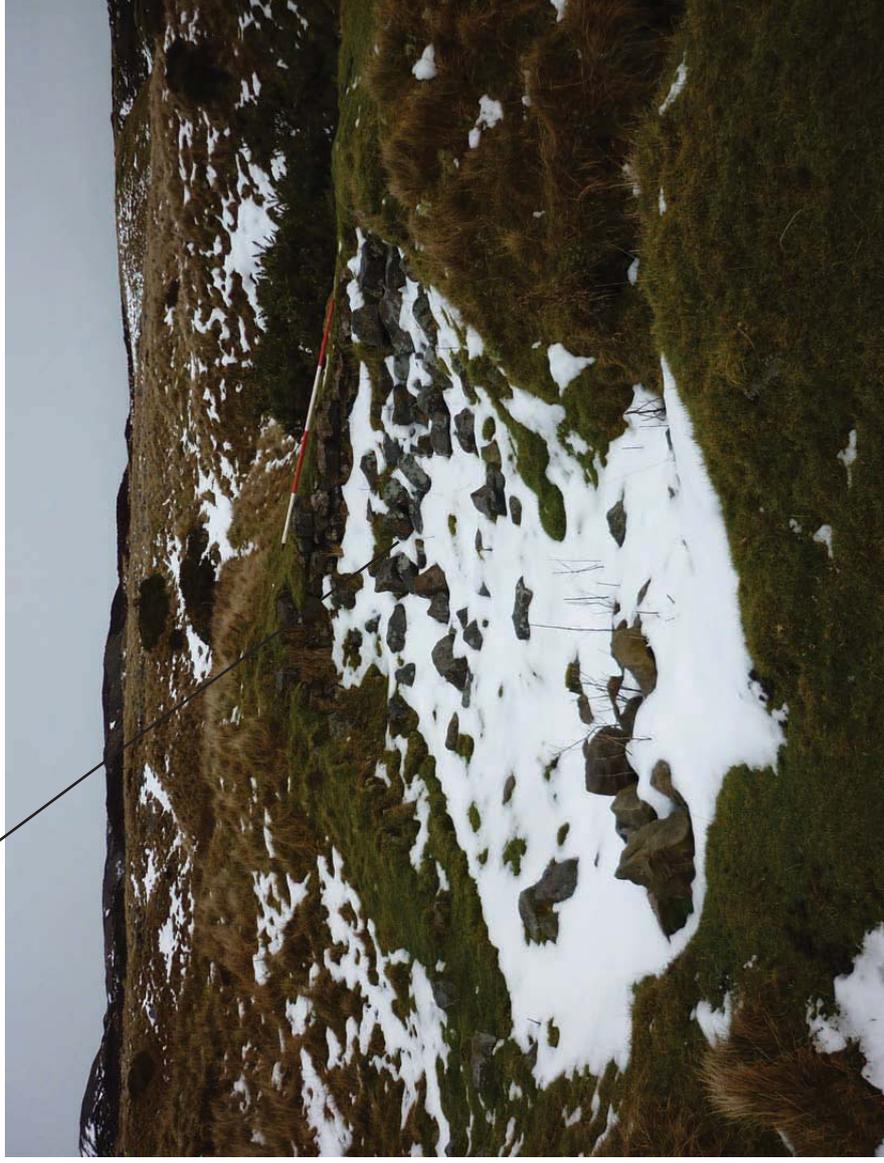
Fig. 21
The Tramway
Incline Brake

The site comprises two separate elements connected by a gully. The remains of the main brake apparatus are located within a sunken structure measuring approximately 4.5m by 3.6m and up to 1.3m deep (fig. 18, 19 and 20). The structure is faced by stone walls mortared with lime, into which twelve corroded iron girders have been built. Two girders are positioned in each corner, with a single girder positioned in the middle of each side. Further iron framework is positioned on the base of the structure, on top of which are the remains of the brake mechanism. On the southern side of the brake mechanism is an iron rod, extending eastwards towards the remains of the brakeman's house. This rod runs for 4m, and is contained within a linear gully lined with stone walls mortared in lime. The gully is 0.5m wide and 0.4m deep, although it would originally have been approximately 1m deep. The gully turns 90° west 6m from the eastern edge of the sunken structure, and joins a second stone built structure. This stone-built structure measures 4.33m north/south by 3.59m east/west. Up to three courses of intact walling are visible, with the majority of the building masked by rubble and vegetation (fig. 21).

Rubble-filled brakeman's house

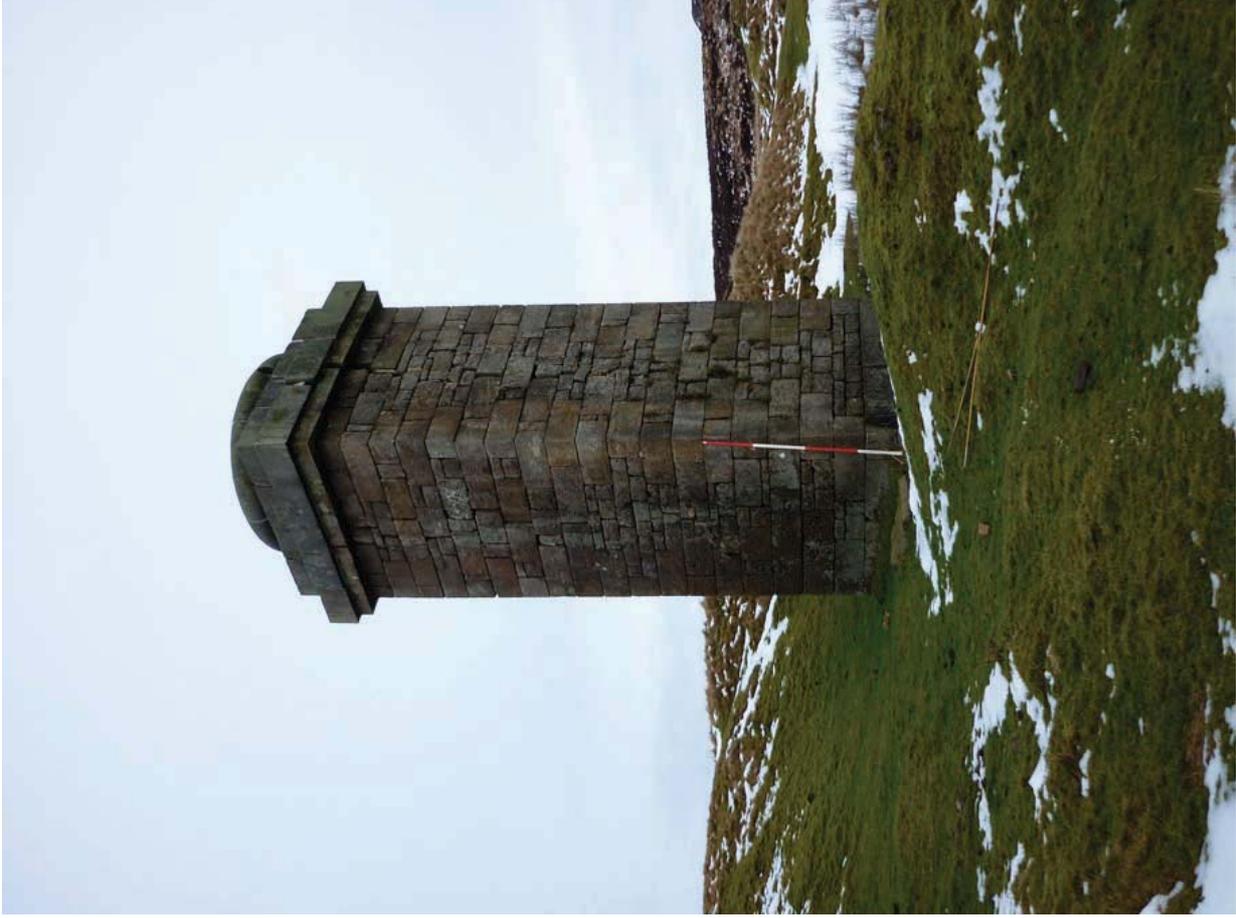
Fig. 23
Hill Pits Chimney

The chimney is in a good state of preservation, having been repaired in 2007/2008. The repair work involved the removal and careful rebuilding of the upper courses of masonry and the plinths, together with extensive re-pointing of the masonry. The structure was pinned together using four CINTEC anchors (see fig. 23). A number of gaps were left in the masonry to allow bats to access the interior of the stack.

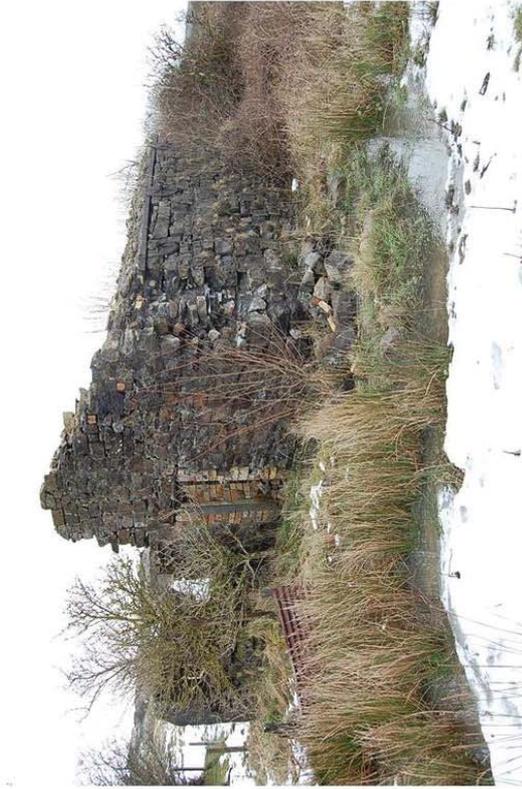
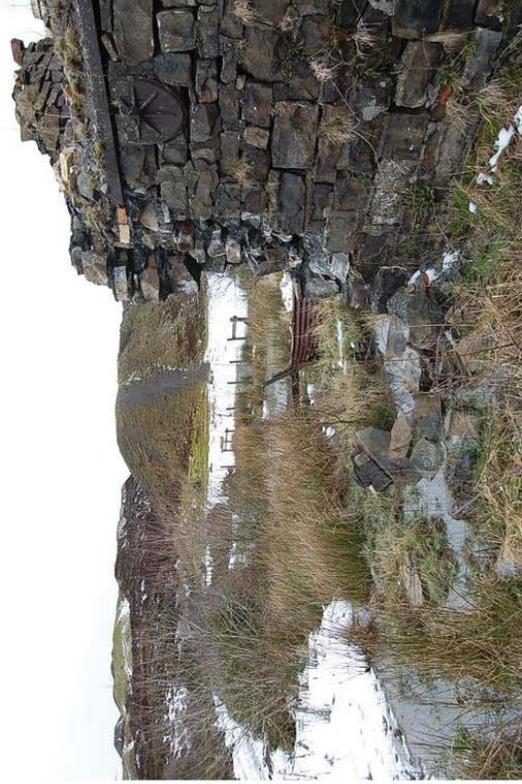
Plate 8: Hill's Pit powder house site. General view of the up-standing remains of the powder house. Note the inundated areas around the base of the building, with its characteristic NVC MG10 marshy grassland habitats. The drier areas, inside and elsewhere, around the powder house are choked with scrub of *Rubus fruticosus* agg., *Sambucus nigra* and *Salix* spp.

Plate 9: Hill's Pit powder house site. General view of the up-standing remains of the powder house. Note the inundated areas around the base of the building, with its characteristic NVC MG10 marshy grassland; Wet-flush habitats that in this view continue towards the pit-banks in the Background, from whence they arise. On the pit-banks can be seen the green-brown NVC U1 grassland, and the darker NVC H12 heathland habitats found at the other two assessed sites.
