Raby's Furnace, Furnace, Llanelli

Archaeological Watching Brief

Report No. 1192

Prepared For:
Natural Resources Wales
at the request of Cadw

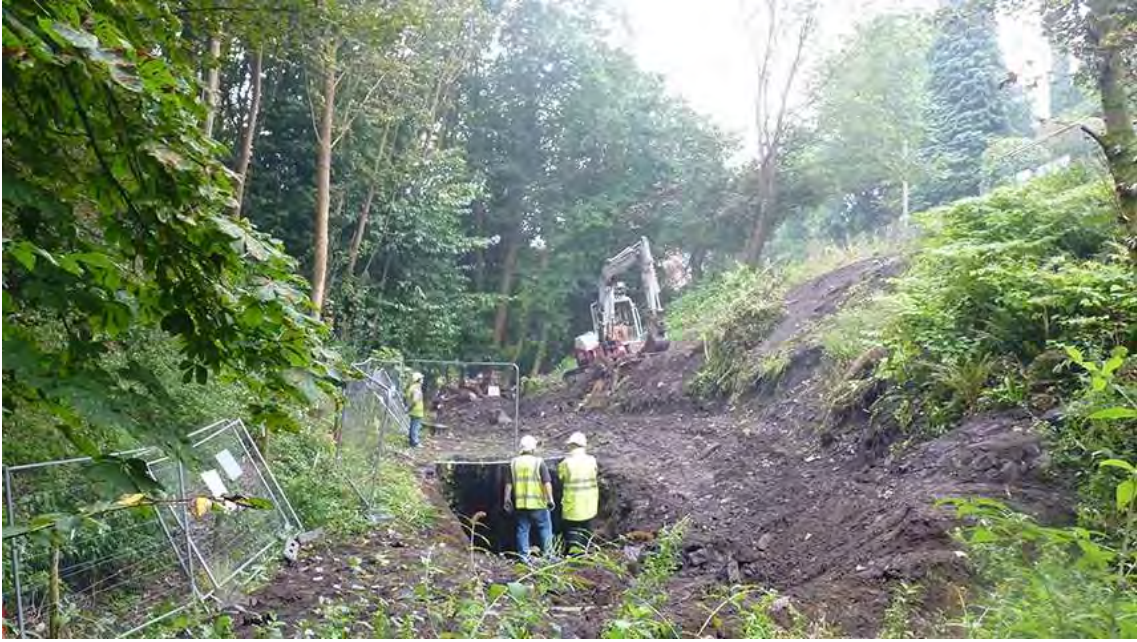
Photo 1: View south down the small valley along which the culvert runs. Showing the area of collapse and the extent of the scoured area at the valley bottom.

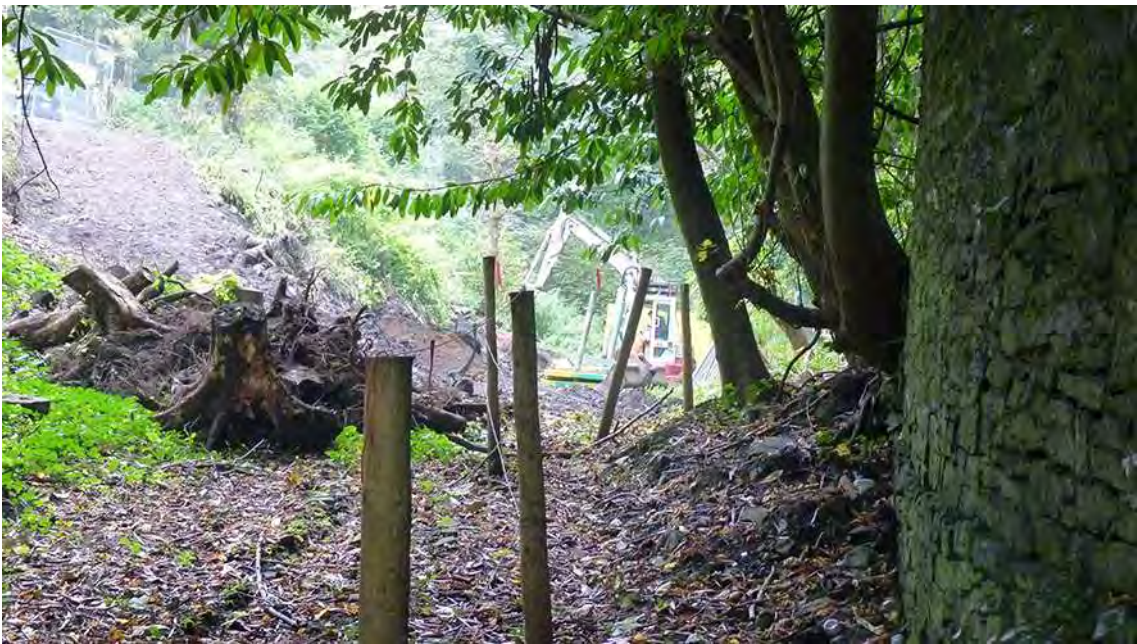
Photo 2: View north up the valley. The wall on the right is associated with the former ironworks, the machine is sat at the southern edge of the collapsed area.

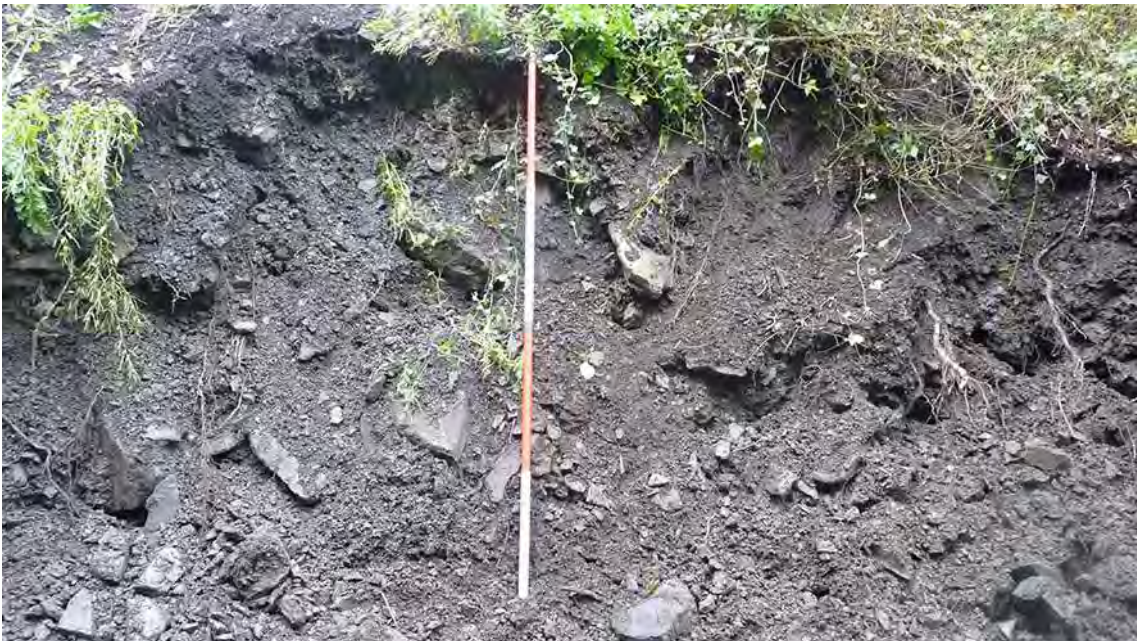
- 5.1.4 In order to both access and assess the area of collapsed culvert, an area c.32m long by c.7m wide at the base of the valley was cleared of vegetation and landscaped. This work exposed surface deposits across the entire area, all of which could be readily associated with modern disturbances, presumably those associated with previous culvert repair work undertaken immediately to the north. Nowhere were original ground levels or pre-modern disturbance deposits uncovered. No evidence of the previous tramway or early-19th century structures was revealed. At the same time, a section of ground on the western side of the valley was exposed to allow for the passage of machinery onto the site. This revealed material at the base of the slope that corresponded closely to that exposed by the cutting of the access ramp, suggesting the upper deposits on the western side of the valley at this point also consists of imported modern material.

Photo 6: West facing shot of the edge of the scoured area at the base of the valley. Showing the current profile of the western side of the valley is made up of loose modern material. 2m scale.

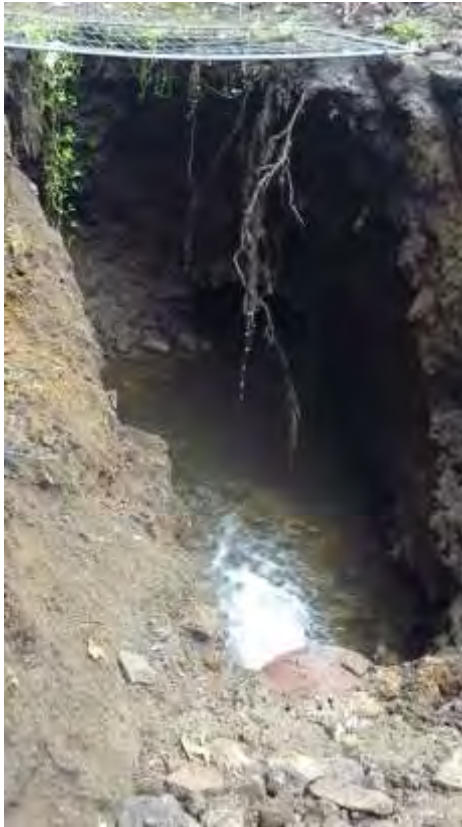
- 5.2.1 A section of culvert c.5m in length had collapsed, roughly from the point at which the modern pipe inserted during the last phase of repair work ended. This pipe had been inserted into the existing stone culvert, but this appears to have concentrated the flow of water, which was clearly very strong, onto specific points of the culvert, weakening and eventually collapsing the stonework. The water then washed away the stonework and scoured out an area several metres in diameter eventually causing the ground to collapse.

Photo 7: South facing shot of the area of collapse, with the surviving section of culvert visible at the rear.

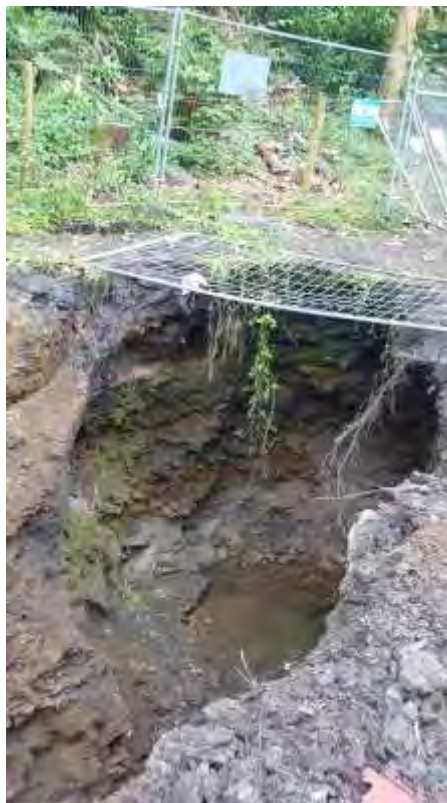
Photo 8: View of the collapsed area, facing southeast.

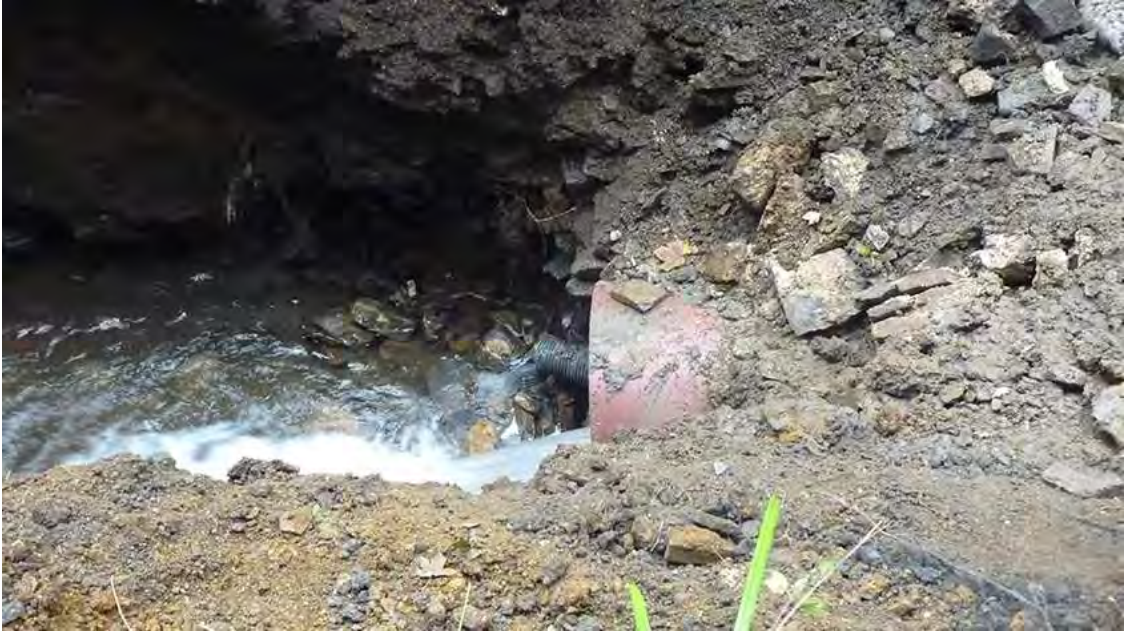
- 6.3 This previous work appears to have contributed to the collapse of the current section. An area, c.5m in length, had fallen in and the strong flow of water exiting from the repair pipe associated with the previous repair had removed the culvert in this area.

Photo 9: West facing shot of the northern end of the collapsed area, showing the pipe inserted through the culvert in the previous stage of repair work.

- 5.4.1 The archaeological watching brief ceased when the exposed deposits had been recorded, thus allowing repair work to the culvert to be undertaken. This work comprised attaching a new metal pipe to the existing one exposed at the northern end of the area of collapse. This pipe was then inserted into the stone culvert as far as the manhole. This new section of pipework incorporated a downward curve to take some of the force of the water flow out of the pipe and prevent the scouring effect that had occurred at the end of the previous section of pipework. No *in situ* remains or collapsed remnants of the original stone culvert survived in the area of collapse, so this section of pipe was encased in concrete and in-filled with imported material.

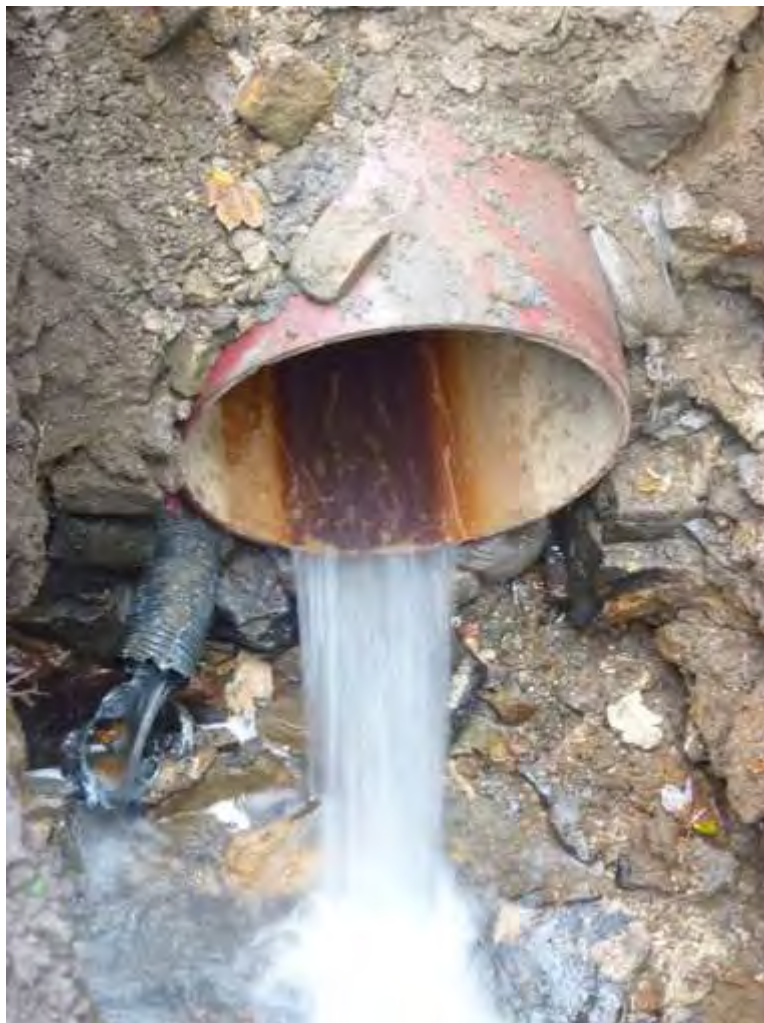
Photo 10: Close-up of the inserted pipe. The remains of the stone culvert is visible on either side of the pipe.

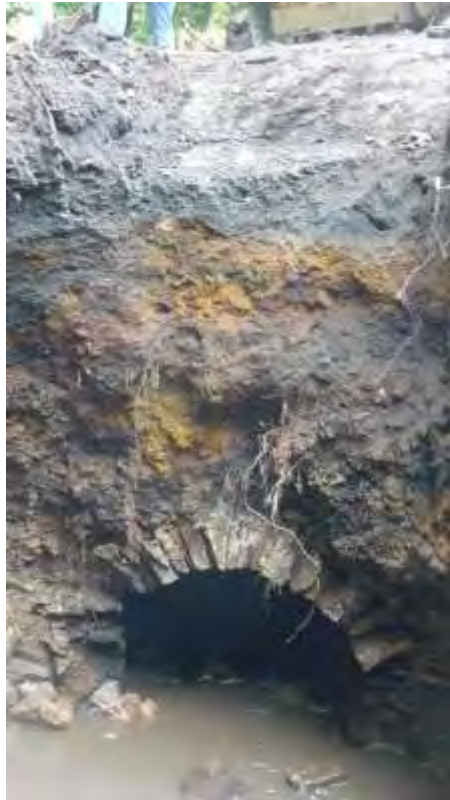
Photo 11: South facing shot of the surviving section of culvert showing the depth of material above it.

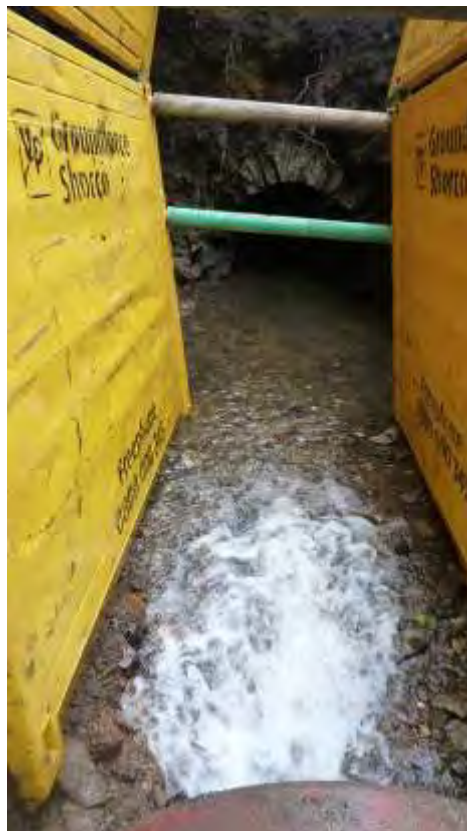
- 4.2.3 The base of the collapsed area was c.3m deep. Therefore, shoring was brought in to provide a safe working area for the repair work. This did not, however, allow a close examination of the surviving section of the stone culvert. Along with potentially unstable overhanging deposits around the edge of the collapse it was not possible to undertake accurately measured and levelled drawings of the culvert and surrounding deposits. Records consisted of high resolution digital photographs (using a 14MP camera), sketch drawings and written AW context sheets.

Photo 12: Facing south, showing the surviving section of culvert and the extent of the shoring within the collapsed area, demonstrating the difficulties of getting a detailed recording of the surviving culvert.

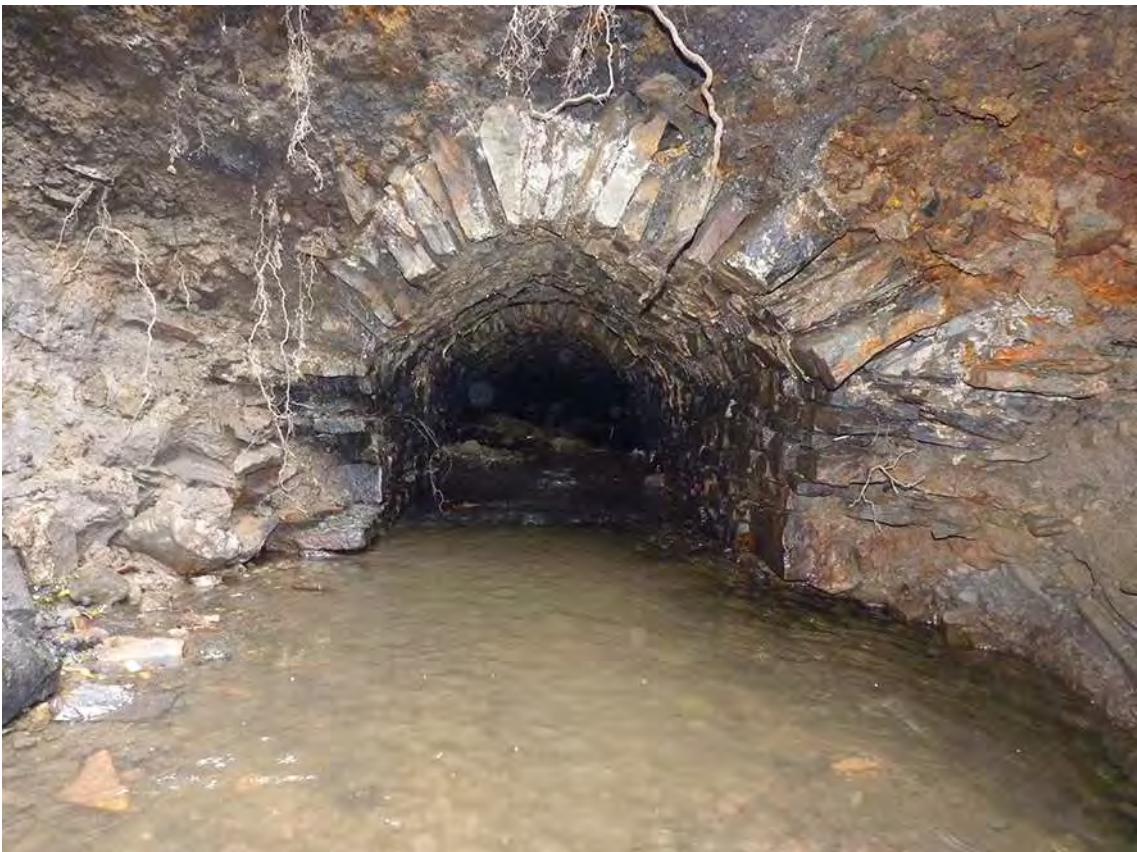
Photo 16: South facing view down the surviving section of culvert. The opening for the manhole is visible in the roof of the culvert a short distance in.

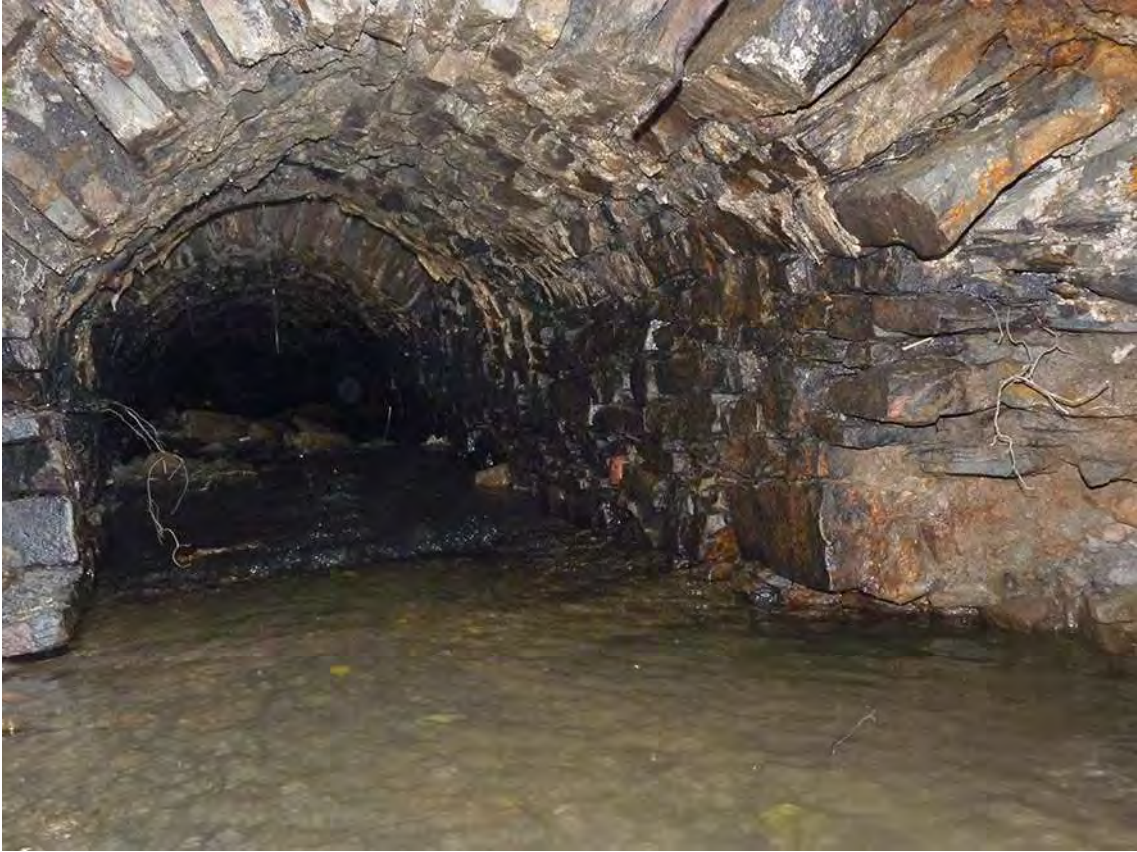
Photo 17: Oblique shot showing more detail for the western wall and arched roof of the culvert. Again the manhole opening is visible in the roof of the culvert.

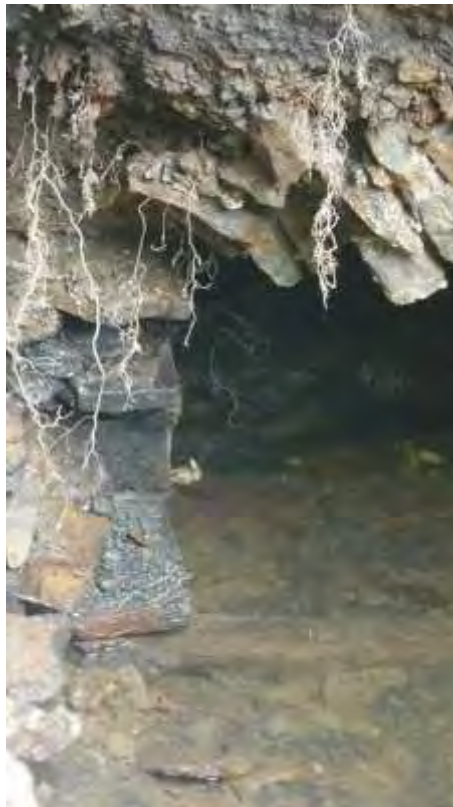
Photo 18: Detail of the eastern wall of the culvert, also showing the tied-in wooden beams along the base of the culvert.

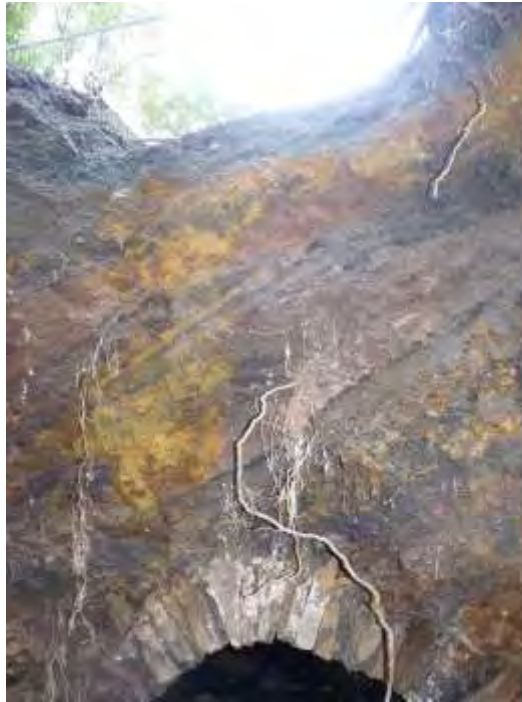
Photo 21: Backfill deposit visible in section above the culvert. Shows tip lines coming in from the west, and iron staining suggesting these deposit derive largely from waste material from the iron working processes.

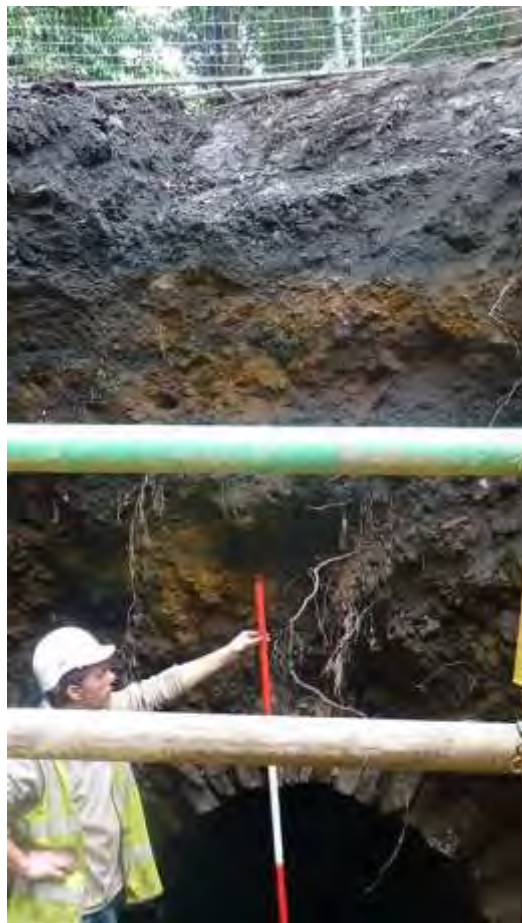
- 5.2.11 These deposits were overlaid by c.1m to 1.5m of dark, grey-brown, clayey-silt mixed with stony-ashy deposits. This was a very mixed deposit representing a combination of topsoil and material formed by past landscaping and repair works.
- 5.2.12 No finds were recovered from, or visible within, any of the deposits underlying the modern topsoil.

Photo 22: Backfill deposits above the culvert, also showing the dark layer of modern disturbance and overburden at the top. The partial scale shown is a 2m scale, divided into 0.5m segments.

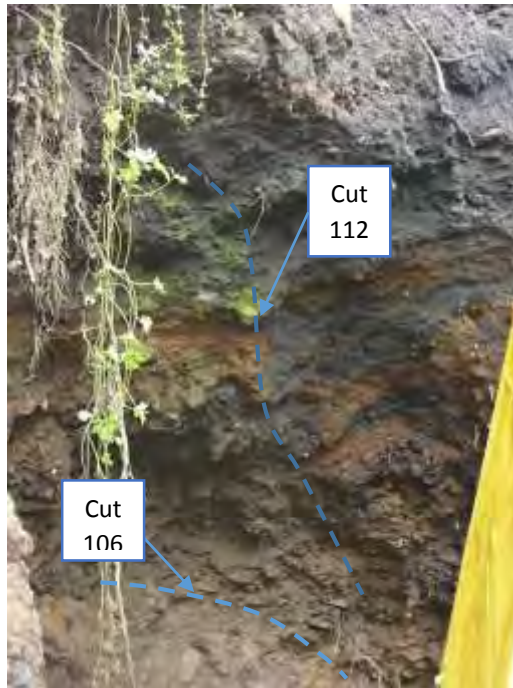
- 5.2.8 A second cut-line (cut 112) is visible as an insertion through these overlying layers (deposits 107 – 110). It has steep, slightly concave sides, which again are largely visible only on the eastern side, as tumbled material obscures the western side. It extends down to the arched roof of the culvert, presumably for later repair or maintenance works, or possibly for work associated with the construction of a nearby manhole, located c.3m to the south. The cut is backfilled with a series of ashy-gritty deposits (deposits 113 – 138), all of which appear to represent waste material from furnace workings. Tip lines within these deposits indicate that they were tipped in from the western side of the valley base.

Photo 23: South facing shot of the deposits revealed above the culvert, showing the original construction cut (106) and the later re-cut (112).

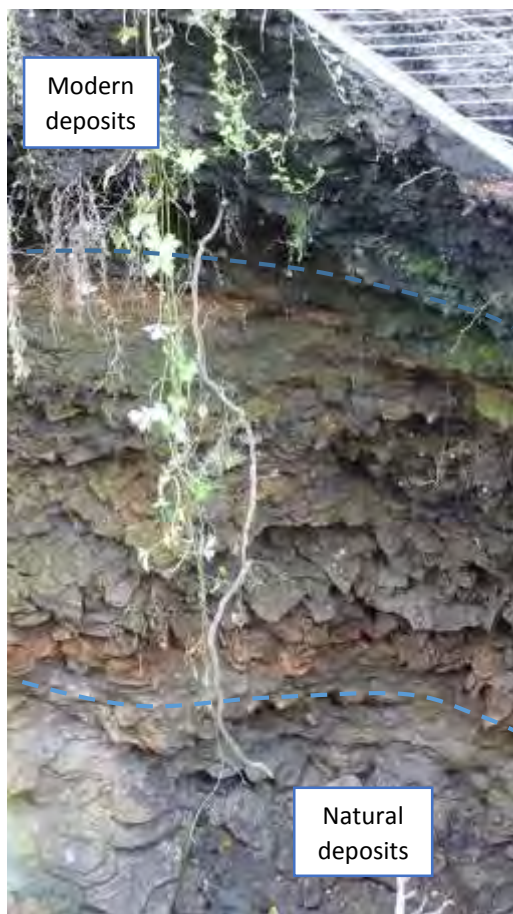
Photo 24: East facing, and slightly downward view of the deposits revealed in the side of the collapsed area. Showing natural stone and clays at the base, overlaid by large amounts of presumed 19th century material that appeared to cover the line of the culvert. The dark deposit of modern disturbance and overburden is visible at the top.

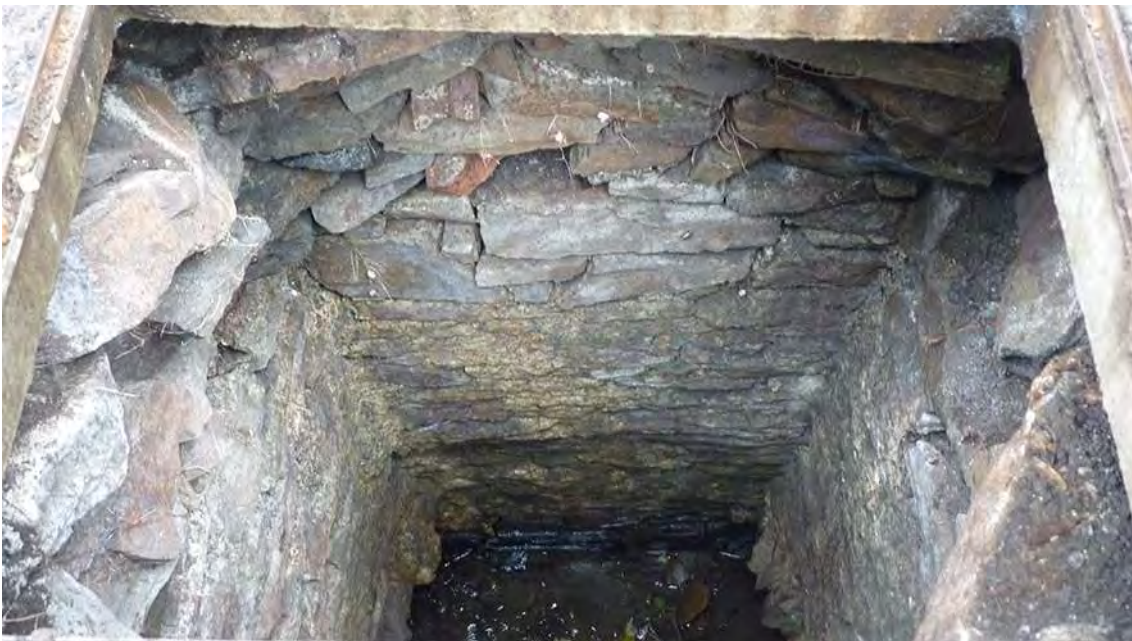
Photo 26: East facing shot of the manhole opening, showing the line of the culvert at the base running left to right and the mortared wall of the shaft topped by unmortared slightly corbelled stonework now carrying the modern concrete and metal manhole cover.
