DALE AIRFIELD  
PEMBROKESHIRE  
Building Photographic Survey  
2005-6

RHIF YR ADRODDIAD / REPORT NO. 2006/53  
RHIF Y PROSIECT / PROJECT RECORD NO. 55592

*A rapid photographic survey was made of most of the building exteriors and runways at Dale Airfield. A few of the buildings are in a poor and dangerous condition, although most are in a fair condition. The interior of the ablution blocks and a few other buildings are recorded in more detail.*

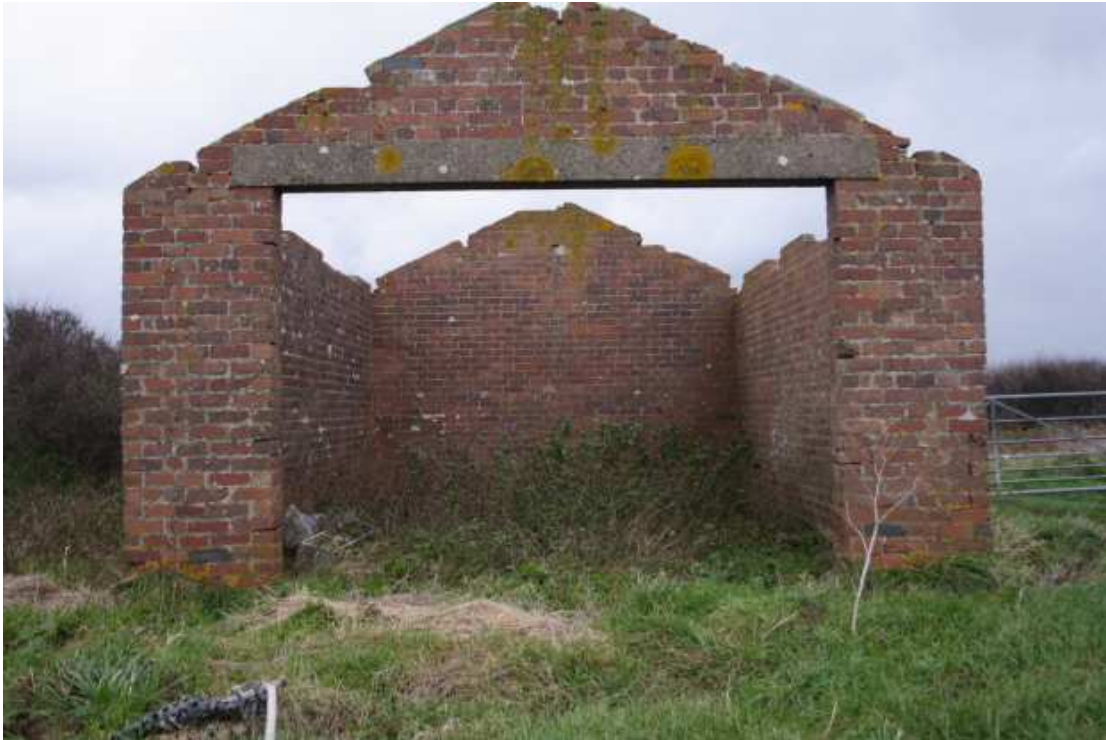
Photo 1 (476): 28565. View E

28565, Military Building. (Fig 4, Photo 1). c1944, Derelict, semi-sunken, 'temporary brick' construction, small rectangular two bay, pitched gable corrugated asbestos roof.. Not present on RAF Dale site plan 1364/44. *Gable roof has gone.*

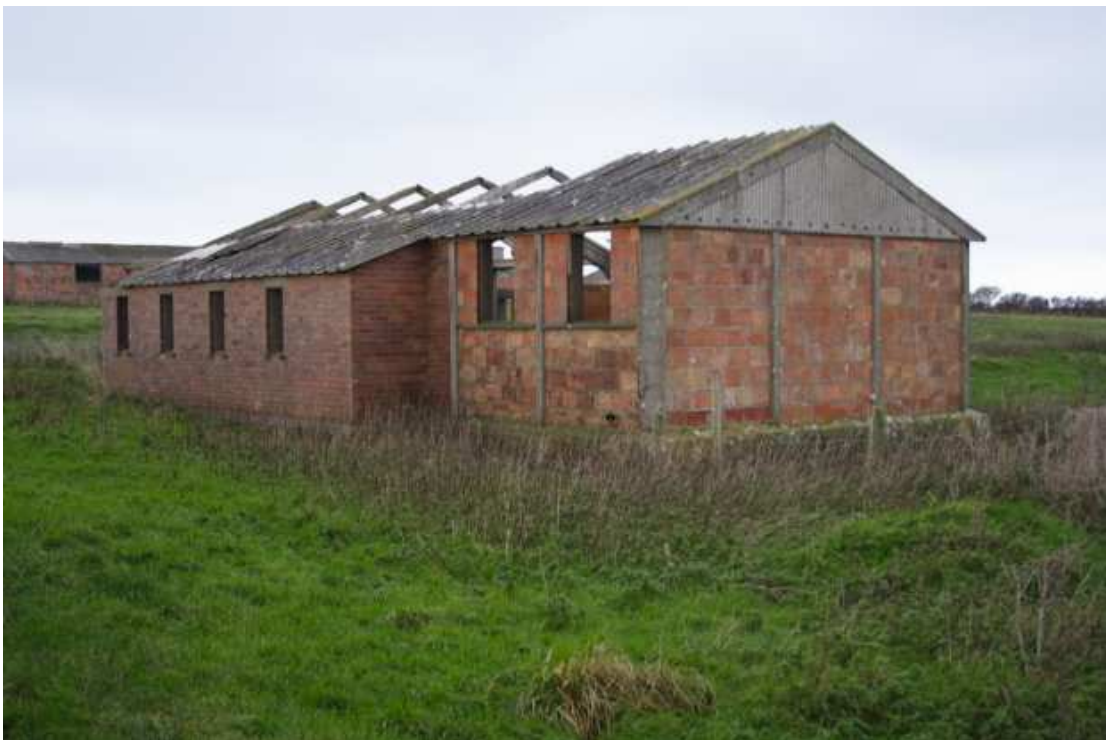
Photo 2 (548): 28566, Chapel. View NW

28566, Chapel (Fig 5, Photo 2). c1944, Chapel, now derelict. Single storey, type 'standard 24' pre-cast concrete frames, corrugated asbestos pitched gable roof. Two bay chancel with hollow brick walls, four bay nave, roof extended beyond wall posts to form aisles resting on brick walls. *Remains of altar base and pulpit?. Porch at west end has no roof.*

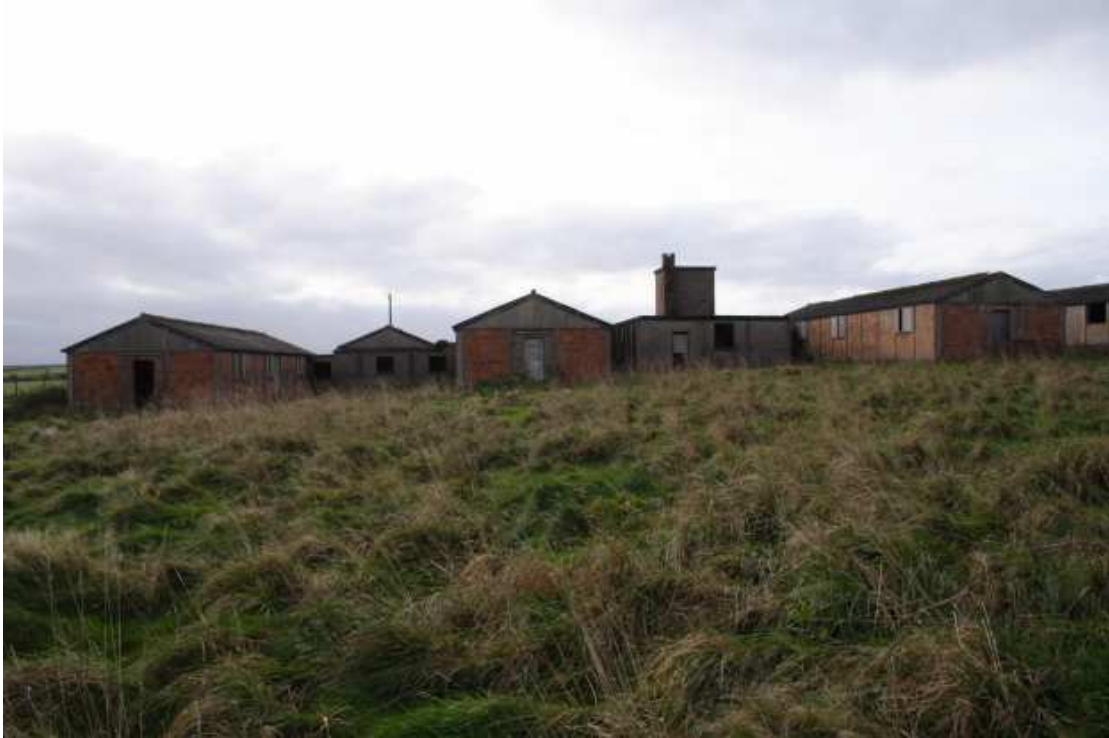
Photo 3 (555). 28568. Eastern part. View S

28568, Quarters. (Fig 6, Photo 3). c1944, Quarters, present use low grade agricultural. Six single storey, 'standard 24 huts linked by two corridors, three either side of a central ablutions block. Concrete common rafters, bolted to concrete posts, pitched gable corrugated asbestos roof. *Roofs nearly all complete. Block northwest of ablution block contains aircraft cartoons (Fig 7, Photos 4-9) on walls at towards southern end. Access to boiler room blocked by debris.*

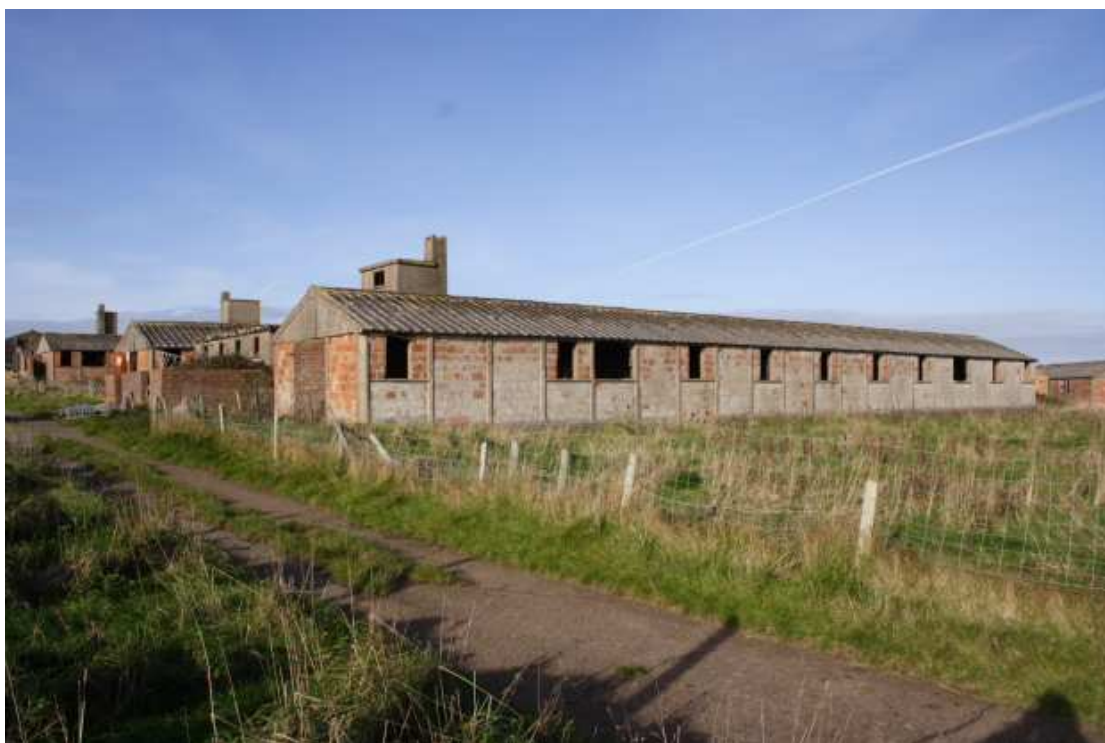
Photo 10 (578). 28569. View NW

28569, Quarters. (Fig 8, Photo 10). c1944, Quarters, present use low grade agricultural. Two single storey, 'standard 24 huts linked by two corridors, to a central rectangular plan, 'temporary brick' construction, flat concrete roofed ablutions block with a combined water tower and chimney. *Modern opening on south end of west building. No access to west block.*

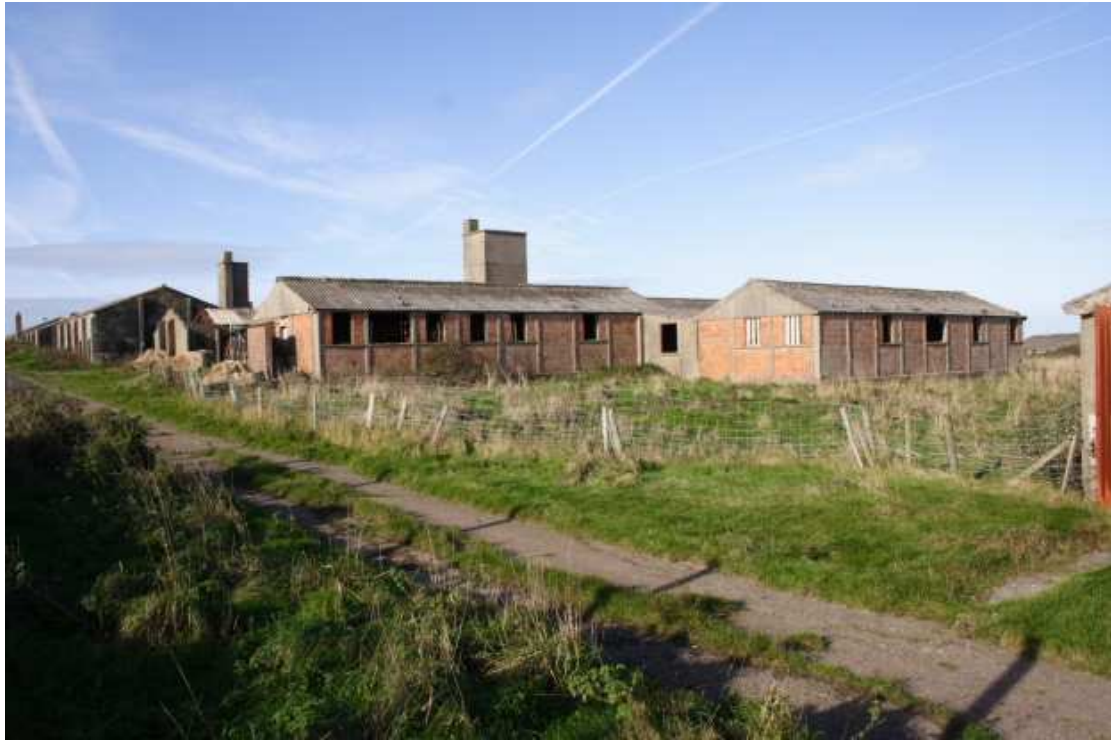
Photo 11 (592). 28570. View NW

28570, Quarters. (Fig 9, Photo 11). c1944, Quarters, present use low grade agricultural. Three, 'standard 24 huts linked to an ablutions block by a single

corridor. Two huts 10 X 3 bays, one 13 X 3 bays. Concrete common rafters, bolted to concrete wall posts, clay brick wall noggin. *Mostly intact.*

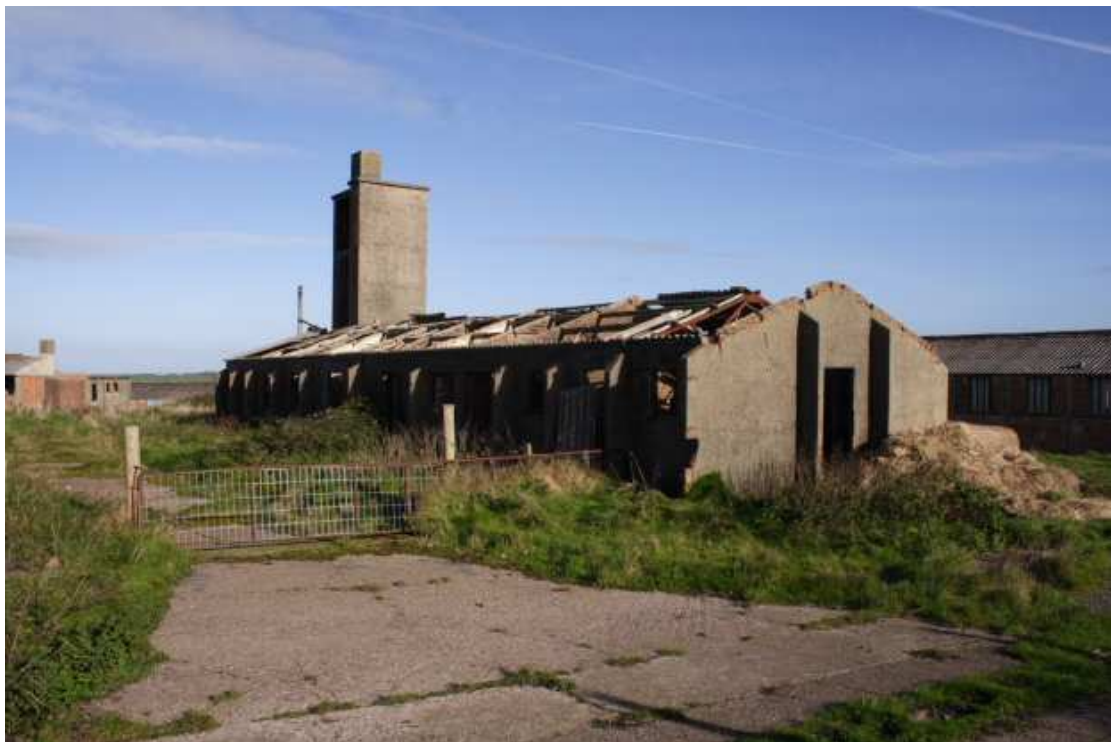
Photo 12 (594). 28571. View NNE

28571, Ablution block. (Fig 9, Photo 12). 1941-47, Sergeant's, Showers, Ablutions and Latrines, now derelict. Single storey, 'temporary brick' construction, /1/2--1/2--5--1/2--1/2--1/2 bay rectangular plan, combined water tower and chimney set at north east corner. Pitched gable corrugated asbestos. *Both gable roofs mainly intact. Shower roof nearly all gone.*

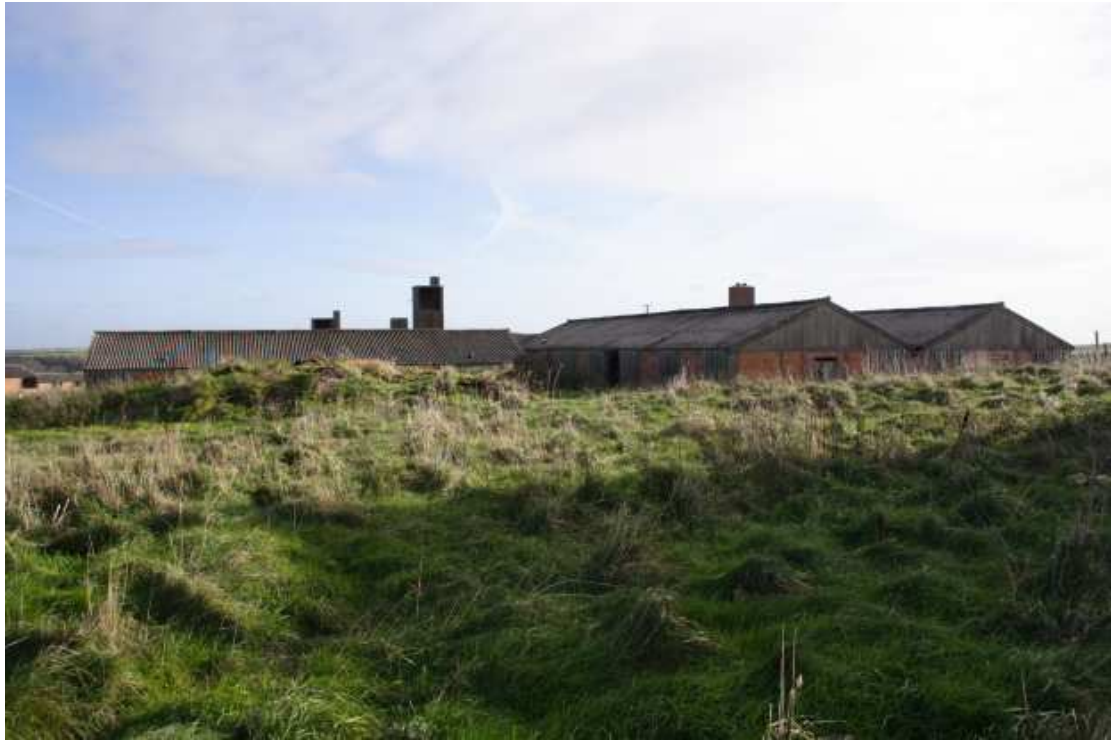
Photo 13 (603). 28570. View SE

28572, Mess. (Fig 9, Photo 13). 1941-47, Sergeant's, Mess, present use low grade agricultural. Single storey, 'temporary brick' construction, pitched gable corrugated asbestos roof. Three ranges. The main range is 14 bays long with a 5 bay return range (Dinning Hall and Kitchen). *Gable roofs mostly intact. Some interior divisions. Part of roof fallen in west of water tower, only NE part of roof very bad or gone.*

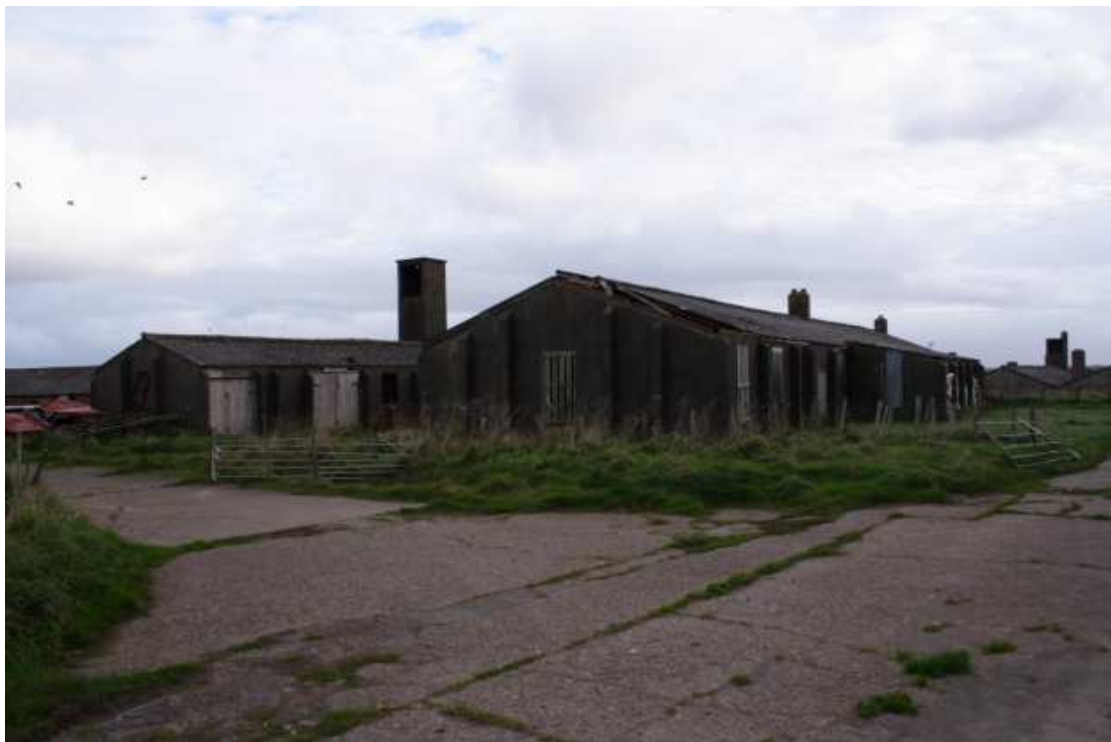
Photo 14 (672). 28571. View NE

28573, Institute. (Fig 10, Photo 14) 1941-47, NAAFI Institute, present use low grade agricultural. Single storey, 'temporary brick' construction, pitched gable corrugated asbestos roof. 'T' plan with parallel return range to main range off west wall of the rear range. *Nearly all gable roofed and mostly intact except small part of NR block and western end of south extension. Contains fore places. North block has modern entrance. No access to adjacent block on northwest side used for car and boat storage. Some windows blocked and doors in this later block and some of the main block.*

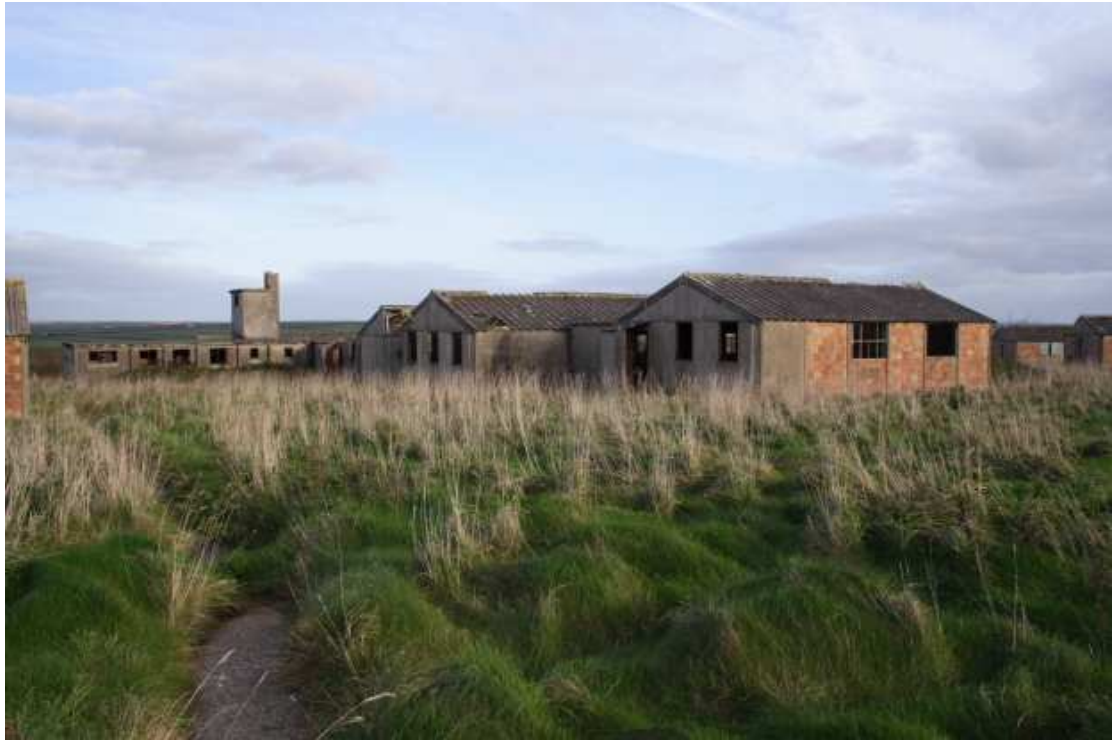
Photo 15 (638). 28576. View E

28576, Quarters. (Fig 11, Photo 15). 1944-47, Quarters, present use low grade agricultural, six single storey,, type 'standard 24' huts. Arranged one 6 bay, two 11 bay and one 9 bay to the south west of a large single storey, rectangular plan, flat roof, rendered brick ablutions block. *East block intact and used for storage. East but one block full of potato boxes no access. Ablution block divisions plus some fittings remain.*

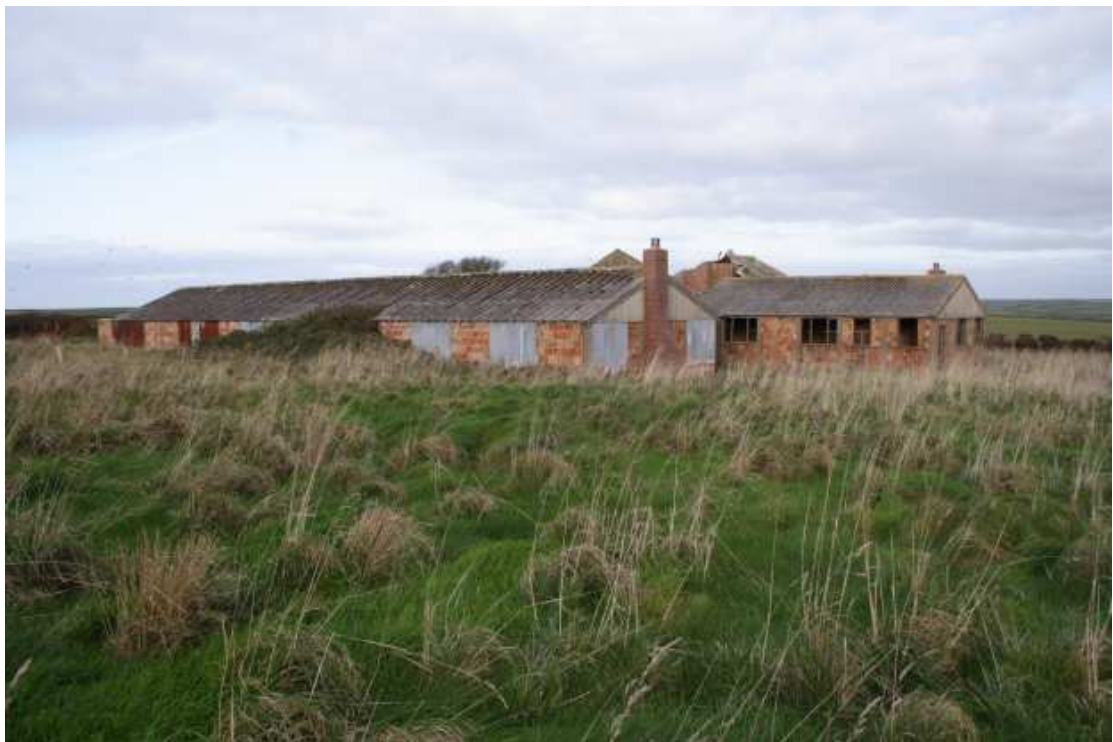
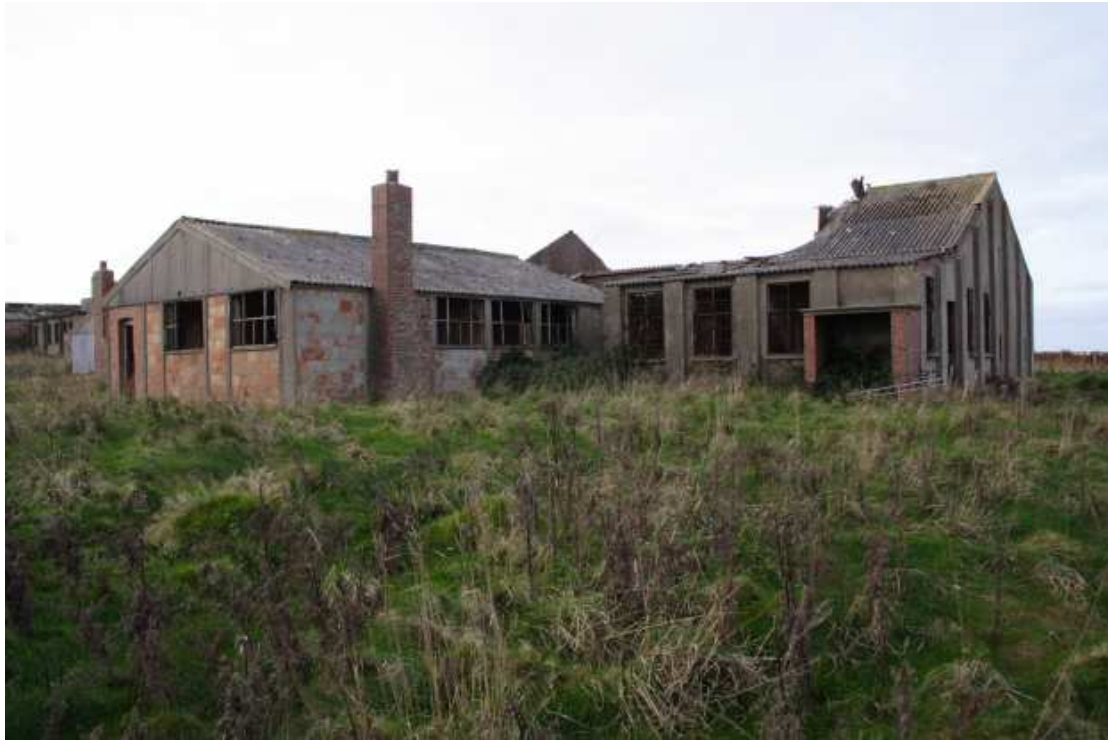
28577, Mess. (Fig 11, Photos 16 and 17). 1944-47, Dining Hall/Mess, now derelict. One 6 bay, one 9 bay and one 17 bay, type 'standard 24' huts adjoining a central, six bay kitchen block. Kitchen block, tall pitched gable corrugated asbestos roof on steel trusses and purlins, ridge ventilator. *Western part of gable roof all intact except north bay which has been removed. No internal access, used for storing boat and car. NE block gable roof ¾ intact. Middle east section roof collapsed. SE block contains fireplace.*

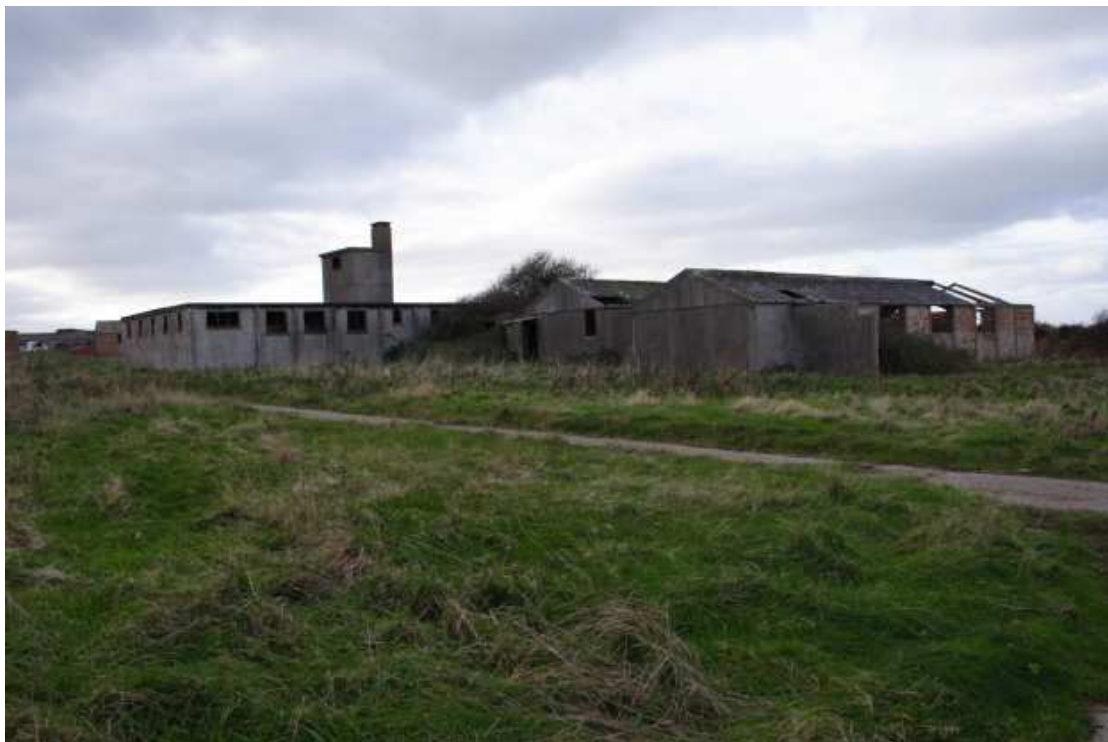
Photo 18 (649). 28578. View W

28578, Quarters. (Fig 12, Photo 18). 1944-47, Quarters, present use low grade agricultural. Single storey, rectangular plan, flat roofed ablutions block with combined water tower and chimney. Linked by a corridor to four 11 bay type 'standard 24' huts to the south west and two 11 bay type. *All gable asbestos roofed except for flat concrete roofed ablution block. West block almost no roof left. West block but one, roof almost complete. West block but two, roof ¾ complete. West block but three, roof ¾ complete. East block but one, roof ¾ complete. East block roof ¾ complete. Building no longer appears to be used*

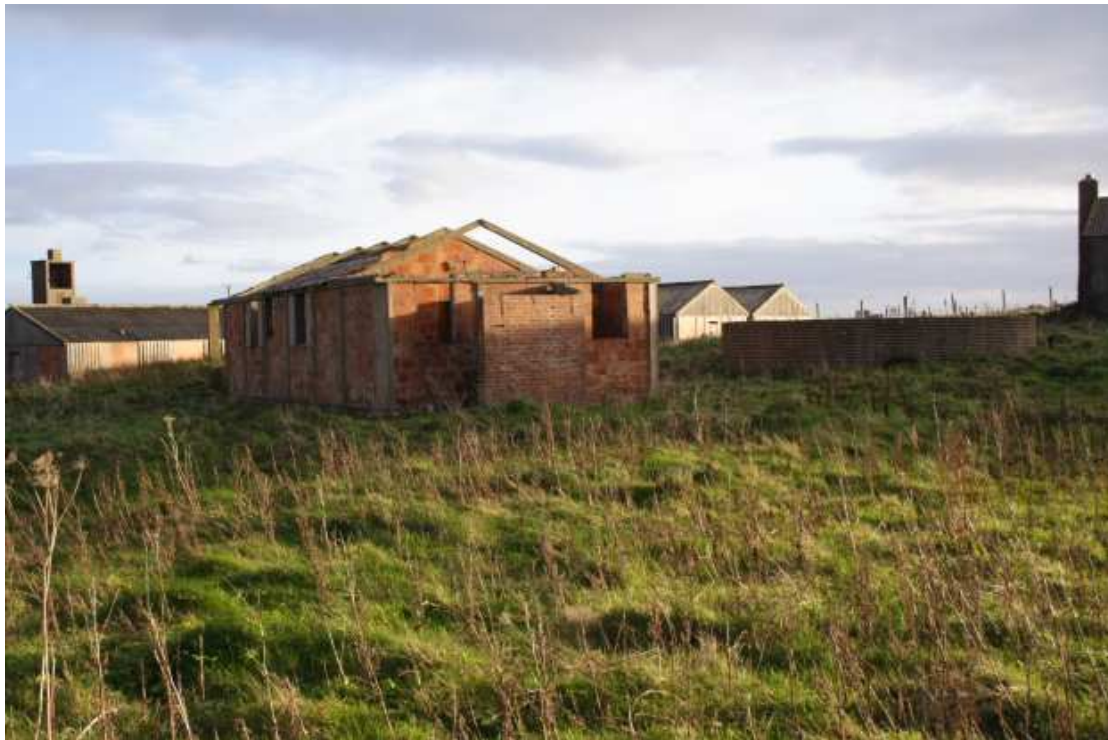
Photo 19 (665). 28579. View S

28579, Military Building (Fig 12, Photo 19). 1944-47, present use low grade agricultural. Single 6 bay type 'standard 24' hut. Concrete rafters bolted to concrete wall posts, large hollow clay brick nogging. *Pitched gable corrugated asbestos roof. Porched doorway in northwest wall. Roof completely gone. Building no longer used.*

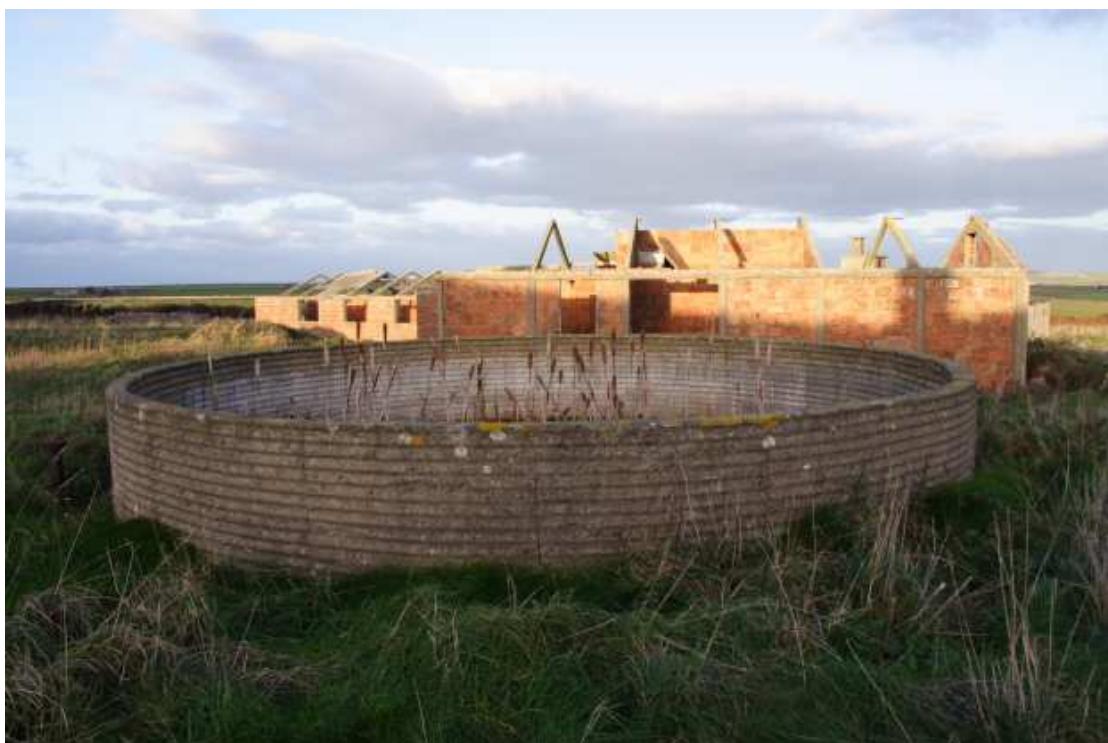
Photo 20 (668). Water Tank 28580. View NE

28580, Emergency Water Supply (Fig 10, Photo 20). 1944-47, Static Water Tank/Emergency Water Supply, present use Water Tank. Approx 4'(1.22m) high

re-inforced concrete, circular static water tank. Cement wall having been shuttered in corrugated zinc sheeting. *No longer used.*

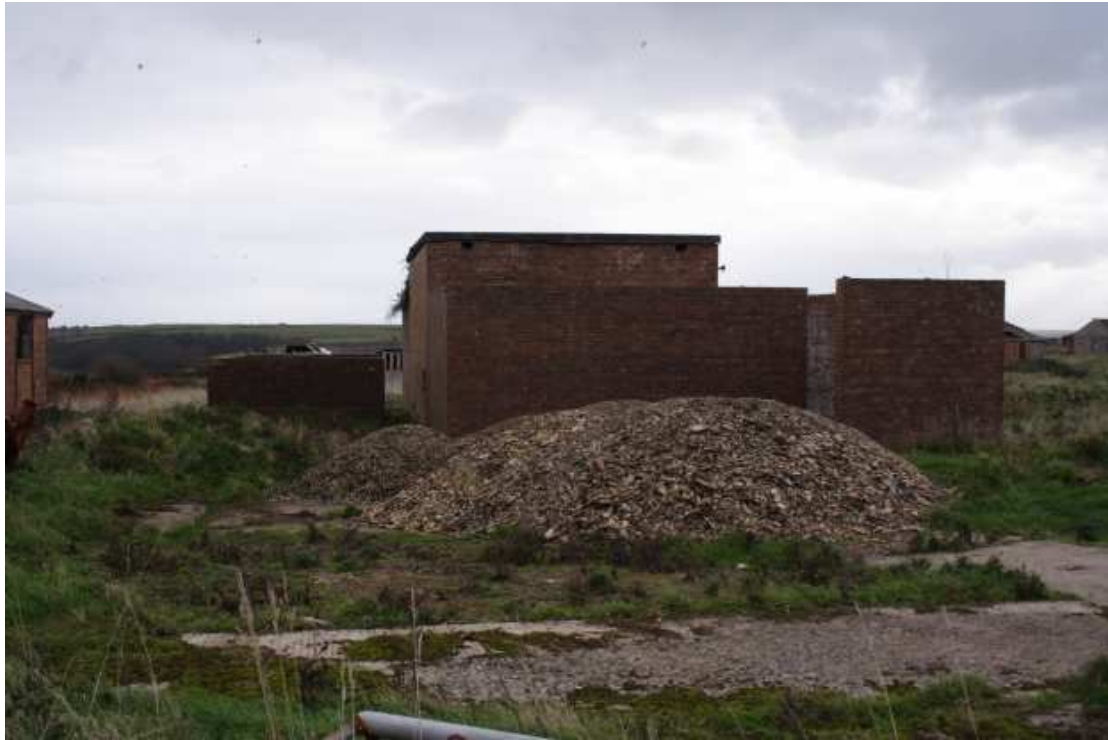
Photo 21 (685). Generator House 29581. View E

28581, Generator House. (Fig 13, Photo 21). 1941-47, Standby Set House, present use low grade agricultural. One and a half storey, brick built, flat concrete roof engine room, protected by a tall rectangular blast wall enclosure. Entrance to enclosure in north west wall, doorway to engine room in south side. *Remain of fuel tank in adjacent surround on north side. All brickwork and roof in good condition. No remains of machinery but some concrete engine beds*

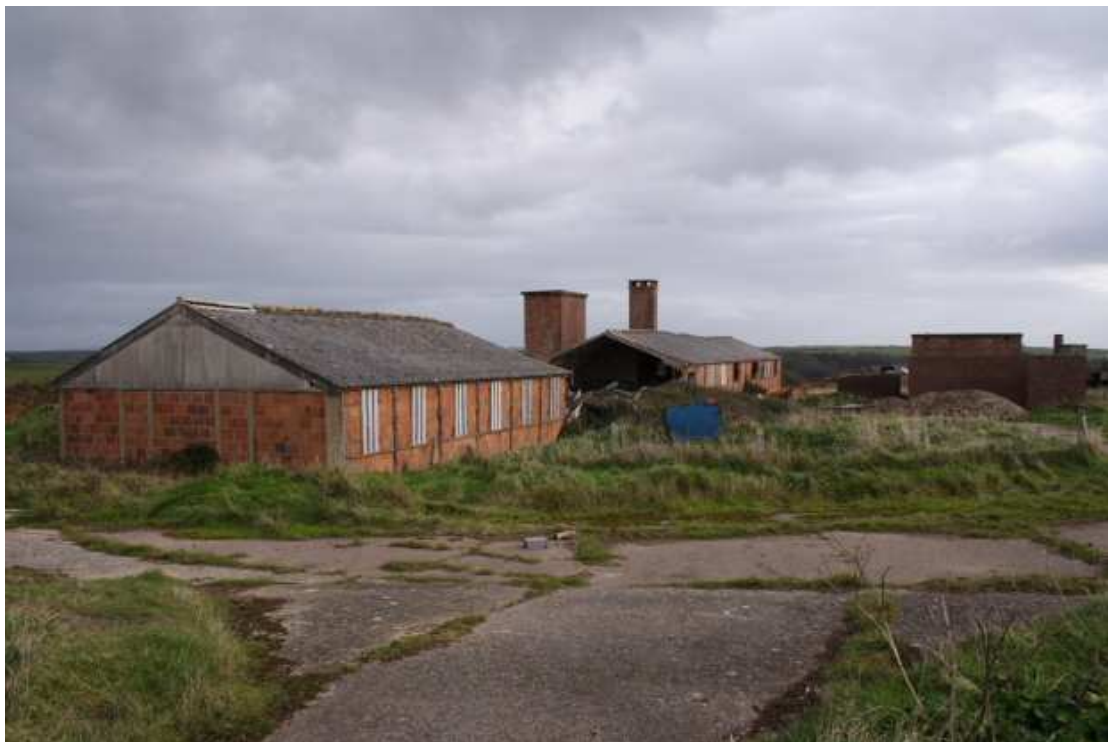
Photo 22 (692). 28582. View W

28582, Military Building. (Fig 13, Photo 22). 1944-47, present use low grade agricultural. Single storey, type 'standard 24' hut, 24 bay length, approx 156' (47.58m) long. Pitched gable corrugated asbestos. Centrally set brick chimney-stack. *Detached brick water tower centrally set against the north. Part of western half totally collapsed but not far west end. **Rest of building especially to the east likely to collapse soon as wall bulging.***

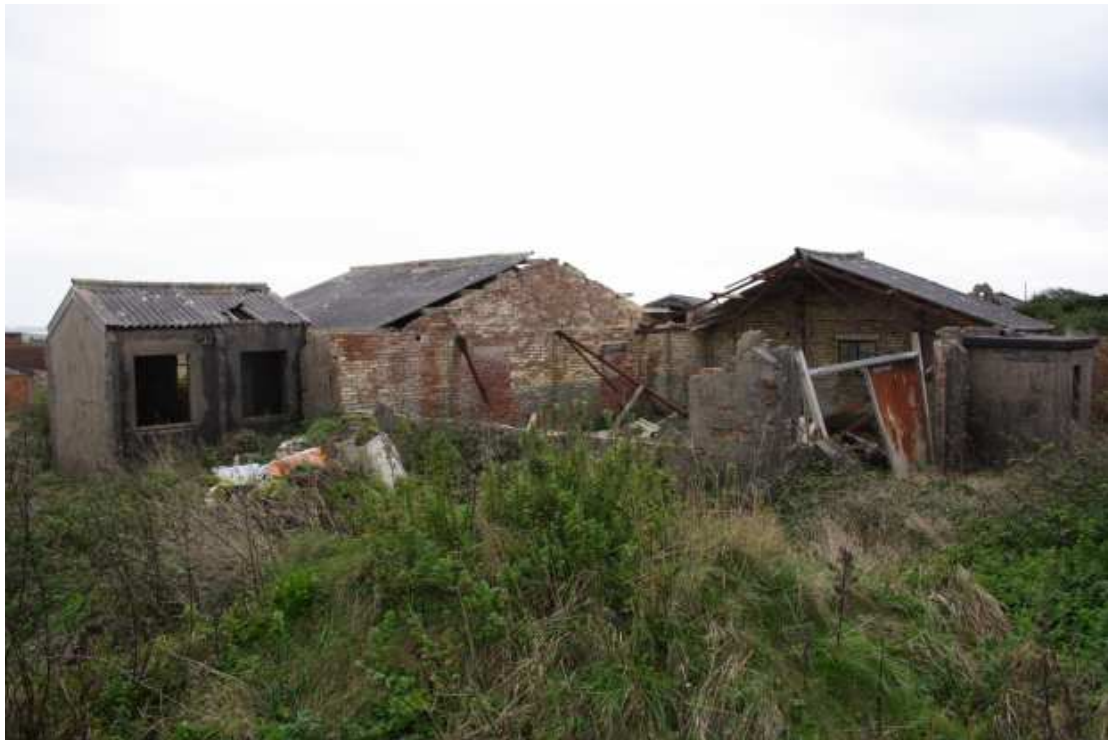
Photo 23 (701). 28583. View SE

28583, Ablutions Block. (Fig 14, Photo 23). 1944-47, Airmen's, Showers, Ablutions and Decontamination Block, now derelict. Single storey, rendered 'temporary brick' construction, 'T' Plan, pitched gable corrugated asbestos roofs. Built per Air Ministry Drawing 7421-41. *Far eastern end demolished. West end gable roof nearly all gone and north wall partly collapsed. Small extension on north side mostly complete. Middle eastern end for starting to go. Used for storage, no access.*

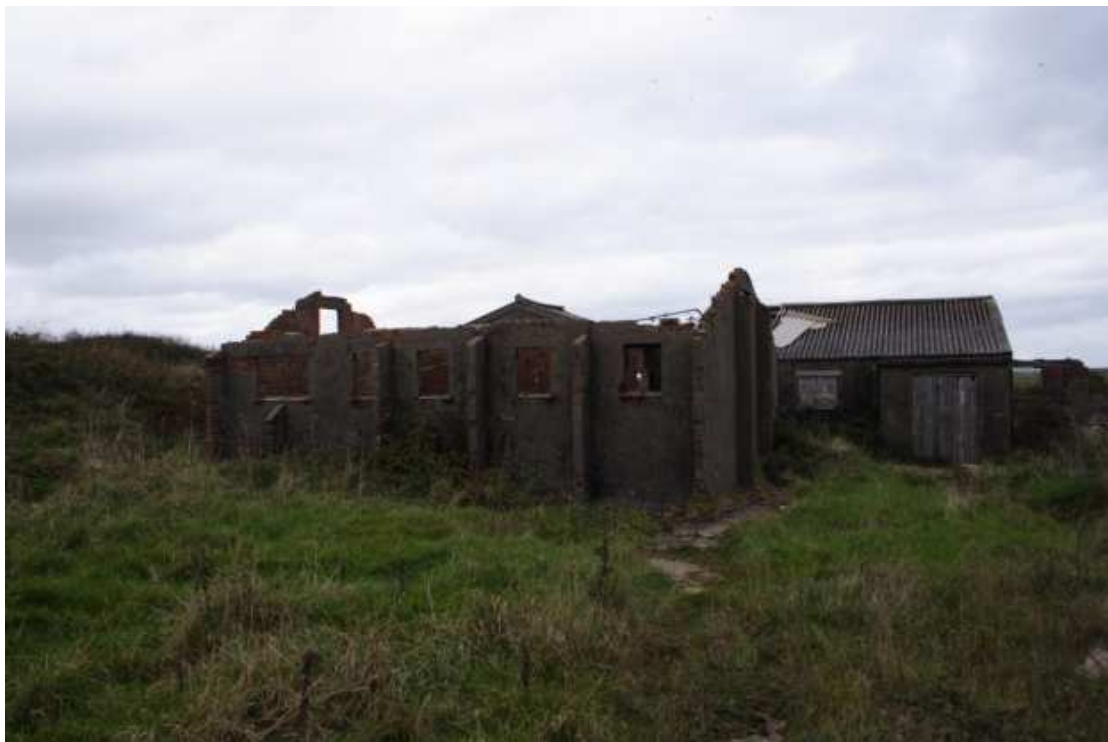
Photo 24 (703). 28584. View N

28584, Latrine. (Fig 14, Photo 24). 1941-47, Airmen's Latrines, now derelict. Single storey, rendered 'temporary brick' construction, 1--1/2--1/2--1/2 bay elevation, divided internally into two and a half bay. Doorway in both gables. Pitched gable corrugated asbestos roof. *Roof totally gone. Remains of urinals plus internal divisions.*

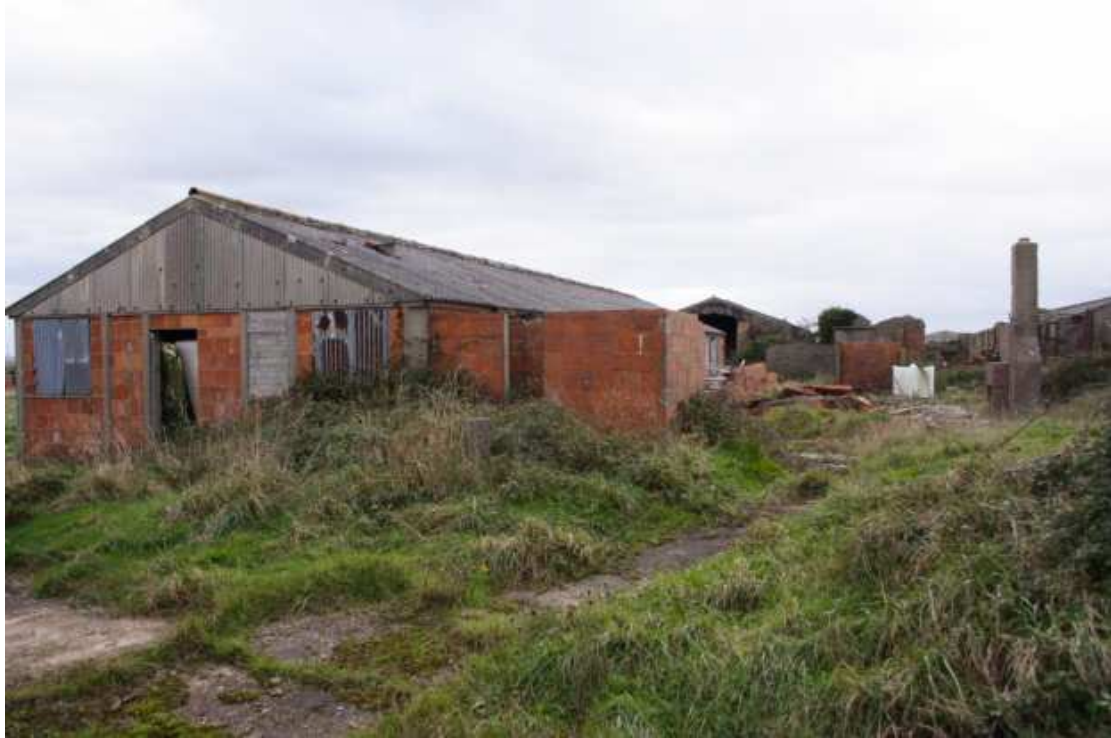
Photo 25 (705). 28586. View S

28586, Military Building. (Fig 14, Photo 25). 1941-47, building type unknown, now derelict. Single storey, type 'standard 24' hut, 15 bay, 90' X 24' (27.45 X 7.32m). Pitched gable corrugated asbestos roof. *Western block demolished except for chimneystack, part of porch and two urinals. East block modern entrance in south gable, roof intact, used for storage and no access.*

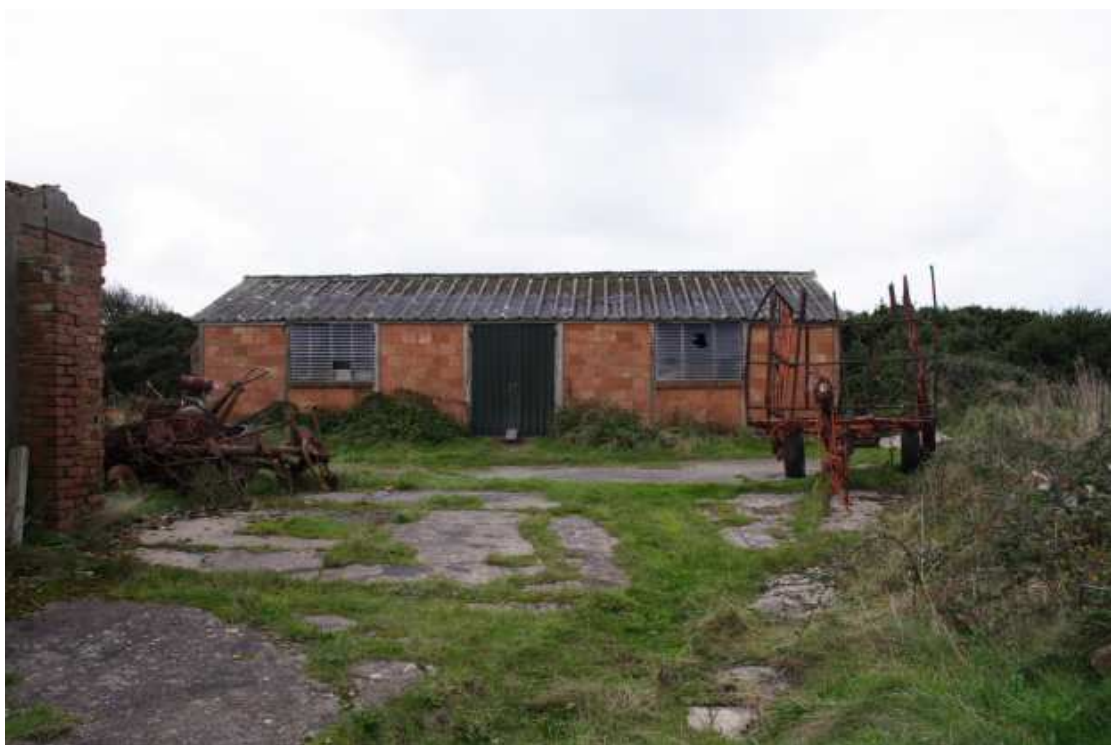
Photo 26 (709). 28587. View W

28587, Military Building. (Fig 15, Photo 26). 1944-47, building type unknown, present use builders store. Single storey, 7 bay, type 'standard 24' hut. *Modern entrance in middle of east side. Used for storage. No access.*

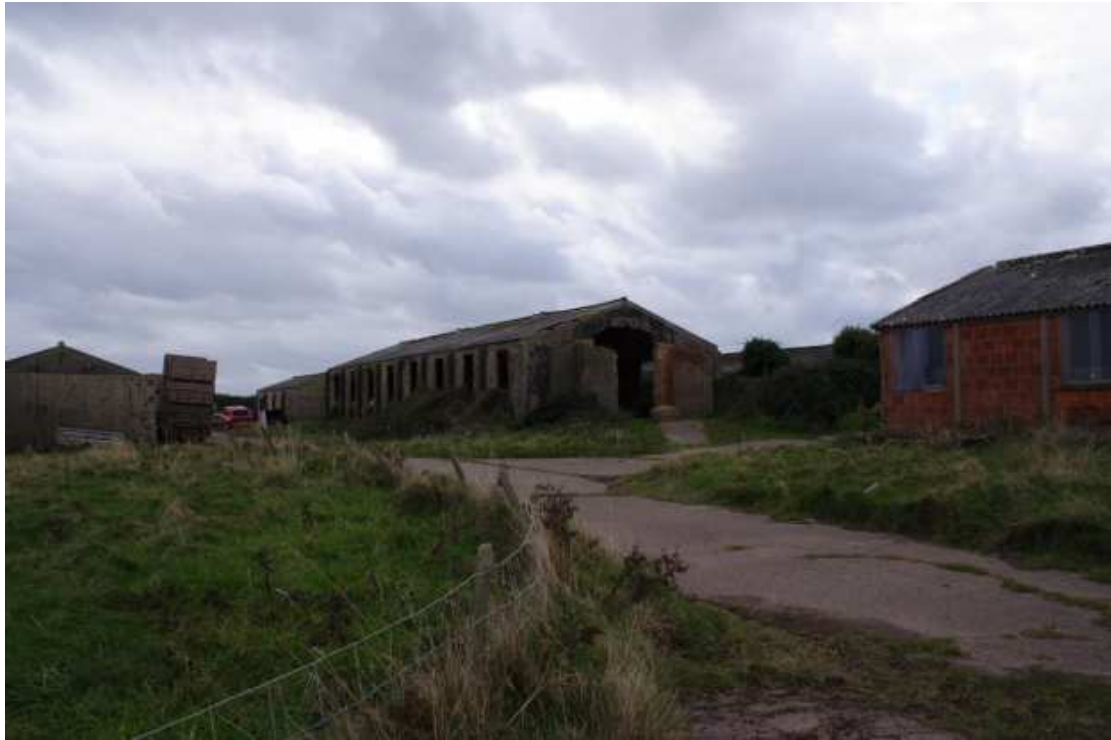
Photo 27 (713). 28588. View SSW

28588, Mess. (Fig 15, Photo 27). 1941-47, Airmen's Dining Room, present use store. Three parallel, rendered 'temporary brick' construction ranges, linked by a corridor. Pitched gable corrugated asbestos roof on steel trusses. Built per Air Ministry Drawings 7418/41. *Middle part collapsed. West and east blocks still have gable roofs. West block has modern entrance in south gable end, no access. East block has modern entrance in north gable end. Used for straw bale storage, limited access, ceiling starting to go.*

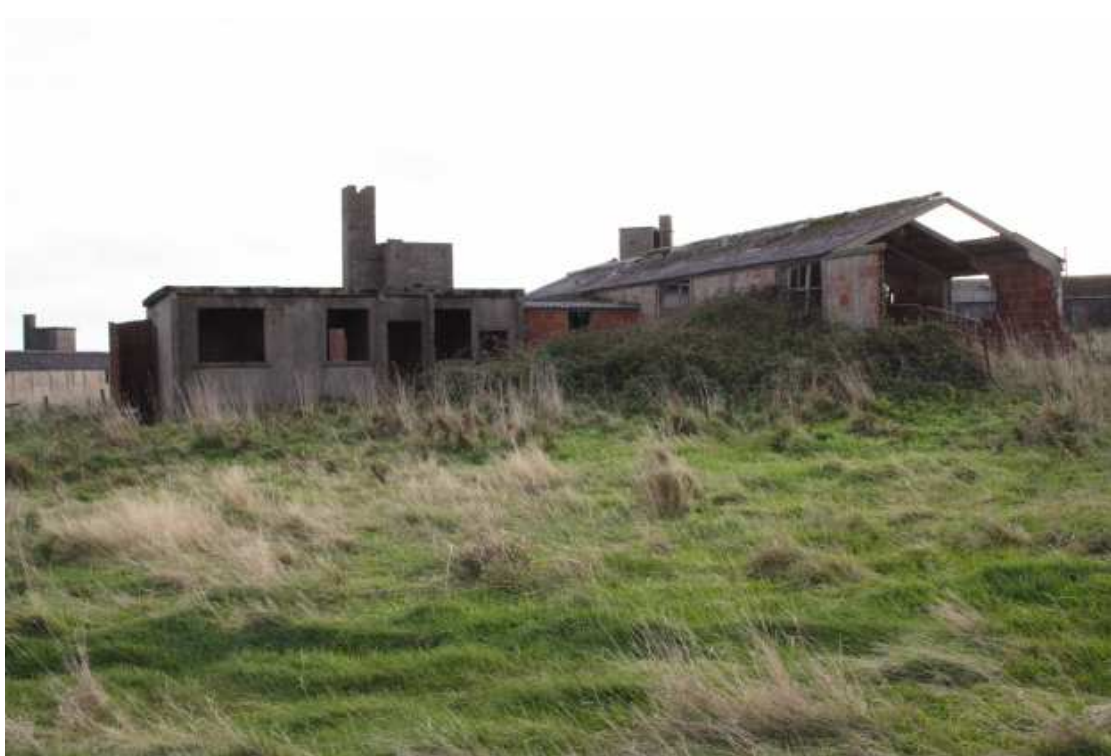
Photo 28 (626). 28589. View SW

28589, Military Building. (Fig 11, 28). 1944-47, Building type unknown, present use low grade agricultural. Single, 12 bay, type 'standard 24' hut, with a small rectangular rendered brick, flat concrete roofed ablutions block set centrally

against the north east wall. Pitched gable corrugate. *Western part gable roof party intact. North end of building destroyed for access.*

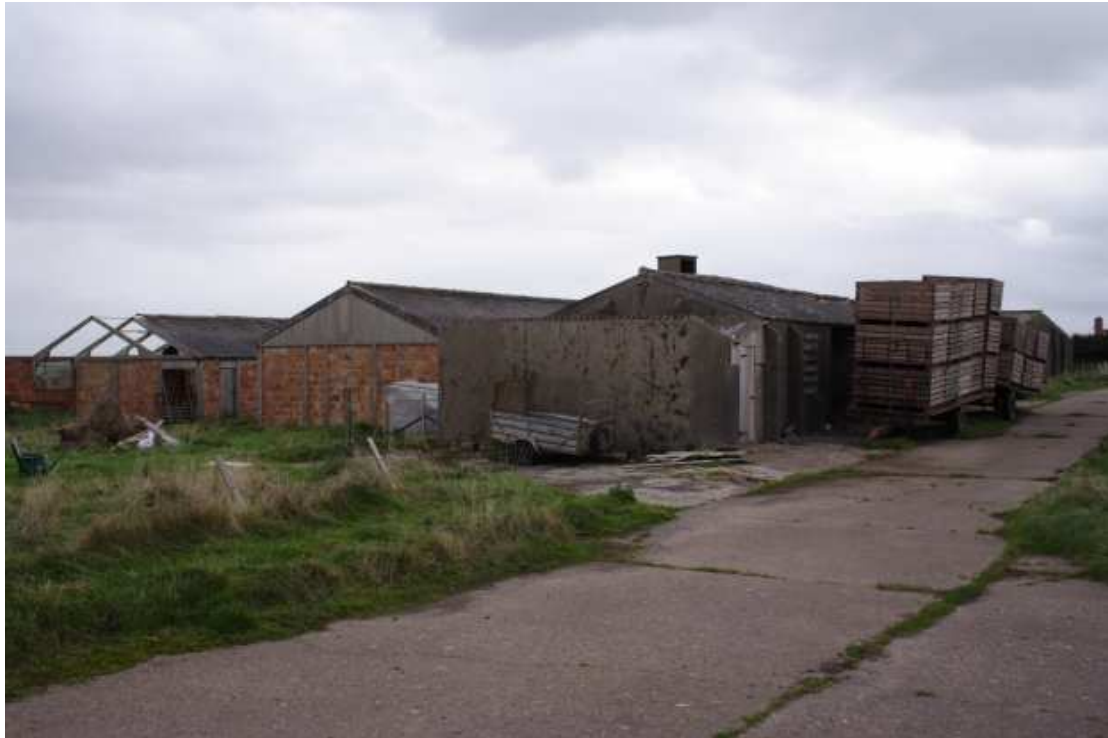
Photo 29 (695). 28590. View SSE

28590, 1941-47, (Fig 15, Photo 29). Grocery and local produce store, present use low grade agricultural. Single storey, rendered 'temporary brick' construction, pitched gable corrugated asbestos roof, 1/2--5--1/2--1/2 bay main elevation, with annex against north gable with corrugated asbestos roof. *Both gable roofs intact. North block has modern entrance on east side towards north. No access, fair condition. North end of west block valley roofed. West block used for storage of caravan and scrap. Internal divisions in southern end including a "decorative" fireplace (Photo 699).*

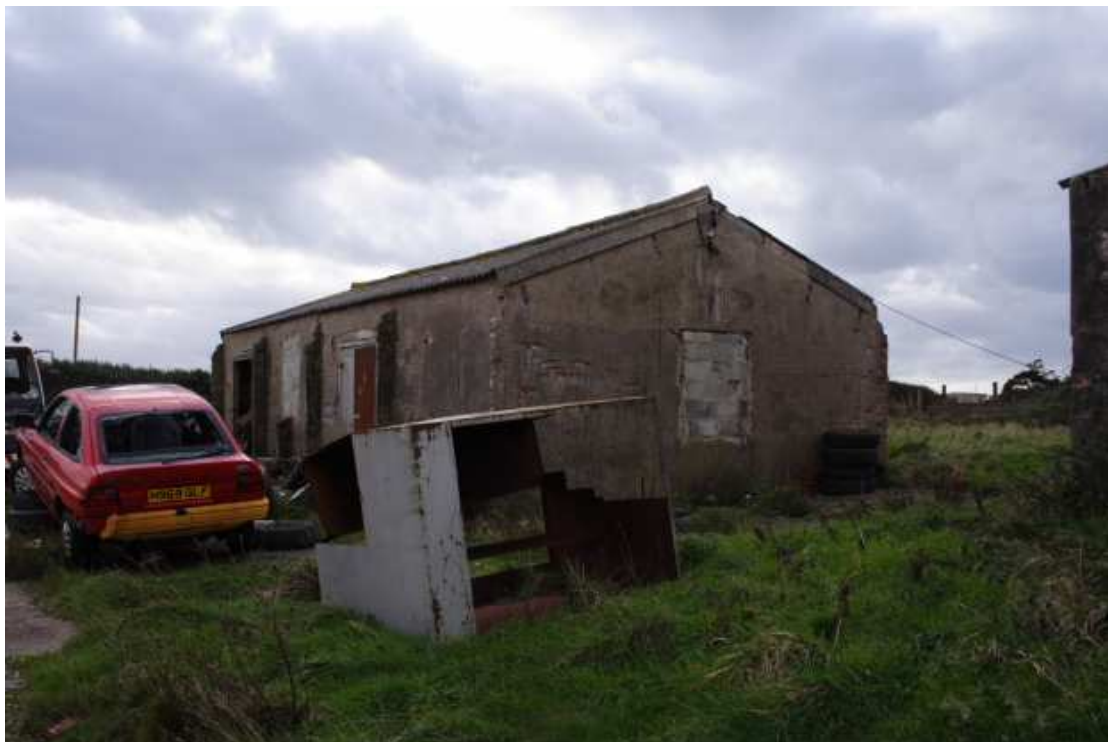
Photo 30 (715) 28591. View SSW

28591, Food Store. (Fig 15, Photo 30). 1941-47, Ration store, present use store. Single storey, rendered 'temporary brick' construction, pitched gable corrugated asbestos roof. Barred windows in south and west elevations. Built per Air Ministry Drawing 7418/41. *Modern? Entrance in east side. Used for storage and scrap. No access.*
