DALE AIRFIELD  
PEMBROKESHIRE  
Building Photographic Survey  
2005-6

RHIF YR ADRODDIAD / REPORT NO. 2006/53  
RHIF Y PROSIECT / PROJECT RECORD NO. 55592

*A rapid photographic survey was made of most of the building exteriors and runways at Dale Airfield. A few of the buildings are in a poor and dangerous condition, although most are in a fair condition. The interior of the ablution blocks and a few other buildings are recorded in more detail.*

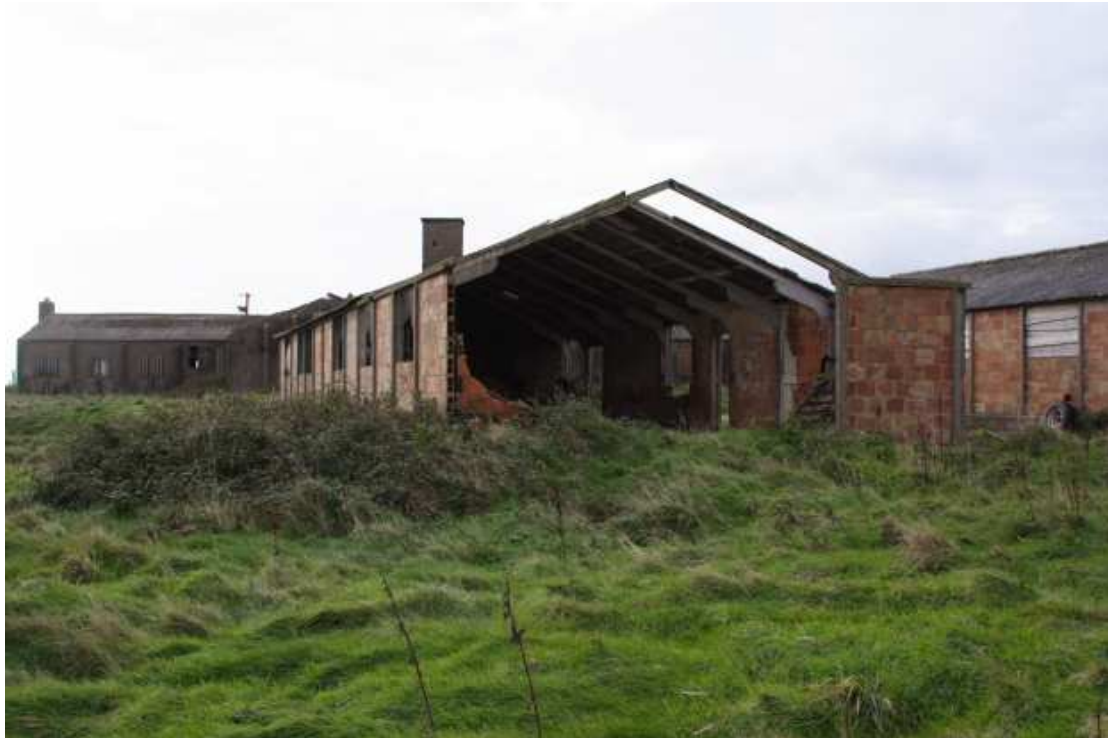
Photo 31 (683). 28592. View S

28592, Military Building. (Fig 15, Photo 31). 1944-47, Building type unknown, present use low grade agricultural. Single storey, 13 bay, type 'standard 24' hut, concrete rafters bolted to concrete wall posts, corrugated asbestos pitched gable roof. *Gable roof intact except for north end that has part roof and gable end missing. **South gable end leaning and likely to collapse.** Used to store straw bales.*

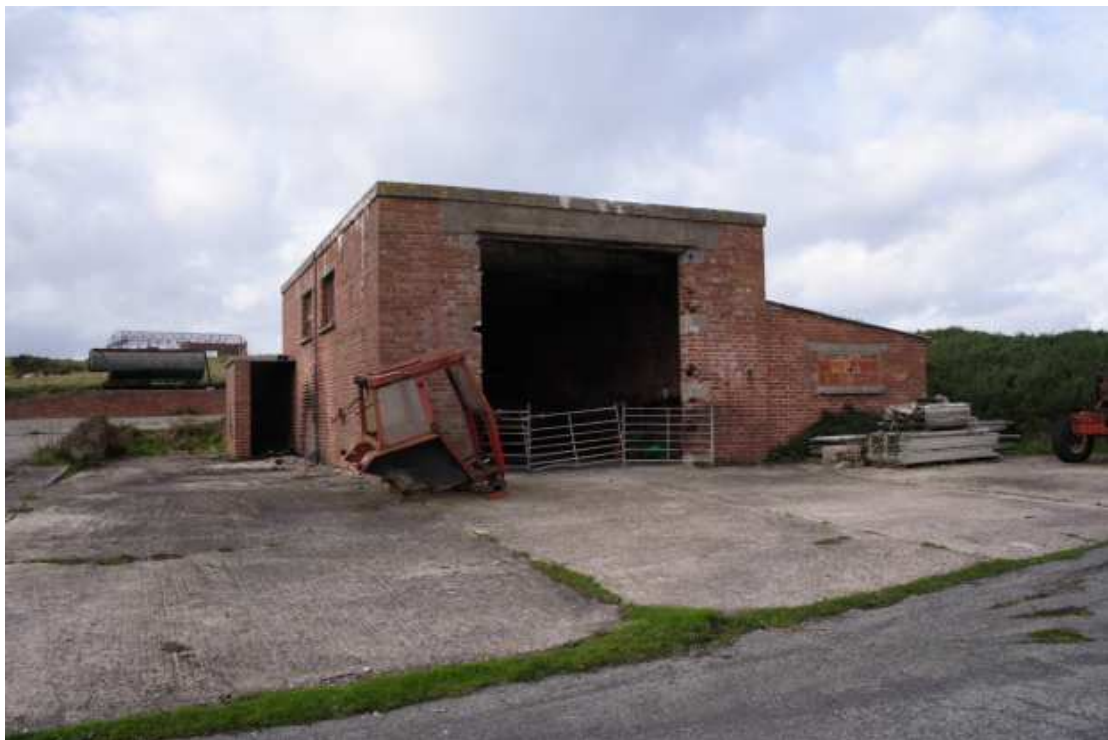
Photo 32 (726). 28602. View NW

28602, Workshop. (Fig 16, Photo 32). 1944-47, Motor Transport Workshop, now derelict. Large, one and a half storey, rectangular plan brick built, flat concrete roof workshop. Single storey brick lean-to. *All good condition. Used for tractor storage.*

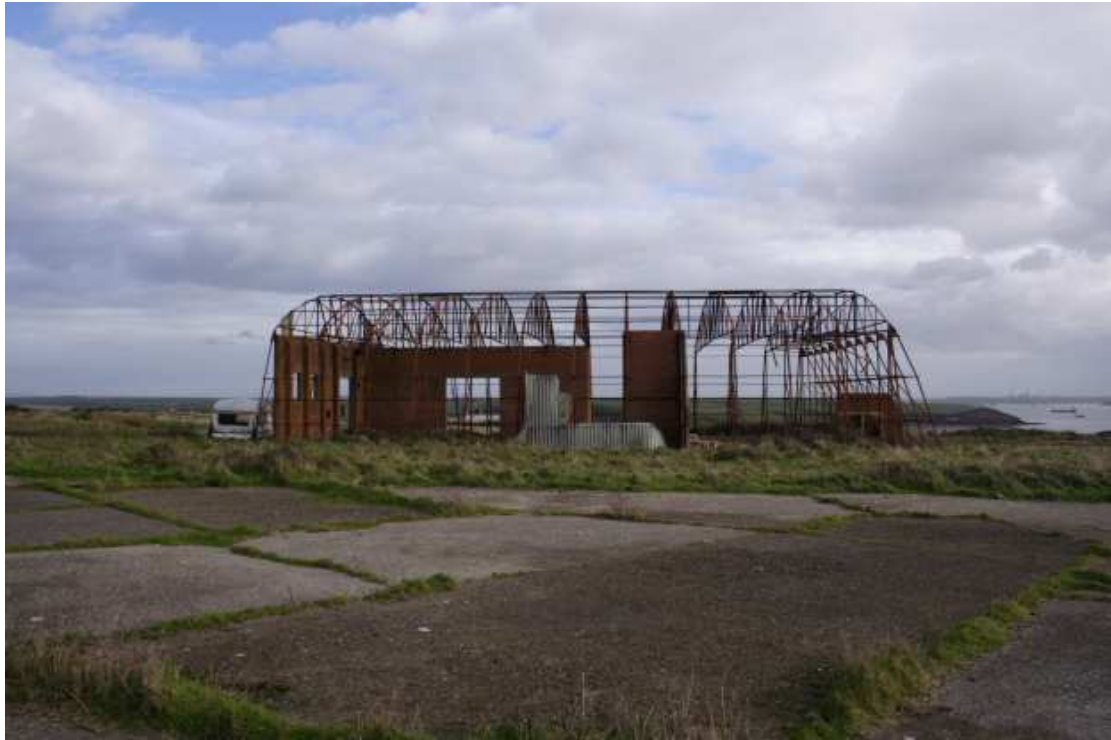
Photo 33 (720). 28612. View E

28612, Workshop. (Fig 16, Photo 33). 1944-47, Workshop, now derelict. Admiralty type 'S' shed, sometimes referred to as a 'Squadron Hangar' 60' X 70' (18.30 X 21.35m), steel framed, depressed arch steel truss roof, battered side walls with six 'deadlight' windows. Corrugated zinc sheeting. *Steel frame survives and some brickwork.*

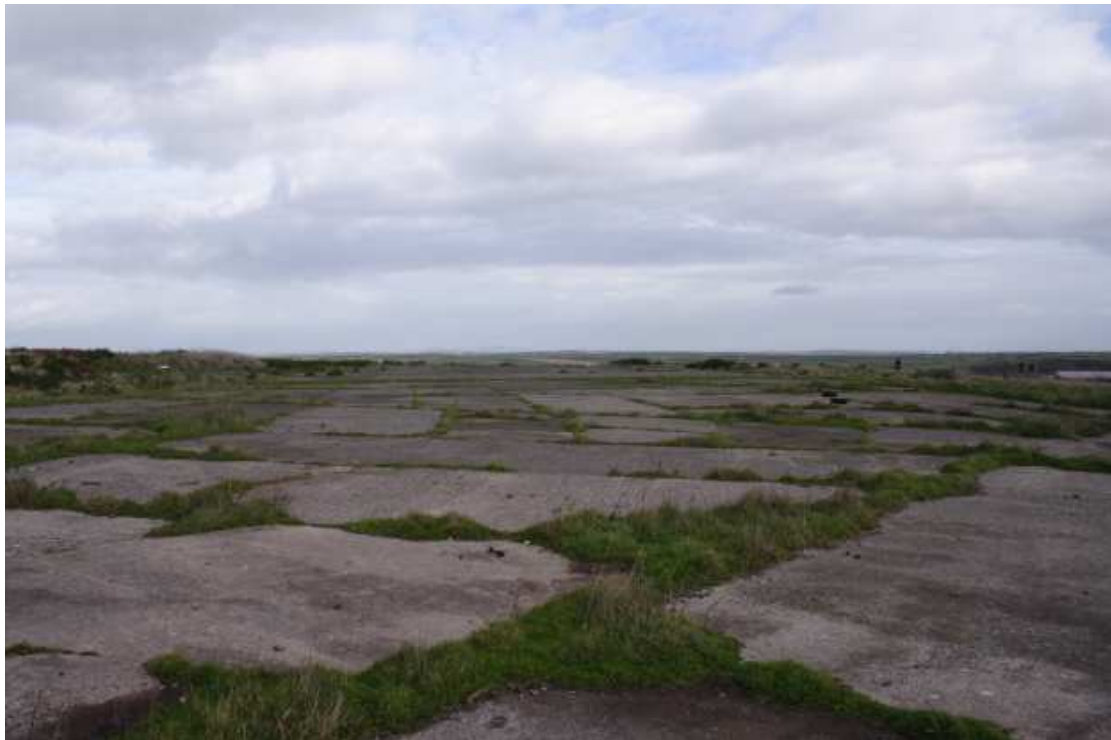
Photo 34 (722). Taxiing area adjacent to 28612. View NE

Taxiing areas adjacent to workshop 28602, (Fig 16, Photo 34) are in fair condition, with some surface weather degradation and slowly becoming overgrown with grass (Photo 34).

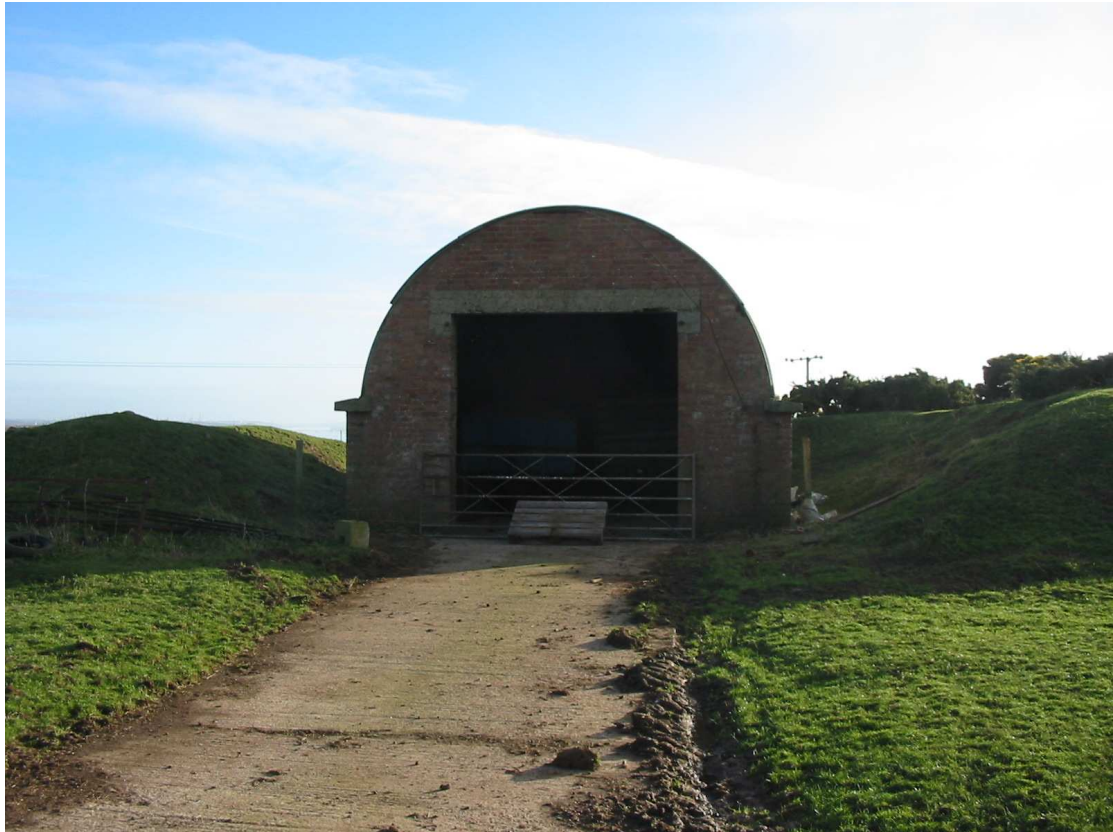
Photo 35 (2320). 29594. View E

29594, Vehicle Store. (Fig 18, Photo 35). 1944-47, Garage, present use low grade agricultural. Curved asbestos hut raised up upon approx 6'(1.83m) high brick walls. Blind brick east gable wall, large double vehicle door below flat concrete beam in brick west wall. *This was a Turner's Curved Asbestos Cement hut raised on brick walls to provide sufficient height as a Fuel Bowser Garage (Thomas pers. comm.). Used for storing trailers and grain.*

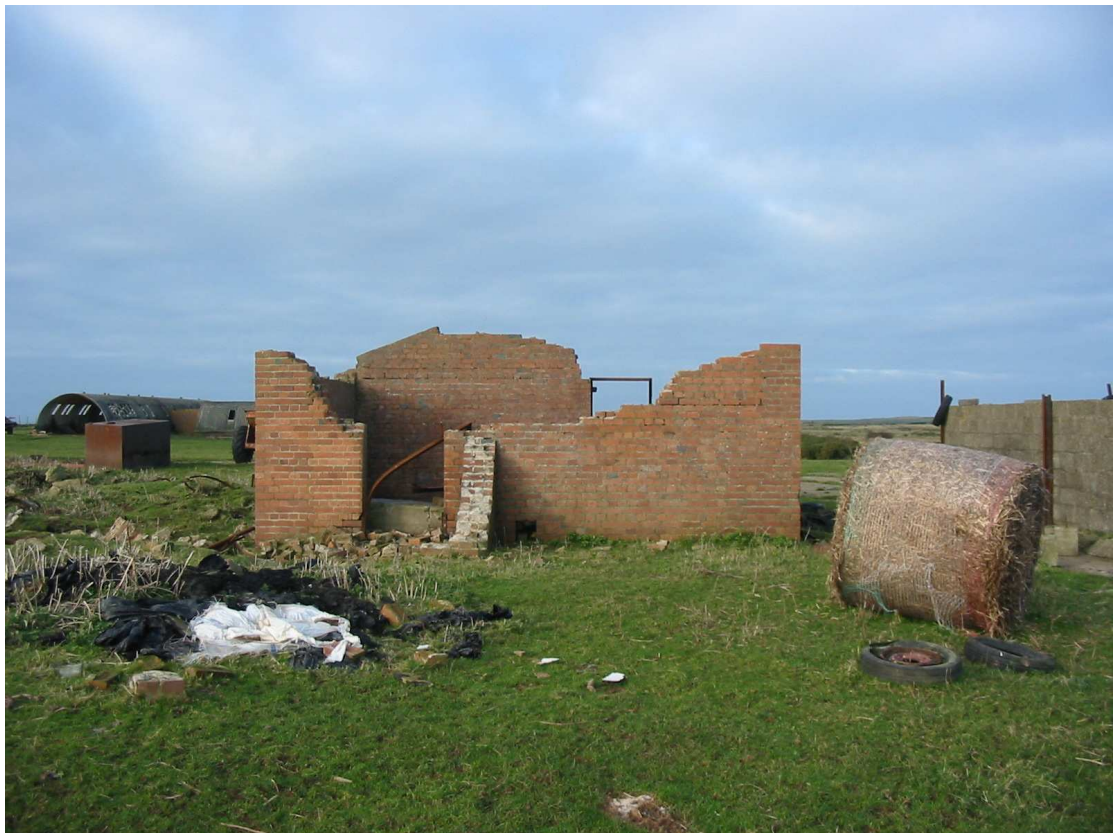
Photo 36 (2324). 28595. View W

28595. Fuel Store. (Fig 18, Photo 36). 1941-47, Petrol installation, now derelict. Single storey, brick built, square plan, doorway in north west corner, and east wall. Pitched gable roof collapsed. Built per Air Ministry Drawing 3941/41. *Walls still stand and some concrete engine beds within.*

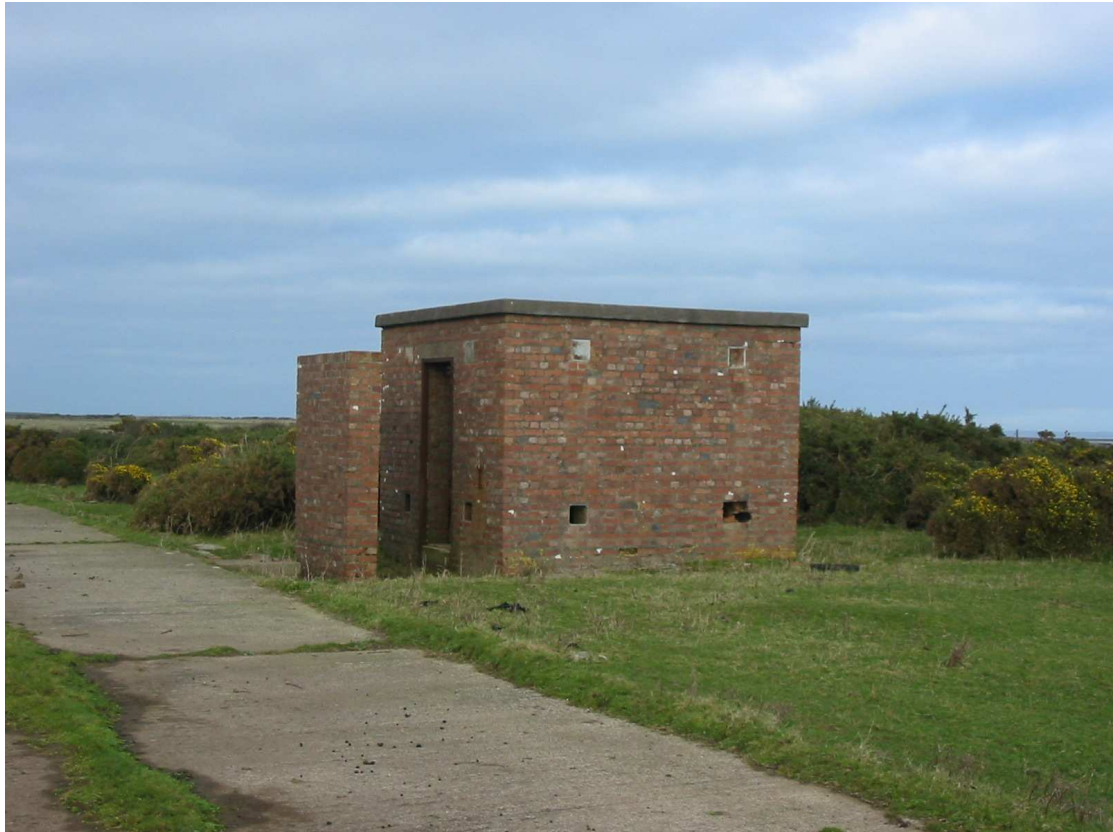
Photo 37 (2329). 28596. View N

28596. Fuel Store. (Fig 18, Photo 37). 1941-47, Petrol installation, now derelict. Small single storey, square brick building, flat concrete roof. Two ventilation grills

near ground level and under eaves course in each wall. North west, north east. south east walls are all blind. Doorway in south side with blast wall. *Still mostly complete and remains of concrete bed within.*

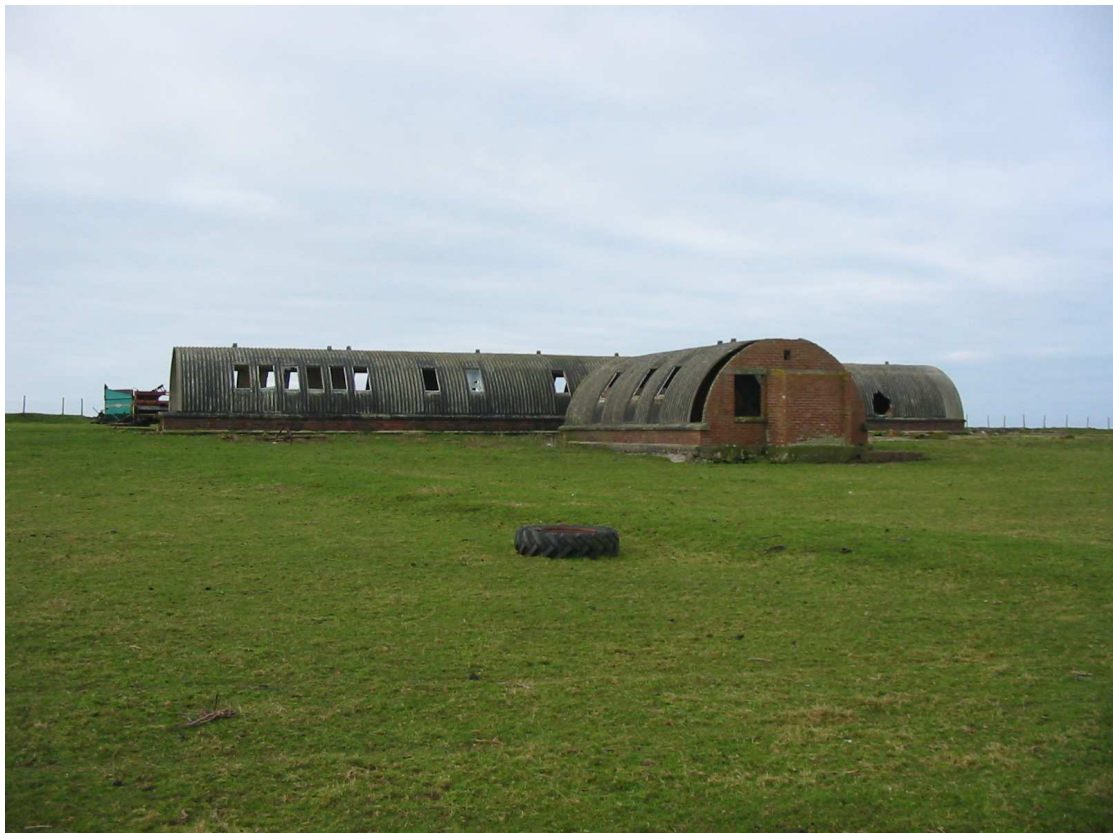
Photo 38 (2333). 28597. View SW

28597. Military Building. (Fig 19, Photo 38). 1944-47, building type unknown, present use low grade agricultural. Single storey, 'T' plan, curved asbestos hut. Approx dimensions 115' X 19.9" X 9'6". Brick gable walls, two 16 light standard steel windows in the south east gable. *All windows gone, as has far eastern end of south block, as has roof at the north end of the north block. These were Turner's Curved Asbestos Cement huts.*

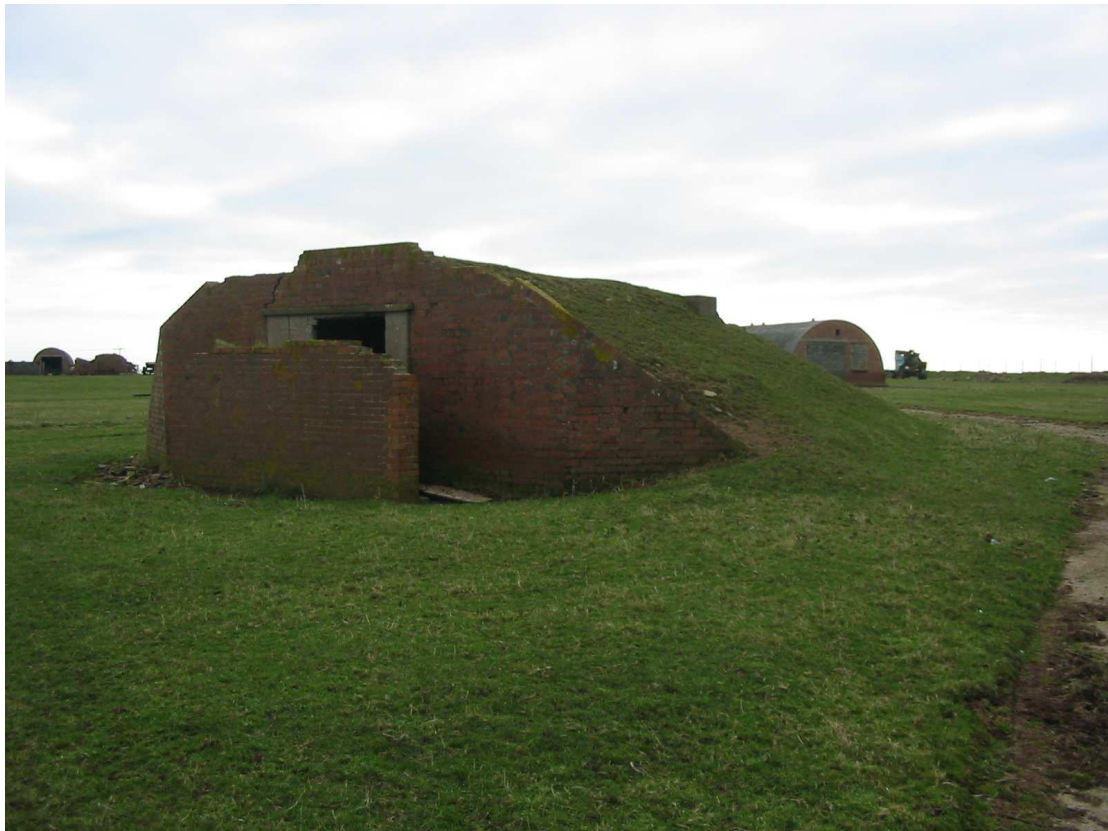
Photo 39 (2340). 28598. View SE

28598. Air Raid Shelter. (Fig 19, Photo 39). 1941-47, Air Raid Shelter, present use low grade agricultural. Single storey, pre-cast concrete bolted panels, square in profile, entrance door in north west wall flanked by brick retaining walls and protected by a brick blast wall. Emergency exit hatch. *Almost complete.*

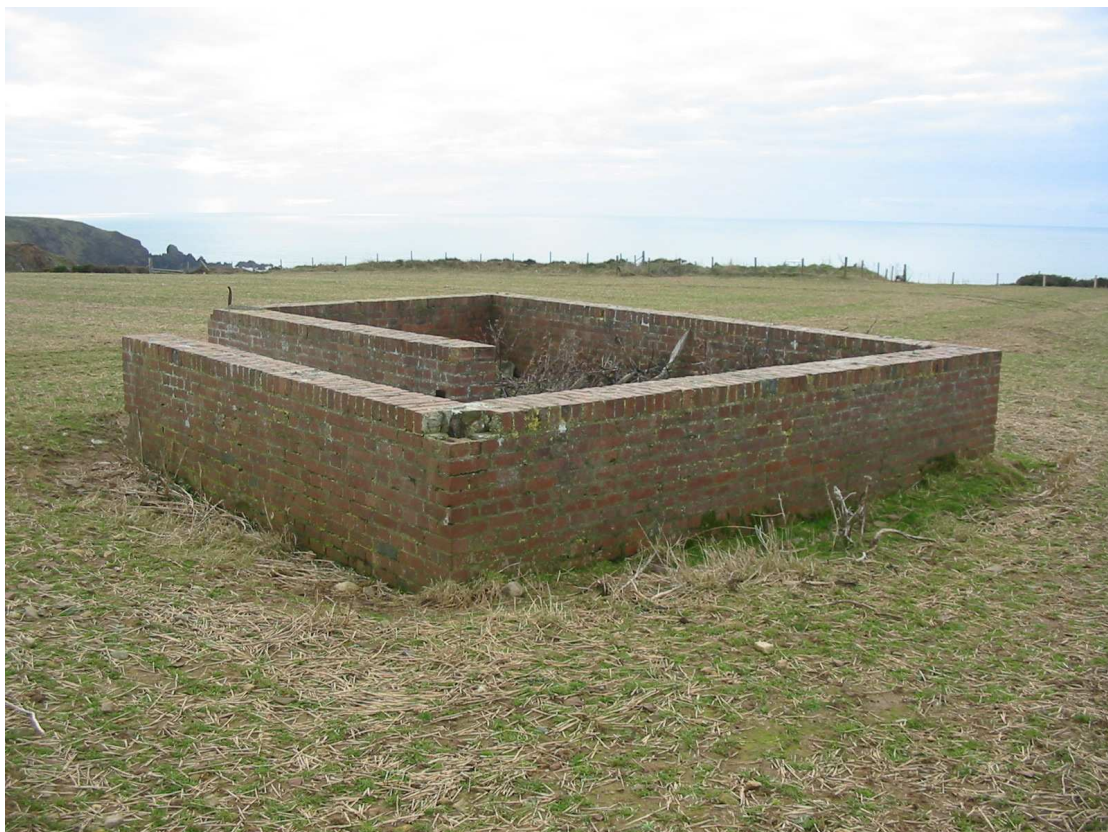
Photo 42 (2361). 28601. View SW

28601. Transformer Plinth. (Fig 20, Photo 42). 1941-47, Transformer Plinth/Transformer Kiosk, now derelict. Semi-sunken, rectangular open brick walled enclosure entered by a descending flight of steps against the wall, entrance in the north east corner. *Wall are in good condition but the interior is mostly filled with rubbish.*

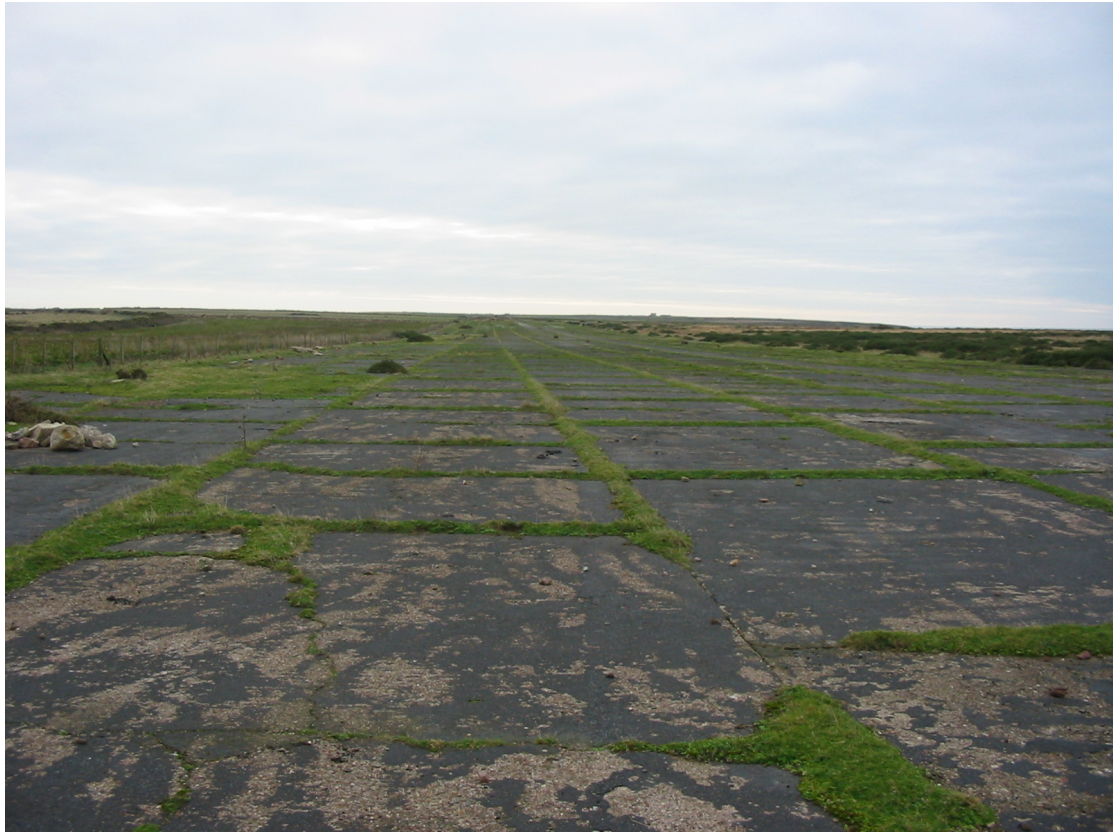
Photo 43 (2351) Runway from main cross over. View SSE

The main runways (Figs 17 and 21, Photo 43), taxiing areas and other had standings are still readily visible, although some grass is encroaching and forming across cracks and joints. Adjacent to the main runways are linear drains (Photo44), a few of which are still visible and some still open. The covers of these drains are no longer in place.

Where most buildings survive they are still in fair condition and do not appear to have deteriorated much since observed in 1993, other than bits of roof which are now missing. The runways and other hard standing are slowly being invaded with grass, but again they are still in reasonable state.

A decision needs to be made either to keep parts or all of the runways clear, or let them naturally grass over. It is strongly recommended that they are not destroyed.
