# North West Wales Dendrochronology Project: Trefadog, Llanfaethlu

Project No. G2113

Report No. 1021

Trefadog, Llanfaethlu, Anglesey. NGR SH 29288613

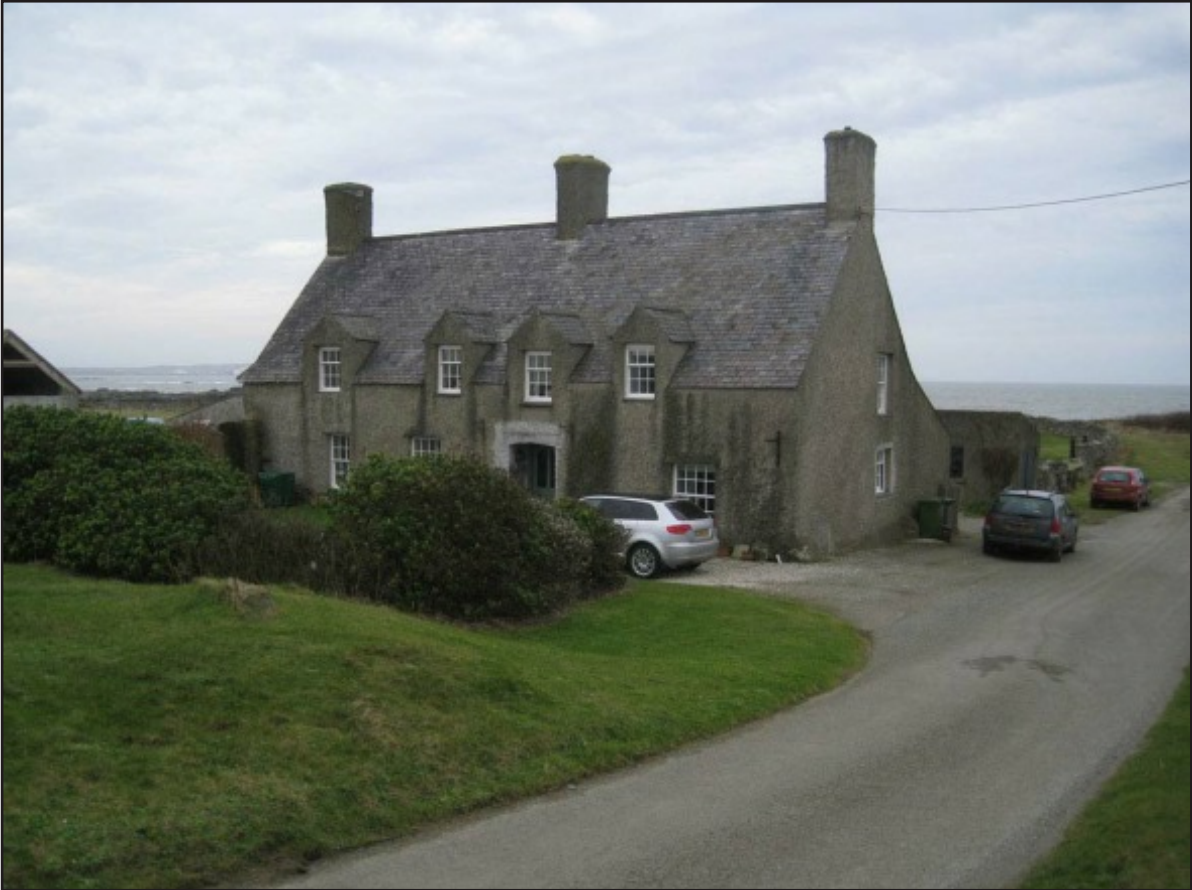
**Plate 01:** The eastern elevation of Trefadog; view from the northeast.

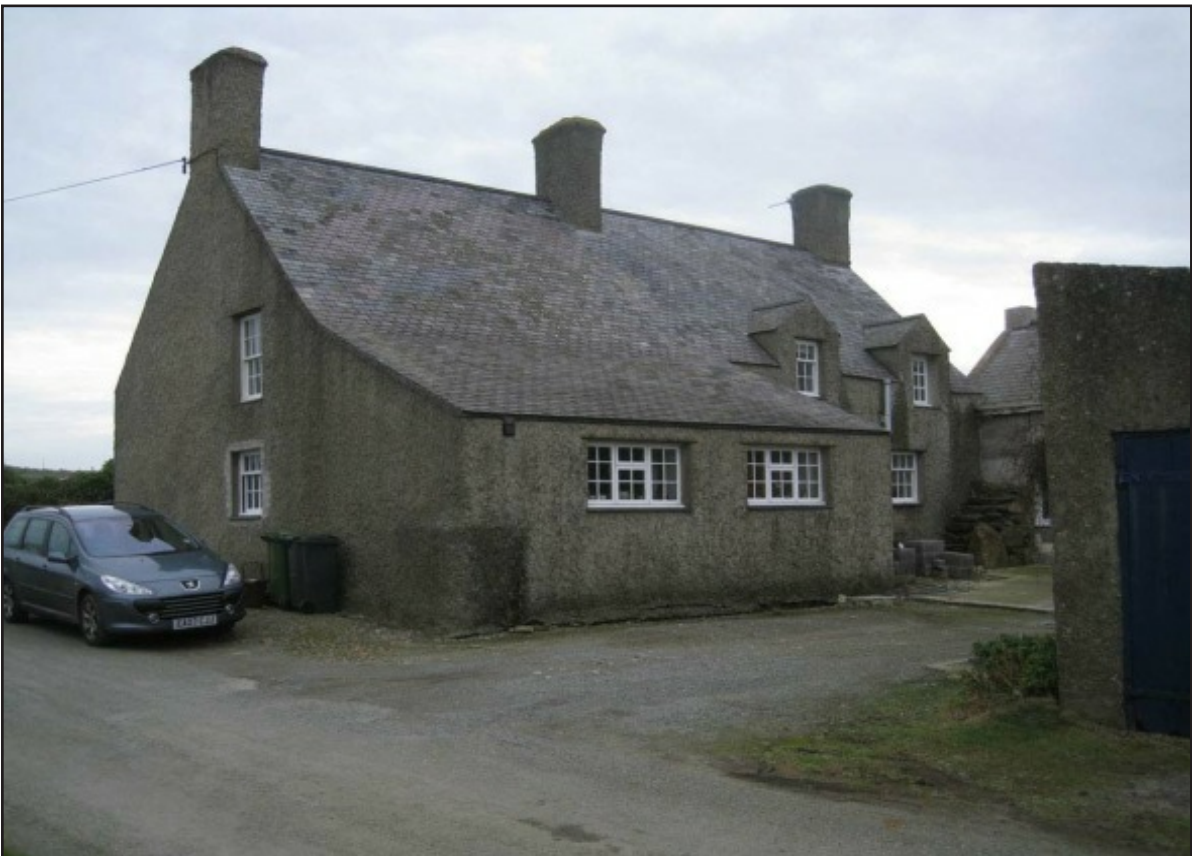
The house is aligned approximately north-south, parallel to the coast edge, and is in a slight hollow 50m from the sea. The house is of two storeys, of rendered stone. The slate roof is modern. There are three rectangular chimney stacks, two at the gables and one to the left (south) of centre. The main front faces east, with an off-centre door to the north, two replaced sash windows to the south and one to the north. Four gabled dormers, all fitted with replaced sash windows, light the first floor. The north side of the house has a catslide addition occupying the north half, of probable 19<sup>th</sup> century date, though with modern horizontal casement windows in the west wall. The south side of the house is lit by a sash window on the ground floor and two gabled dormers on the first floor. A rear door lies in the corner created by the catslide extension (see plate 2).

**Plate 02:** The western elevation of Trefadog; view from the northwest.

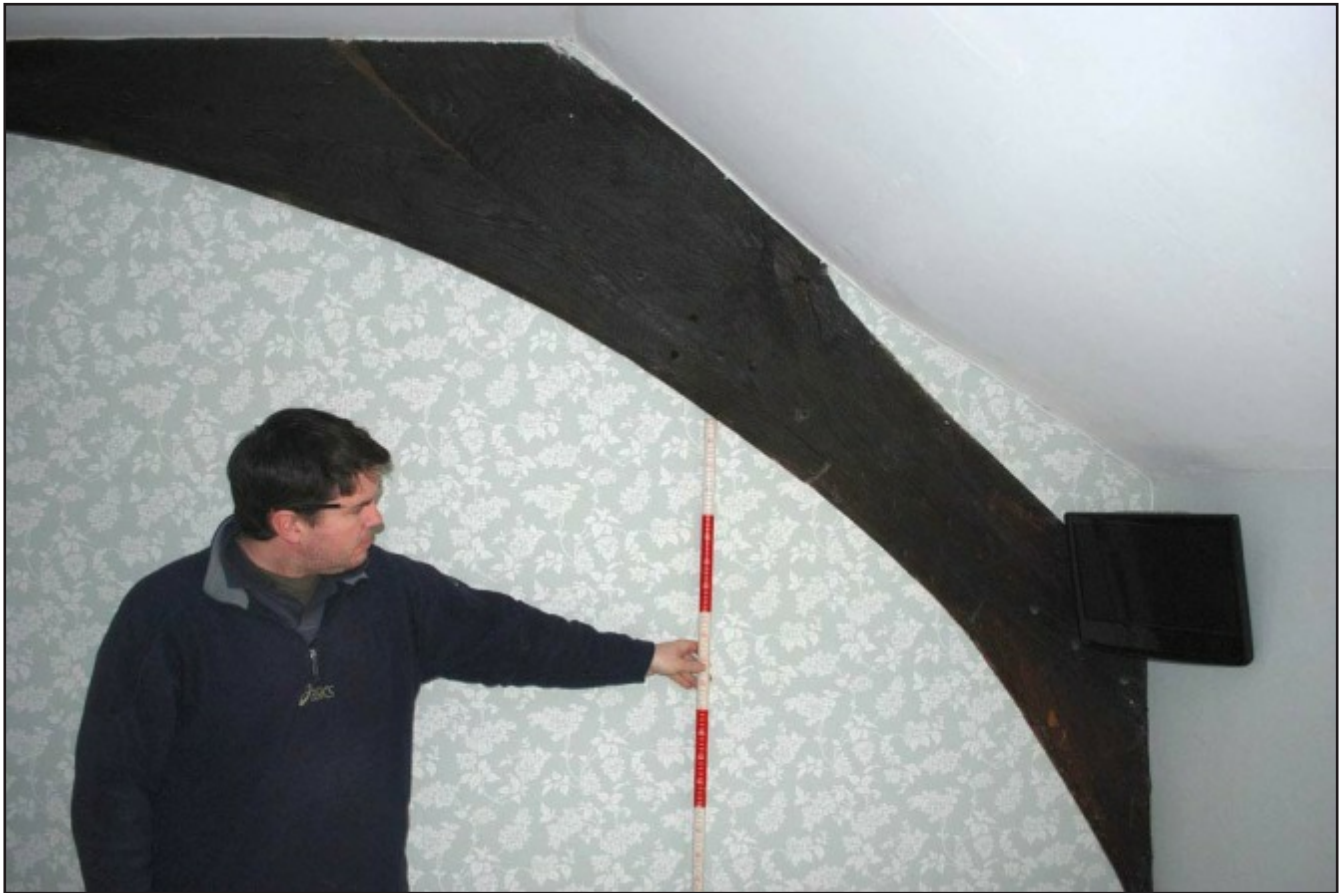
The cruck which divides the hall consists of two principals which disappear into the wall on either side. These have a jointed vertical post which curves onto the principal to form the bend of the cruck. The two are fastened by a wide mortise and tenon joint held with three pegs. It is not possible to see how far the vertical post goes into the wall. None of the vertical posts appear to go below the level of the present first floor, and it is not known if they ever went below that level. An arch-braced collar beam is partly visible below first-floor ceiling level – the remainder hidden by the ceiling. The braces are joined to the collar and principals by mortise and tenon joints (see plates 1 to 6).

**Plate 3:** The eastern side of the southern face of the southern cruck which divides the hall; view from the south.

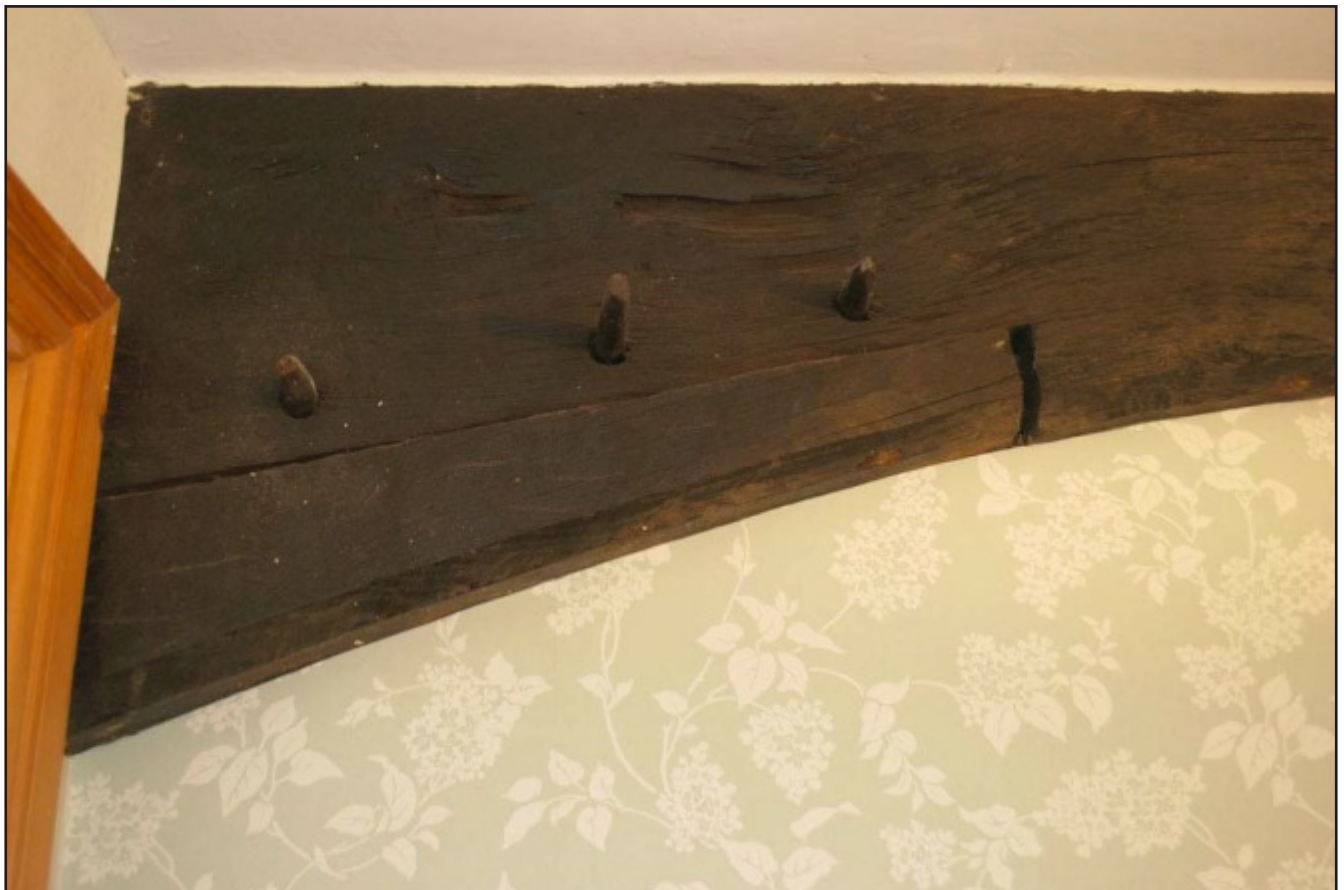
**Plate 4:** Close up of the pegs which join the jointed vertical post with the principal to form the bend of the southern cruck. This is the western side of the southern face; view from the south.

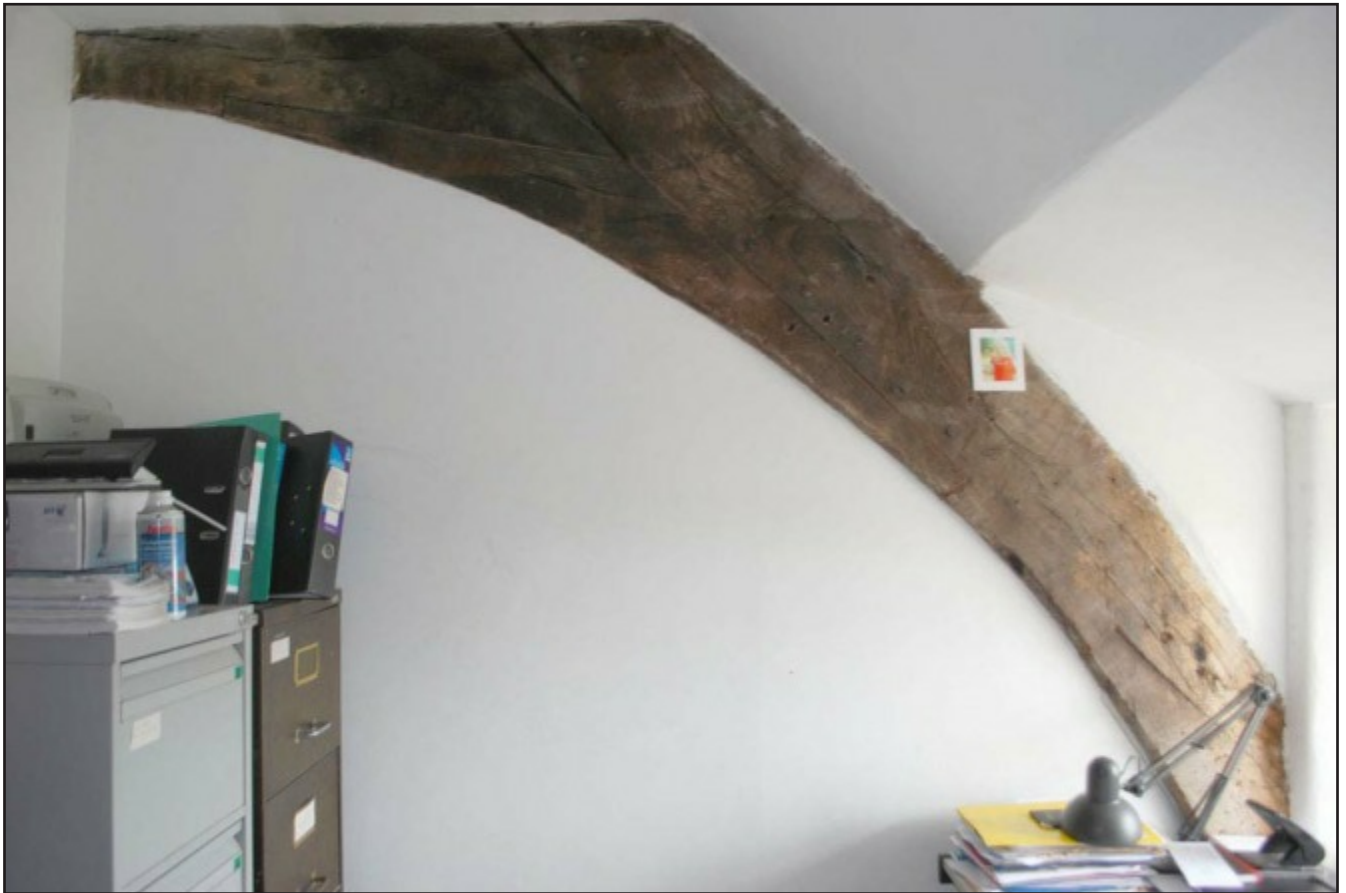
**Plate 5:** The western side of the northern face of the southern cruck which divides the hall; view from the north.

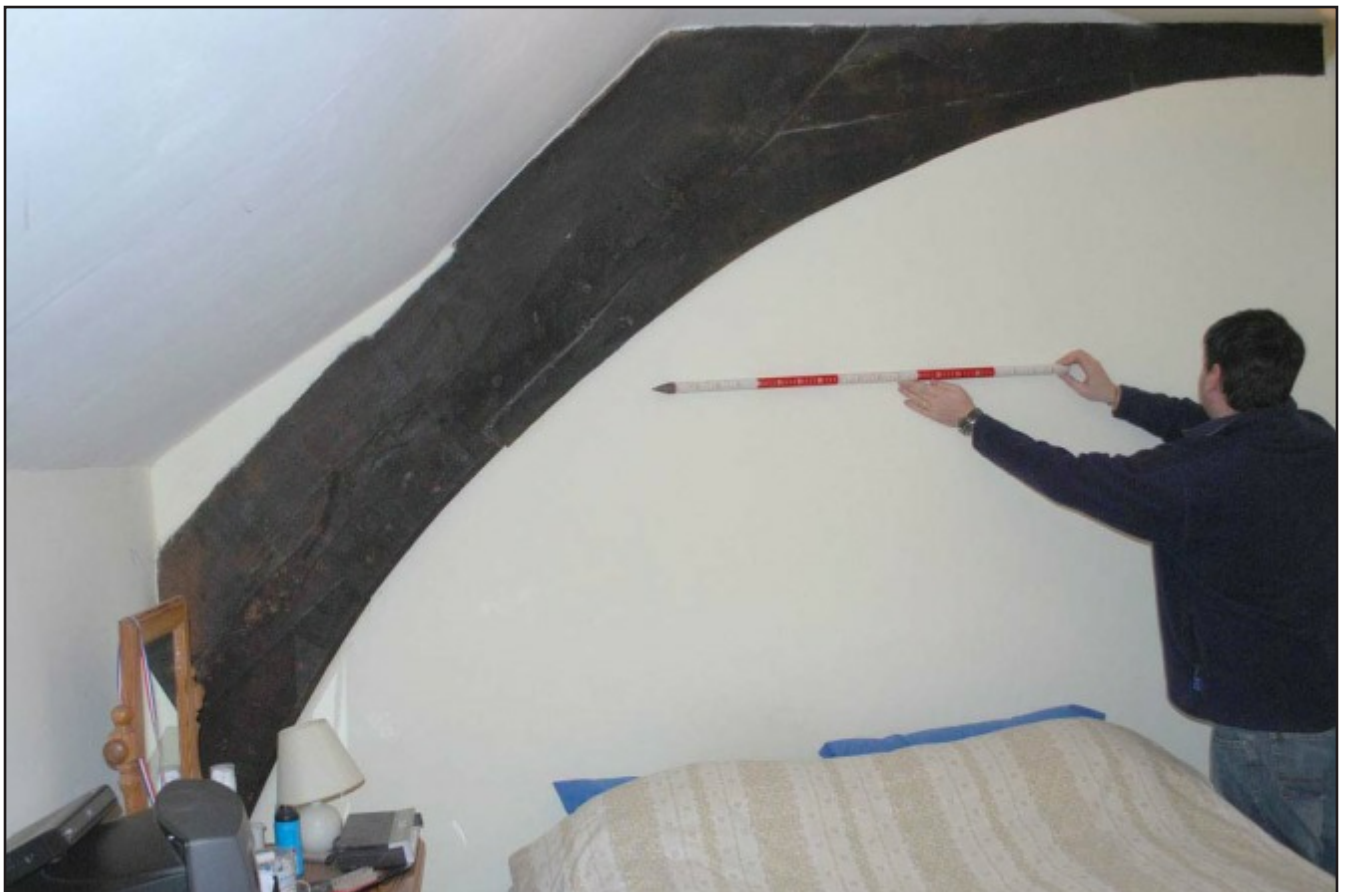
**Plate 6:** The eastern side of the northern face of the southern cruck which divides the hall; view from the north.

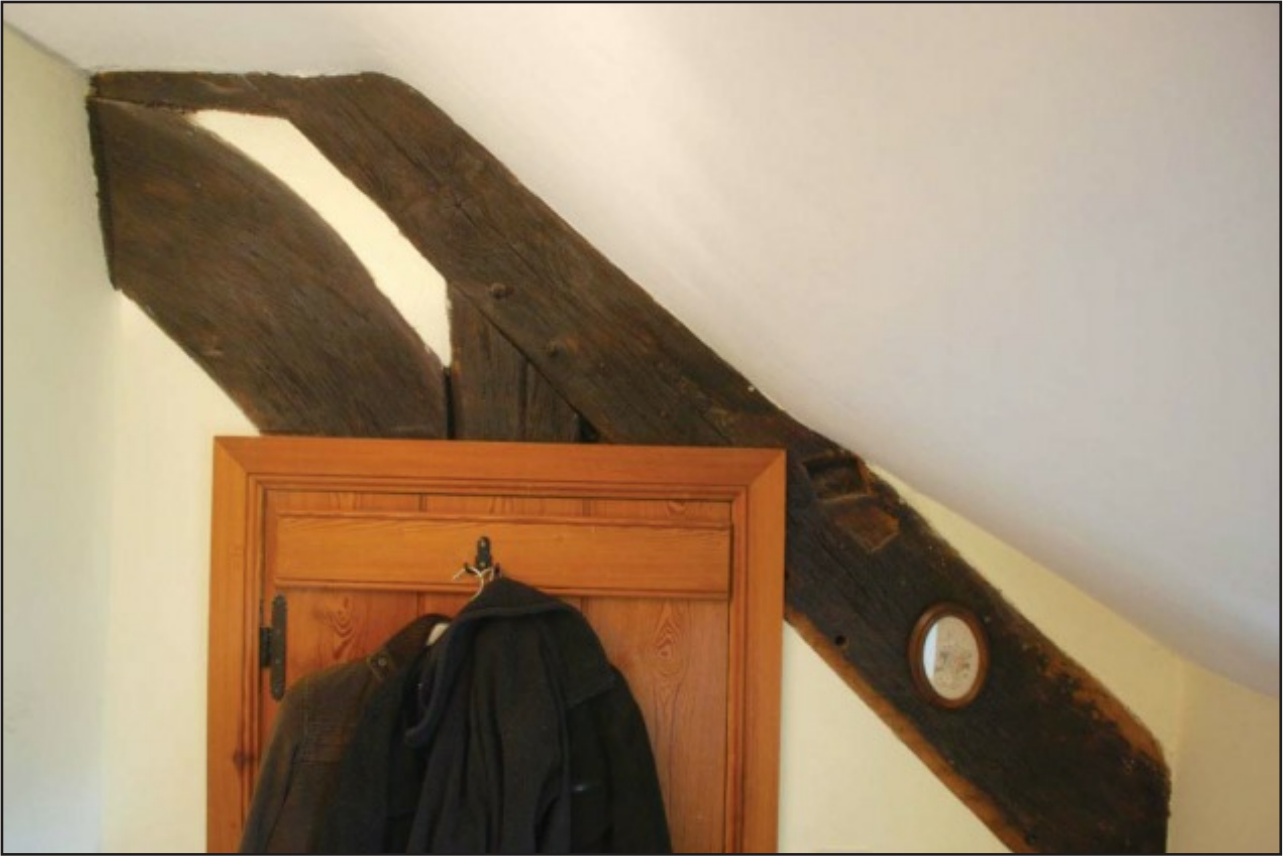
The cruck forming the south side of the screens passage is only partially visible and appears to have been modified on the west side. The arch-bracing to the collar beam on the east side links to a vertical post. There is only a small section left of this, as it has been cut by a door, but it is probable that this vertical post once continued down to ground floor level, and formed part of the screens partition. A vertical wall post, but with less of a curve than on the hall cruck, is linked to the end of the principal, and continues downwards in the lateral wall. This is partly mirrored on the west side, but the vertical post has been replaced with a modern one lower down the principal. Two dowel holes mark the likely location of the original vertical post. There is no evidence for a curving brace to the collar beam, though not enough of the collar beam is visible to confirm if one formerly existed (see plates 7 to 9).

Plate 7: The eastern side of the southern face of the central cruck which forms the south side of the screens passage; view from the south.

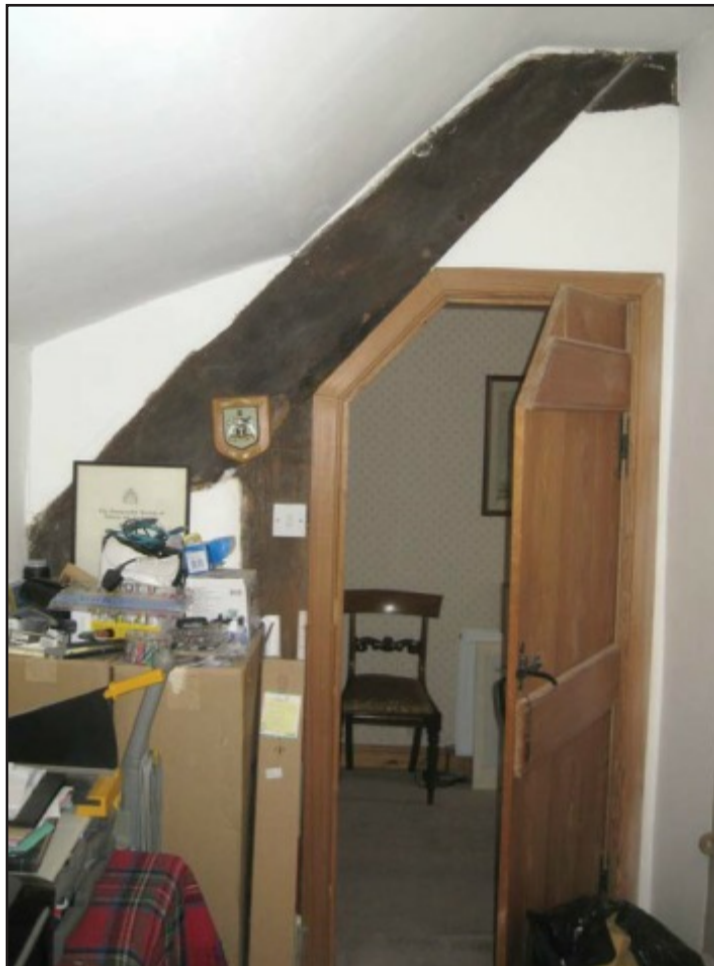
Plate 08: The western side of the southern face of the central cruck which forms the south side of the screens passage

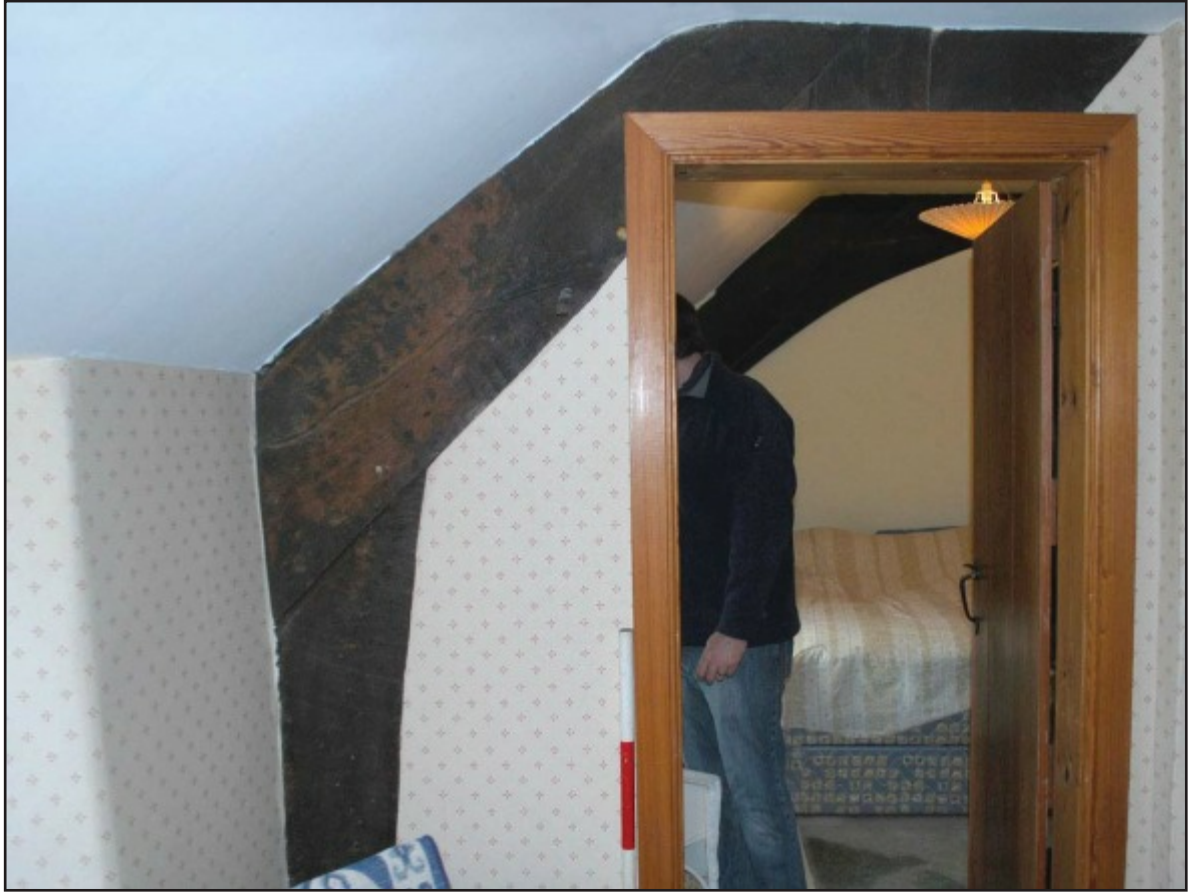
Plate 9: The eastern side of the northern face of the central cruck which forms the southside of the screens passage; view from the north.

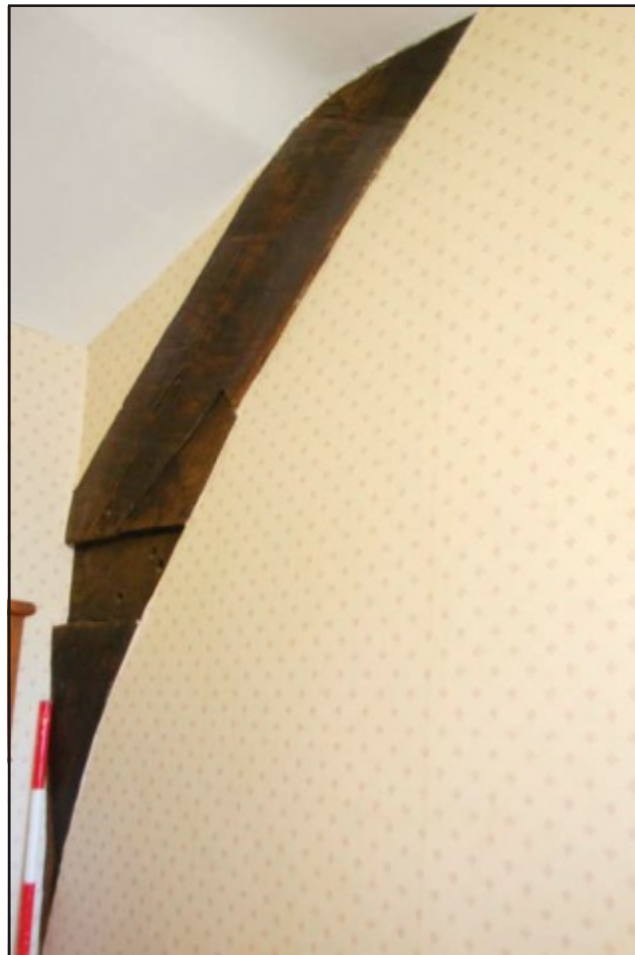
The northern passage cruck is different again. Here the principles are jointed onto vertical wall plates, but there is no collar beam visible, nor any bracing. A housing for a tie beam, however, lies across the cruck joint on the south face – an odd arrangement, but possibly original. The tie beam has been removed, but a housing exists on both east and west sides. The different nature of this truss suggests the outer rooms were two storey (see plates 10 to 12).

Plate 10: The eastern side of the southern face of the northern cruck which forms the southside of the screens passage

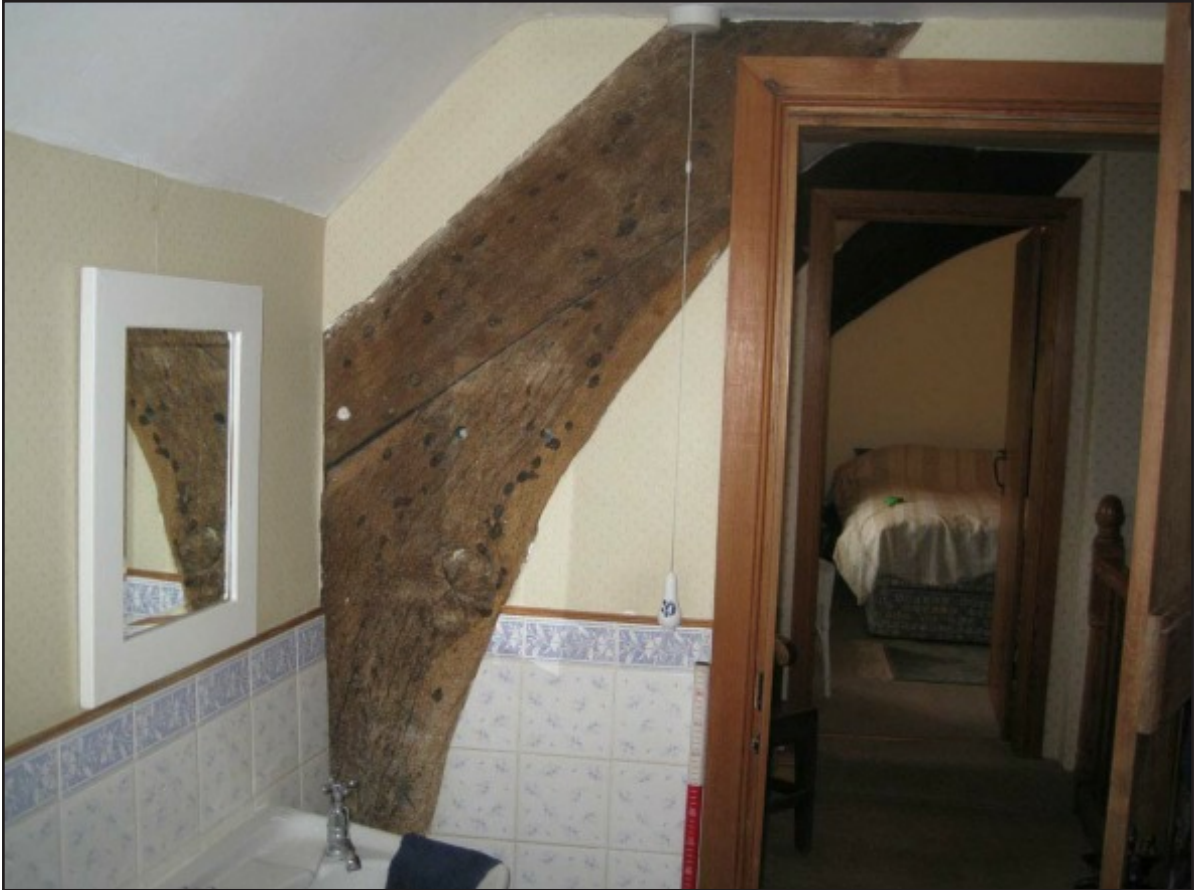
Plate 11: The eastern side of the northern face of the northern cruck which forms the northside of the screens passage; view from the north.

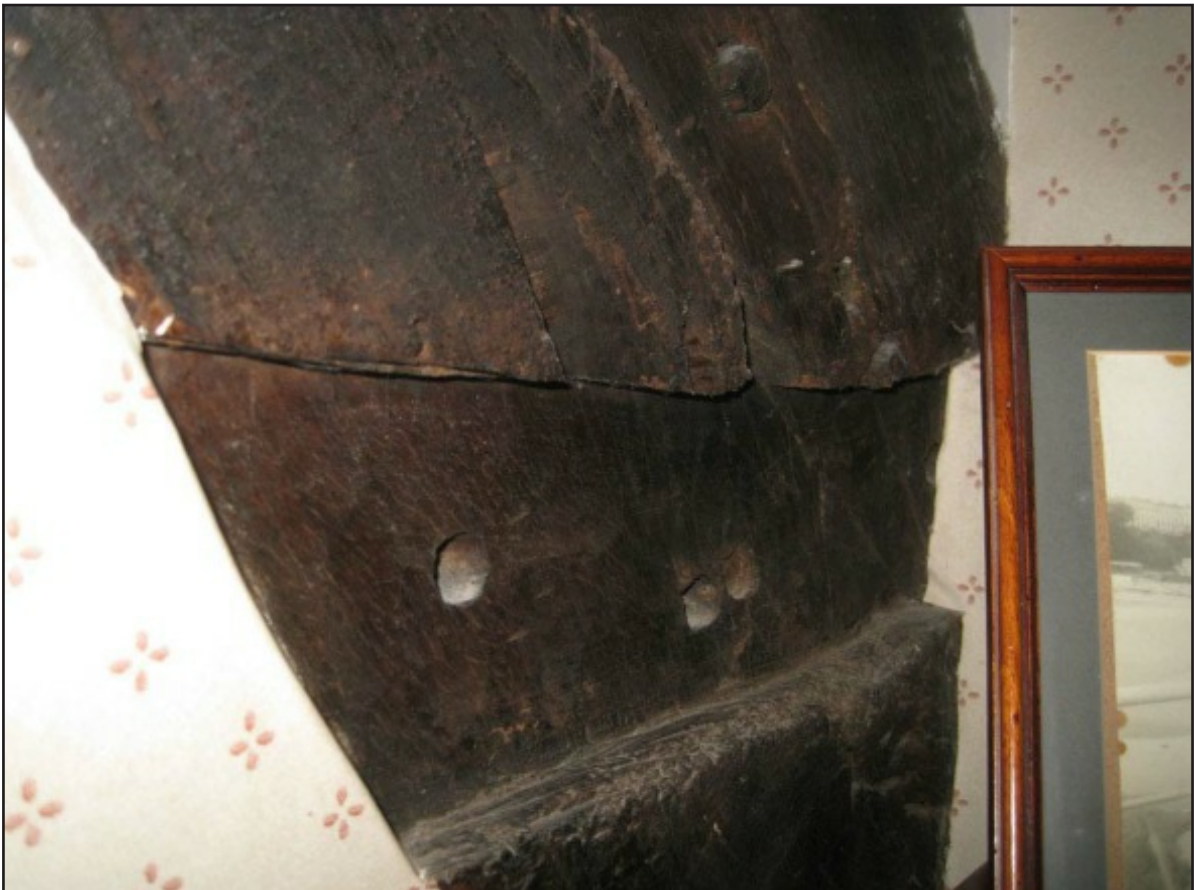
Plate 12: Close up of the housing for a tie beam on the eastern side of the southern face of the northern cruck, which forms the southside of the screens passage; view from the south.
