Llanerch

Cynwyd, Denbighshire, LL21 ONB

Architectural Record 2017

For Discovering Old Welsh Houses Group

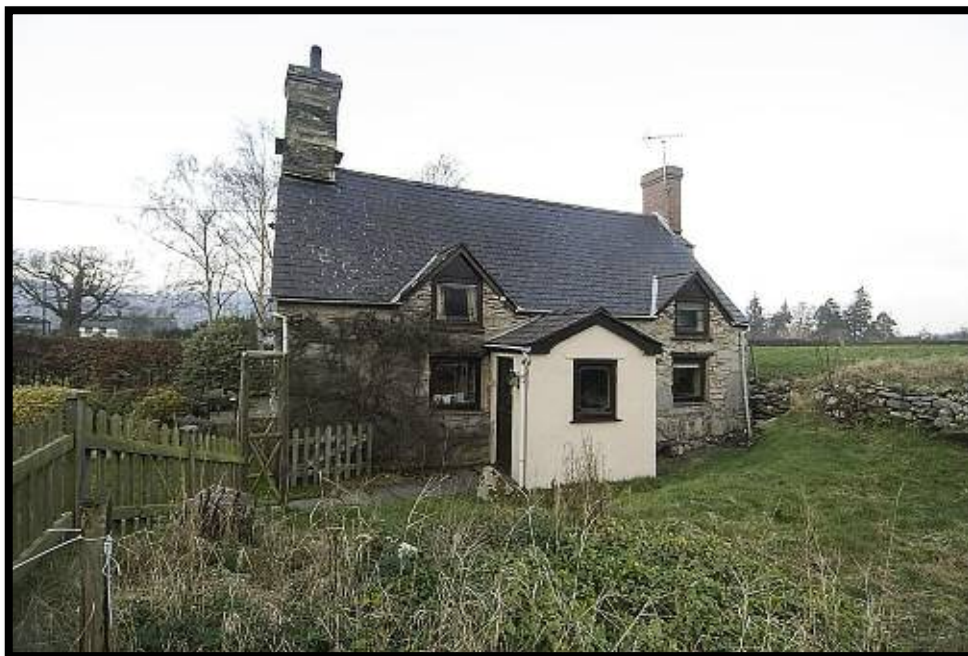
Llanerch is now a simple two-unit, storeyed house of rectangular plan and the initial construction dates from c 1502 with a second phase of alteration in 1614/5. It occupies a south west to north east axis and is constructed of random rubble stone and roofed in slate on a steep pitch, possibly originally thatched. The external dimensions of the original structure surviving is 10.6m x 6.2m with a modern extension to rear. This replaced an earlier rear extension. The western end has a tall gable chimney while the east end has a later stone chimney stack and small brick chimney planted onto the gable wall. The exterior now has a modern porch on the front elevation and a rebuilt two storey extension to the rear of the house. It is most likely that the building was timber framed originally and replaced at a later date or dates by masonry walling. The interior displays a bi-partite plan repeated on both floors as exists now. Three impressive cruck trusses of individual form survive remarkably intact with a secondary inserted chimney stack and floor. Much of the original timber work has been revealed by recent renovations that illustrate the development of the building. This report will concentrate on the older part of the building, the main 2 storey section. (Fig 4)

Figure 4: Llanerch front elevation from south.

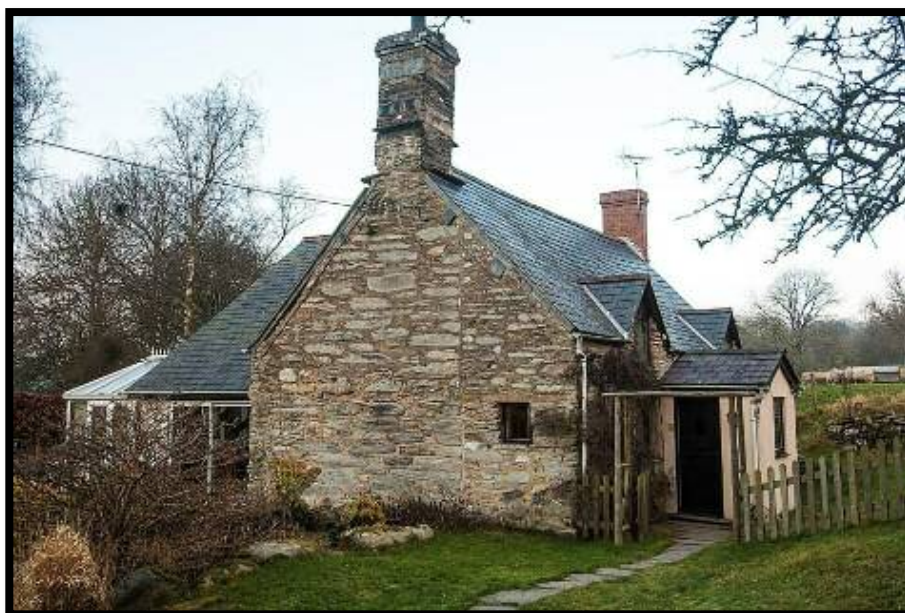
4.1.4 The western gable reveals details that clearly mark the development and alterations to the house suggested by variations in the masonry. A clear vertical break in the masonry about two thirds across the gable from the left side shows the original return or corner of what was once an internal inserted chimney. Later masonry has been erected and butted against this clear vertical to a poorer standard and probably was built when this masonry replaced earlier timber framing that walled the building. A stone in this section bears the date 1661 in crudely scribed graffiti. This may denote this later phase. A small window with later frame is set into the gable to the right. The left gable corner is disturbed and without quoins and is suggestive of a wall being removed or poorly constructed later (fig 5). A tall chimney sits flush on the gable with evidence of alteration. Slightly projecting verge.

Figure 5: Llanerch from SW showing gable and vertical masonry joint.

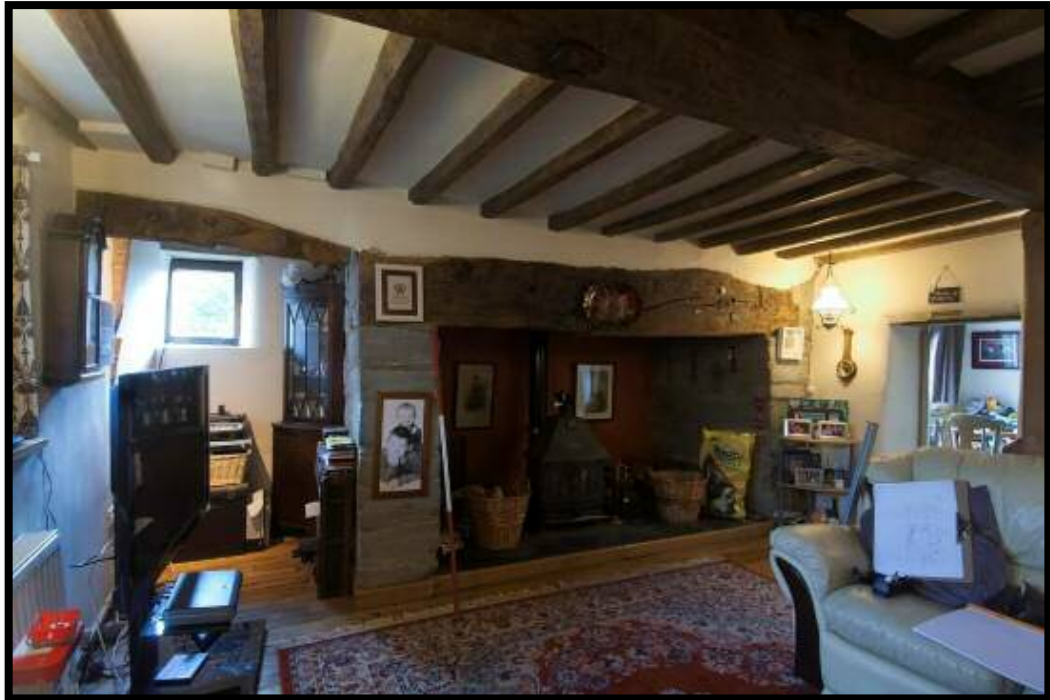
Figure 6: Former hall with inserted floor and fireplace.

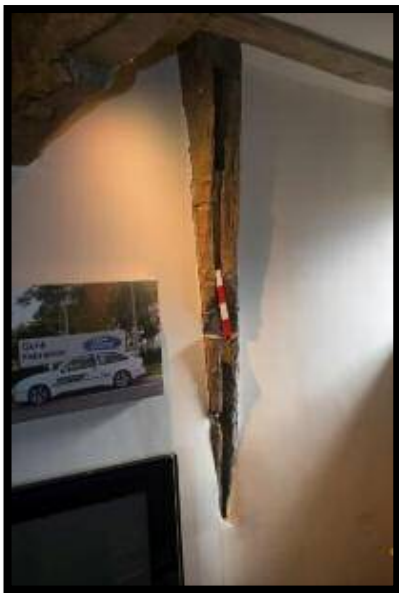
Figure 8: Left cruck blade of T1 with mortise and groove.

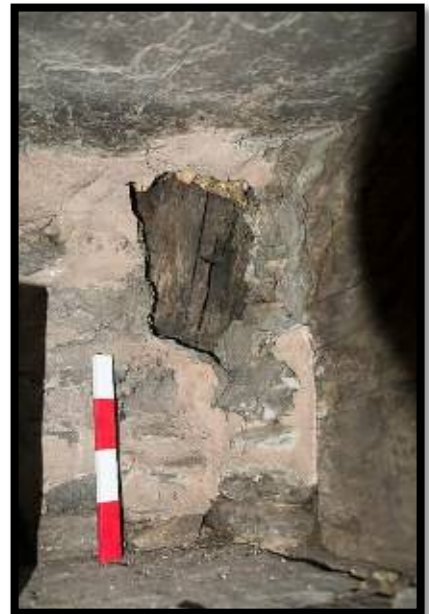
Figure 7: Right cruck blade with mortise and remnant of tie beam also mortised for partition.

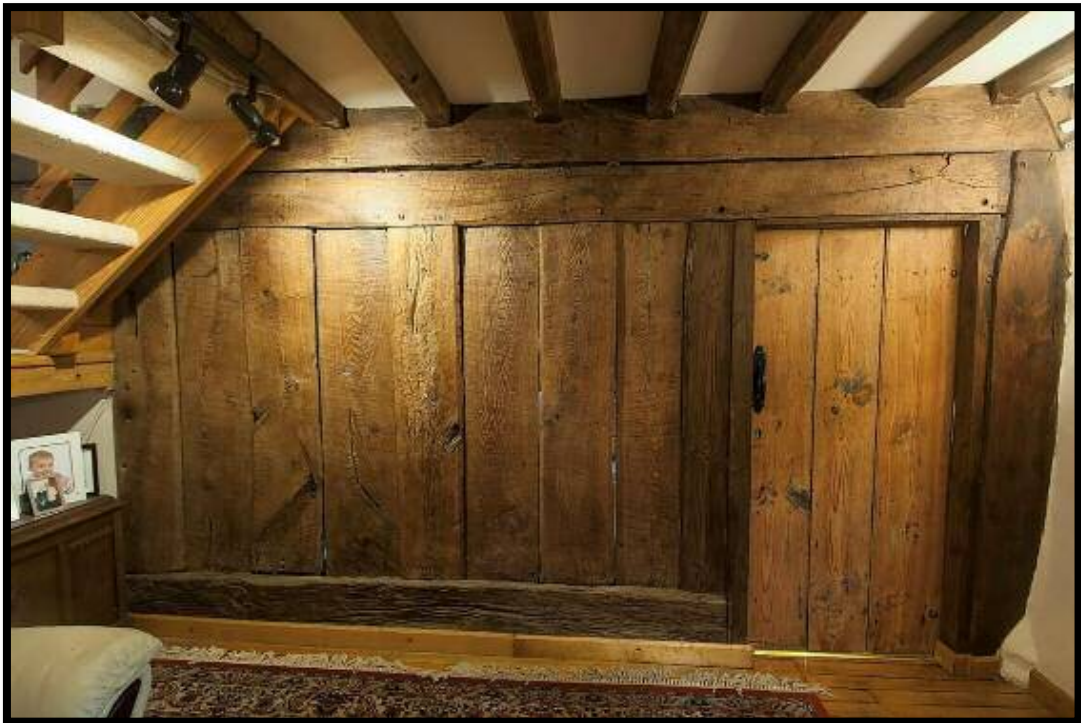
- The wall to the right consists of a good plank and muntin screen retaining eight of the original uprights including one door jamb L which is jointed for a doorhead. (fig 9, 10 and 12) The muntin boards are chamfered on three edges. Two doorways, one at either end of the wall. LH door is blocked and plastered. Some timber replaced with softwood and a Victorian door with bead moulding in RH doorway. The head beam and large cill beam are mortised to accommodate the boards. The muntins are double pegged at the top and the door jamb to L is mortised and pegged to accommodate a bench (fig 12 for reverse) but the right door has no original timber so the detail for this doorway is absent. The cill beam has been cut away at doorways presumably to ease access into rooms. The screen is set below the tie beam of the middle cruck truss. The owner recounts a previous occupant relating that there was a door through the left doorway into a scullery or coal store and possibly a stairway? The room was therefore divided at this time within living memory.

Figure 9: Plank and muntin screen at high end.

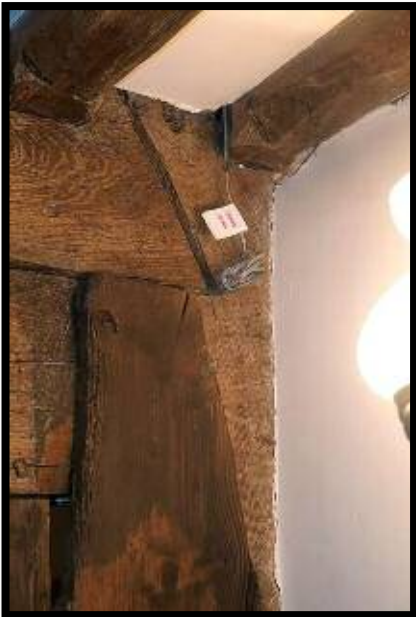
Figure 10: Tie beam house into cruck blade. Head beam below.

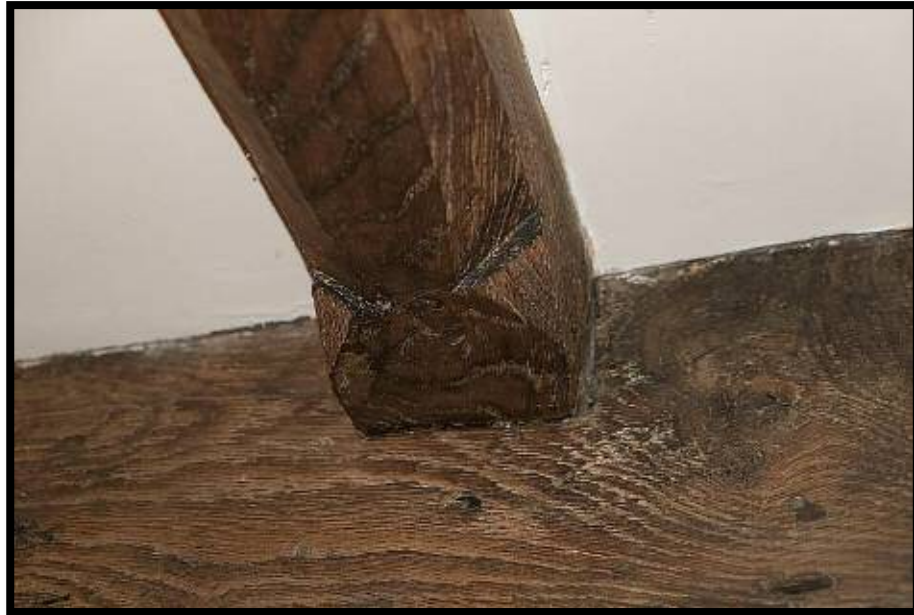
main beam) (fig 11) There are matching large dimension chamfers and stops on main transverse beam. Graffiti of three intersecting circles on the soffit of the main beam.

Figure 11: Joist from inserted floor showing deep chamfer and stopped and run out stop.

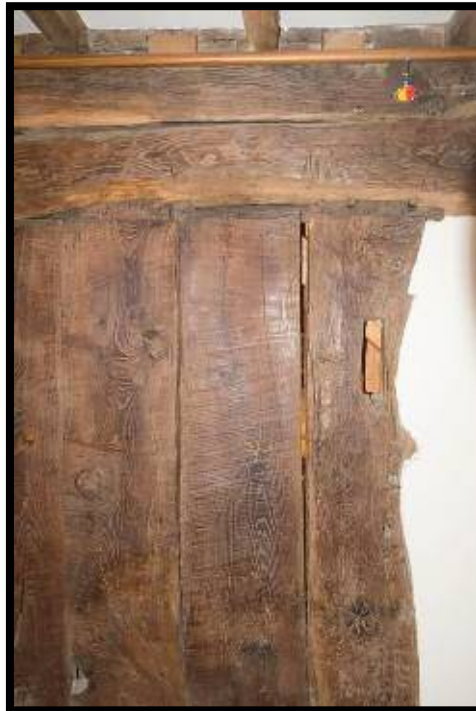
Figure 12: Inner room side of plank & muntin screen. Top of right hand post rebated for door head. Mortise for fixing bench to screen.

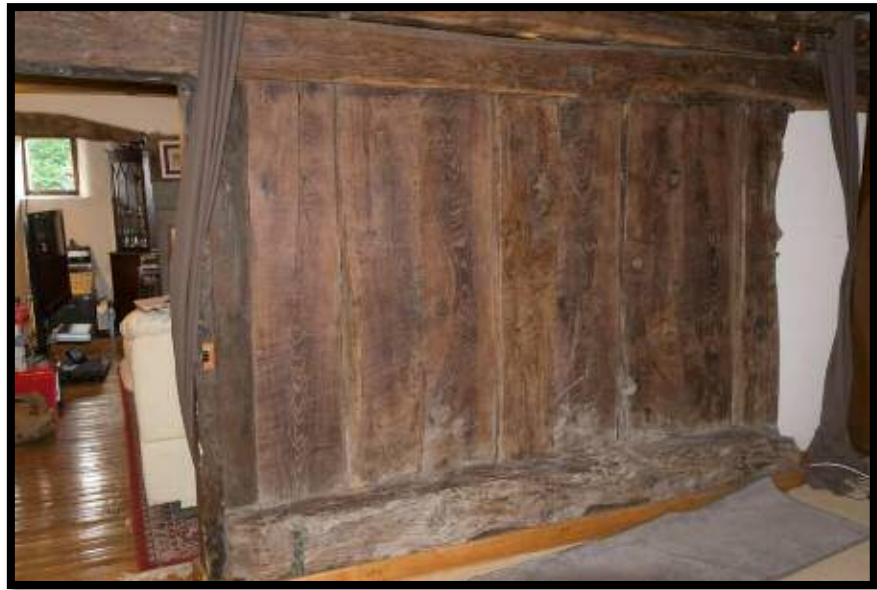
Figure 13: Plank & muntin screen from inner room

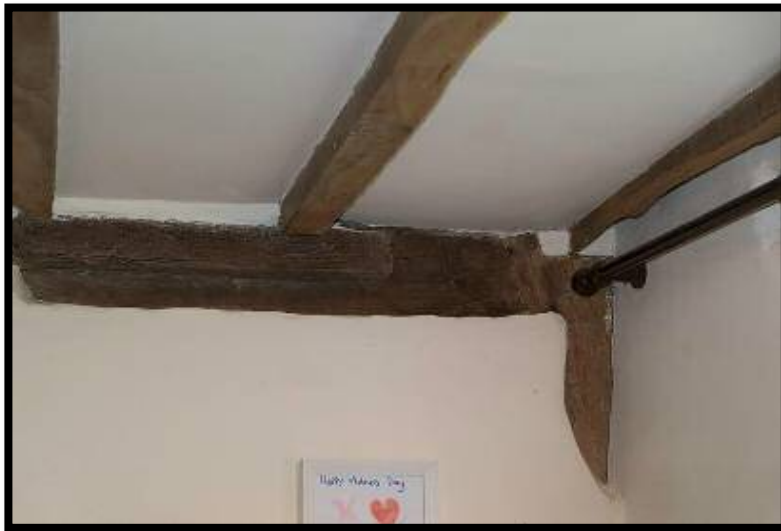
Figure 14: Gable of inner room. Cruck t right with jointed tie beam. Planted joist 'hanger' onto tie beam.

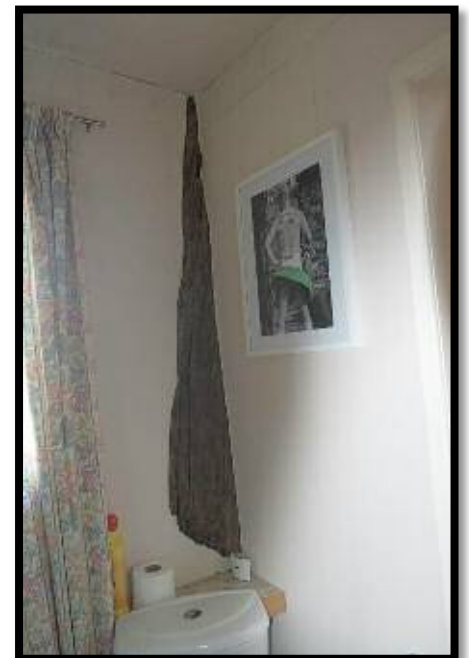
Figure 15: Cruck blade protruding outside the external northern elevation.

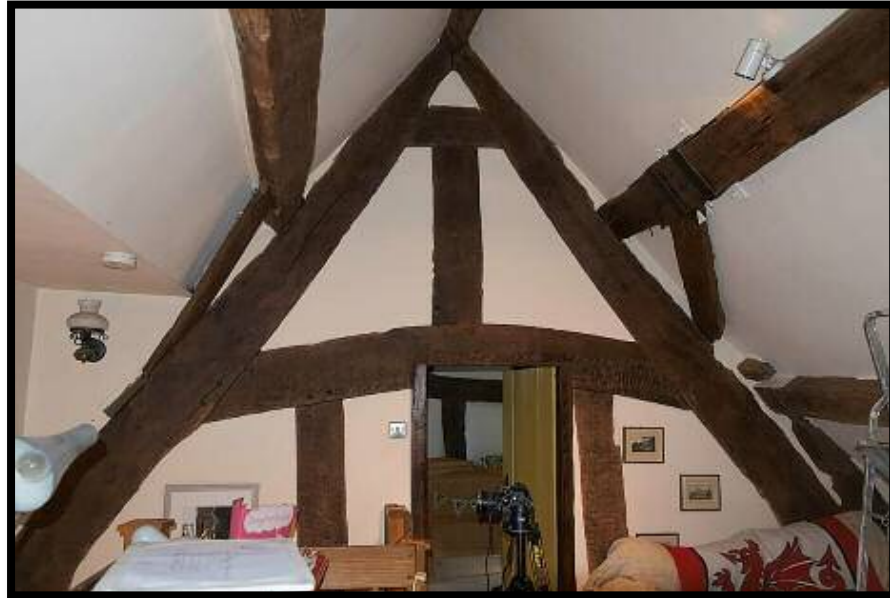
Figure 16: Truss 2, the central former closed partition. Note wind braces.

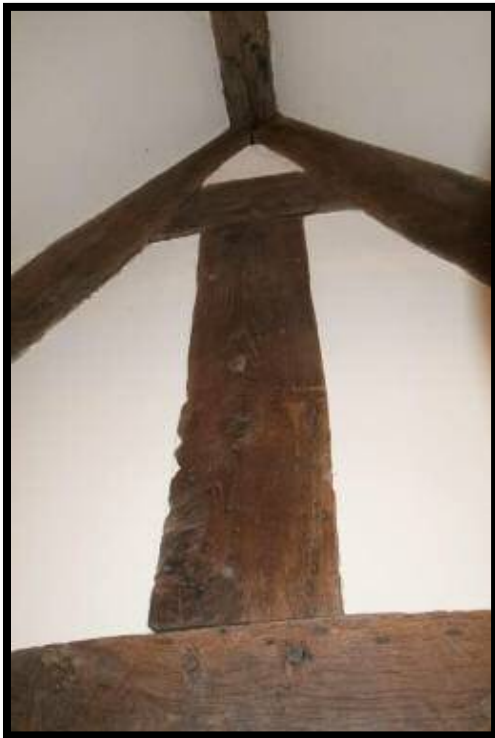
Figure 17: Truss 2. King strut sitting on collar.

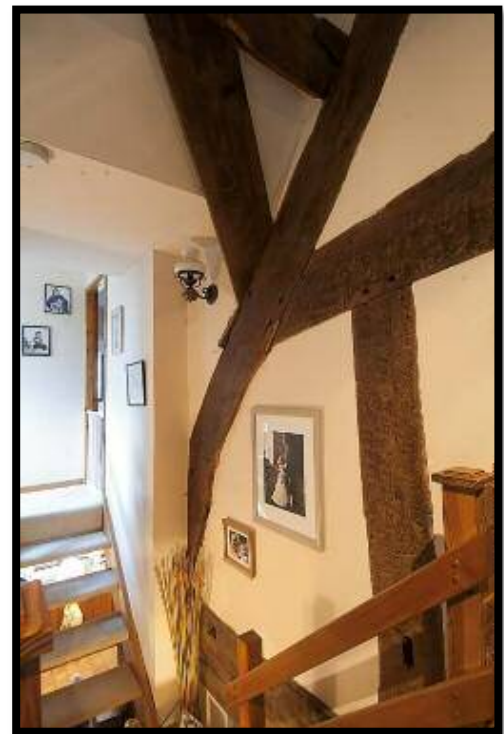
Figure 18: junction of truss showing cruck, wind brace and studs.

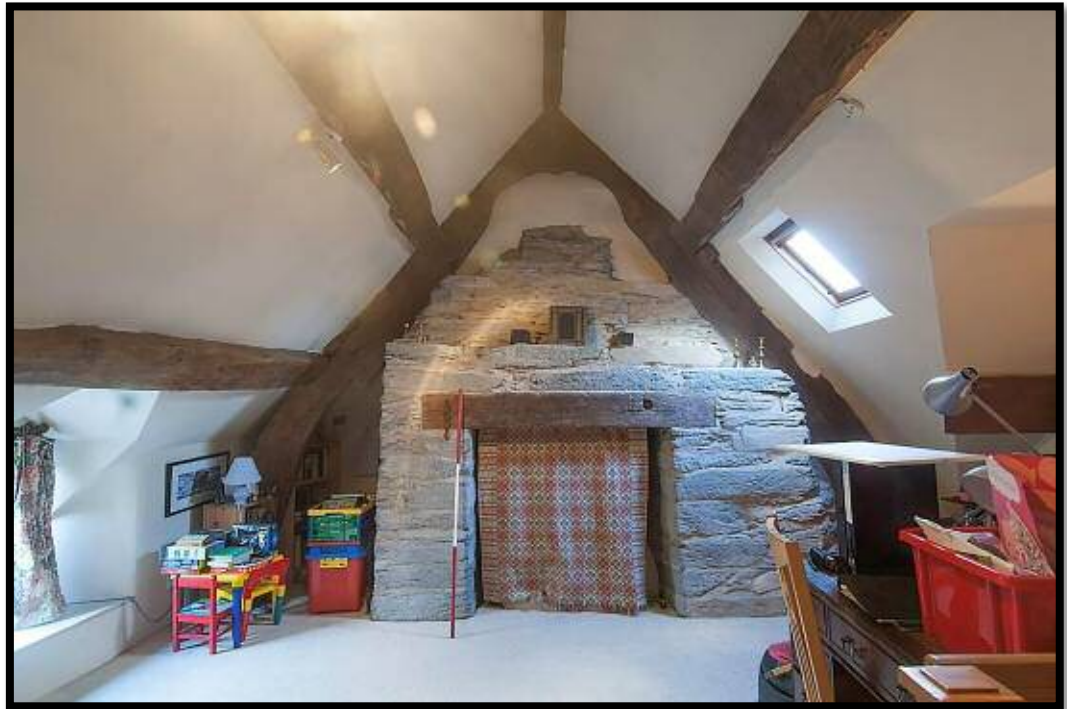
4.3.1 Three early purlins remain, the lower north side is missing, and run to the right to the west cruck truss 1 AA (fig 19, 20) which has been underbuilt by the masonry of the inserted chimney. The upper purlin is joined with a scarf joint and pegged. A fireplace occupies the centre of this masonry stack on the first floor. With oak mantel beam. The truss rises above the chimney breast which is slightly offset to the right. The left cruck blade has a section removed on soffit below lower purlin and there are housings for windbraces on the upper face of the principal to meet the upper purlin. It appears that this upper face is also jointed to accept a windbrace

Figure 19: Truss 1. Remnant of truss sitting over the later inserted chimney stack. Encroachment of masonry enforced the removal of all the lateral timbers of the truss.

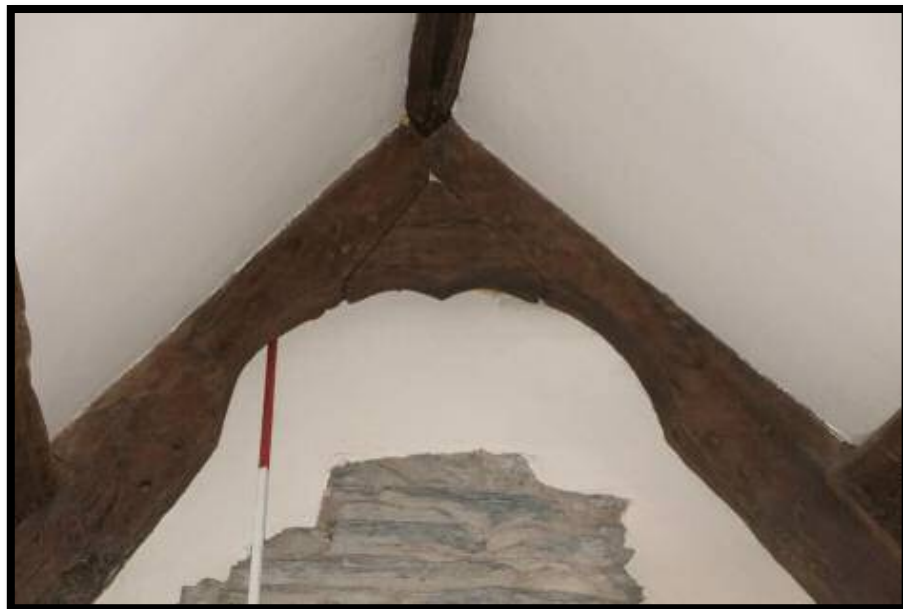
Figure 20: Detail of the apex of open truss. note triangular block at apex, a common feature in this area. In this case cusped to complement similar treatment on timbers.

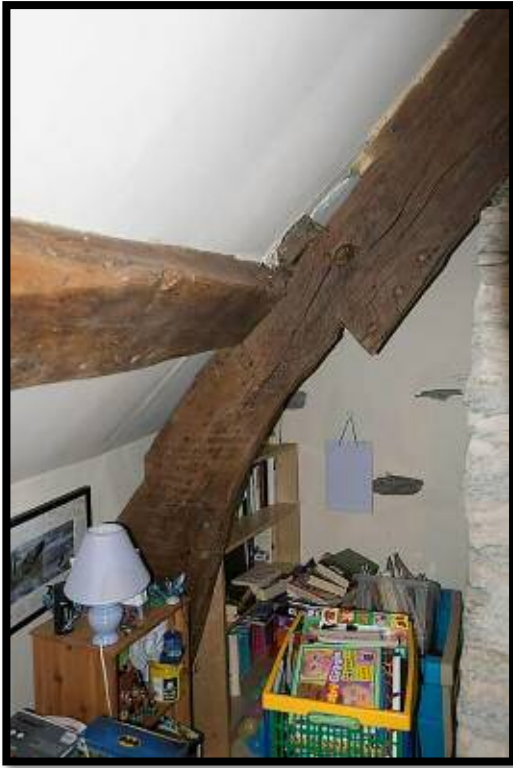
projecting to the west, beyond the truss, another indication that a further bay of some form existed before the insertion of the chimney. (fig 21) On the outer face of the L cruck blade is a large peg which may indicate the existence of a wall post and associated roof structure. Although this post is not evident, a matching post or remnant is still in situ outside the right cruck blade. (fig 22) The upper part of the truss, cusped for decoration demonstrates that it was meant to be displayed and was open to view. Although the collar is now missing the block at the apex and the adjacent sections of the principal rafters have been cusped. Possibly shaped in the form of a quatrefoil, without the evidence of the missing collar the form of the complete decoration cannot be appreciated with any certainty. If this hall was open to the roof a fire would normally have heated the room from a hearth on the ground floor. This would be evidenced by smoke blackening on the roof timbers as smoke percolated upwards towards its escape from the hall. However, there is little evidence of this smoke blackening. This might be explained by the sandblasting that has occurred during renovation but the interior of some joints revealed little evidence of smoke blackening. As has been noted, a little over 100 years elapsed between phases and it has to be acknowledged there should be some sign of blackening unless there was another arrangement to heat the chamber.

Figure 21: Left cruck blade T1. Three pegs for a collar. Evidence of several wind braces at this point, one heading beyond the purlin to a further bay now gone.

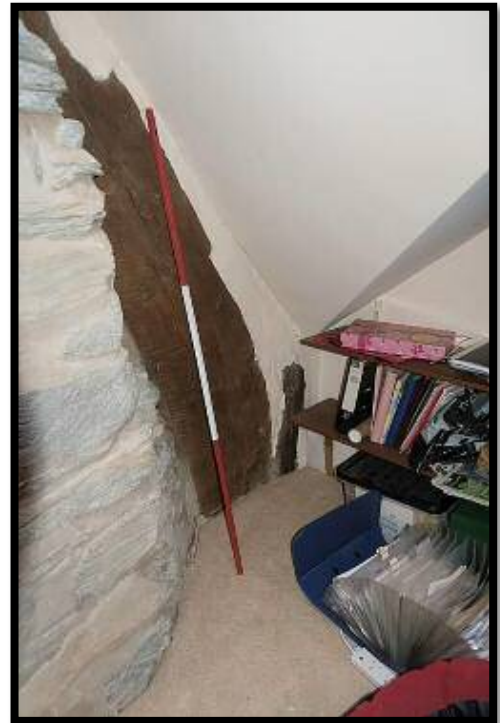
Figure 22: Right cruck blade Truss 1. Remnant of wall post signifying an alternative roof structure, probably timber framed.

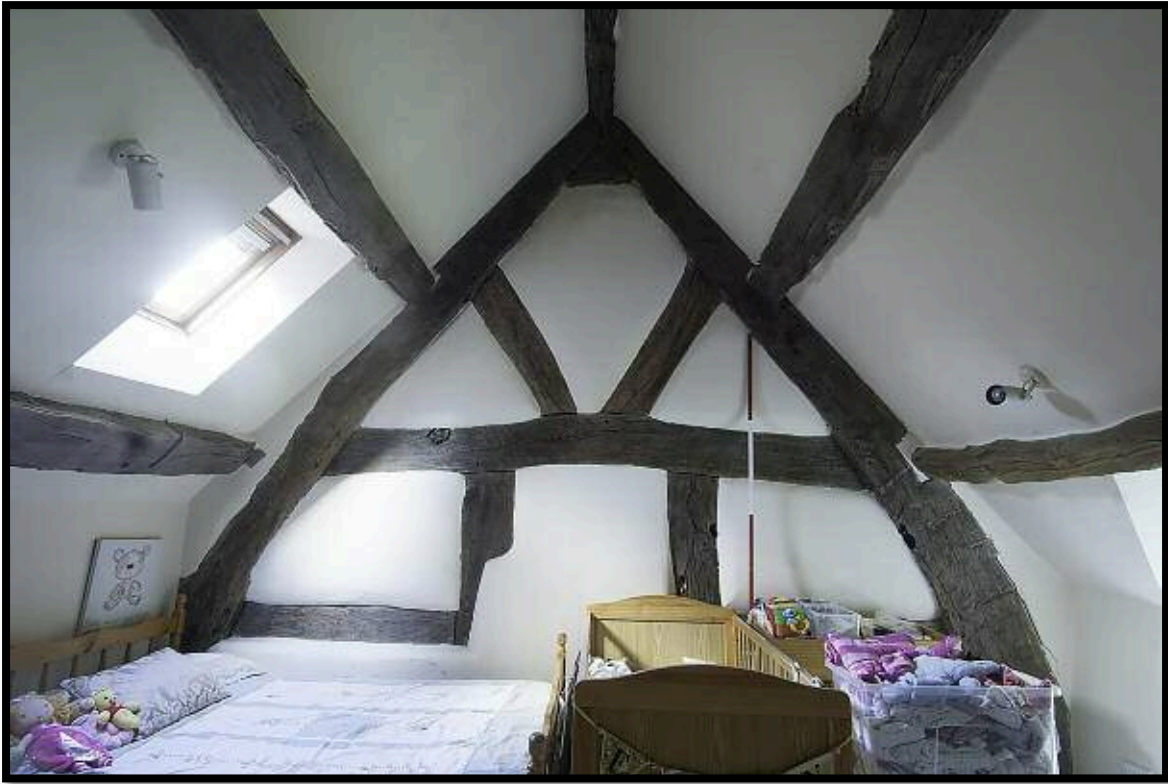
The pegging for this truss, which once formed the external wall, was driven in from the outside face, as many of the pegs still display their points on the inside of the wall within the peg holes suggesting this frame presented as an external wall before being encased or replaced in stone.

Figure 23: Fine timber framed gable Truss 3. Pegged from other, external, face. 3 Replaced purlins. Central panel not pegged on internal edge so possibly a window or even a door.

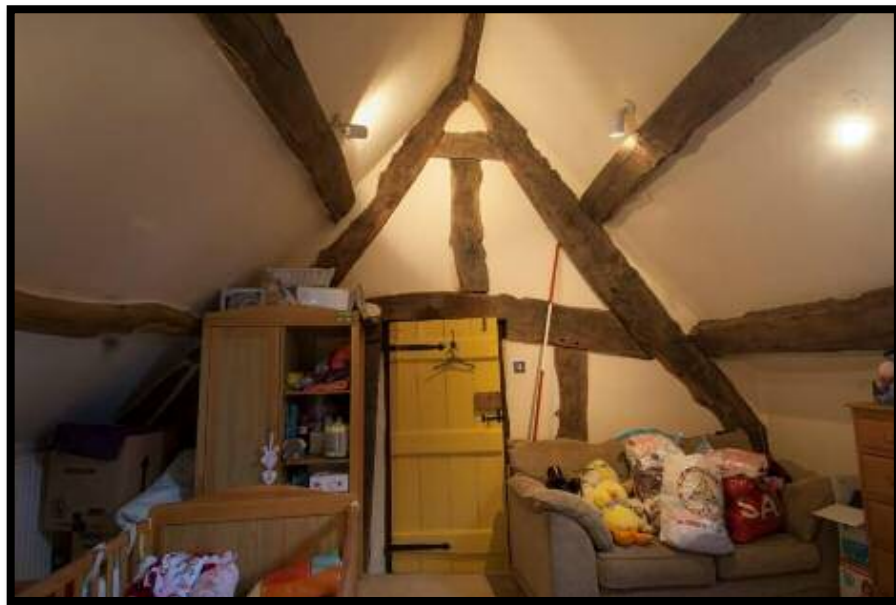
Looking back the reverse face of Truss 2 is seen. (fig 24 and 27 section)

Figure 24: Reverse side of Truss 2 from FF2 upper inner room.
