DATING OLD WELSH HOUSES

PROSIECT DENDROCRONOLEG
GOGLEDD ORLEWIN CYMRU

Llawr-dref, Llangian, Gwynedd

ARCHITECTURAL RECORD

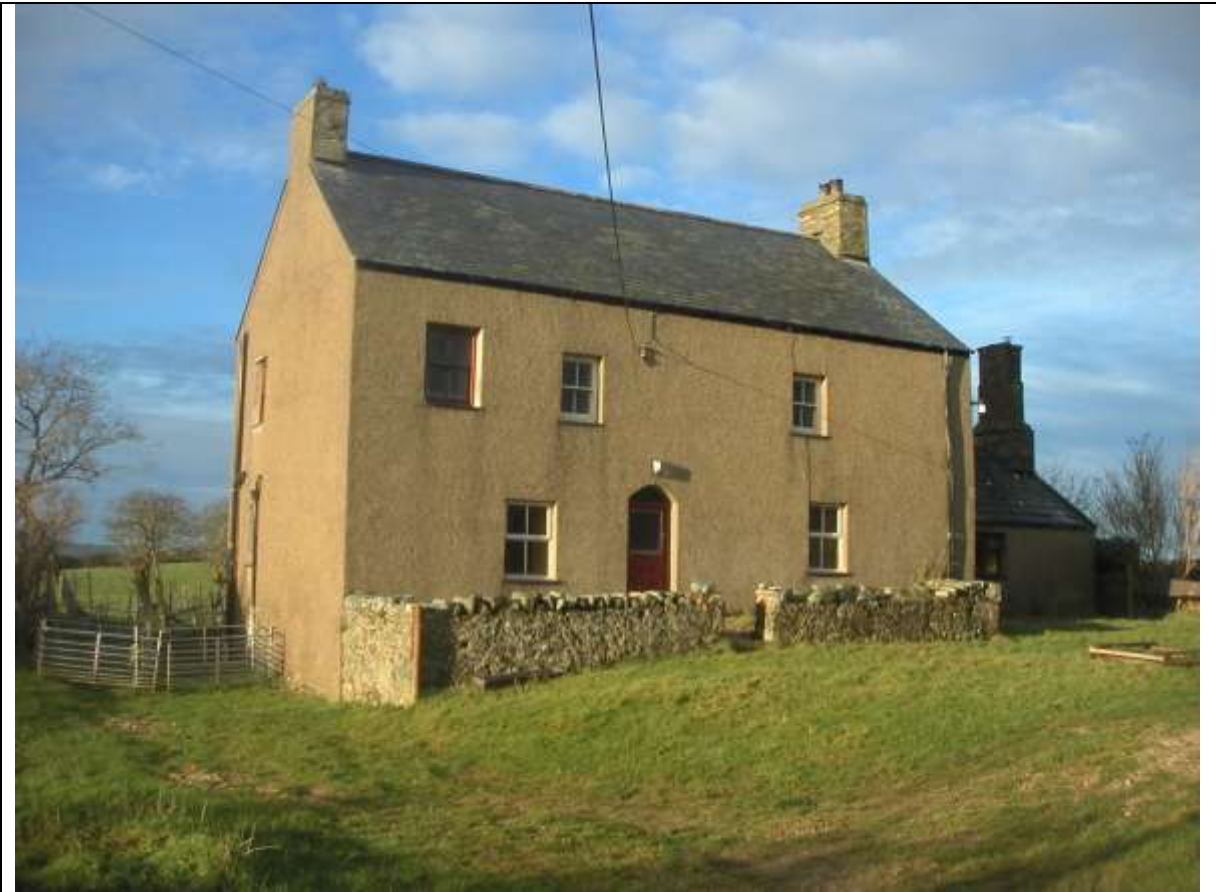
Plate 1 East elevation

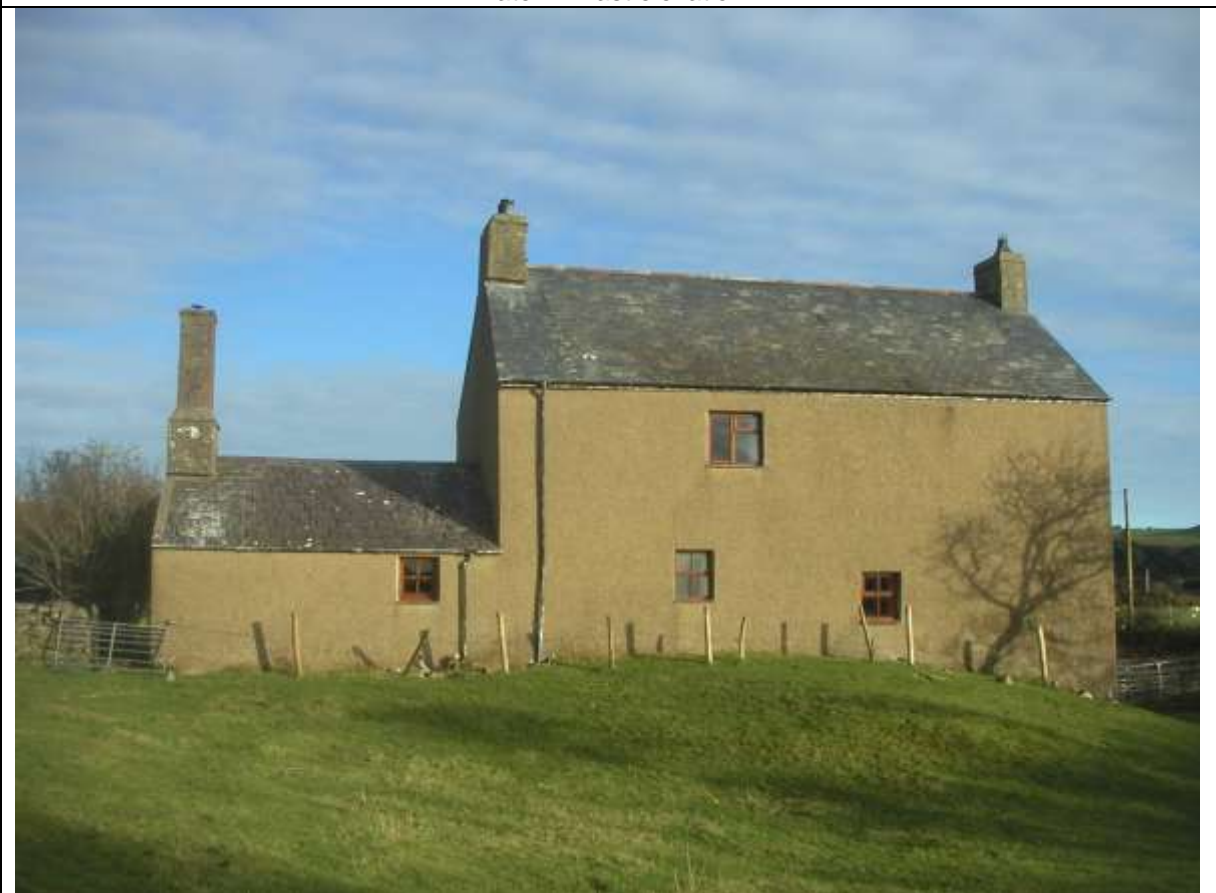
Plate 2 West elevation

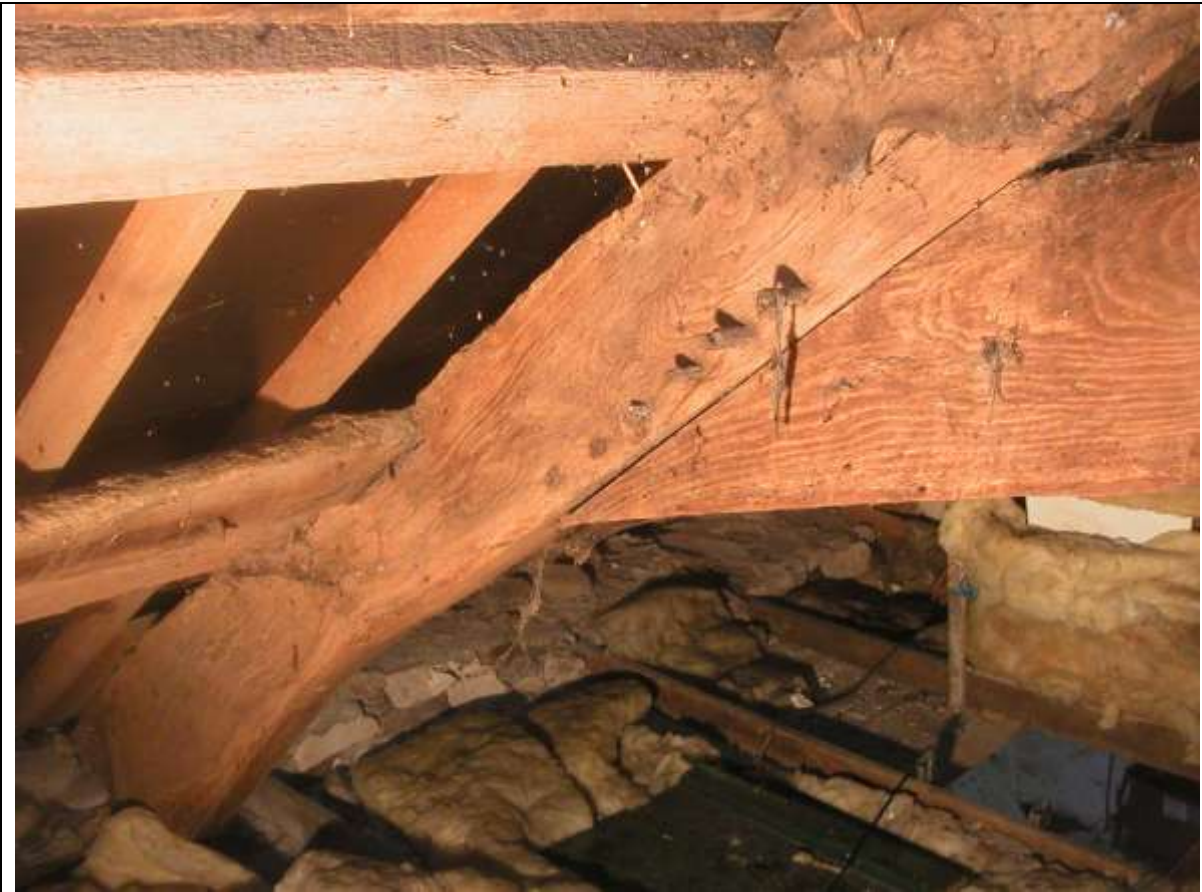
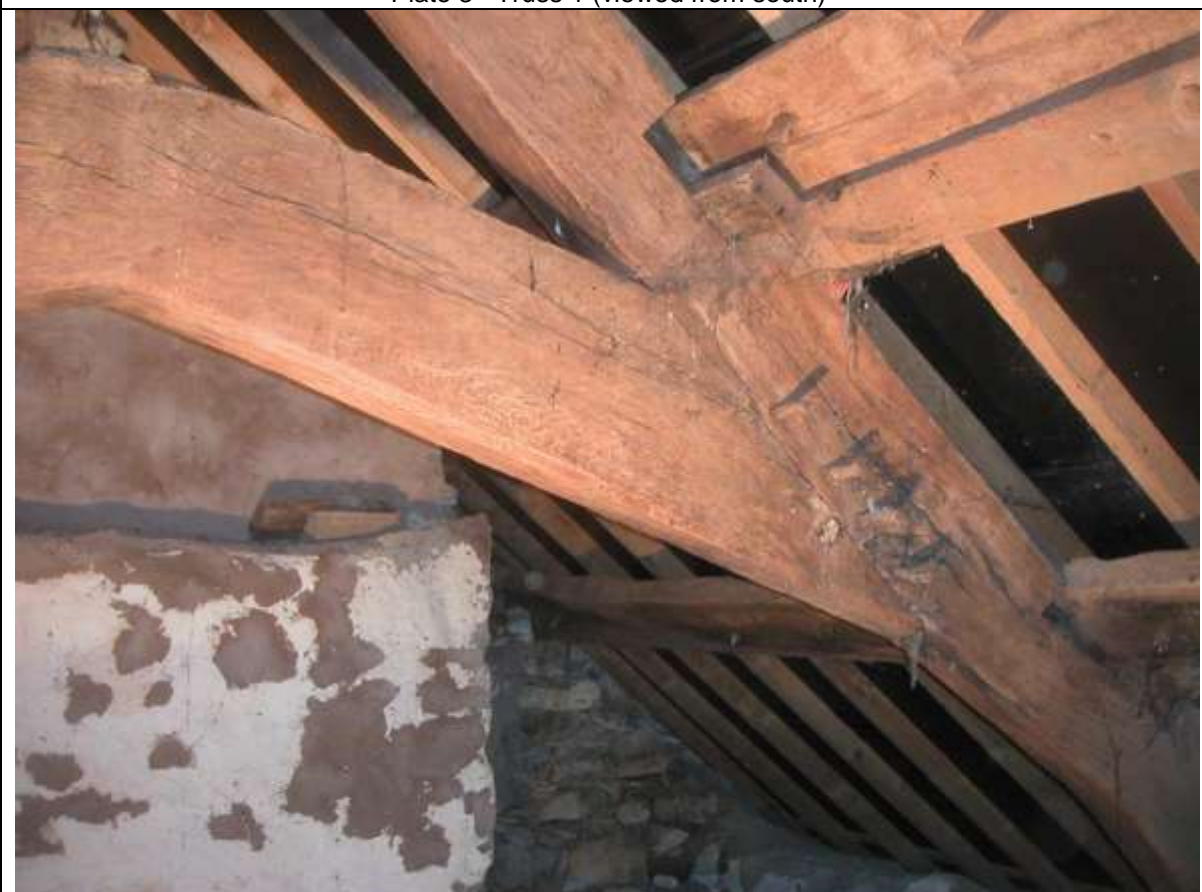
Plate 3 Truss 1 (viewed from south)

Plate 4 Truss 1 (viewed from south)

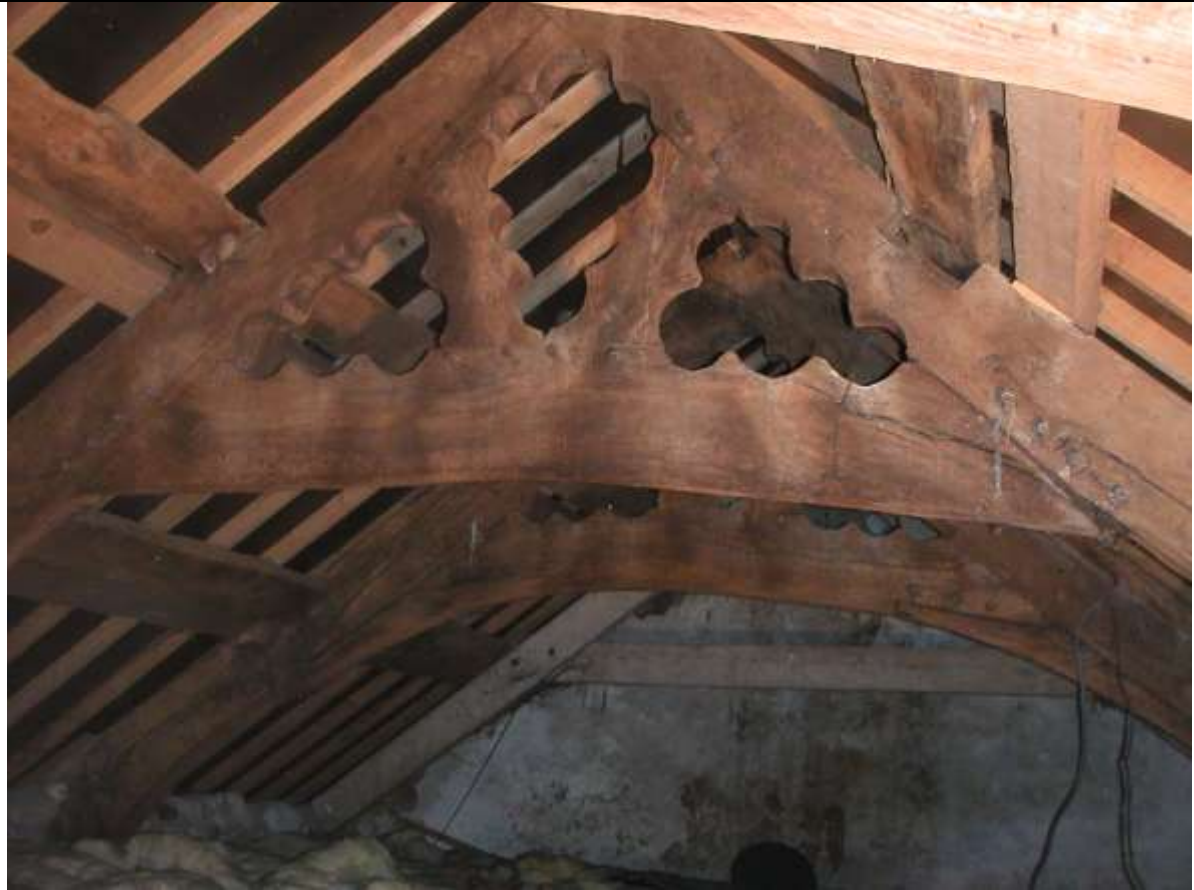
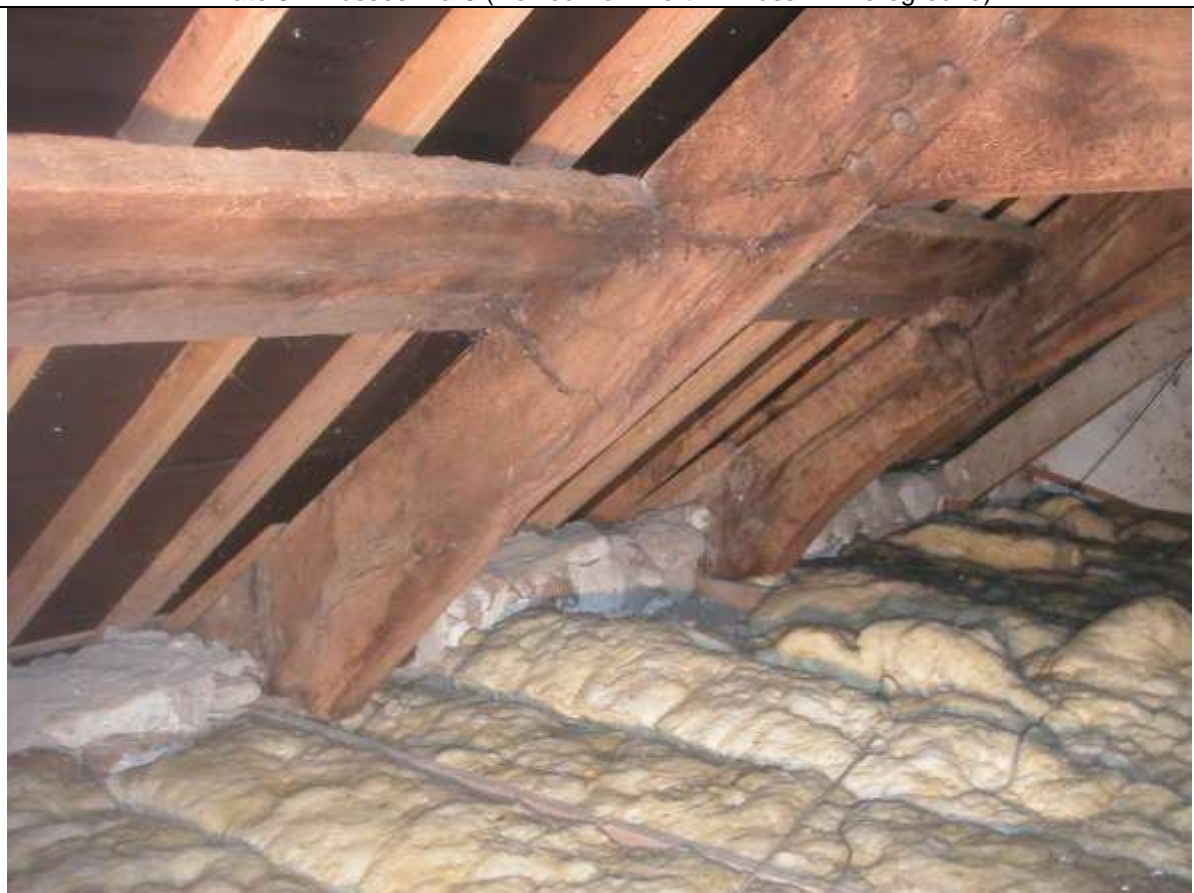
The inspection confirms that there are three oak trusses in the roof space, two with ornate cusping at and above collar level (Trusses 2 & 3) and one with a plain cambered collar without cusping (Truss 1). However, there are no wind-braces nor is there any evidence of any, for instance mortises in the purlins or trusses (this is contrary to Peter Smith's distribution map). Nor are there any holes for partition uprights in the collar and principals of the plain truss (Truss 1) - these might have been expected here, though not in the other two trusses.

Plate 5 Trusses 2 & 3 (viewed from north - Truss 2 in foreground)

Plate 6 Trusses 2 & 3 (viewed from north - Truss 2 in foreground)

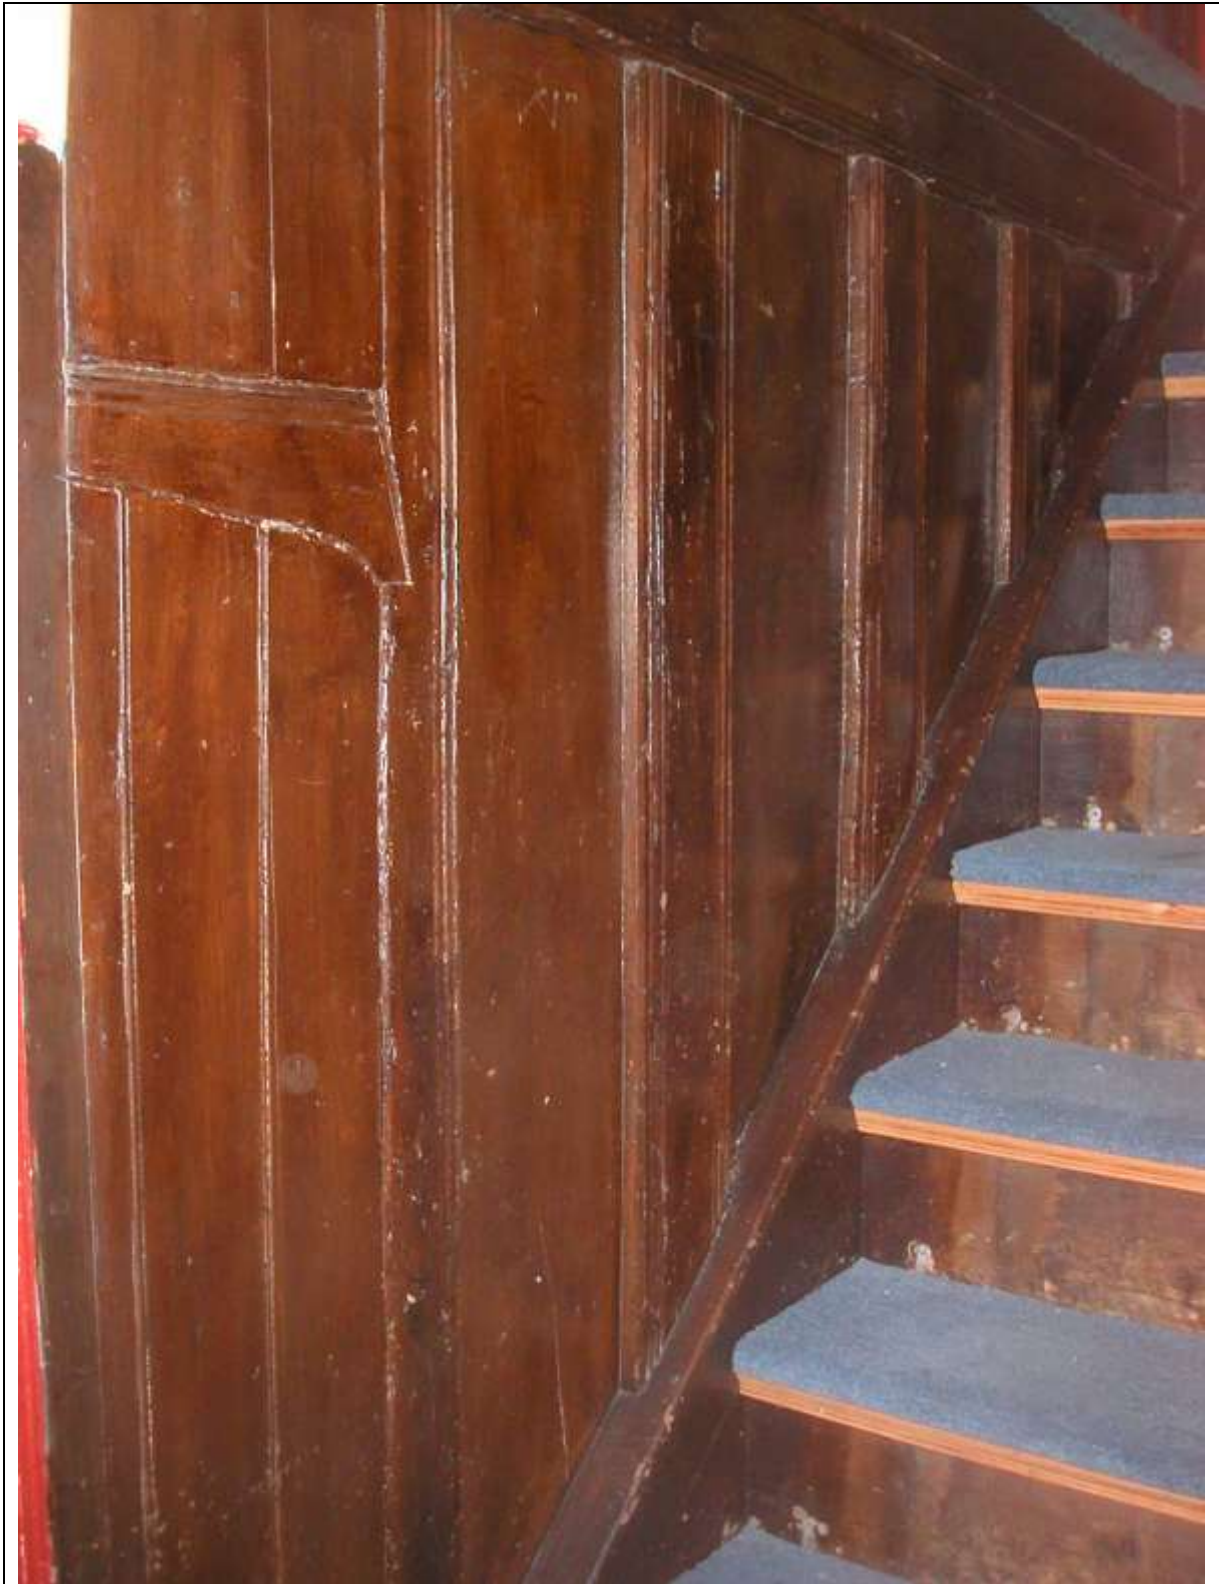
Plate 9 Partition

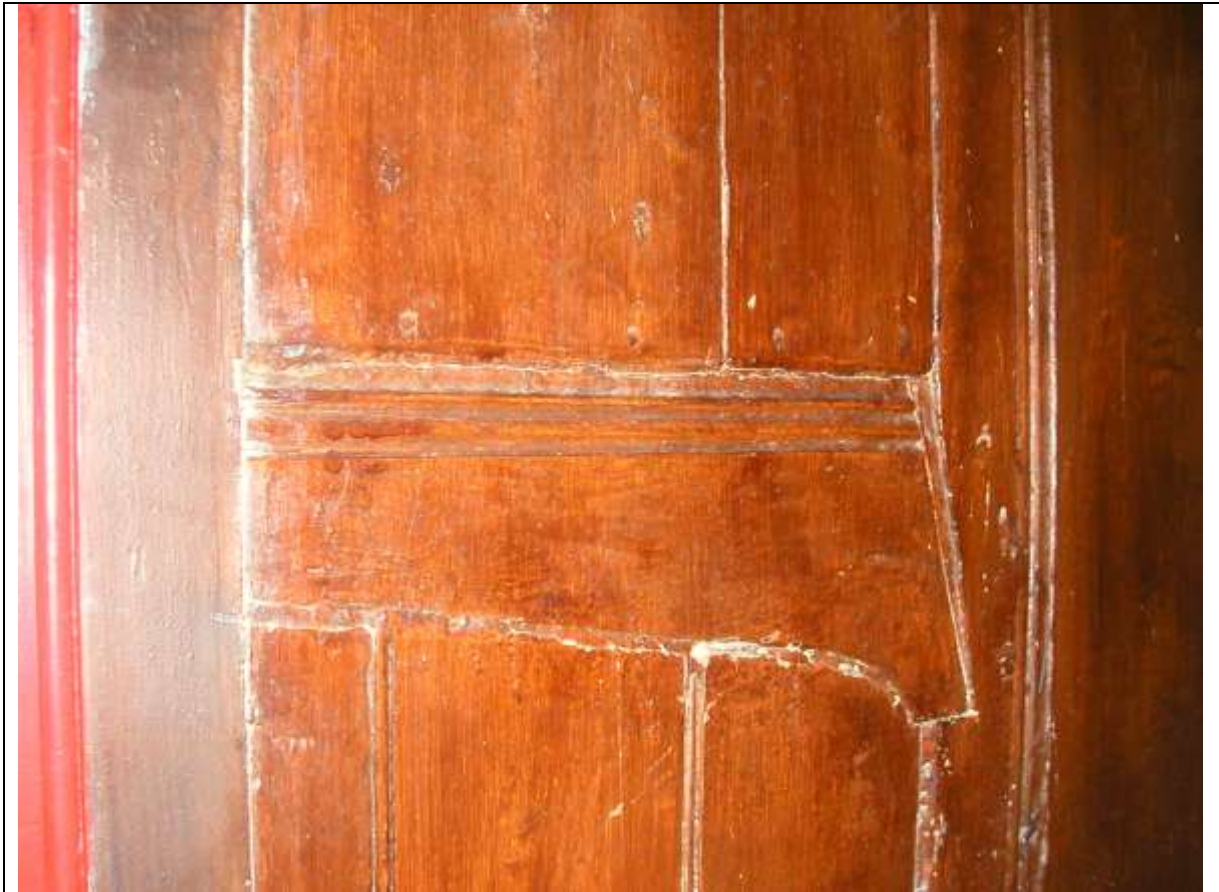
Plate 10 Partition (part of blocked doorhead)

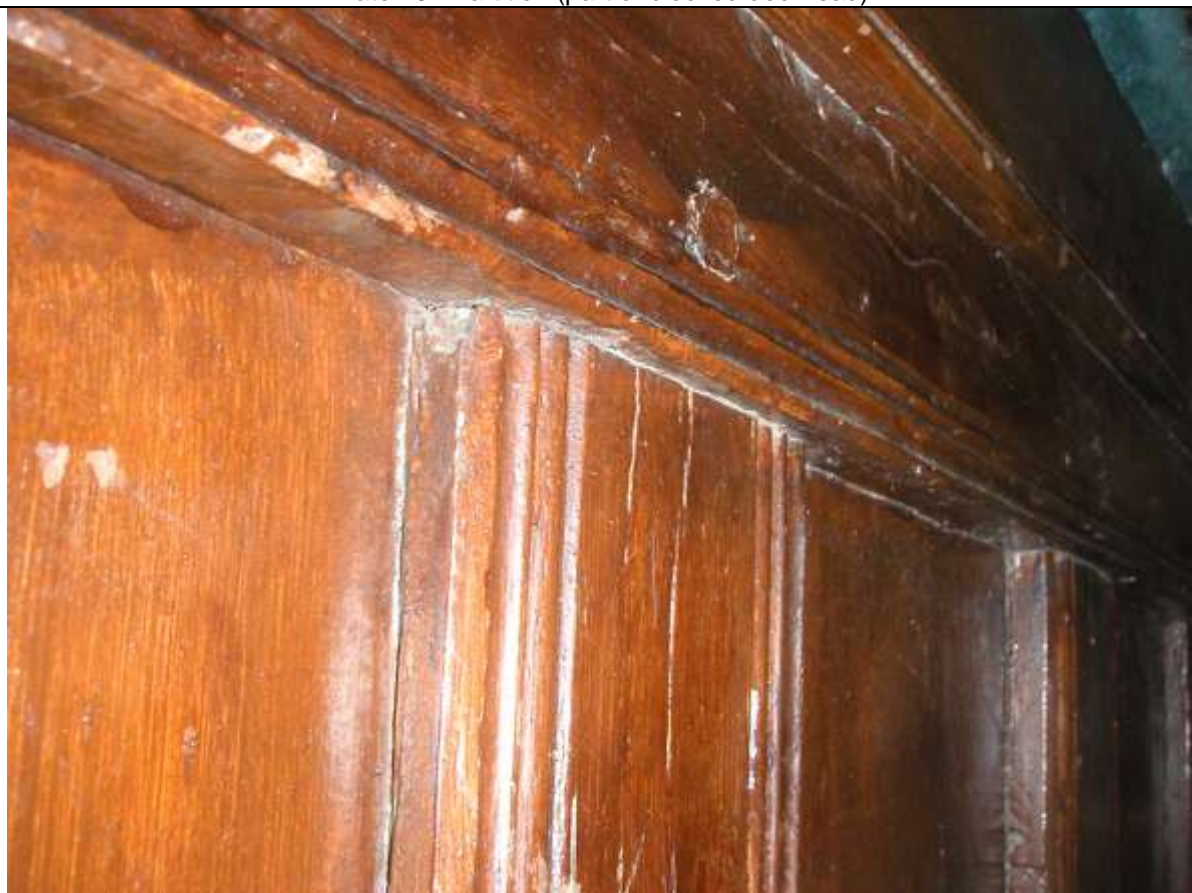
Plate 11 Partition (detail of post and head mouldings)

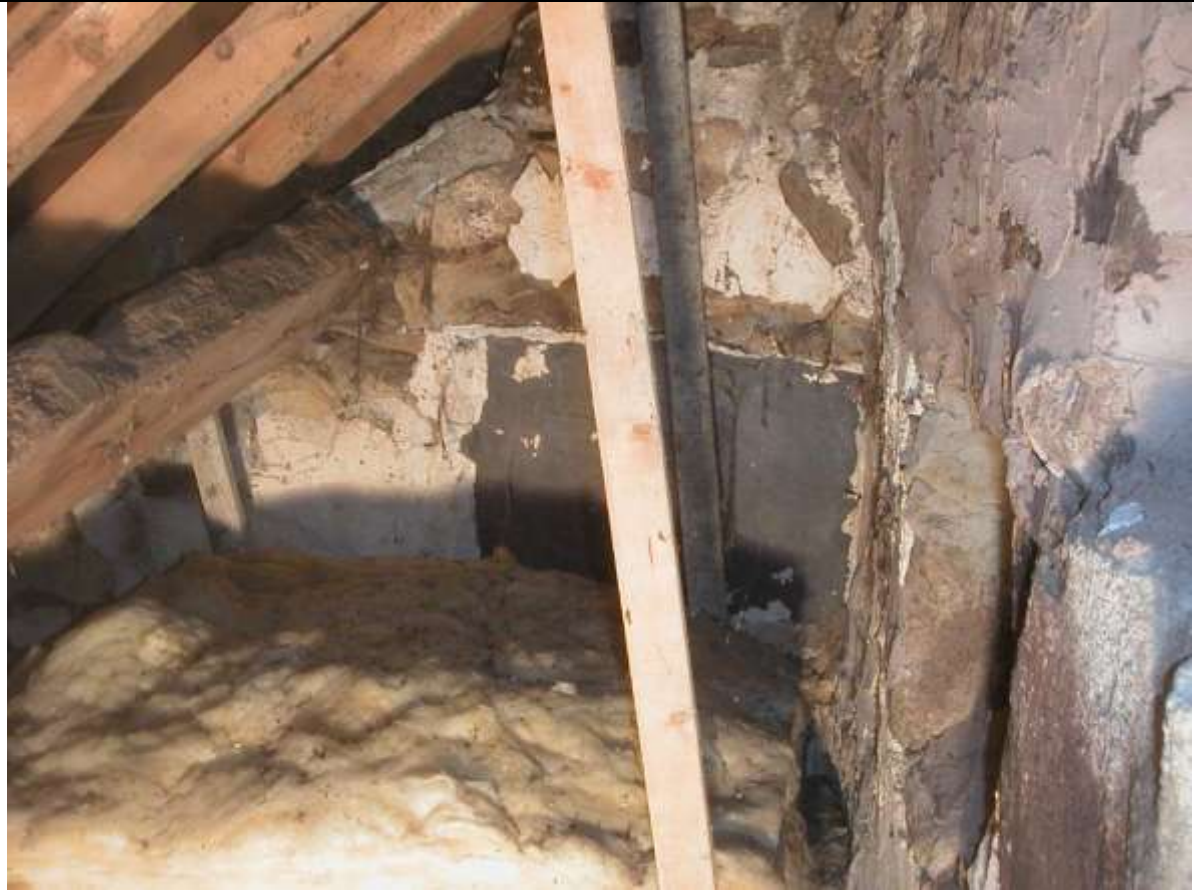
The remainder of the Cadw description appears to be accurate, but it omits (as does the RCAHMW description) the possible blocked window to the top of the former staircase, in the north gable. The high position of this window is unusual so it is possible that it is not original but was perhaps formed when the stonework above the former mural stair was removed. Stubs of stone projecting radially from the external north wall, in line with the window, give the superficial appearance that the stair might have once continued up to the roof-space, but this would be unusual and the stone stubs are more likely to be the ends of the stones forming the 'ceiling' above the mural stair. The most likely function of the window was to light the attic space when it was used for accommodation by servants or farm-hands (there are scraps of wall-paper evident on the south gable).

Plate 12 Possible blocked window in north gable

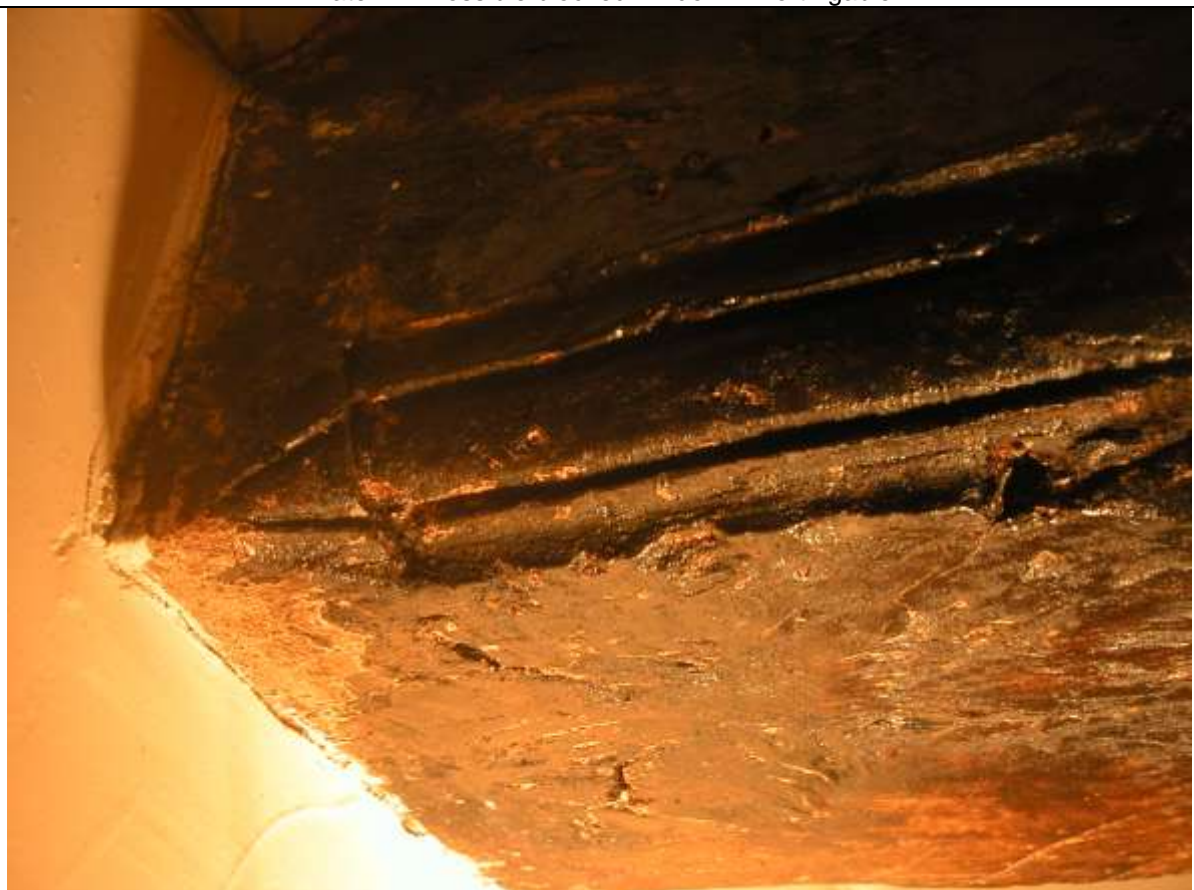
The RCAHMW states that there are no stops to the ground floor beams, but one does survive, on the south side of the main beam at its western end (in passage). The stop on the north side is less clear.

Plate 13 Stop to main beam (west end, south side)

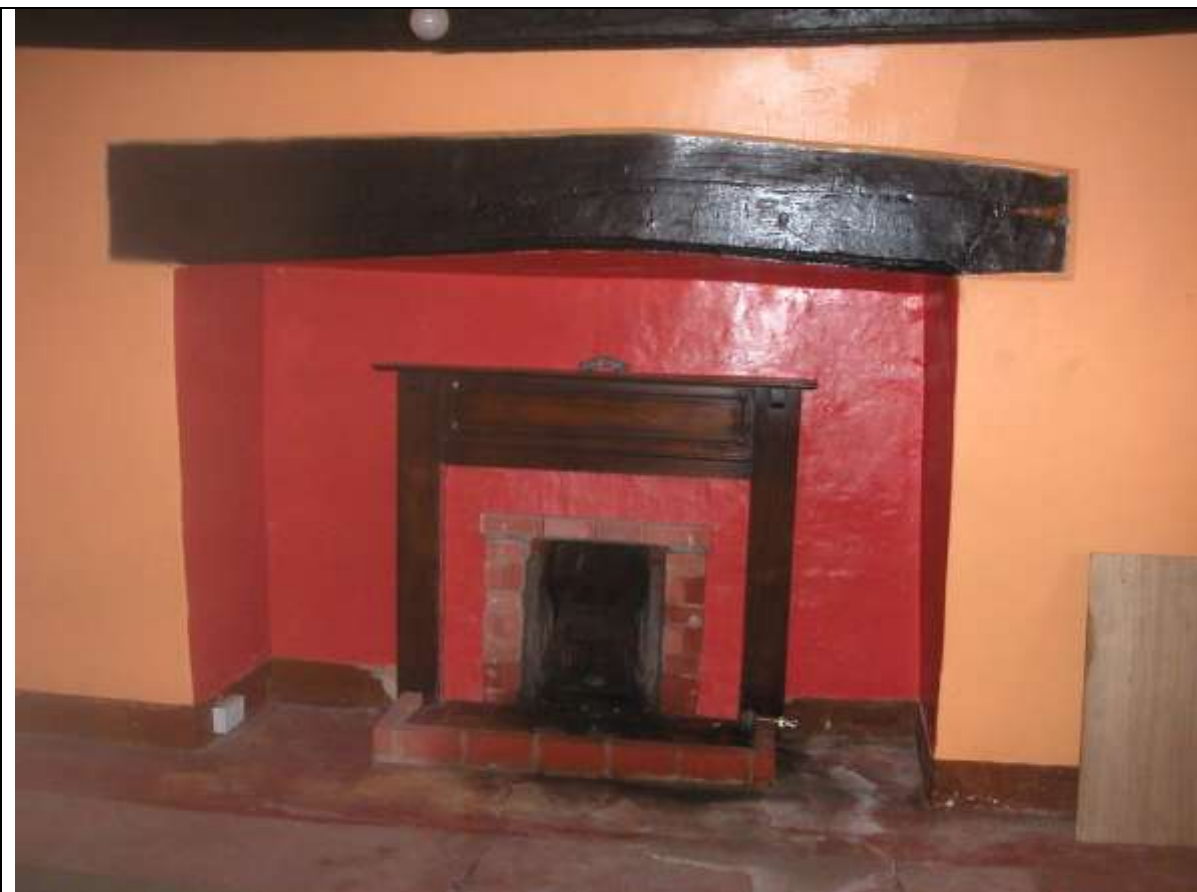
Plate 14 Fireplace (bressummer)

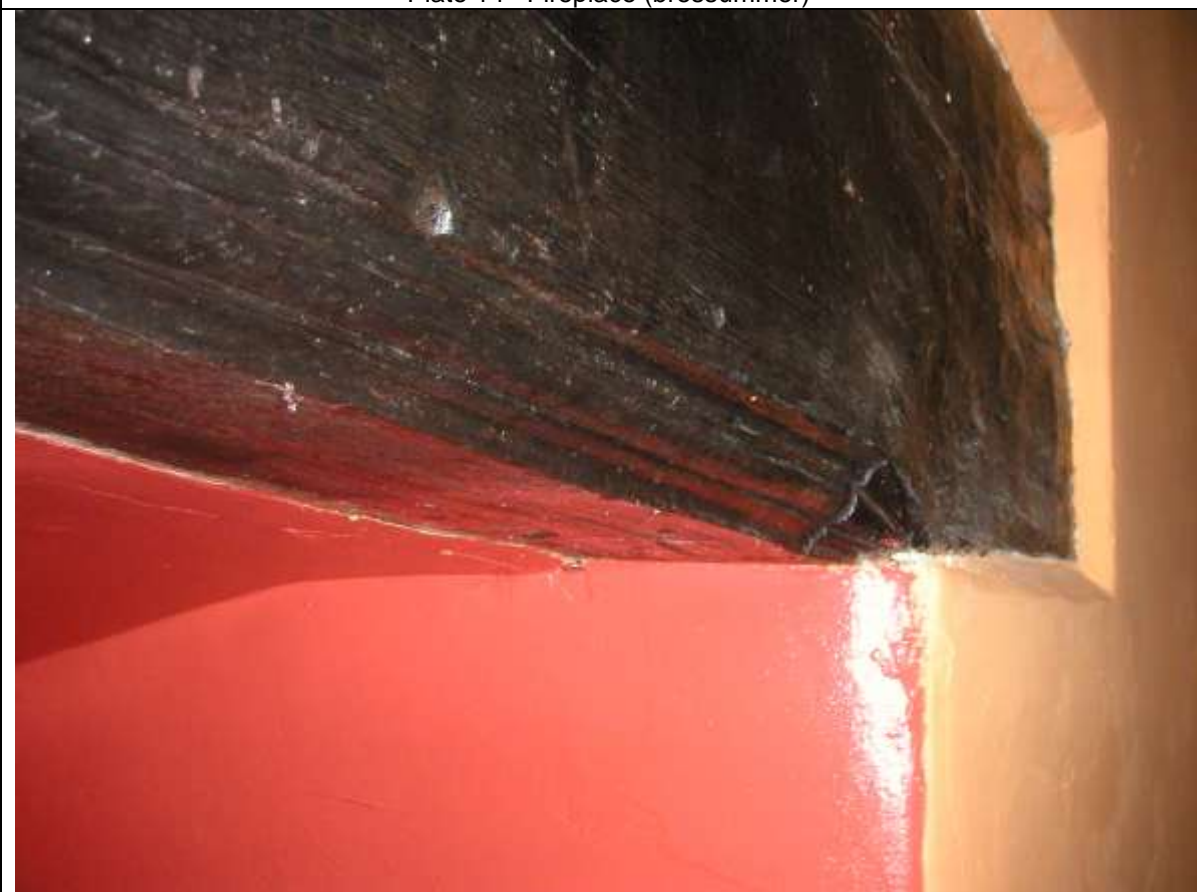
Plate 15 Stop at east end of bressummer

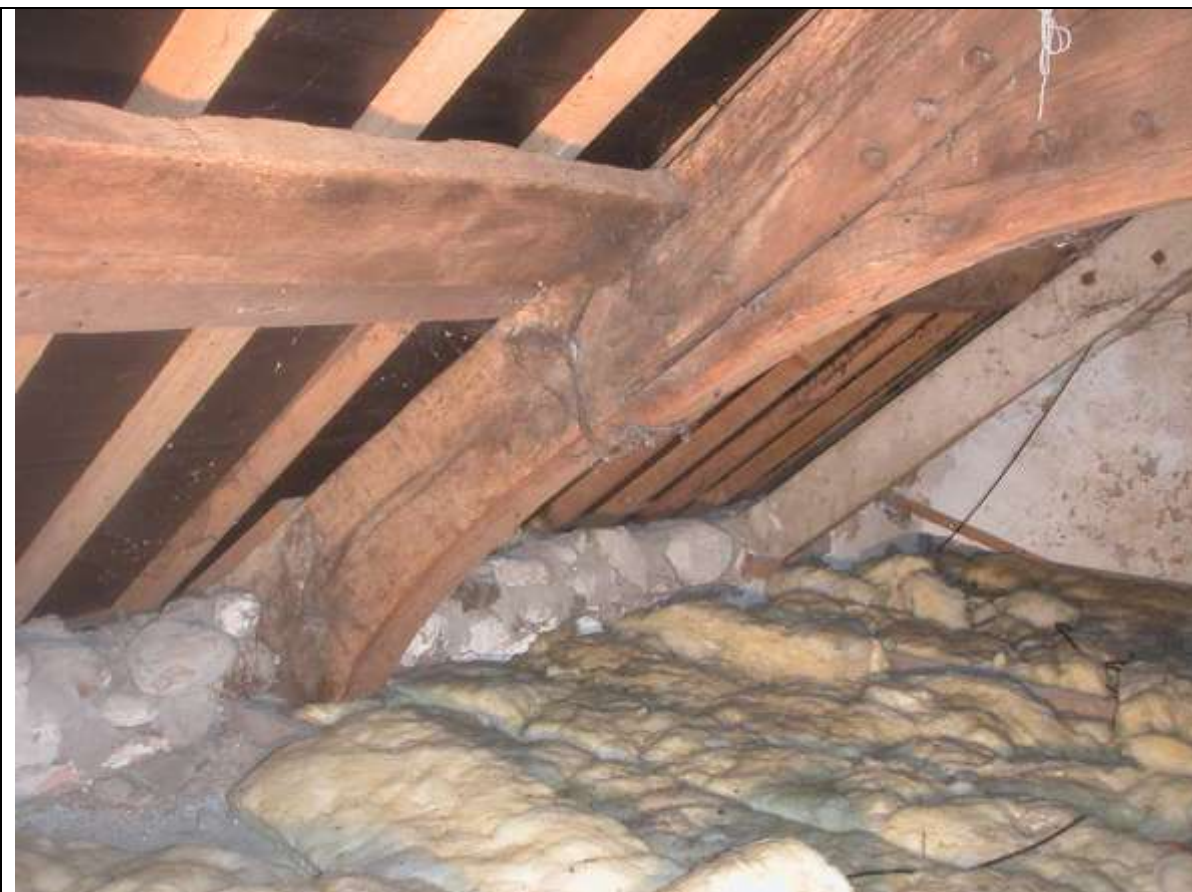
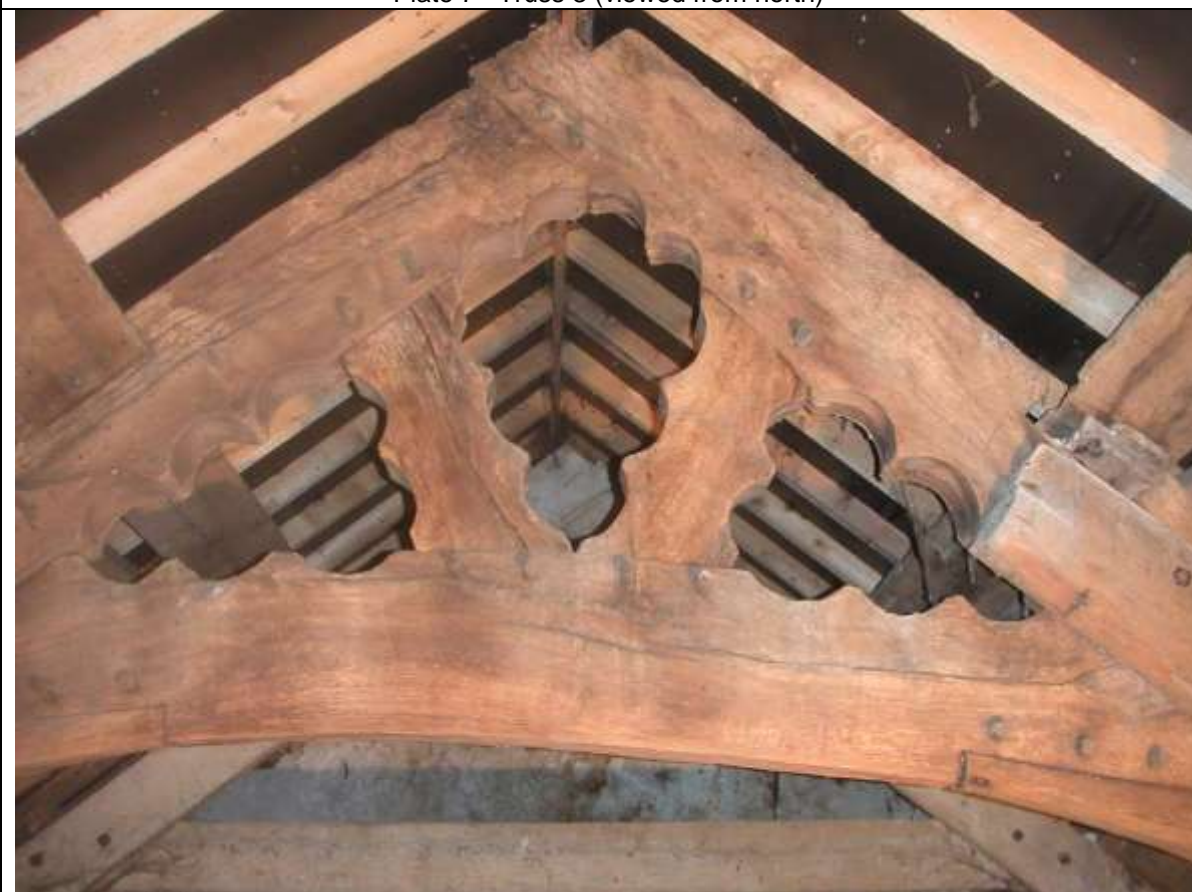
Plate 7 Truss 3 (viewed from north)

Plate 8 Truss 3 (viewed from north)
