BEDD MORRIS STANDING STONE EXCAVATION 2012

RHIF YR ADRODDIAD / REPORT NO. 2012/23 RHIF Y PROSIECT / PROJECT RECORD NO. 102644

BEDD MORRIS STANDING STONE: EXCAVATION 2012

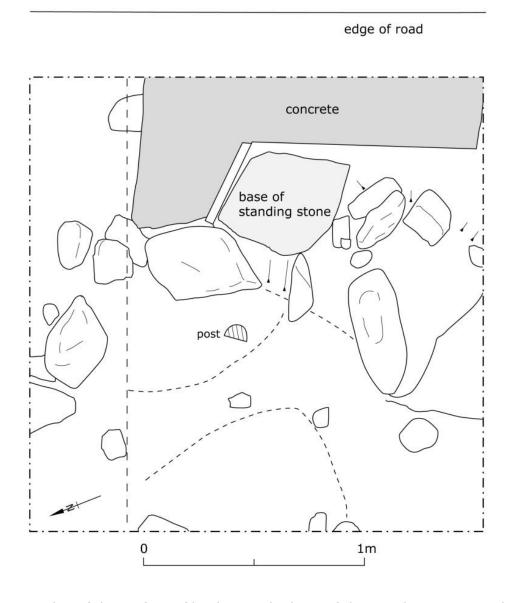
Bank 102 consisted of mixed layers of soil and occasional large rounded stones and boulders (Fig. 2; Photos. 2 and 3). It ran parallel to the road, occupied the whole width of the trench, apart from where removed in 2007, and stood up to 0.5m high. This seems to be the remains of a turf/soil and stone built boundary bank into which the standing stone had been incorporated. The bank is not recorded on any map, and as no archaeological dating evidence was found, the date of its construction and use is unknown. Hammer stones assigned to the bank may have come from the underlying layer (103).

Figure 2. Plan of the surface of bank 102, the base of the standings stone and the concrete fillet.

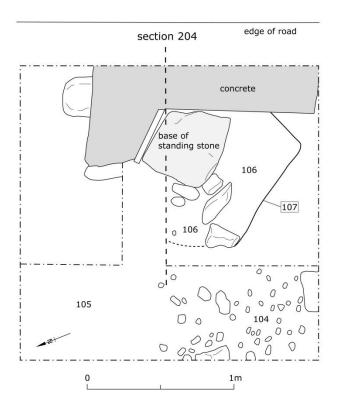
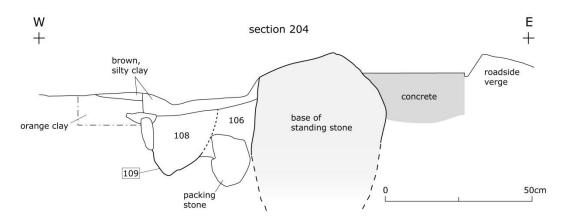
The stone socket cut through silty-clay geological deposits. Resting on these in the south-west corner of the excavation trench was a stony surface (104) made up of rounded and angular pebbles, and some larger rounded stones (Fig. 3: Photo. 4). There was no discernible relationship between this layer and the stone socket or the posthole.

Figure 3. Plan and section of the stone socket showing the packing stones and also layer 104.

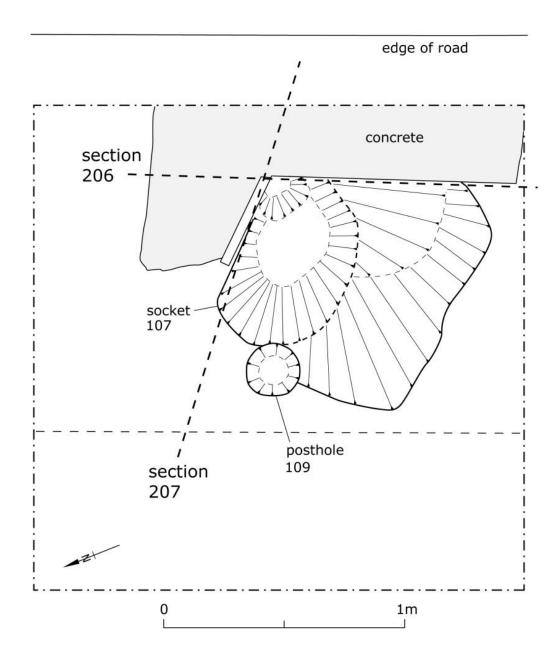
It was not possible to completely excavate the whole of the socket (106, 107) due to the presence of the concrete fillet and to the sharply tapering nature of its base. It was approximately 1m across and 0.7m deep, with its pointed bottom formed by the base of the stone (Figs. 3, 4 and 5; Photos. 3, 4 and 5). Several large rounded stones, including what appeared to be hammer stones, had been jammed into the pit acting as packing stones. Several stone flakes, possibly a result of dressing the standing stone, were included in the stony silty-clay fill (106) of the socket. Bulk soil samples and a charcoal sample were taken from the fill of the socket. The snapped-off base of the standing stone mirrored the shape of the base of the socket (Photos. 6 and 7). Originally the stone would have been embedded at least 0.7m in the ground. A posthole (109, filled by 108) cut through part of the fill (106) of the stone socket.

Figure 4. Plan of the stone socket 107.

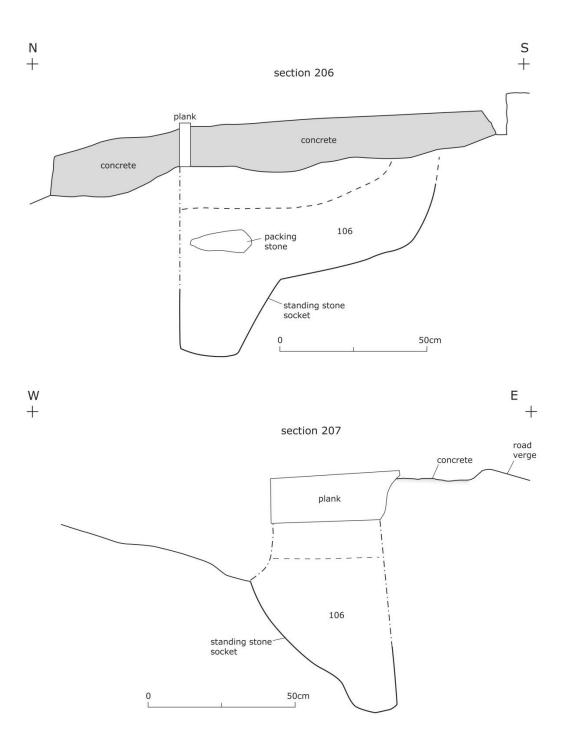
Figure 5. Sections 206, 207 across stone socket 107.

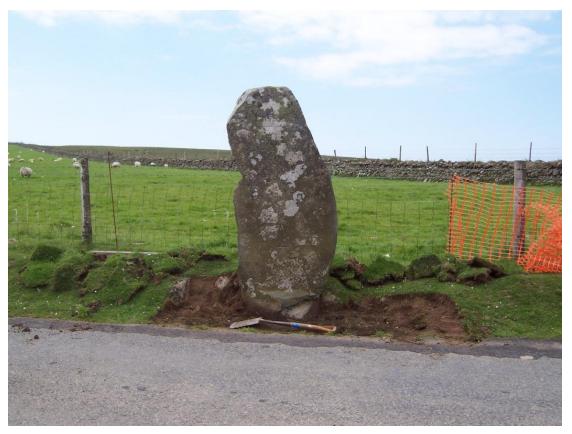
In 2007, graziers reported that the stone had become unstable and raised concerns that it could topple. It was unclear what had caused this to happen, but it was most likely a combination of factors; vibration from vehicles, animals rubbing against it, erosion around the base of the stone, impact from a vehicle. It was decided that stabilisation was required; this was undertaken in June 2007 by Pembrokeshire Coast National Park Authority staff under the supervision of their Archaeologist, Polly Groom (2007). This stabilisation consisted of removing turf and loose material from an eroded hollow between the stone and the road to create a solid surface to build from. This work revealed a crack in the stone. It would seem that the bottom of the stone had been 'squared off'. It was noted that hardcore from the road spread almost to the base of the stone. Beams of recycled plastic were placed against the squared sides of the stone and concrete poured in behind them with the intention of providing a solid buffer and preventing movement of the stone. Earth was then mounded up over the concrete and the turf reinstated.

Photograph 1. Bedd Morris standing stone in 2007 following stabilisation.

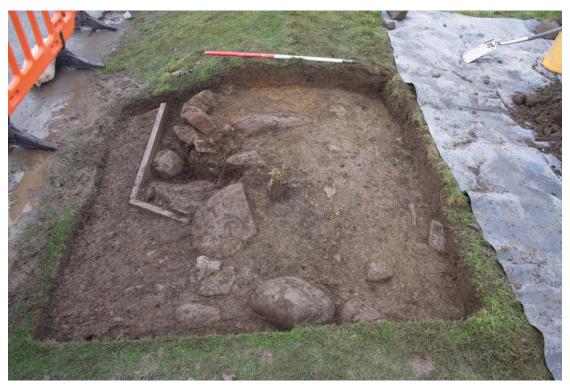
Removal of turf and topsoil (101), which included rounded boulders, pieces of plastic and metal, and debris from the 2007 stabilisation work, revealed the surface of a low bank (102) through which the base of the standing stone protruded.

Photograph 2. The site after the removal of topsoil showing the surface of the bank (102) and the in situ base of the standing stone. Scales 1m and 0.5m.

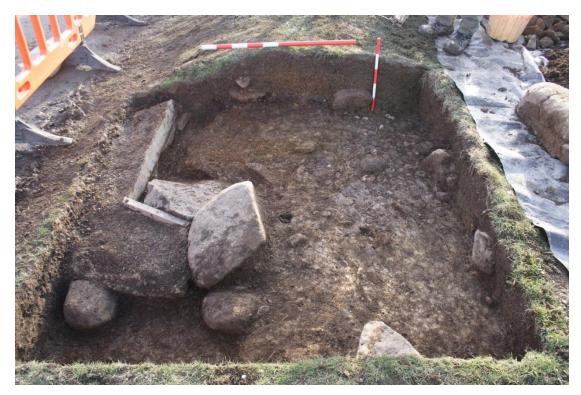
Photograph 3. The *in situ* base of the stone with packing stones and stony surface 104.Note the section through bank 102 at the end of the trench. Scales 1m and 0.5m.

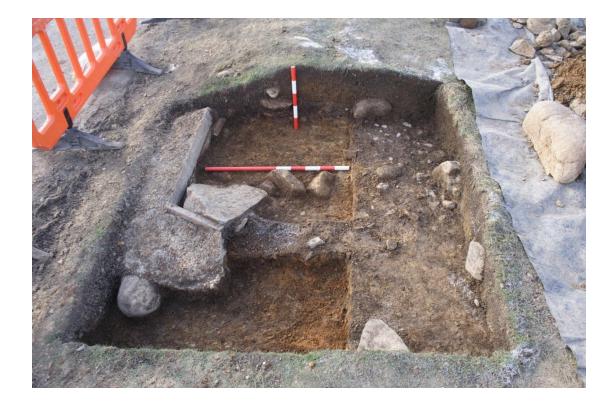
Photograph 4. The *in situ* base of the stone with packing stones and stony surface 104. Scales 1m and 0.5m.

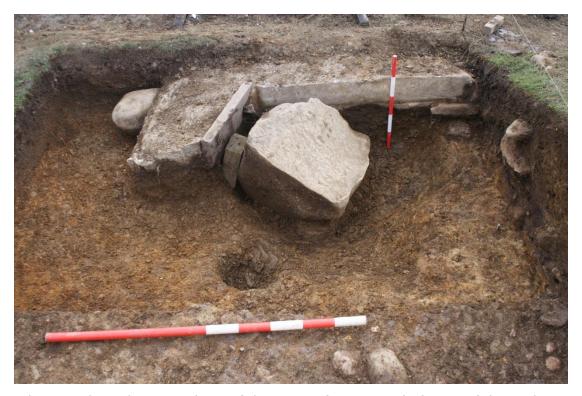
Photograph 5. The *in situ* base of the stone after removal of most of the packing material. Scale 1m and 0.5m.

It is recommended that the stone is repaired and re-erected in its original socket. It would be useful to obtain a radiocarbon date from the charcoal from the stone socket. Depending on the date obtained it might be useful to analyse the samples obtained from the stone socket.

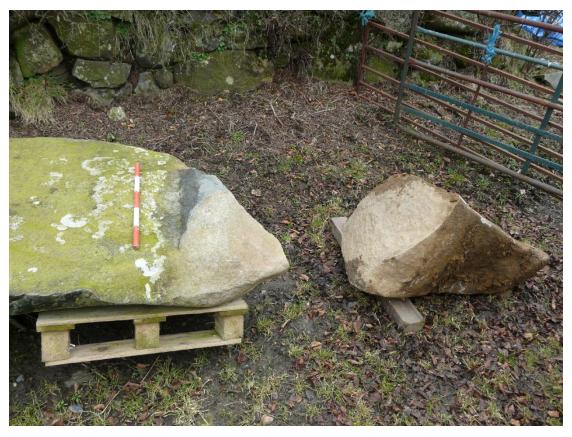
During the weekend of $8^{th}/9^{th}$ October 2011 the standing stone toppled over, fracturing across the crack noted in 2007. The reason for this is unknown, but it is considered likely that a vehicle clipped it. The stone was removed to a nearby farm for safekeeping. The preferred option of Cadw and the Pembrokeshire Coast National Park and others was to return the stone to, or very close to, its original upright position. However, before this could be achieved the base of the stone had to be recovered. As there was the possibility that it had remained *in situ* since the Bronze Age, this had to be achieved as part of an archaeological excavation. Dyfed Archaeological Trust therefore submitted a request for grantaid to excavate the site. This was approved and the excavation was undertaken in the week of the 6^{th} - 10^{th} February 2012.

Photograph 6. The base of the standing stone reunited with its upper section. Photo: Geoff Wainwright.

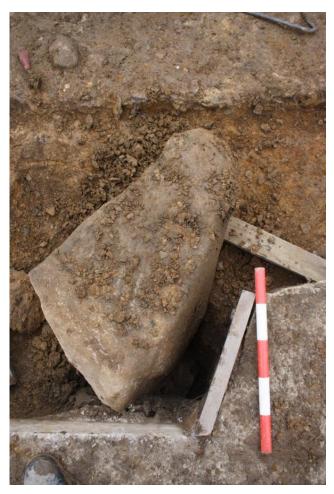
Photograph 7. The base of the standing stone following removal from the socket. Scale 0.5m. 7871
