# EAST BLOCKHOUSE, ANGLE ARCHAEOLOGICAL EXCAVATION JULY 2011

RHIF YR ADRODDIAD / REPORT NO. 2011/33 RHIF Y PROSIECT / PROJECT RECORD NO. 100752

## EAST BLOCKHOUSE, ANGLE, PEMBROKESHIRE: ARCHAEOLOGICAL EXCAVATION

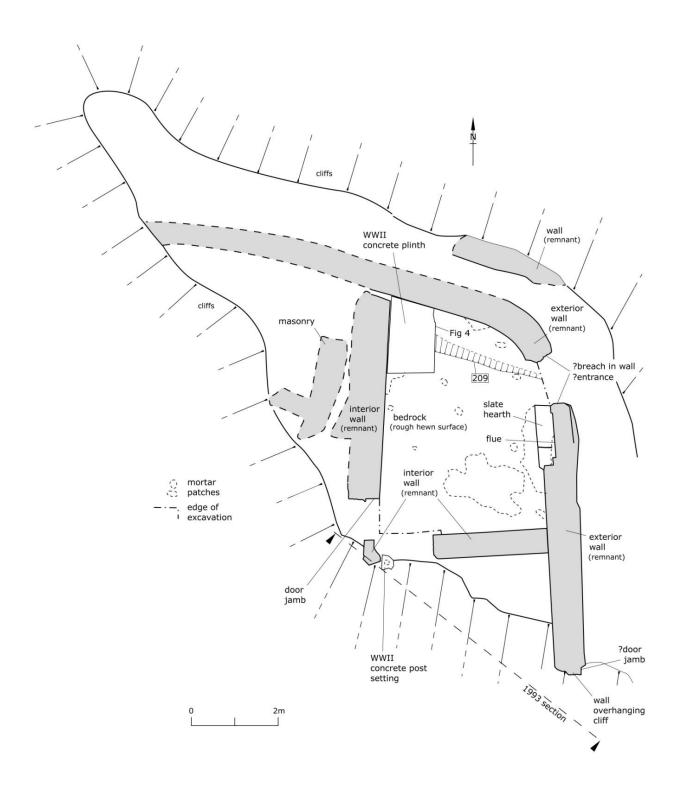
Figure 3: Plan of the East Blockhouse, Trench 1.

The whole of the surviving room within the Blockhouse was examined in Trench 1 (Fig. 3; Photos. 4-7). The partially surviving room to the west was not examined due to safety considerations. Removal of turf and a thin (150mm) stony soil (202) revealed shattered bedrock. A few sherds of 20<sup>th</sup> century ceramics, oyster shell and bone were found in layer 202. There was no rubble or stone from the dilapidated walls and there were no surviving floor surfaces. Patches of mortar lay on the surface of the bedrock, and a slate hearth-stone was revealed in the east wall at its northern end. A concrete plinth occupied the northwest corner of the interior, constructed over layer 202 (Fig. 4; Photo 7). A shallow trench (209), filled with a silty soil, stones and mortar lumps, lay parallel to the north wall.

It would seem that the whole of the interior of the Blockhouse was cleared out during the  $20^{th}$  century (probably during the Second World War) removing rubble and floor deposits. The concrete plinth was almost certainly for a small shed constructed during the Second World War. The shallow trench (209) is probably a foundation trench dating to the original  $16^{th}$  century construction of the Blockhouse.

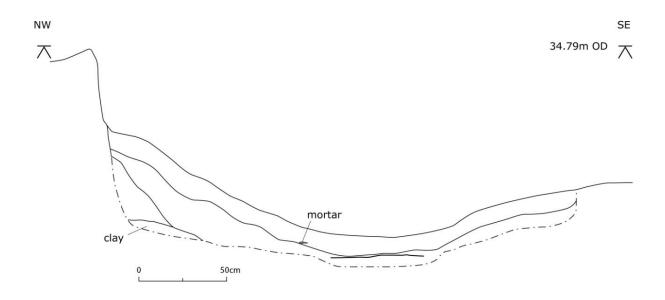
**Figure 5:** Section of the hollow, Trench 2.

The hollow (203) was half-sectioned (Fig. 5; Photos. 8-9). It was filled by layers of sandy-clay soil one of which contained a .22 calibre bullet case, and included a discrete sand deposit within the fill. A thin layer of clay lined the bottom of the hollow.

This hollow is most likely to have been a Second World War machine gun position, with the sand deposit the decayed remains of one of the sand-bags that surrounded the hollow.

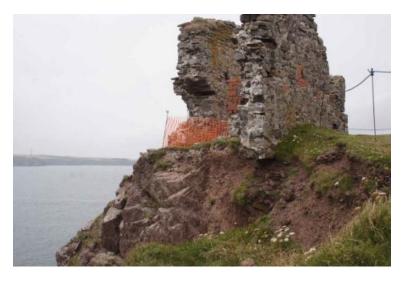
Angle Blockhouse occupies the edge of a narrow promontory at  $c.35 \mathrm{m}$  above sea level, connected to higher ground to the east by a shallow saddle (Fig. 2). The western end of the Blockhouse has fallen into the sea, and what remains is in danger of falling away to the west and south (Photo. 3). The standing remains have been previously recording (Glamorgan-Gwent Archaeological Trust 1993) when three phases of building were noted, the first two probably of  $16^{\mathrm{th}}$  century date and the third dating to the  $20^{\mathrm{th}}$  century. Three courses of wall foundation similar in character to those of the Blockhouse lie  $c.15 \mathrm{m}$  to the southeast on the cliff edge; they were photographically recorded, but not investigated further owing to their precarious location. A  $c.3 \mathrm{m}$  diameter hollow probably of  $20^{\mathrm{th}}$  century date lies immediately to the east of the Blockhouse, and a slight earthwork bank some  $35 \mathrm{m}$  to the east may have had an association with the structure.

Photograph 3. The undercut east wall at the south end.

It is recommended that site is monitored a least once a year and that any remains revealed by erosion and landslips are recorded.

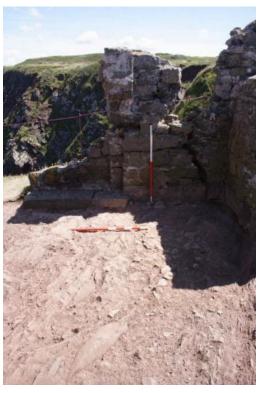
Photograph 6. The interior of the Blockhouse after removal of turf and topsoil showing the slate hearth stone in the east wall, north end. Scales 1m.

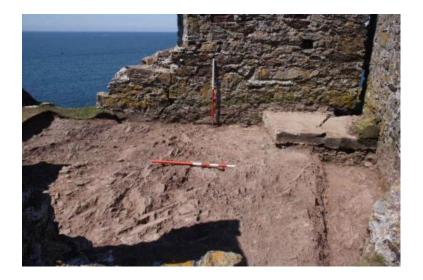
Photograph 7. The interior of the Blockhouse after removal of turf and topsoil showing the concrete plinth in the north-west corner and the foundation trench. Scales 1m.

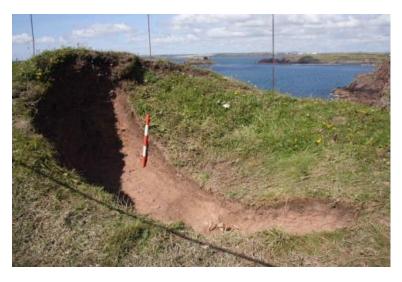
Photograph 9. Section of the hollow (Trench 2). Scale 0.5m.

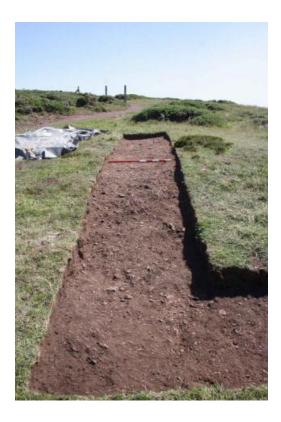
Bedrock was revealed along the length of this trench following removal of turf and topsoil (Photo. 10). The slight earthwork visible on the surface is therefore considered to be entirely natural.

Photograph 10. Trench 3. 1m scale

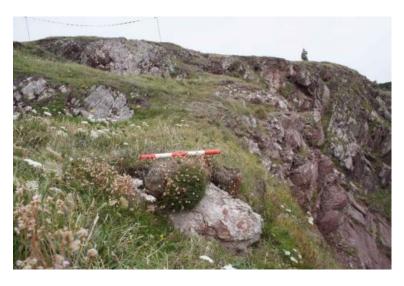
Photograph 12. The wall on the cliff edge 15m to the southeast of the Blockhouse. 0.5m scale
