BEDD MORRIS STANDING STONE EXCAVATION AND RE-ERECTION 2012

RHIF YR ADRODDIAD / REPORT NO. 2012/23
RHIF Y PROSIECT / PROJECT RECORD NO. 102644

March 2012
Revised February 2013

**BEDD MORRIS STANDING STONE
EXCAVATION AND RE-ERECTION
2012**

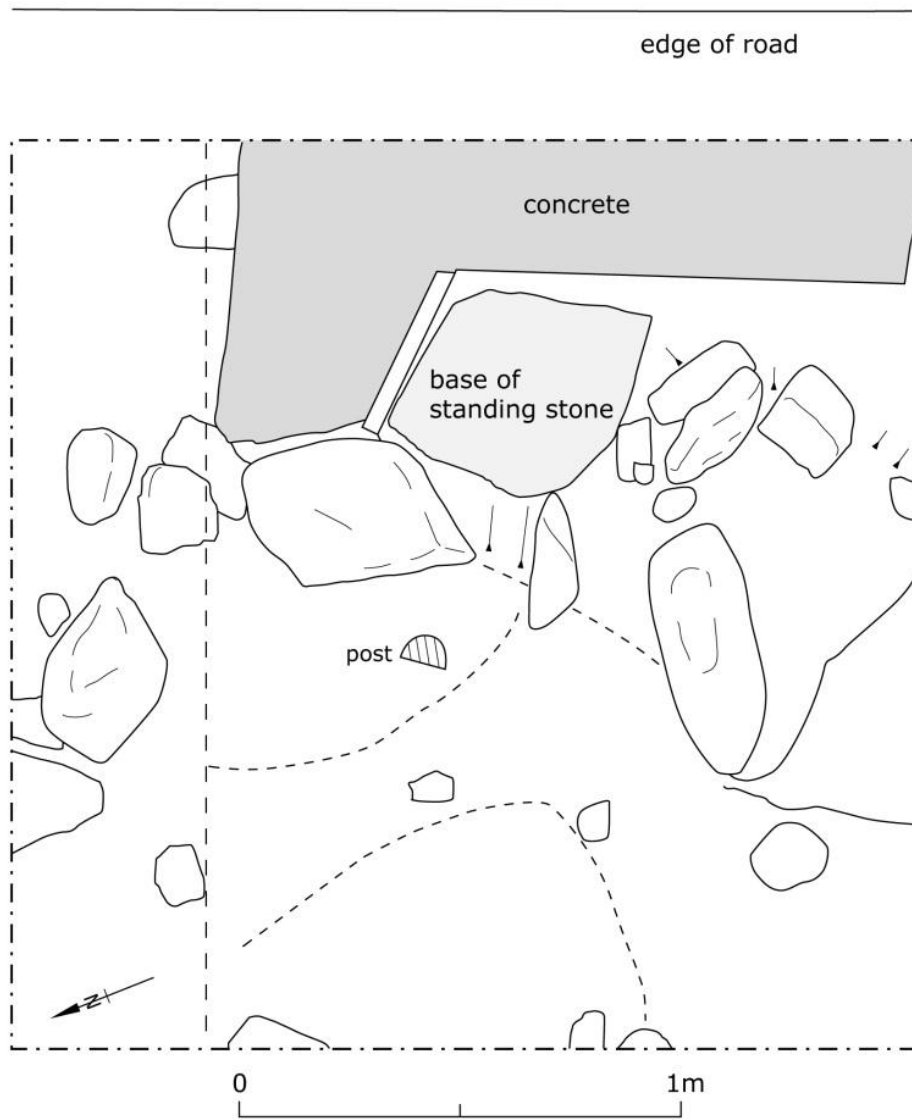
Bank 102 consisted of mixed layers of soil and occasional large rounded stones and boulders (Fig. 2; Photos. 2 and 3). It ran parallel to the road, occupied the whole width of the trench, apart from where removed in 2007, and stood up to 0.5m high. This seems to be the remains of a turf/soil and stone built boundary bank into which the standing stone had been incorporated. The bank is not recorded on any map, and as no archaeological dating evidence was found, the date of its construction and use is unknown. Hammer stones assigned to the bank may have come from the underlying layer (103).

Figure 2. Plan of the surface of bank 102, the base of the standing stone and the concrete fillet.

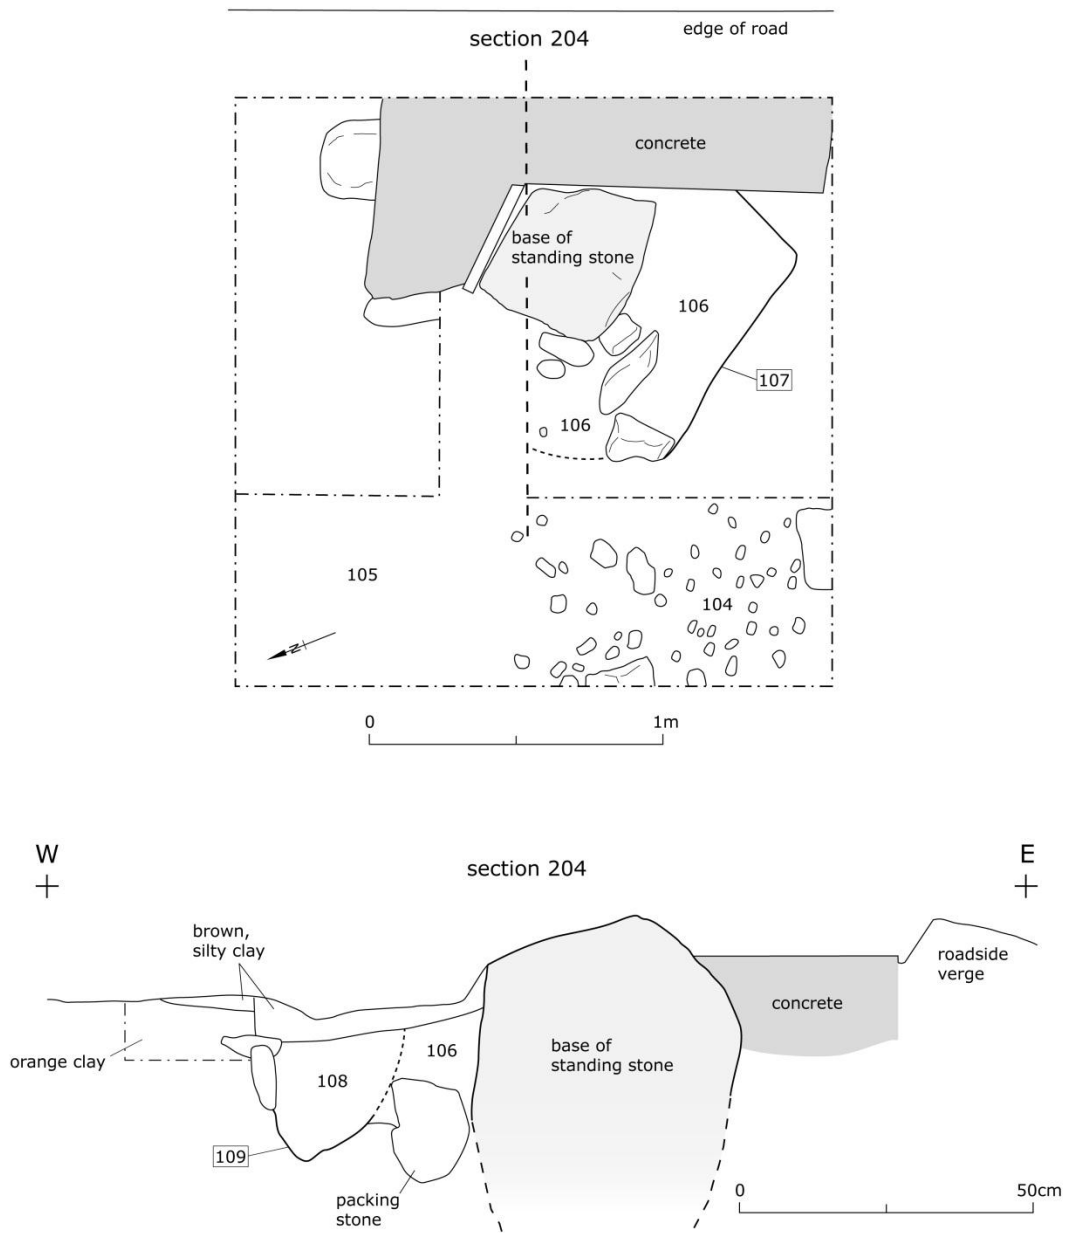
It was not possible to completely excavate the whole of the socket (106, 107) due to the presence of the concrete fillet and to the sharply tapering nature of its base. It was approximately 1m across and 0.7m deep, with its pointed bottom formed by the base of the stone (Figs. 3, 4 and 5; Photos. 3, 4 and 5). Several large rounded stones, including what appeared to be hammer stones, had been jammed into the pit acting as packing stones. Several stone flakes, possibly a result of dressing the standing stone, were included in the stony silty-clay fill (106) of the socket. In early 2013, two Radiocarbon determinations were obtained from charcoal from the fill (106) of the stone socket: 1735 to 1535 Cal. BC (SUERC-44258) and 2430 to 2145 Cal. BC (SUERC-44262) The snapped-off base of the standing stone mirrored the shape of the base of the socket (Photos. 6 and 7). Originally the stone would have been embedded at least 0.7m in the ground. A posthole (109, filled by 108) cut through part of the fill (106) of the stone socket.

up of rounded and angular pebbles, and some larger rounded stones (Fig. 3: Photo. 4). There was no discernible relationship between this layer and the stone socket or the posthole.

Figure 3. Plan and section of the stone socket showing the packing stones and also layer 104.

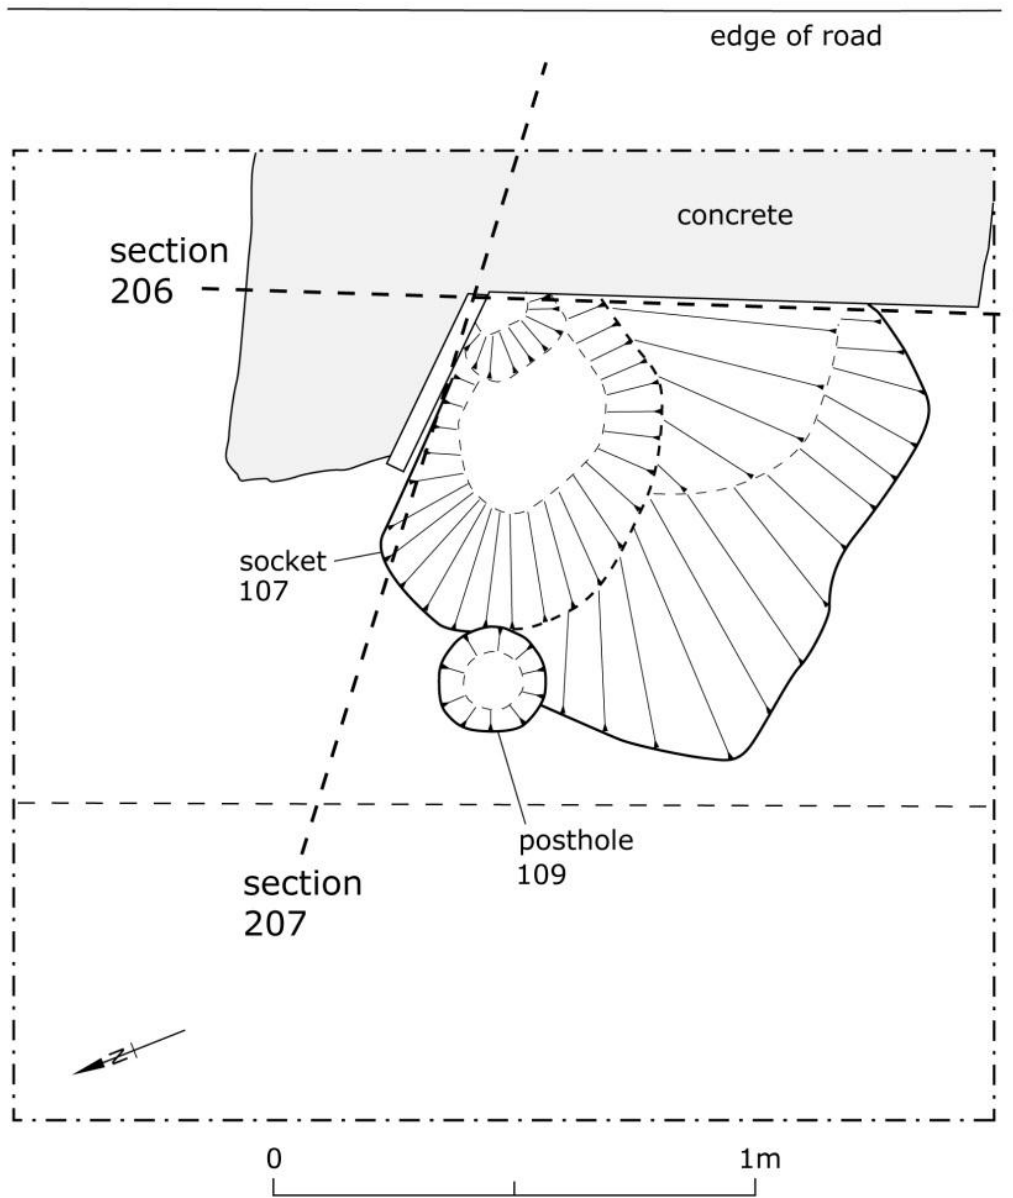
Figure 4. Plan of the stone socket 107.

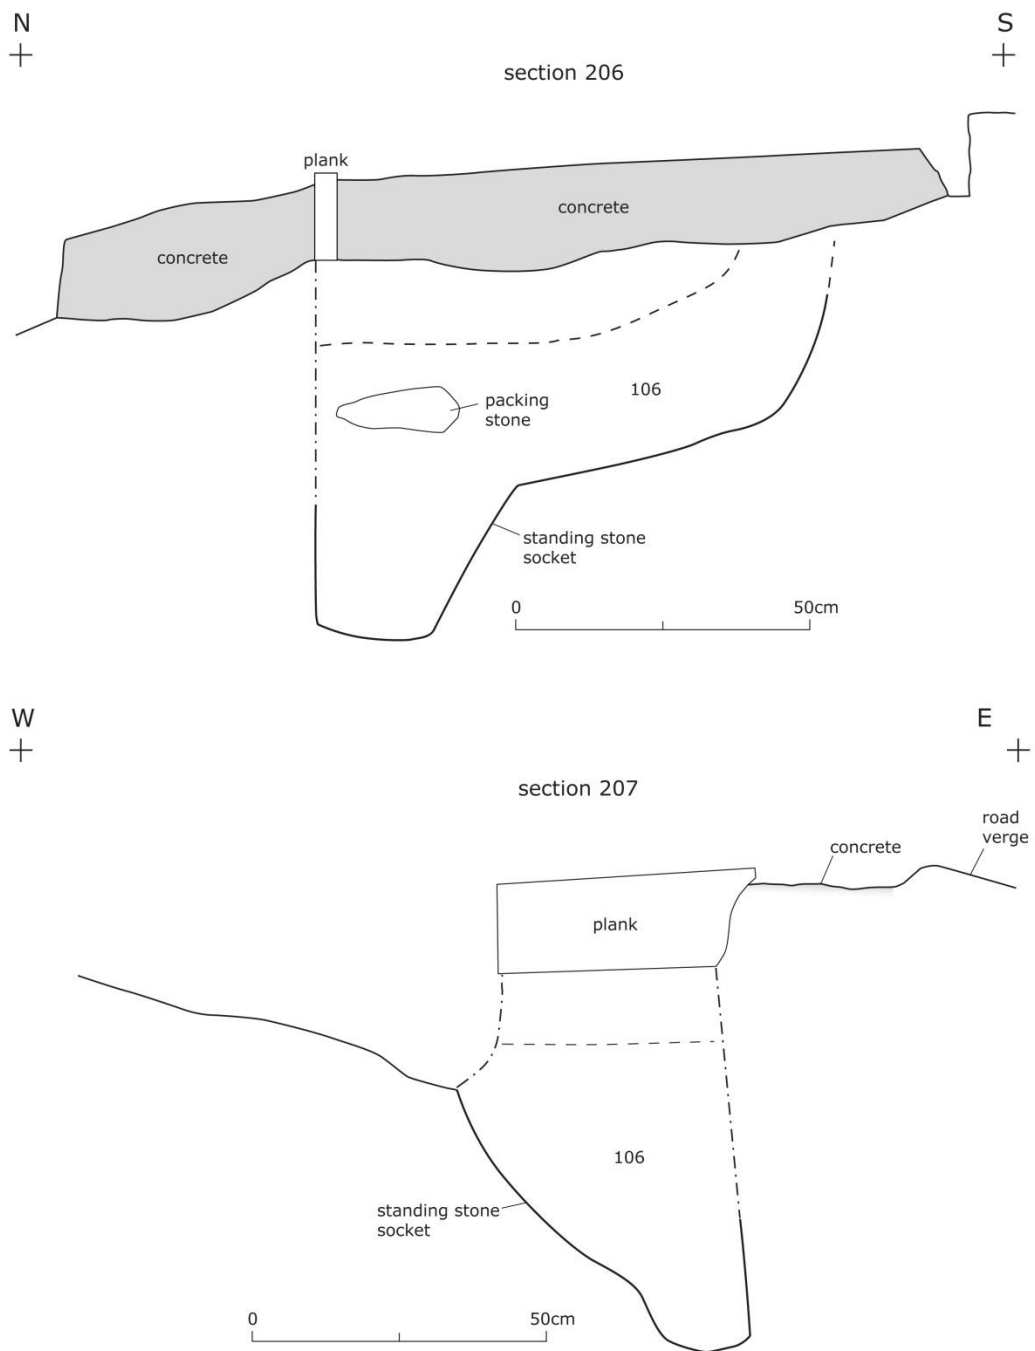
Figure 5. Sections 206, 207 across stone socket 107.

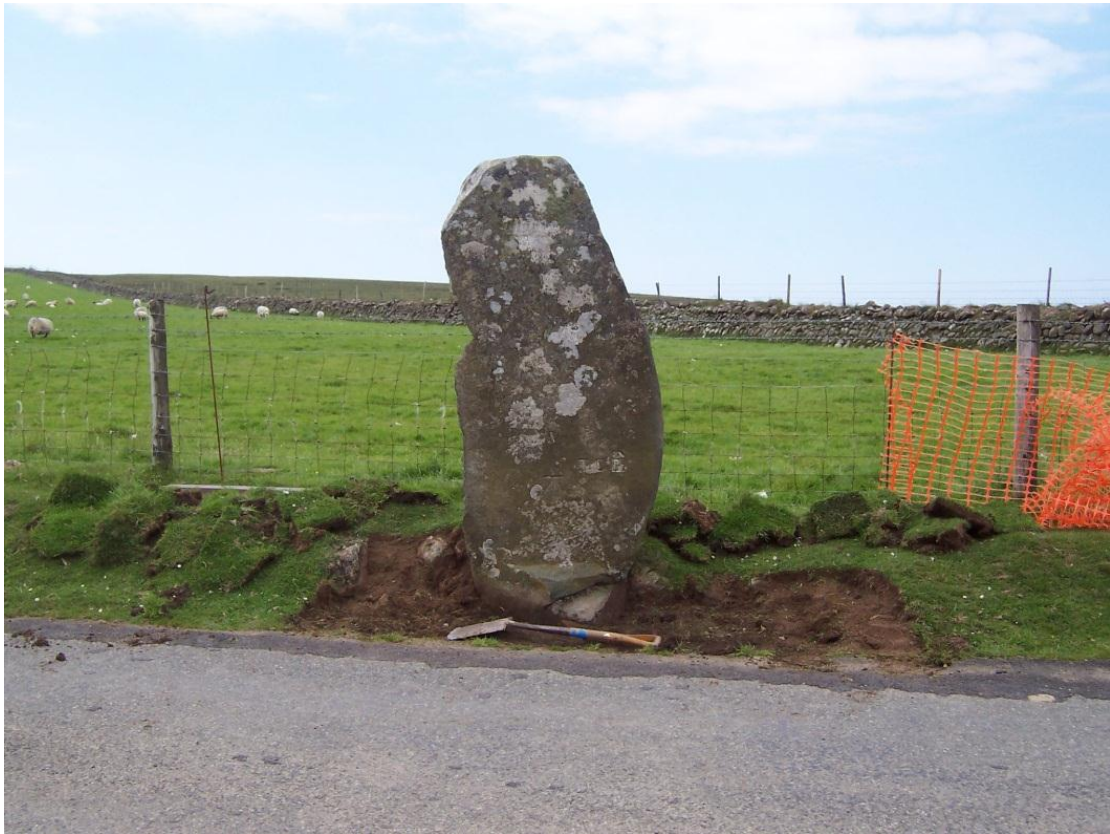
In 2007, graziers reported that the stone had become unstable and raised concerns that it could topple. It was unclear what had caused this to happen, but it was most likely a combination of factors; vibration from vehicles, animals rubbing against it, erosion around the base of the stone, impact from a vehicle. It was decided that stabilisation was required; this was undertaken in June 2007 by Pembrokeshire Coast National Park Authority staff under the supervision of their Archaeologist, Polly Groom (2007). This stabilisation consisted of removing turf and loose material from an eroded hollow between the stone and the road to create a solid surface to build from. This work revealed a crack in the stone. It would seem that the bottom of the stone had been 'squared off'. It was noted that hardcore from the road spread almost to the base of the stone. Beams of recycled plastic were placed against the squared sides of the stone and concrete poured in behind them with the intention of providing a solid buffer and preventing movement of the stone. Earth was then mounded up over the concrete and the turf reinstated.

Photograph 1. Bedd Morris standing stone in 2007 following stabilisation.

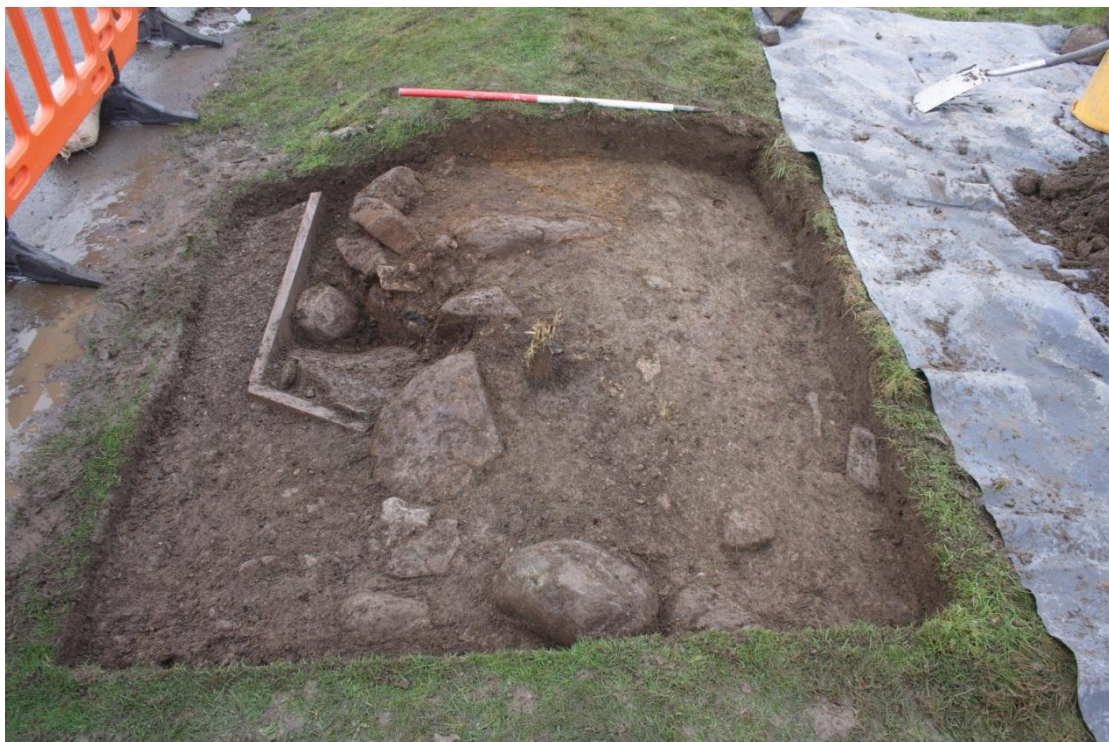
Photograph 2. The site after the removal of topsoil showing the surface of the bank (102) and the in situ base of the standing stone. Scales 1m and 0.5m.

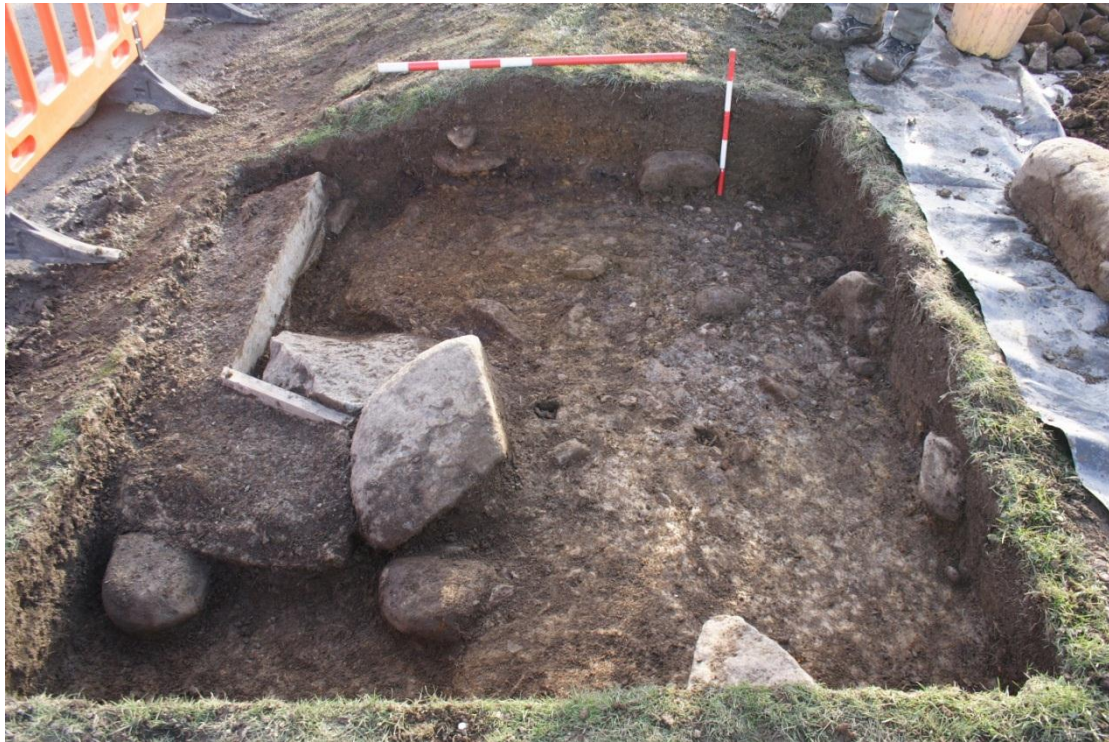
Photograph 3. The *in situ* base of the stone with packing stones and stony surface 104. Note the section through bank 102 at the end of the trench. Scales 1m and 0.5m.

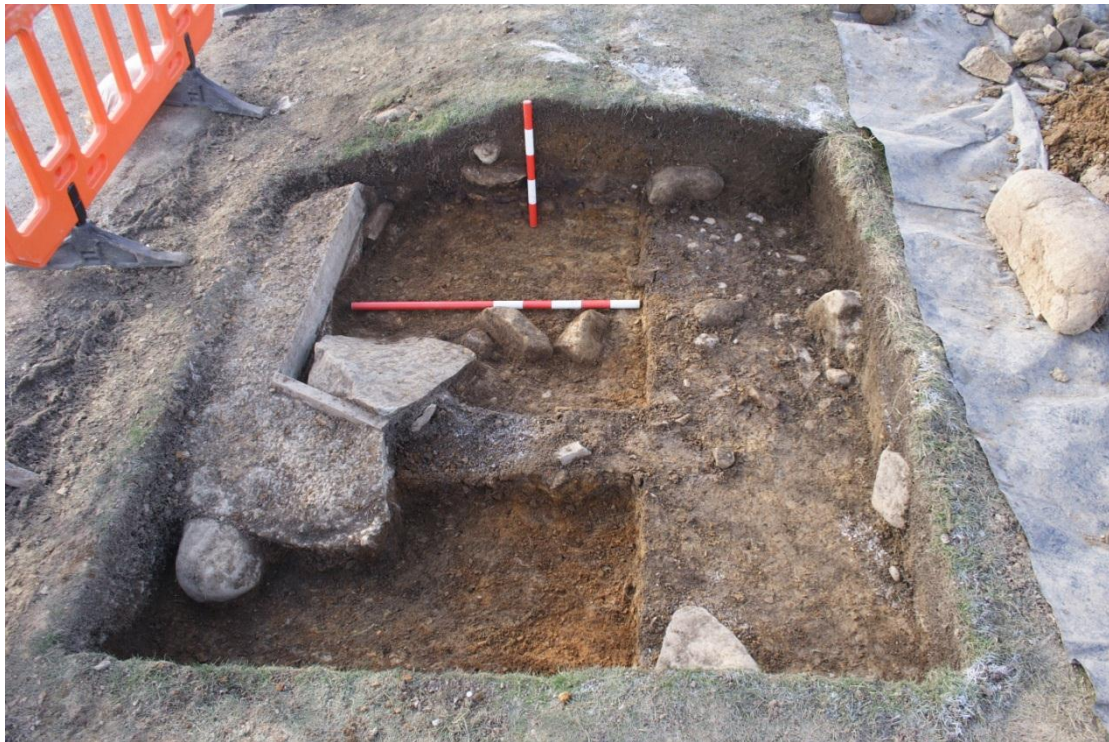
Photograph 4. The *in situ* base of the stone with packing stones and stony surface 104. Scales 1m and 0.5m.

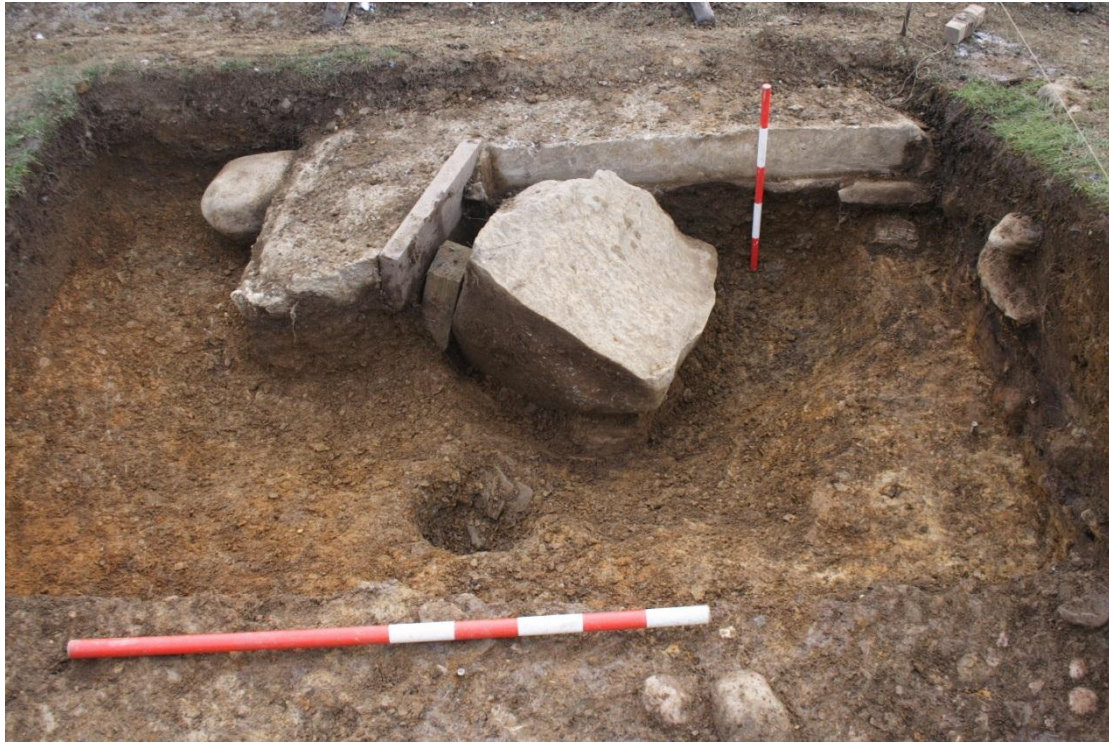
Photograph 5. The *in situ* base of the stone after removal of most of the packing material. Scale 1m and 0.5m.

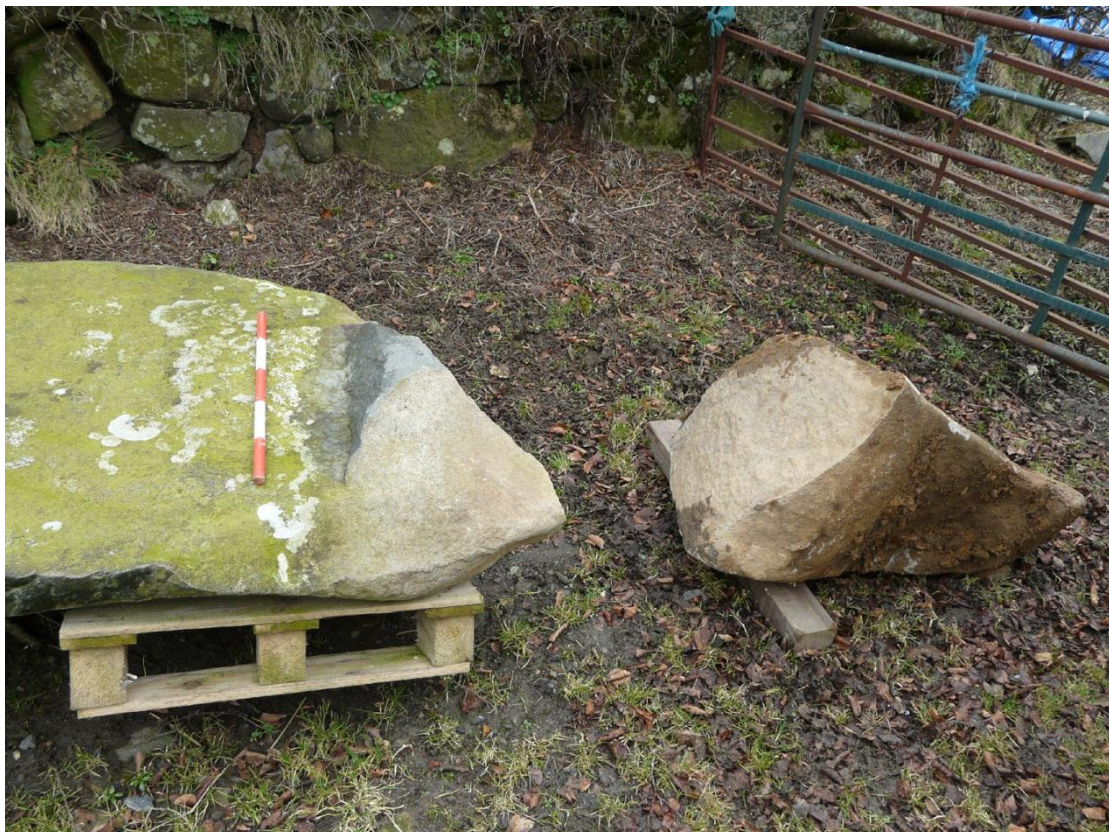
Photograph 6. The base of the standing stone reunited with its upper section.
Photo: Geoff Wainwright.

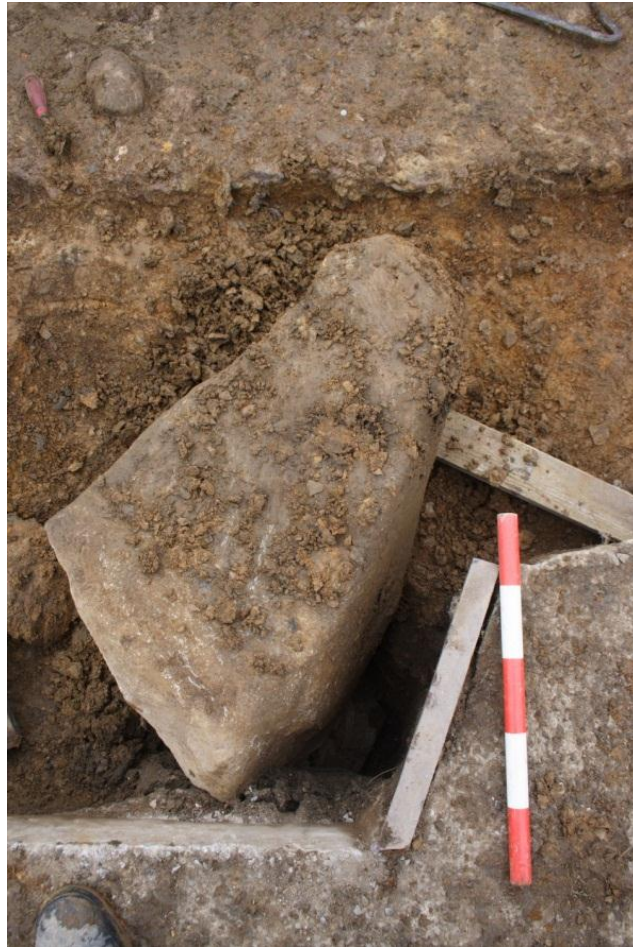
Photograph 7. The base of the standing stone following removal from the socket.
Scale 0.5m. 7871

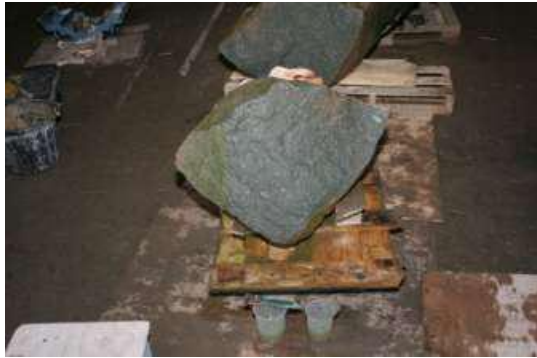
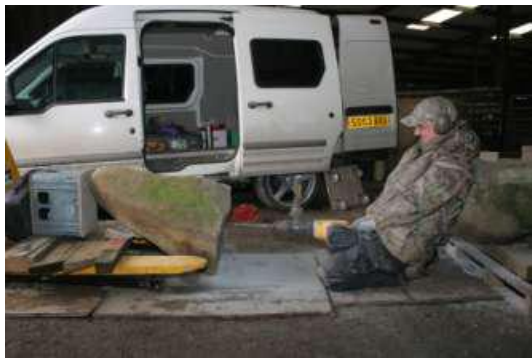
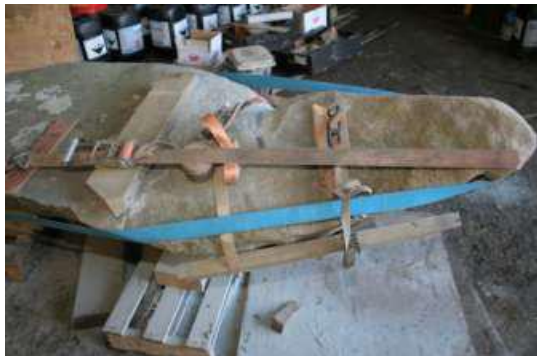
Photographs 13-15. Views of the stone undergoing repair. Photographs: Elliot Ryder Conservation.

Due to the low porosity of the stone, both faces of the fracture were cleaned with de-ionised water and stiff bristle brushes, to remove all biological growth and ensure a good bond with the resin employed. This was carried out using two beakers of constantly changing water so as not to re-distribute biological rich, dirty water. Surfaces were dried with paper towelling but very little water had penetrated due to the low porosity of the material.

The larger section was chocked up with flat timbers and folding wedges so in a largely flat horizontal plane. The smaller section was offered up and lines denoting horizontal and vertical planes marked on the surfaces with chalk, to facilitate drilling straight, deep holes.

Two opposing horizontal holes were drilled roughly in the centre of the block to a depth of 460mm each side, with a 30mm diameter tungsten drill bit. Both holes were de-dusted to depth with the aid of a bottle brush and hand pump. A single stainless-steel, threaded dowel 20mm in diameter and 860mm in length was inserted into the large stone section and the smaller section offered up dry to ensure a 'natural' fit, which was achieved first time.

A two part external quality, pure epoxy resin 'HPE 385' (from VJ Technology, Ashford, KENT) was injected into both pre-drilled holes, smeared around the dowel and applied to both break edges, making sure to keep resin back from the outer perimeter. The small section was offered up to the larger section and manoeuvred into its final 'natural' position with the aid of crow-bars and ratchet straps. The small section was then chocked into position with folding wedges. The ratchet straps were left on overnight to assist with alignment during curing and contain any potential movement during transportation the following day.

Two diagonally opposing holes 12mm in diameter were drilled close to the central vertical dowel. These were drilled such that the entry point was drilled up into the block, so any moisture ingress (when back in the ground) has to migrate upwards and were positioned so that the line where the dowels cross or converge was at the horizontal fracture site, making for a stronger bond, even though the join would eventually be under compression.

The same pure epoxy resin was injected up into the two holes and two lengths of stainless-steel 'Helibar' both 640mm long and 8mm in diameter were hammered into position. 'Helibar' is flexible and helical in shape and is designed for repairing horizontal subsidence cracks and dealing with shear forces. It was hammered into position due to the volume of resin in the holes, which it relies upon to produce a solid bond once the resin has cured. The 'Helibar' was kept back 20mm from the surface of the stone and a plug of mortar comprising of the stone-dust drillings mixed into a thixotropic paste with the epoxy resin was applied to the drill entry hole to prevent the ingress of moisture. Although the resin cures in low temperatures the join was covered with a blanket and left overnight to ensure a strong bond, as the barn, although dry, was subject to external temperatures.

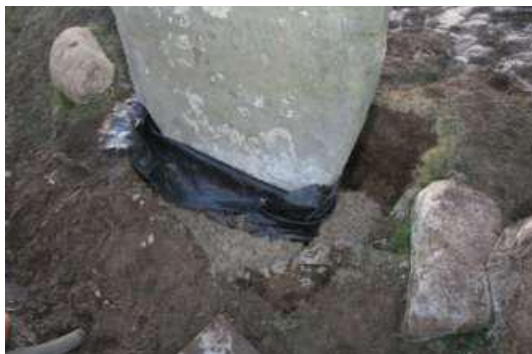
Photograph 16. General view of the stone replaced in the socket with geotextile acting as a separation layer between limecrete and the stone. The limecrete ring was the third of five overall layers, securing the stone firmly in position. Excess geotextile was removed before the turf was re-laid. Photographs: Elliot Ryder Conservation.

Large stones that had been excavated from the hole originally were re-positioned in the hole around the base of the slab, so as to have tight contact with the slab. These were built up in a ring around the slab and tamped into position with a punner such that they were forced into the soil and provided a solid layer. Clean stone scalpings were then put in to fill the interstices between the large stones, before a layer of scalpings 75 – 100mm thick were put on top and also tamped into position. A layer of water permeable 'Terram' was applied to cover the surface of the stone slab and act as an intervention layer between the limecrete before a layer of limecrete 100 – 150mm thick was applied. This was a 2.5 : 1 , 'all-in' concrete ballast (provided by the National Parks team) and Natural Hydraulic Lime (NHL 3) mixed with clean water. This provided a ring around the slab and was also tamped into position, before another thick layer of scalpings and finally the original cut turf squares.

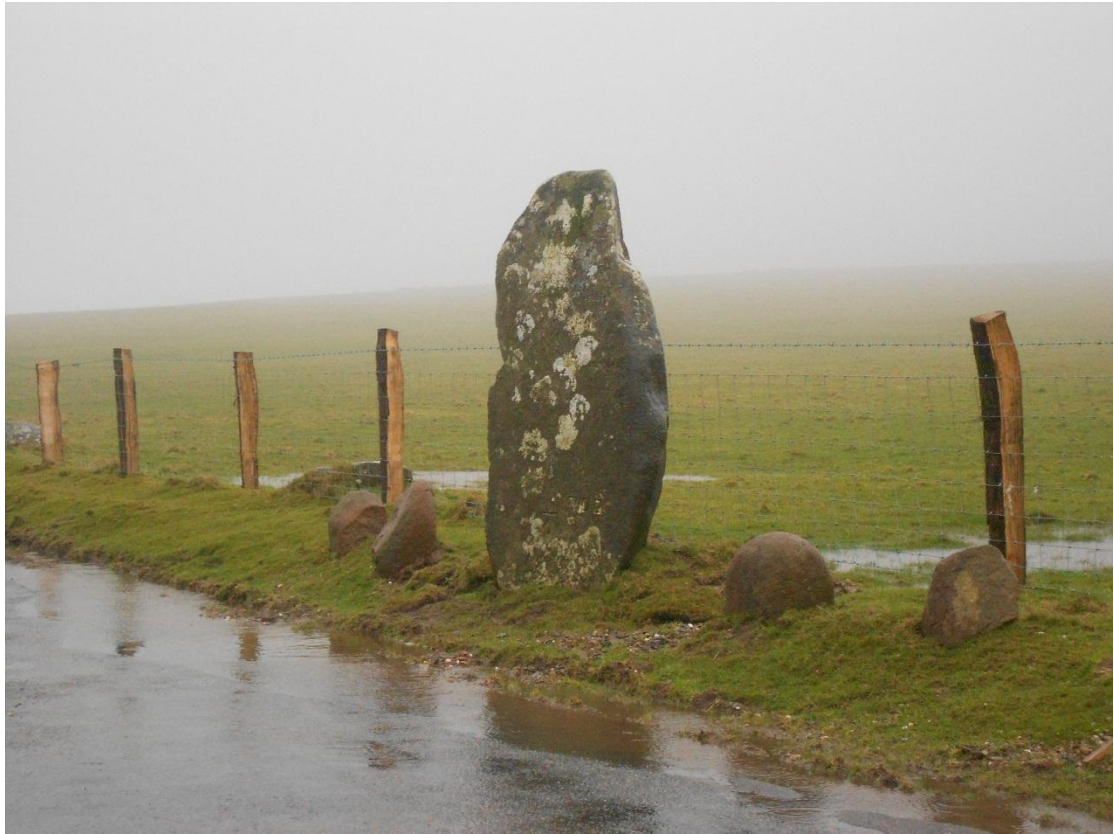
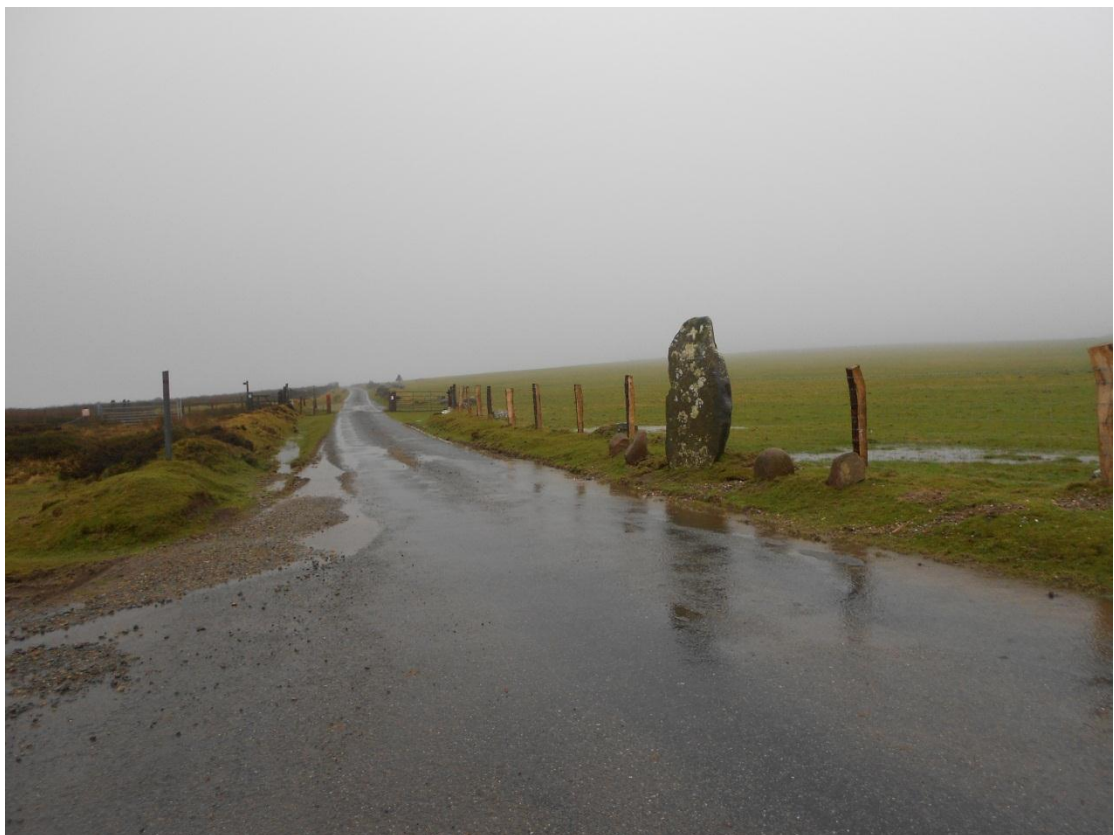
Photographs 17 and 18. Two views of the re-erected stone, February 2013.
