St. Winefride's Well, Holywell

An assessment of surviving decoration

June 2009

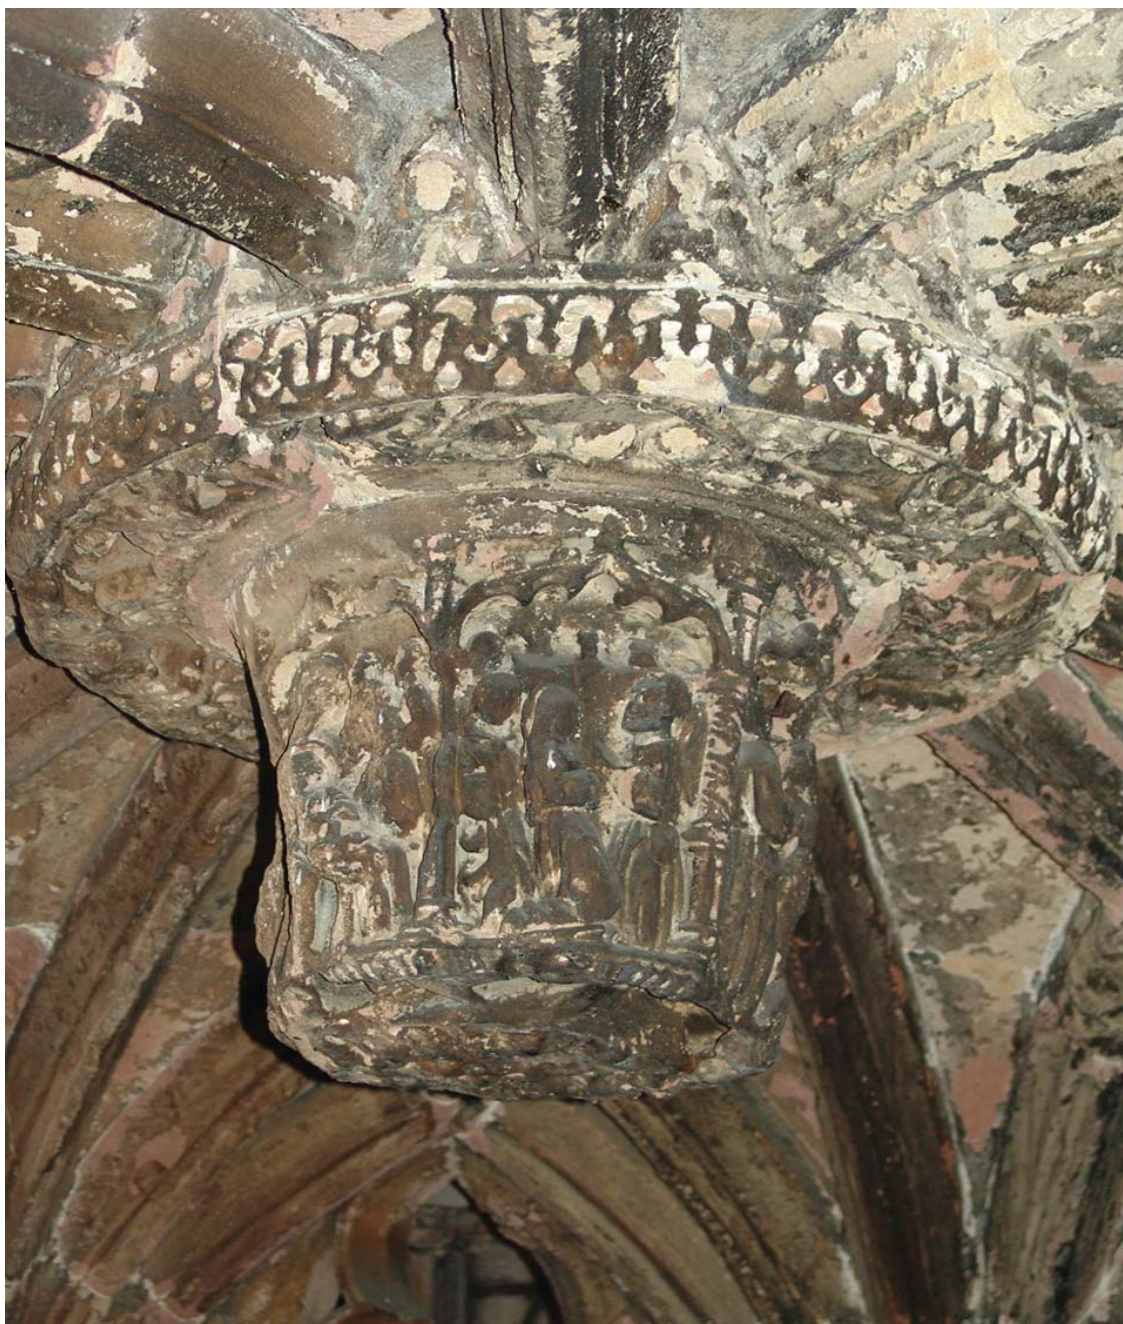
Plate 3 (above). The central boss, showing current condition.

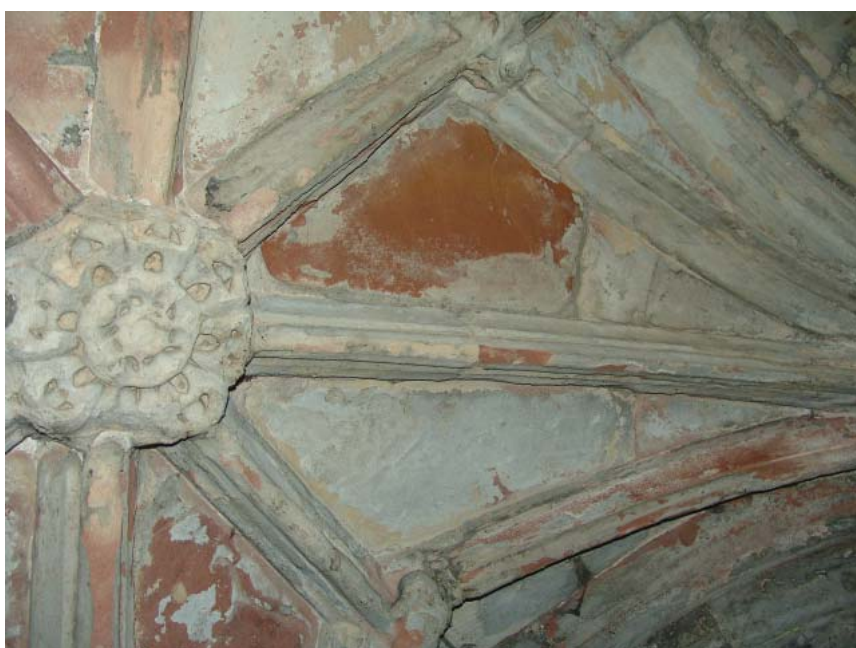
Plate 4 (left). General view showing characteristic condition of vault: flaking limewash layers; disaggregation of stone support; and dust and other surface accretions.

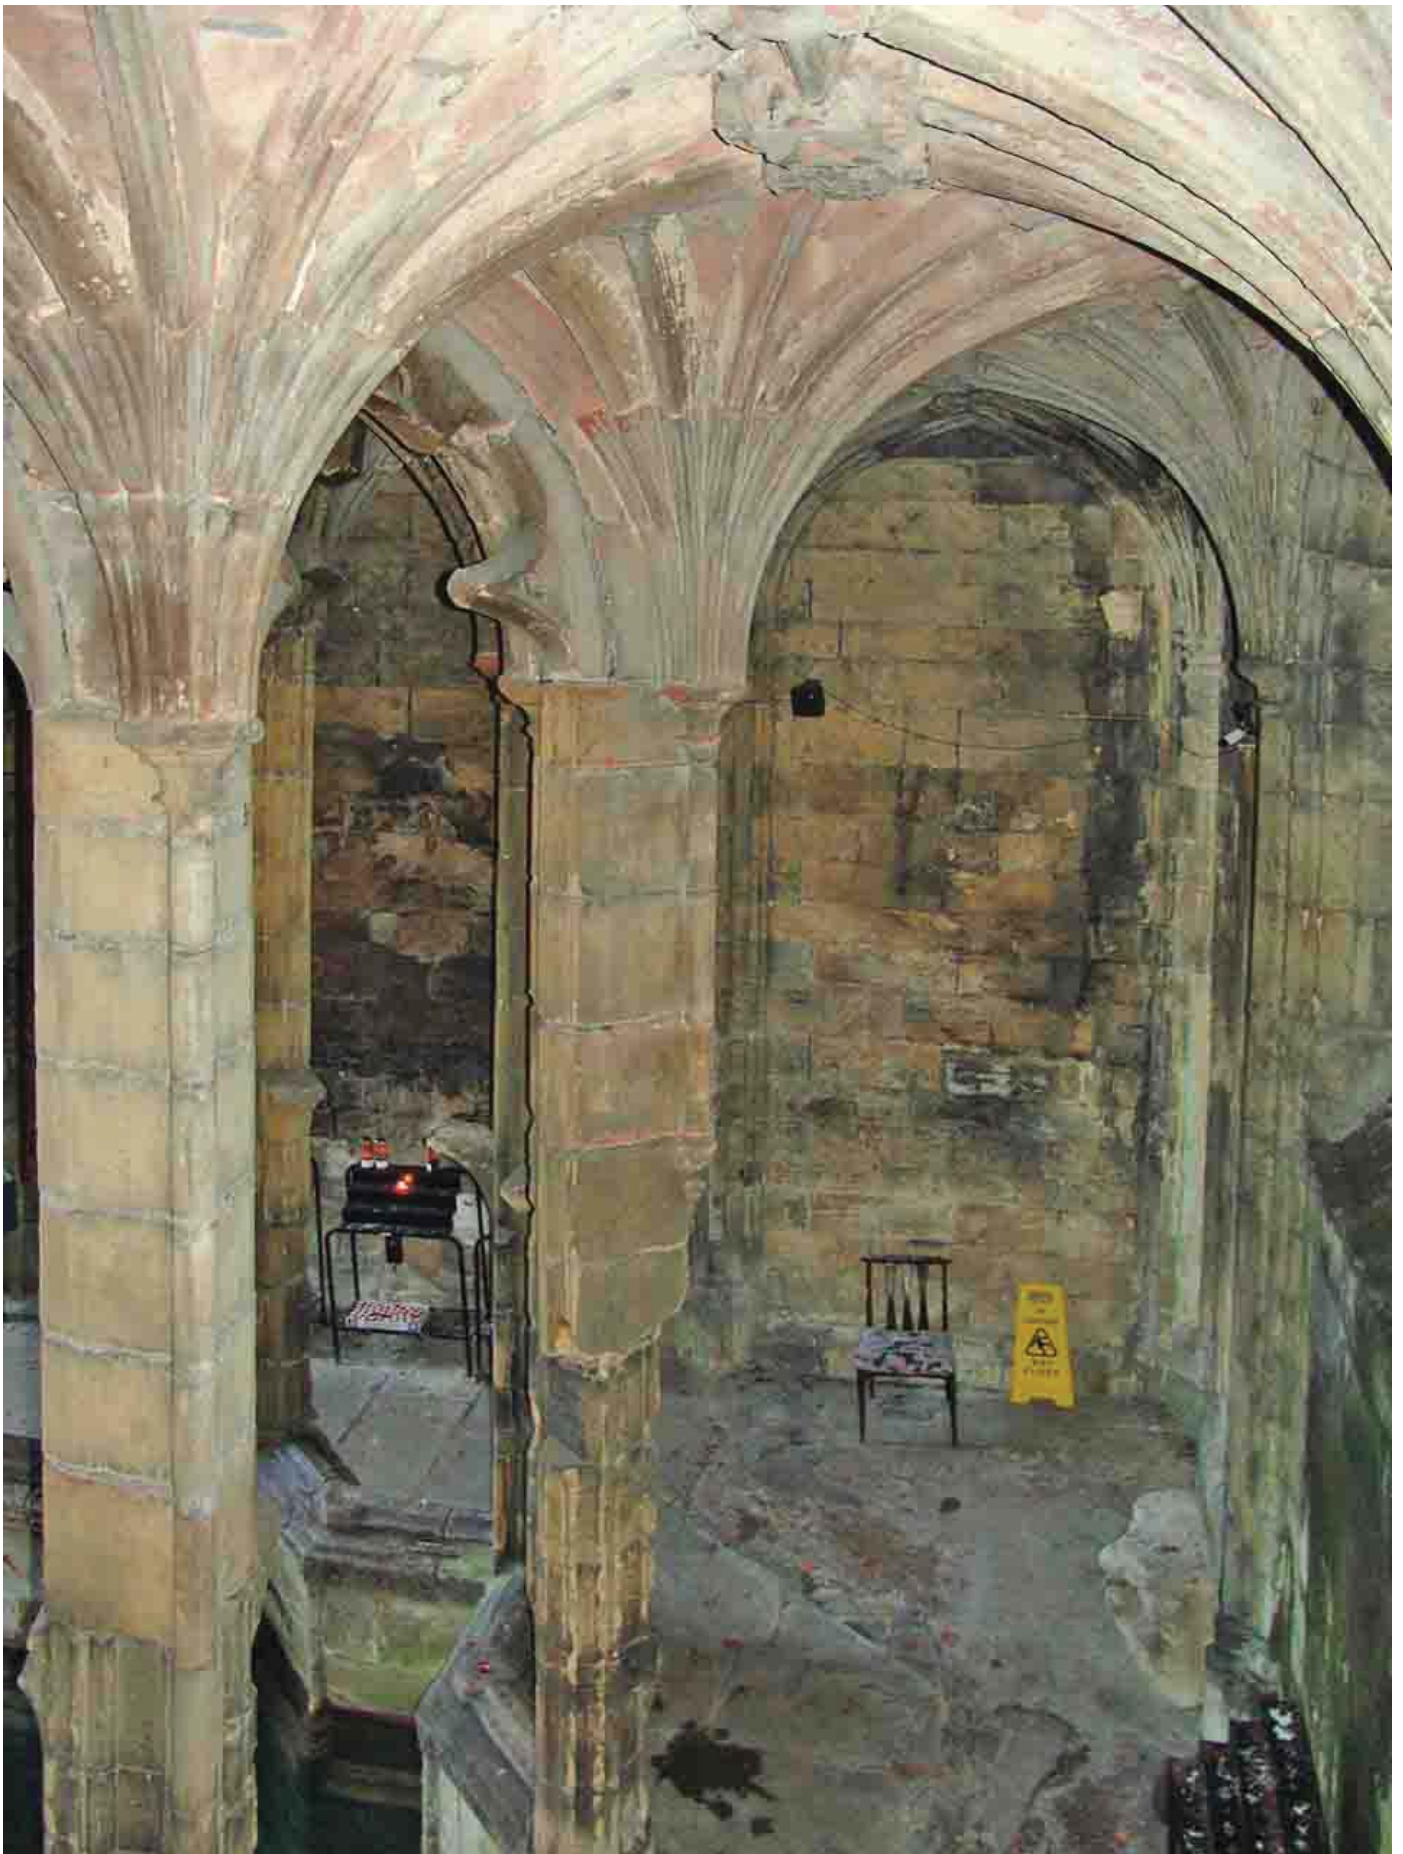
The interior of the building is essentially exposed to external environmental conditions. In addition there is also an ongoing problem with the infiltration of water through the stonework beneath the window on the south side of the main body of the building, which has clearly caused extensive biodeterioration (as mentioned above). It is understood that this window was blocked comparatively recently. Environmental monitoring was therefore initiated by Odgers Conservation, and samples of the stone as well as salt activity also undertaken.

Plate 5 (above). General view to the rear of the chamber, showing current condition: mould resulting from excess moisture infiltration, graffiti and other surface damage as well as extensive surface dust and other accretions.

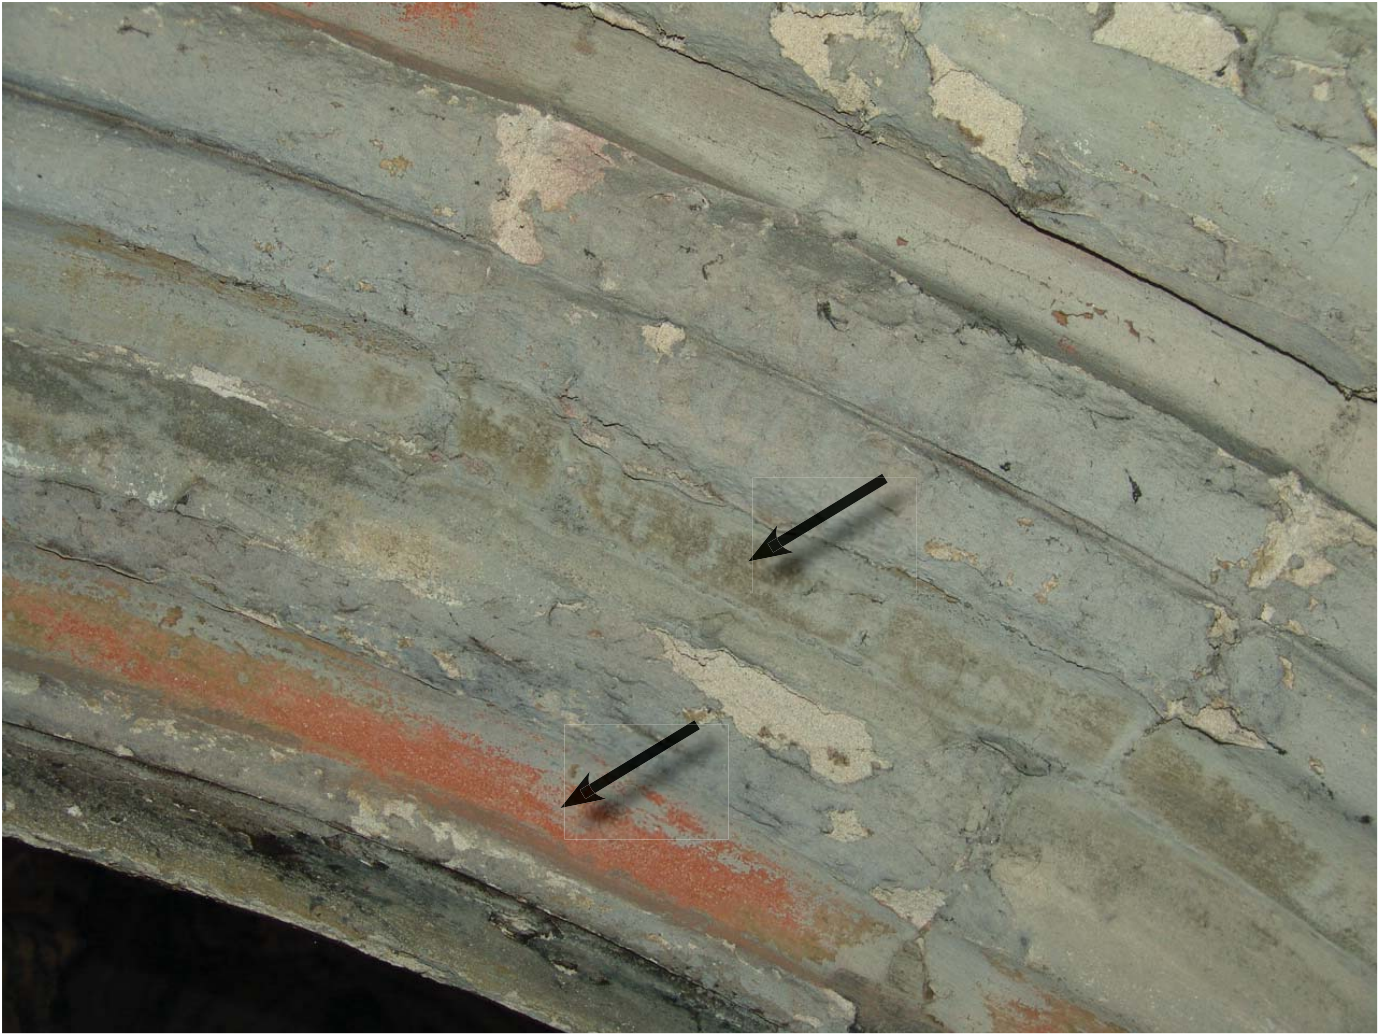
In addition, in cross-section the simple alternating scheme of green and red banding within the ribs of the narthex clearly shows multiple underlying white limewash layers. Such evidence strongly suggests that this is a later scheme of decoration, composed of simple repetitive motifs.

Plate 6 (above). Pigment can be noted defining the ribs of the inner narthex arcade - here red and green. These colours both overlay earlier whitewash layers, but also themselves covered by later decorative coatings now much disfigured by dust and other accretions, that today read as a grey layer.

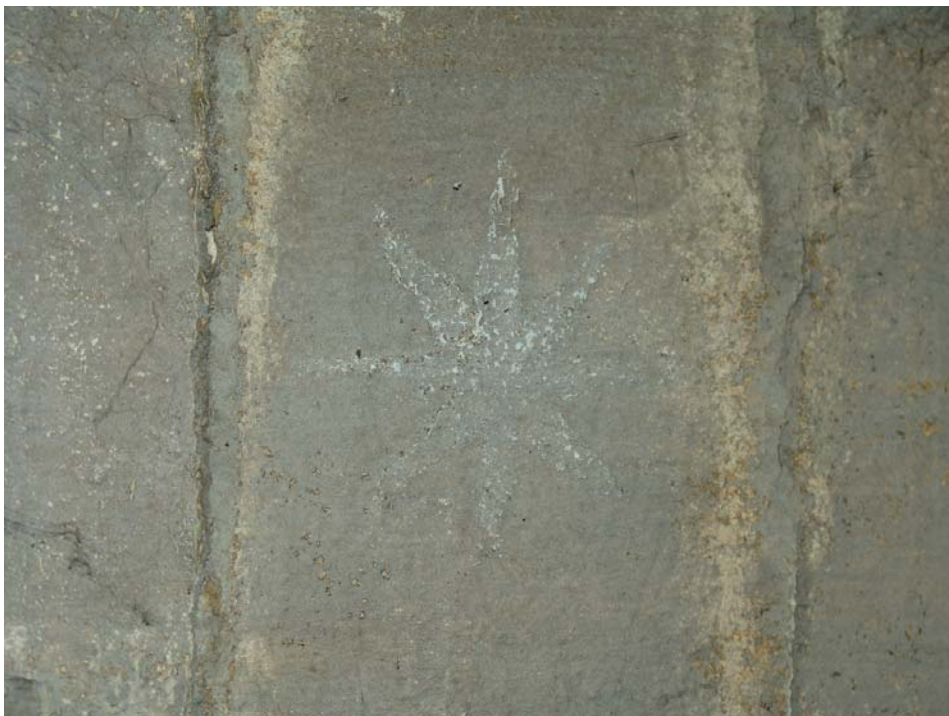
Plate 7 (below). A star motif within the vault area of the narthex was noted, the date of which is unknown. The inclusion of this rather more elaborate use of colour banding and star motifs accords with the significance of the entry portal into the well itself. No such elaboration was found elsewhere within the vault of either the ambulatory or choir.

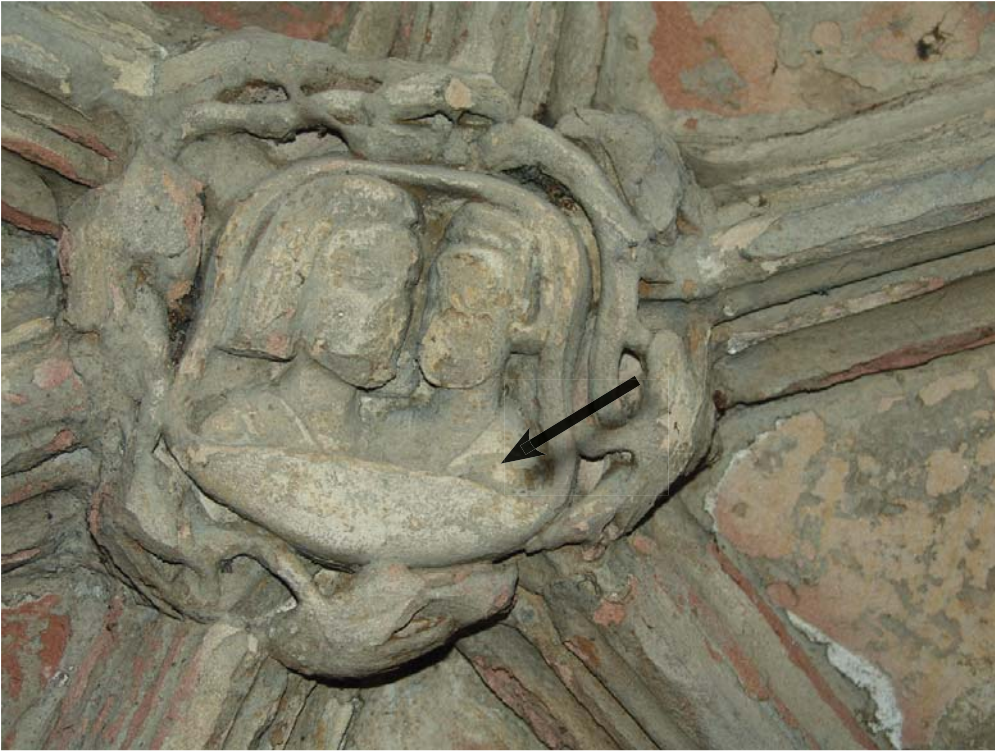
Plate 8 (above). Evidence for a green pigment was noted across a number of different areas of the vault - here within boss 63 CB N.

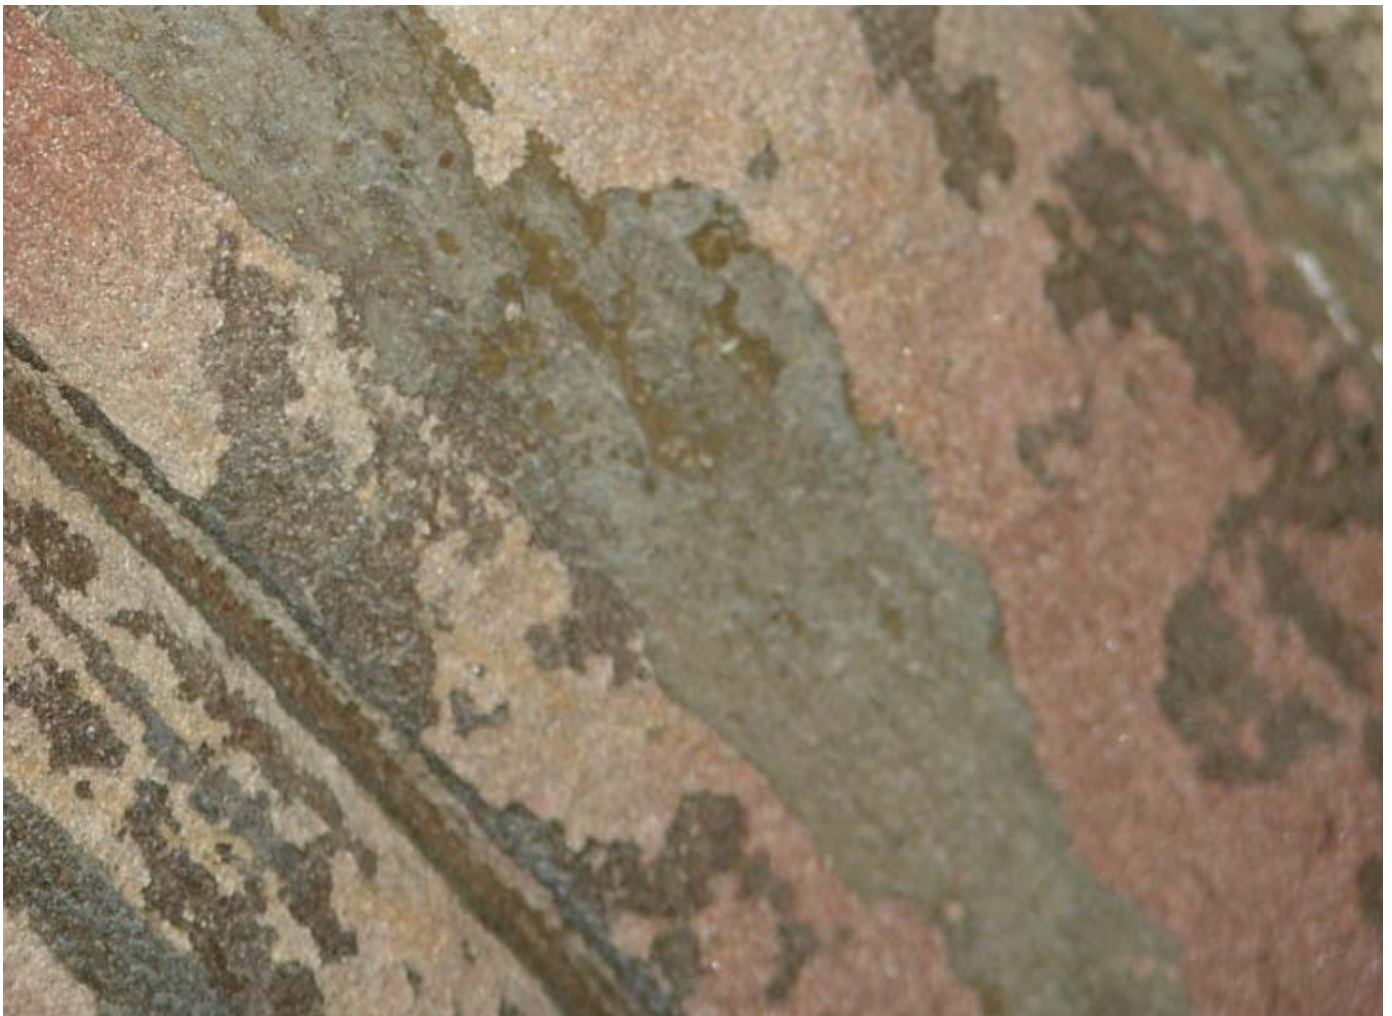
Plate 9 (below). Detail of this pigment occurring within the ribs of the vault.

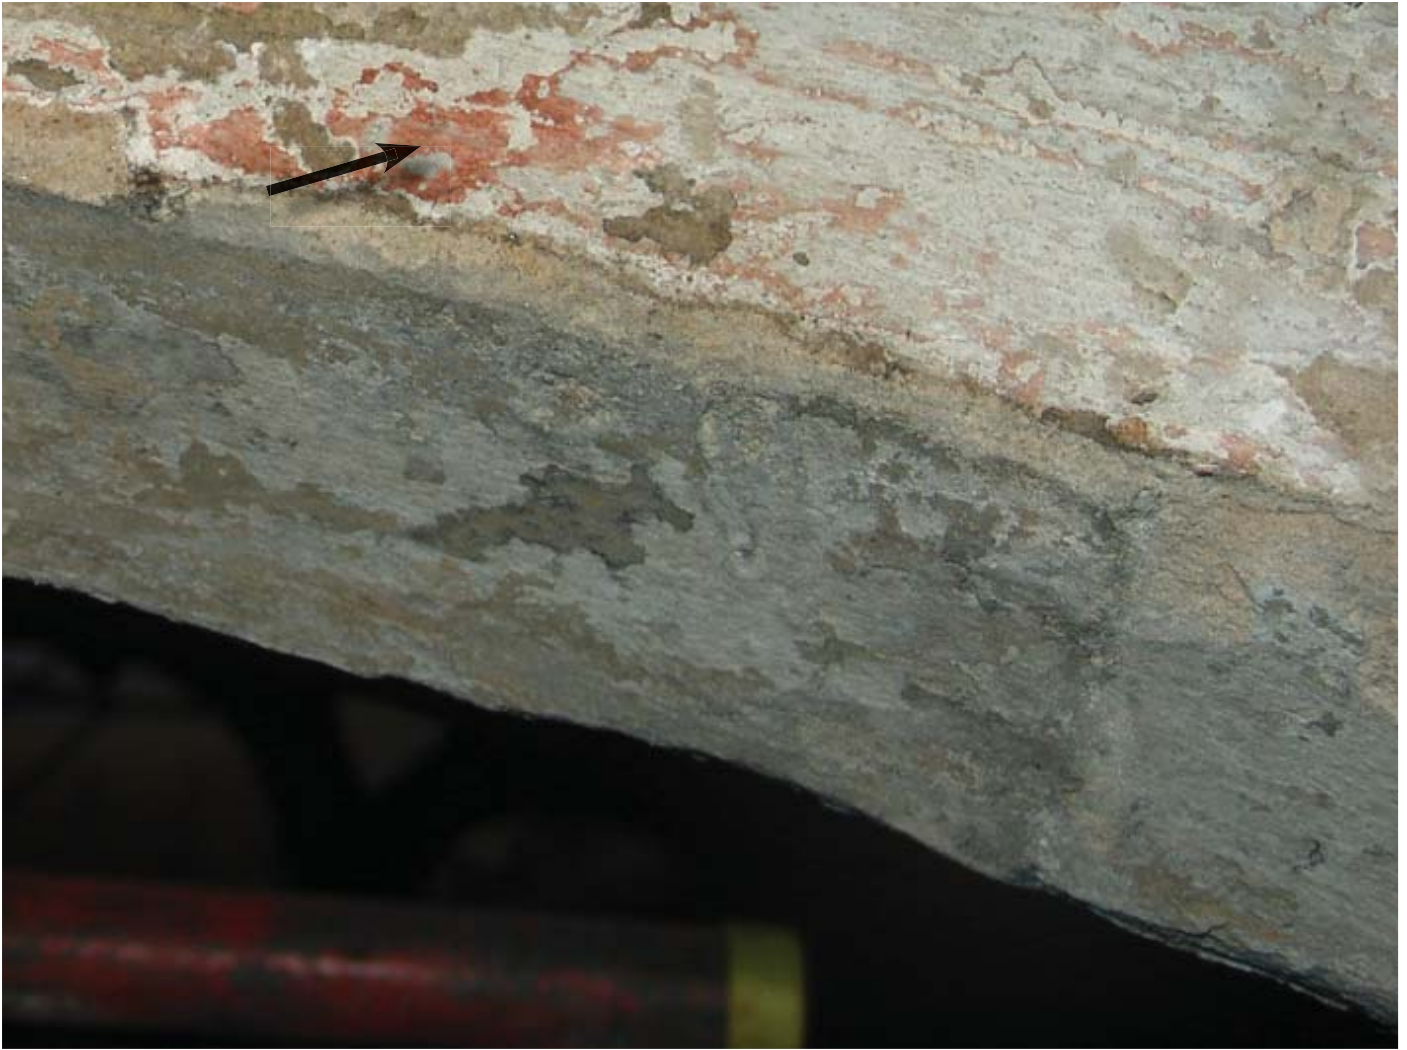
Plate 10 (above). Red pigment was found in small isolated areas across the vault, although as the cross-section analysis proves this has been applied over a number of white layers, suggesting it is of a later date.

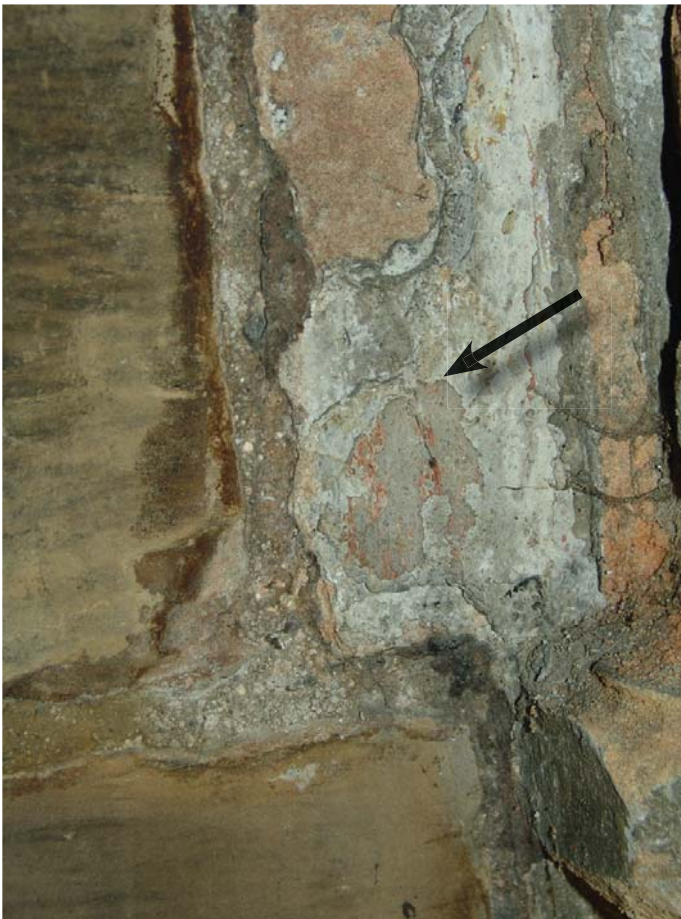
Plate 11 (below). Further example of a red pigment applied over multiple underlying white wash layers.

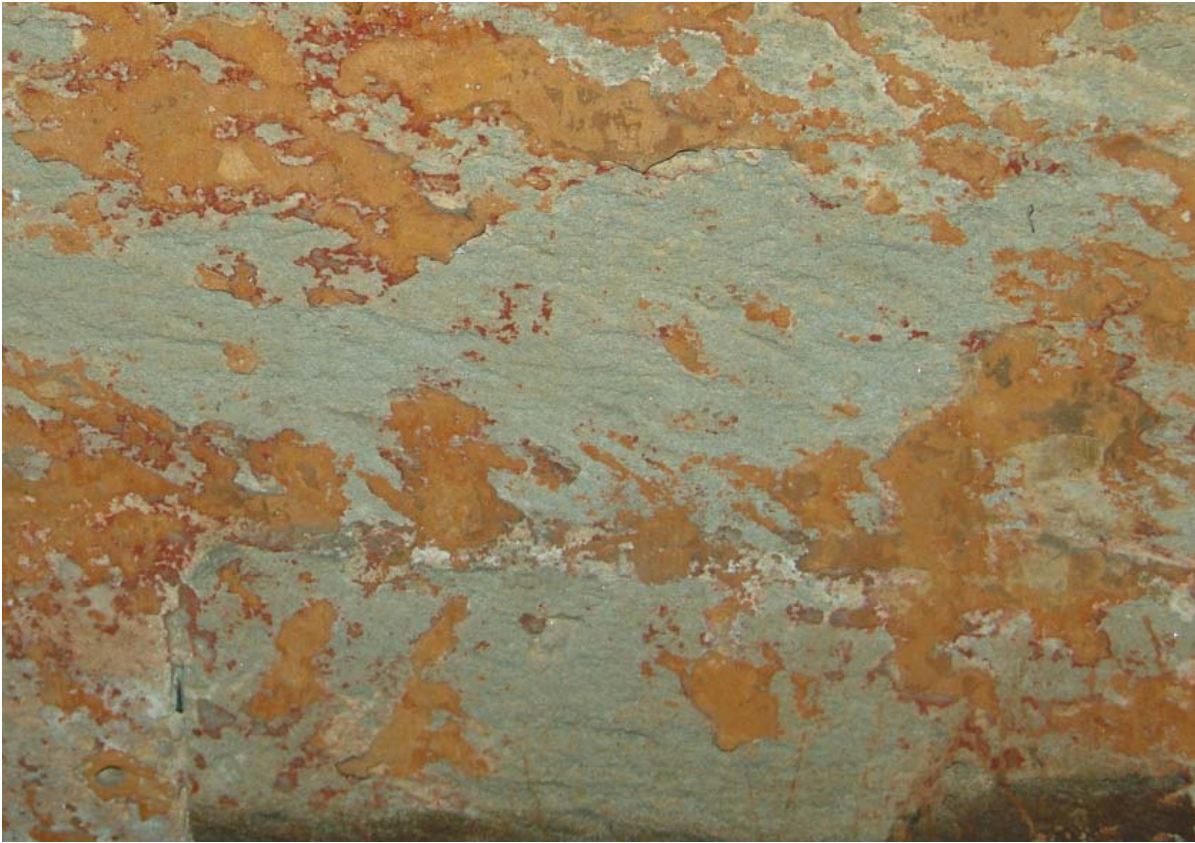
Plate 12 (above). In the choir, a yellow pigment over red was noted on a wall surface. Since red oxide is known to have been used as a traditional preparatory layer on stone, this could account for its use here, rather than necessarily a separate and specific decorative scheme. Again, the date unknown.

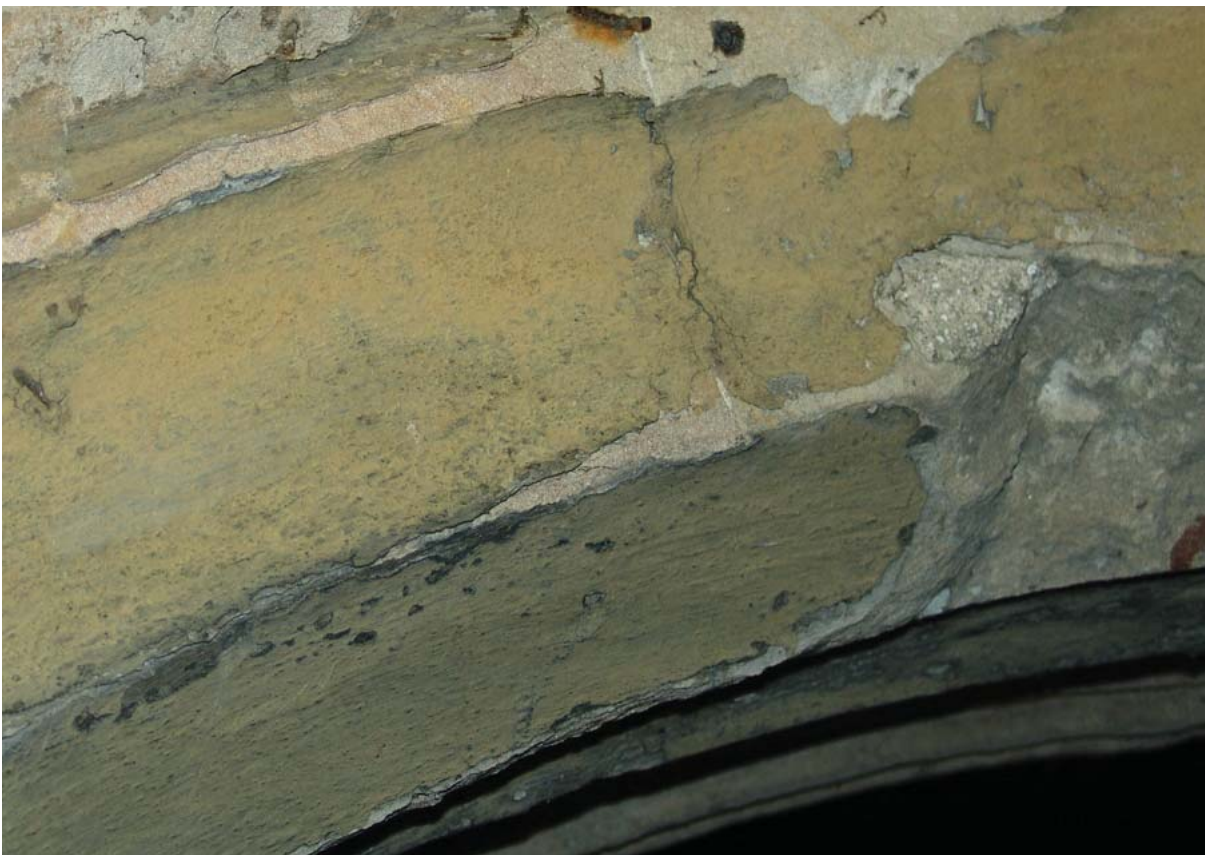
Plate 13 (below). This paint layer was noted within the ribs of the narthex. This paint layer was noted. It is not considered to be of any particular historical merit, but rather represents perhaps the most recent campaign of a whole series of previous re-decorations.

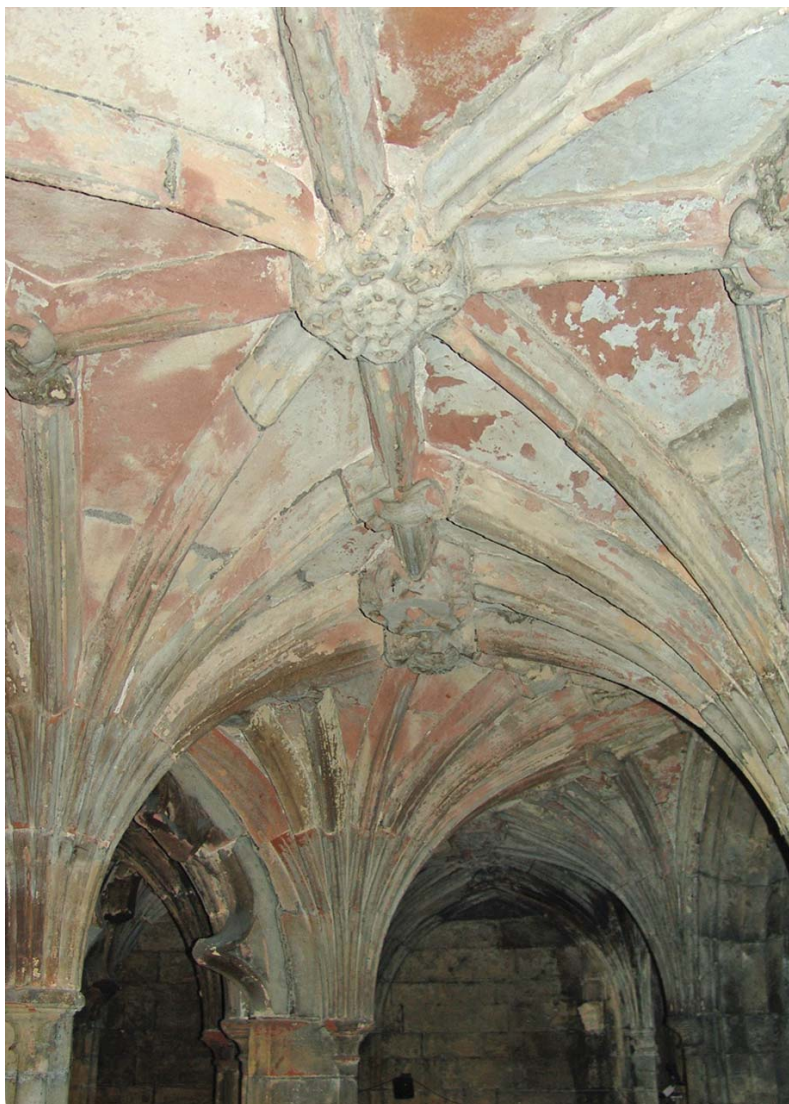
Plate 14 (above). Surface erosion of the stone boss and past overlying paint layers can be noted here.

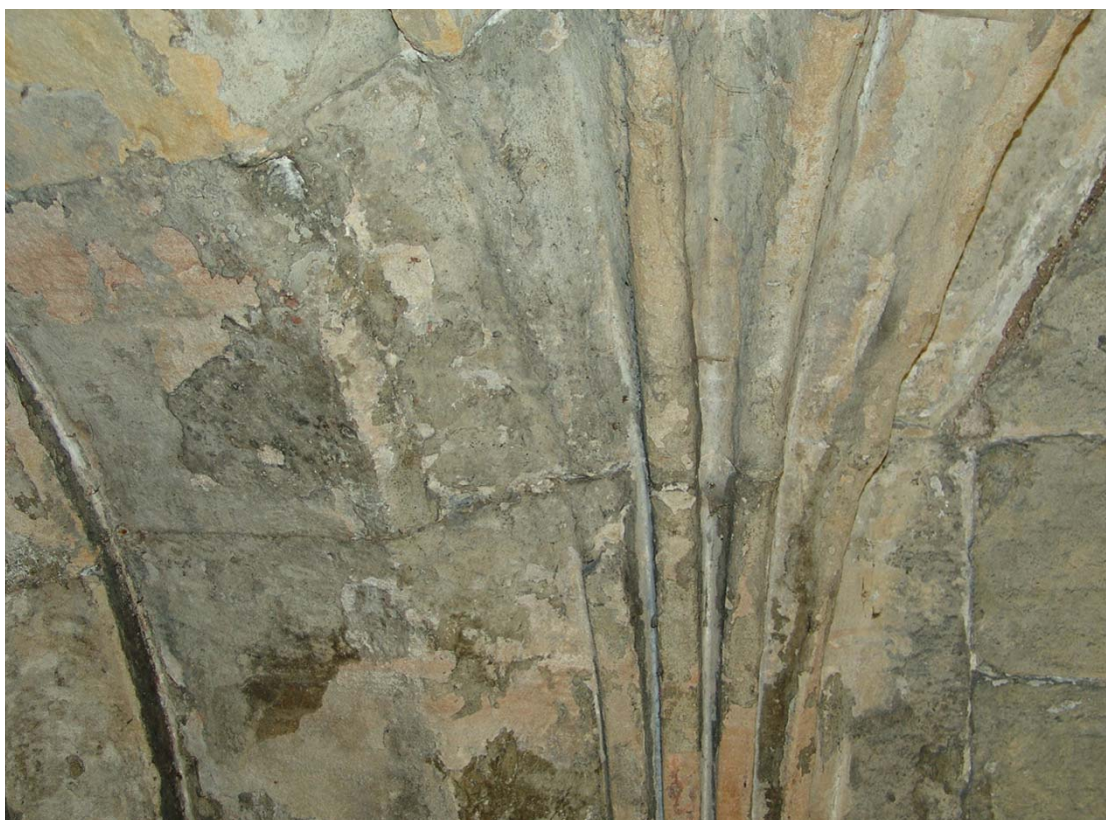
Plate 16 (below). Typical example of the palimpsest of multiple applied limewash layers evident across many areas of the vault.

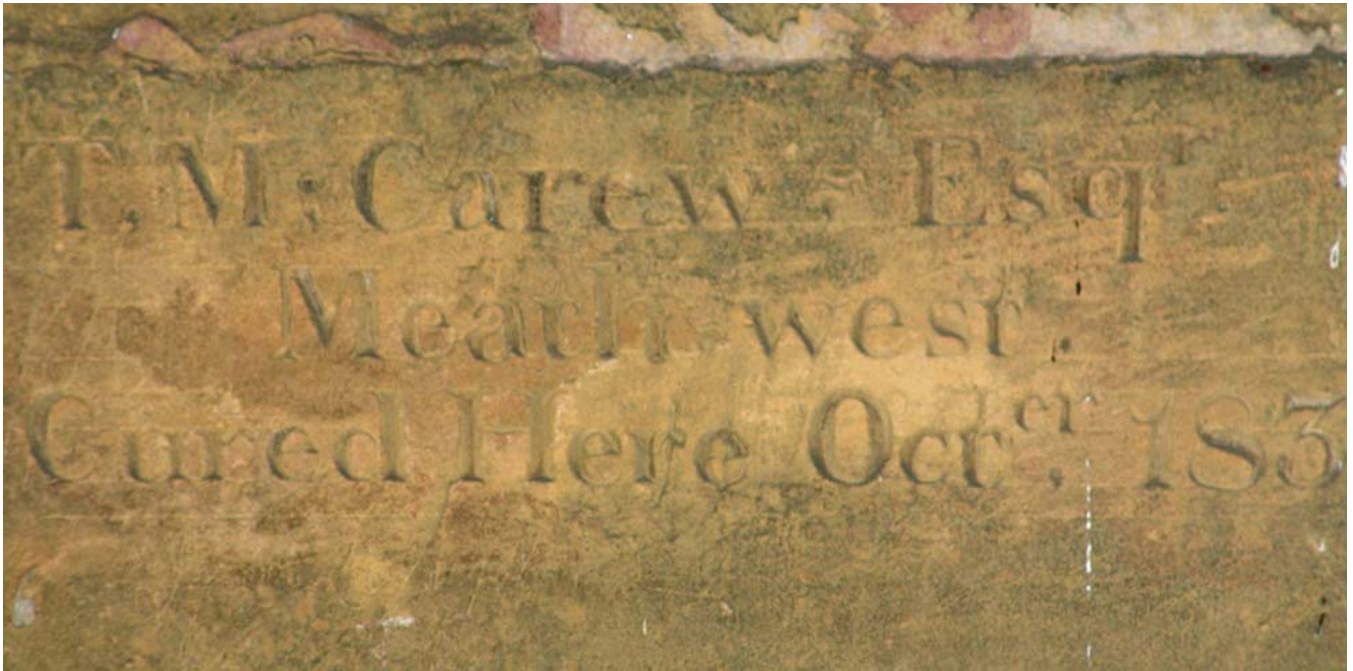
Plate 17 (above). Certain graffiti has a genuine historic interest.

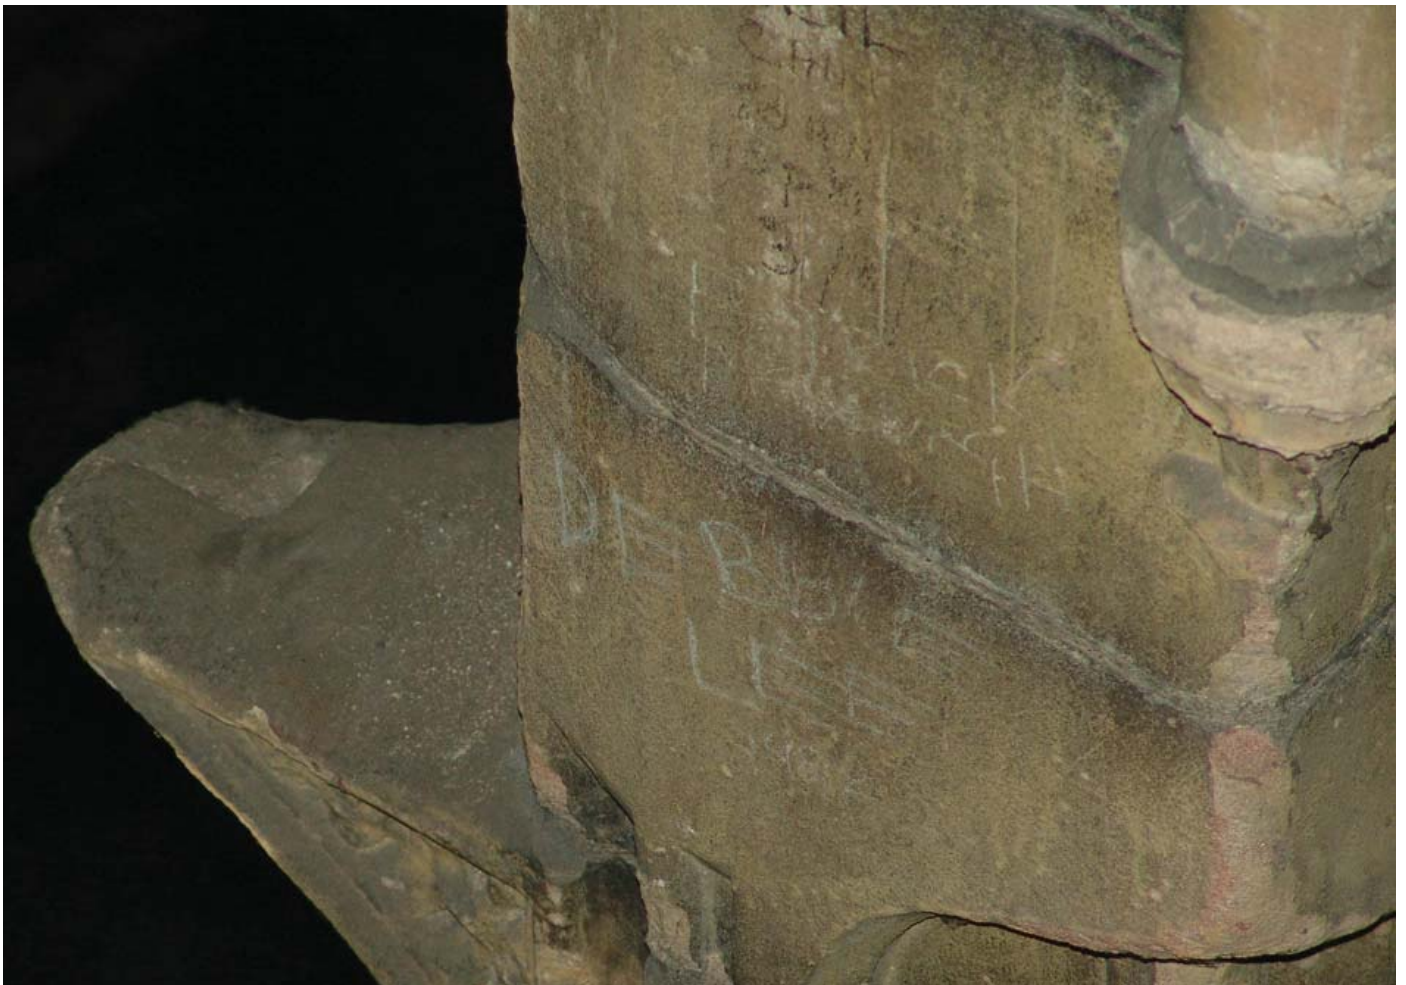
Plate 18 (below). In contrast, much modern graffiti is devoid of any socio-historic interest and is visually disruptive.

- testing to assess the possibility of reducing the most visually disruptive graffiti, as well as instigating better means to control this current and active problem.

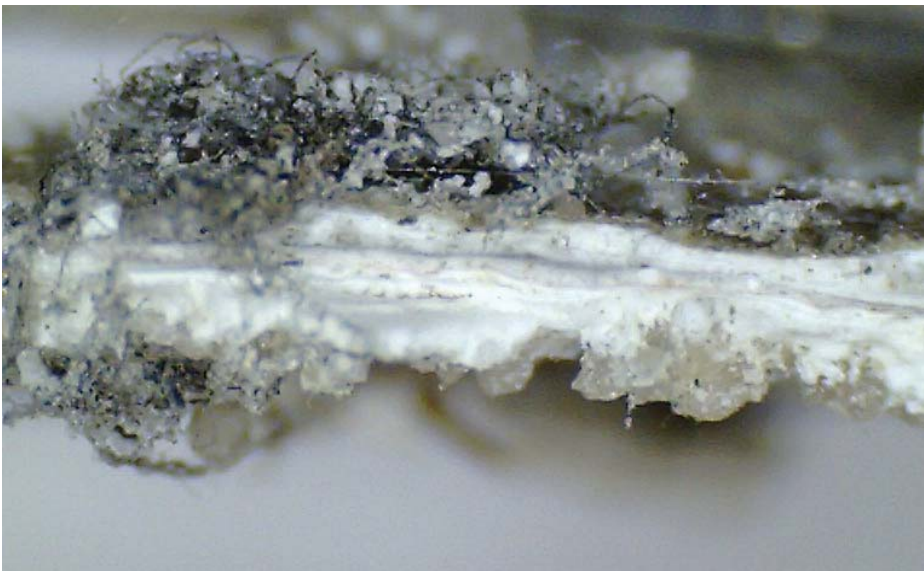
Figure 2. Sample 1. Stratigraphy in cross-section at x 200 magnification shows surface accumulations of microbiological fungal hyphae; soot and dust particles; salt crystals; and up to 6 limewash layers; and stone support.

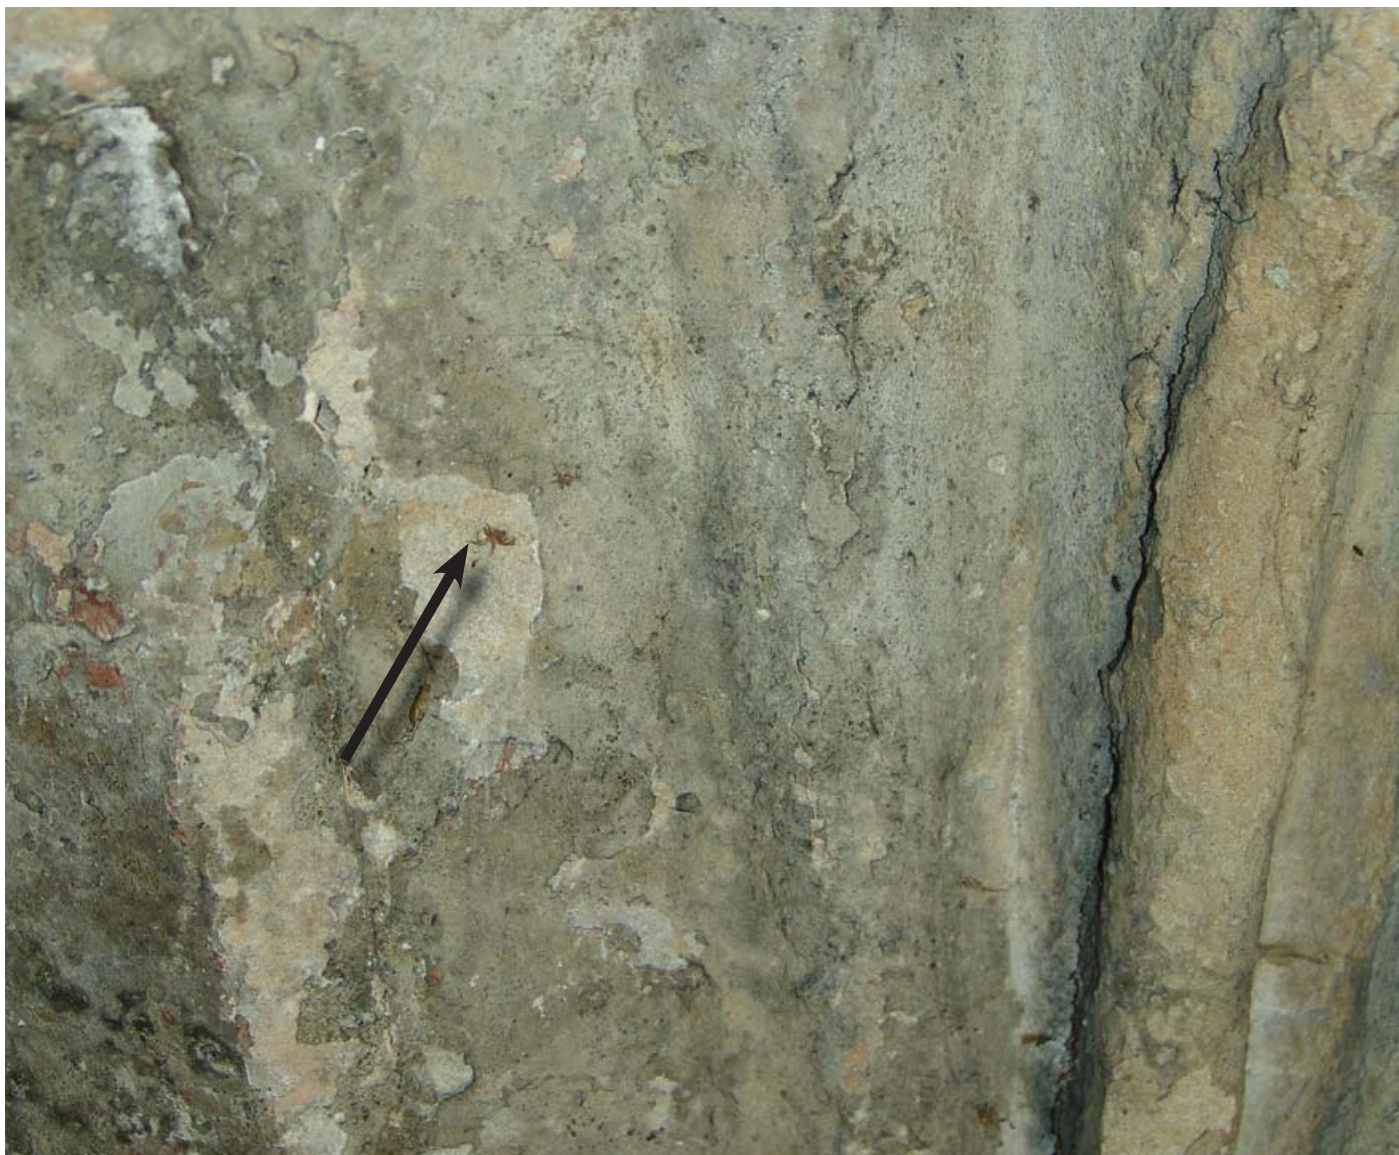
Figure 3. Sample site 2. Area of south wall of upper choir showing typical distribution of fragmentary limewash layers interleaved between dirt layers.

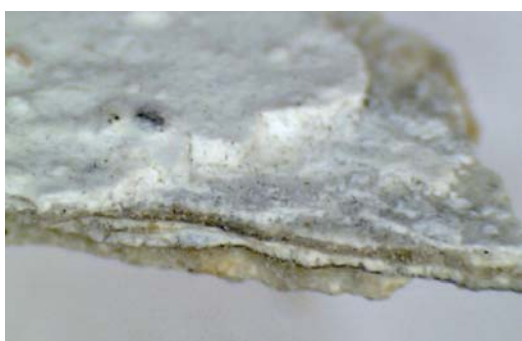
Figure 4. Sample 2. Overlying limewash layers of varying thickness, interleaved between dirt layers. (x 200 magnification)

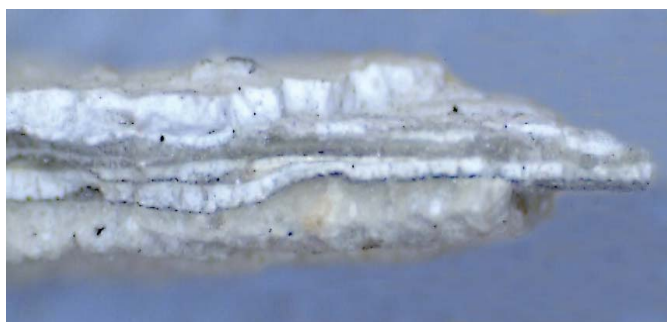
Figure 5. Sample 2. In cross-section showing at least 6 limewash layers, interleaved with soot particles; and the stone support. (x 200 magnification).

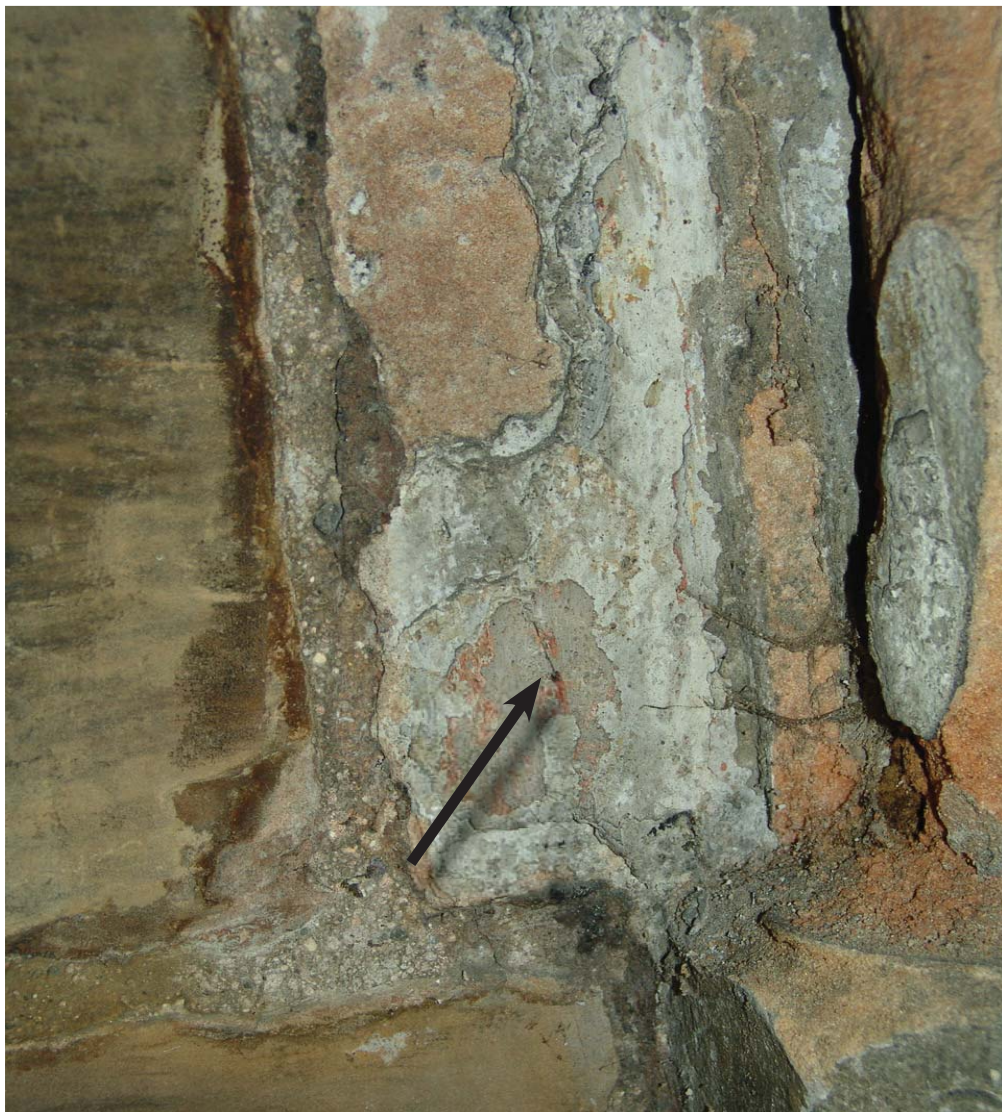
Figure 6. Sample site 3. South east corner springing of vault. Fragments of red pigment underlying later limewash layers can be noted. No discernible design could be noted, which is typical for the entire space.

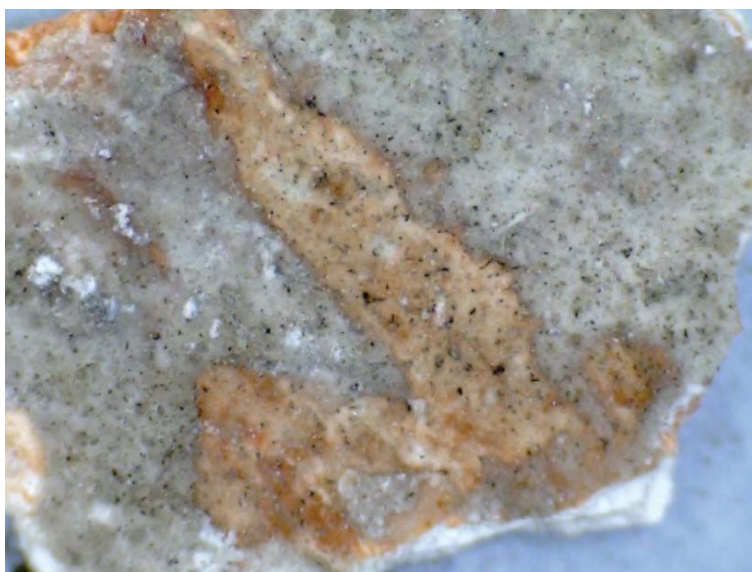
Figure 7. Sample 3. At x 200 magnification this surface aspect reveals soot particles; overlying limewash layer; a red paint layer; and ground.
