St. Winefride's Well, Holywell

An assessment of surviving decoration

June 2009

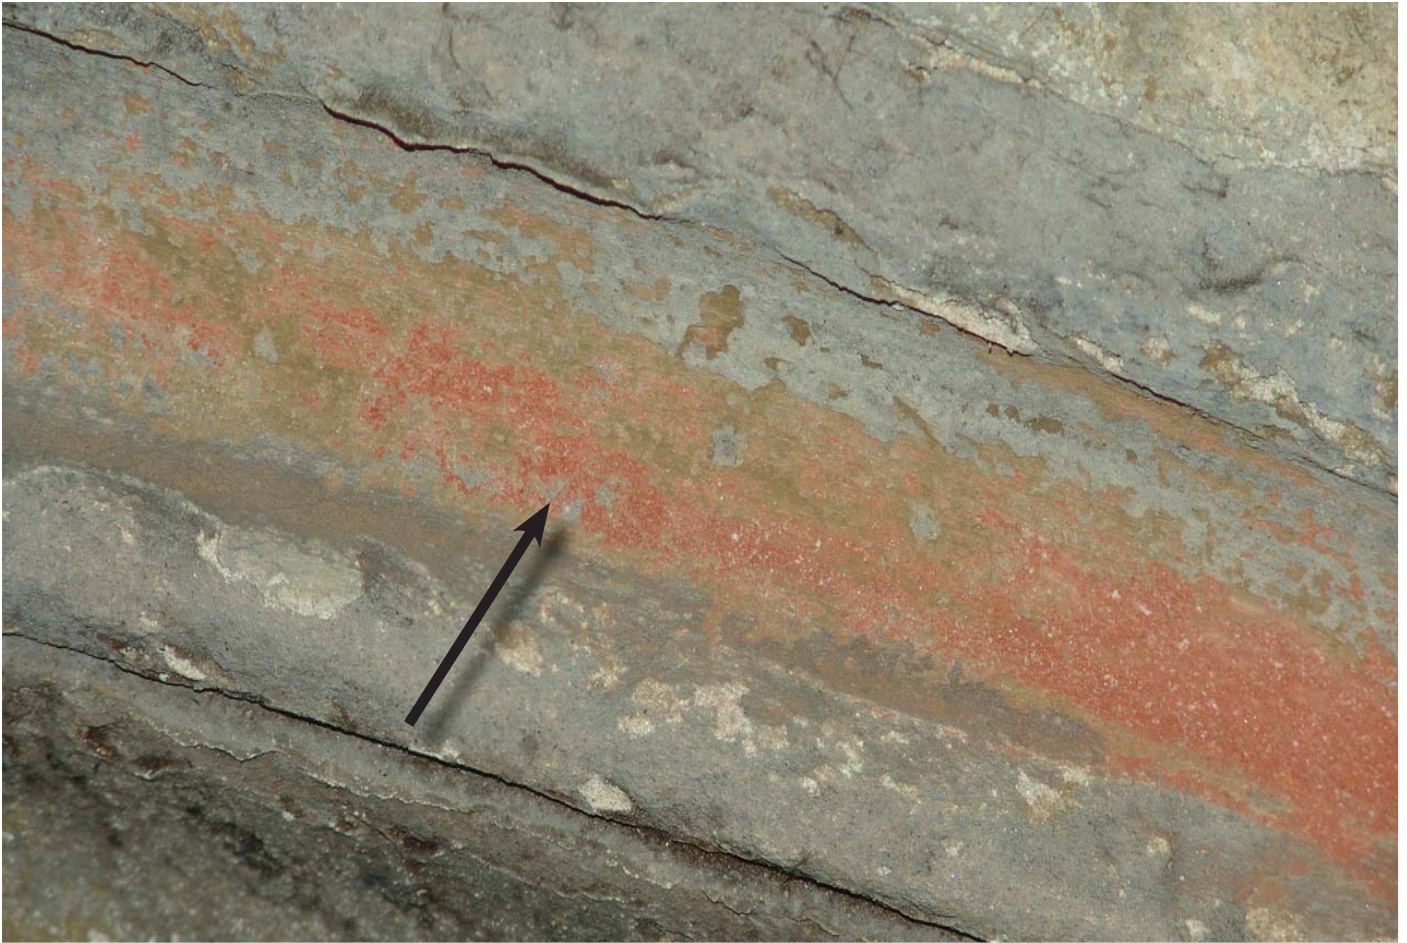
Figure 8. Sample site 4. West side of the central entry arch. Red and green colouration can be noted within the mouldings of the arch ribs.

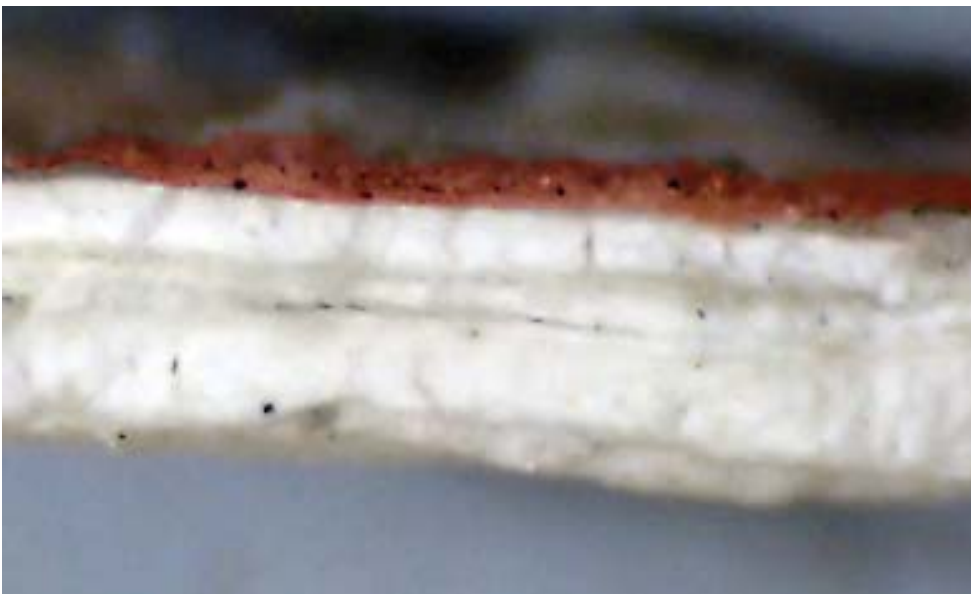
Figure 9. Sample 4. At x 200 magnification the multiple paint layers can be noted. The underlying plain limewash layers suggest that the red pigment is not original to the building, but forms part of the later decoration to this entry area.

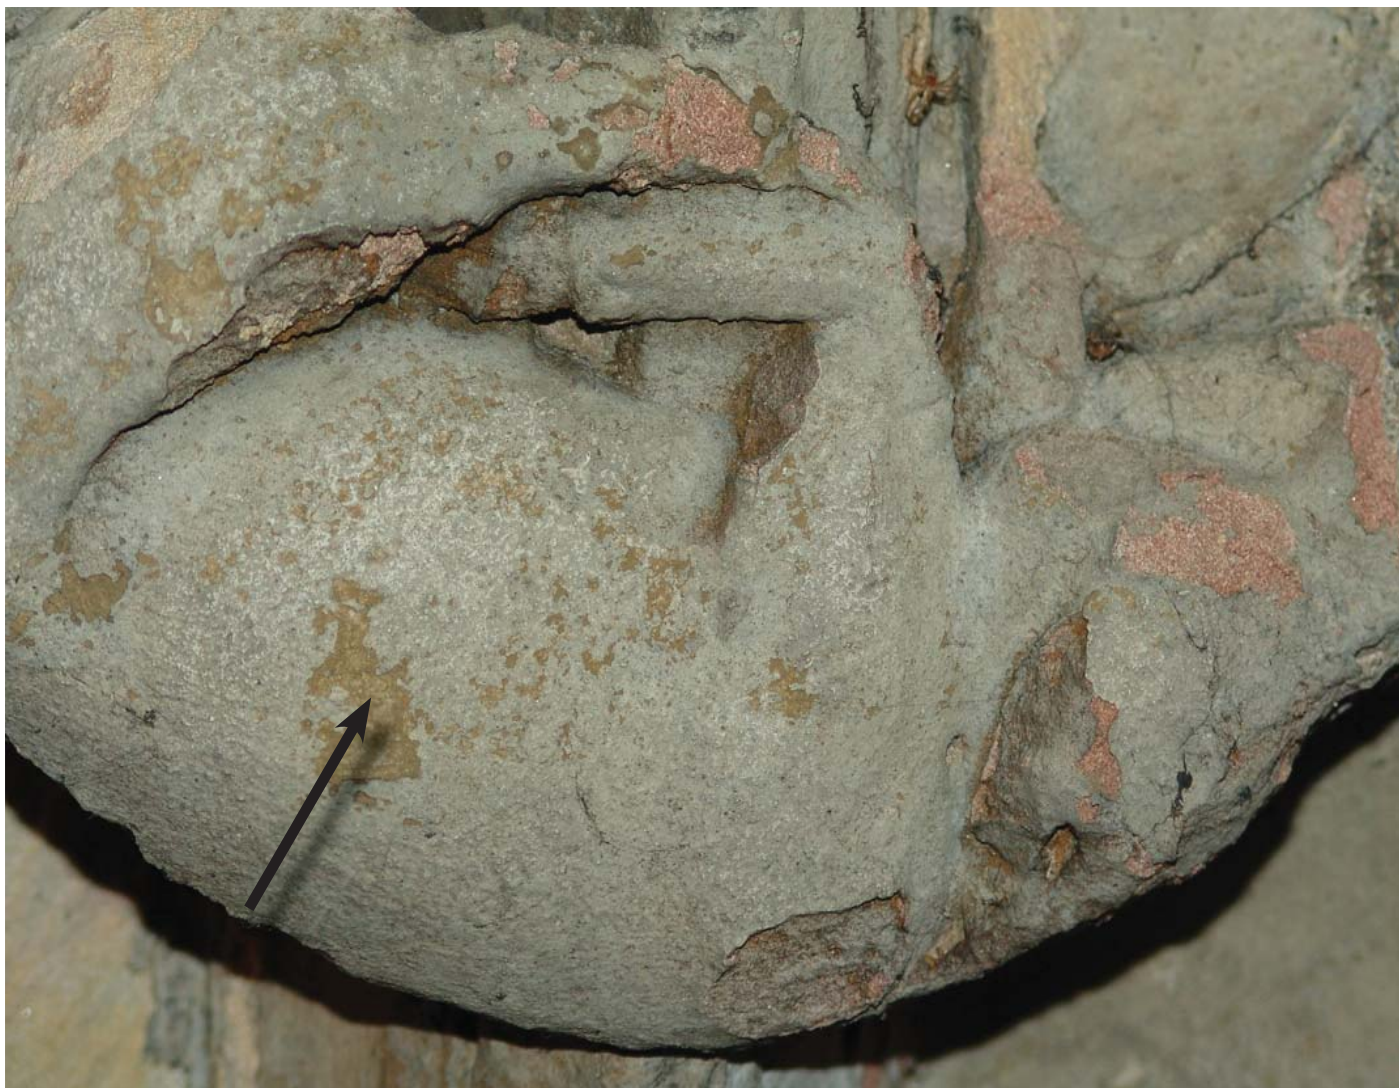
Figure 10. Sample site 5. Boss 64 SB. Here evidence for the underlying green pigment can be noted, as well as general levels of deposited dirt and other debris.

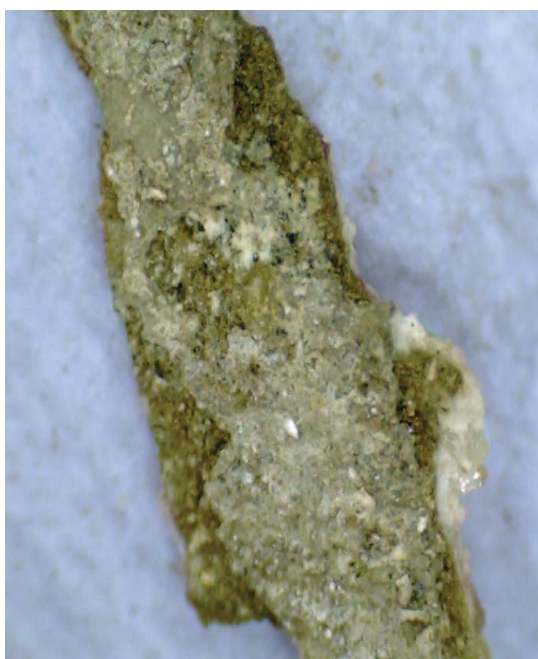
Figure 11. Sample 5. An overhead projection shows the deposition layer of discoloured lime wash and added pollutants. (x 200 magnification)

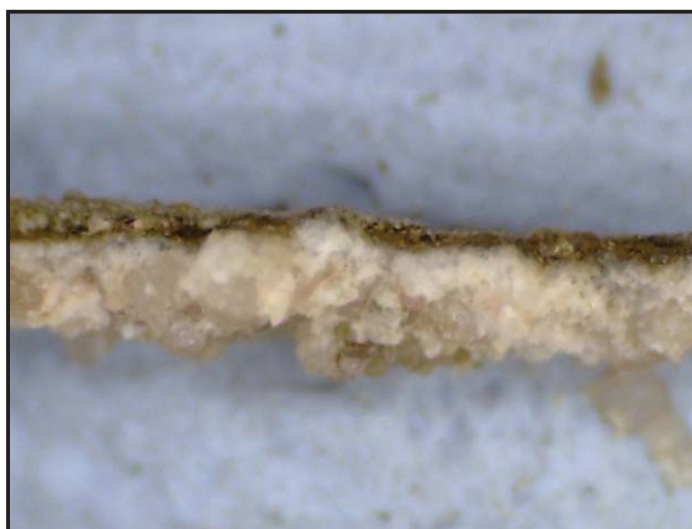
Figure 12. Sample 5. This rather concentrated green pigment is likely to be a green earth, a common material in use from the 12th to 19th centuries. (x 200 magnification)
