Report on an Archaeological Watching Brief:
Erection of New Garage at Cefn y Gaer
Trefecca, Brecon, Powys LD3 0PR
NGR SO 1446 3132
Planning Application 16/14050/FUL

CPAT HER Event PRN 142682

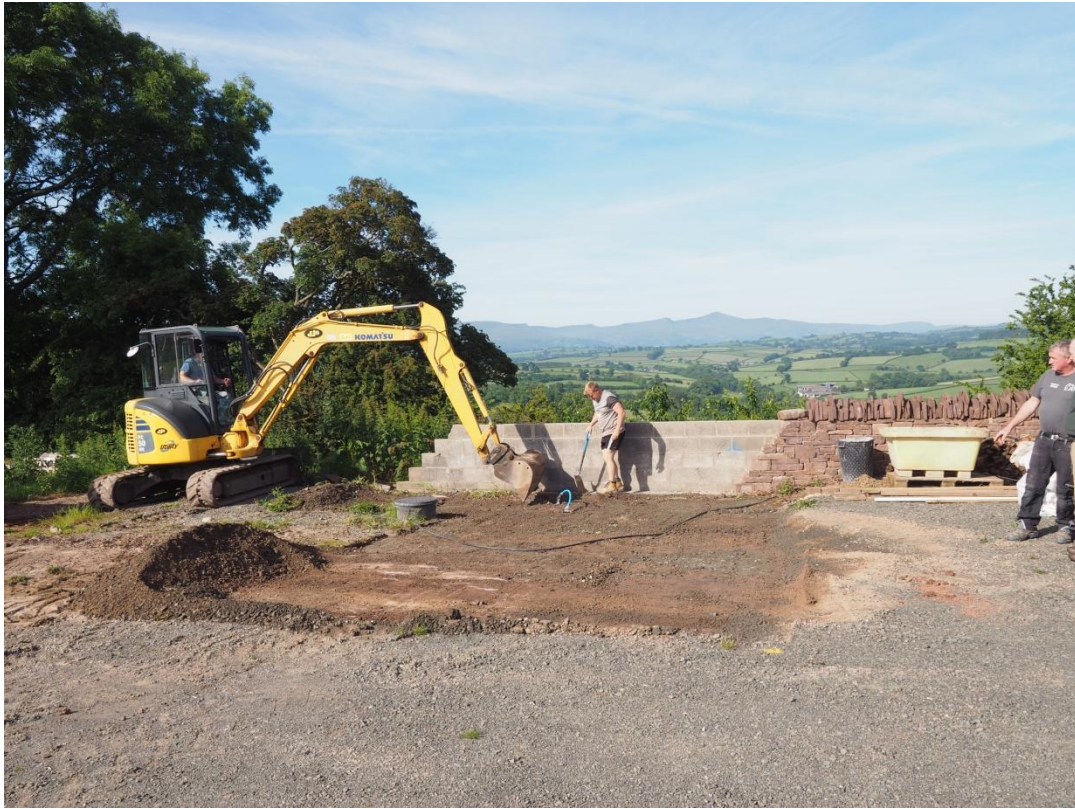
- 5.1 Information obtained from the owner/developer prior to the current construction work indicated that the area had been subject to significant erosion during its use as an agricultural building and the passage of cattle across the area had exposed the Old Red Sandstone bedrock across the entire area to be occupied by the garage. As a consequence of this erosion and in order to facilitate easy vehicular access the area had been levelled by putting down a layer of scalplings. These were removed prior to the cutting of the foundation trenches and this removal was also observed as part of the watching brief (figure 4). The depth of the scalplings was between 0.20m and 0.30m.

Figure 4: Stripping of scalplings layer

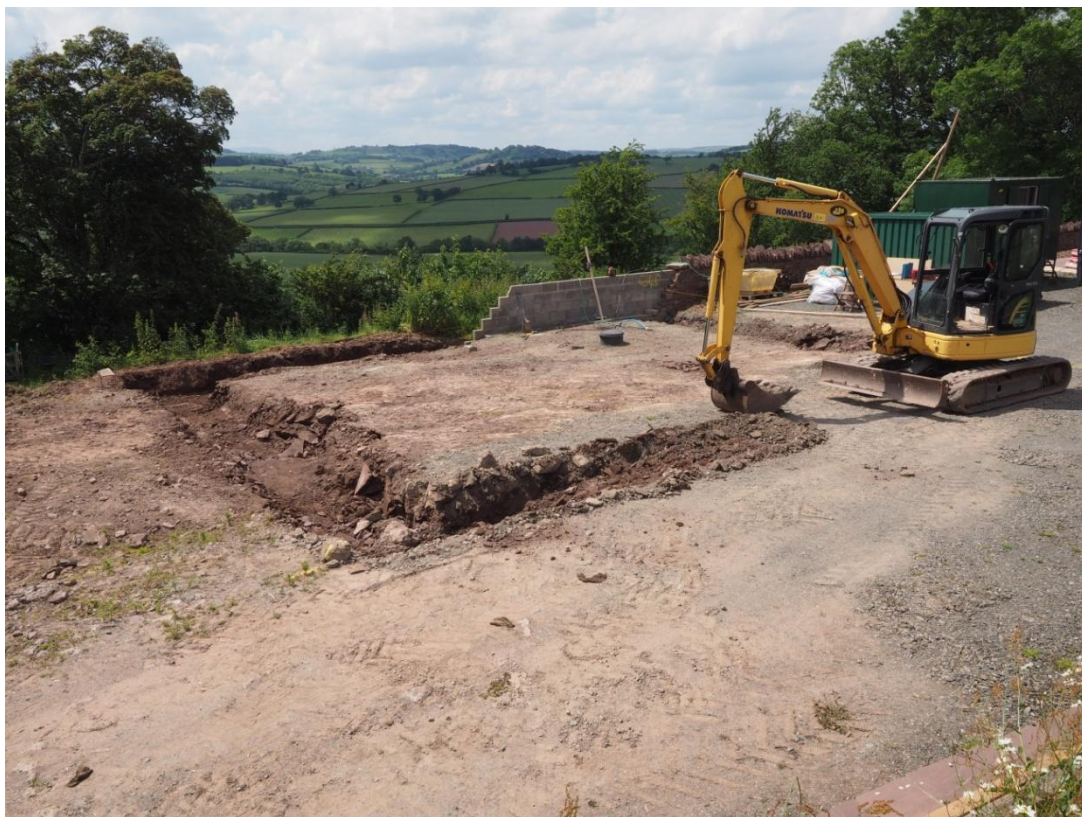
Figure 5: Completion of excavation of the foundation trenches

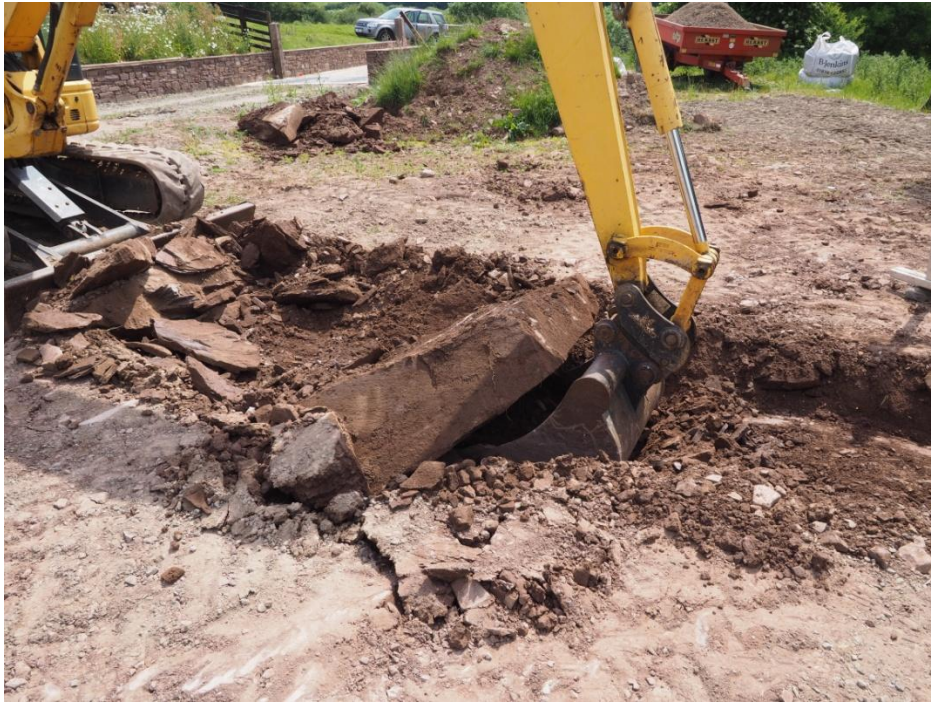
- 5.3 At least one third of trench B had been excavated during the main barn conversion work for the foundation of the property boundary wall.
- 5.4 There were no superficial deposits surviving within the development area, all the trenches were excavated entirely through solid Sandstone bedrock and the interleaved crumbly red clay (figures 6 and 7). The bedrock split along the bedding planes laminating into pieces between 0.02m and 0.30m thick.

Figure 6: Trench C during excavation showing the nature of the bedrock

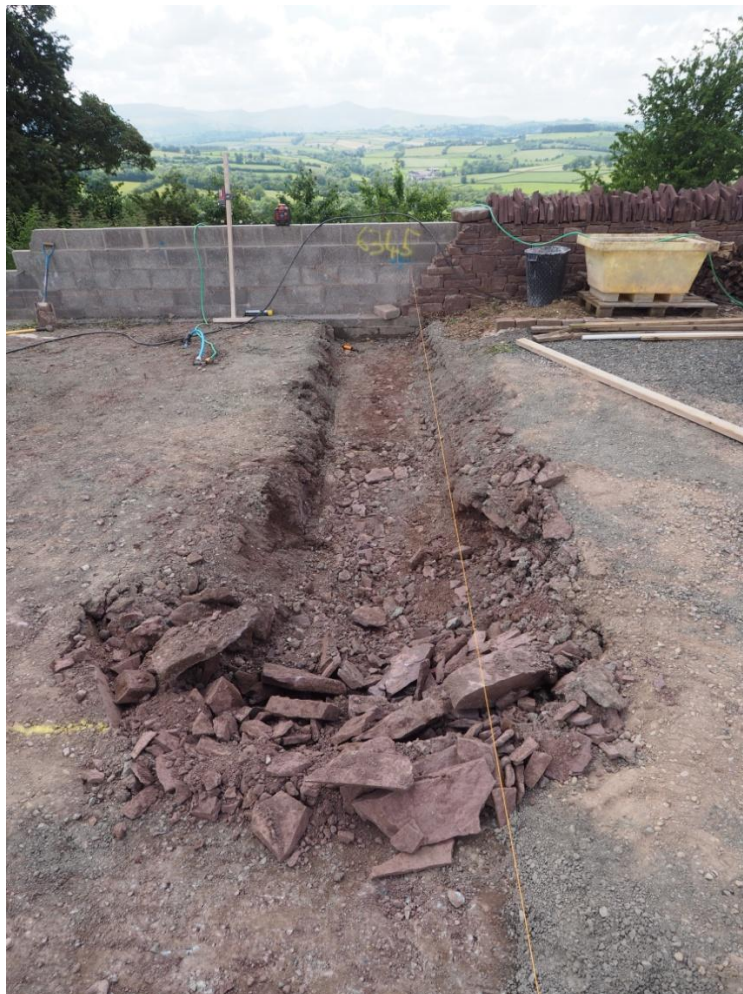
Figure 7: Trench A on completion of excavation
