A: Wall-top Capping - stone slabs

B: Wall Capping - mortar works (wall-tops and masonry tears)

Da: Repointing to Random Coursed Pennant Stone Walls

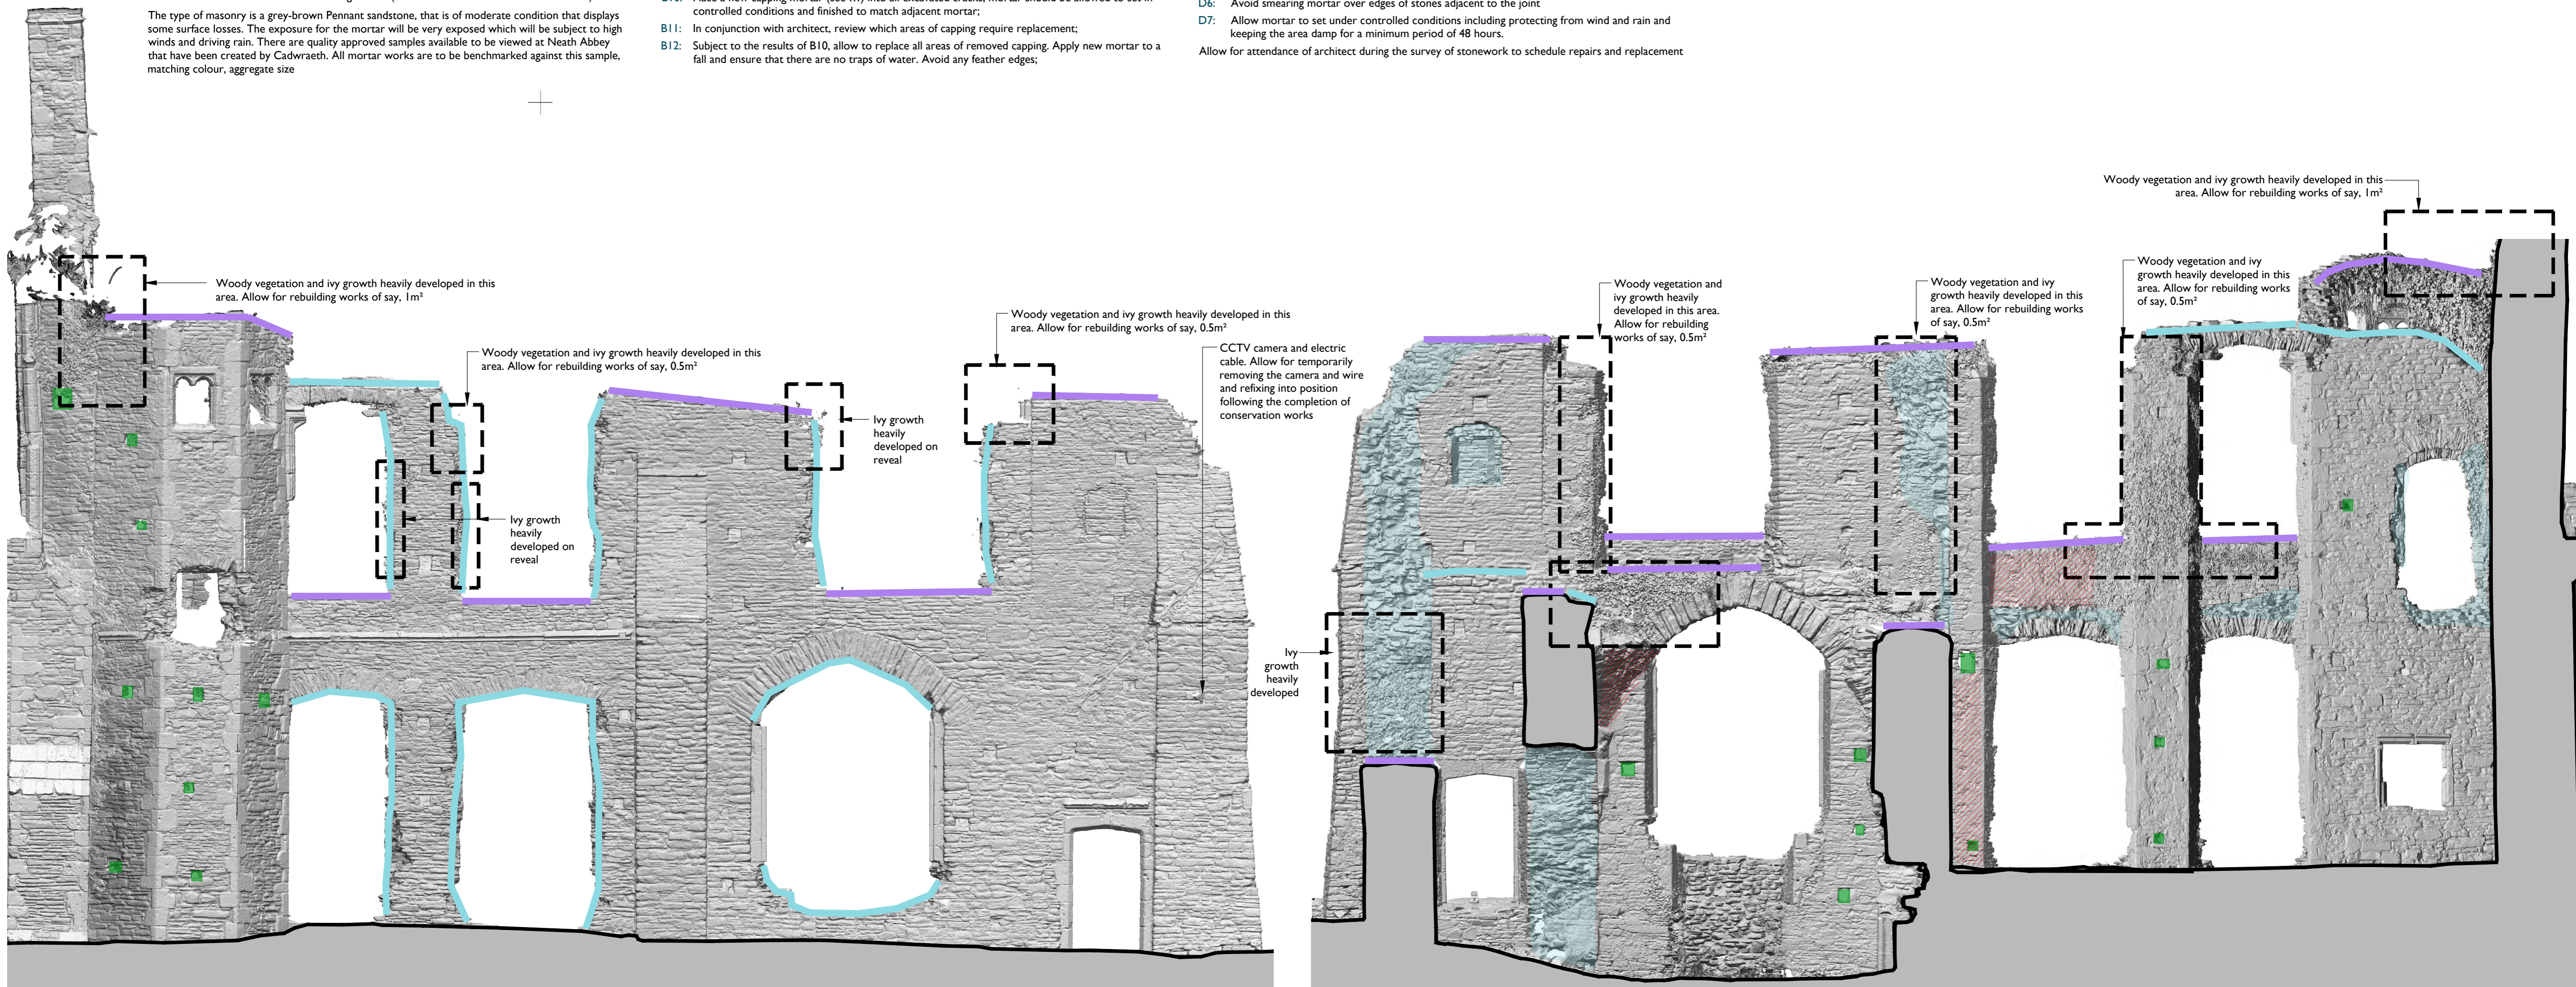
1 Elevation 1.1.1 (South face RHS) 210 1:50

QUANTITY OF WORK - ELEVATION 1.1.1
 A: Wall capping - stone slabs = As indicated
 B: Wall capping - mortar works = As indicated
 Da: Repointing to random coursed pennant stone = 50%
 Db: Repointing to dressed ashlar stone = 100% ; Dowel pinning = Allow 25 dowels
 E: Removal of vegetation = As indicated

Elevation approximately measures 130m²
