A: Wall-top Capping - stone slabs

B: Wall Capping - mortar works (wall-tops and masonry tears)

Da: Repointing to Random Coursed Pennant Stone Walls

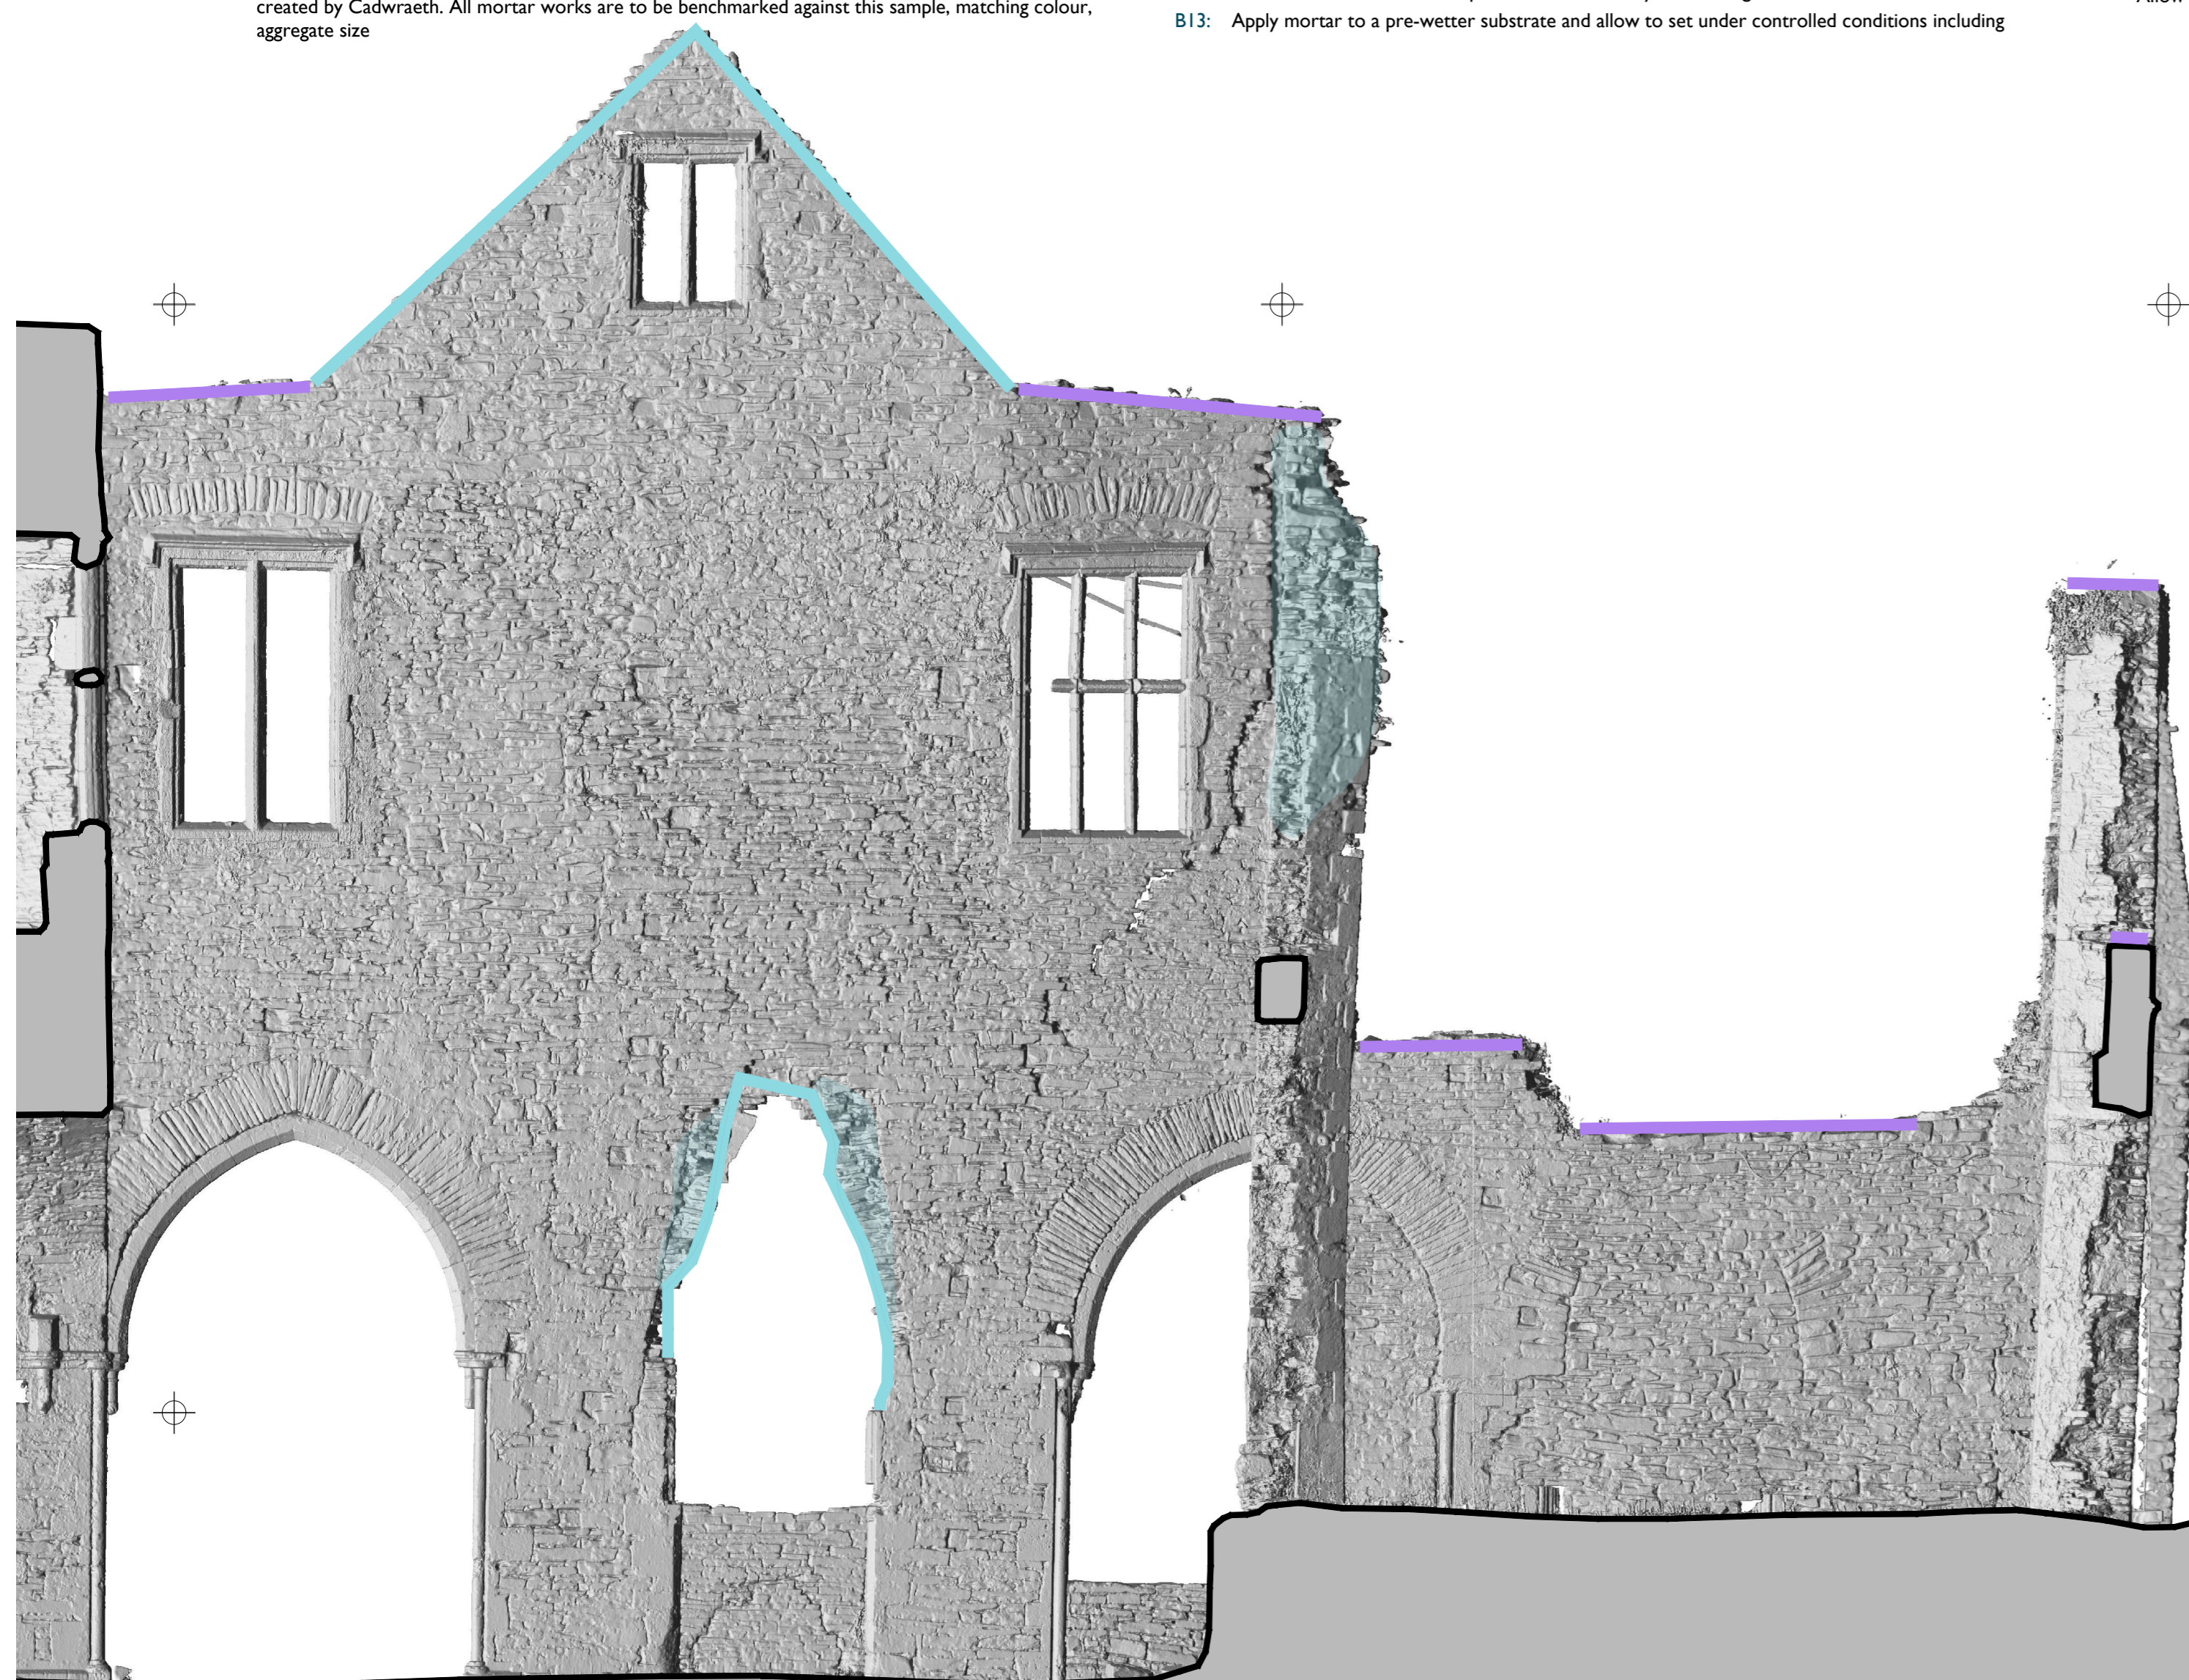
1 Elevation 1.2.4 and 1.2.8 (West face)
1:50
QUANTITY OF WORK - ELEVATION 1.2.4 and 1.2.8
A: Wall capping - stone slabs = As indicated
B: Wall capping - mortar works = As indicated
Da: Repointing to random coursed pennant stone = 90%
Db: Repointing to dressed ashlar stone = 100% ; Dowel pinning = Allow 50dowels
E: Removal of vegetation = As indicated

Elevation approximately measures 90m²

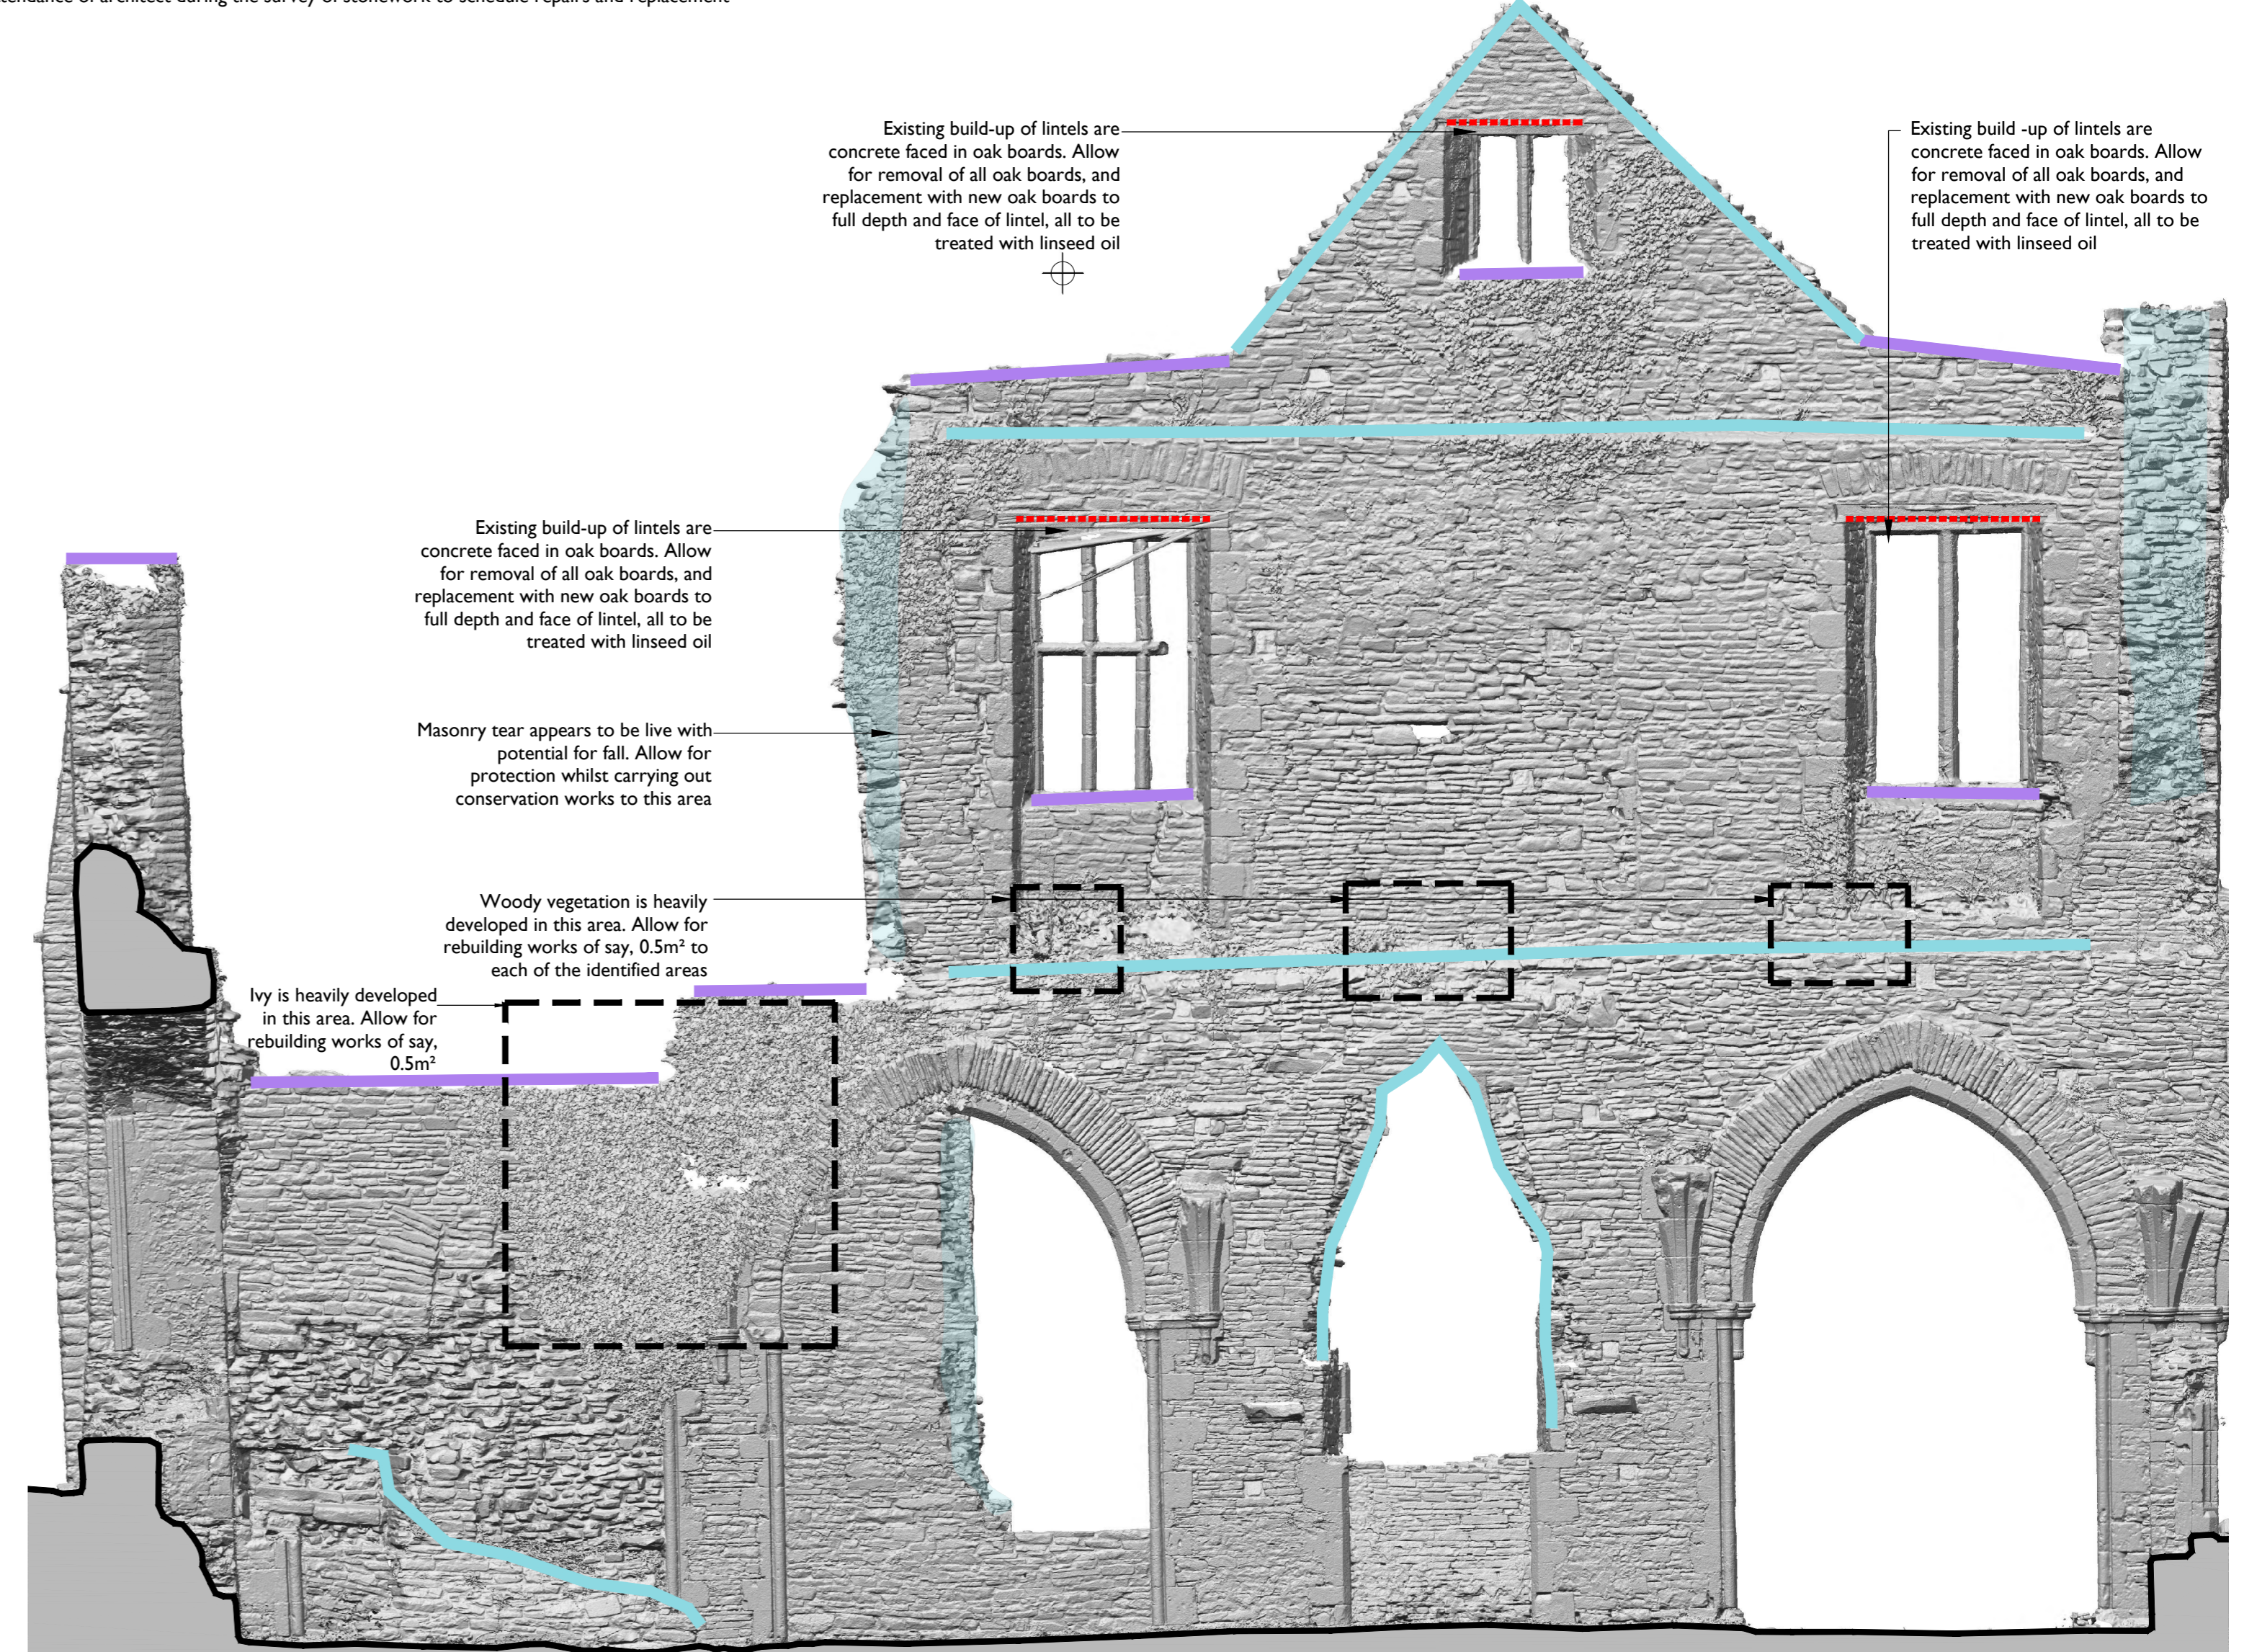
2 Elevation 1.4.2 (East face)
1:50
QUANTITY OF WORK - ELEVATION 1.4.2
A: Wall capping - stone slabs = As indicated
B: Wall capping - mortar works = As indicated
Da: Repointing to random coursed pennant stone = 80%
Db: Repointing to dressed ashlar stone = 100% ; Dowel pinning = Allow 60 dowels
E: Removal of vegetation = As indicated

Elevation approximately measures 90m²
