**MATHERN PALACE, CHEPSTOW,  
MONMOUTHSHIRE  
(ST 5228 1908)**

**HISTORIC BUILDING RECORDING**

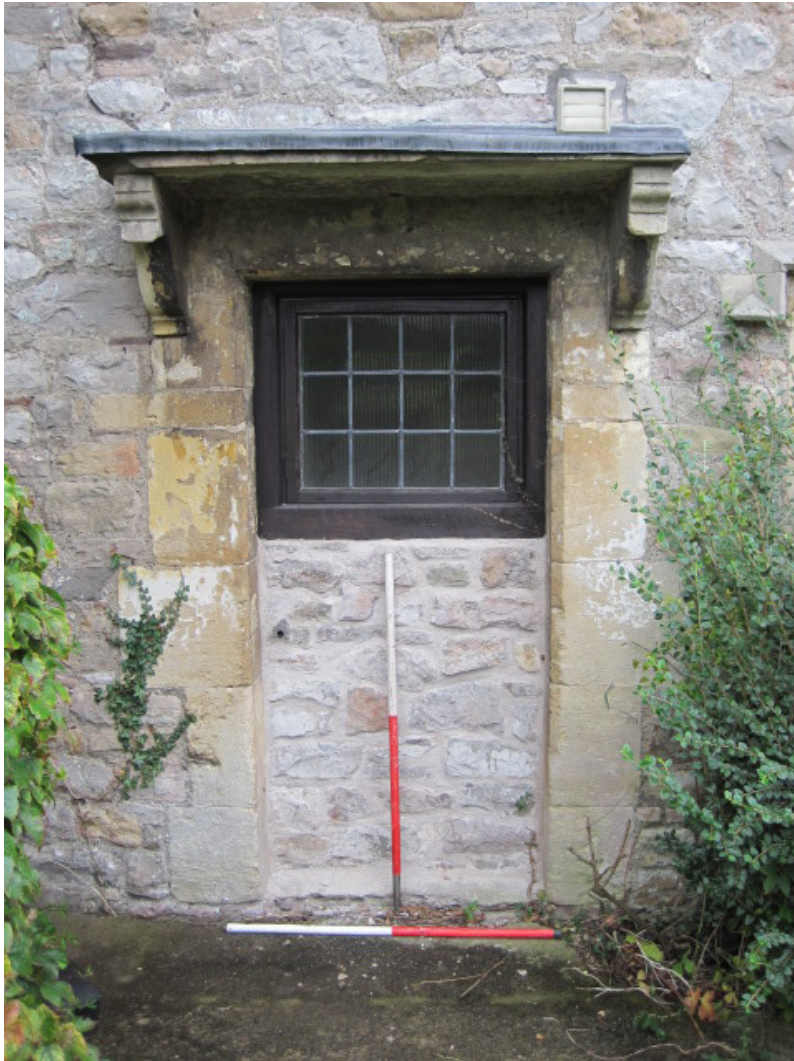
Photo 15: Doorway D005 prior to unblocking

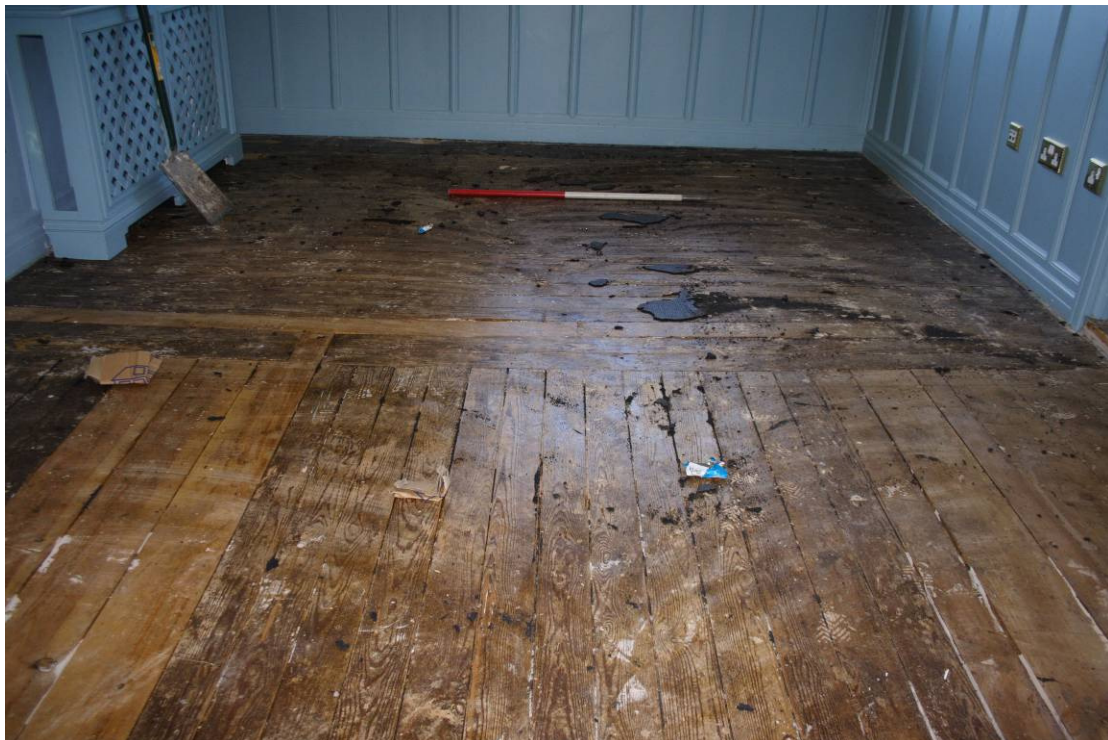
Photo 27: Room 105 viewing SW prior to removal of floorboards, showing change in floorboard direction

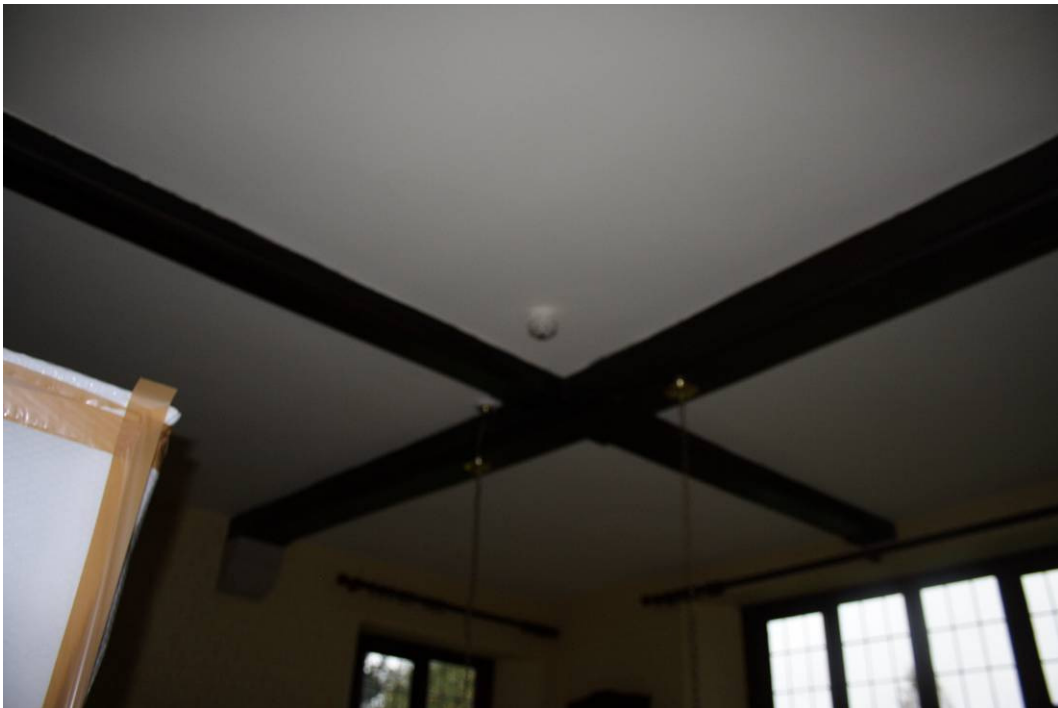
Photo 33: Ceiling of Snooker Room 006 showing exposed crossing beams

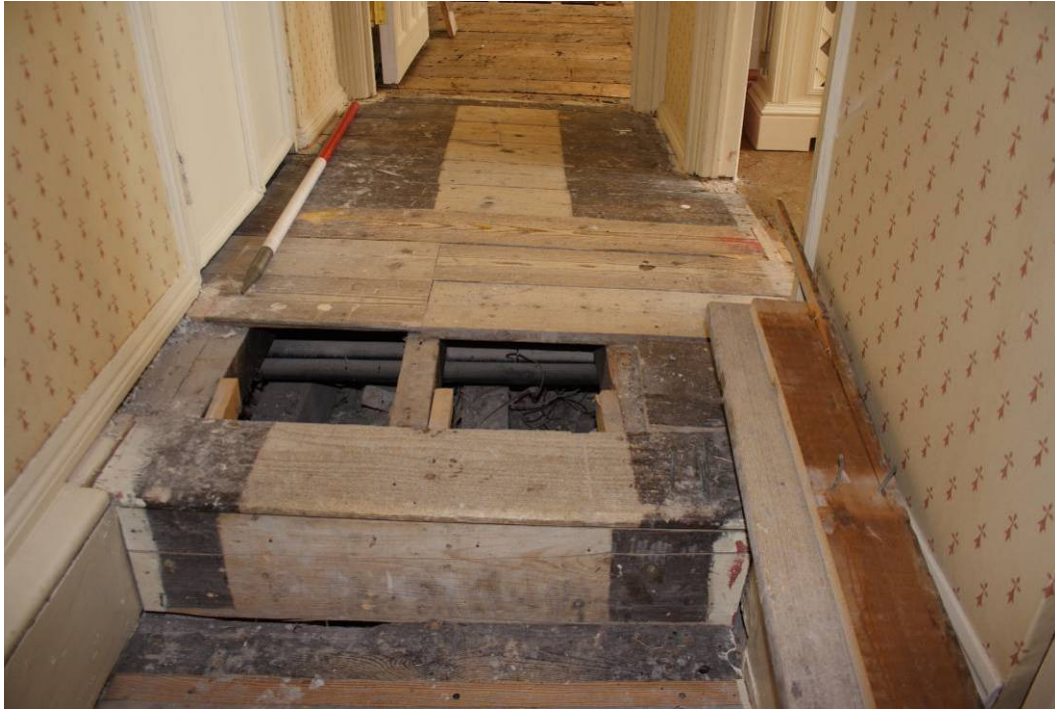
Photo 45: Corridor 119, showing start of stairs prior to floorboard removal

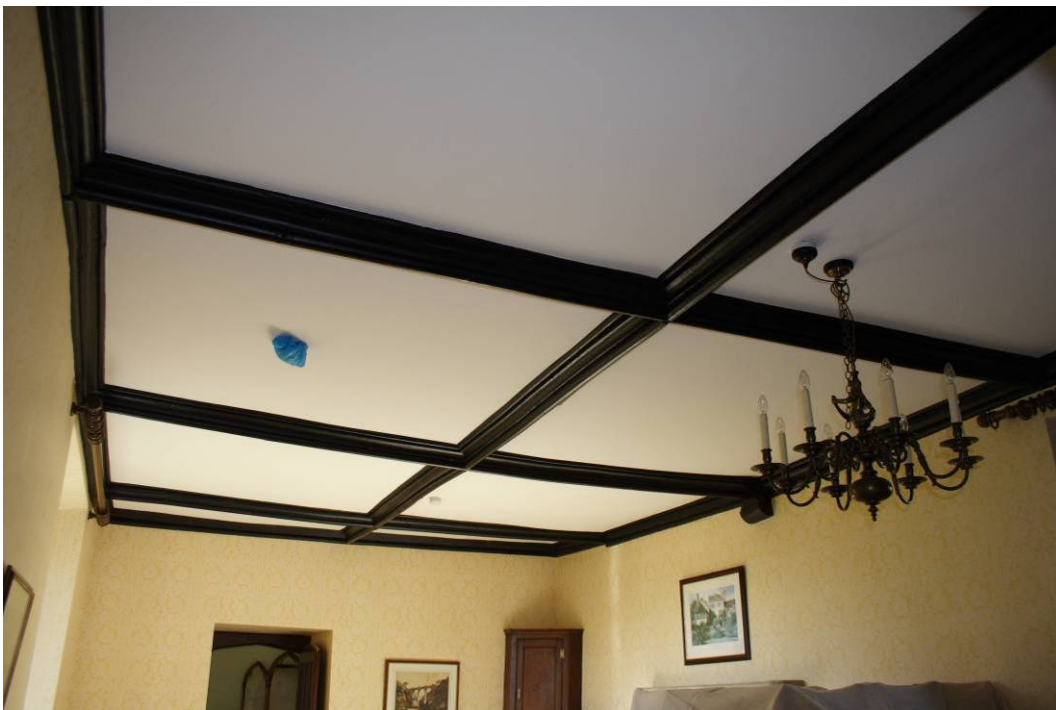
Photo 59: Ceiling of Lounge 015, viewing NW, showing ornate beams

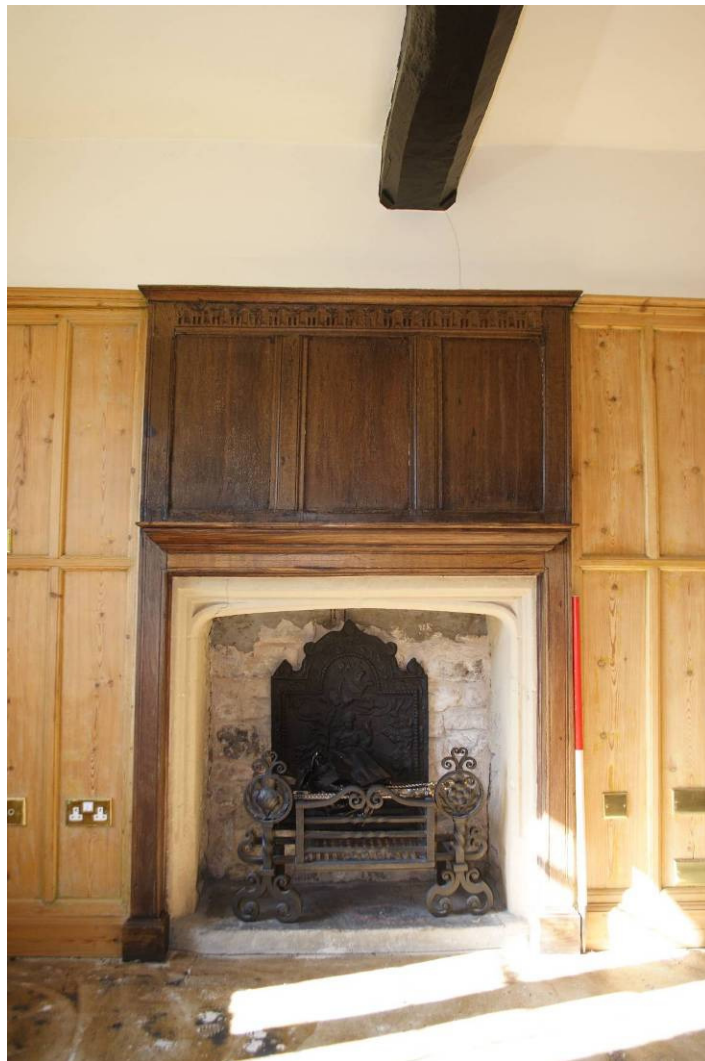
Photo 77: Fireplace in Bishop de La Zouche Lounge

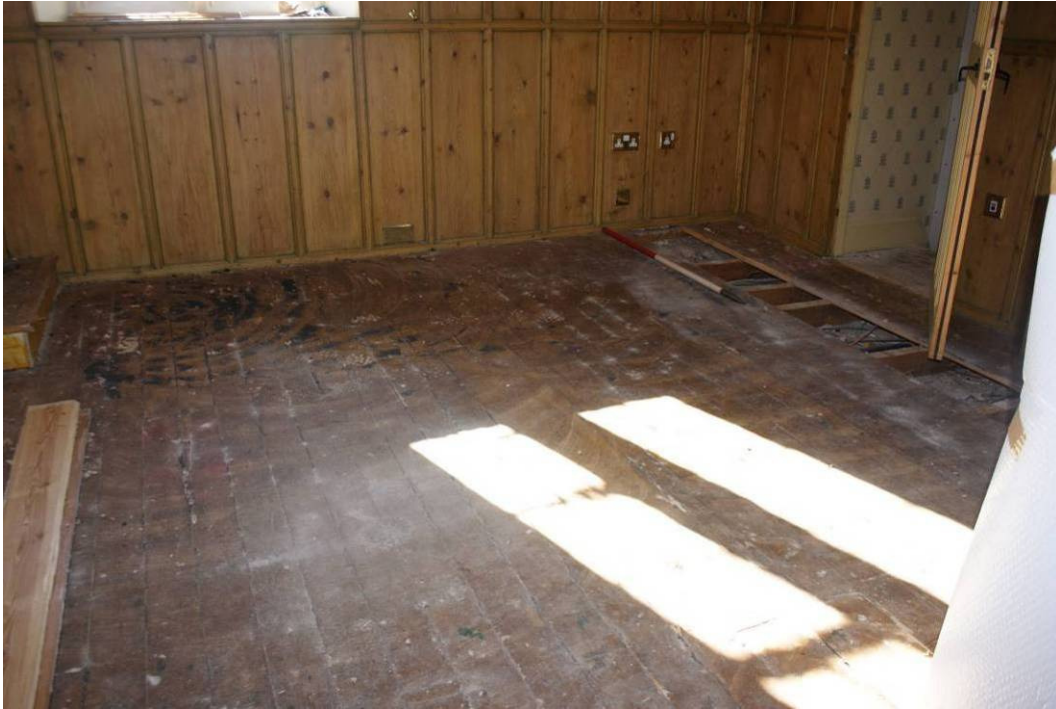
Photo 81: Bedroom 109, floorboards prior to removal

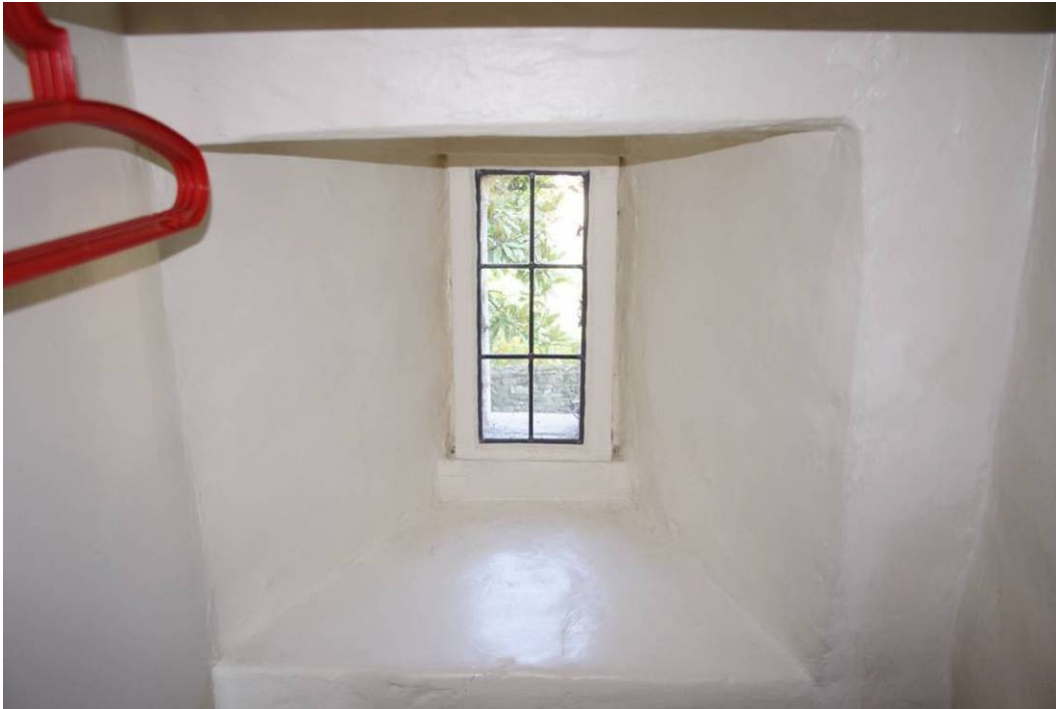
Photo 85: Window in NE wall of Store 110

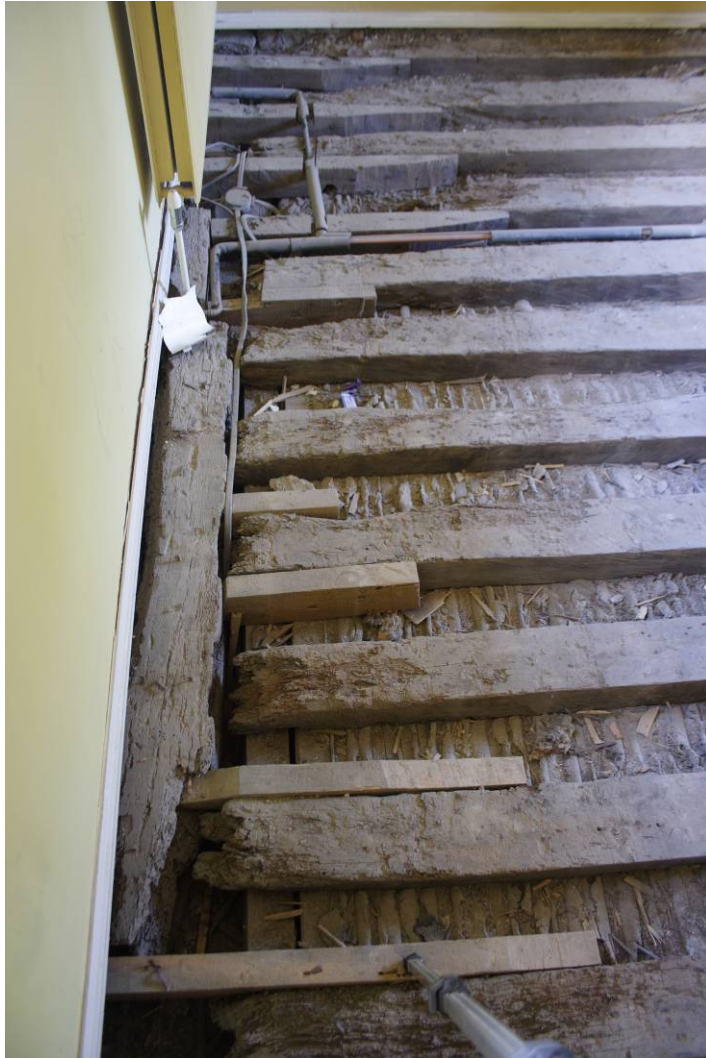
Photo 89: Wall plate along SW stone wall of Bishop Morgan Bedroom, showing decayed timbers and joists, and more recent repairs (as well as lath and plaster ceiling to Room 109 below)

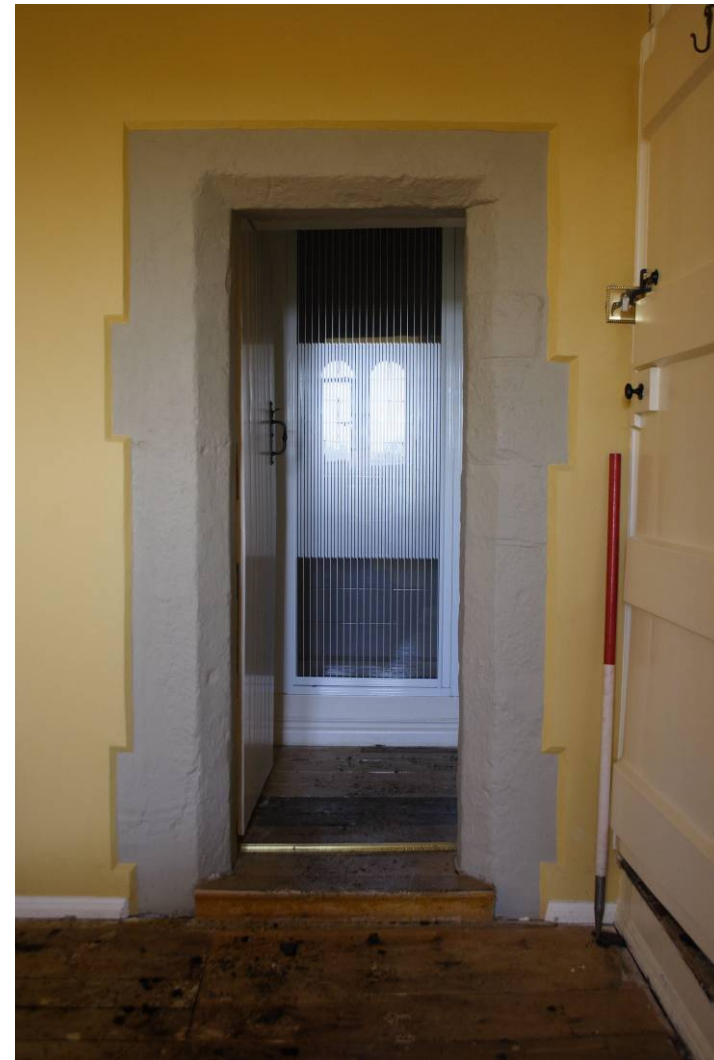
Photo 90: Stone framed doorway to Bathroom 202

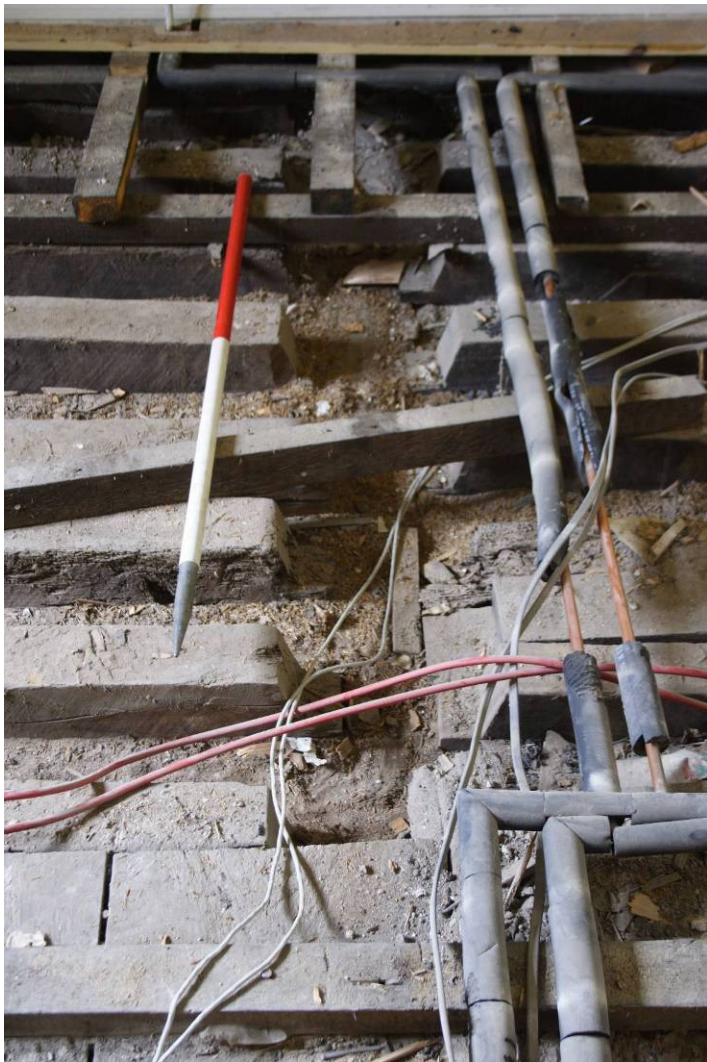
Photo 105: Decayed beam across floor of Bedroom 203 showing joists resting on top of the surviving part

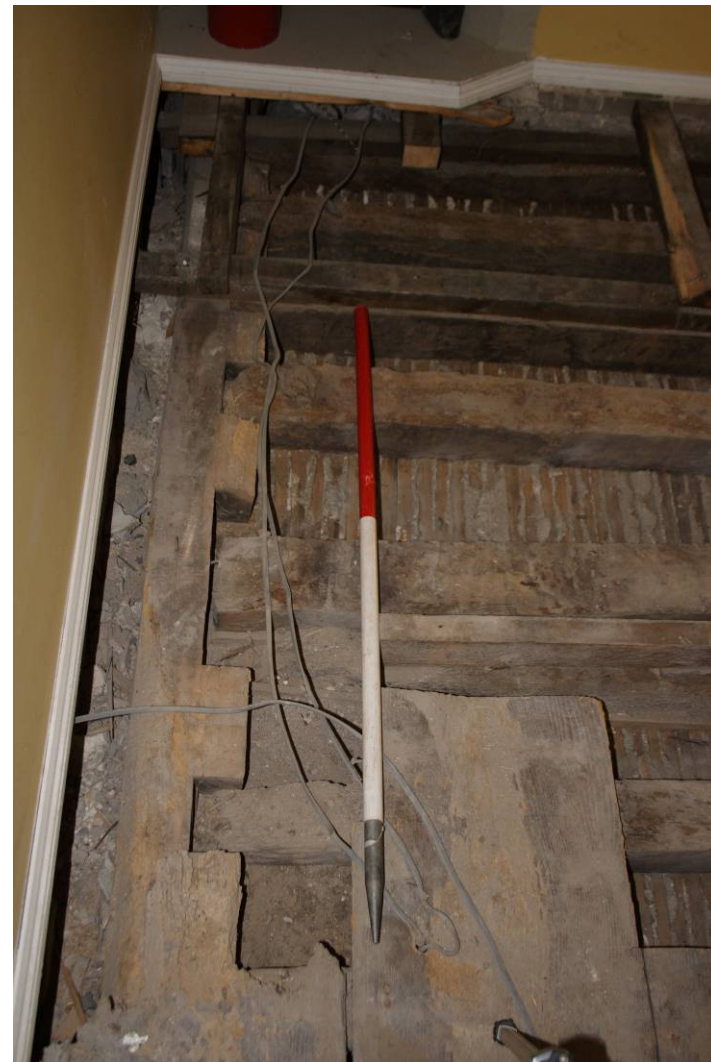
Photo 106: Wall plate beam on SW wall of room showing notches for joists
