CPAT Report No. 1926

Church of St Trinio, St Peter & St Paul,
Llandrinio, Powys

ARCHAEOLOGICAL WATCHING BRIEF

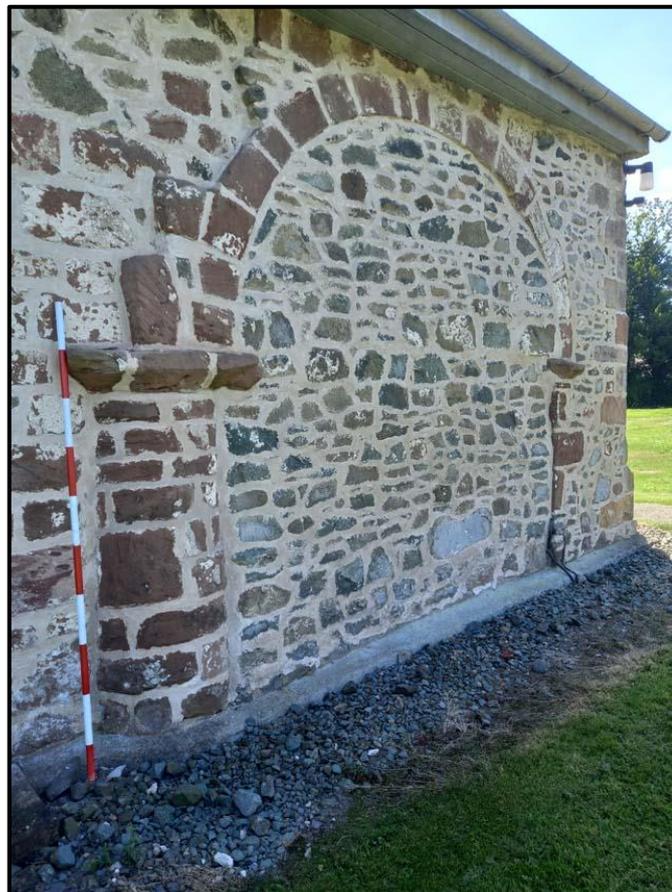
- 2.3. The Church fabric suggests that the 15th century was a period of great decline for the area as large modifications were made that reduced the size of the building by nearly half. These modifications included the removal of the previous Northern aisle and arcade, with the exception of one arch which was then filled in (Fig 3).

Figure 3. Bricked in aisle arch. Photo CPAT 2646-0013

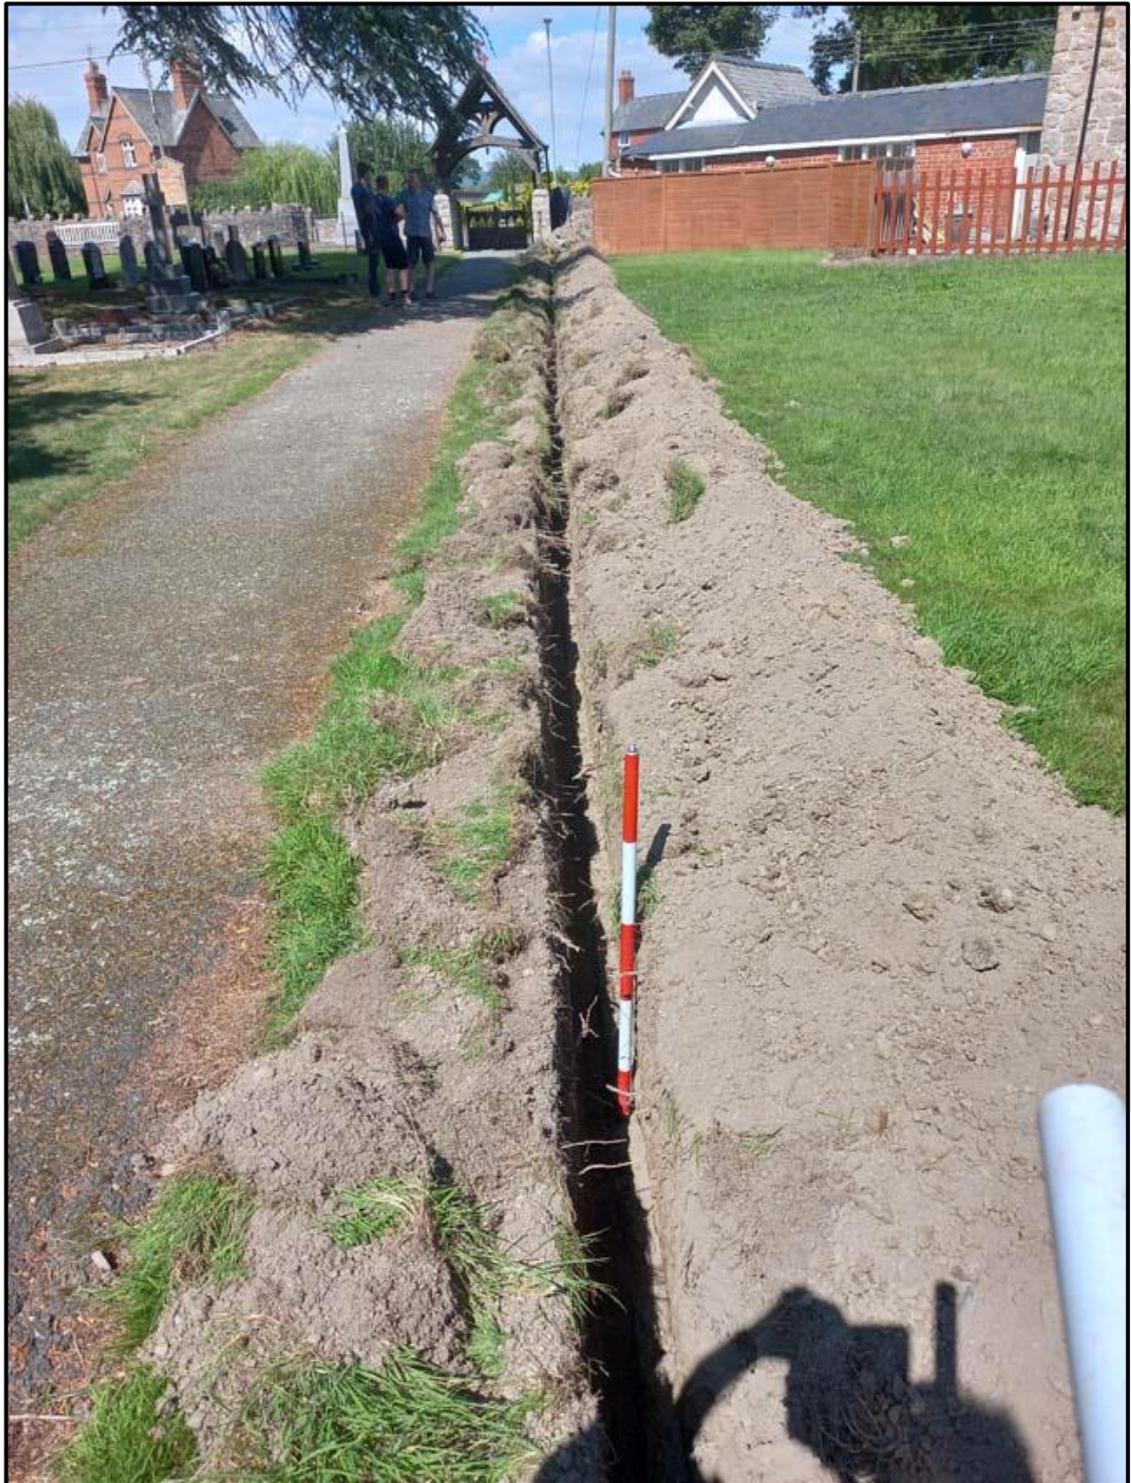
- 3.2. The pipe trench was primarily orientated north/north-west by south/south-east, changing to north/south at the northern churchyard boundary and east/west where it connected to the church wall. The trench measured around 57.5m total in length, 0.25m wide and 0.5/6m deep (Figs 6-7).

Figure 6. Pipe trench looking north. Photo CPAT 2646-0008.

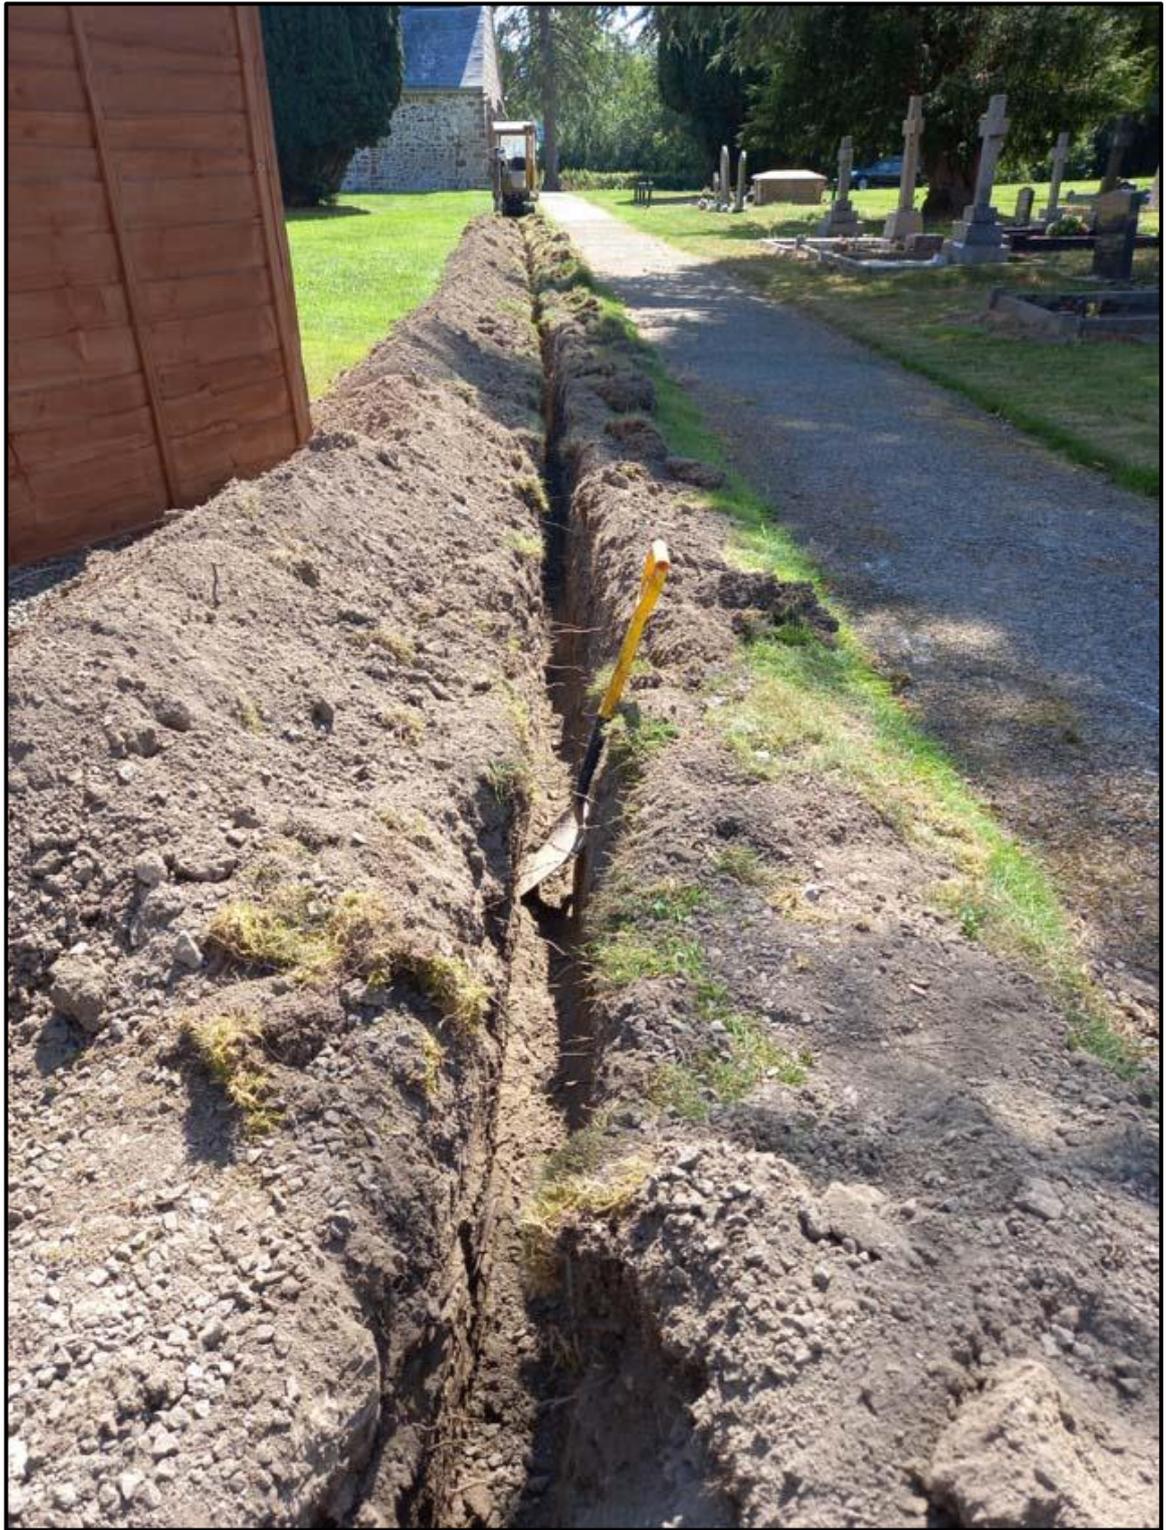
Figure 7. Pipe trench looking south. Photo CPAT 2646-0008.

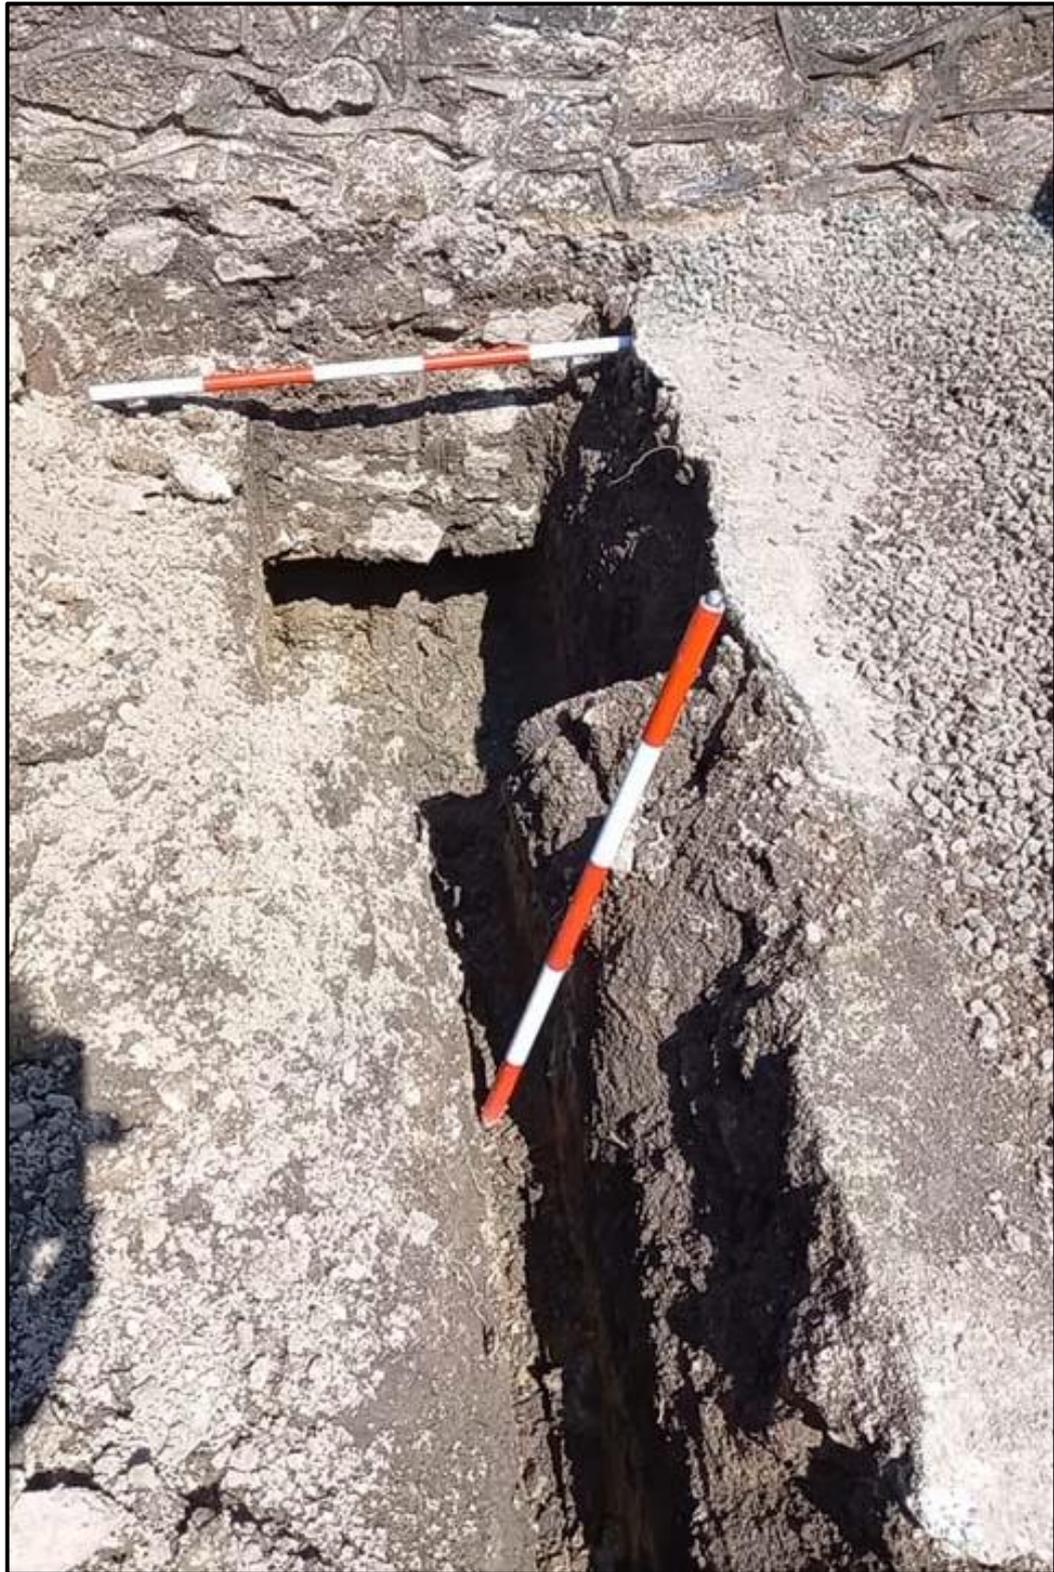
Figure 8. Northern end of pipe trench at churchyard boundary. Photo CPAT 2646-0003

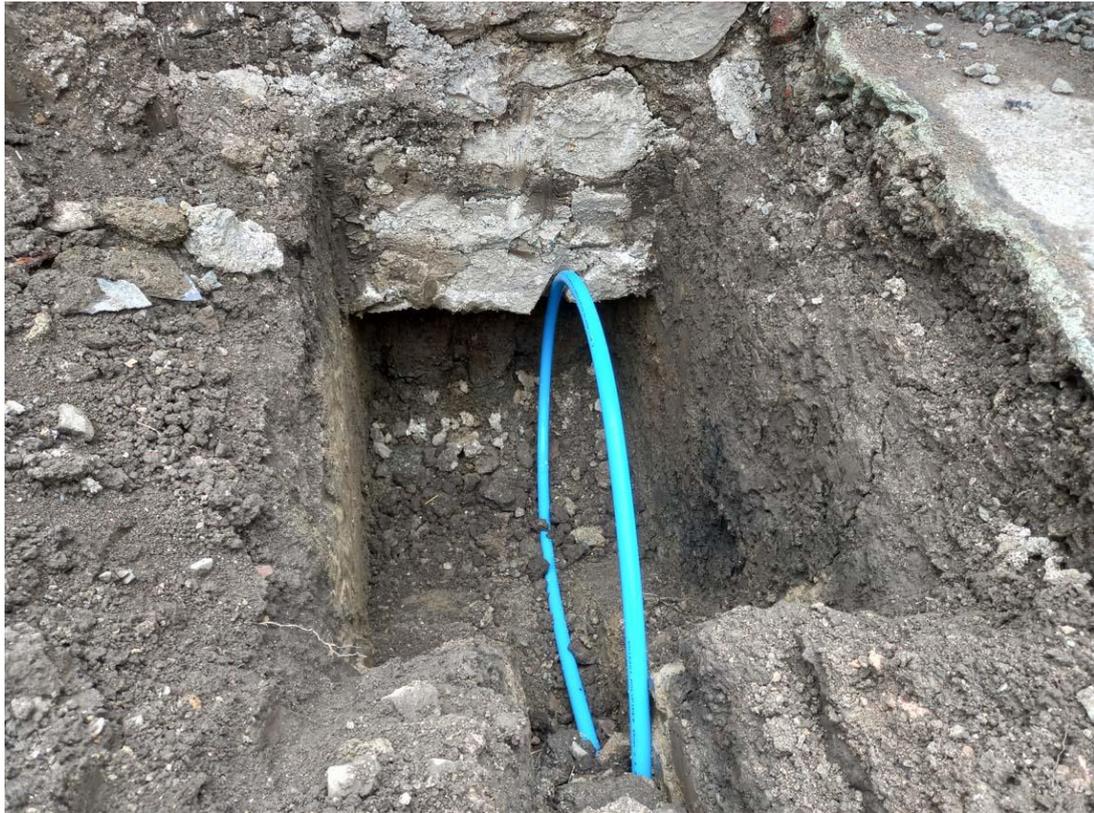
- 3.3. A standard deposition sequence of natural yellow clay below a deposit of grey sandy silt with inclusions of pebbles and small stones was recorded, sealed by modern topsoil. At the north-west corner of the church a layer of mortar, slate and occasional sandstone with sherds of post-medieval pottery was encountered below the topsoil and interpreted as debris from a 20th century repointing phase of the church. At the northern boundary of the church the trench was excavated to a larger depth in order to run the pipe under the churchyard wall (Figs 8-9). This area was c.1.5m deep and 0.8m wide. A charcoal deposit was identified on the east side of the wall interpreted as a pit cut into the natural clay; no artefacts were found.

Figure 9. North end showing clay deposit to west and charcoal-filled cut to east. Photo CPAT 2646-018
