Old Plas, Llantwit Major

County: Glamorgan

Date of Survey: 16th January 2013

Old Plas, Llantwit Major, Glamorgan

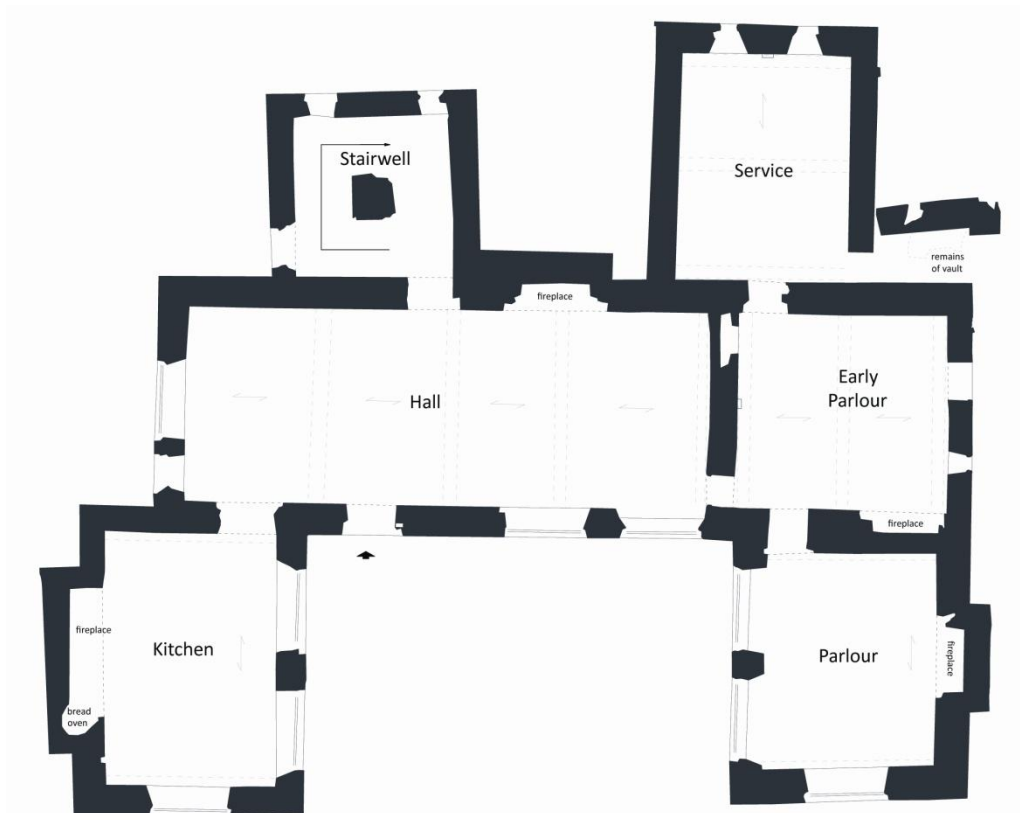
Period IV

This phase forms the additions undertaken by Edmund Vann, c. 1598, which transformed the house into what we see today. This included the addition of the three storey Kitchen (7.59 x 8.39m) and ParLOUR (6.89 x 7.66m) wings, Stairwell (6.11 x 5.45m) and second floor (23.73 x 7.41m). Clear butting of the wings demonstrates the later addition of these to Old Plas, see Fig. 5. The height of the front lateral wall was also raised within this period of construction to create a second floor and to take the building to the same eave height across the facade whilst the rear lateral wall being raised to a lower level. The added height of c. 1.5m created enough height for the addition of second floor Long Gallery and three new windows finished with false rendered quoins, within this the gables were raised to accommodate this new use. To provide warmth to the Long Gallery a corbelled fireplace was inserted, which is clearly visible protruding from the north elevation. The kitchen wing has a large chimney, which serves both a large fireplace and bread oven on the ground floor, and a single

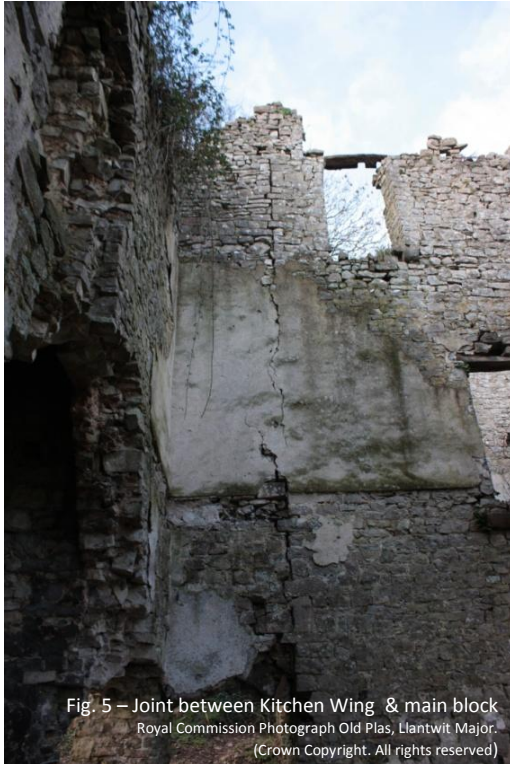
Fig. 5 – Joint between Kitchen Wing & main block
 Royal Commission Photograph Old Plas, Llantwit Major.
 (Crown Copyright. All rights reserved)

fireplace on the first floor. Unusually a large relieving arch has been constructed underneath the kitchen fireplace, which may be to bridge a fault in the bedrock or boggy ground. At the first floor level near to the north-east corner is a blocked doorway, though no evidence remains for its use. The Parlour wing demonstrates similar butting to the earlier structure and, as with the Kitchen wing; it has a large chimneystack to provide fireplaces for the ground and first floor rooms. Within the Parlour wing the early lateral chimney can be seen in the wall with a doorway directly above the stack; the wall at the second floor level between the Long Gallery and Attic is considerably narrower than that of the main facade, demonstrating its later origin as an internal wall. The pillar stairwell is of the same date as the increased height and front wings, built to provide access to each floor; this was once completed with an oak staircase of which nothing remains. Both the wings and stairwell were gabled, with
