Marian Mawr, Dolgellau

Archaeological Assessment

Prosiect Rhif / Project No. G2457

Adroddiad Rhif / Report No. 1293

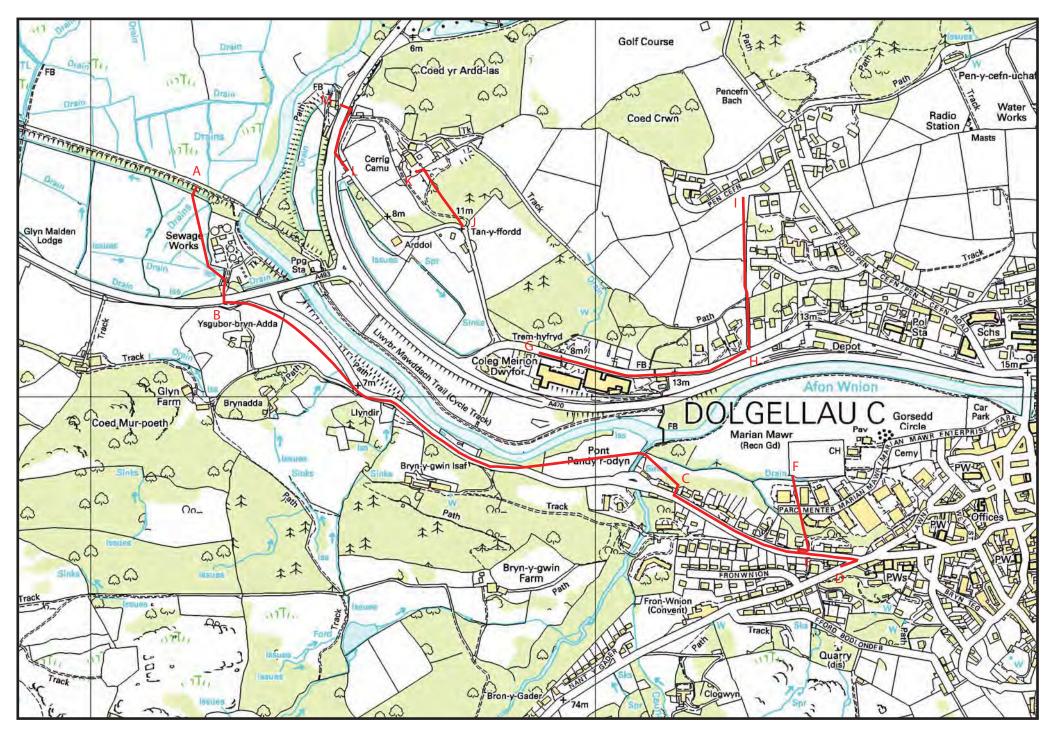
Figure 01 - Location Map denoting scheme route along with route sub-divisions A to M. Based on Ordnance Survey 1:10000 Series County Series Map Sheet SH71NW. Scale: 1 to 7500@A4. Crown Copyright. All Rights Reserved. License number AL100020895.

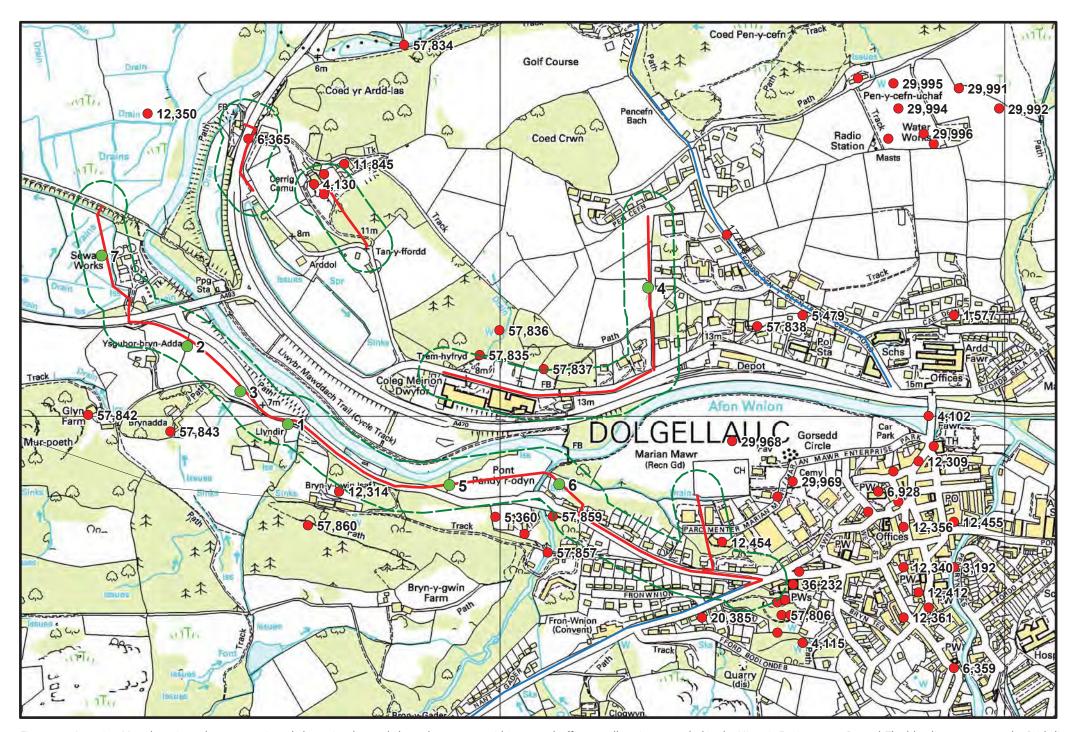
Figure 03 - Location Map denoting scheme route in red along sites located along the route or within a 50m buffer as well as sites recorded in the Historic Environment Record. The blue lines represent the Brithdir to Pennal and Tomen y Mur to Brithdir Roman Roads. Based on Ordnance Survey 1:10000 Series County Series Map Sheet SH71NW. Scale: 1 to 7500@A4. Crown Copyright. All Rights Reserved. License number AL100020895.

Sites noted on the Gwynedd HER are shown on Figure 03 and listed in Appendix III

The features listed below (located on Figure 03) were identified during the desk based assessment and the walk over at Marian Mawr, Dolgellau, with recommendations for further assessment and mitigatory measures, where appropriate. They are located within the 50m buffer zone either side of the proposed water main renewal route. Definitions of the categories used and impact assessments are given in Appendix IV.

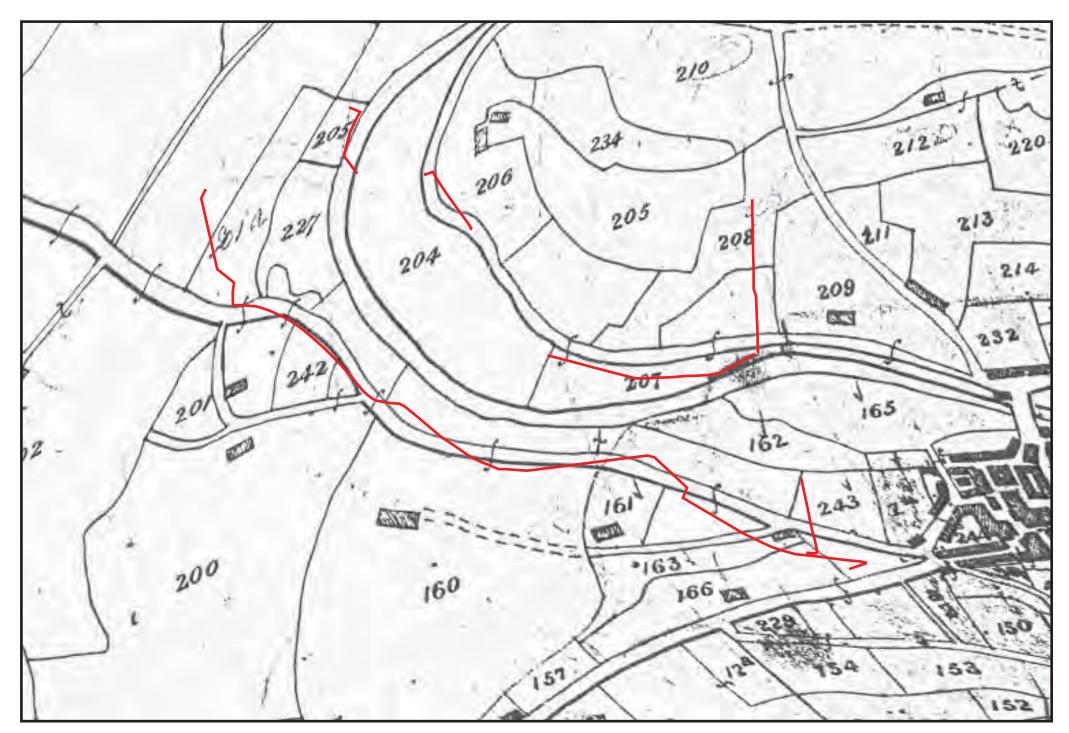
Figure 04 - Reproduction of 1840 Dolgellau Parish Tithe Map, with scheme route along with route sub-divisions A to M. NOT TO SCALE (Source: Gwynedd Archives)

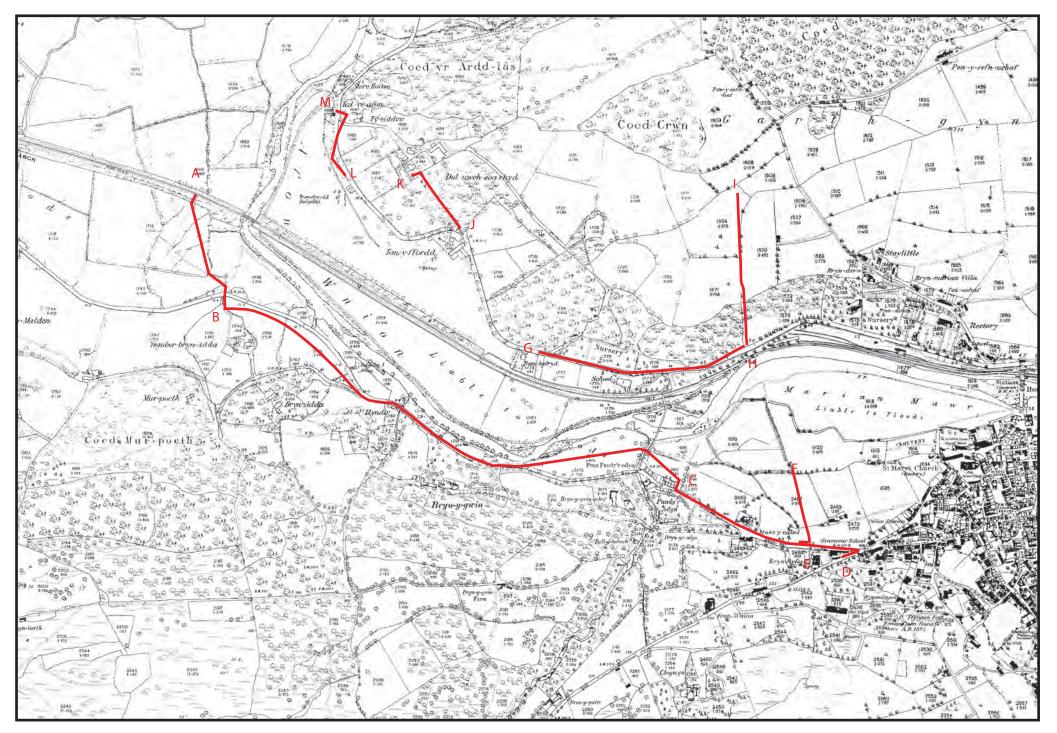
Figure 05 - Reproduction of 1889 First Edition 1" to 25-Mile County Series Map Sheets XXXIII.14, XXXIII.15, XXXVII.02 & XXXVII.03, with scheme route along with route sub-divisions A to M. Scale: 1 to 7500@A4 (Source: Historic Environment Record)

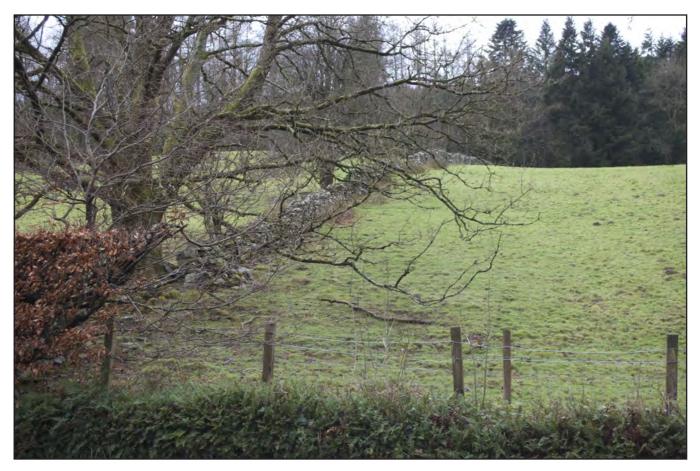
Plate 05: Section B-C: View southwest of drystone wall [Feature 2]

Recommendations for mitigatory measures: Basic record during watching brief.

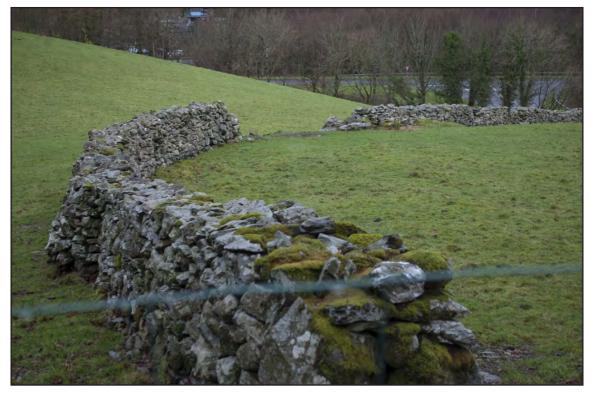
Plate 08: Section B-C: View north showing sinuous drystone wall [Feature 2]

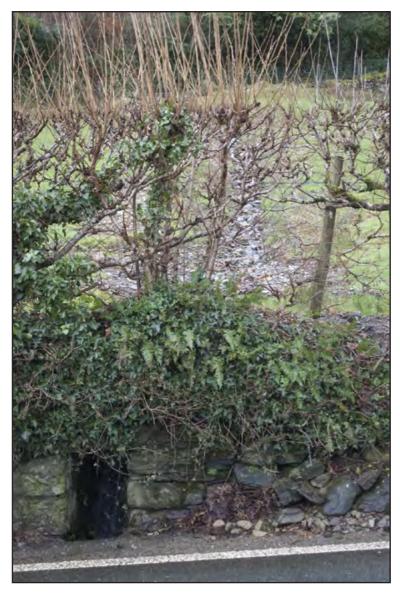
Plate 09: Section B-C: View southwest of modern drainage channel [Feature 3]

Recommendations for mitigatory measures: Basic Record during Watching Brief

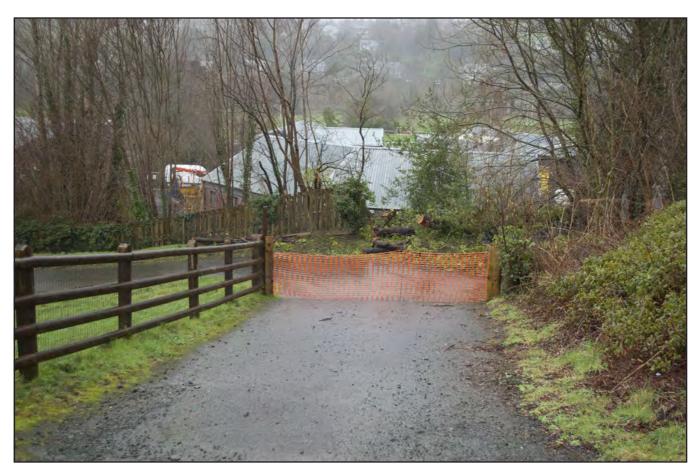
This section of the pipe route crosses a depot area and council works yard, between the public road to the south with the Marian Mawr to the north (Plate 16). No new archaeological features were identified within this area, but the following sites are noted on the Gwynedd HER close to the route.

Plate 16: Section D-E: View looking north through council works area

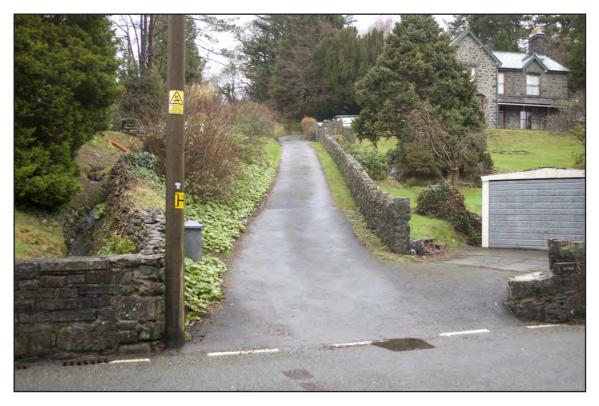
This section follows a northerly course along a lane between the properties of Argoed and Bod Eryl. The lane is to the south bounded by drystone property boundary walls that may be 19th century in date (Feature 4) which continue north past further properties and garden and yard boundary walls before opening out into open fields, with the boundary walls noted only on the eastern side. The walls are of 19th and 20th century dates, and up to 0.65m high and constructed of local freestone rubble. That to the west becomes a bonded wall and is entirely modern in character. The following site is noted on the Gwynedd HER close to the proposed pipe route:

Plate 17: Section H-I: View north from the road up lane between houses along which pipeline route will run

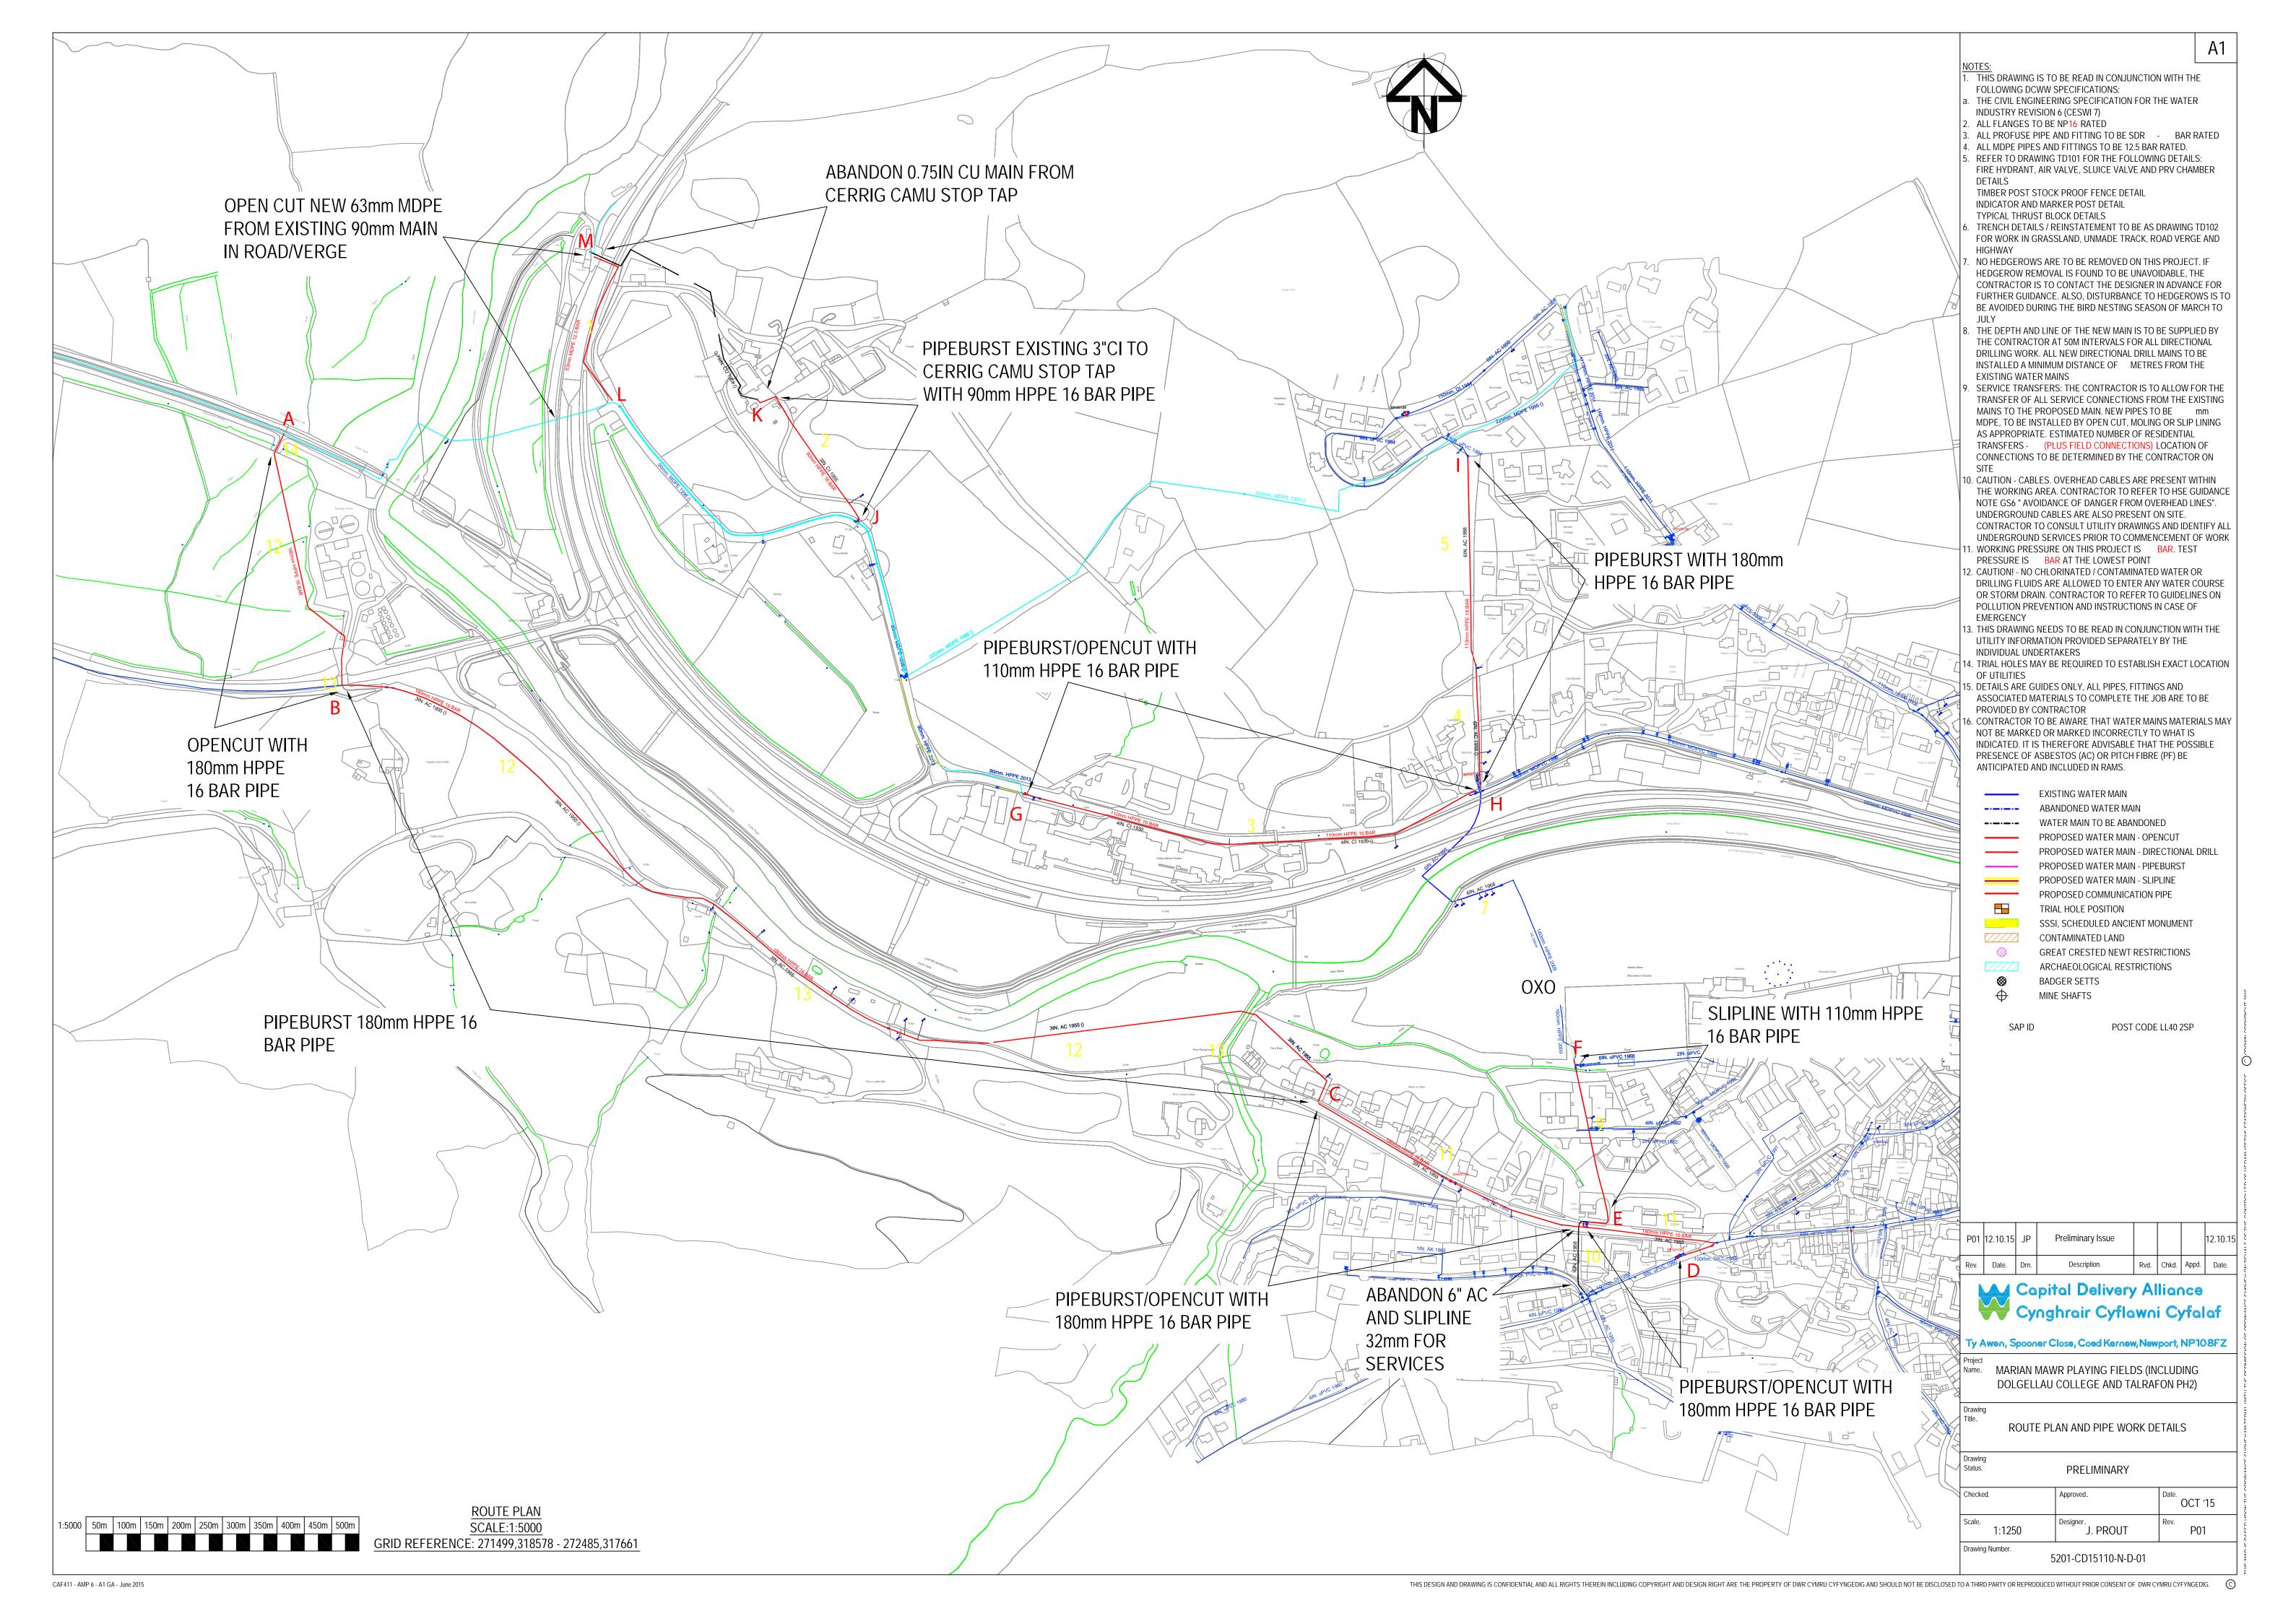
FIGURE 01

Reproduction of Dŵr Cymru drawing 5201-CD15110-N-D-01 with Gwynedd Archaeological Trust amendments to include the location of Sections A to M
