PARCIAU HOME FARM, MARIANGLAS YNYS MÔN

Archaeological Watching Brief

GAT Project No. 2195
Report No. 964
July 2011

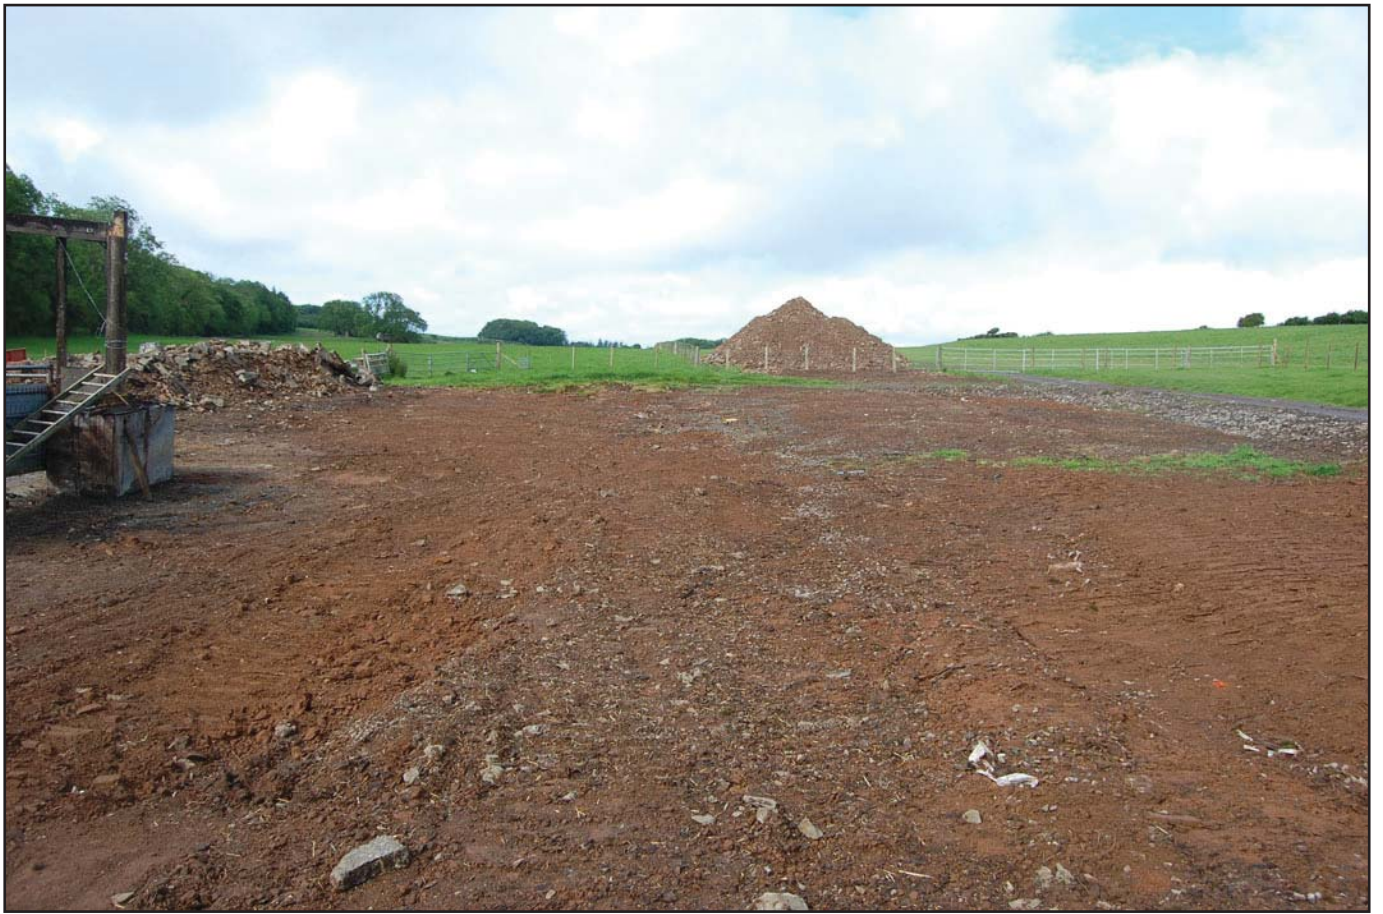
Plate 1: Pre-excitation shot of the site following the removal of the previous structure (view from the north-east).

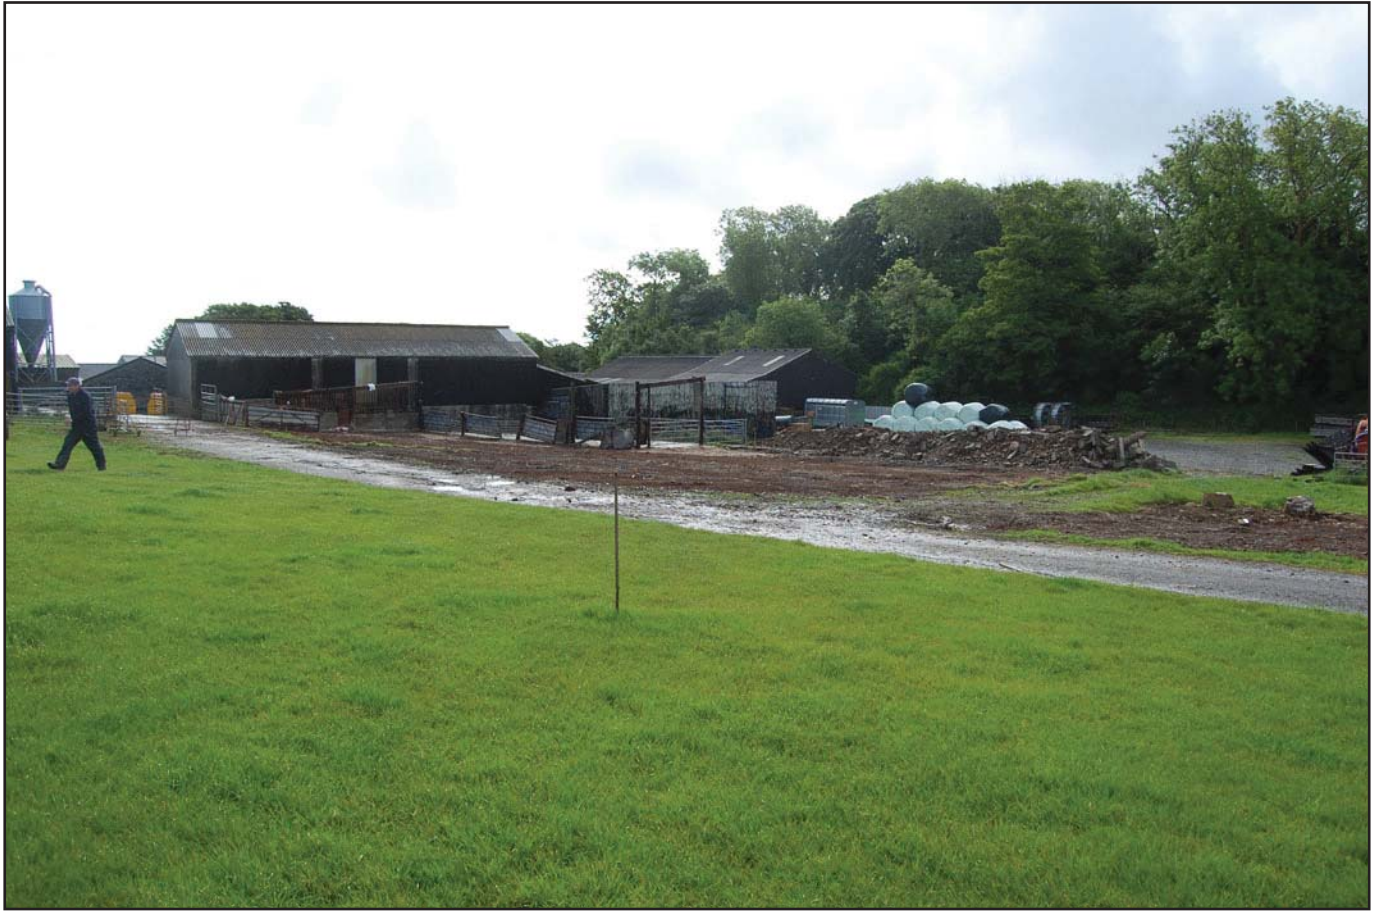
Plate 2: Pre-excitation shot of the site following the removal of the previous structure (view from the east).

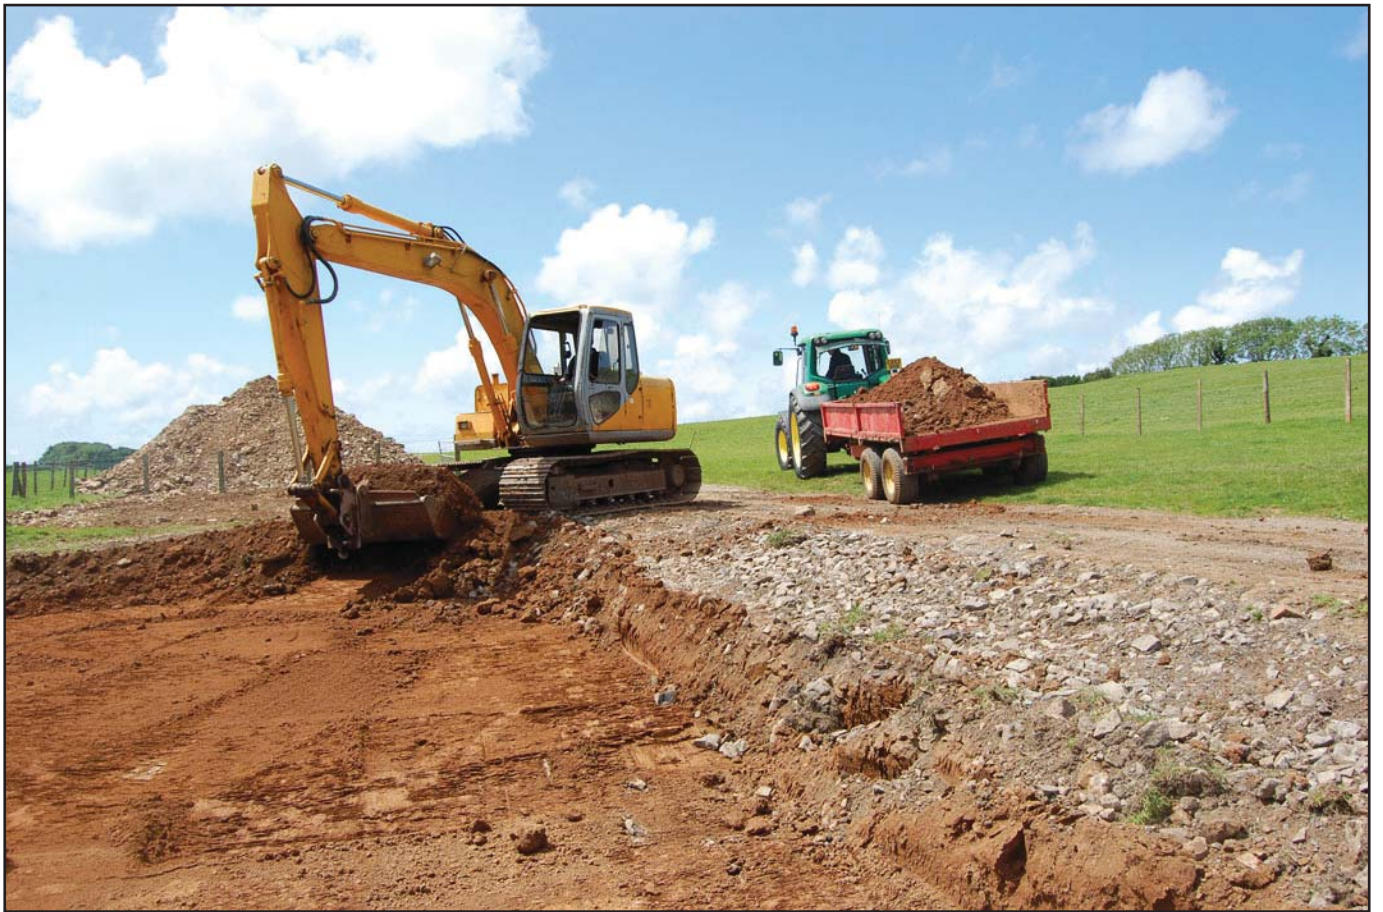
The main area of excavation therefore cut into the hillside along the north-western side of the plot. This was required in order to continue the level base for the construction of the new structure. This excavation involved the removal of a wedge shaped strip of land some 5.0m in width and 53m in length. At its deepest point these excavations reached a depth of 0.6m. The area to the south-west of the original structure, was topsoil stripped only, in order to create an area of hard standing outside the new building.

Plate 3: Working shot, showing excavation into the hillside along the north-western side of the plot.

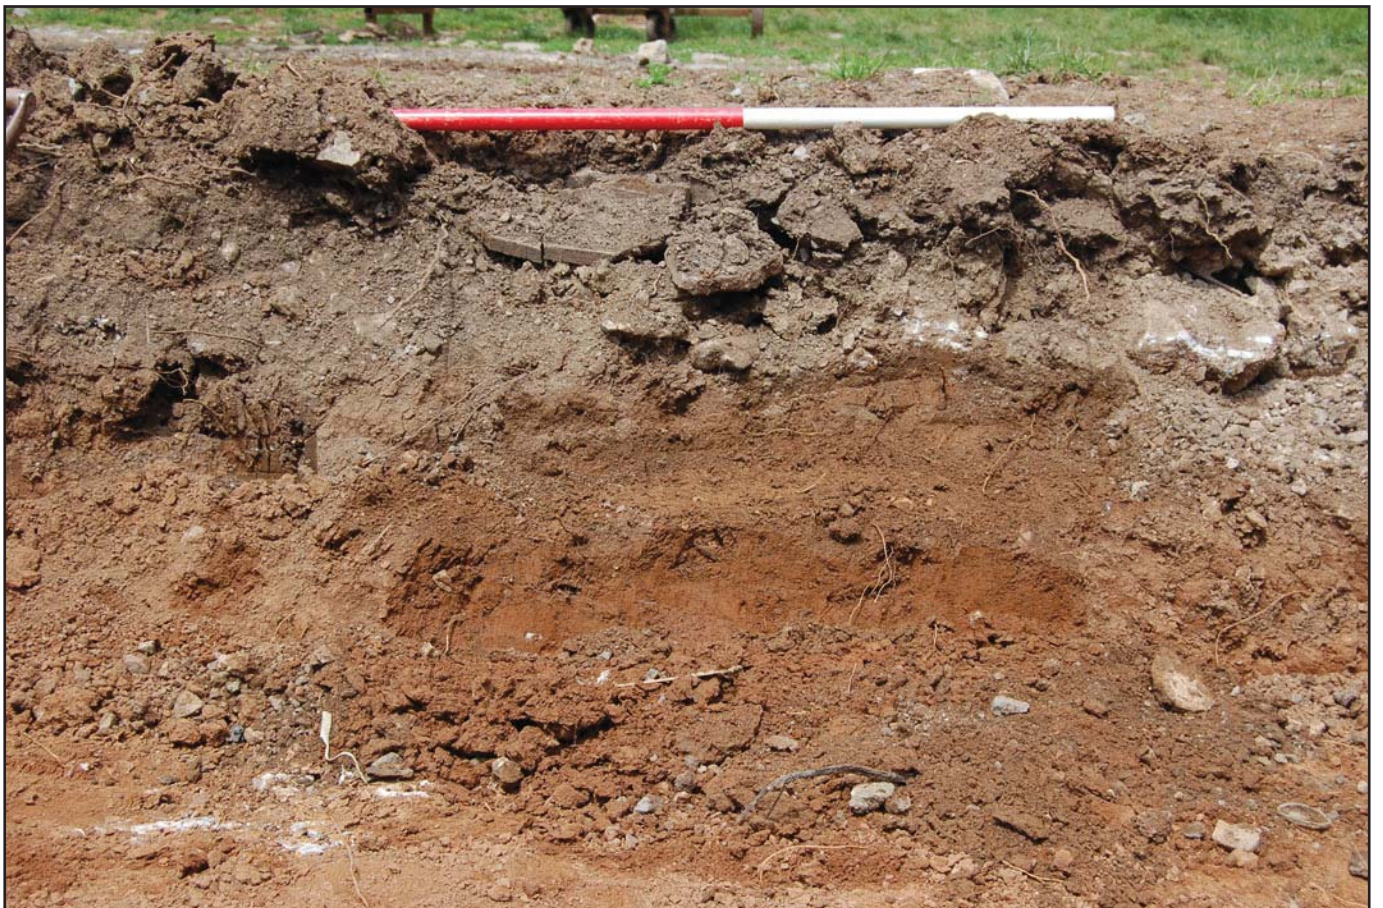
A fairly substantial gravel/hardcore track, leading up to Parciau Home Farm from the south-west, lay partially within the development plot. This track was some 3m wide and had a foundation cut some 0.4m in depth. A second track of similar construction led off this main track way and ran south-east across the south western half of the development plot to a yard below.

Excavation revealed a topsoil of pale, orange-brown fine sand-silt containing occasional sub-rounded cobbles. This deposit was approximately 0.2m in depth and overlay a very similar colluvial deposit of a slightly darker shade, with a maximum proven depth of 0.4m. The interface between these two deposits was very diffuse. Below this an undulating bedrock was observed rising close to the surface in places. The nature of this second deposit was unclear, it resembled natural, but it is possible that it was a post glacial colluvial deposit which may overlie archaeology.

Plate 4: South-east facing section showing the north-east/south-west running gravel track overlying coluvial deposits.

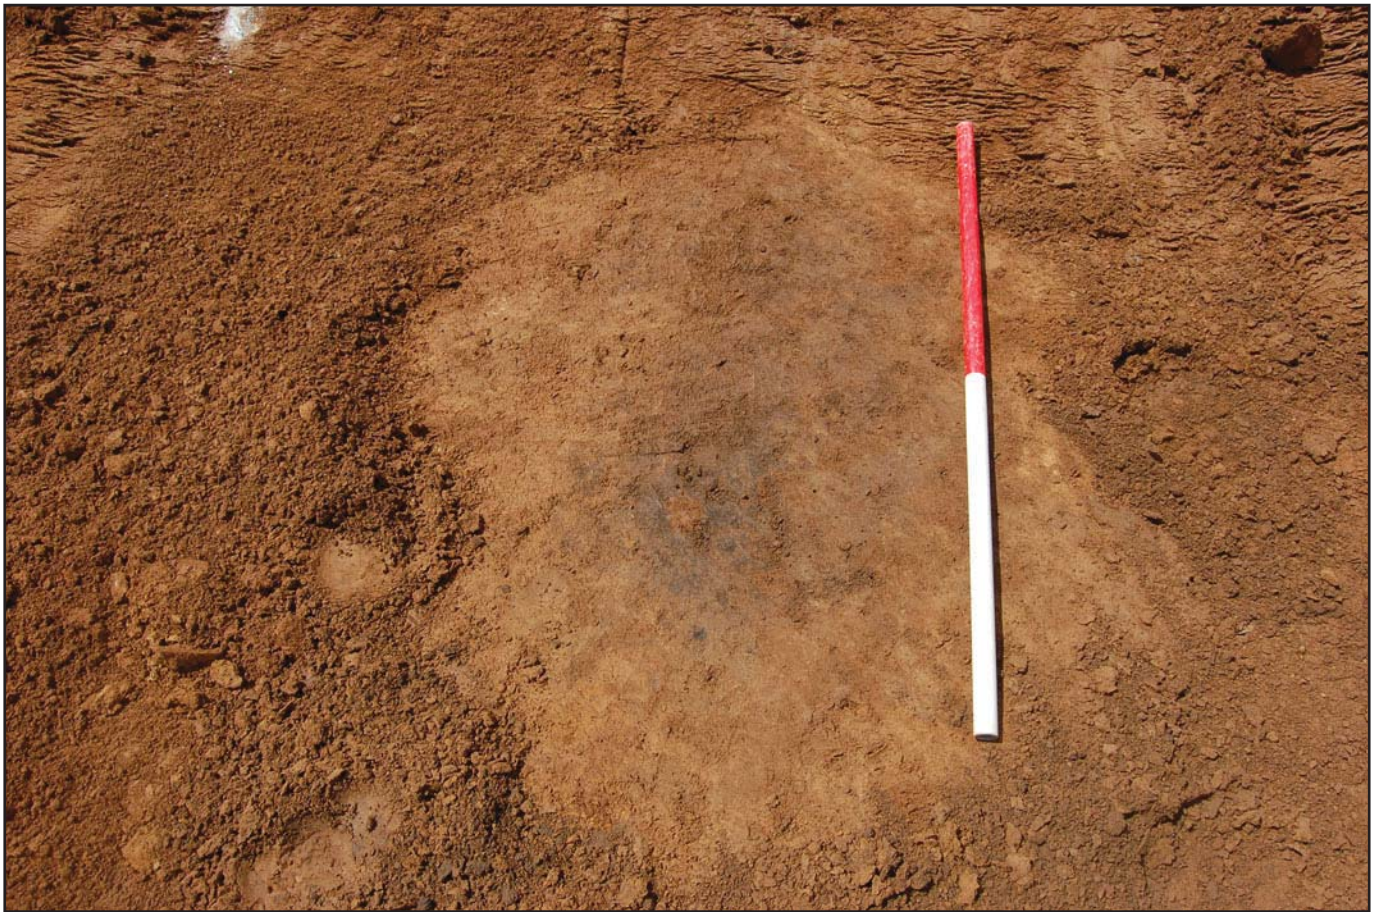
The only feature observed was a small sub-rounded tree-bowl which contained a small quantity of charcoal, indicating it may have been burnt. A section cut across the feature revealed it to be very shallow in depth. Such features are very common in such agricultural areas. This was not deemed significant enough for further investigation.

Plate 5: Pre-excitation shot of a small tree-bowl.

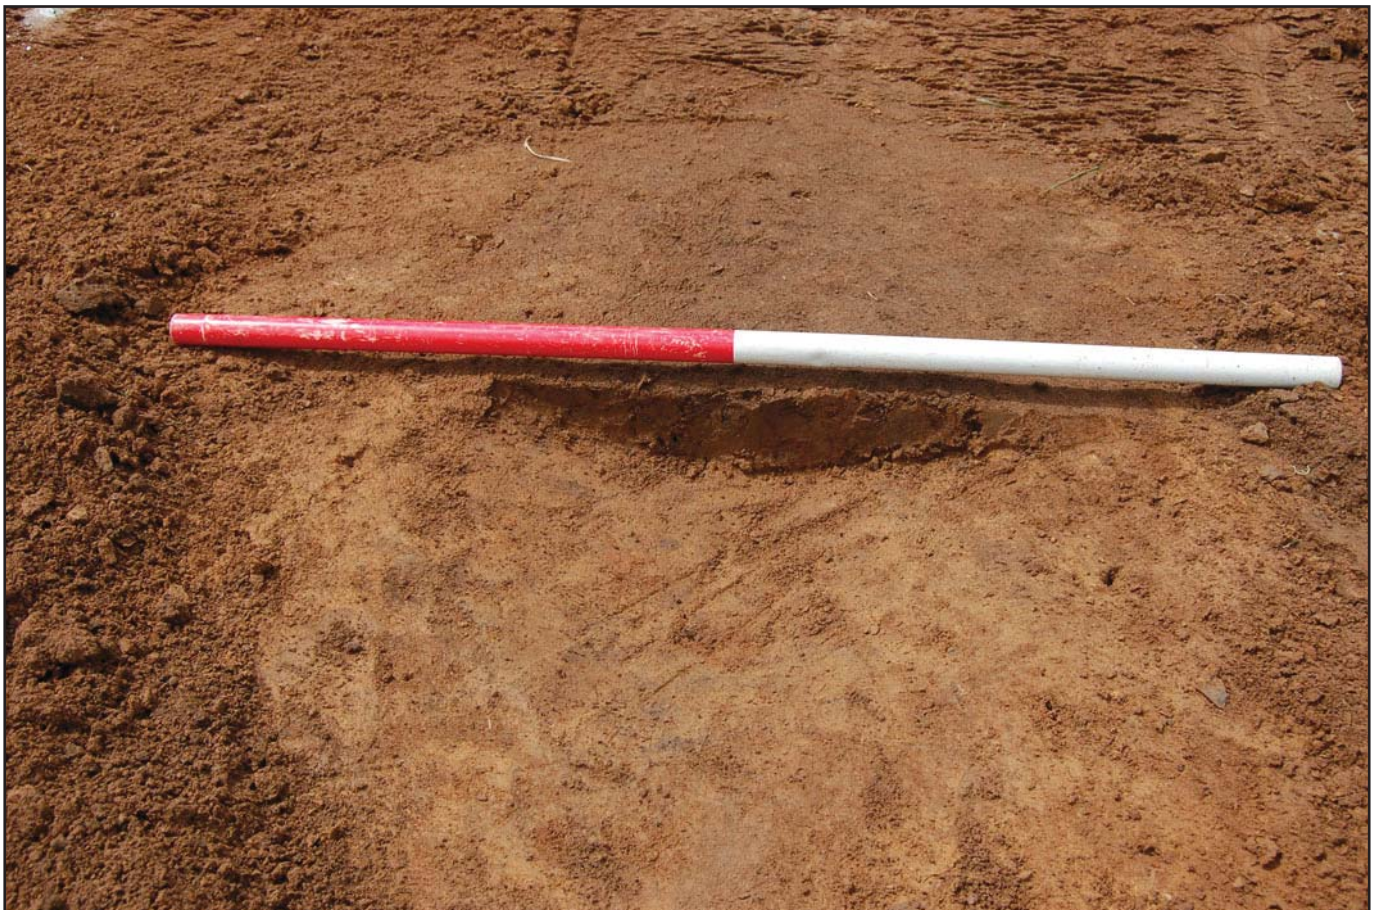
Plate 6: North-east facing section through a small tree-bowl.

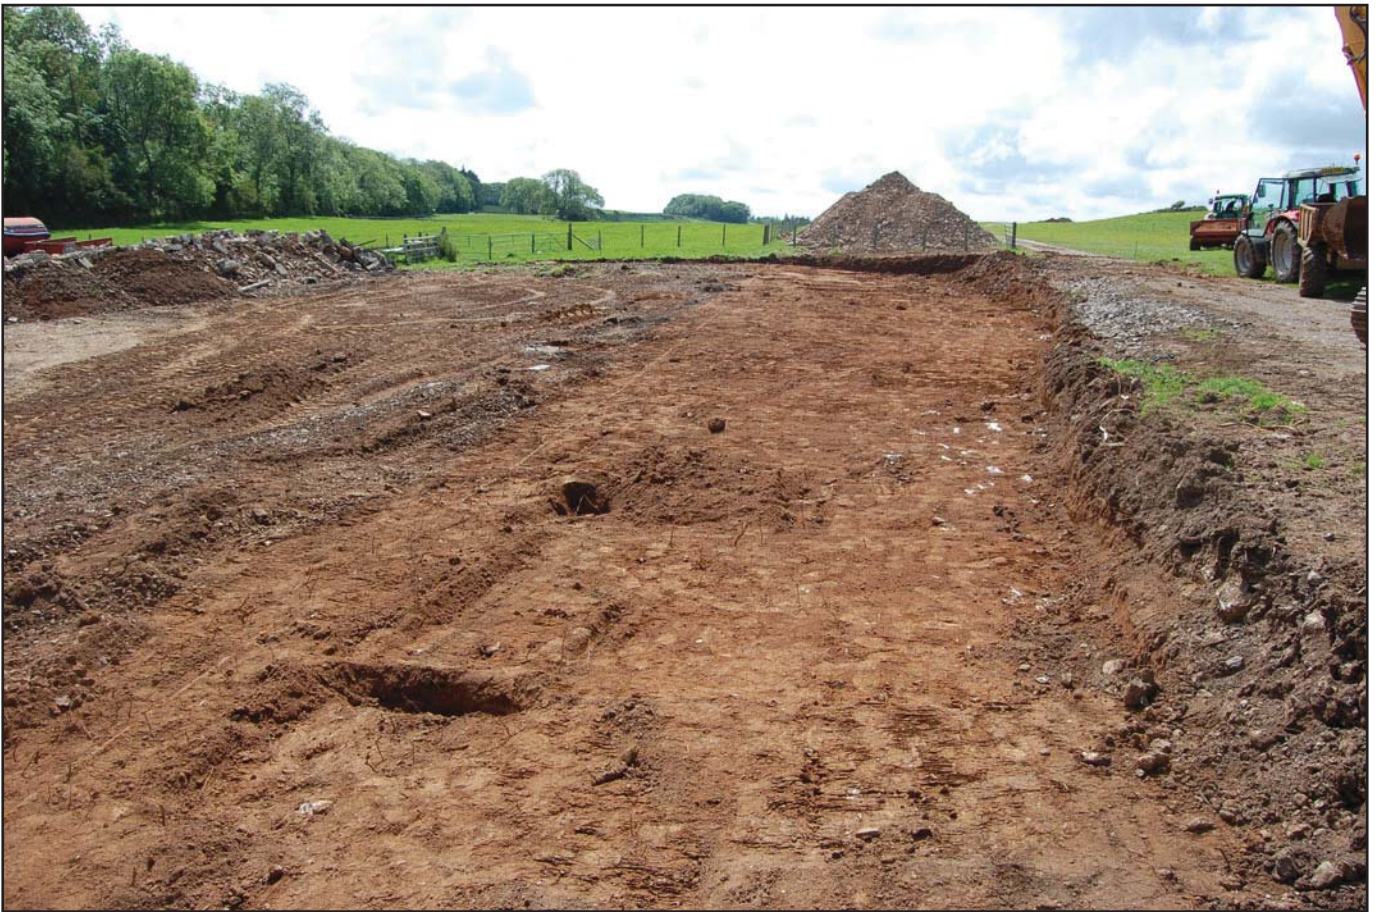
Plate 7: Post-excitation shot of the main area (view from the north-east).

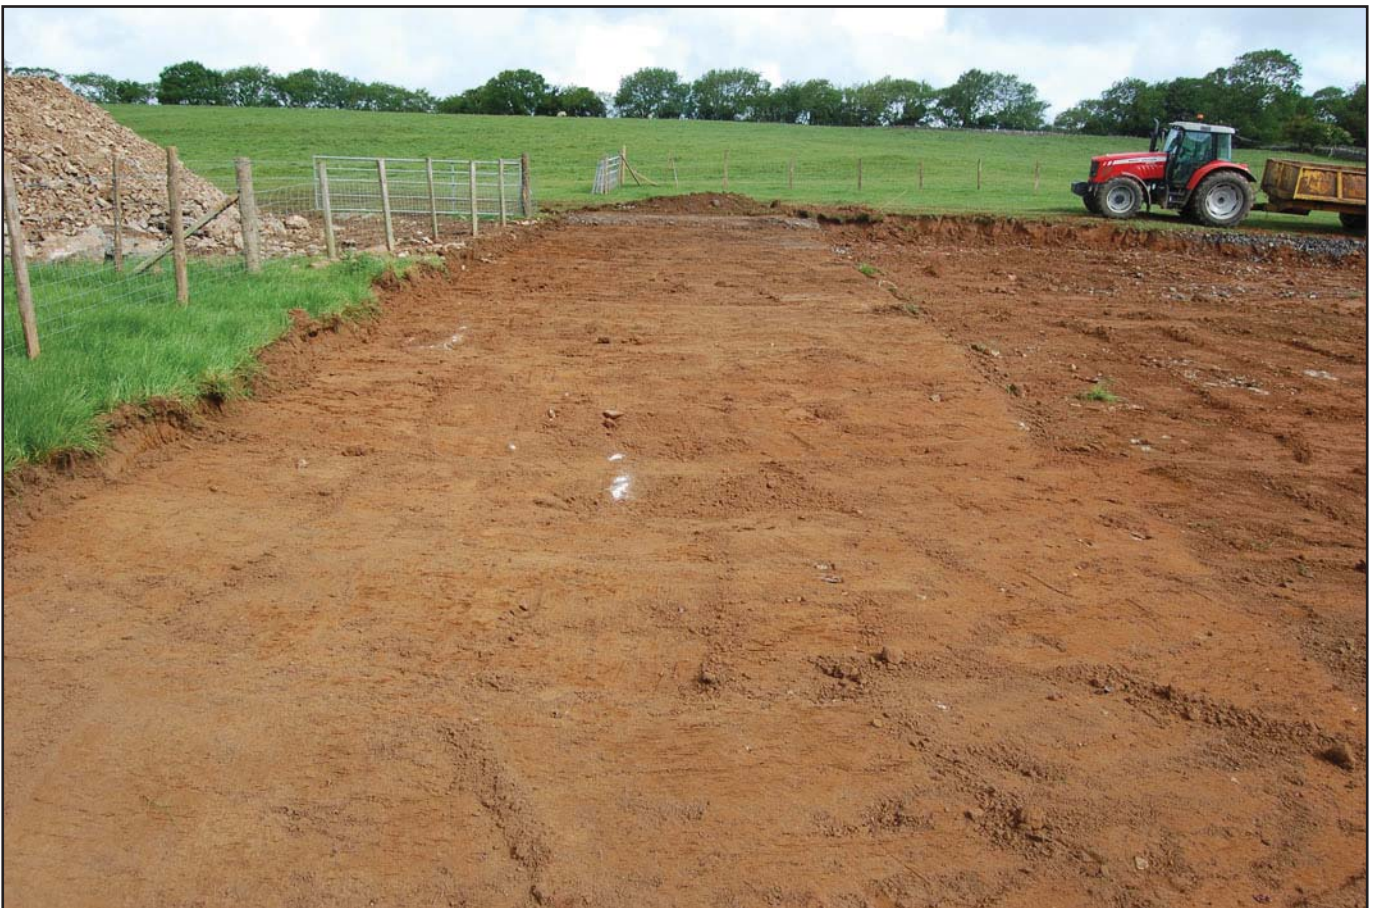
Plate 8: Post-excitation shot of the south-west end of the site, which was topsoil-stripped only.

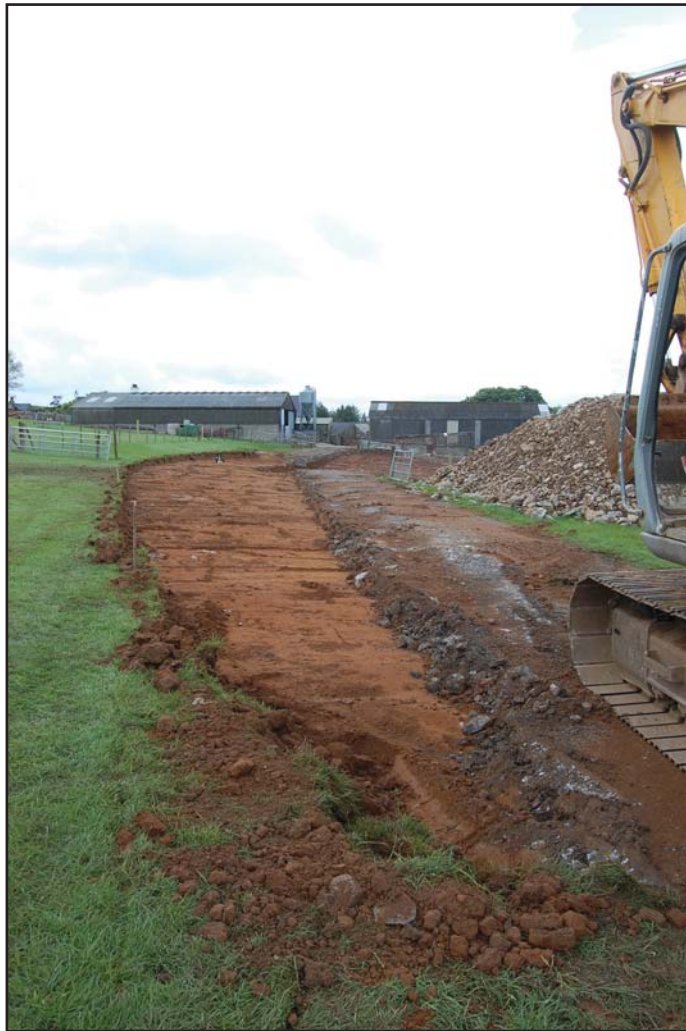
In order to replace the portion of north-east/south-west running track removed during the excavation of the development plot, a foundation trench for a replacement track was excavated immediately to the north-west. This foundation trench was 17m in length and was a maximum of 6m wide. The average depth was 0.3m

Plate 9: Post-excavation shot of the foundation trench for the replacement track (view from the south-west).

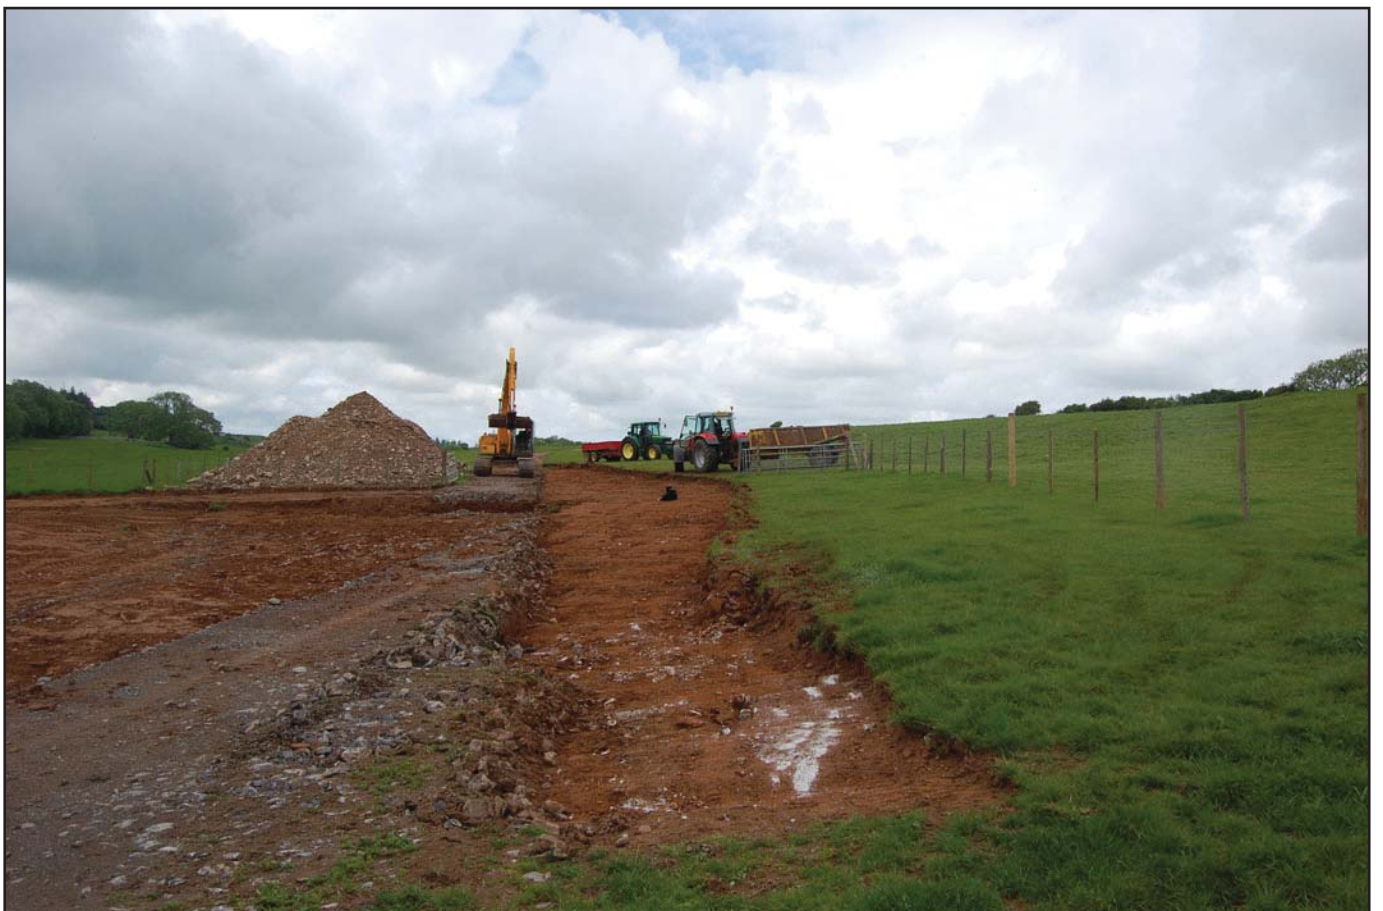
Plate 10: Post-excavation shot of the foundation trench for the replacement track (view from the north-east).
